HERITAGE IMPACT ASSESSMENT SUBMISSION

**REVITALISATION OF THE FORMER FANLING MAGISTRACY INTO THE HKFYG INSTITUTE
FOR LEADERSHIP DEVELOPMENT**

PREPARED FOR : THE HKFYG INSTITUTE FOR LEADERSHIP DEVELOPMENT LIMITED

COPYRIGHT RESERVED BY: LWK CONSERVATION LTD.

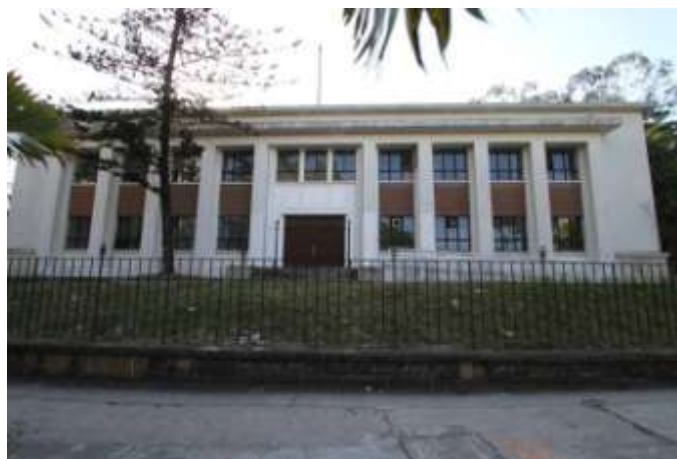
Fig 2.2 : East Elevation of FFM

This symmetrical elevation is composed of 9 bays with 10 expressed columns spanning two-storey height. At the wider central bay, there is a main entrance door with granite steps in front and ornamented lampposts (altered with position changed) on two sides at ground floor entrance. Above the entrance door, there is a frieze panel decorated with embossed rectangles and 3 identical casement windows at first floor. At a typical bay (4 bays on both sides of the central bay), window openings on two levels are separated by a spandrel finished with brown coloured ceramic tiles.

No.	Description	Level of Significance	Photo
2.4	<p>Simple "Giant Order" arrangement on east elevation including</p> <ul style="list-style-type: none"> • Columns and pilasters • Overhanging eave <p><i>This simple version of "Giant Order" is a key feature on the front façade and represents the image of the building.</i></p>	HIGH

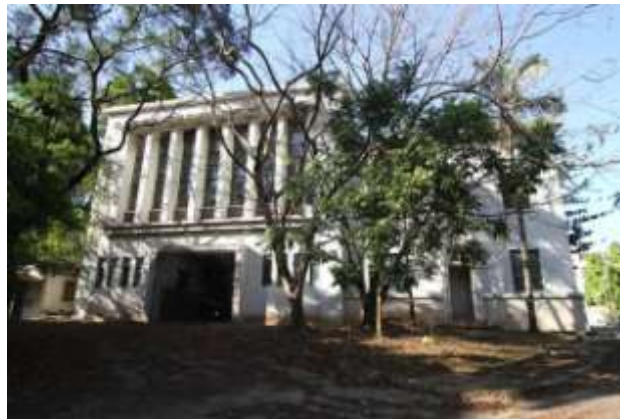
Fig 2.3 : South Elevation of FFM

This elevation generally comprises of two parts: a projected high block to the west (3 storey high) and a lower block to the east (2 storey high) forming a stepped profile. This elevation is ordered and is symmetrical within the blocks. The high block accommodates a large courtroom on first floor. The fenestration of the large courtroom is divided into seven equal bays by eight expressed pillars. Each bay is further divided into seven panels vertically with solid panels in brown ceramic tiles at top and bottom and five glazed panels in the middle. This large courtroom elevation is decorated with moulded top eave and bottom stringcourse supported by simple corbels under each pillar. On ground floor, the opening of the defendants' carport is placed at the centre of the high block with four narrow windows on both sides. The low block on its right is divided into three bays with casement windows on first floor and a doorway (with granite moulded architrave, door head panel and steps, now blocked) at the centre of ground floor with casement window on both sides.

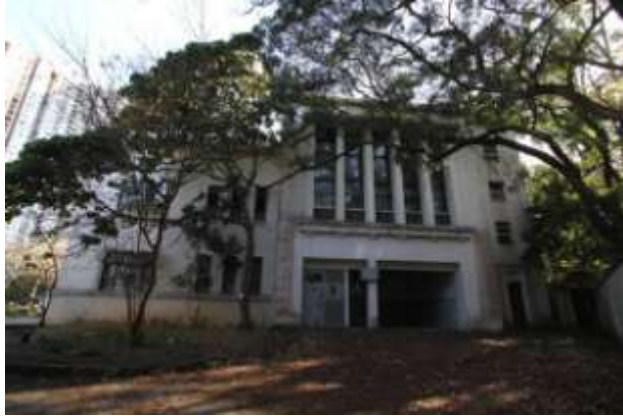
Fig 2.4 : North Elevation of FFM

Perhaps not facing the road, this elevation is less ordered compared to the south elevation. The elevation generally comprises of three parts: a high block to the west (3 storey high), a high projected block at the centre (3 storey high) and a lower block to the east (2 storey high). There is no symmetry within the high and low blocks. The elevation design follows the function of internal layout. On the high projected block, the fenestration of the small courtroom is similar to the large courtroom on the south but it is divided into five equal bays by six expressed pillars. The elevation of ground floor underneath this small courtroom is asymmetrically divided into two portions as the plant room and the magistrates' carport. The high block contains a doorway for the magistrates (with granite moulded architrave, door head panel and steps) and 3 windows on top to give light to the magistrates' stairway. The lower block contains four windows on each floor but one of them is of larger size.

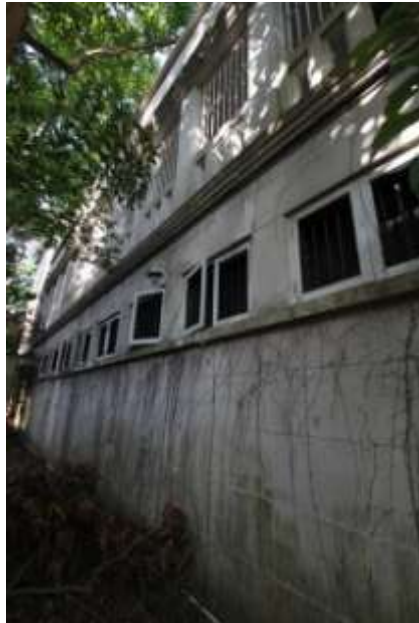
Fig 2.5 : West Elevation of FFM

This elevation is symmetrical. The verandah for the Magistrates on the first floor is divided into ten bays by column. Each bay is featured with three narrow rectangle slots at the parapet. Following the order on first floor, there are ten identical openings along the control corridor to the cells at the ground floor. One opening at north end is blocked by the enclosed corridor linking the Former Fanling Magistracy and the Annex Court Building. Metal grilles are installed at all openings for security reasons.

No.	Description	Level of Significance	Photo
2.13	<p>Open verandah on west elevation, including</p> <ul style="list-style-type: none"> • Featured parapet wall • Metal security grilles <p><i>The verandah is a key design feature promoting natural lighting and ventilation.</i></p>	MODERATE

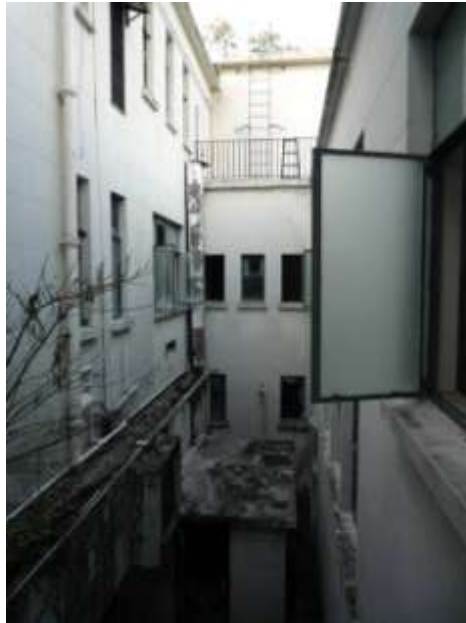
Fig 2.6 : Central light well

A light well is located at the centre of the building promotes natural daylight and ventilation, though the building is central air-conditioned. The windows around light well are arranged in a symmetrical manner. An air duct in box section constructed in reinforced concrete attached to the high level on ground floor serves as an exhaust vent for the four cells. Public lobby and magistrates' offices at first floor and entrance lobby and toilets at ground floor are all benefited from natural daylight of the open light well.

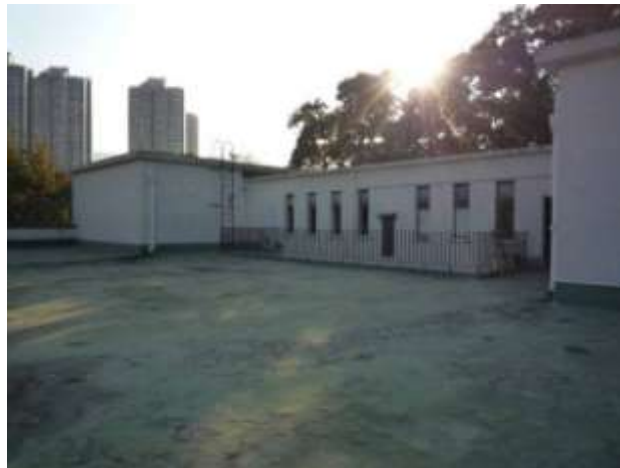
Fig 2.7 : Flat roof

The roof is accessed via the Magistrates' staircase at northwest corner. The roof mainly houses the air-conditioning plant room. The upper parts of the courtrooms are also visible on the flat roof. There is a solid concrete parapet around the perimeter of the flat roof and metal railings around the

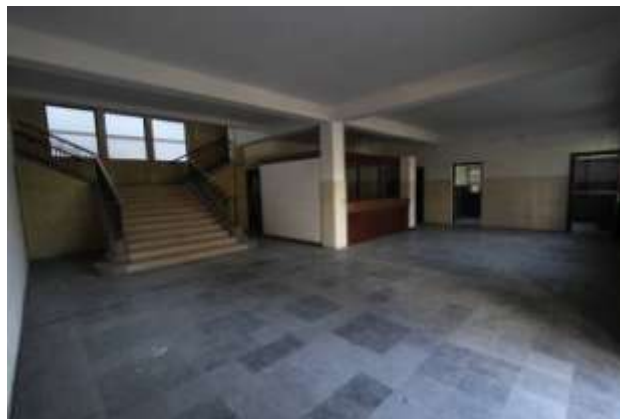
Fig 2.8 : Public entrance lobby on ground floor

In the public entrance lobby on ground floor and public lobby on first floor, terrazzo floor tiles are laid in a jumbled pattern of light and dark grey colours. The wall surface is finished with terrazzo tiles in beige colour up to dado level and white emulsion paint is applied above dado level. Along the grand T-shaped staircase and around the void at first floor lobby, metal balustrade with abstracted pattern painted in black and profiled solid timber handrails are installed. The steps and curb of the grand staircase are laid with mosaic tiles in beige colour and nosing tiles in brown colour.

No.	Description	Level of Significance	Photo
3.1	<p>Terrazzo wall and floor tiles in the public entrance lobby at the ground floor and public hall at the first floor</p> <p><i>These are the original finishes and should be retained and repaired as necessary.</i></p> <p><i>There are two layers of vinyl tiles covered up the original floor tiles in the later addition of the courtroom at the ground floor.</i></p>	HIGH

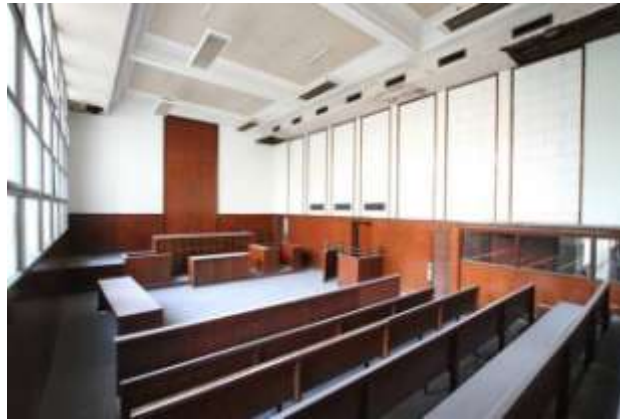
Fig 2.9 : The interior of the larger courtroom with south facing windows

There are two courtrooms on the first floor sharing similar design and using the same finishes. Timber is widely used in the courtroom interior, including flooring, wall finishes, raised platform and fixed furniture. Walls are finished with timber panels up to the height of door head and white emulsion paint above. A full height timber panel is located at the back of the judge's bench as the backdrop. It should have housed the Coat of Arms of Hong Kong (1959-1997) and the regional emblem of HKSAR after 1997.

The layout of the two court rooms are designed with separated zones and access for different users. The raised judge benches are east facing to public while public seating are west facing. The defendant's docks are located at the centre of the side to face both the public and the judge. The public seating areas are basically in stepping arrangement with a row of hardwood bench on each step. The judge and clerk area, the defendant area and the public area are accessed by separate circulation namely the magistrate's corridor connecting the magistrate's chambers, the defendant's staircase connecting the cells on ground floor and the central public lobby respectively.

The larger courtroom on the south side has seven bays of tall windows facing south. Seven bays of acoustic panels laid in running pattern and framed with timber architraves on the opposite wall mirror the window pattern. The ceiling is divided into three coved ceilings with acoustic infill panels and bulkheads on both long sides. The bulkhead along the solid wall houses air ducts and air diffusers. Dummy bulkhead along the window wall is used to achieve a symmetrical ceiling design. Suspended ceiling light fixtures are used.

No.	Description	Level of Significance	Photo
3.3	<p>Two courtrooms in similar design and materials including</p> <ul style="list-style-type: none"> • Entrance vestibule • Original teak parquet floor • Timber wall veneer up to door head level • Coved acoustic ceiling • Timber framed acoustic wall panels • Wooden built-in furniture, including seating in tiered platform for public, judge's bench and its backdrop, clerks' bench, witness box, jury box and defendant's dock. <p><i>The courtroom is the most important space in a court building. One of the courtrooms is in a better condition and having more original materials could be retained and repaired using salvaged materials from the other courtroom. The smaller courtroom is recommended to be retained as more original materials are found. The routing between the defendant's carport to cell, and through staircase to carport is spatially important and should be preserved and unblocked as much as possible.</i></p>	HIGH

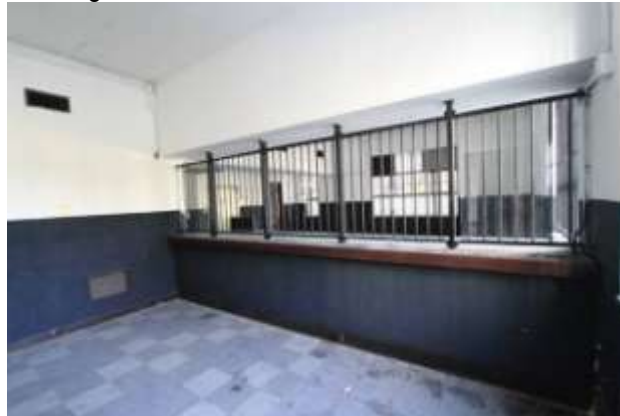
Fig 2.10 : The counter and metal grille in the shroff office at ground floor

Located north to the public entrance lobby at the ground floor, the shroff office is fitted with full width wooden counter supported by metal frames across the length of the room used for collection of money. For security reason, metal fence with vertical bars above countertop is installed. This secured counter separated the area from the public waiting space. Wall surface is painted in naval blue up to dado level and white above. Ceiling is also painted in white. Vinyl floor tiles in different grey colours were laid in checkerboard pattern. There is no evidence to prove these are original finishes and colours. However, the layout of the room, including the location of the entrance and exit doors, remains authentic according to original plans. A police office with a counter was originally located west of the public waiting space but is now replaced with a full height wall. Overall, the shroffs had retained its original use since it was built until its closure in 2002.

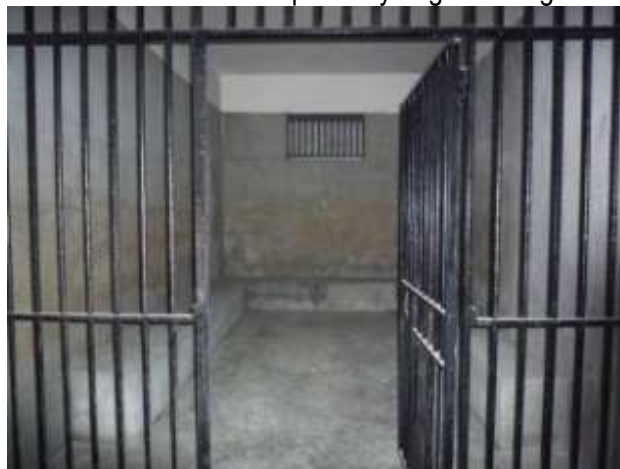
Fig 2.11 : The interior of the cell at ground floor

There are four identical cells located at the ground floor. They are connected to the defendant's dock inside the courtrooms on the first floor via a common corridor and two staircases with mirrored layout dedicated for defendants.

Each cell is fitted on its short side facing corridor with a gate on a full-height metal fence. The U-shaped bench along the other sides of the room together with walls are finished in terrazzo and floor is finished in plain screeding. Except beams below the ceiling and the ceiling soffit are painted in white, the layout and finishes of the cells are probably original design.

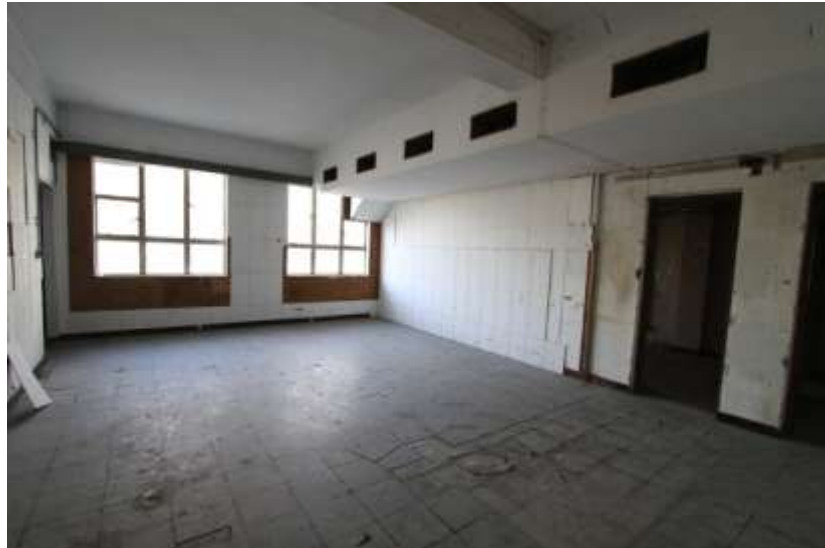
Fig 2.12 : Later addition of a courtroom on ground floor

An additional courtroom for district court was added after 1980 on the ground floor due to the increasing demand of judiciary services. It occupies part of the original entrance lobby. The design of the addition and alteration works was carried out by Architectural Office, Public Works Department. The works included a new courtroom on ground floor to the south side of public entrance lobby, re-provision of affected pantry at the north side of the grand staircase and a new clerk room west to the public side of the shroff office (original police counter).

Two layers of vinyl tiles are laid on top of original terrazzo floor tiles in the additional courtroom. Wall surfaces are clad with acoustic wall panels and ceiling soffit is painted in white. An air duct with diffusers is concealed in a ceiling bulkhead. The interior is in very poor condition and all timber furniture inside the courtroom is removed. Apart from the function as a courtroom, there is no significant finishes or materials found in this courtroom, except the covered terrazzo floor of the original lobby. There are probably terrazzo wall tiles of the original lobby hidden behind the current acoustic panel finish, subject to further open up investigation.

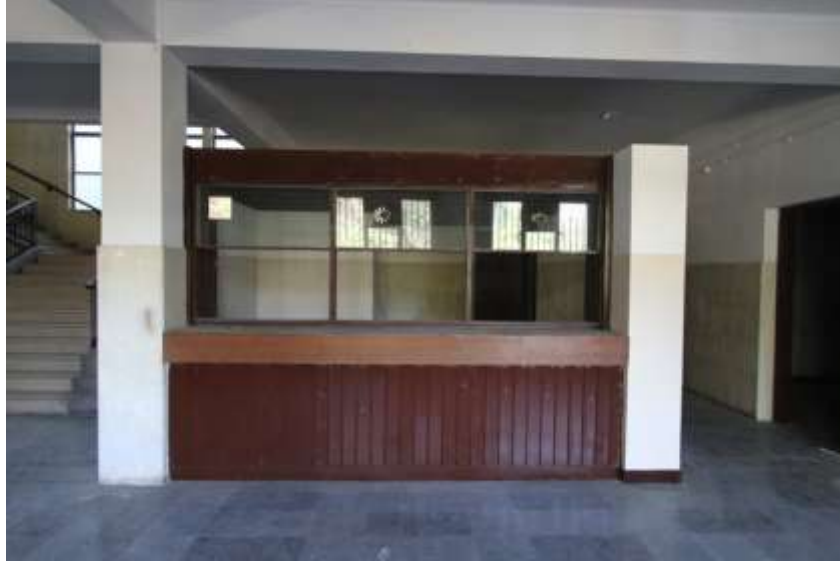
Fig 2.13 : The later added pantry

The pantry is located at ground floor next to the grand staircase. As mentioned, it was a later addition. It was constructed of timber and brick wall (not up to ceiling soffit) as a freestanding pantry with its own wood joist ceiling. Above a straight timber bench with laminate a countertop, there is timber frame above the countertop with upper glazed panels and openings between glazed panels and countertop. The wooden finishes are teak. Again, this later added pantry has taken up space of the public lobby and obstructed the original symmetrical design of the lobby.

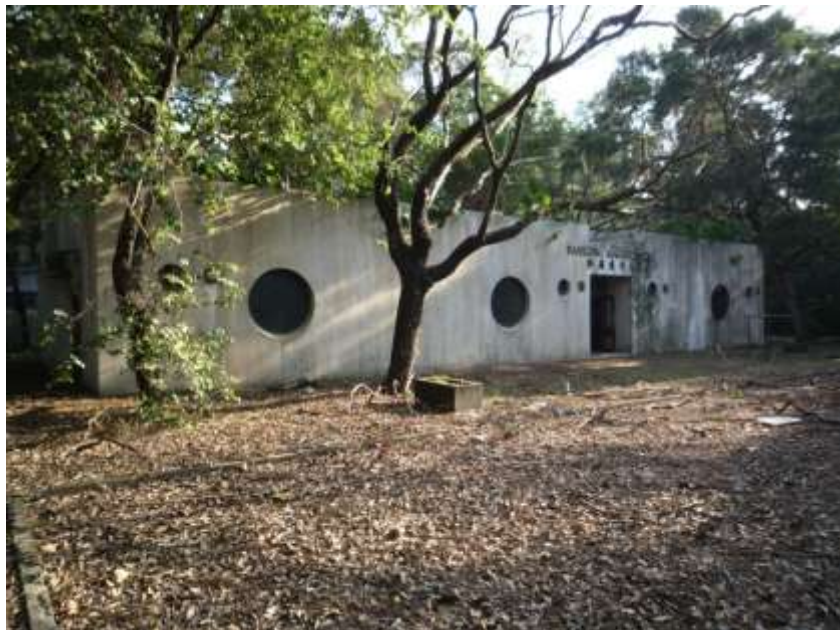
Fig 2.14 : Exterior of the Annex Court Building

The Annex Court Building is a one-storey building in reinforced concrete load bearing wall and beam construction. There is an enclosed corridor linking the defendant entrance to the cells located at the Former Fanling Magistracy.

Its exterior is in form of a rectangular box featured with circular shaped windows in two different sizes. The exterior walls are plastered and painted in white. The doorways are rectangular in shape. The two courtrooms are finished with timber veneer wall panels and equipped with wood furniture including seating for public, docks for defendants and judge's bench.

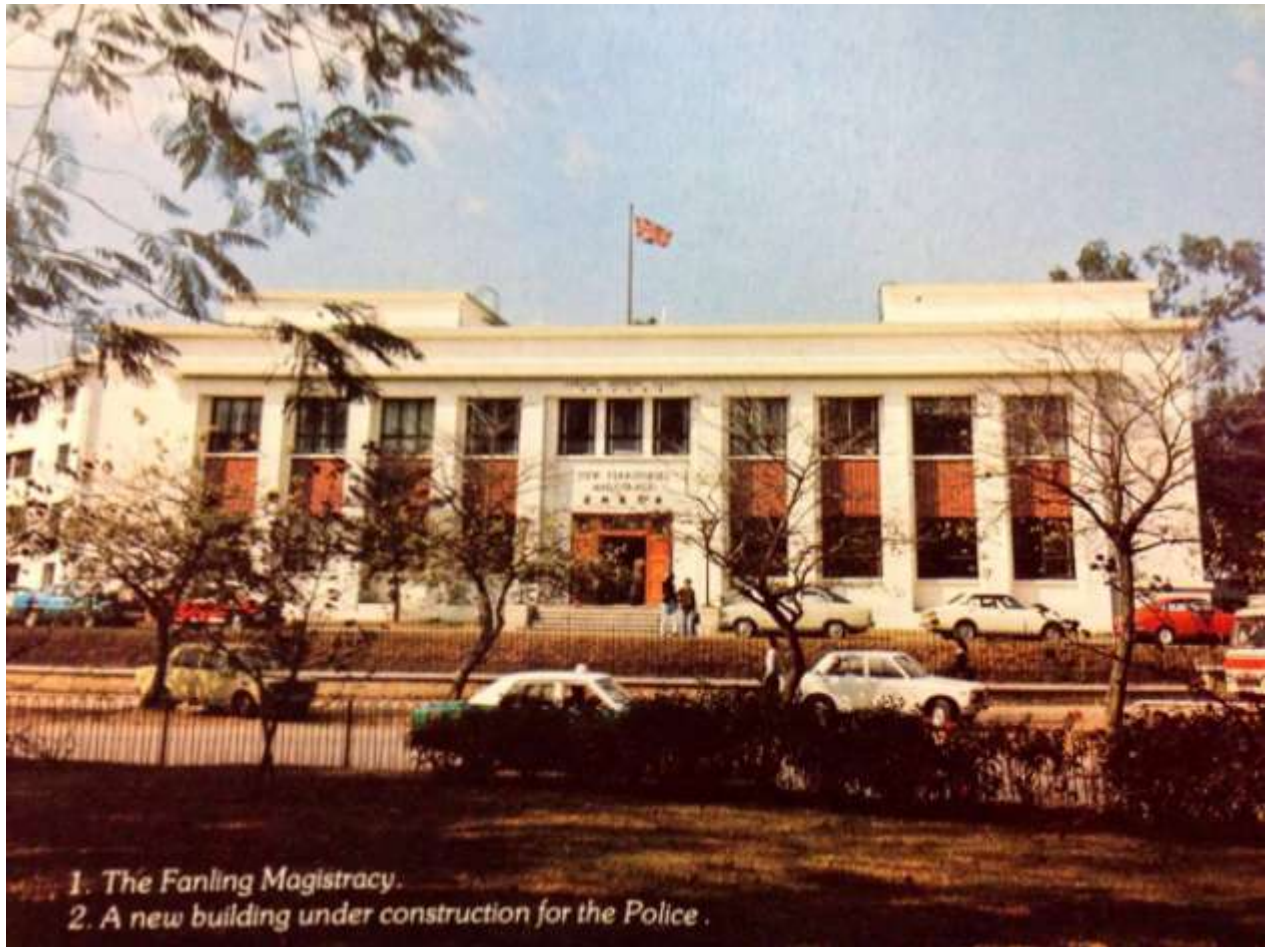
Fig 3.7 : The New Territories Magistracy in 1978. The metal character of building name “New Territories Magistracy” and “Fanling District Court” are visible from the photo (Source: New Town Development: North District, Planning Department, 1980)

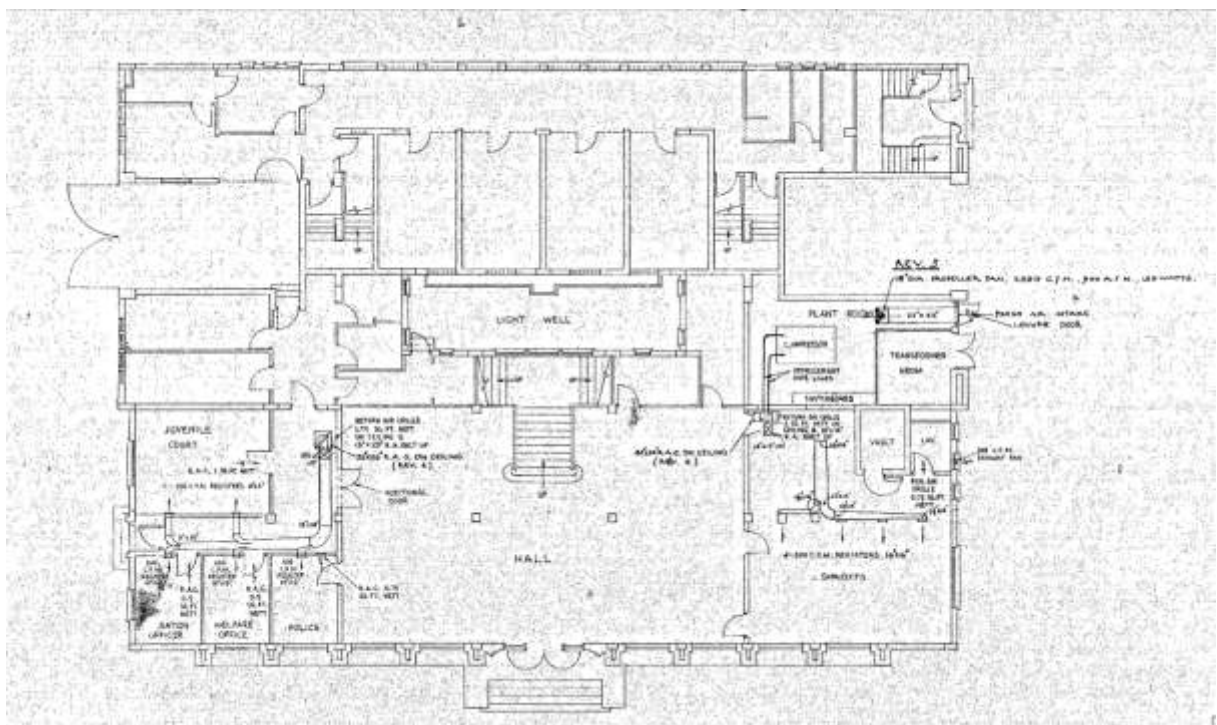
Fig. 3.9 : Ground Floor Plan with BS installation (1959)

E&M rooms (still remain) and the magistrates' garage (still remains) are located to the north of G/F. A staircase with separate entrance was located next to this garage for magistrates' access to 1/F remain. The staircase was decorated with ornamental metal balustrade and mosaic floor tiles (still remain). A shroff located to the north of the central lobby was used for fines collections. The shroff was fitted with both grilled service counter (still remains) and a police counter (now replaced by a block wall) for security reason. Besides, a built-in safe (still remains) and a separate lavatory (still remains) were provided inside the Shroff.

Fig. 3.9 – Fig. 3.11 (Source: Public Records Office)

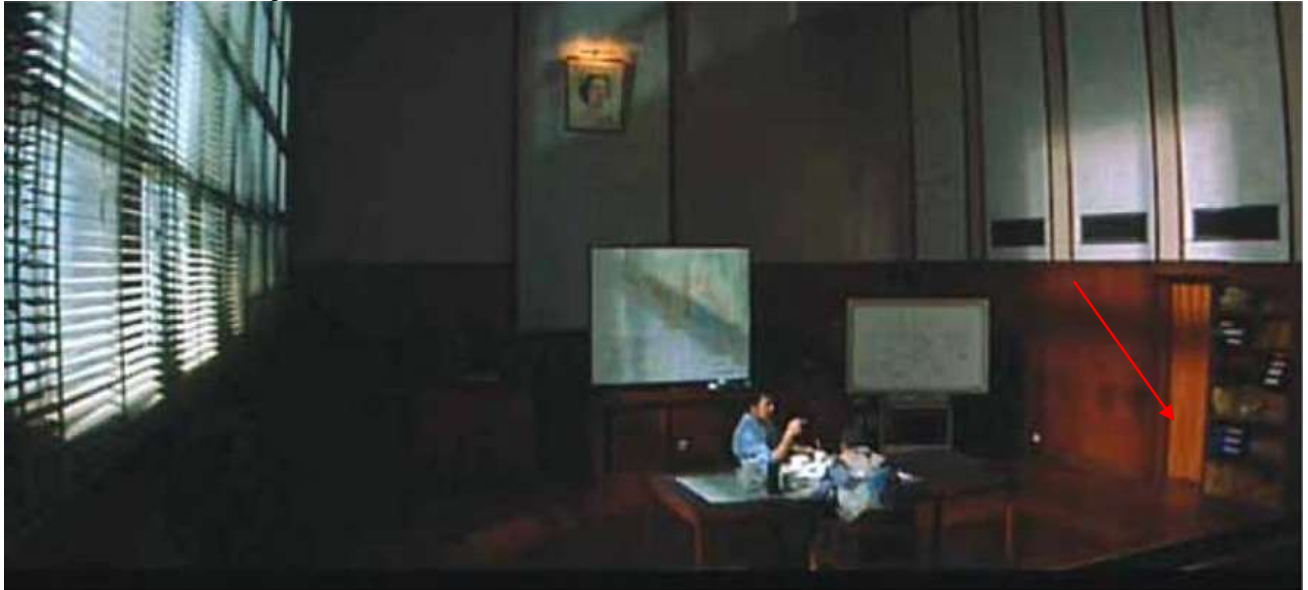
Fig 3.12 : Scene of No. 1 Court Room used in the guise of Kowloon West Police Station in the film *Infernal Affairs II* in 2003. Except the full height wooden panel is covered with white board. The dock was temporary removed for film showing (pointed) (Photo adopted from World Film Locations: Hong Kong)

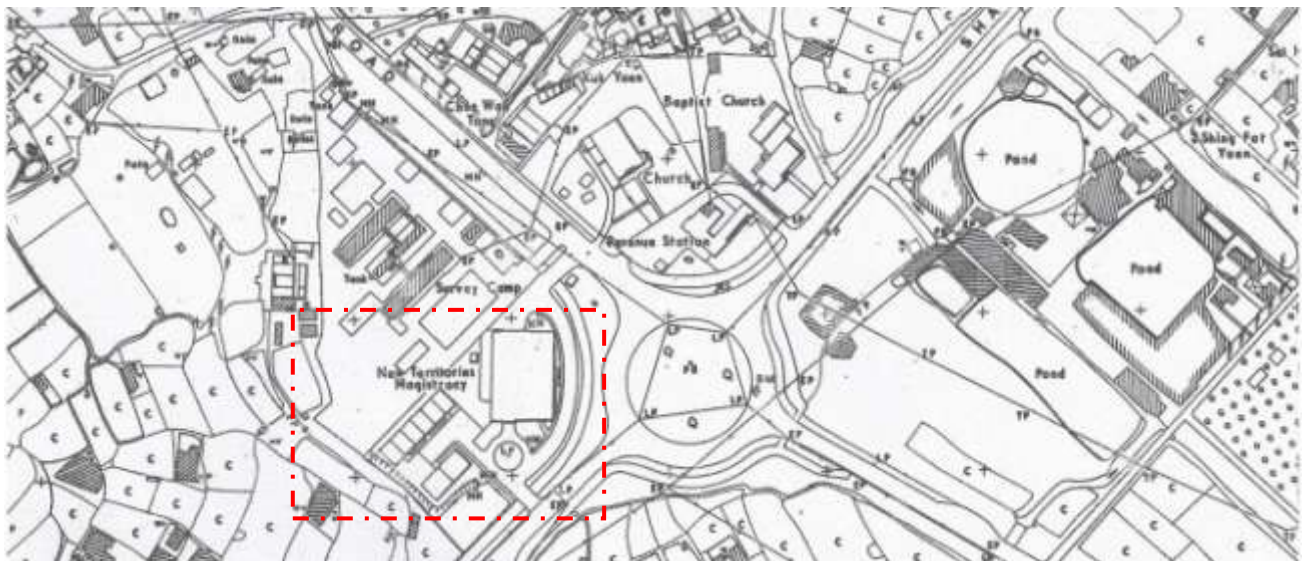
Fig 4.1 & 4.2 (top down) : Survey map in 1962 (up) and 1980 (below) at the round-about region showing the development within 20 years (Source: Lands Department)

Due to its site context, the disposition of Former Fanling Magistracy is unique amongst other existing former magistrates' courts in Hong Kong. Instead of sitting parallel to roads, it orients diagonally to Jockey Club Road and Sha Tau Kok Road – Lung Yeuk Tau with the front elevation facing east towards the roundabout.

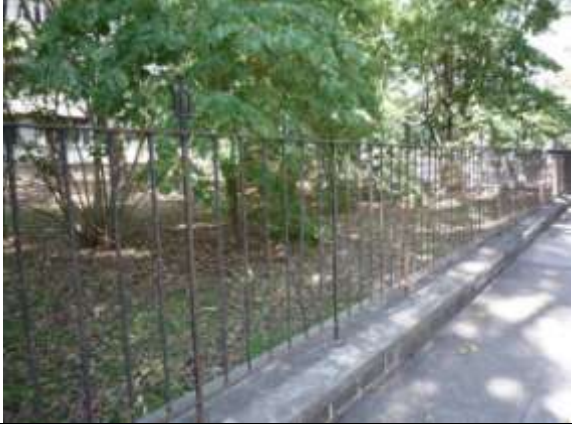
No.	Description	Level of Significance	Photo
1.1	<p>Stone based cast iron fence wall with simple ornamented spears</p> <p><i>The fence wall signifies the site boundary of the Magistracy.</i></p>	HIGH

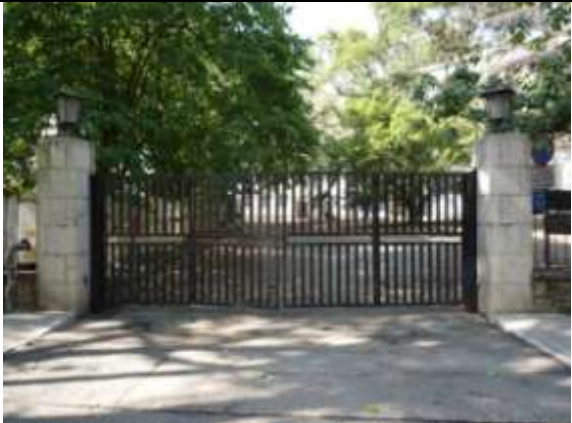
1.2	<p>Granite cladded posts with ornamental light fittings on top of two entrance gates</p> <p><i>The posts and entrance gates form part of the fence wall for the site.</i></p>	HIGH

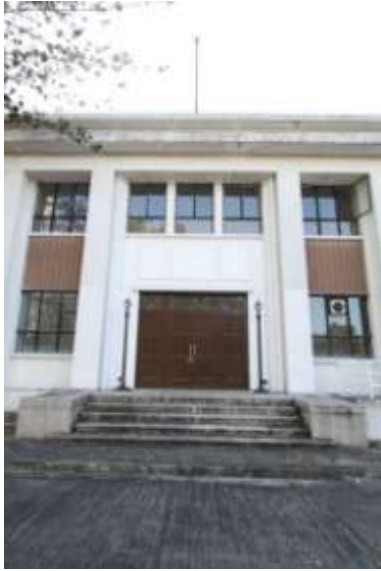
2.2	<p>Main Entrance, including</p> <ul style="list-style-type: none"> • Granite steps • Main entrance door in panelled wood • Profiled projecting architraves • Two decorative lamp posts on both sides • Frieze above the main entrance <p><i>The steps, entrance door, frieze, lampposts and projecting architraves are key features on the front elevation. They should be repaired and retained unaltered.</i></p> <p><i>Original characters showing the name of the Magistracy have been removed. They should be restored by replica.</i></p>	HIGH

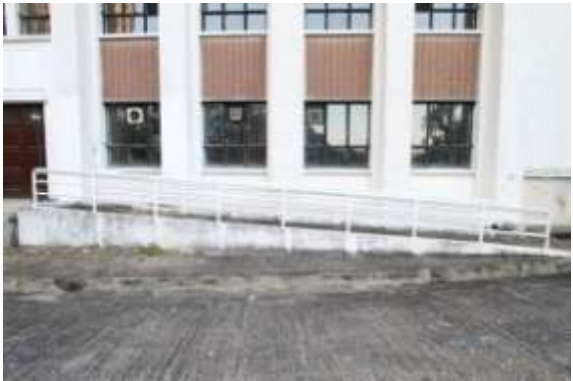
2.3	<p>Ramp on the right hand side of the Main Entrance</p> <p><i>The ramp is a later addition to provide barrier free access to the building; however, it affects the symmetry of the east elevation.</i></p>	INTRUSIVE

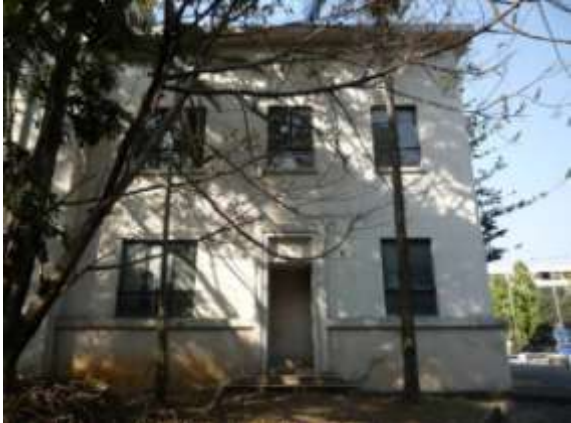
2.7	<p>Side entrance on south elevation, including</p> <ul style="list-style-type: none"> • Moulded architrave • Door head panel • Granite steps <p><i>This entrance is a key feature on the south elevation for old Juvenile Court; however, it was blocked due to layout changes. Any modification works should respect the original design.</i></p>	HIGH

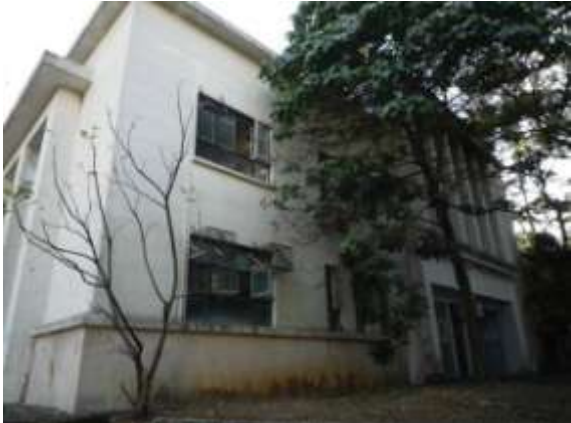
No.	Description	Level of Significance	Photo
2.8	<p>Corner granite cladded base at southeast and north east corners, including</p> <ul style="list-style-type: none"> • String course above the base <p><i>Being the most expensive material used on the exterior, the granite base is an important feature on the elevation. They should be cleaned and retained unaltered.</i></p>	HIGH

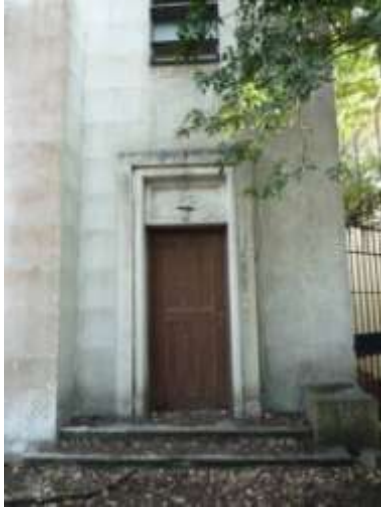
2.9	<p>Side entrance for Magistrates, including</p> <ul style="list-style-type: none"> • Timber door • Granolithic door surrounded with moulding • Moulded doorhead with decorative wall mounted light fitting • Granite steps in front of the entrance <p><i>This entrance is designed solely for the use of Magistrates and is a key feature on the north elevation. It should be repaired and retained unaltered.</i></p>	HIGH

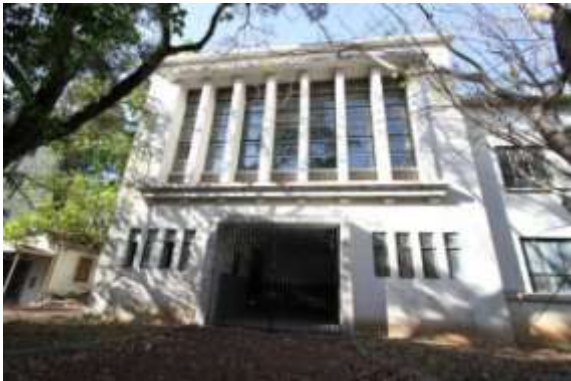
2.10	<p>External window wall on north and south elevations providing daylight into the courtrooms including</p> <ul style="list-style-type: none"> • Expressed columns • Narrow and tall steel casement windows • Tiled panel above and below the windows • Overhanging eave and horizontal moulding together with simple corbels under the window wall <p><i>Although these two facades are less prominent compared to the front façade, these expressed columns and narrow and tall window echo with the "Giant Order" on the front.</i></p>	HIGH

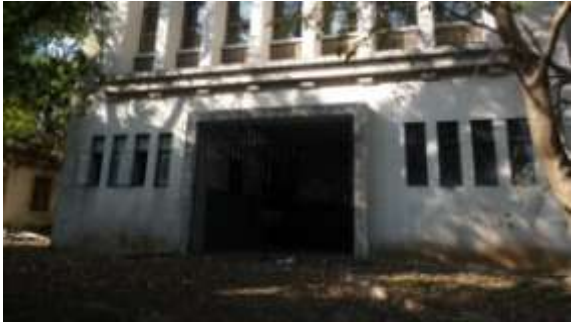
2.11	<p>Defendants' garage entrance with metal gate and projected opening</p> <p><i>The garage is used for defendants' car port and is a key feature on the south elevation. It should be repaired and retained unaltered.</i></p>	HIGH

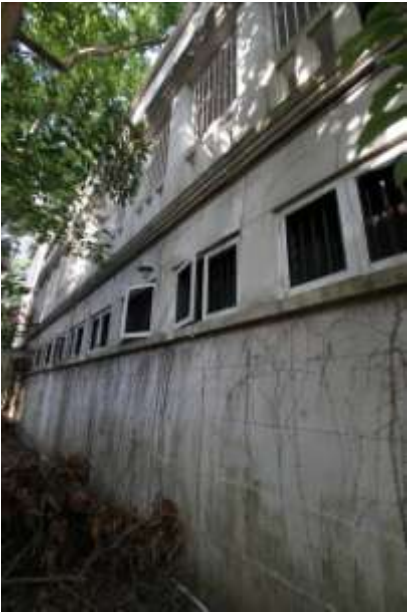
2.12	<p>West Elevation, including</p> <ul style="list-style-type: none"> • Grooved stucco wall finish • Ornamental light fittings <p><i>This façade is of less prominent and was hidden by rich plant growth. However, this façade is designed specially with a open verandah with featured parapet wall which is unique compared with other elevations.</i></p>	MODERATE

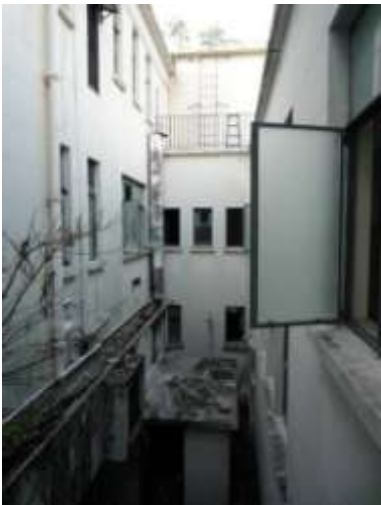
2.14	<p>Central Light Well, including</p> <ul style="list-style-type: none"> • Existing windows to atrium <p><i>The central light well is a key design feature promoting natural lighting and ventilation.</i></p> <p><i>The later addition of small structure at the ground floor and service ducting are intrusive and should be removed.</i></p>	MODERATE

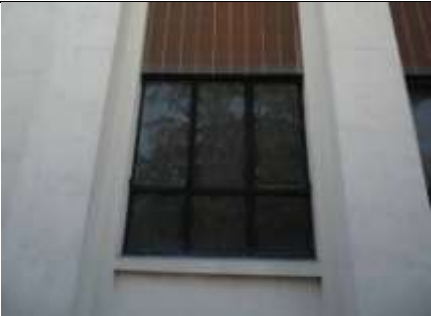
2.15	<p>Original steel windows and windows opening at all elevations, including</p> <ul style="list-style-type: none"> • Regular spacing arrangement • Metal grilles or mesh behind • Protruding window sills <p><i>The steel windows are a key element of the façade design, however, some of the windows are in poor condition and some had been modified to house mechanical ventilation.</i></p> <p><i>Any replacement windows should respect the original design and original ironmongery should be re-used where possible.</i></p>	HIGH

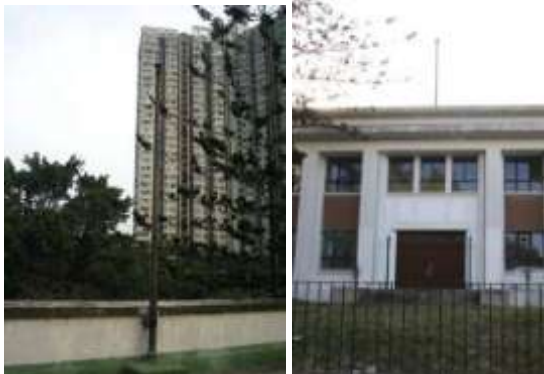
No.	Description	Level of Significance	Photo
2.16	<p>Flagpole on the roof</p> <p><i>Flagpole is a common feature found in government buildings. The single flagpole is found in pre-1997 government buildings. After 1997, two flagpoles are used. This flagpole is an evidence of colonial court building. It should be retained.</i></p>	MODERATE

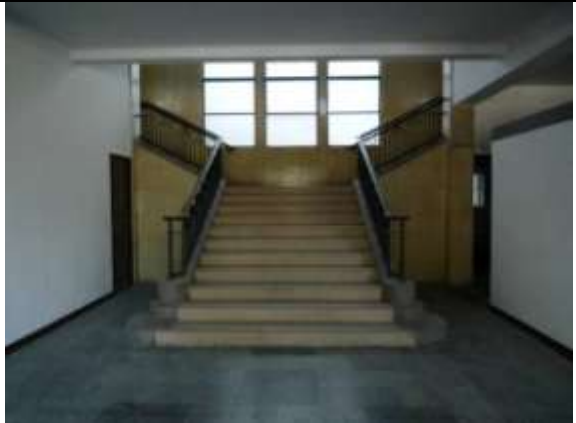
3.2	<p>T-shaped grand staircase and staircase void including</p> <ul style="list-style-type: none"> • Wooden handrail • Metal decorated balustrade including the balustrade at 1/F <p><i>The staircase is an original and prominent feature located in the centre of the building and it should be left unaltered. This may create difficulties in compiling with present requirement of means of escape and alternative escape staircase would be required.</i></p>	HIGH

3. Means of Escape (MOE)
 - Since two escape staircases will be needed for the new use of the FFM and the current four staircases in the building cannot fulfil the current MOE requirement, any adaptive reuse will require the introduction of two MOE staircases, either by converting and upgrading the existing ones or adding new ones internally or externally. The former method is preferred since it will create less impact to the FFM. It is recommended to convert one of the defendants' staircases and the magistrates' staircase for MOE purpose, since damages to the more important central open staircase and the other defendants' staircase can be avoided in this aspect;

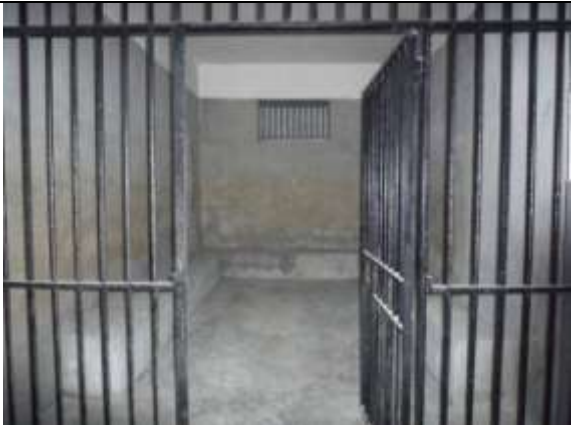
3.4	<p>Cells including</p> <ul style="list-style-type: none"> • Metal fence and door • U-shaped bench and wall in terrazzo finishes • Cement screeding • High level opening with metal grilles and mesh facing open light well <p><i>The cells are essential parts of court buildings. There are four original and identical cells at ground floor. One of them should be retained for future interpretation.</i></p>	HIGH

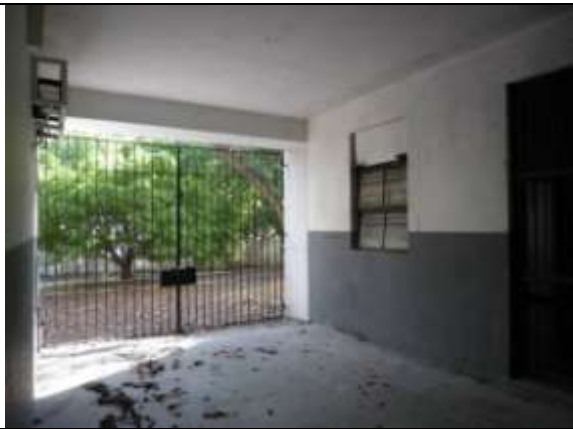
No.	Description	Level of Significance	Photo
3.5	<p>Defendant's car port</p> <ul style="list-style-type: none"> • Metal gates • Steel window <p><i>It is desirable to retain it for future interpretation.</i></p>	MODERATE

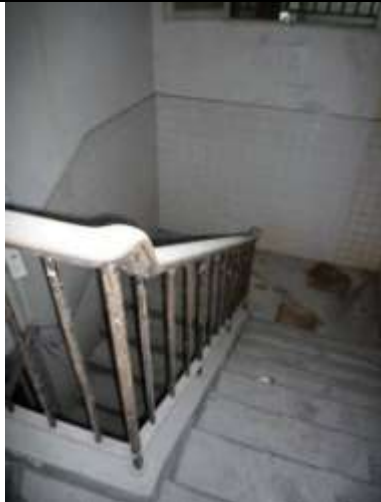
3.6	<p>Two defendant's staircases including</p> <ul style="list-style-type: none"> • Original white glazed ceramic wall tiles up to dado level • Original plain screeding • High level steel windows with metal grilles and mesh • Metal gates • Wooden handrail and metal balustrade <p><i>The defendant's staircase shows the unique circulation for a court building – they are two identical staircases with mirrored layout directly connecting the cells and the defendant's dock in the courtrooms exclusively used by defendants. One specimen should be retained for future interpretation. The other one can be upgraded to suit the new layout for access and escape.</i></p>	HIGH

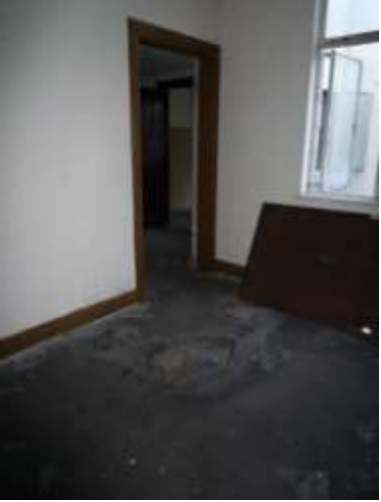
No.	Description	Level of Significance	Photo
3.7	<p>Magistrate's Offices at the first floor including</p> <ul style="list-style-type: none"> • Original teak parquet floor and timber skirting • Air inlet slot at skirting level under the sill of window facing open light well <p><i>The original wooden floor should be retained or repaired if it suits the new use. The air inlet slot provides the evidence of central air-conditioning was serving these rooms; however, they would cause water leakage. If they are going to be filled, they should be properly recorded.</i></p>	MODERATE

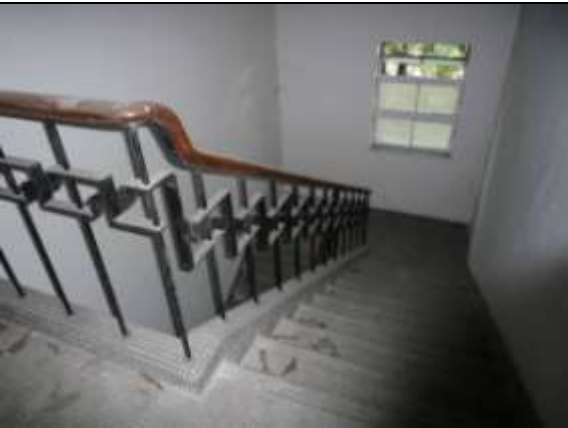
3.8	<p>Magistrate's staircase including</p> <ul style="list-style-type: none"> • Metal balustrade with simple decoration • Wooden handrail • Metal gate at 1/F to magistrate's verandah <p><i>The magistrate's staircase also shows the unique circulation for a court building – it directly connects the magistrates' entrance and their offices. The original finishes should be retained as far as possible and it can be upgraded to suit the new layout for access and escape.</i></p>	MODERATE

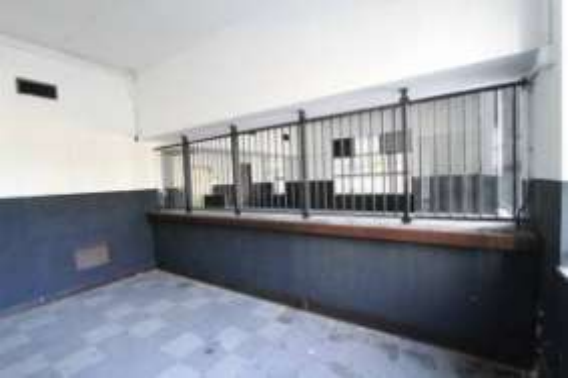
3.9	<p>Shroff office at the ground floor including</p> <ul style="list-style-type: none"> • Counter and metal security grilles above countertop • Timber skirting • Metal security gate • Safe <p><i>If it is compatible with the new use, it is very desirable to keep these features for future interpretation.</i></p>	MODERATE

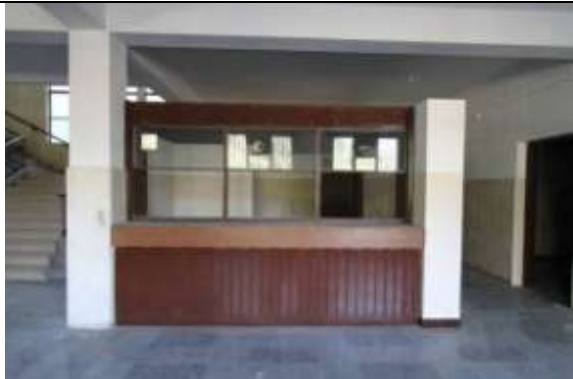
No.	Description	Level of Significance	Photo
3.10	<p>Pantry at the ground floor entrance lobby</p> <p><i>This was a later addition around 1980. Its presence affects the original grandeur of the ground floor entrance lobby. It should be removed to reveal the original design and finishes of the entrance lobby.</i></p>	INTRUSIVE

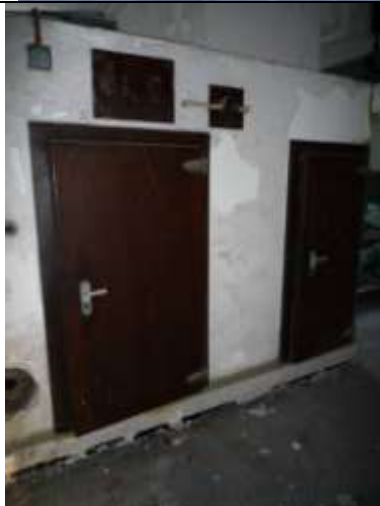
3.11	<p>Wooden access panels inside the air conditioning plant room at the roof and associated ironmongeries.</p> <p><i>The original centralised AC plant shows the mechanical design in mid 20th century; however, it would not serve the present needs. If it is to be removed it should be properly documented.</i></p>	LOW

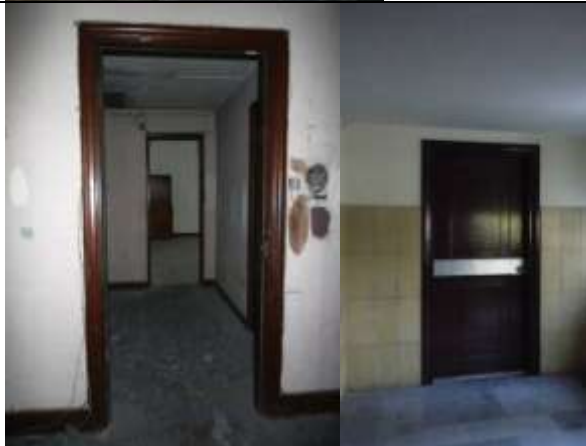
3.12	<p>Internal timber doors including door frames and architraves</p> <p><i>Different treatment is required for a variety of internal timber doors in different conditions. Types of door panels include plain solid, solid with mouldings and glazed infill. Door panel finishes include lacquered and painted. Two types of hinge include side-hung (only remain seen) and top & bottom hinged. Moulded architrave should be original one while flat architrave should be later addition. If the condition of doors is desirable and fits for the new use, they should be retained. Otherwise, replacement should respect the original design where feasible.</i></p>	LOW

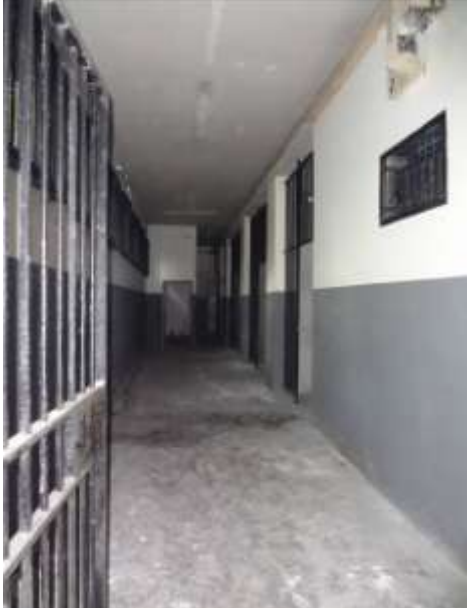
No.	Description	Level of Significance	Photo
3.13	<p>The controlled corridor from Defendant's garage along the cell area to the defendant's staircase, including:</p> <ul style="list-style-type: none"> • The security gates • The screeding on floor <p><i>The corridor has preserved much of its spatial arrangement except some minor addition of a room and a new opening access to the Annex Court Building.</i></p> <p><i>The spacing of these areas and those security gates should be preserved and retained in-situ as far as possible to recall its secured function.</i></p>	MODERATE

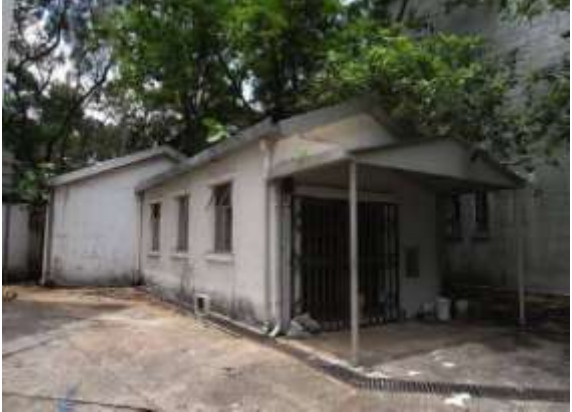
No.	Description	Level of Significance	Photo
4.1	<p>Duty Lawyers' Office</p> <p><i>This temporary building has no particular significance. It was used as a transitional space before the new Fanling Magistracy was completed. It also impedes the appreciation of the Former Fanling Magistracy by blocking the access to its rear façade.</i></p>	INTRUSIVE

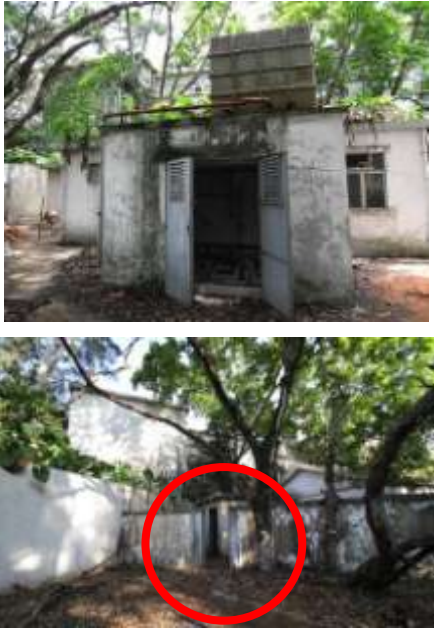
4.2	<p>Two small plant room buildings</p> <p><i>These plant room buildings have no particular significance. They are not compatible with the rear façade of the Former Fanling Magistracy.</i></p>	INTRUSIVE

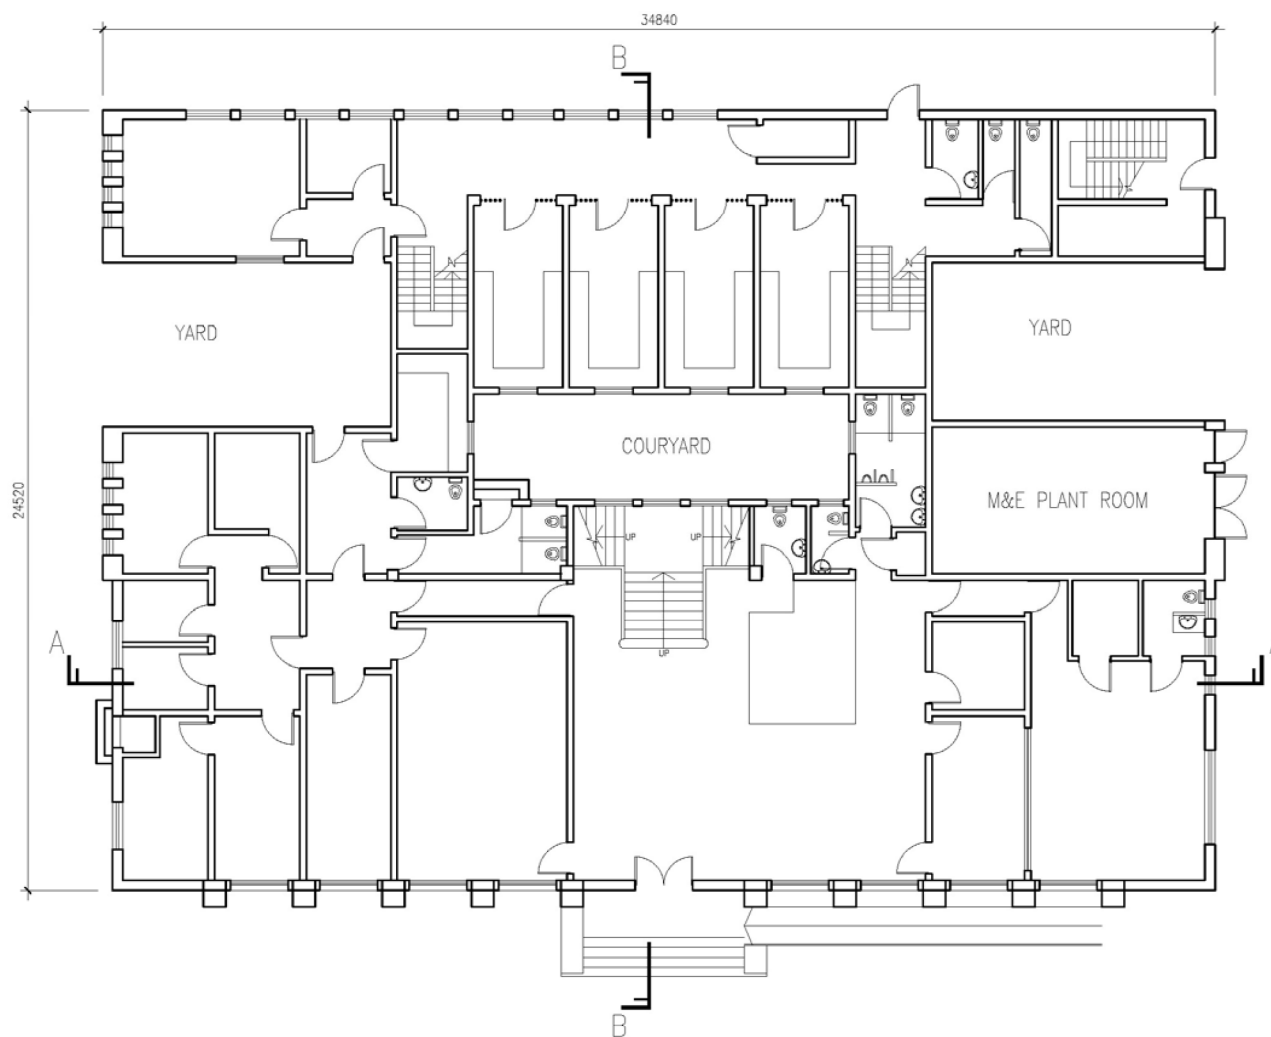
DRAWING NO.:
FM-02

DRAWING TITLE:
**GROUND FLOOR PLAN OF FORMER
FANLING MAGISTRACY**
SCALE:
1 : 150
