HERITAGE IMPACT ASSESSMENT SUBMISSION

**REVITALISATION OF THE FORMER FANLING MAGISTRACY INTO THE HKFYG INSTITUTE
FOR LEADERSHIP DEVELOPMENT**

PREPARED FOR : THE HKFYG INSTITUTE FOR LEADERSHIP DEVELOPMENT LIMITED

COPYRIGHT RESERVED BY: LWK CONSERVATION LTD.

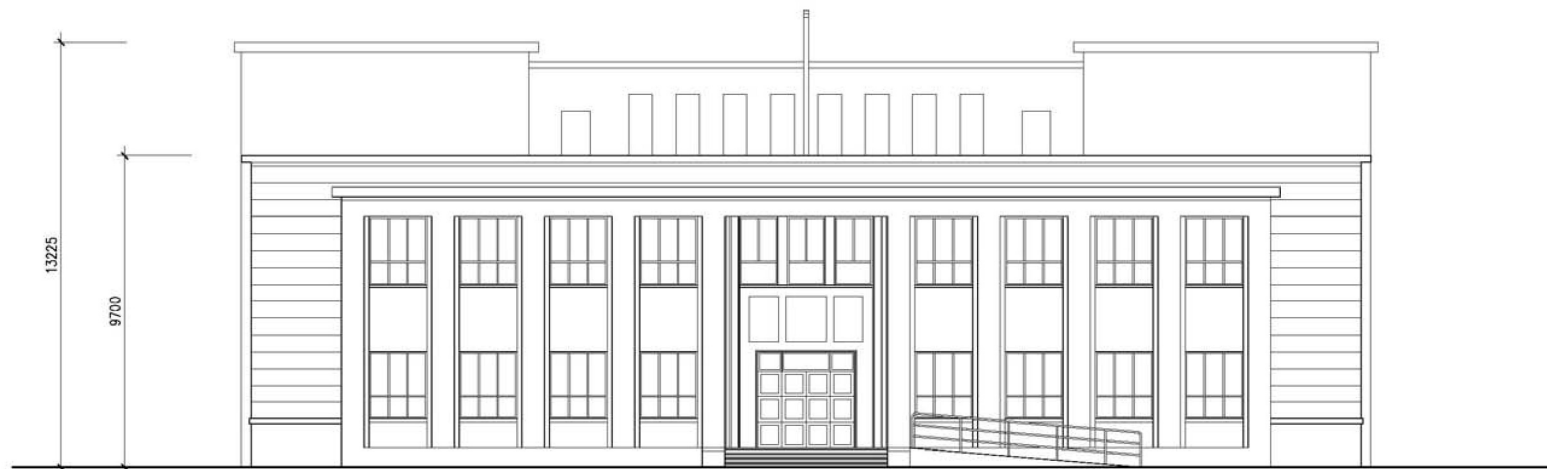
EAST ELEVATION

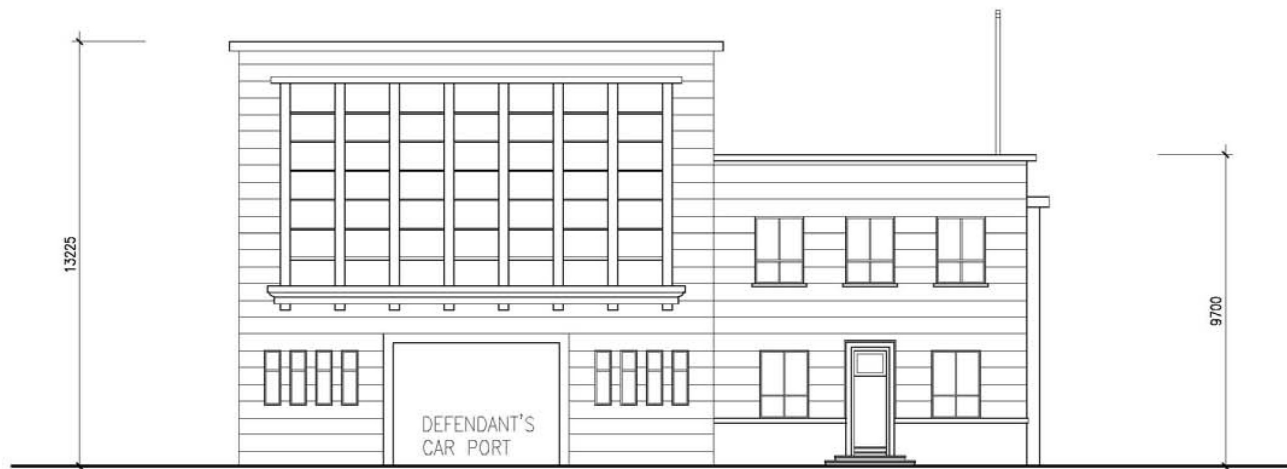
SOUTH ELEVATION

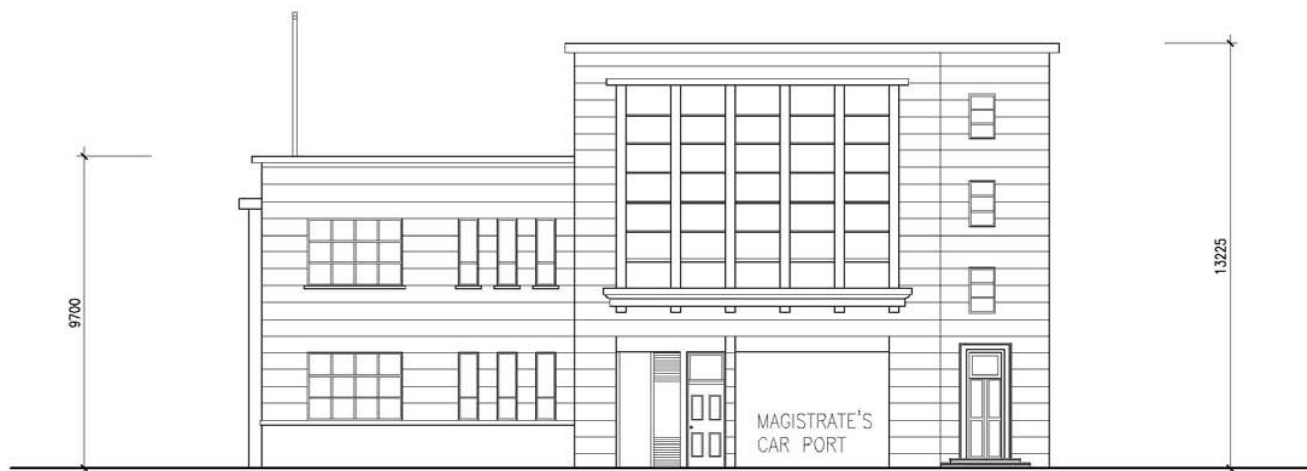
DRAWING NO.:
FM-07

DRAWING TITLE:
NORTH ELEVATION OF FORMER
FANLING MAGISTRACY
SCALE:
1 : 150 (A3)

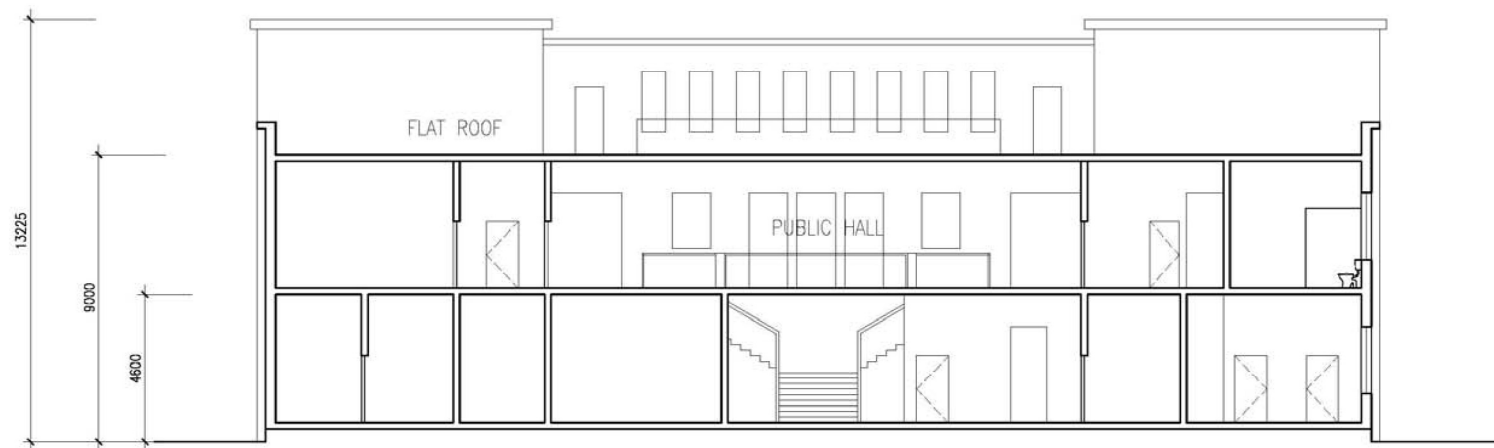
SECTION A-A

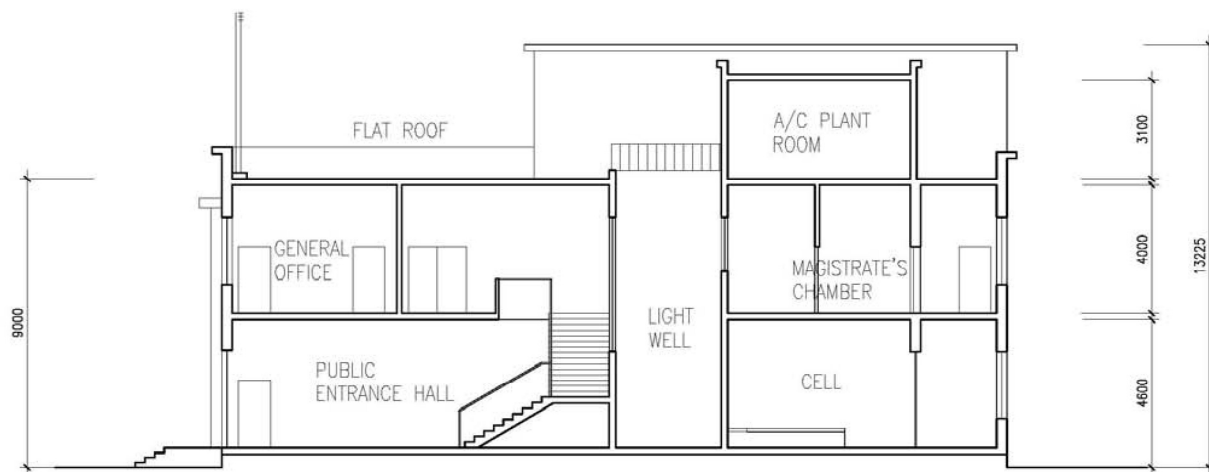
SECTION B-B

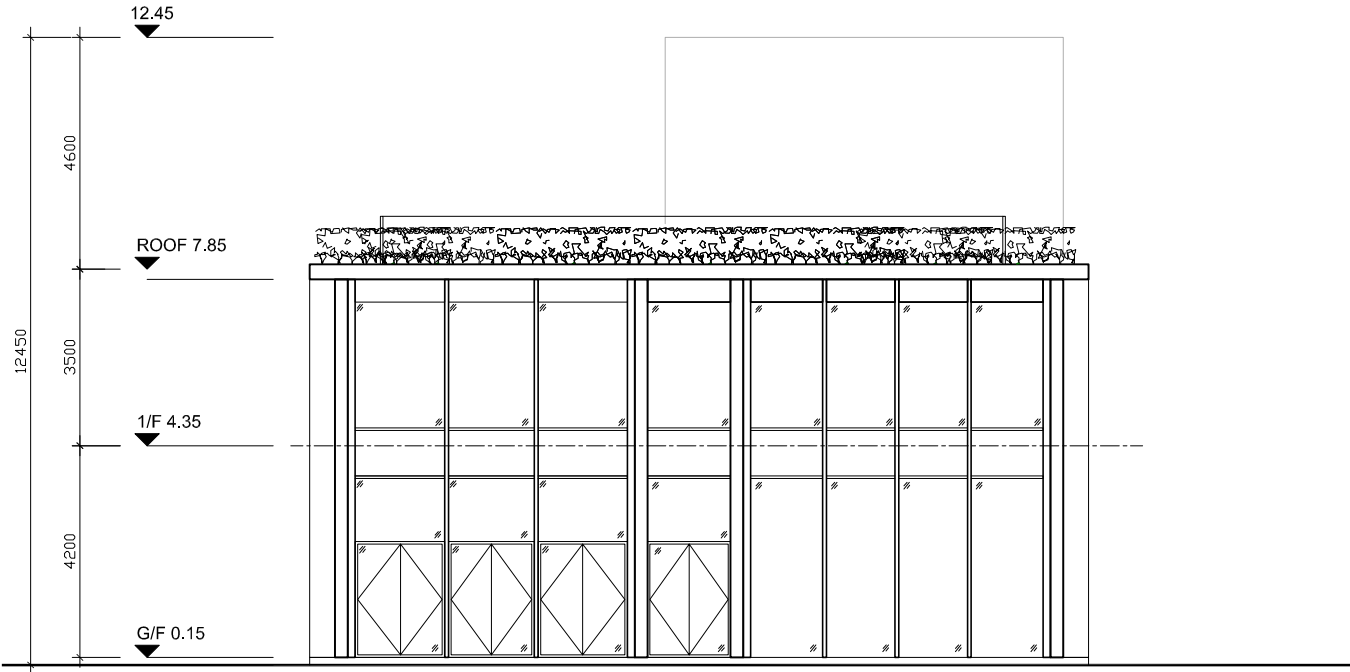
Rev.	Date	Amendment	Purpose	Client The Hong Kong Federation of Youth Groups	Project Revitalisation of the Former Fanling Magistracy into The HKFYG Institute of Leadership Development			Job No. 8062H	Drawing Title HOSTEL -NORTH ELEVATION			Date May 2014	<div>- This drawing and the contents herein are the copyright of LWK & Partners (HK) Ltd. - No part of the drawing and the design contained herein may be reproduced without the prior written consent of a director of LWK & Partners (HK) Ltd. - Do not take measurements directly from this drawing. - Check and verify all dimensions on site. - Read this drawing in conjunction with the specifications and all other related drawings - Notify the Architect immediately of any discrepancy found herein.</div>
					B.D. Ref.	F.S.D. Ref.	CAD Ref.	Drawn	Checked	Approved	Drawing No. DS015	Revision No. -	Scale 1:150

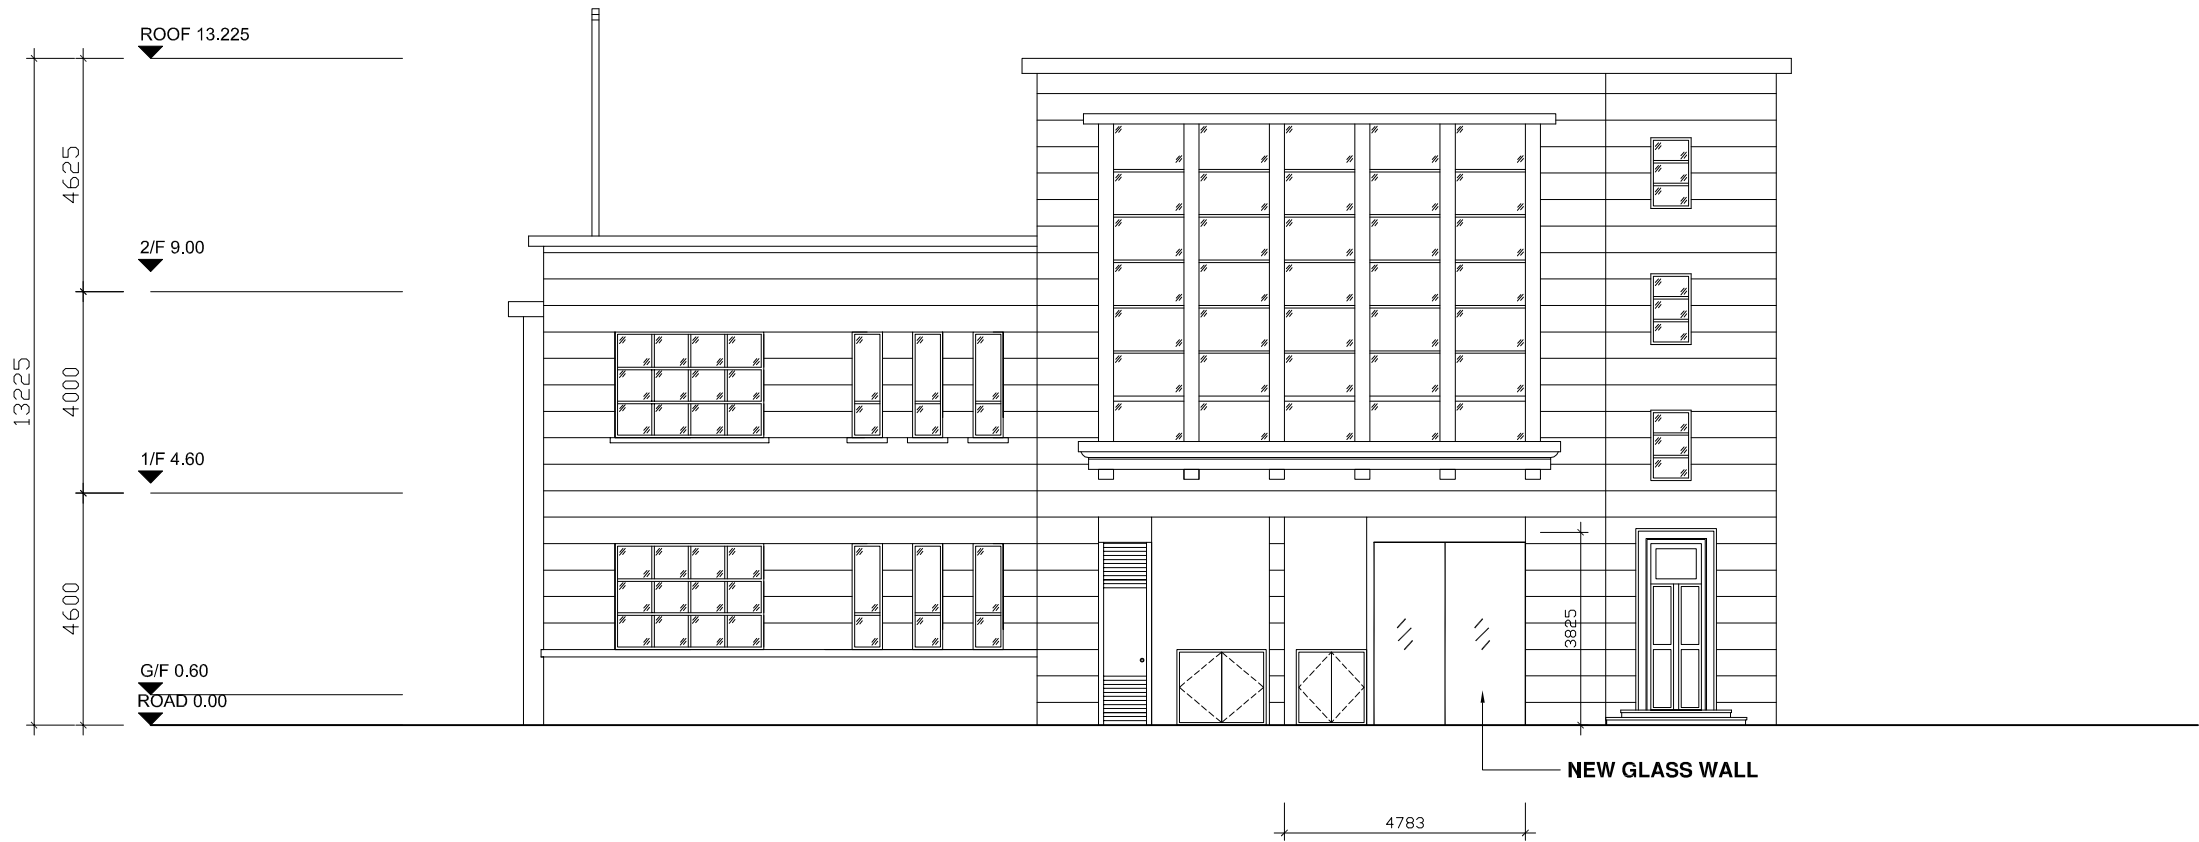
* LANDSCAPE DETAIL SHOULD REFER TO LANDSCAPE PROPOSAL

Rev.	Date	Amendment	Purpose	Client	Project			Job No.	Drawing Title			
				The HKFYG Institute for Leadership Development Limited	Revitalisation of the Former Fanling Magistracy into The HKFYG Institute for Leadership Development			8062H	TRAINING CENTRE -NORTH ELEVATION			
					B.D. Ref.	F.S.D. Ref.	CAD Ref.	Drawn	Checked	Approved	Drawing No.	Revision No.
											DS018	-
											Scale	Date

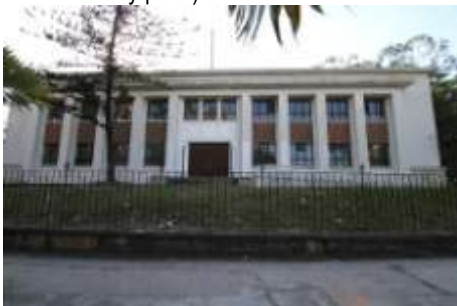
Item No.	Assessment Items/ Proposed New Works	Affected CDEs/ elements	Level of Significance	Reasons for Changes	Suggested Mitigation/ Recommendation	Overall Impact Level
E-1	<p>Façade preservation, repair & restoration</p> <p>Remove later added ramp</p> <p>Restore original affixed metal character of building name (subject to Judiciary's comment)</p> <p>Install new signage for the proposed new use</p>	<p>East elevation</p> <ul style="list-style-type: none"> • Main entrance, including <ul style="list-style-type: none"> - Granite steps - Main entrance door in panelled wood - Profiled projecting lintel - Two decorative lampposts on sides (whose location has been later altered) - Frieze above the main entrance (which is later added to replace the affixed metal character of building name) • Simple "Giant Order" arrangement including <ul style="list-style-type: none"> - Columns and pilasters - Overhanging eave • Granite base at corners • Central projecting bay with four strips of double height narrow windows on each side • Grooved stucco wall finish • Tiled spandrel panels (which has been later covered by paint)

<ul style="list-style-type: none"> • Preserve in-situ the entire elevation • Thoroughly survey the external wall before any repairing works • Carry out paint analysis to verify original colour and material of paint • Repair plaster as necessary and repaint the external wall with porous paint while maintaining the horizontal groove lines. Choice of colour of new paint should be light and not overwhelming the image of a law court building and stripped classical style • Replace and repair defected steel windows to match existing • Repair and restore existing main entrance timber door • General cleaning to granite surface by soft brush and water • General cleaning to spandrel tiles by soft brush and water. Expose its original tile surface if possible and repair grouting as necessary • Reconnect the two decorative lampposts on two sides of the main entrance; relocate existing lampposts to its original location. • Restore original granite steps after removal of ramp • Restore original affixed metal character by making reference to historic photo and those on the existing Annex Court entrance • If the new signage conflicts with the restored metal characters, the new signage can covered the restored as long as it does not damage the restored and is done in a reversible manner 	Beneficial

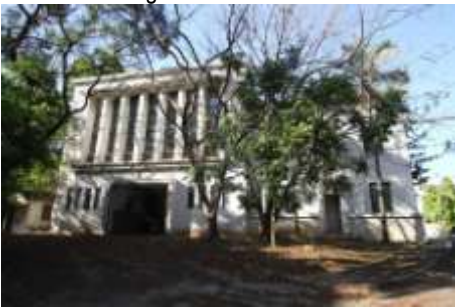
Item No.	Assessment Items/ Proposed New Works	Affected CDEs/ elements	Level of Significance	Reasons for Changes	Suggested Mitigation/ Recommendation	Overall Impact Level
E-2	Façade preservation, repair & restoration	South elevation <ul style="list-style-type: none"> Side Entrance <ul style="list-style-type: none"> Moulded architrave Door head panel Granite steps Granite cladded base with string course at low block External window wall <ul style="list-style-type: none"> Expressed columns Narrow and tall steel casement windows Tiled panel above and below the windows Overhanging eave and horizontal moulding together with simple corbels under the window wall Defendants' garage entrance with metal gate and projected opening surround Façade which divides into two bays Grooved stucco wall finish Original steel windows <ul style="list-style-type: none"> Regular spacing arrangement Metal grilles/mesh behind Protruding window sills 	Moderate	Improve the condition of the external wall	<ul style="list-style-type: none"> Preserve in-situ the entire elevation Thoroughly survey the external wall before any repairing works Repair plaster as necessary and repaint the external wall with porous paint while maintaining the horizontal groove lines. Choice of colour of new paint should be light and not overwhelming the image of a law court building and stripped classical style Replace and repair defected steel windows to match existing General cleaning to granite steps in front of entrance and granite cladding by soft brush and water General cleaning to tiled panels by soft brush and water. Expose its original tile surface if possible and repair grouting as necessary Repair the metal gate of the garage and repaint the gate to prevent corrosion 	Beneficial

Add a full height glass enclosure behind the existing defendant's garage

Convert the defendant's garage into a usable indoor space	<ul style="list-style-type: none"> Use full height glass to reduce visual impact to the facade 	Acceptable with mitigation measures

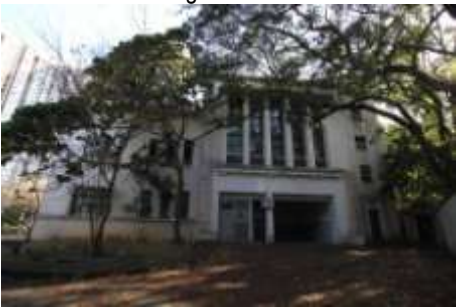
Item No.	Assessment Items/ Proposed New Works	Affected CDEs/ elements	Level of Significance	Reasons for Changes	Suggested Mitigation/ Recommendation	Overall Impact Level
E-3	Façade preservation, repair & restoration	North elevation <ul style="list-style-type: none"> Side entrance for Magistrates, including timber door , granolithic door surround with moulding, moulded doorhead with decorative wall mounted light fitting, granite steps in front of the entrance Granite cladded base at low block External window wall <ul style="list-style-type: none"> Expressed columns Narrow and tall steel casement windows Tiled panel above and below the windows Overhanging eave and horizontal moulding together with simple corbels under the window wall Original steel windows <ul style="list-style-type: none"> Regular spacing arrangement Metal grilles/mesh behind Protruding window sills 	Moderate	Improve the condition of the external wall	<ul style="list-style-type: none"> Preserve in-situ the entire elevation Thoroughly survey the external wall before any repairing works Repair plaster as necessary and repaint the external wall with porous paint while maintaining the horizontal groove lines. Choice of colour of new paint should be light and not overwhelming the image of a law court building and stripped classical style Replace and repair defected steel windows to match existing General cleaning to granite steps in front of entrance and granite cladding by soft brush and water General cleaning to tiled panels by soft brush and water. Expose its original tile surface if possible and repair grouting as necessary Reconnect the existing light fitting at the door head panel of the side entrance, if possible 	Beneficial

Add FS inlet, water meter and electricity room, as well as a glass enclosure next to them on the façade where original magistrates' garage and E&M room locate

Utilities and new rooms necessary for the adaptive reuse	<ul style="list-style-type: none"> Keep the new addition to the original magistrates' garage and original E&M room, which are of less significance among the entire façade Make use of the existing openings for the new door openings to avoid forming new openings on the façade 	Acceptable with mitigation measures

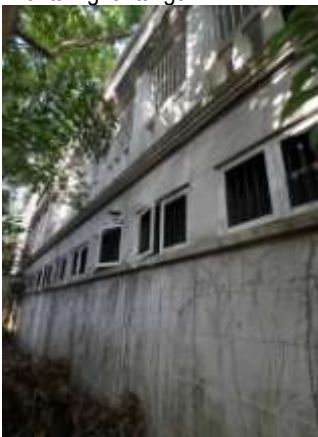
Item No.	Assessment Items/ Proposed New Works	Affected CDEs/ elements	Level of Significance	Reasons for Changes	Suggested Mitigation/ Recommendation	Overall Impact Level
E-4	Façade preservation, repair & restoration	West elevation <ul style="list-style-type: none"> Open verandah on first floor Existing window openings and steel windows <ul style="list-style-type: none"> Metal grilles/mesh behind Protruding window sills Grooved stucco wall finish Ornamental light fittings

Moderate	Improve the condition of the external wall	<ul style="list-style-type: none"> Preserve in-situ the entire elevation Thoroughly survey the external wall before any repairing works Repair plaster as necessary and repaint the external wall with porous paint while maintaining the horizontal groove lines. Choice of colour of new paint should be light and not overwhelming the image of a law court building and stripped classical style Replace and repair defected steel windows to match existing Reconnect the existing light fittings above openings on ground floor Maintain the design of the open verandah without enclosing it Reconnect the existing light fitting if possible 	Beneficial
