Heritage Impact Assessment

Revitalization of the Lady Ho Tung Welfare Centre into
Lady Ho Tung Welfare Centre Eco-Learn Institute

SIK SIK YUEN LADY HO TUNG WELFARE CENTRE
ECO-LEARN INSTITUTE LIMITED
耆色園何東夫人醫局生態研習中心有限公司

馬海
Spence Robinson Ltd.
Architects Project Managers Interior Designers
馬海(建築顧問)有限公司

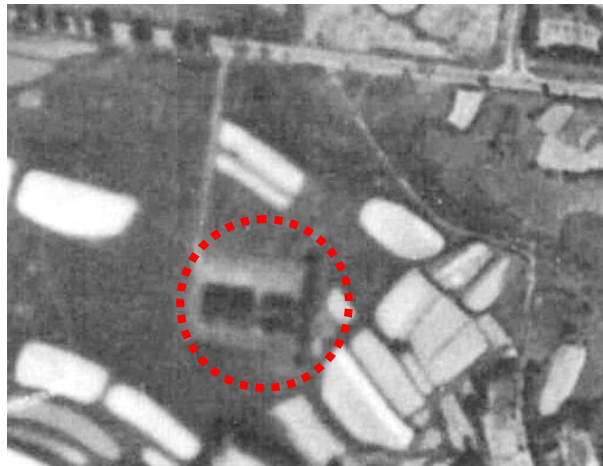
Fig 17. The aerial photo of Lady Ho Tung Welfare Centre in 1945. Source: Survey and Map Office.

The earliest aerial photo of the LHTWC could be found was taken in 1945, from which we could identify the original layout of the building and the site. A covered corridor connected the Main Block and the Bungalow as at today. However, there were fewer trees and more fields around the building. The setting and context were retained as it was in 1956 and one of the additional latrines was not existed in the aerial photo until 1961. It can be concluded that one of the additional latrine was constructed between 1957 and 1961.

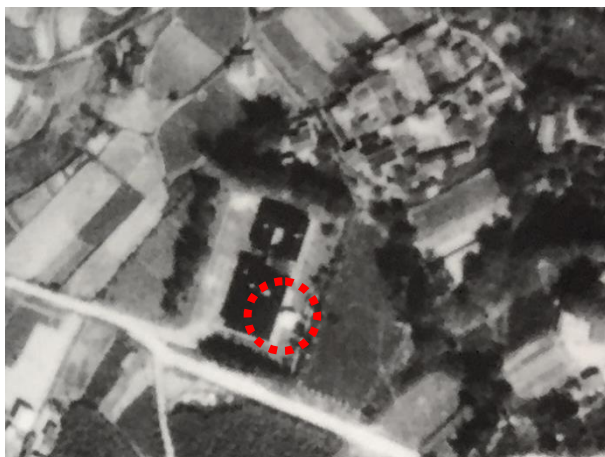
Fig 19. The aerial photo of Lady Ho Tung Welfare Centre in 1961. The additional latrine could be found at the rear side of the Main Block (circled in red). Source: Survey and Map Office. Edited by Hannah Liu

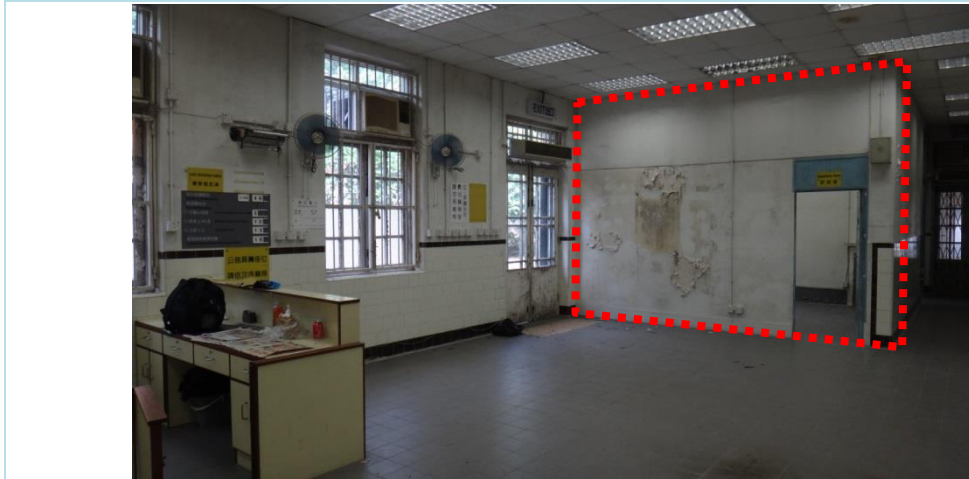
Fig 21. The existing photo of Lady Ho Tung Welfare Centre in 2016. The part of the later-added fiberboard partition wall is retained in-situ (highlighted in red).
Edited by Hannah Liu

A 6-foot high wall was added to partition a ward of 22' x 15'6" (approx. 32m²). The partition (37'6" x 6') was made of fiberboard and included two hardwood doors completed with locks.²⁶

Today, the partition wall is still retained *in-situ*.

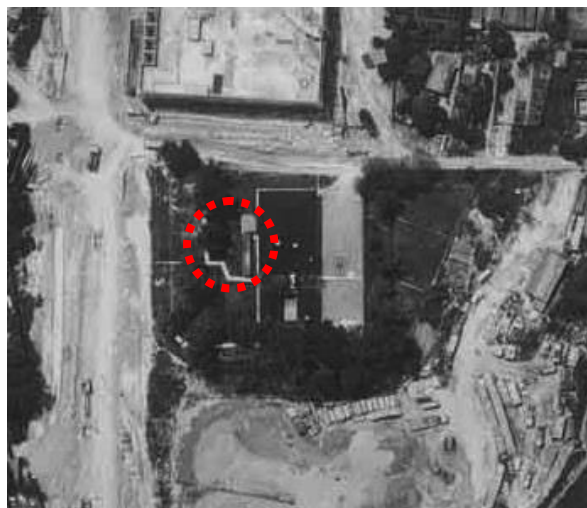
Fig 23. The aerial photo of Lady Ho Tung Welfare Centre in 1985. The longitudinal block was on the rear side of the Main Block next to the latrine (circled in red). Source: Survey and Map Office. Edited by Hannah Liu

When it came to 1980s, a longitudinal block could be found situated beside the additional latrine. Its usage, appearance and volume cannot be traced due to limited record on this structure.

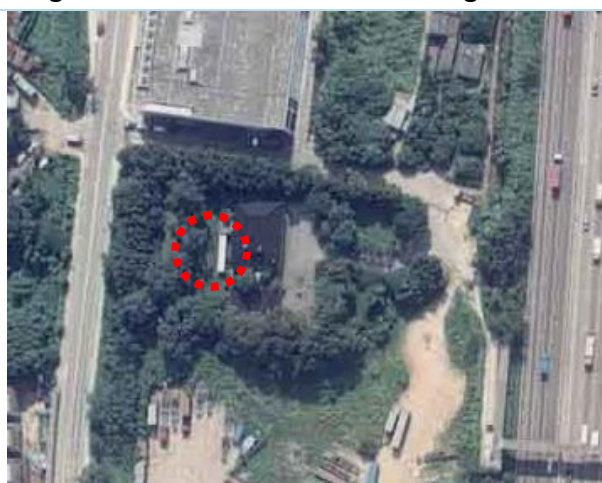
Fig 24. The aerial photo of Lady Ho Tung Welfare Centre in 1995. The longitudinal block was still on the rear side of the Main Block (circled in red). Source: Survey and Map Office. Edited by Hannah Liu

In 1980s, mandatory requirements for barrier free access of persons with disabilities were first imposed on various kinds of buildings under Building Ordinance (Cap.123). As a result, between 1995 to 1996, a new disable toilet was built at the place where the unknown longitudinal block situated. The longitudinal block was demolished.

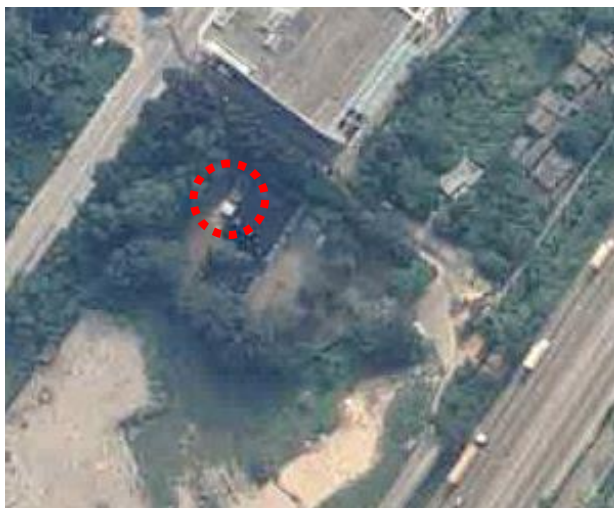
Fig 25. The aerial photo of Lady Ho Tung Welfare Centre in 1996. The longitudinal block was replaced by the new disable toilet. (circled in red). Source: Survey and Map Office. Edited by Hannah Liu

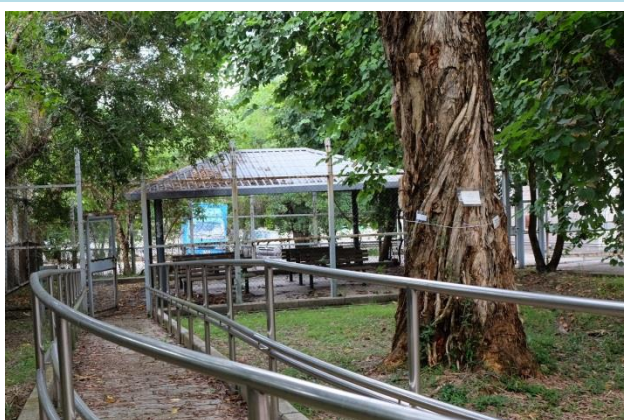
Fig 26. The later-added metal shelter at external waiting area of Lady Ho Tung Welfare Centre today. Photo taken by Betty Tay in 2014

A metal shelter was erected at the entrance of the site by Architectural Services Department in 2000²⁷, providing a covered place for the patients who were queuing for doctor consultation.

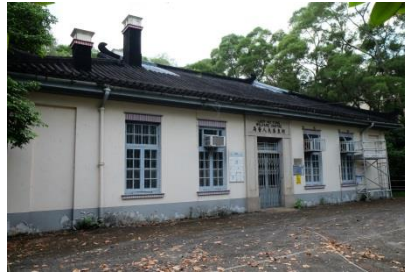
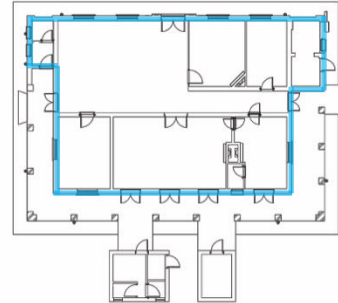
No.	CDE	Level of Significance	Photo	Location
A-01	Building Façade	High

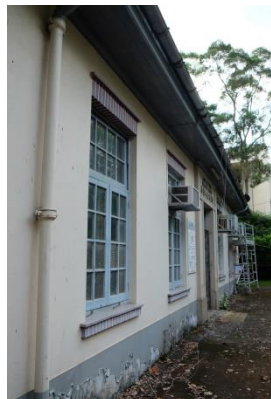
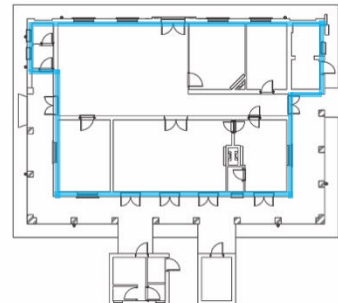
G/F Plan
A-02	External rendered and painted external walls	Moderate

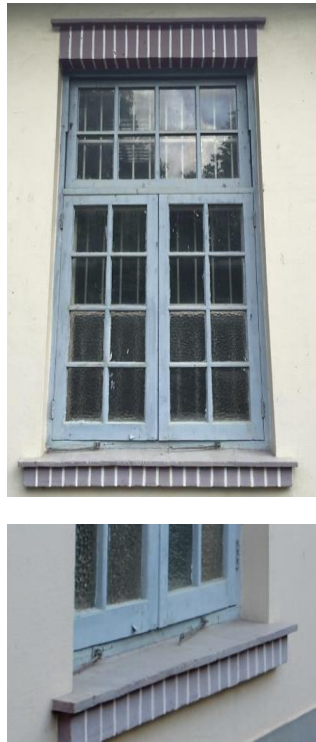
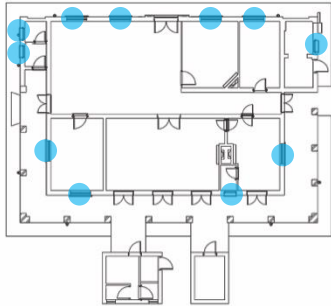
No.	CDE	Level of Significance	Photo	Location
A-05	Timber casement windows and horizontal pivoted windows on top, including original glazing scheme of obscure and clear glass, original ironmongeries and window frames	High

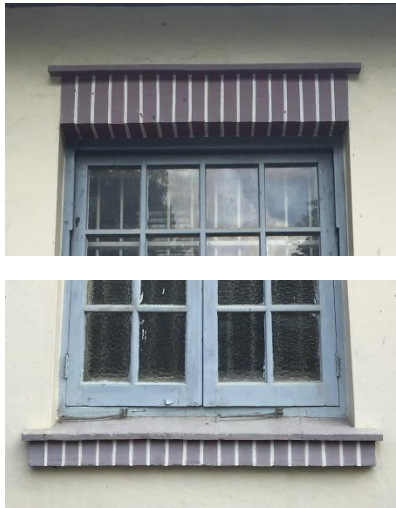
No.	CDE	Level of Significance	Photo	Location
A-06	Brick window head and sill with quarry tiles finish painted in red with white brick lines	High

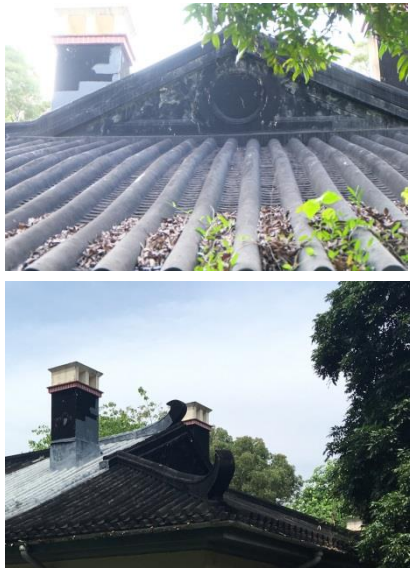
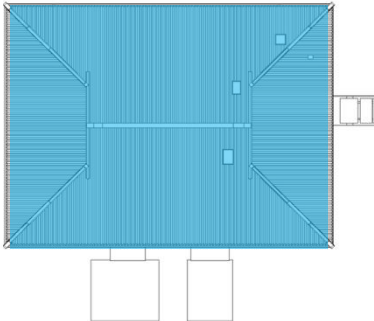
No.	CDE	Level of Significance	Photo	Location
A-07	Chinese style roof with hip and gable roof structure, including curled-up ends of roof ridges, circular decorative moulding on pediment and double layered pan and roll tiles	High

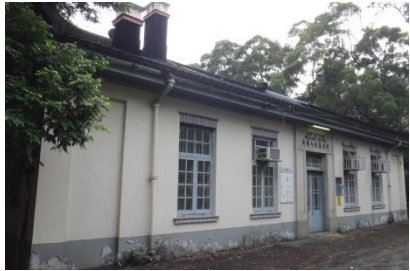
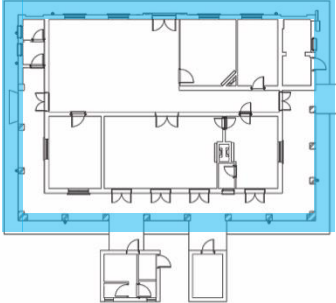
Roof Plan
A-08	Over-hanging roof eaves with suspended timber battened ceiling	High

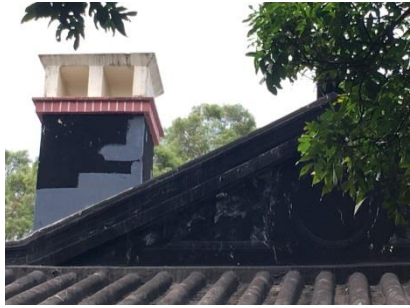
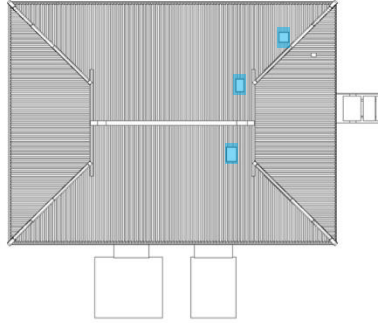
No.	CDE	Level of Significance	Photo	Location
A-09	Chimney stacks with ornamental band painted in red and white brick lines	High

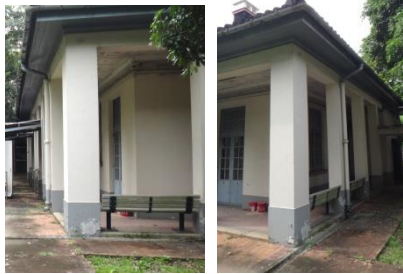
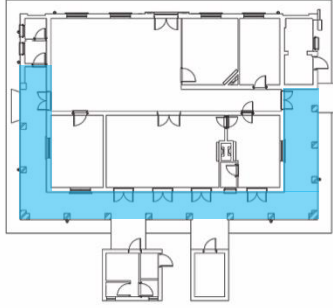
Roof Plan
A-10	Colonnaded verandah, including square concrete columns and granite edge stones to paving	High

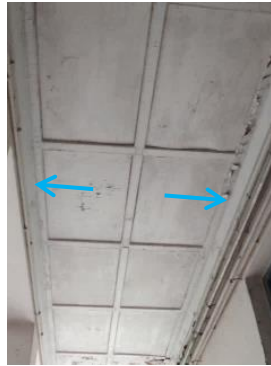
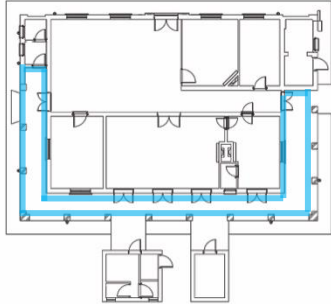
No.	CDE	Level of Significance	Photo	Location
A-11	External moulded cornices at ceilings	High

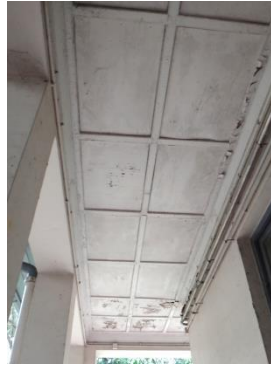
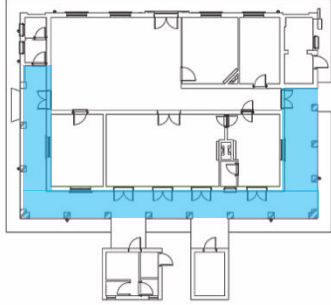
G/F Plan
A-12	Timber suspended ceiling along the colonnaded verandah	Moderate

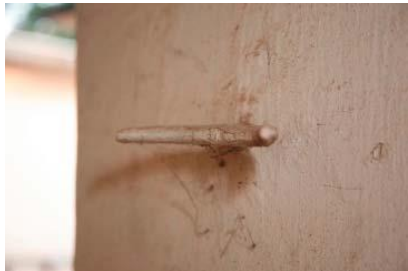
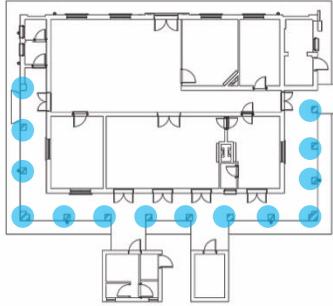
No.	CDE	Level of Significance	Photo	Location
A-13	Cow's horn cleats mounted on the verandah columns	High

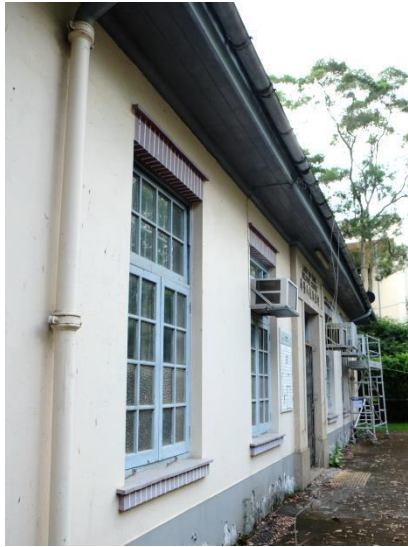
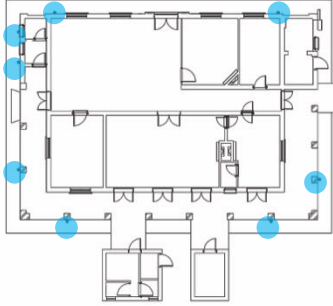
G/F Plan
A-14	Cast iron rainwater pipes and eave gutters at the elevations	High

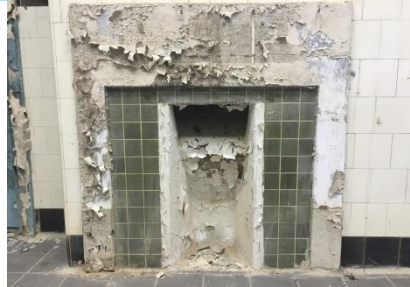
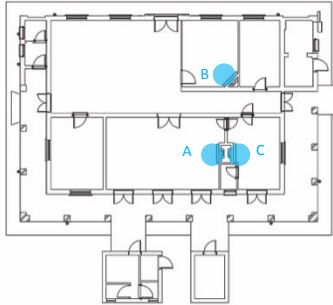
Fireplace A in the Treatment Room

G/F Plan
B-02	Fireplaces (3 nos.) in the Consultation Room, Treatment Room and Interview Room, including tiling, surrounds, grates, hearths, and mantel shelf	High

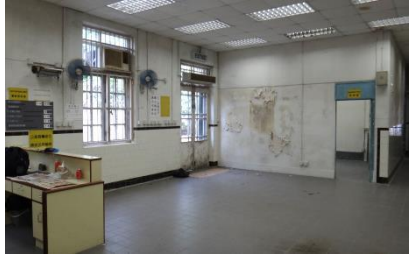
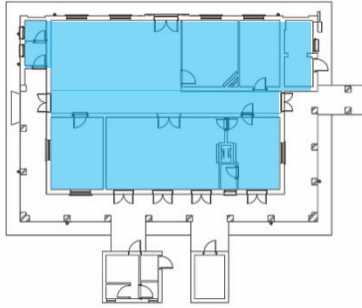
No.	CDE	Level of Significance	Photo	Location
B-03	Internal floor finishes	Low

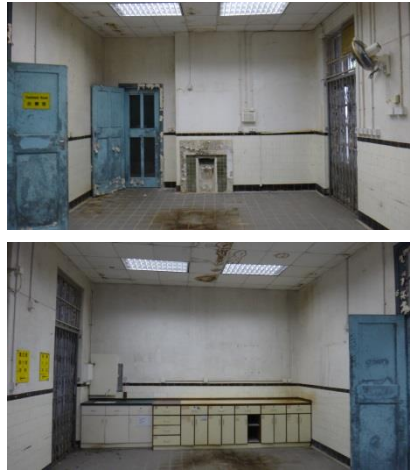
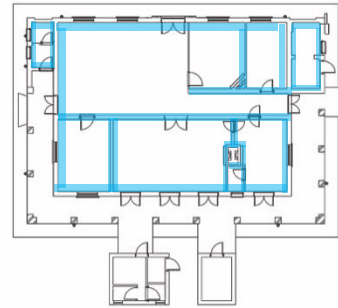
No.	CDE	Level of Significance	Photo	Location
B-04	Internal painted plaster finishes	Low

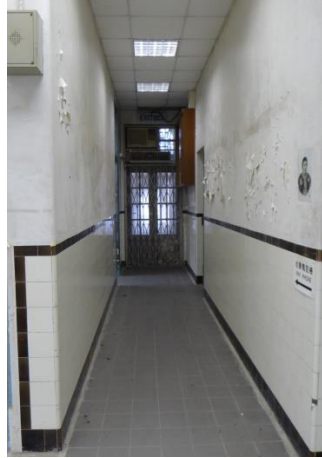
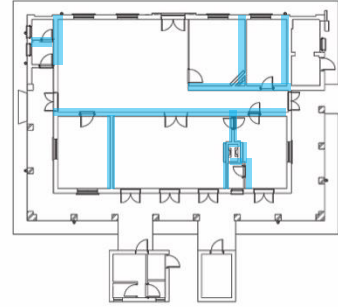
G/F Plan
B-05	Internal brick walls	Moderate

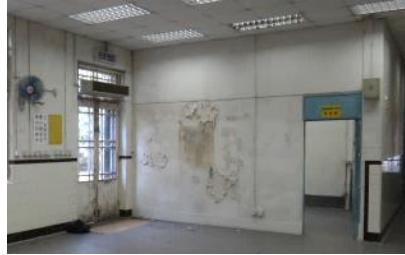
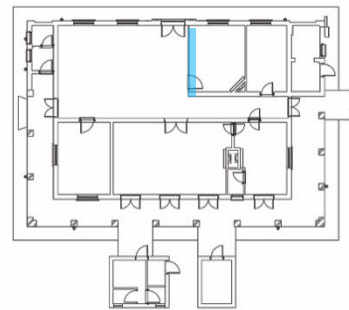
No.	CDE	Level of Significance	Photo	Location
B-06	Fiberboard partition	Low

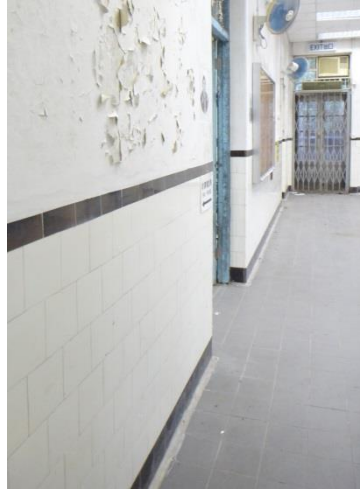
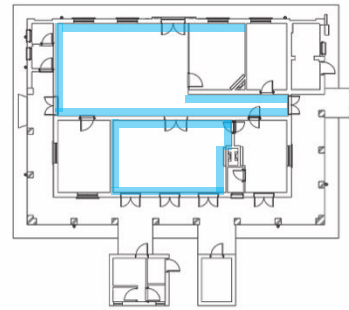
G/F Plan
B-07	Original glazed dado wall tiles and window sill tills in the corridor, Waiting Room and Treatment Room	High

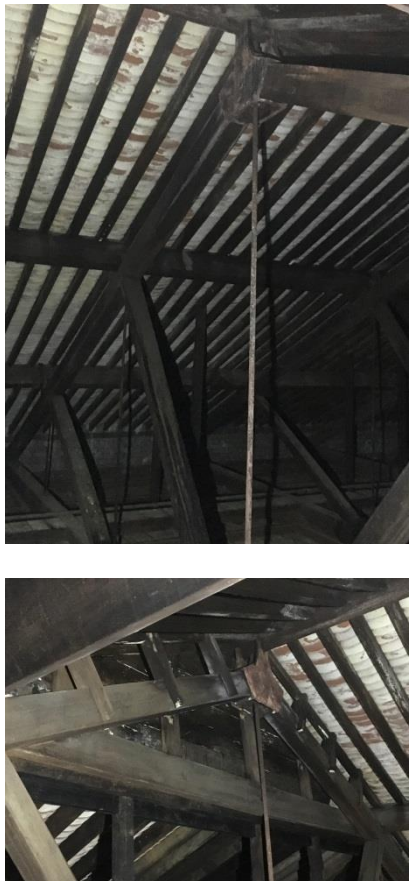
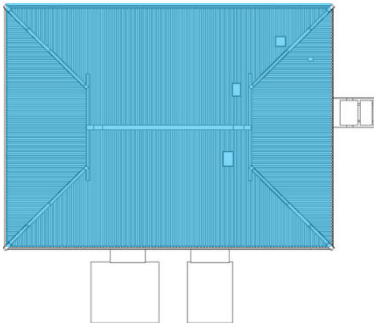
No.	CDE	Level of Significance	Photo	Location
B-08	Timber roof structure including roof trusses, ties and rafters etc.	High

There were 14 concrete vertical columns of 400mm x 400mm with 4.0m height. It was measured and found that the timber trusses did not sit on these concrete columns. It was observed that the timber trusses are supported by horizontal concrete beams spanning between these concrete columns at south and sited on the brick walls above these beams. However, the timber trusses are supported by the load bearing brick walls directly at north.

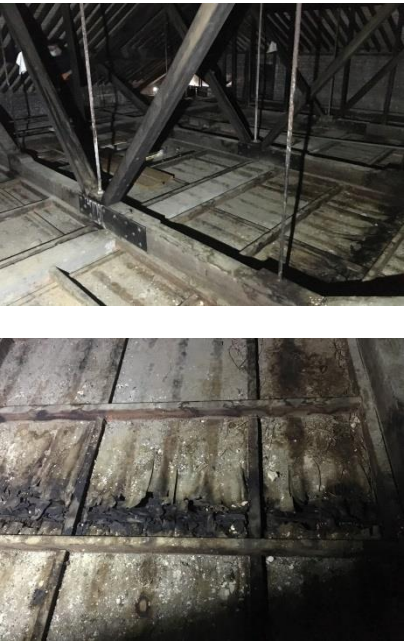
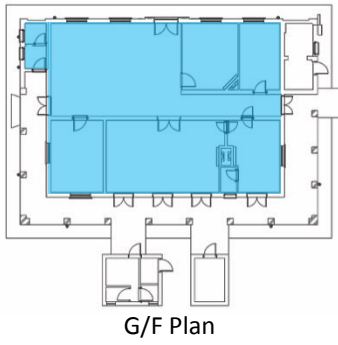
No.	CDE	Level of Significance	Photo	Location
B-09	Timber suspended ceilings in the building	High

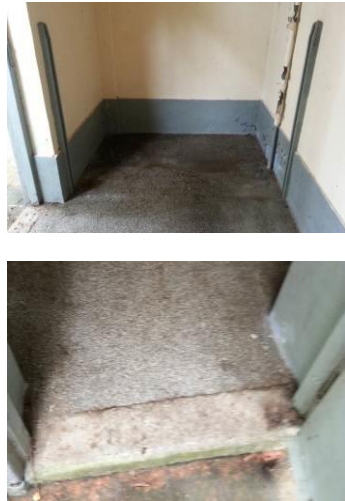
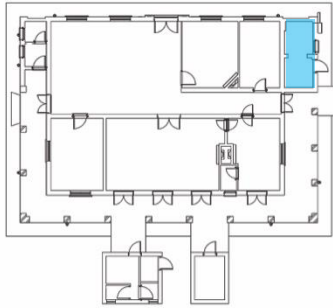
No.	CDE	Level of Significance	Photo	Location
B-10	Timber fence holder, terrazzo floor finishes and the granite threshold in the Watchman Room	High

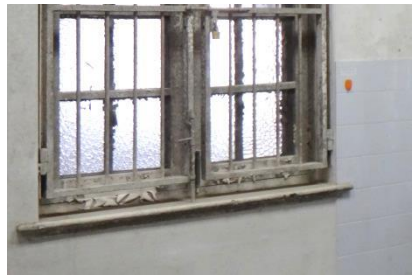
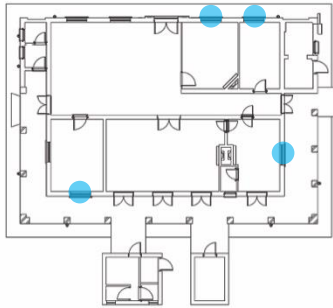
G/F Plan
B-11	Internal wooden window sills with mouldings	High

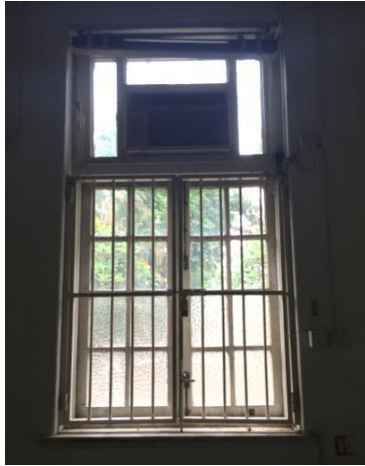
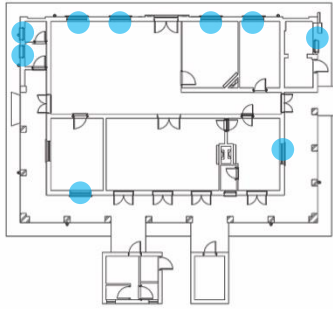
No.	CDE	Level of Significance	Photo	Location
B-14	Burglar bars / metal grilles at windows or fanlights	Intrusive

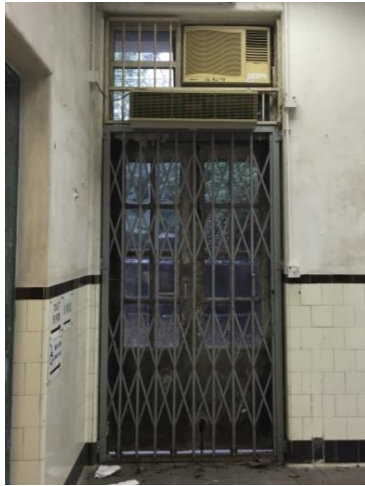
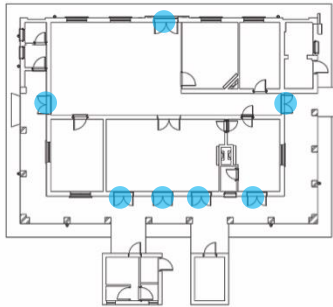
G/F Plan
B-15	Bostwick gates	Intrusive

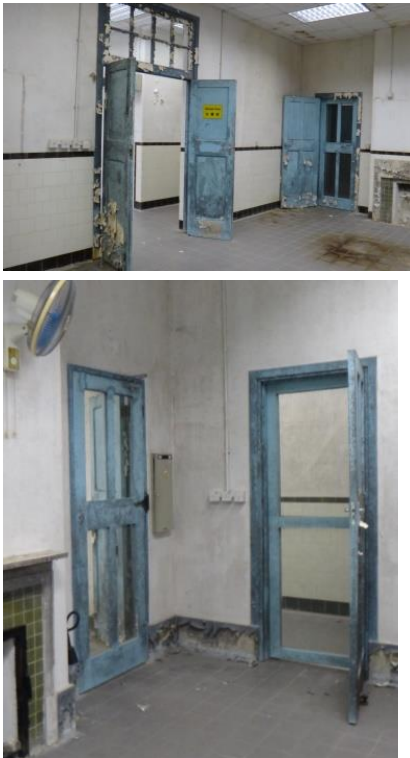
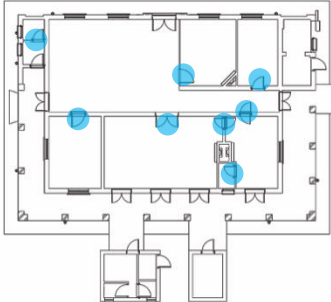
No.	CDE	Level of Significance	Photo	Location
B-16	Internal timber doors (including insects screens and ironmongeries)	Moderate

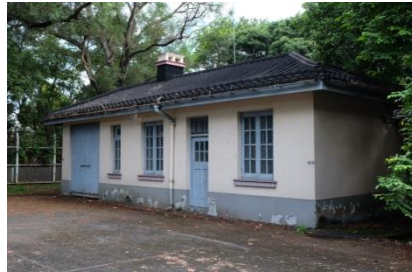
No.	CDE	Level of Significance	Photo	Location
C-01	Building Façade	High

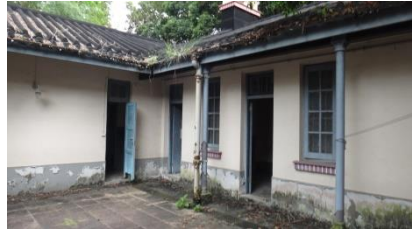
G/F Plan
C-02	External rendered and painted finishes	Moderate

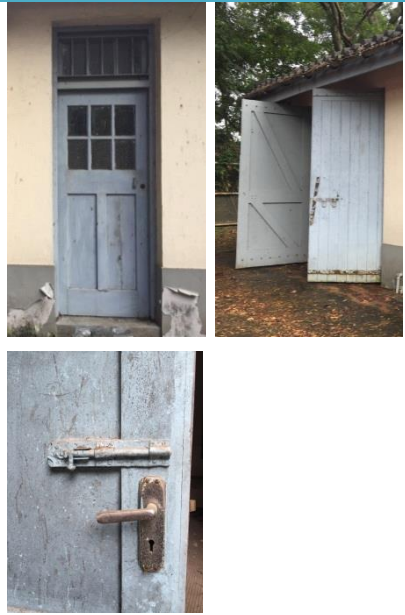
No.	CDE	Level of Significance	Photo	Location
C-03	Timber battened doors to the Garage and all original external timber doors, including door panels with grid pattern, door frames, fanlights, original glazing scheme of obscure and clear glass, granite thresholds and original ironmongeries and timber door bars	High

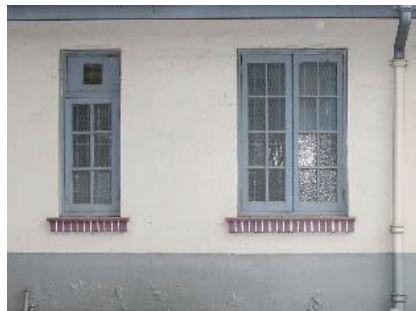
G/F Plan
C-04	Timber casement windows including original glazing scheme of obscure and clear glass, ironmongeries and window frames	High

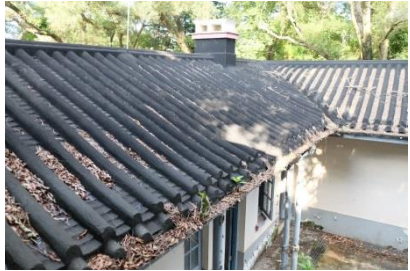
G/F Plan
C-06	Chinese pitched roof with double layered pan and roll tiles and rendered ridges	High

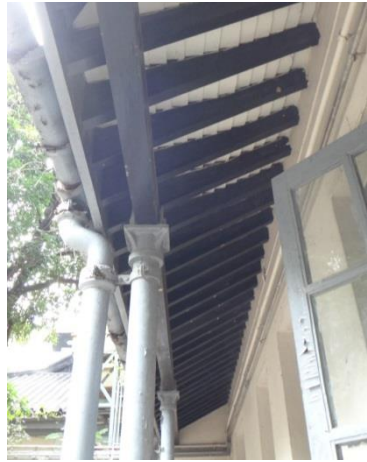
No.	CDE	Level of Significance	Photo	Location
C-07	Over-hanging roof eaves	High

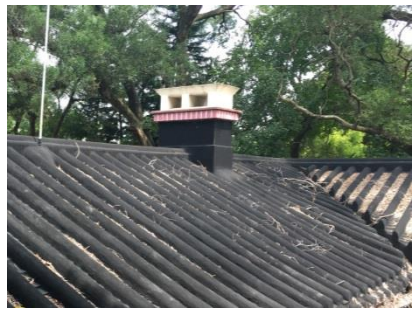
G/F Plan
C-08	Chimney stacks with ornamental band painted in red and white brick lines	High

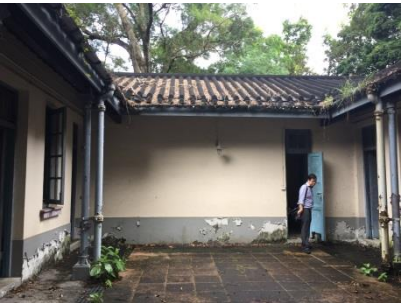
No.	CDE	Level of Significance	Photo	Location
C-09	Open courtyard	High

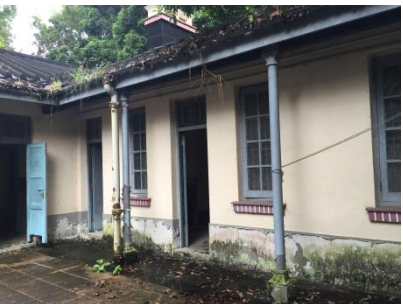
G/F Plan
C-10	Cast iron columns with concrete plinths supporting the roof eaves	High

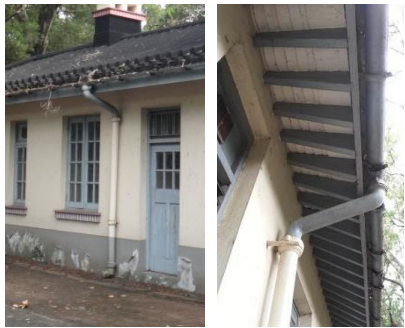
No.	CDE	Level of Significance	Photo	Location
C-11	Cast iron rainwater pipes and eave gutters	High

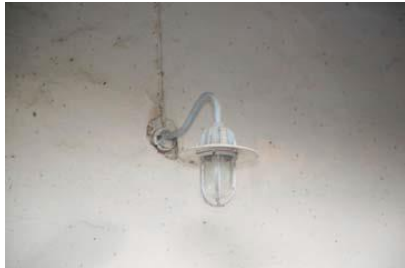
G/F Plan
C-12	Wall lamp	High

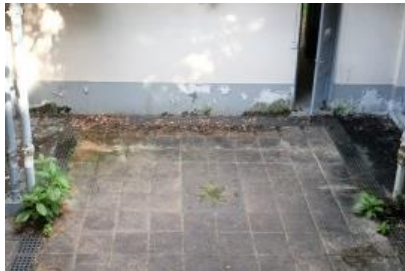
G/F Plan
C-13	Floor tiles at the open courtyard	Low

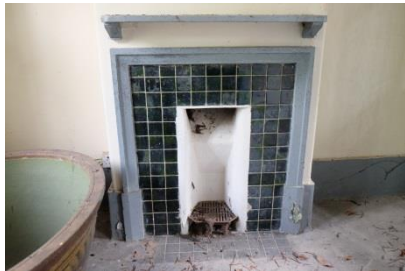
No.	CDE	Level of Significance	Photo	Location
D-01	Fireplaces (2 nos.), including tiling, surrounds, grates, hearths, and mantel shelf	High

<p>Fireplace D in the Sitting Room A</p>

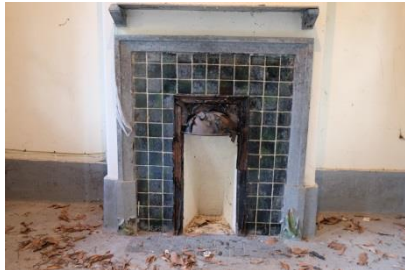
<p>Fireplace E in the Sitting Room B</p>

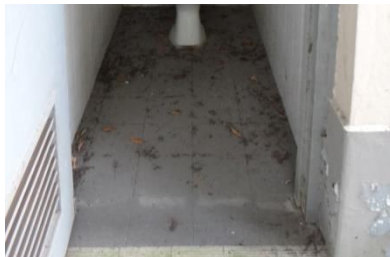
<p>G/F Plan</p>
D-02	Internal floor finishes	Low

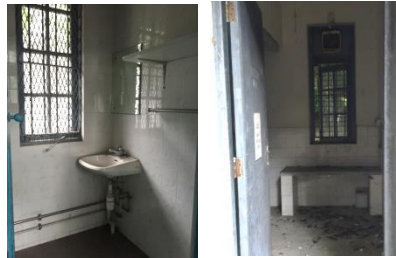
No.	CDE	Level of Significance	Photo	Location
D-03	Internal painted plaster finishes	Low

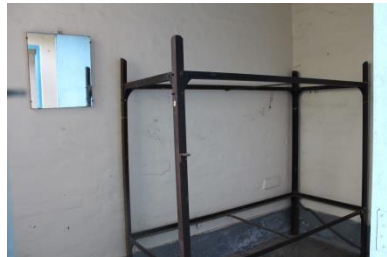
G/F Plan
D-04	Internal brick walls	Moderate

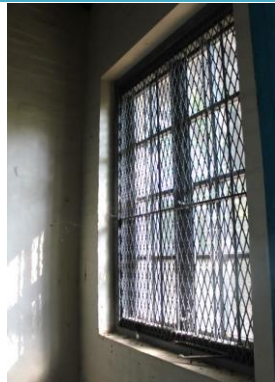
No.	CDE	Level of Significance	Photo	Location
D-07	Burglar bars / metal grilles to windows and fanlight	Intrusive

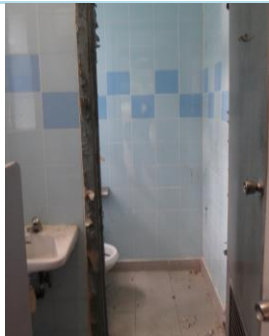
G/F Plan
D-08	Internal timber doors	Moderate

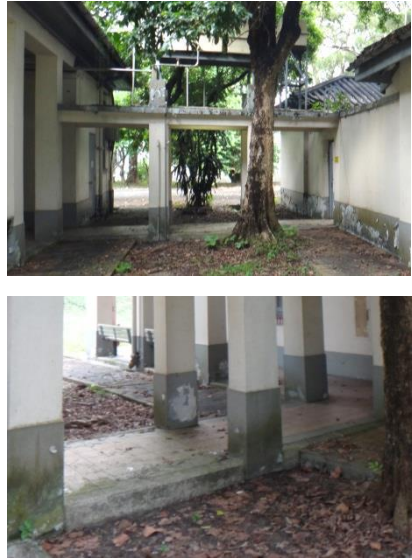
No.	CDE	Level of Significance	Photo	Location
E-01	Covered walkway including brick square columns and granite edge stones to paving	High

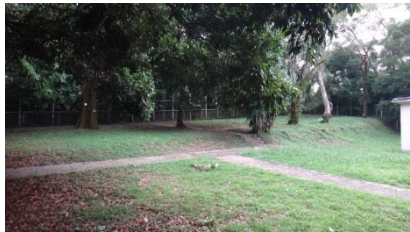
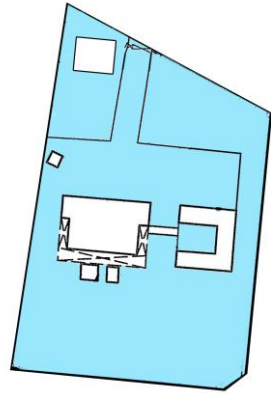
No.	CDE	Level of Significance	Photo	Location
E-02	Open Space	Moderate

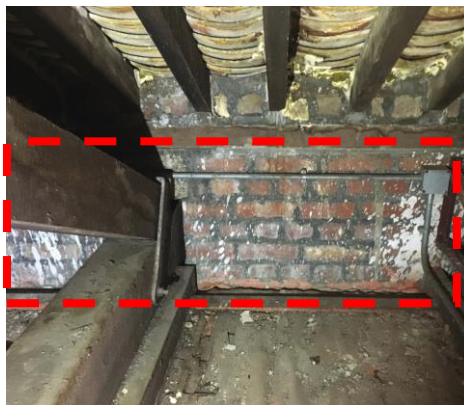
Fig 31. The timber trusses are sited on the brick wall above the horizontal concrete beams at south.

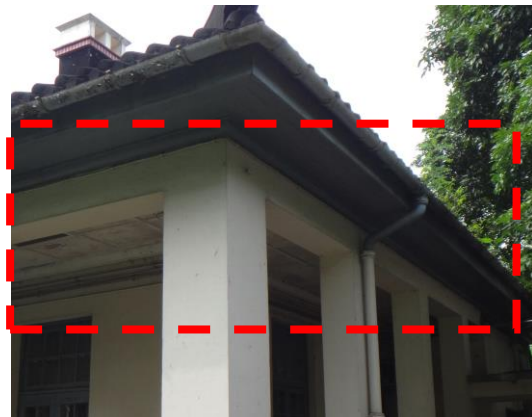
Fig 32. The horizontal concrete beam spanning between the concrete columns

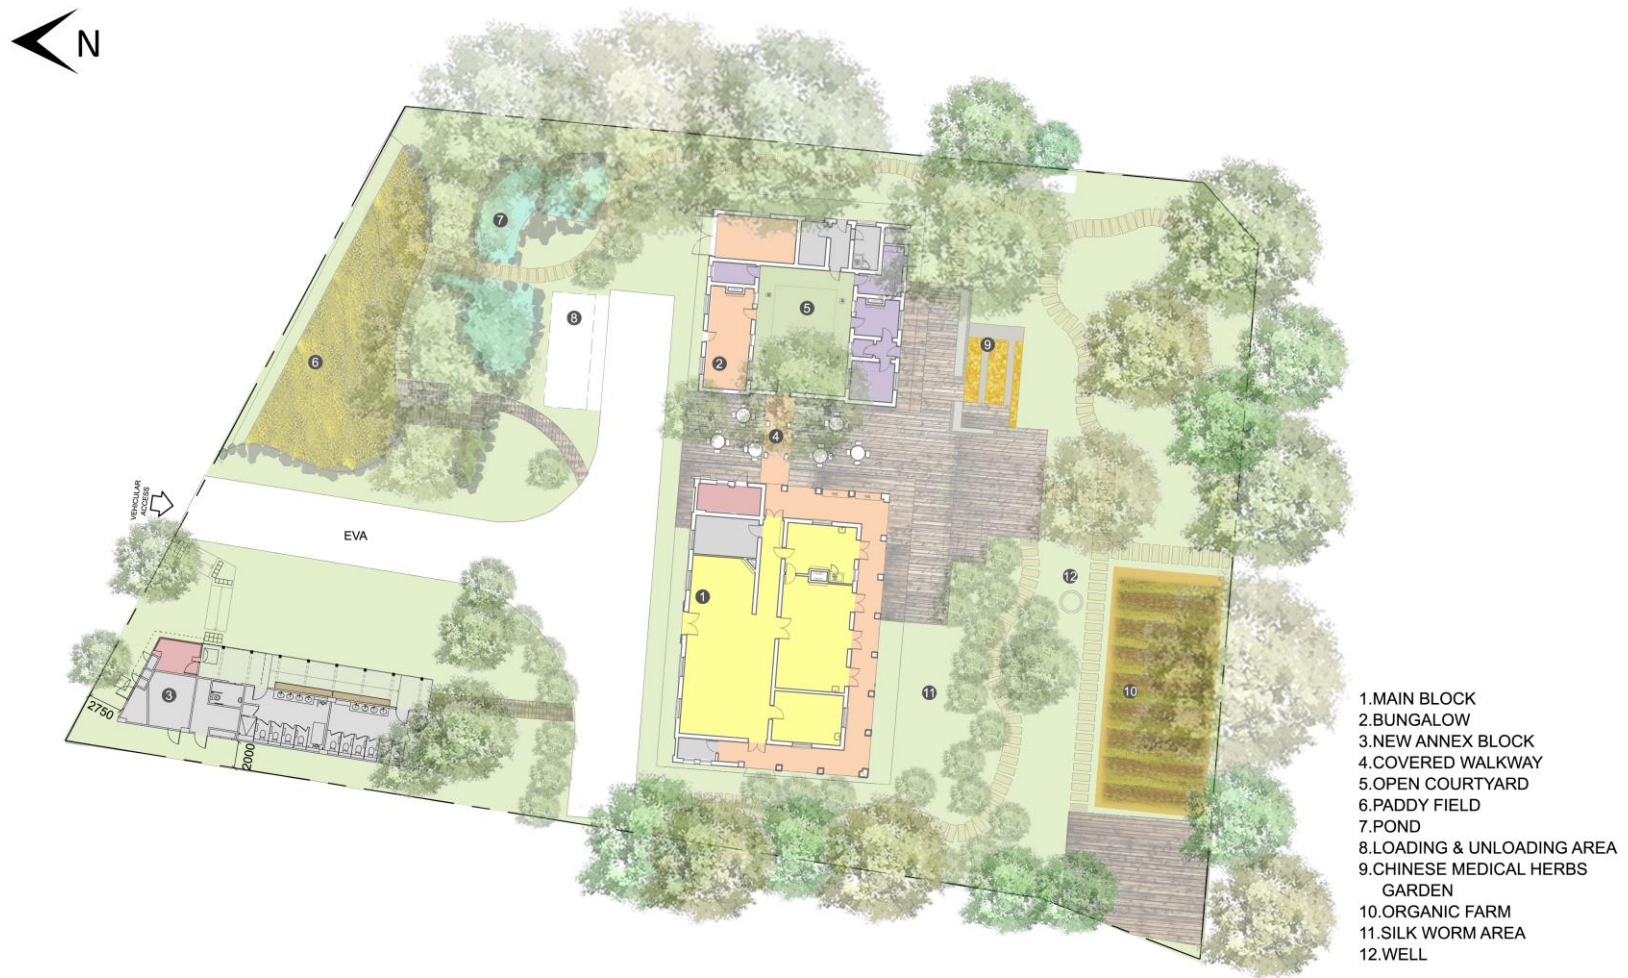
Fig 39. The proposed site plan. Edited by Hannah Liu.

The LHTWC and its site will be revitalized into a heritage interpretation-cum-local ecology discovery centre to showcase the history and memory of the historic buildings and the contribution of Sir Robert Ho Tung family; it also provides a series of training programmes and activities with the theme of “Rural Bioblitz Experience” for the school sector and local community. The full set drawings are shown in **Appendix I**.

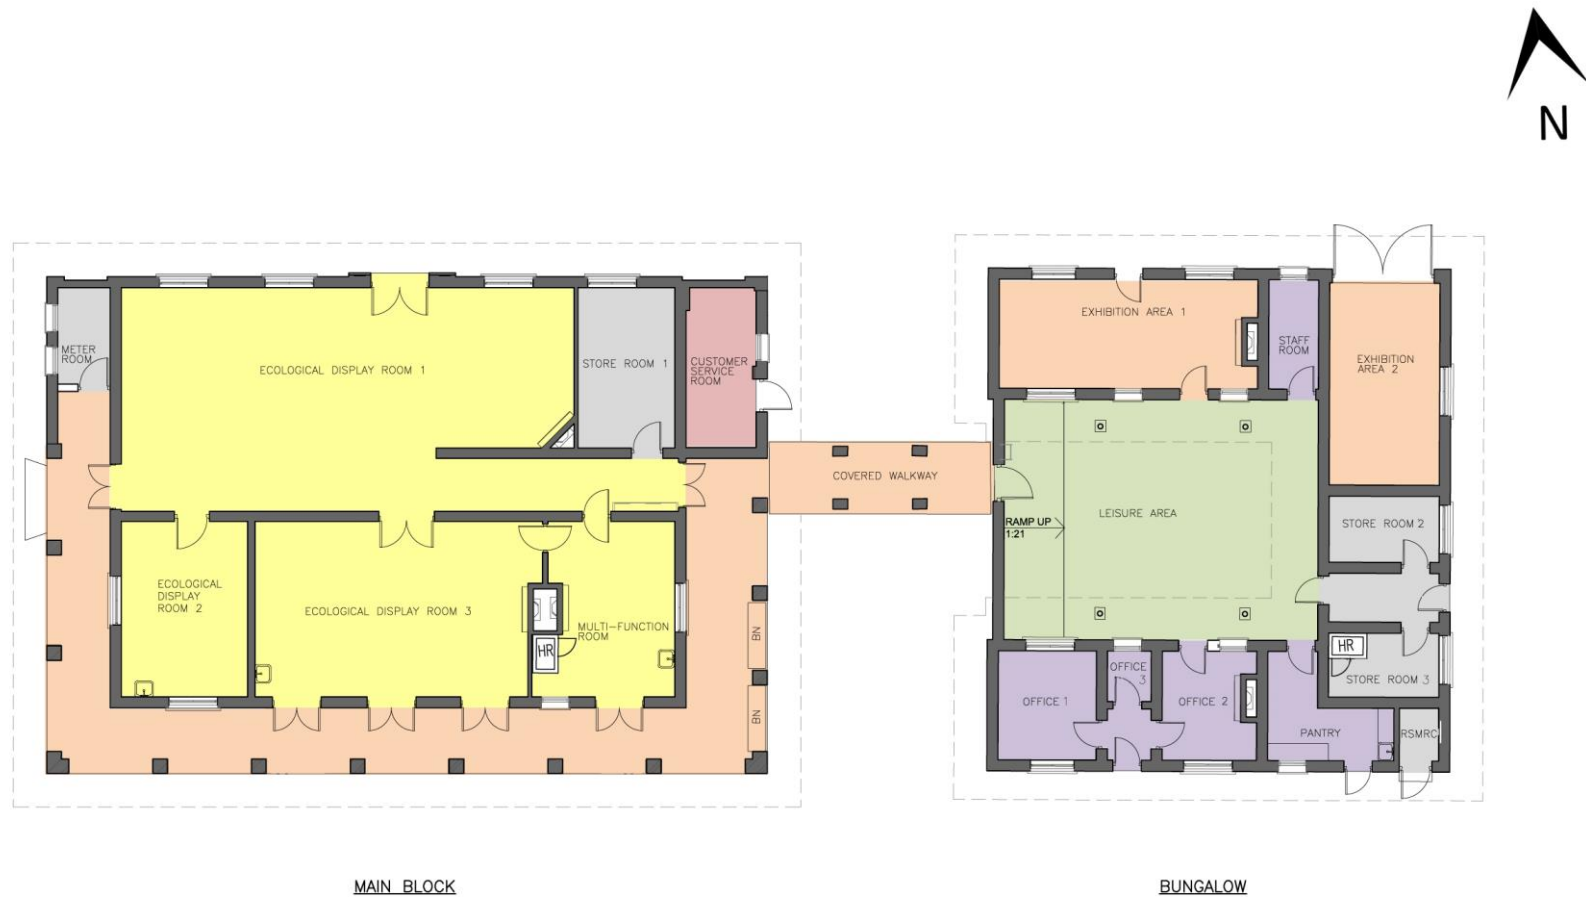
Fig 40. The proposed layout plan for existing buildings. Edited by Hannah Liu.

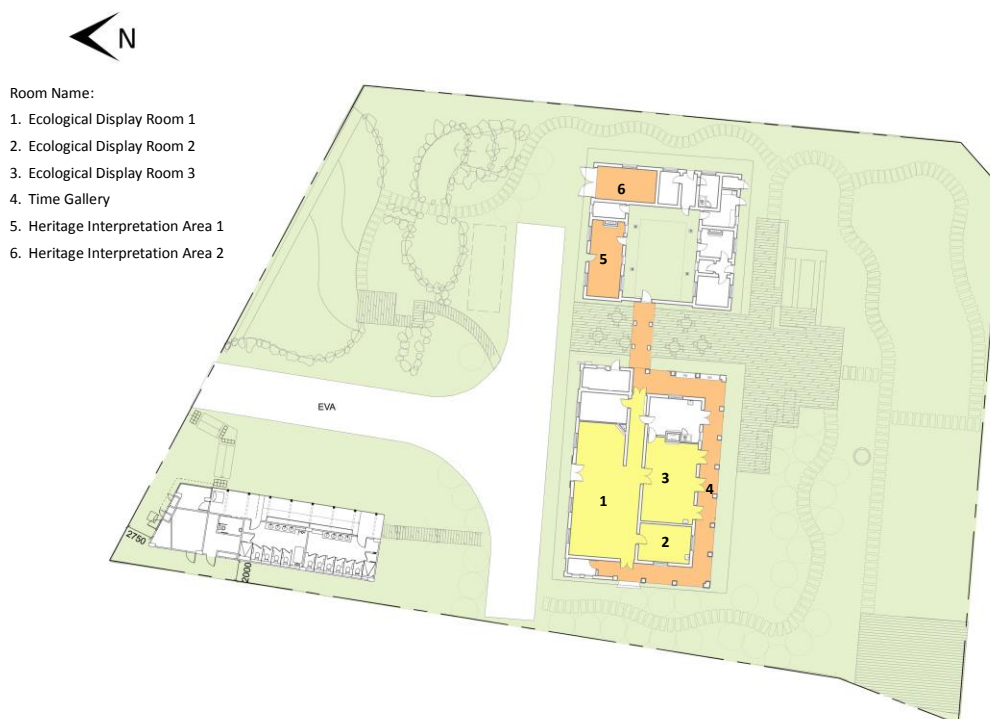
Fig 42. The plan of the areas opened for public in business hours. The area coloured in yellow are Ecological Discovery Area. The area coloured in orange are Heritage Interpretation Area. The area coloured in green are Agricultural Microcosm Area and other open area. Edited by Hannah Liu.

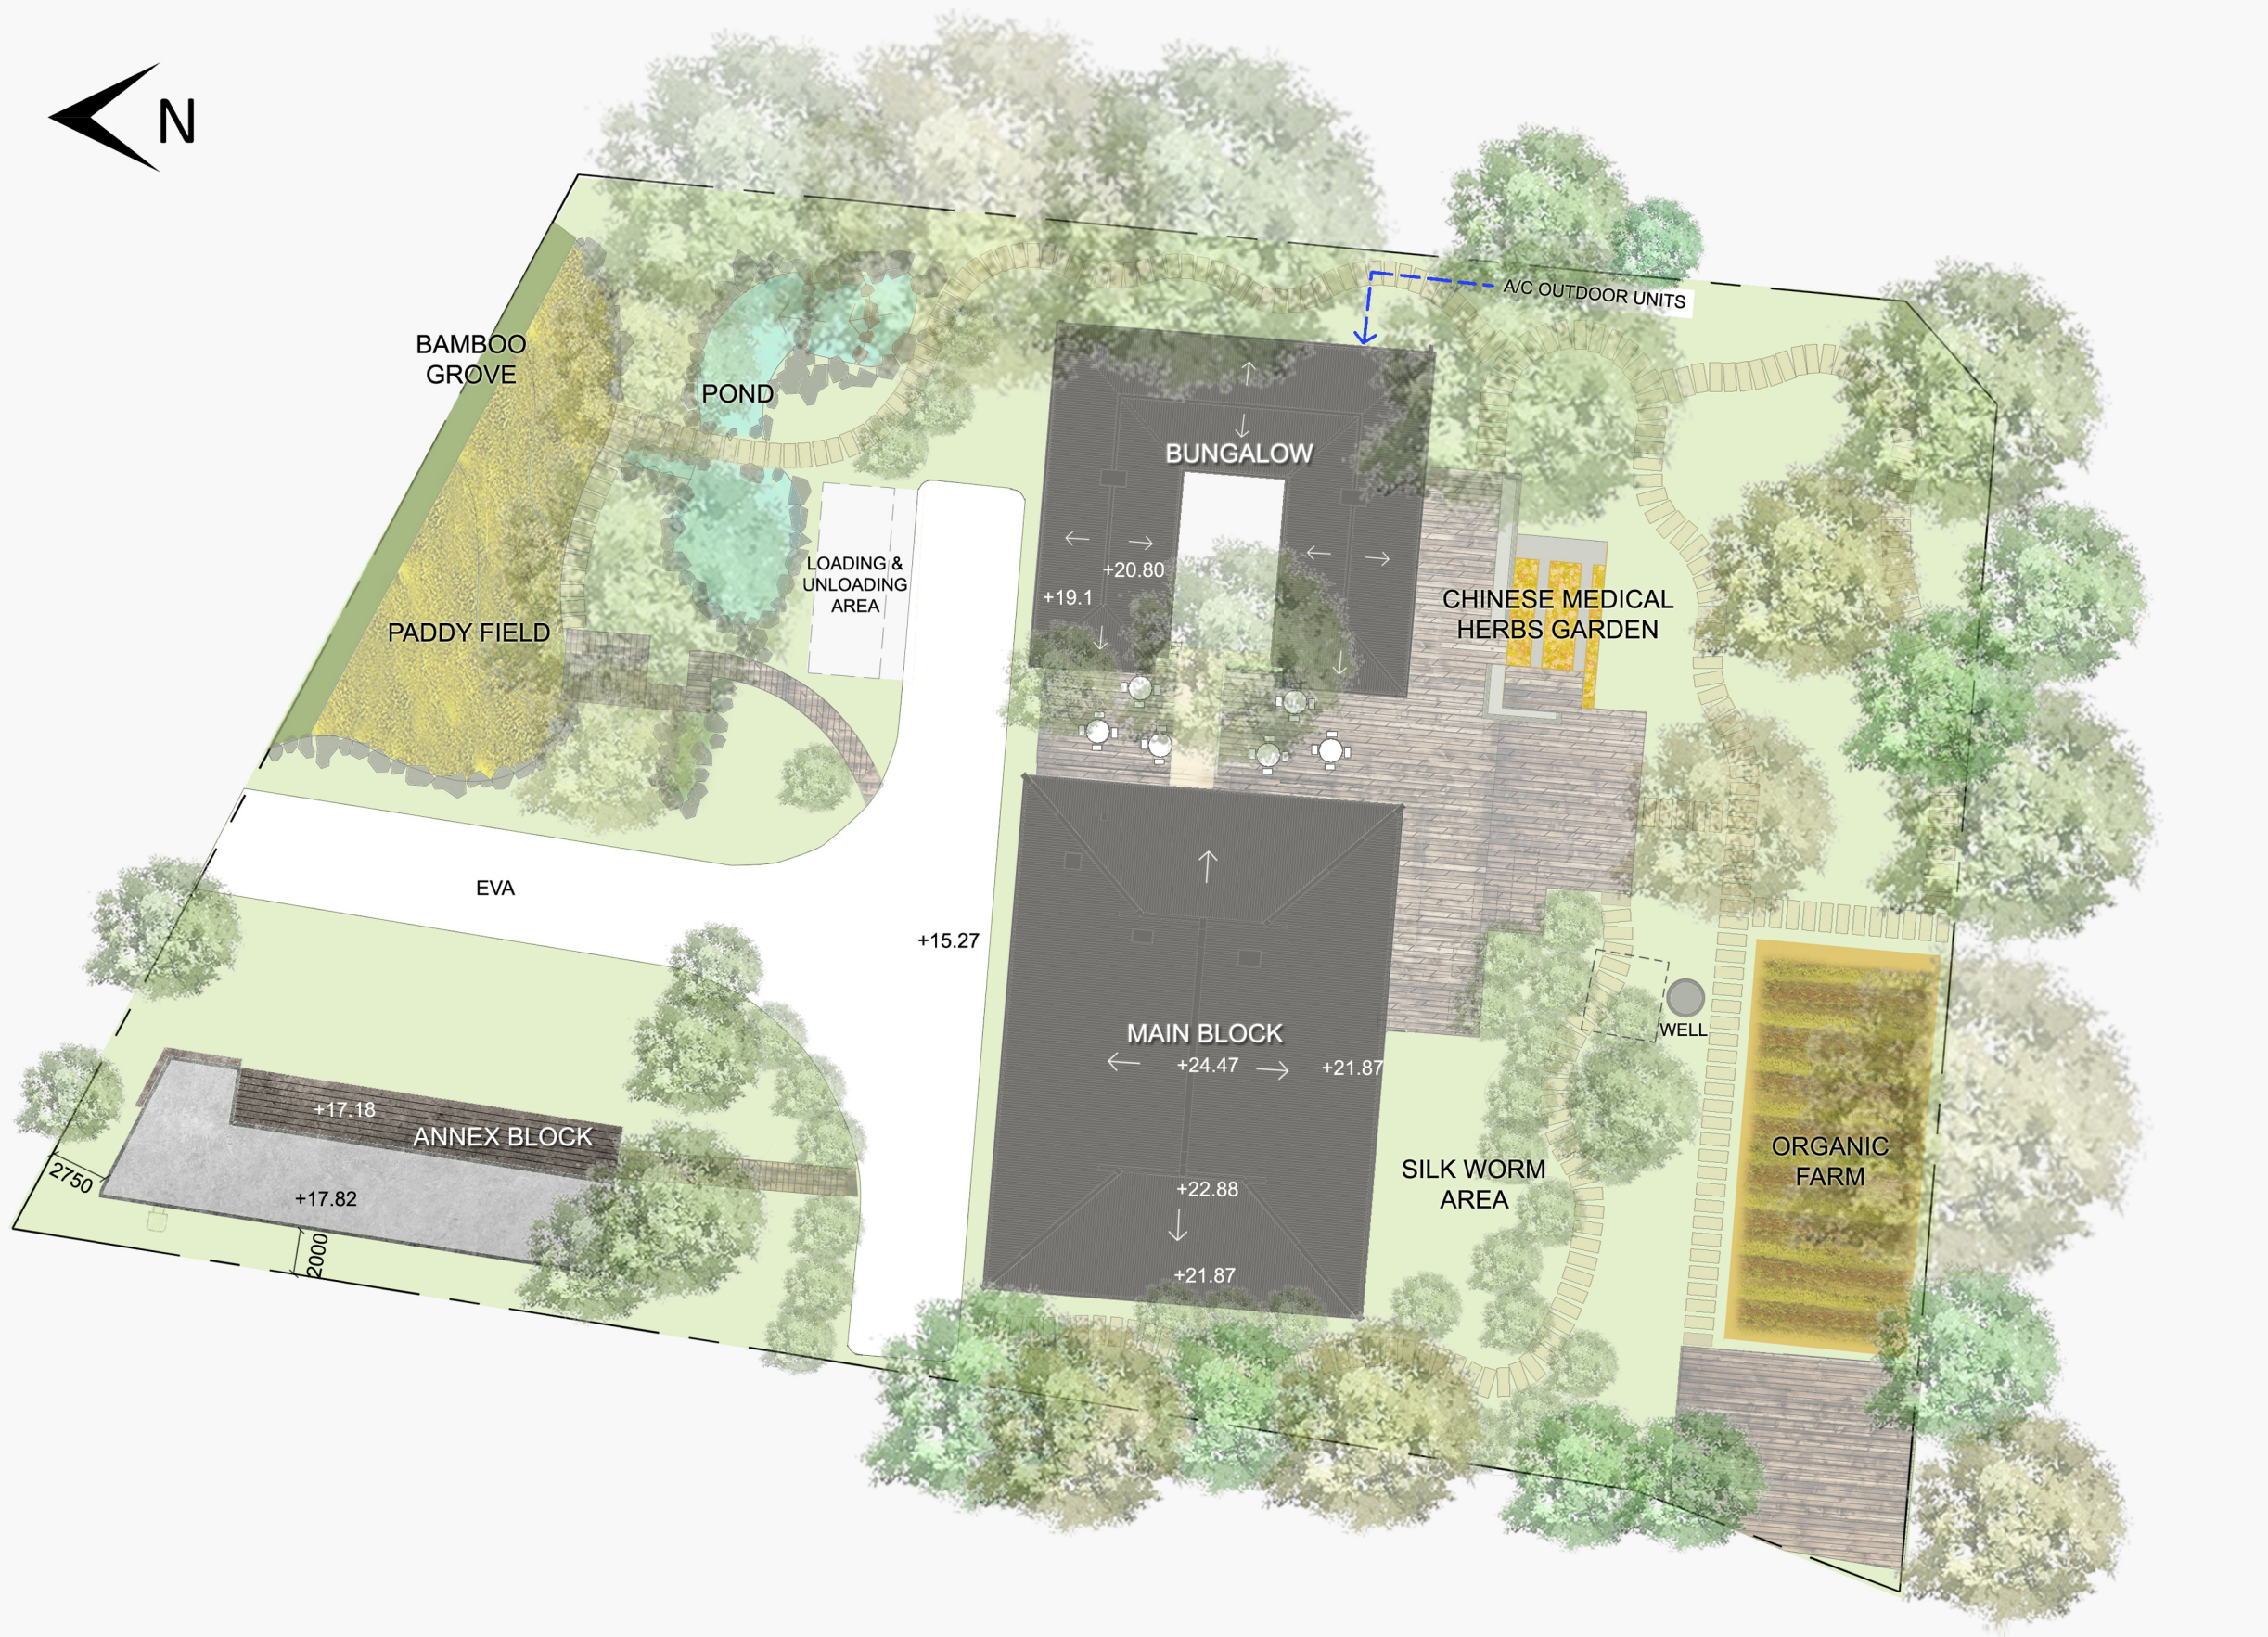
DRAWING TITLE :
SITE LAYOUT PLAN

--- AC PIPES ROUTING TO ENTER BUILDING (PARTIALLY UNDERGROUND)

--- UNDERGROUND RAINWATER RECYCLING SYSTEM (APPROX. 3m(L) x 3m(W))
