Hong Kong Heritage
Conservation Foundation Limited
香港歷史文物保育建設有限公司

CONSERVATION MANAGEMENT PLAN FOR THE OLD TAI O POLICE STATION

HONG KONG HERITAGE CONSERVATION
FOUNDATION LIMITED

APRIL 2009

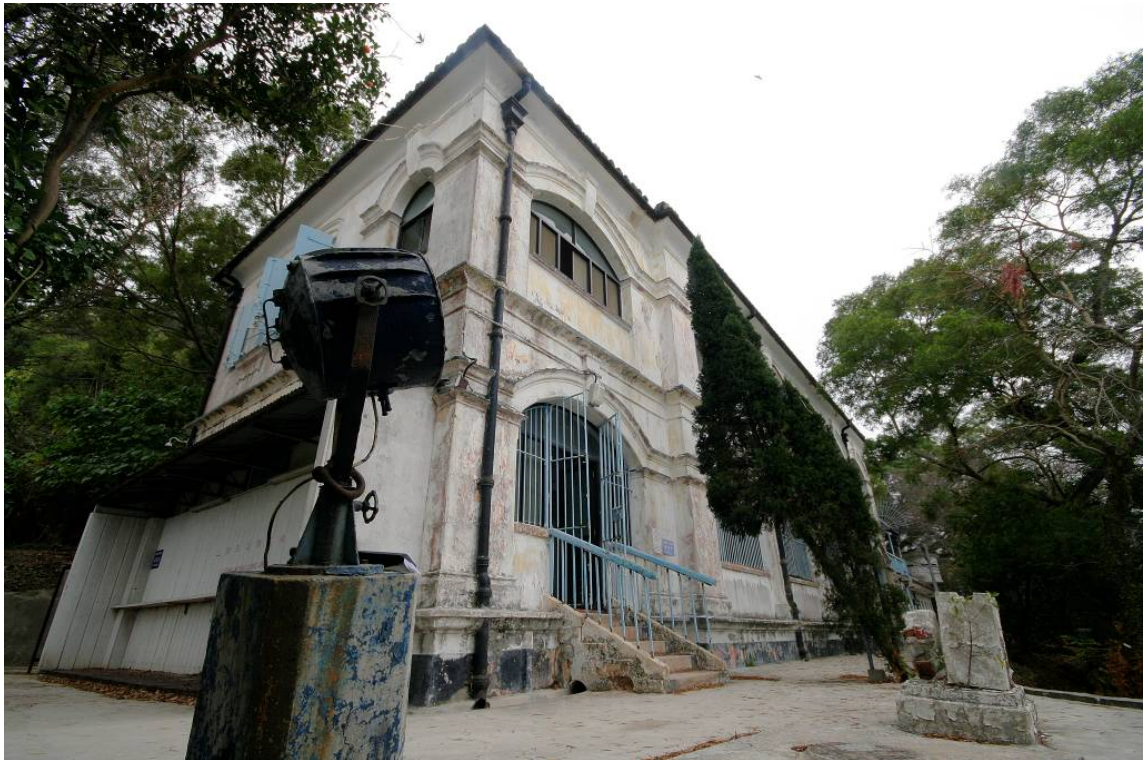
**Figure 6. (2008) A View of the Old Tai O Police Station
– the façade of the Main Building after over a decade of deterioration**
(Source: Hong Kong Heritage Conservation Foundation Limited)

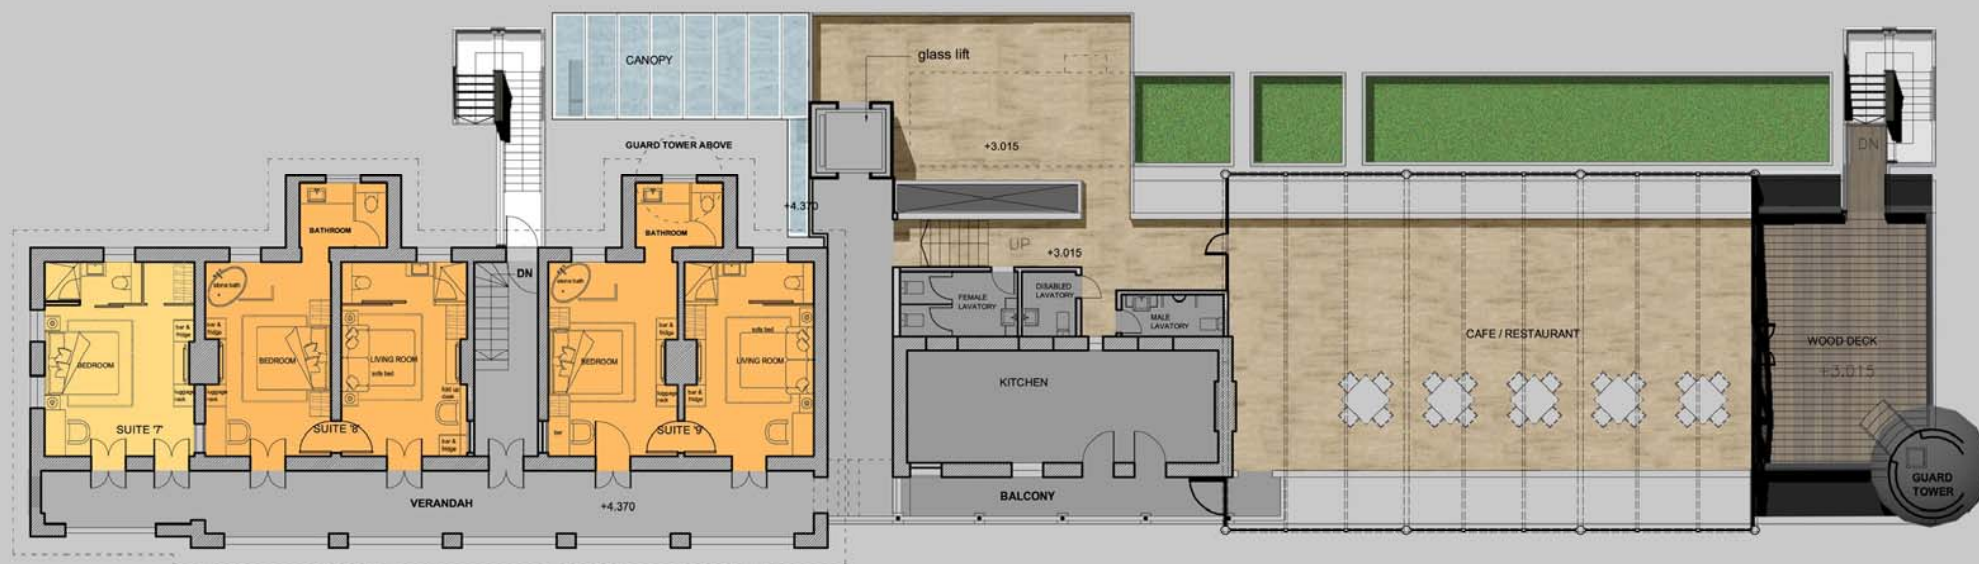
FIRST FLOOR PLAN

First level Floor plan

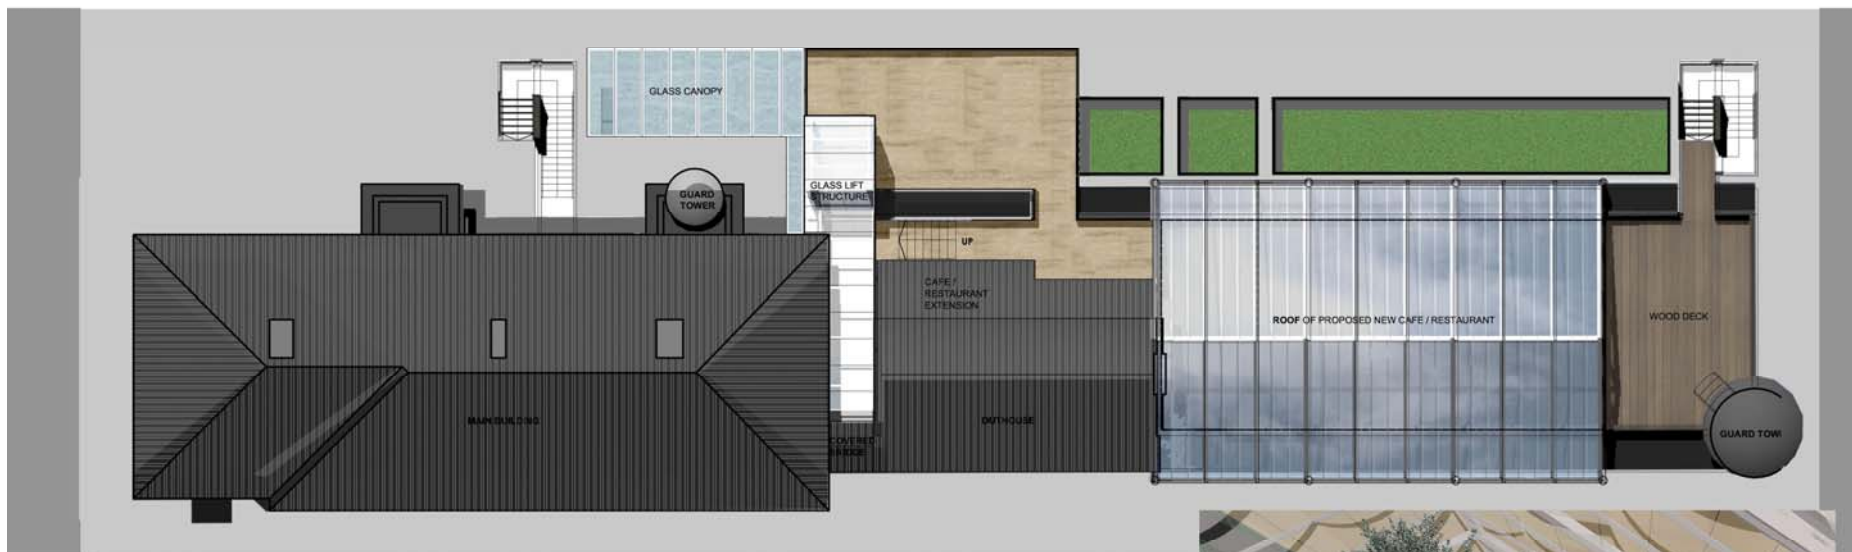
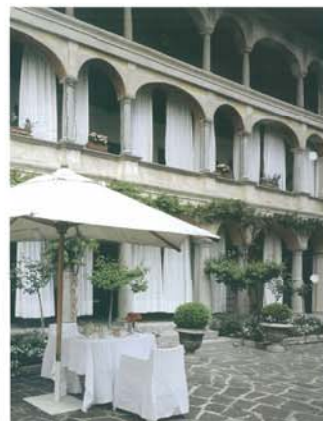
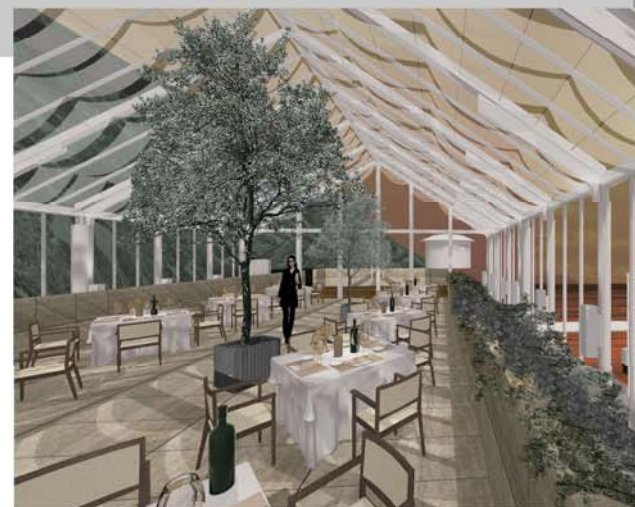
ROOF PLAN

Roof plan
