Heritage Impact Assessment

Revitalization of the Old Dairy Farm Senior Staff Quarters
into The Pokfulam Farm

Spence Robinson Ltd.
Architects Project Managers Interior Designers
馬海(建築顧問)有限公司

March 2017

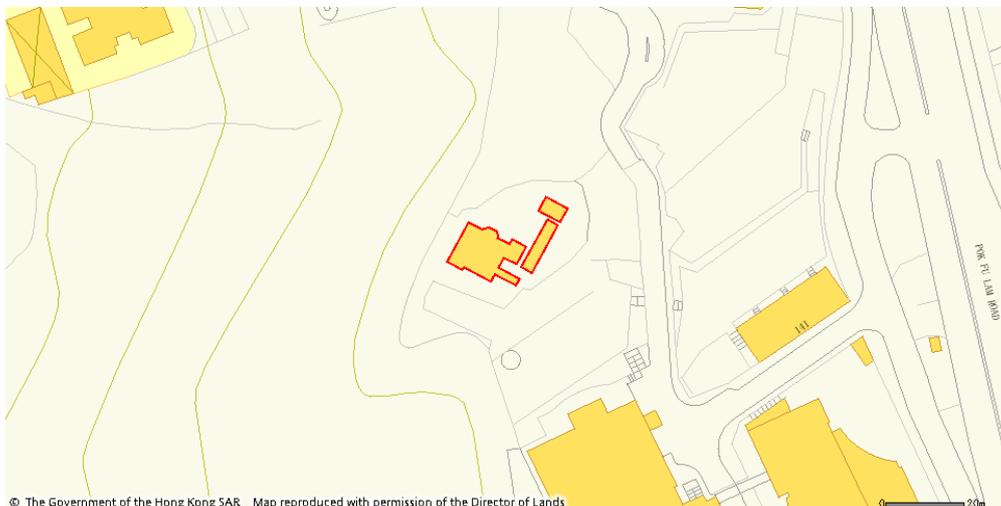
The following map shows the grading boundary of the building.

Fig 2. Grading Boundary Plan. (Source: *The Geographical Information System on Hong Kong Heritage, 2012*)

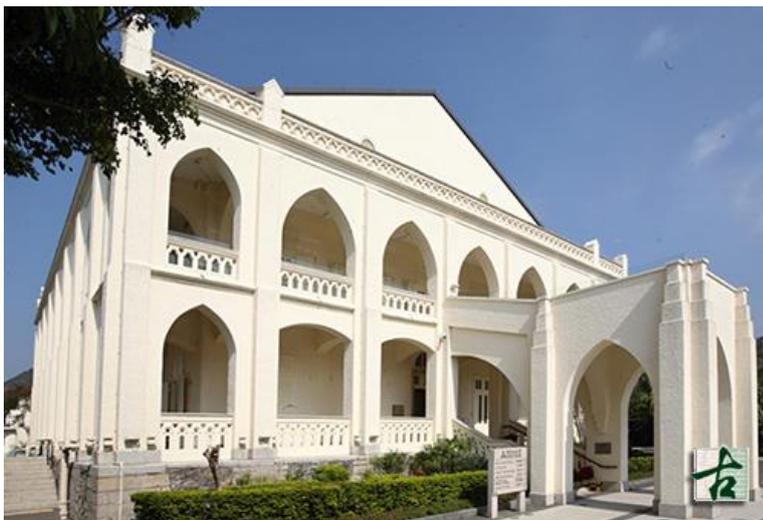
Fig 7. South elevation of today's Béthanie with a porch added in the 1920s. (Source: Antiquities and Monuments Office, Hong Kong, 2009)

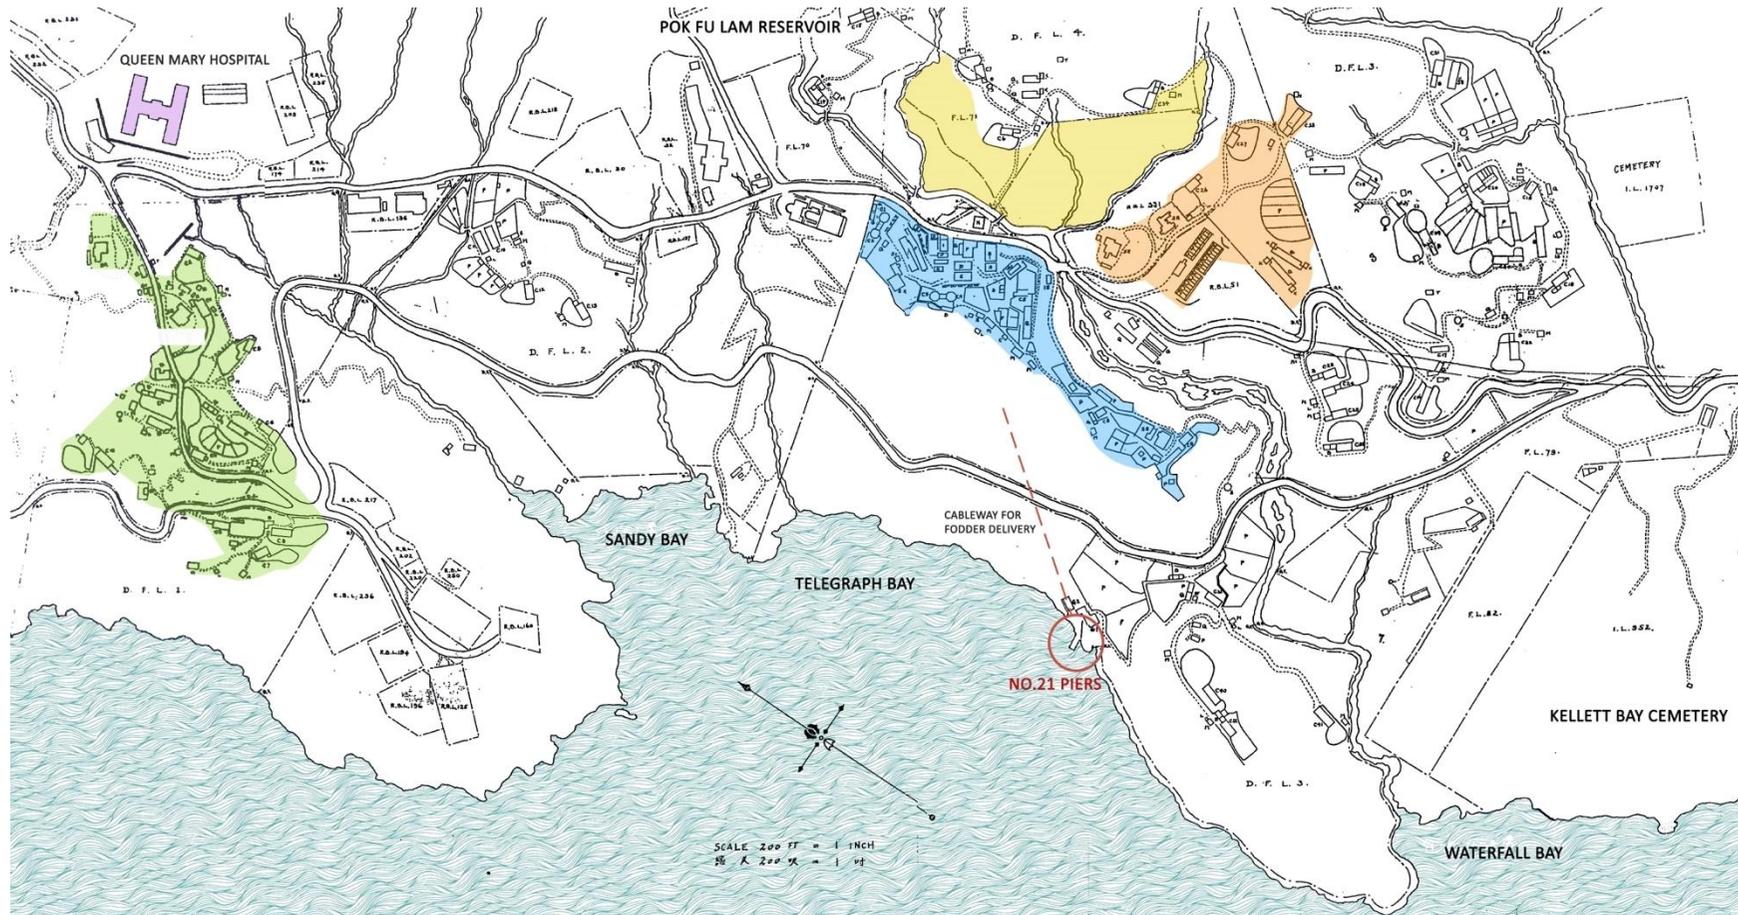
Fig 15. Survey map done by the Japanese during 1941-45. This is the earliest record that could have found showing the large span of Dairy Farm structures at that time, mainly located along water streams. Area shaded in blue is the Mains. Green refers to properties at Sassoon Road. Orange refers to Claymore. Yellow refers to the Pokfulam Village. It also recorded in Nigel Cameron's book that the land of Queen Mary Hospital, which on the opposite side of the Sassoon's Properties (shaded in purple), was originally formed part of the farm. (Source: Public Records Office, 1941-45, Record ID: MM-0340; *The Milky Way*, Nigel Cameron, 1986, p.77) Edited by Hannah Liu

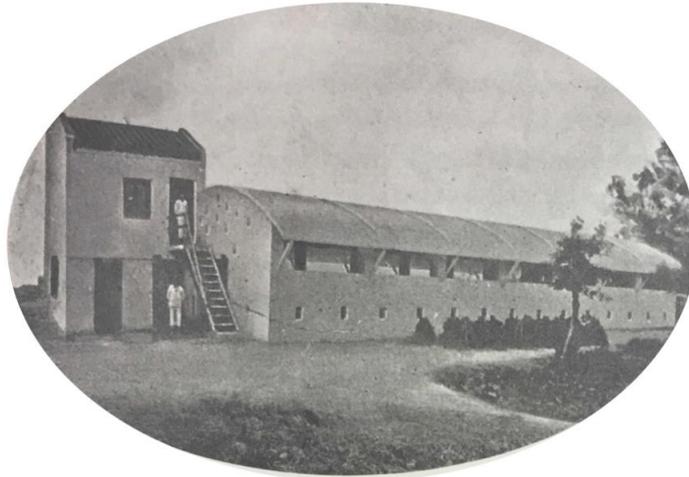
As mentioned in the previous section, the farm had also brought new population to the area. The workers of Dairy Farm were on three shifts a day. In order to save their traffic time from going back and forth home, the workers would stay up in the small house erected on the top of the cowsheds. Some of them even chose to build huts in the Pokfulam Village or rent houses from villagers.¹⁸

Fig 16. Cowshed, with attendants' quarters attached to it. Exact year of photo taken is not known. (Source: *The Dairy Farm, Ice and Cold Storage Co. Ltd. Hong Kong, 1919, p.40*)

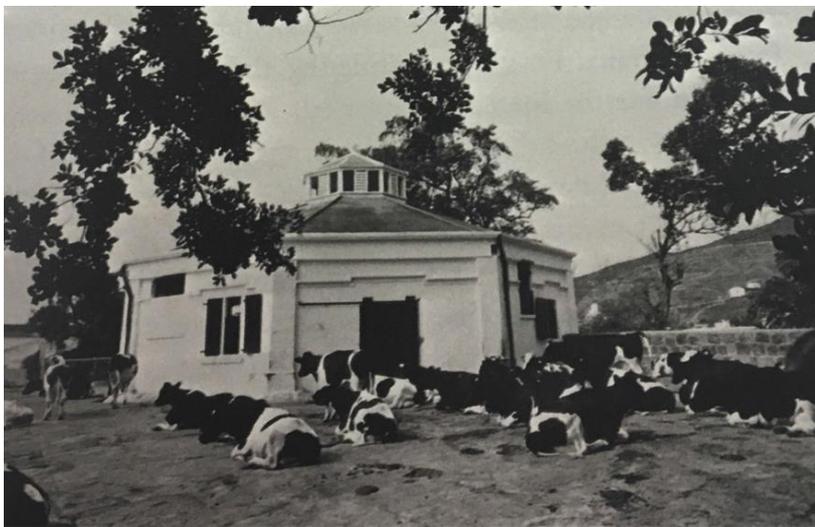
Fig 17. View of octagonal cowshed at Mains. Exact year of photo taken is not known. (Source: *Dairy Farm Co. Ltd., 1986, p.6*)

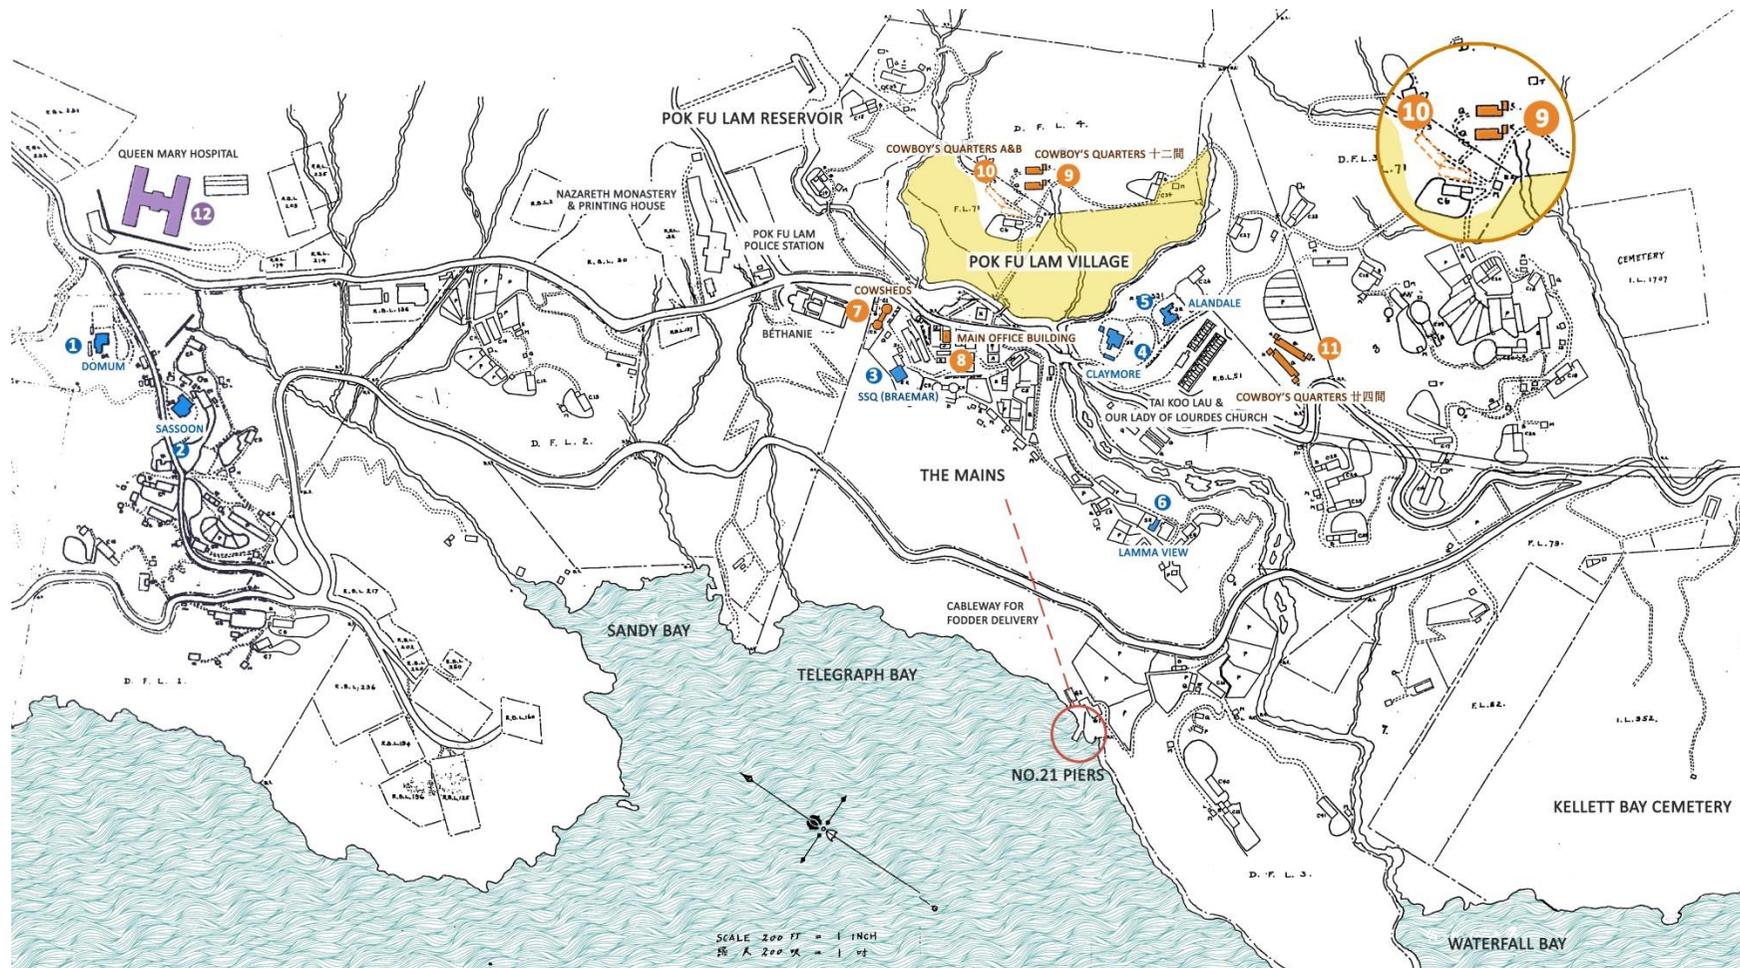
Fig 19. Fig 1. Survey map done by the Japanese during 1941-45. Properties shaded in blue are the senior staff quarters. Orange refers to office and cowboy's quarters. Building shaded in purple is the Queen Mary Hospital today, which the land originally formed part of the farm. The Cowboys' Quarter Block A&B (item no.10, highlighted in orange dotted line) are not indicated in the original Japanese map due to they were constructed in 1956 and 1961. (Source: Public Records Office, 1941-45, Record ID:MM-0340) Edited by Hannah Liu.

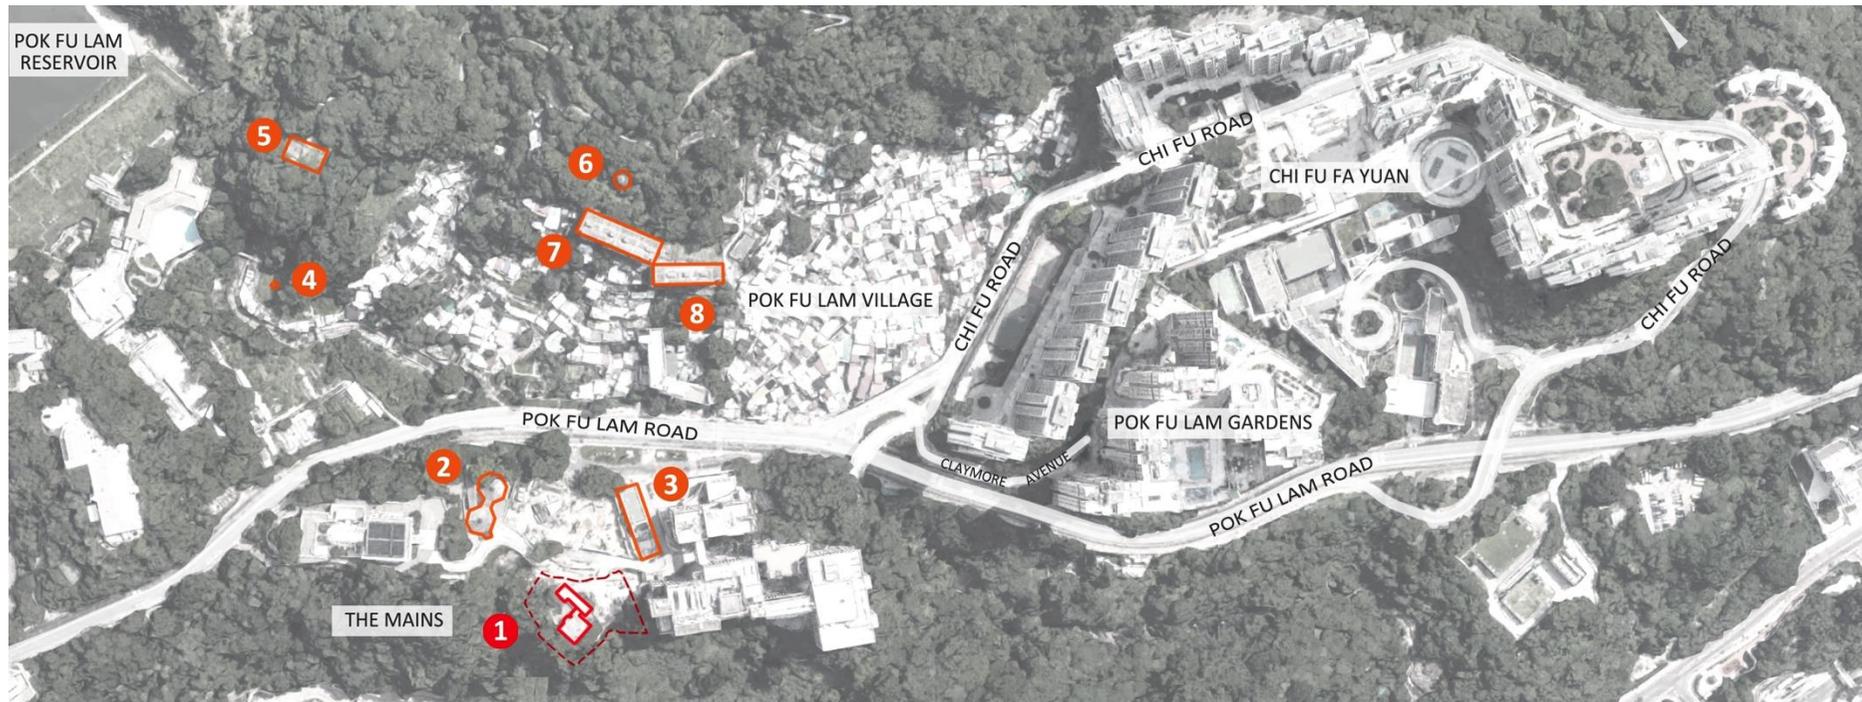
Fig 20. Location of the main Remains around the Mains of the Old Dairy Farm. (Source: Google Map) Edited by Hannah Liu

No.	The Remains	Completion Year
1	Old Dairy Farm Senior Staff Quarters (Braemar)	1887
2	Old Dairy Farm Cowshed	1887
3	Old Dairy Farm Main Office Building	1920s
4	Old Dairy Farm Manure Pit	Unknown
5	Old Dairy Farm Paddock (Partial)	Unknown
6	Old Dairy Farm Silo	Unknown
7	Old Dairy Farm Staff Quarter Block B	1950s-1960s
8	Old Dairy Farm Staff Quarter Block A	1950s-1960s

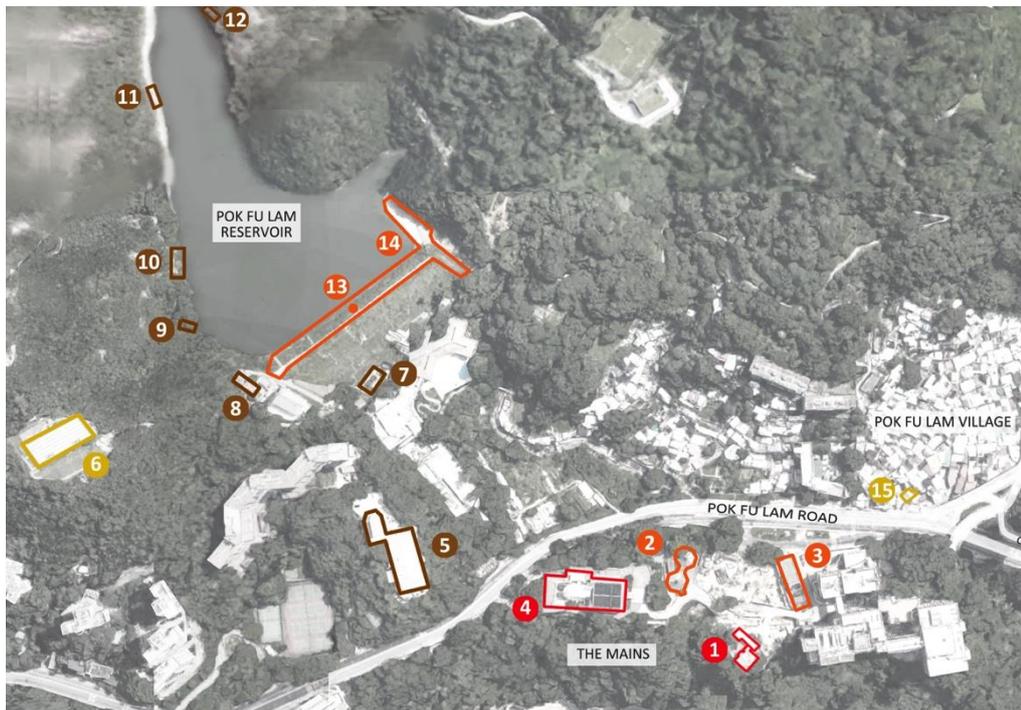
Three of the remaining buildings (the SSQ, the Cowshed and the Main Office Building) as well as other historic buildings / structures in the surrounding are identified and recorded by the AMO as graded historic buildings and declared monuments. A table and site map below shows the allocation and the year of completion of the graded historic buildings in the context:-

Fig 21. Location of the Built Heritage around the Mains of the Old Dairy Farm (Source: Google Map) Edited by Hannah Liu

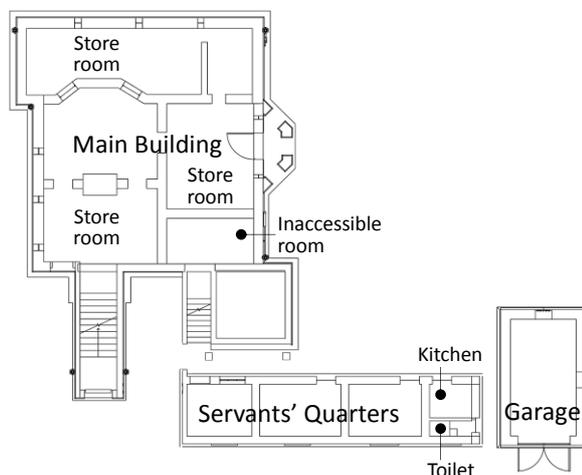
The Old Dairy Farm Senior Staff Quarters comprise the Main Building, the Servants' Quarters and the Garage Block. The Main Building is a 2-storey building. The ground floor storey has thick granite block walls pierced at regular intervals by circular bull's eye windows for ventilation. These granite walls act as a plinth to support the principal storey at first floor level. The first floor wall was built by brick. The ground floor, which has clear headroom of less than 2m, is probably used as storage. The first floor, which consists of period fireplaces, is probably used to be living room and bedroom for the farm manager. The roof was constructed of concrete ribbed slab which is not original.

Fig 22. Existing ground floor plan, Drawn by Hannah Liu

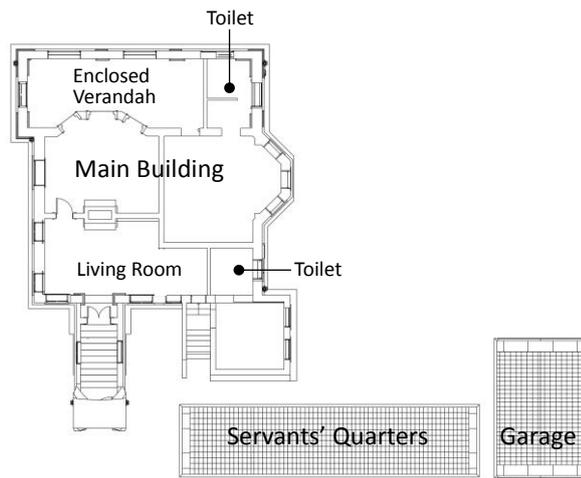
Fig 23. Existing first floor plan, Drawn by Hannah Liu

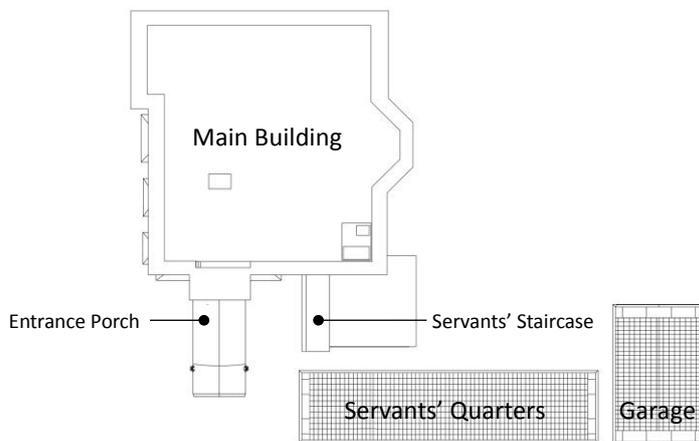
The Servants' Quarters and the Garage are 1-storey building constructed by brick and granite block respectively. Both buildings have double layered pan and roll tiles pitched roofs.

Fig 24. Existing roof plan, Drawn by Hannah Liu

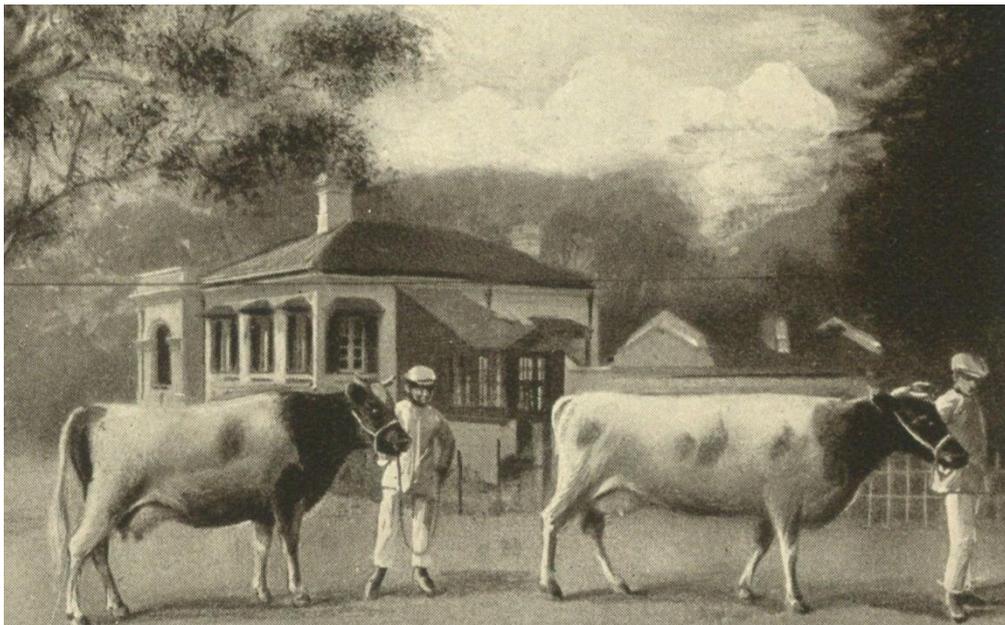
Fig 25. The oldest record photo of the SSQ. Exact year of photo taken is not known. (Source: Report of The Dairy Farm, Ice and Cold Storage Co., Ltd., Hong Kong 1886-1919,

Window awning and louvre could be found from the 1919 historic record image. As seen from site photos in 2013, the window louvre were already gone, and the window awnings had been removed during the basic repair works in 2014. Further research will be needed to verify the construction material of the window awnings.

According to the 3D laser scanning conducted in 2013, a chimney could be found near the south west side of the Servants' Quarters. The same chimney could also be seen from the 1919 historic record image but now it does not exist. Instead there is another chimney left at the opposite end of the block. It is believed there are originally two chimneys in the Servants' Quarters.

No.	CDE	Level of Significance	Photo	Location
A-12	<p>Flat roof of the Main Building</p> <p>* The portion of roof above the verandah is originally a flat roof according to old photo as shown in Fig. 25</p>	Low

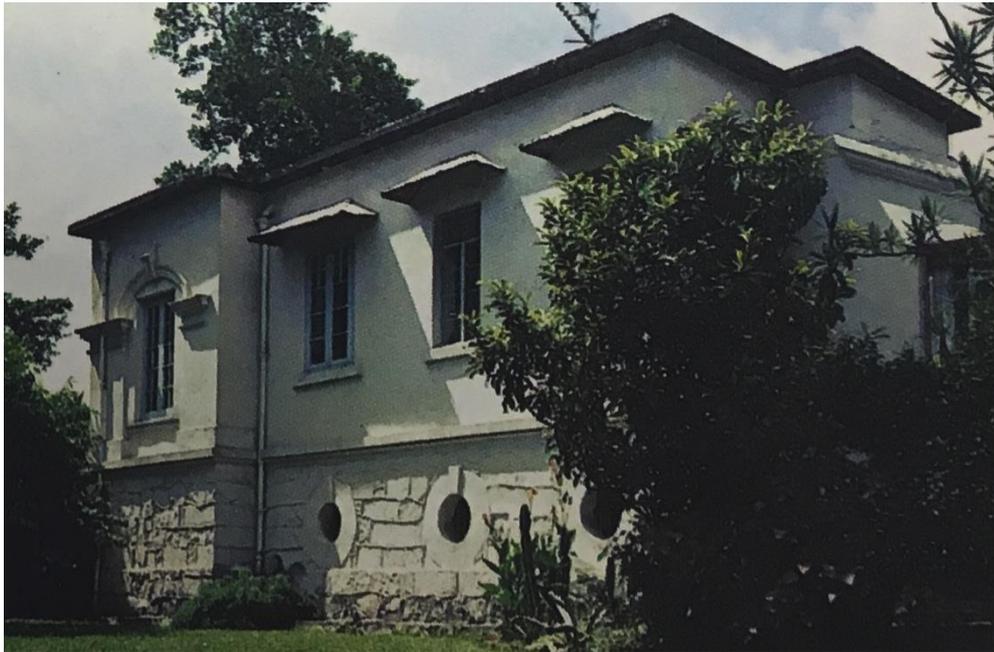
Fig 26. View of the SSQ in 1980s. (Source: Nigel Cameron, The Milky Way: the history of Dairy Farm. Hong Kong: Dairy Farm, 1986)

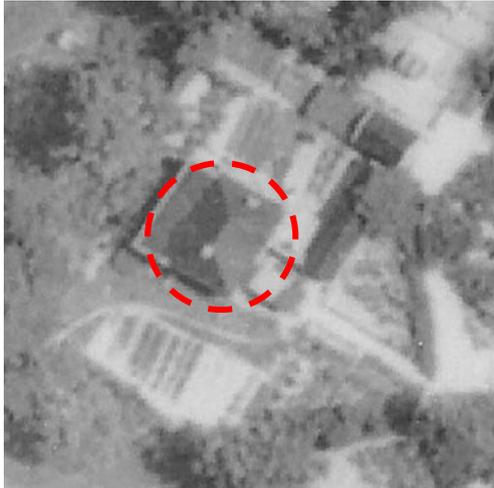
Fig 27. Aerial Photo of the SSQ in 1949 shows the roof of the Main Building as hipped pitch roof. (Source: Survey and Mapping Office, Hong Kong)

The roof of the Main Building composed of a flat roof and a hipped pitch roof. According to the aerial photos from the Survey and Mapping Office in 1949 and 1960, the roof of the Main Building had been converted from pitched roof into flat roof and one of the chimney had been demolished in between these years.

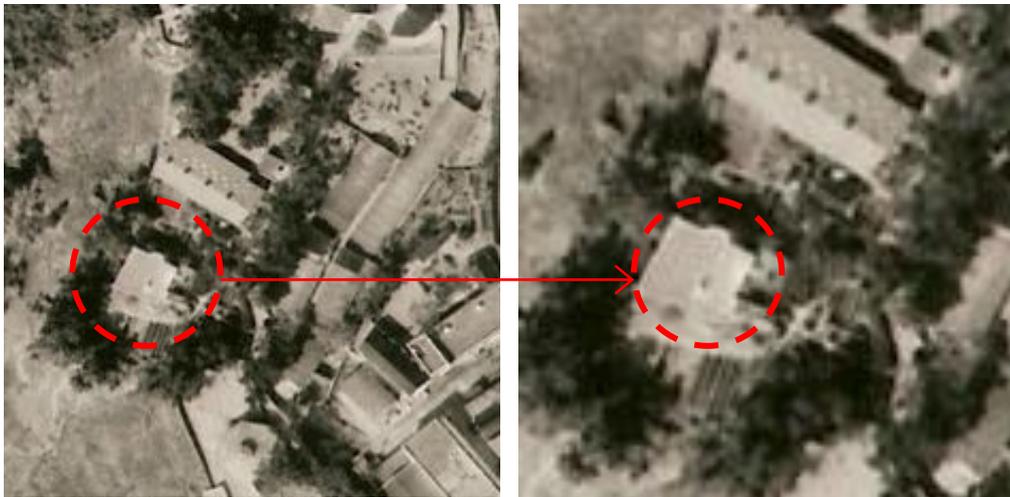
An aerial photo in 1963 shows a clearer picture convincing to illustrate the evolution of roof form. Apart from the change of pitched roof into one flat slab, one of the chimneys had also been demolished.

Fig 29. Aerial photo of the SSQ in 1963. (Source: Survey and Mapping Office, Hong Kong)

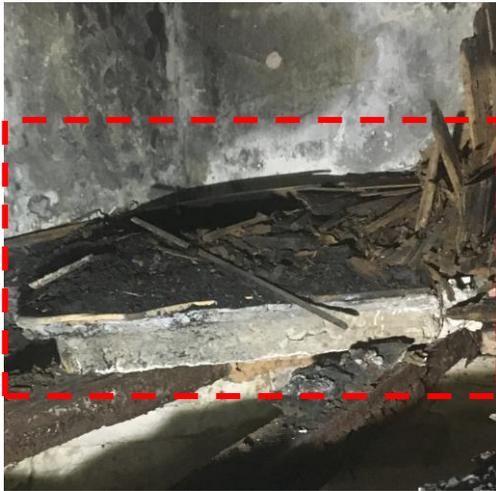
Site photos below show the relic of the chimney stack and plinth of the fire place evidence the existence of the chimney in the past.

Fig 30. Site photo showing the plinth of the fire place, 2016 (Source: Photo took by Betty Tay)

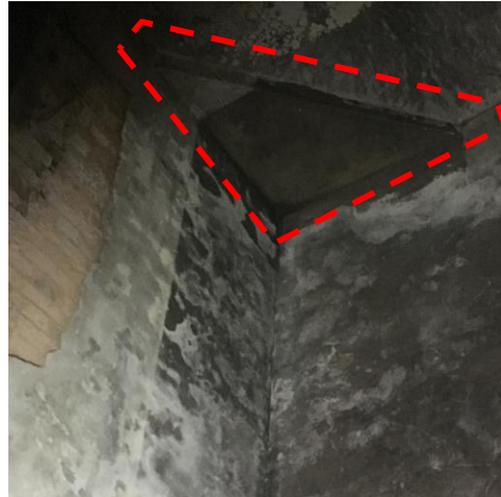
Fig 31. Site photo showing the relic of the chimney stack, 2016. (Source: Photo took by Betty Tay)

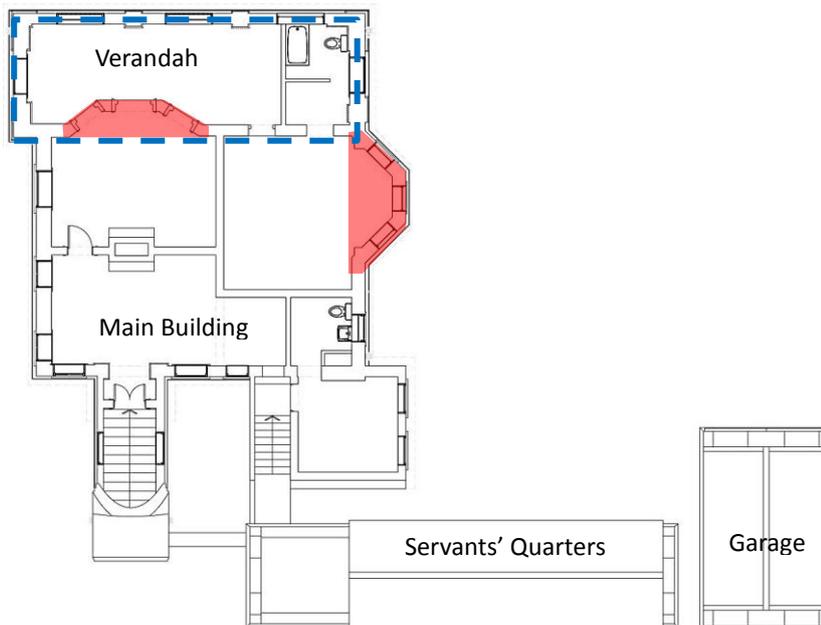
Fig 32. Existing layout plan of SSQ. (Source: Prepared by Betty Tay)

Two octagonal bays could be found in the Main Building. The octagonal projecting bay window (or projecting bay) is important feature of Arts and Crafts movement (which began in Britain in the second half of the 19th Century and continued into the 20th Century). Normally adopted for use in main room, gives panoramic view and feel of home.

Although the verandah has long existed in the historical record image found in the Report of The Dairy Farm, Ice and Cold Storage Co., Ltd., Hong Kong 1886-1919, it is believed that the verandah is a later added structure since the octagonal bays should face externally, for people's appreciation of the scenic view of East Lamma Channel.

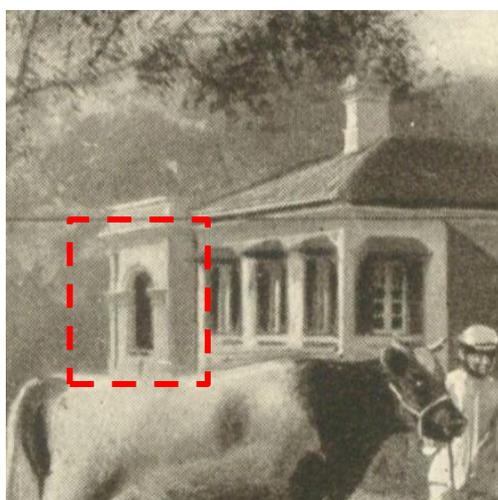
Compared with the historical record image, the openings on the façade of the verandah had been enclosed, and installed with timber windows.

Fig 33. The oldest record photo of the SSQ. Exact year of photo taken is not known. (Source: Report of The Dairy Farm, Ice and Cold Storage Co., Ltd., Hong Kong 1886-1919, issued by The Dairy Farm, Ice and Cold Storage Co. Ltd., Hong Kong in 1919)

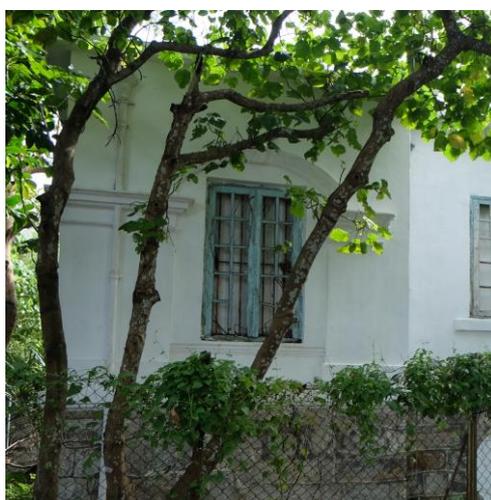
Fig 34. Site photo showing the enclosed verandah (Source: Photo took by Betty Tay, 2016)

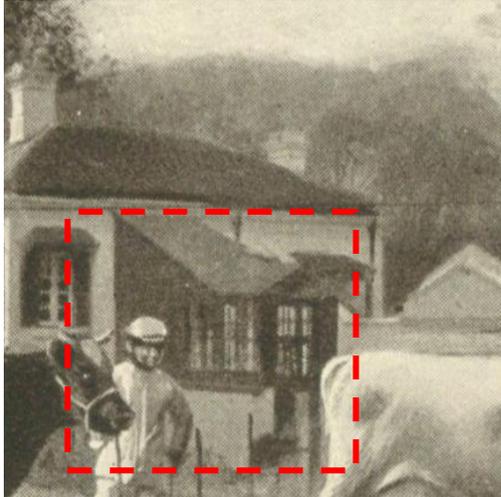
Compared with the historical record image, the entrance porch had been completely altered. The original pitched roof had been changed to arched roof. The grid like structure supporting the roof had been changed to enclosed brick wall.

Fig 35. The oldest record photo of the SSQ. Exact year of photo taken is not known. (Source: Report of The Dairy Farm, Ice and Cold Storage Co., Ltd., Hong Kong 1886-1919, issued by The Dairy Farm, Ice and Cold Storage Co. Ltd., Hong Kong in 1919)

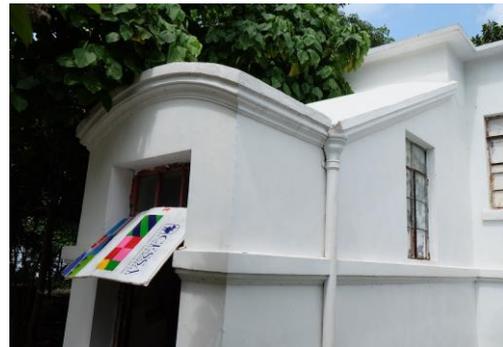
Fig 38. Site photo showing the arched roof porch, 2016 (Source: Photo taken by Betty Tay)

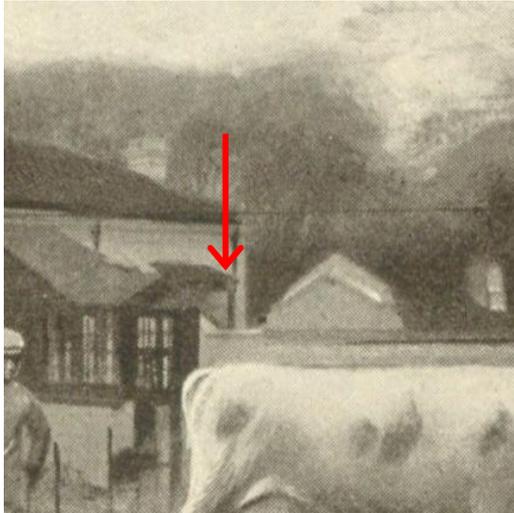
A flat roof structure had been built adjoining the Main Building. The window located at the South East facade had been blocked. It is believed to be a later added structure since it doesn't exist in the historical record image.

Fig 39. The oldest record photo of the SSQ. Exact year of photo taken is not known. (Source: Report of The Dairy Farm, Ice and Cold Storage Co., Ltd., Hong Kong 1886-1919, issued by The Dairy Farm, Ice and Cold Storage Co. Ltd., Hong Kong in 1919)

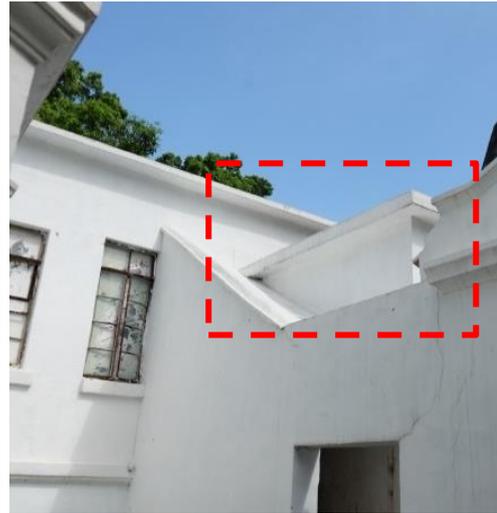
Fig 40. Site photo showing the flat roof structure attached to the Main Building, 2016 (Source: Photo took by Betty Tay)

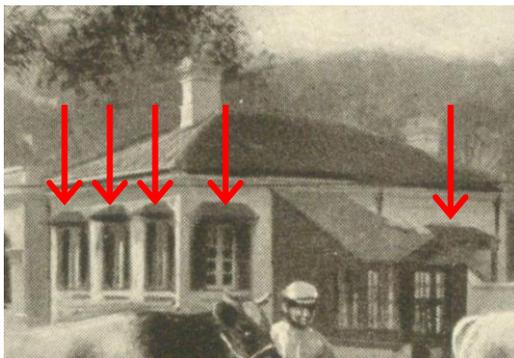
Fig 41. The oldest record photo of the SSQ. Exact year of photo taken is not known. (Source: Report of The Dairy Farm, Ice and Cold Storage Co., Ltd., Hong Kong 1886-1919, issued by The Dairy Farm, Ice and Cold Storage Co. Ltd., Hong Kong in 1919)

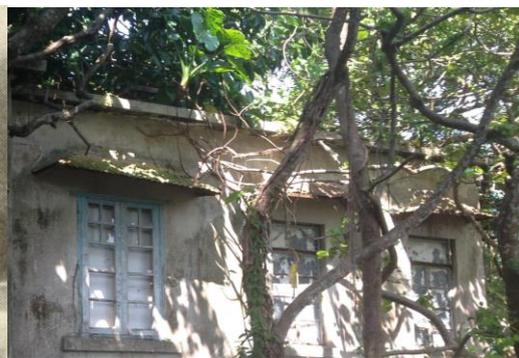
Fig 42. Site photo showing the flat roof structure, 2013 (Source: Photo took by Betty Tay)

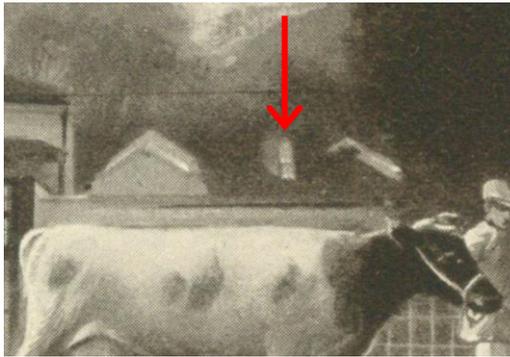
Fig 43. The oldest record photo of the SSQ. Exact year of photo taken is not known. (Source: Report of The Dairy Farm, Ice and Cold Storage Co., Ltd., Hong Kong 1886-1919, issued by The Dairy Farm, Ice and Cold Storage Co. Ltd., Hong Kong in 1919)

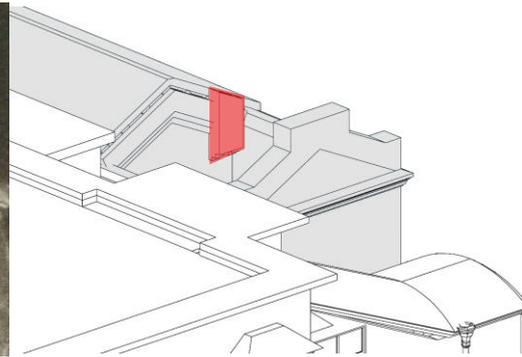
Fig 44. 3D laser scanning showing the remaining chimney in the Servants' Quarters, 2016 (Source: Photo took by Betty Tay)

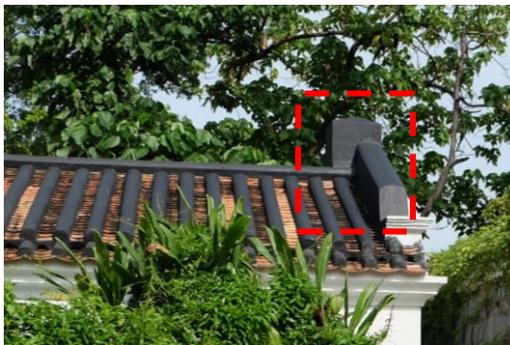
Fig 45. Site photos showing the remaining chimney in the Servants' Quarters (exterior), 2016 (Source: Photo took by Betty Tay)

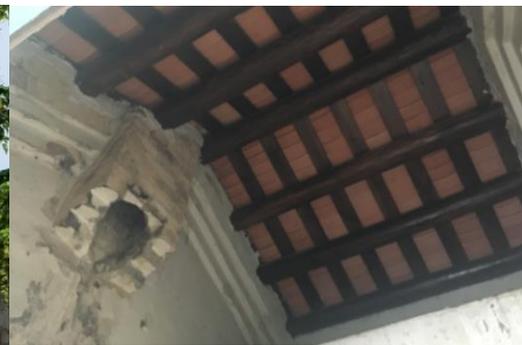
Fig 46. Site photos showing the remaining chimney in the Servants' Quarters (interior), 2016 (Source: Photo took by Betty Tay)

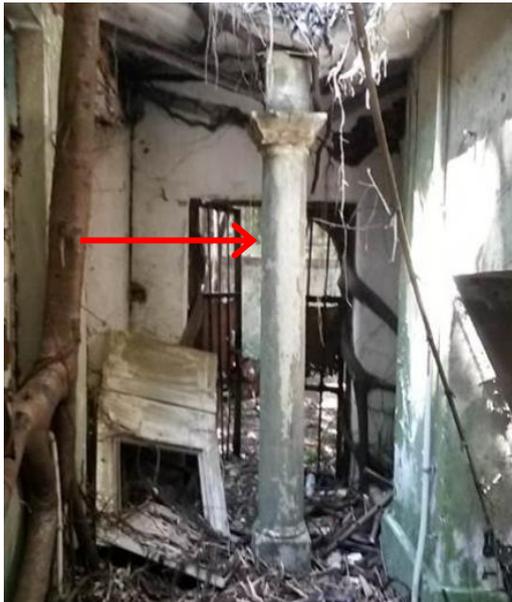
A site photo in 2013 shows the column of the covered walkway at the rear side of the Servants' Quarter which now being removed. Only two column bases were left insitu.

Fig 47. Site photo showing the column of the covered walkway, 2013 (Source: Revitalising Historic Buildings Through Partnership Scheme – Old Dairy Farm Senior Staff Quarters – Resource Kit, 2013, P.75)

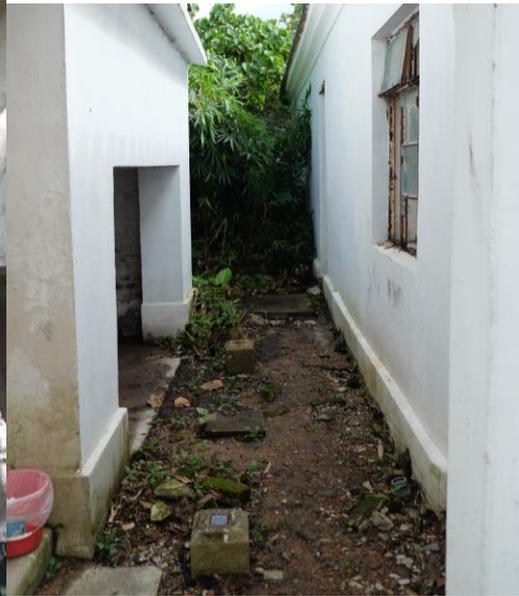
Fig 48. Site photo showing the remaining column base, 2016 (Source: Photo taken by Betty Tay)

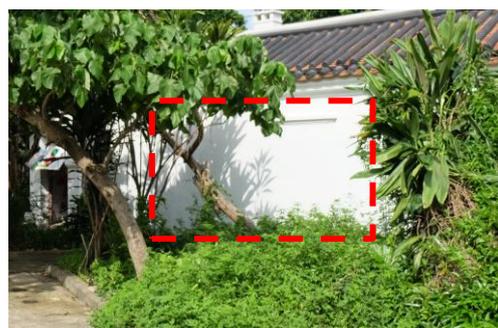
The original timber window frames and window sills of the Servants' Quarters had been removed and the window openings had been infill by the bricks.

Fig 50. Site photo showing the windows had been blocked with original moulded canopies, 2016 (Source: Photo taken by Betty Tay)

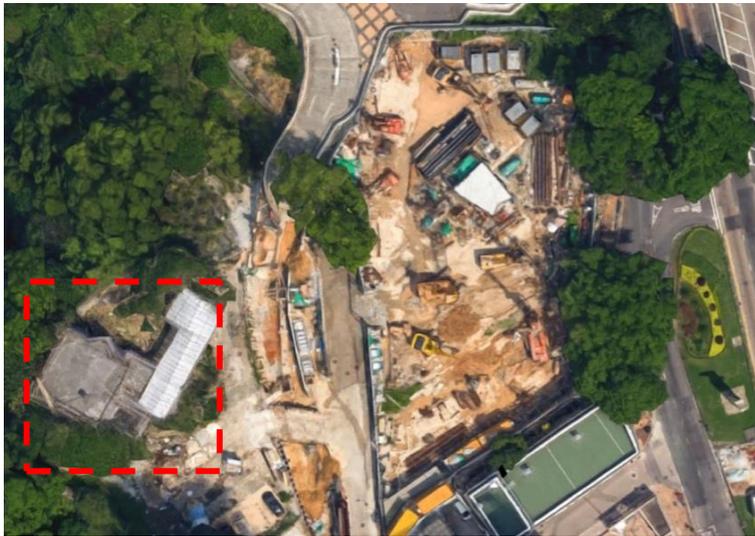
Until now, the later alteration and additional works including the concrete

flat roof, the only one remaining chimney, arch roof porch and additional flat roof structure were still remained.

Fig 51. Google Earth Photo of the SSQ in 2016 years. (Source: Google Map)

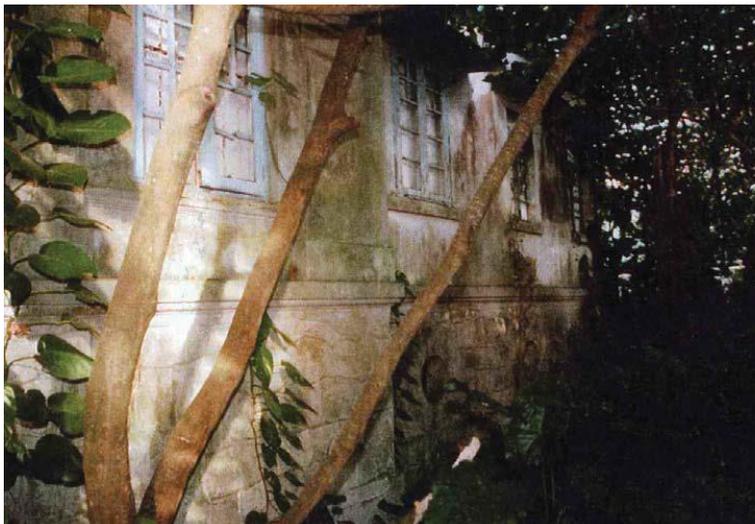
Since the SSQ has been vacant for long years out of repair, the overall condition is poor and the buildings are in need of a basic repair not including the power, water supplies and sewerage system. In 2013, an inspection was conducted by ArchSD. All of the three buildings are badly dilapidated in particular the upper floor of the Main Building which a bedroom was damaged by fire. The Servants' Quarters and the Garage were enclosed and extensively damaged by the intrusive tree and brushes growing.²³

Fig 52. View of the SSQ before the basic repair works carried out by ArchSD. Year of photo taken is unknown. (Source: Antiquities and Monuments Office, Hong Kong)

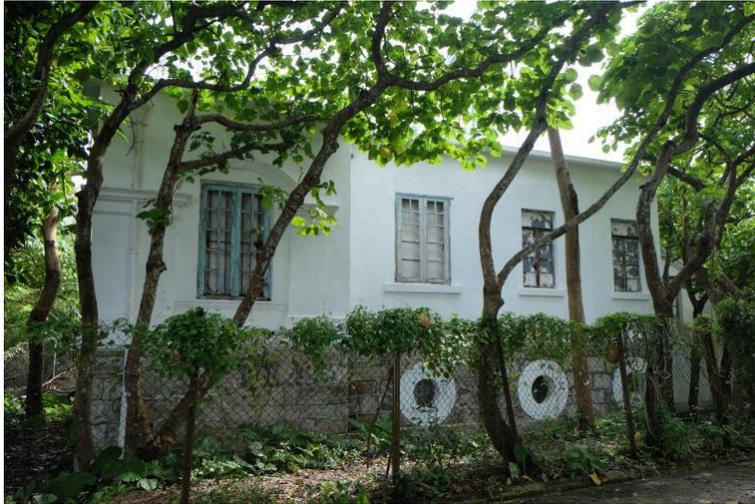
- Tree felling and clear all vegetation.
- Complete re-roofing at Servants' Quarters
- Basic repair of the building elements and components
- Surface drainage to prevent flooding
- Repair to perimeter fencing and necessary external works

Fig 53. View of the SSQ after repair works, 2016 (Source: Photo taken by Betty Tay)

However, the above repair works have not revealed the original appearance of the SSQ. The later altered flat roof, additional structure, arched roof porch and the enclosed verandah are still kept intact.

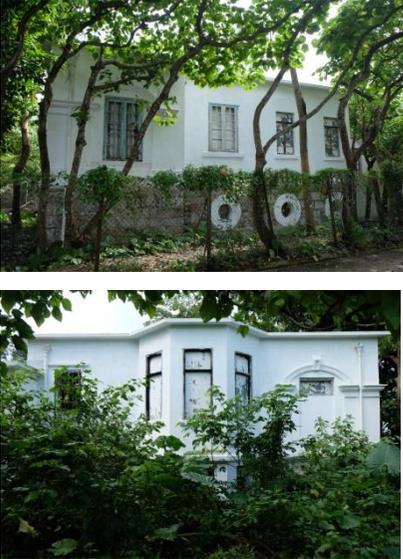
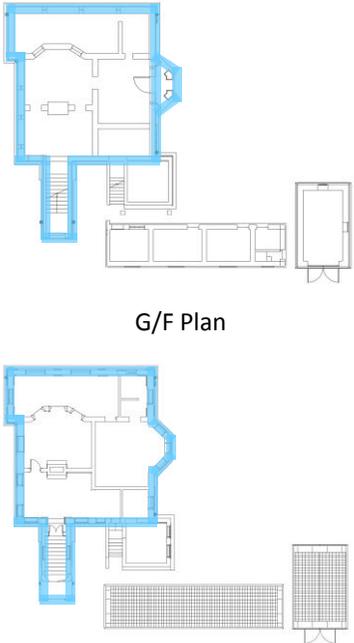
No.	CDE	Level of Significance	Photo	Location
A-01	All elevations with granite block walls at the lower floor and the rendered walls at the upper floor	High

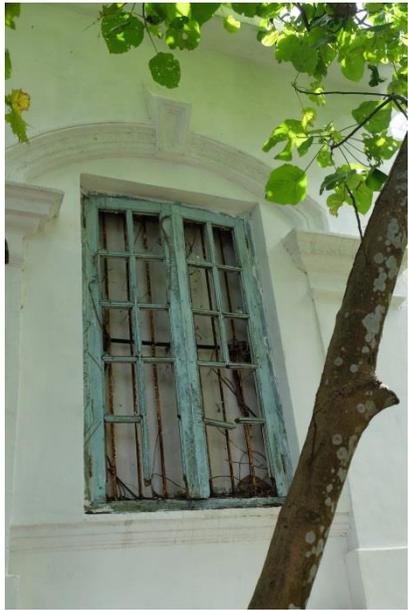
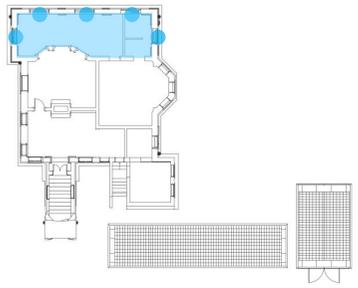
No.	CDE	Level of Significance	Photo	Location
A-02	Original verandah with classical architectural features on the elevations at the upper floor including columns, window sills, architraves and keystones.	High

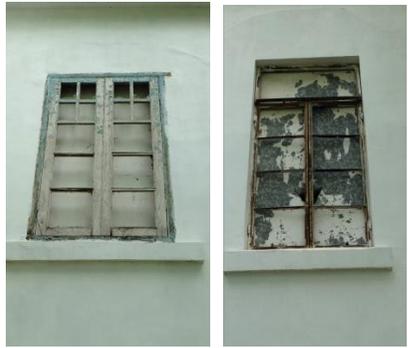
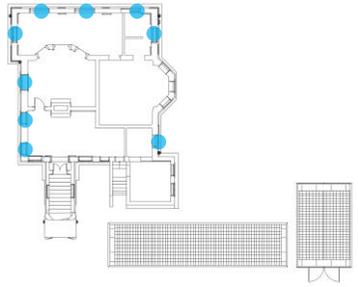
<p style="text-align: center;">1/F Plan</p>
A-03	Window openings at all elevations, including the timber window frames and the window sills (Steel windows are not original)	High

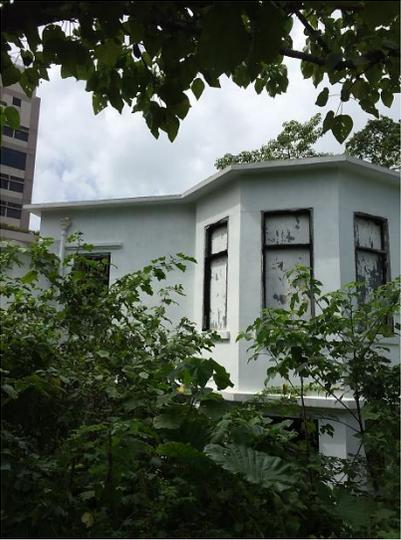
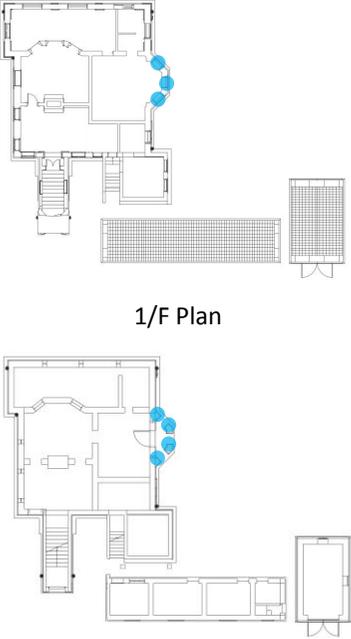
No.	CDE	Level of Significance	Photo	Location
A-04	Bay window at the north-east elevation, including the window openings, the window sills and the supporting columns	High

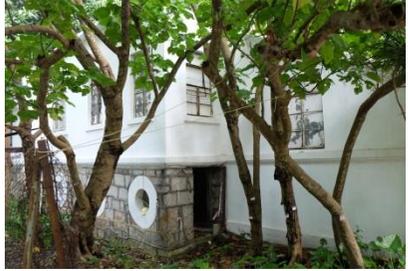
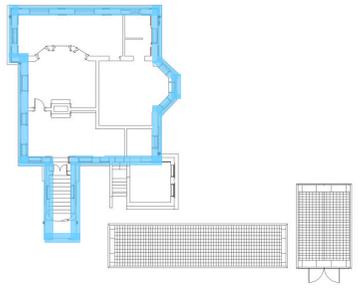
No.	CDE	Level of Significance	Photo	Location
A-05	Horizontal moulded bands aligned with the floor slab	High

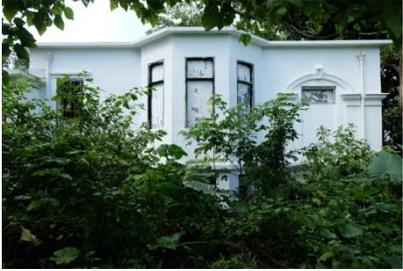
<p>Roof Plan</p>
A-13	<p>Flat roof structure attached to the Main Building</p>	Intrusive

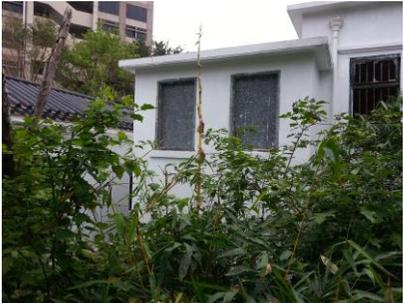
<p>Roof Plan</p>
A-14	<p>Servants' staircase and the wall connecting the Main Building and Servants' Quarters</p>	Moderate

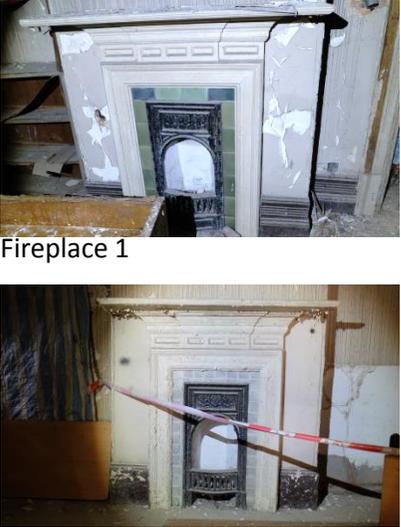
<p style="text-align: center;">Fireplace 1</p> <p style="text-align: center;">Fireplace 2</p>

No.	CDE	Level of Significance	Photo	Location
B-01	Fireplaces, including the stack, surrounds, tiling, grates and hearths	High

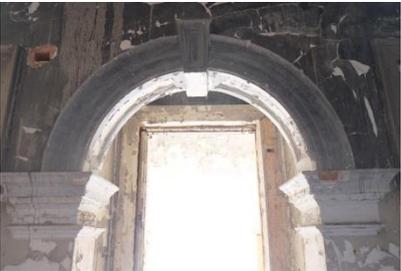
<p style="text-align: center;">1/F Plan</p>
B-02	Classical architectural features including columns, architraves, keystones and mouldings	High

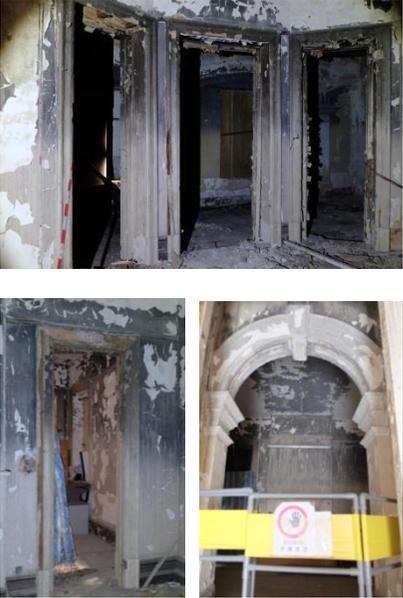
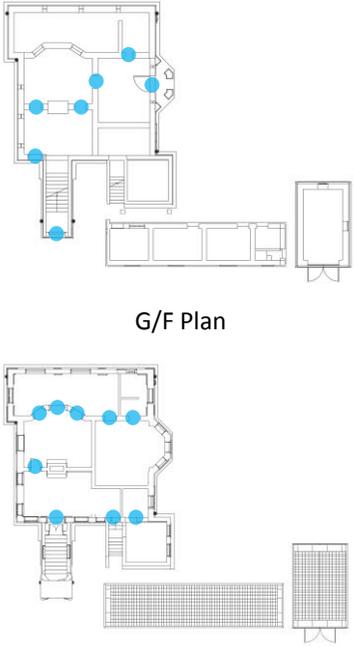
No.	CDE	Level of Significance	Photo	Location
B-03	Door openings, including the timber door panels, glass panels, moulded frame and ironmongeries	High

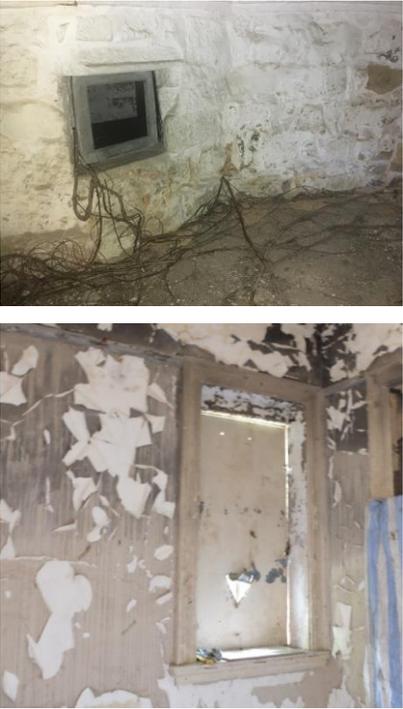
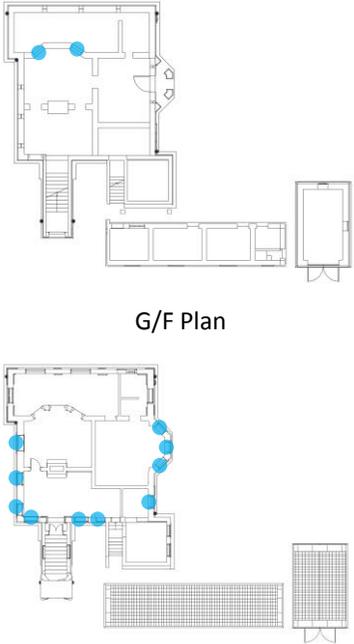
No.	CDE	Level of Significance	Photo	Location
B-04	Window openings, including the moulded window frames	High

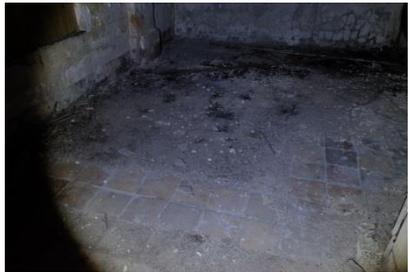
No.	CDE	Level of Significance	Photo	Location
B-05	Ceramic floor tiles at the enclosed verandah	Moderate

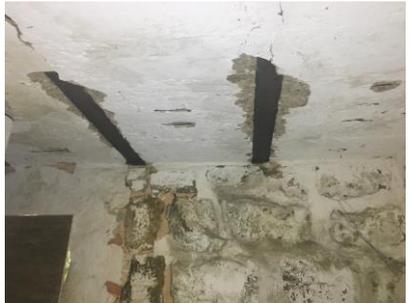
1/F Plan
B-06	Reinforced concrete slab floor embedded with I beams at the verandah	Moderate
