Heritage Impact Assessment

Revitalization of the Old Dairy Farm Senior Staff Quarters
into The Pokfulam Farm

Spence Robinson Ltd.
Architects Project Managers Interior Designers
馬海(建築顧問)有限公司

March 2017

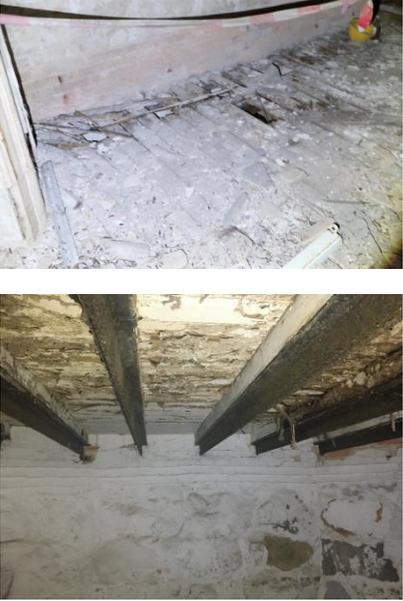
No.	CDE	Level of Significance	Photo	Location
B-07	Timber floor with timber joist supported on steel T-beam over corbelled mouldings	High

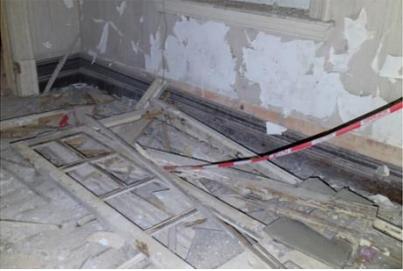
<p style="text-align: center;">1/F Plan</p>
B-08	Timber wall skirting	High

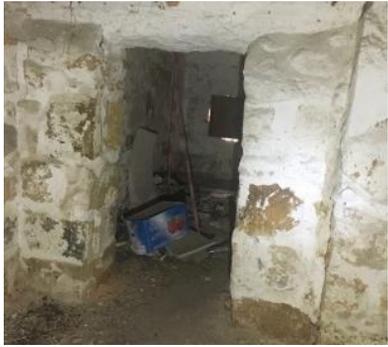
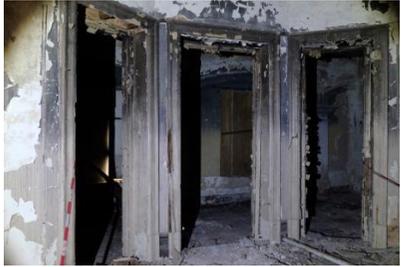
<p style="text-align: center;">G/F Plan</p>
B-10	Internal partitioning	Moderate

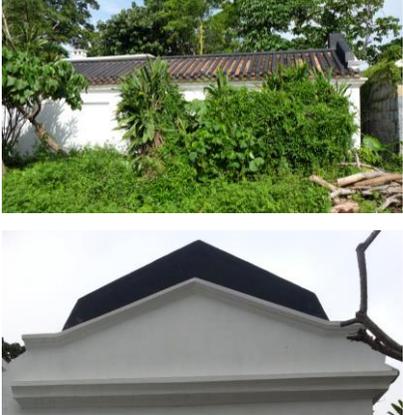
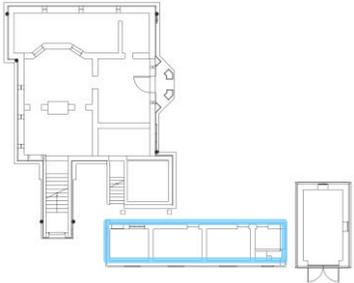
No.	CDE	Level of Significance	Photo	Location
C-01	All elevations of the Servants' Quarters, including the moulded pediments

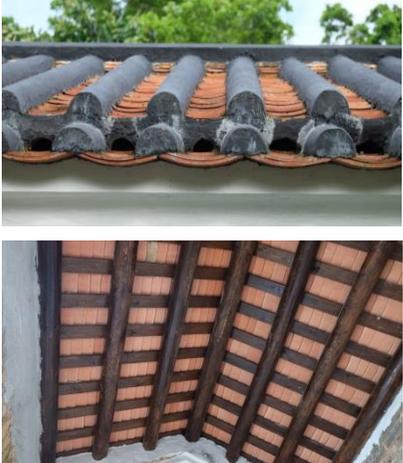
<p style="text-align: center;">G/F Plan</p>
C-02	Pitched roof with double layered pan and roll tiles and the timber roof systems	High

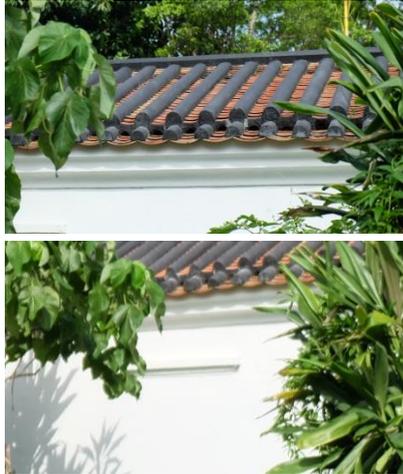
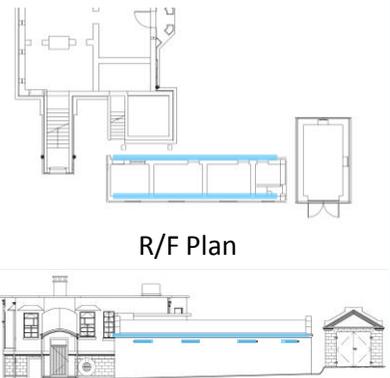
No.	CDE	Level of Significance	Photo	Location
C-03	Moulded copings and horizontal moulded bands to the pitched roof, and the moulded canopies of the blocked window openings	High

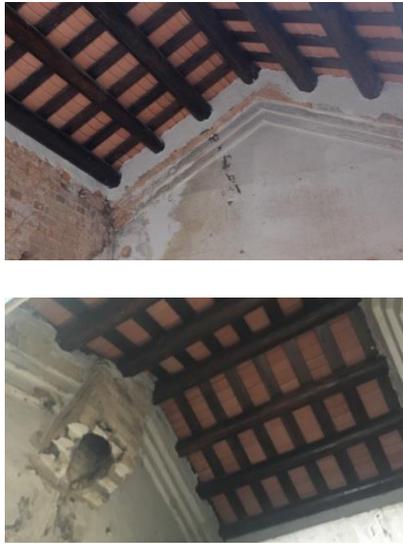
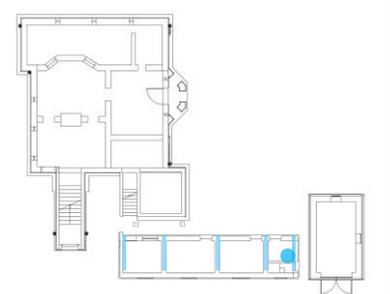
<p style="text-align: center;">R/F Plan</p> <p style="text-align: center;">Front Elevation</p>
C-04	Internal walls with Corbelled mouldings at two sides of each rooms and the remains of chimney	High

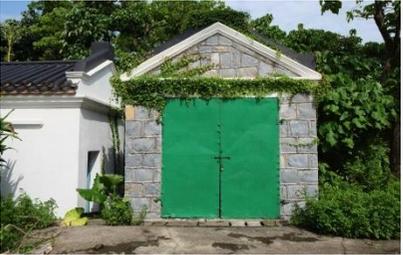
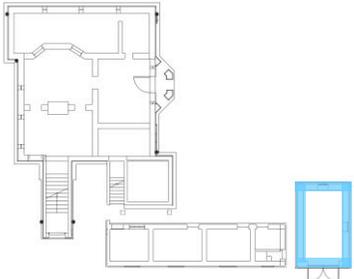
No.	CDE	Level of Significance	Photo	Location
D-01	All elevations of the Garage Block, including the moulded pediments and the granite blocks and joints	High

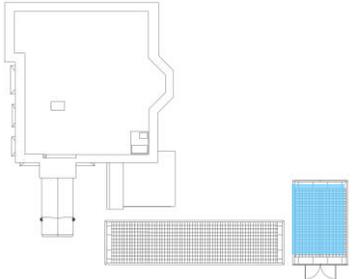
G/F Plan
D-02	Pitched roof with double layered pan and roll tiles and the timber roof systems	High

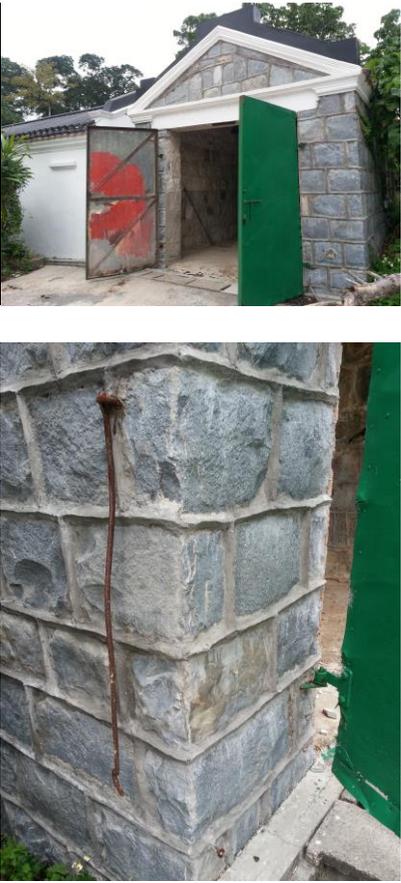
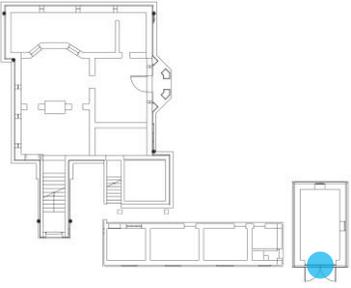
No.	CDE	Level of Significance	Photo	Location
D-03	Door opening at the Garage Block, including the door hinges and door stays	High

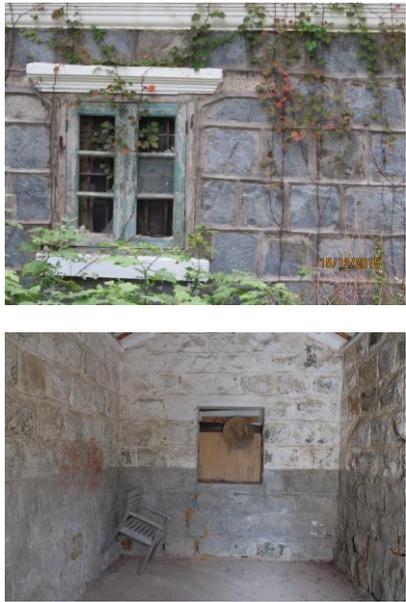
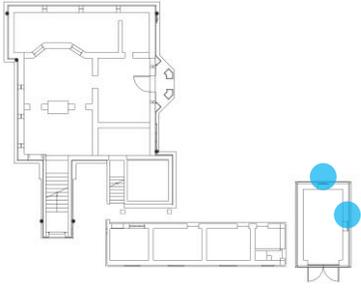
No.	CDE	Level of Significance	Photo	Location
D-04	Window opening including timber windows, window sill and the moulded canopies

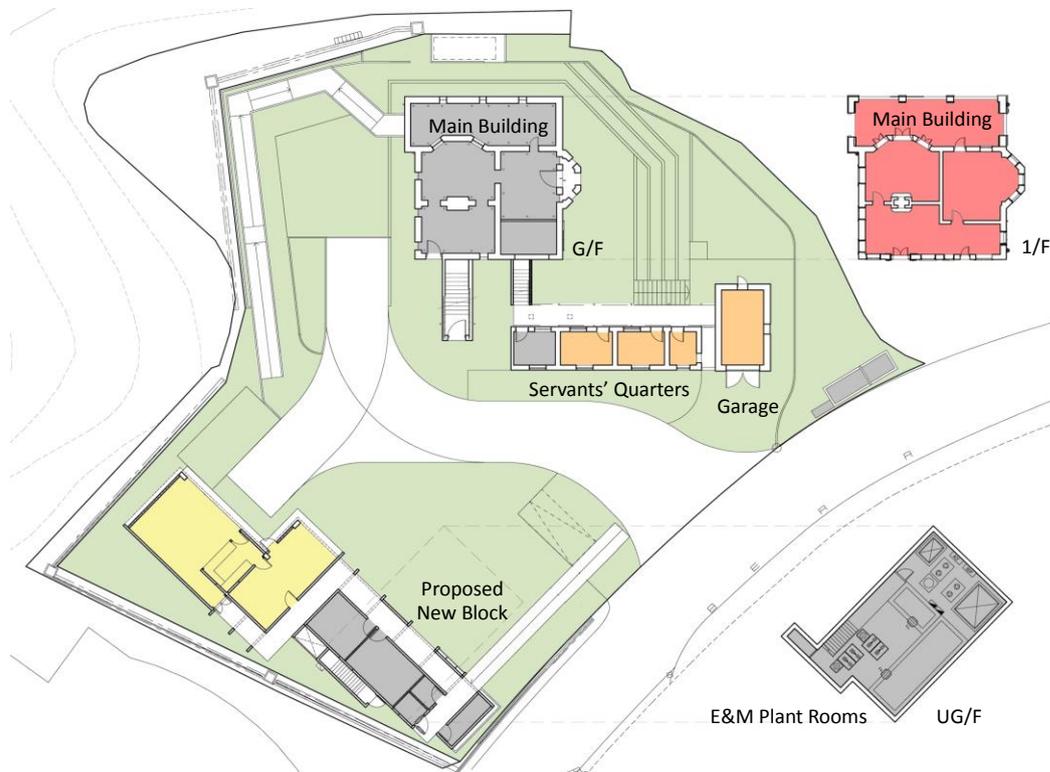
Fig 54. Diagram of proposed different function. Edited by Hannah Liu. Details of the proposed plans can be referred to Appendix I.

Fig 54. Diagram of proposed different function. Edited by Hannah Liu. Details of the proposed plans can be referred to Appendix I.....85

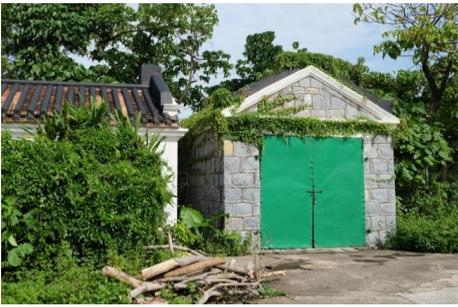
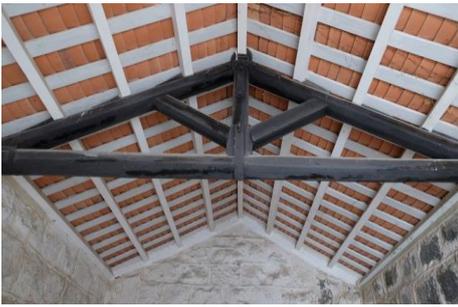
Building Name	Yr. of Const.	Roof and Frame System	Original Use	Grading
1	Old Dairy Farm SSQ – Garage	1887	King post system, Gable roof	Garage	1
Photos

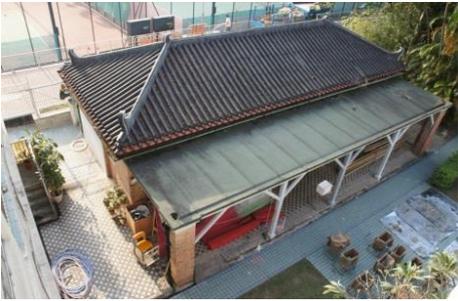
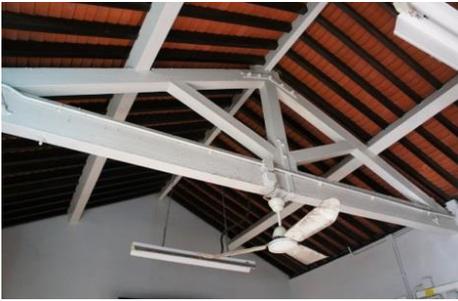
2	Scout Den, Queen's College	1898	King post system, Hip roof	Changing room	2
Photos

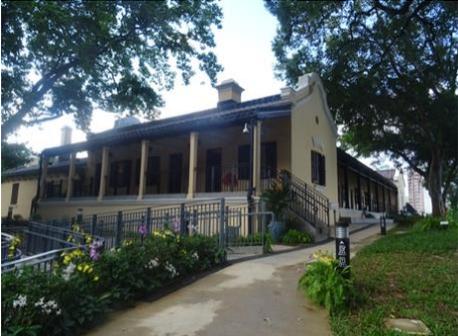
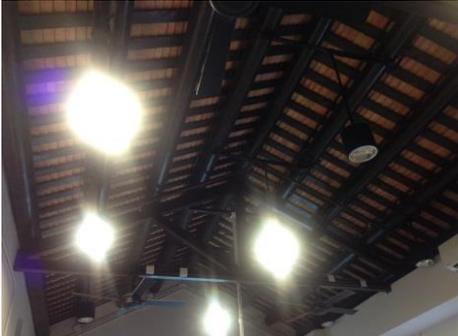
3	Old Tai Po Police Station	1899	King post system, Gable roof	Police station	1
Photos

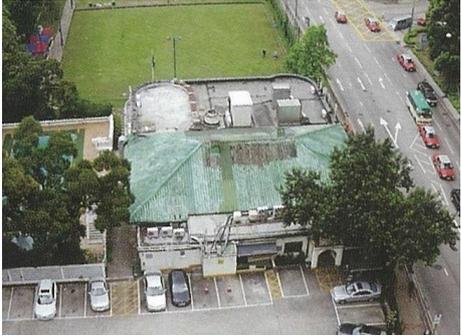
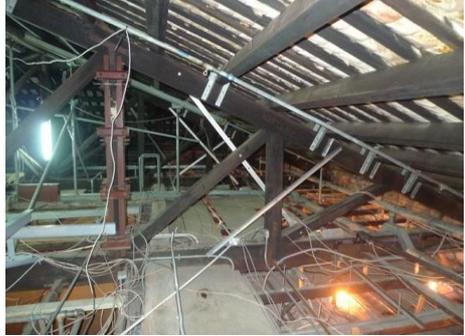
4	Kowloon Bowling	1926	King post	Club house	3

Building Name	Yr. of Const.	Roof and Frame System	Original Use	Grading		
	Green Club		system, Hip roof				
Photos

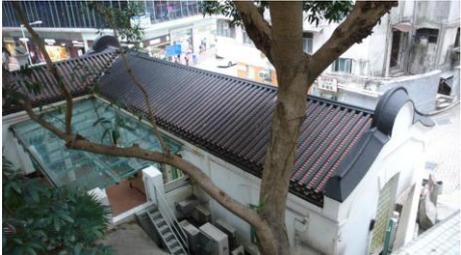
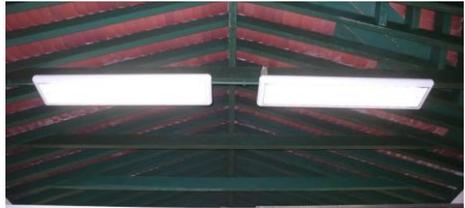
5	Old Wan Chai Post Office	1912-1913	Coupled rafter system, Gable roof	Post Office	DM
Photos

King post system could be found in most of the roofs. For large span structure, like Cheung Chau Theatre, Queen post system is usually adopted. Coupled rafter system is usually used in small span structure e.g. Old Wan Chai Post Office.

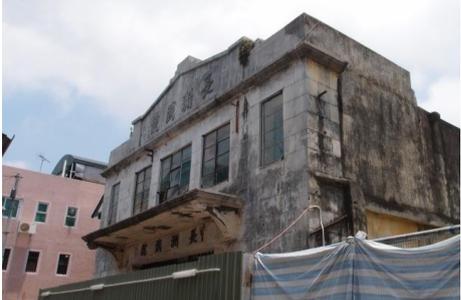
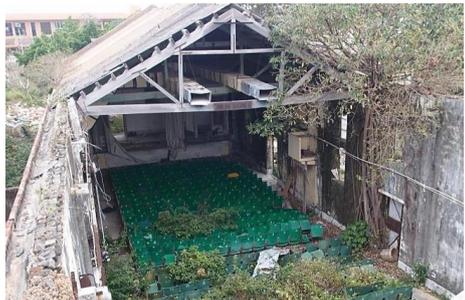
6	Cheung Theatre	Chau 1931	King and Queen post system, Gable roof	Theatre	3
Photos

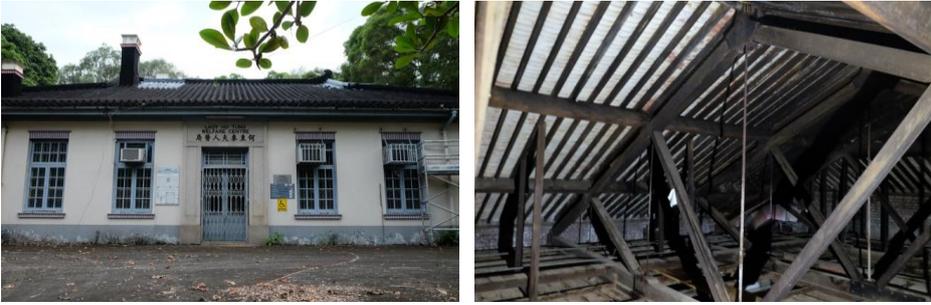
Building Name	Yr. of Const.	Roof and Frame System	Original Use	Grading
7	Main Block, Lady Ho Tung Welfare Centre	1932-33	King post system, Hip-and-gable Roof	Welfare centre	2
Photos

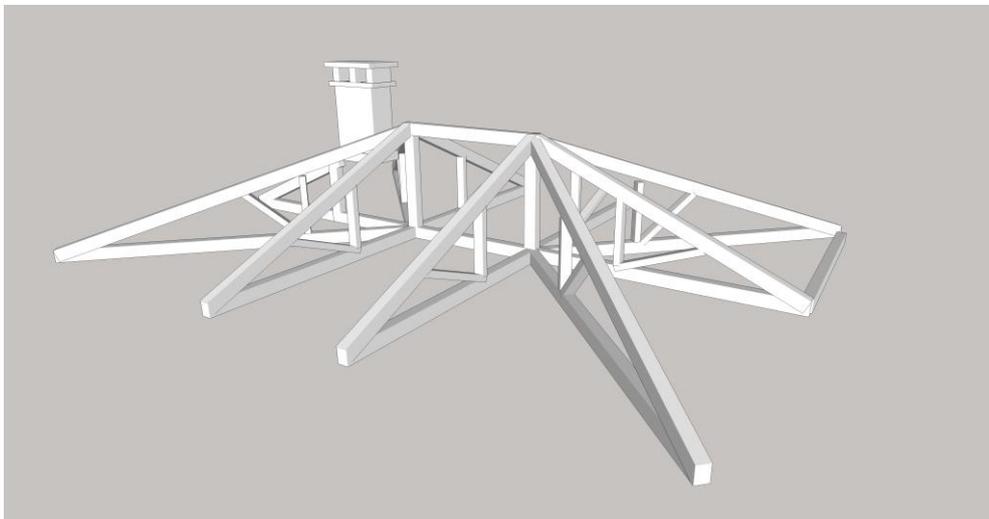
The roof truss system for the original pitched roof is estimated as shown below:-

Fig 55. A Sketchup model simulate the original roof truss system. (Source: Built by Zenny Cheung)

Fig 55. A Sketchup model simulate the original roof truss system.(Source: Built by Zenny Cheung).....88

Since the original pitched roof no longer exists. In order to understand the original roof truss system, several Colonial buildings have been studied:-

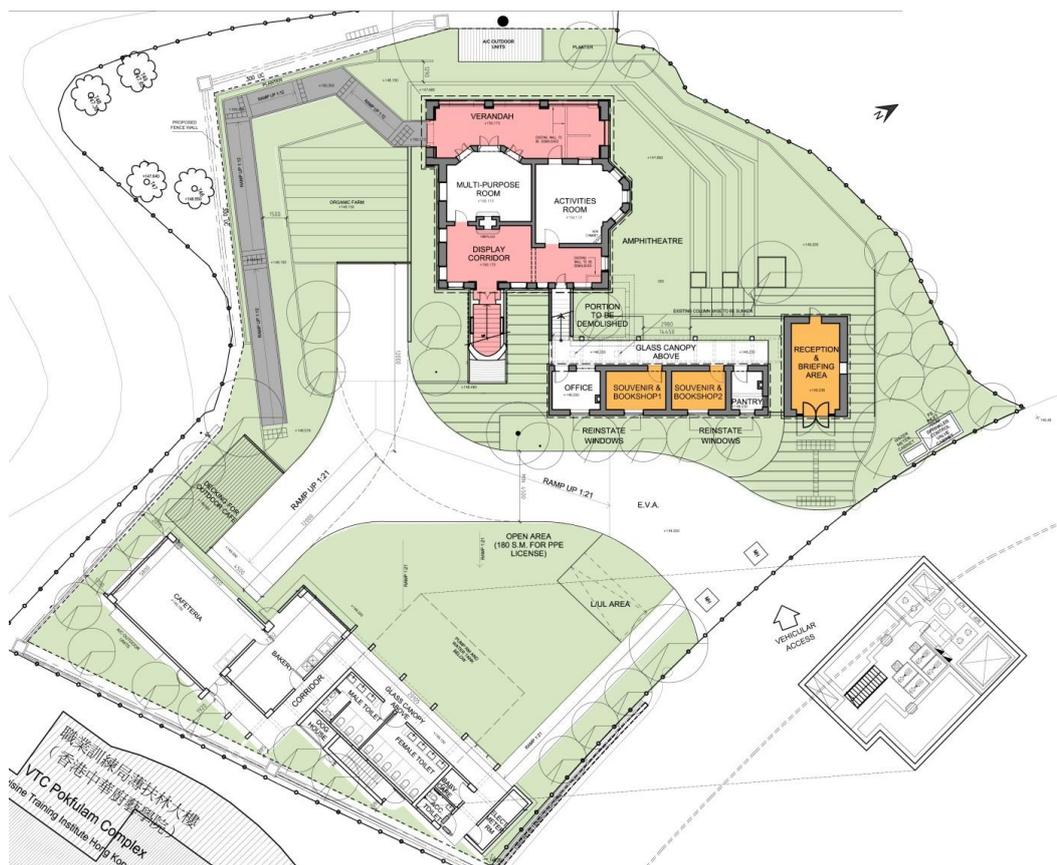
The plan of the area opened for public in business hours. The area coloured in orange is the reception and briefing area. The area coloured in red are the living museum area. The area coloured in green are the organic farm, amphitheater and other open area. Edited by Hannah Liu.

Main Building	Display Corridor (1/F), Verandah (1/F)
Servants' Quarters	Souvenir & Bookshops
Garage	Reception and Briefing Area
Open Space	Organic Farm, Amphitheatre

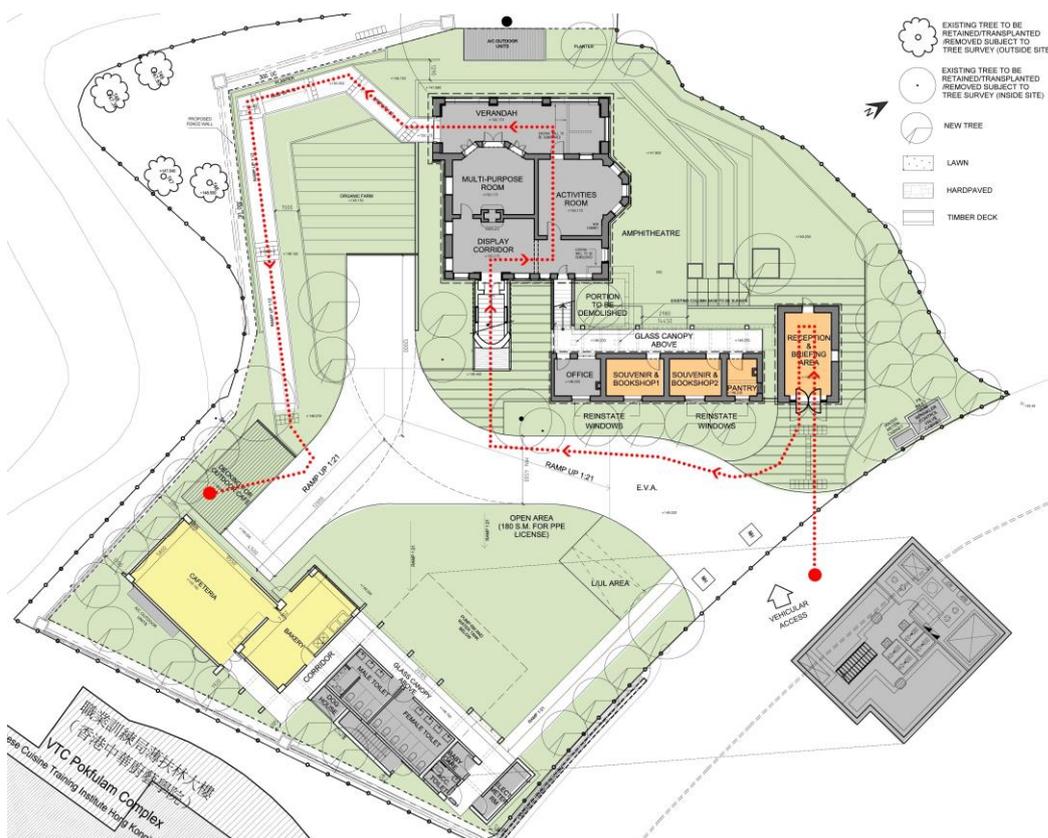
Detail route for the guided tour is shown in below plan.

Fig 56. Diagram of proposed interpretation route. Edited by Betty Tay.

Fig 56. Diagram of proposed interpretation route. Edited by Betty Tay.120

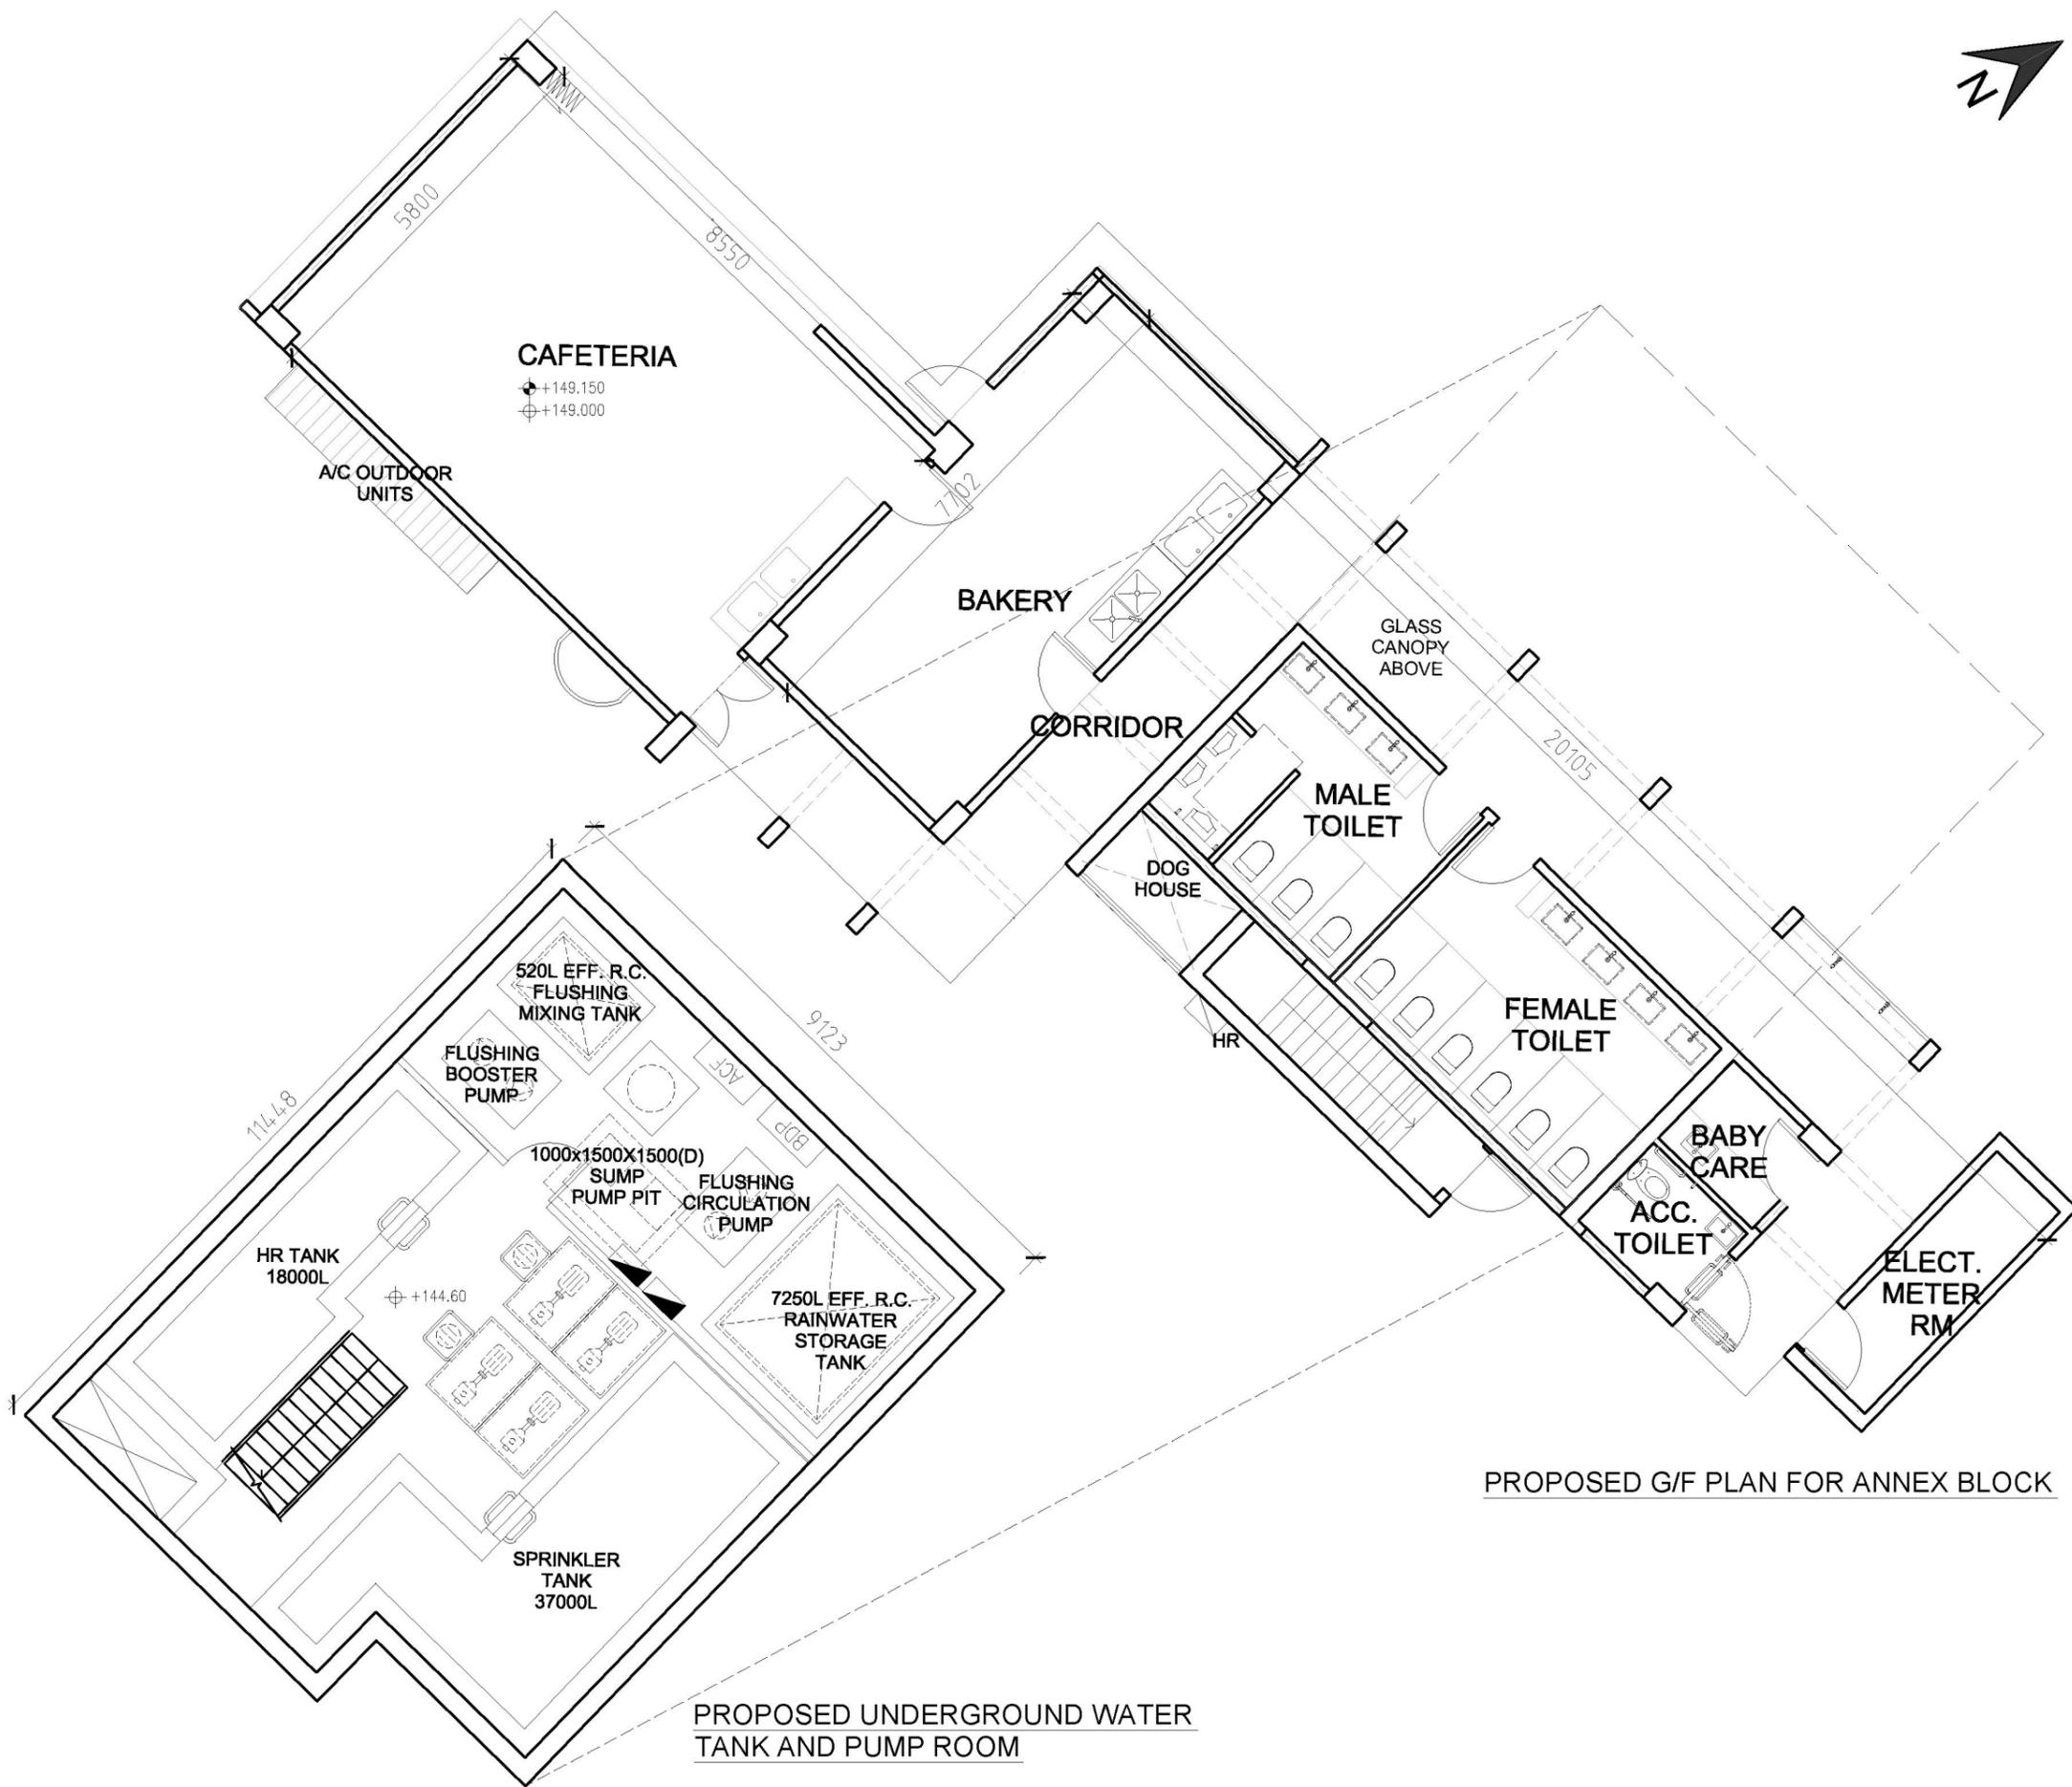
DRAWING TITLE :			
PROPOSED G/F PLAN AND UNDERGROUND WATER TANK AND PUMP ROOM FOR ANNEX BLOCK			
DRAWN BY:	CHECKED BY:		
-	-		
SCALE:	DATE:		
1:100	16 JAN 2017		
PROJECT:	DRAWING NO.:	REV.:	
2591	20170228	PRELIMINARY PLAN

PROPOSED G/F PLAN FOR ANNEX BLOCK

PROPOSED UNDERGROUND WATER TANK AND PUMP ROOM
