**Revitalising Historic Buildings Through Partnership Scheme
Batch I Project**

**Conservation Management Plan
prepared for Heritage Impact Assessment**

Mei Ho House

Adaptive Re-use of Mei Ho House as Youth Hostel Conservation Management Plan

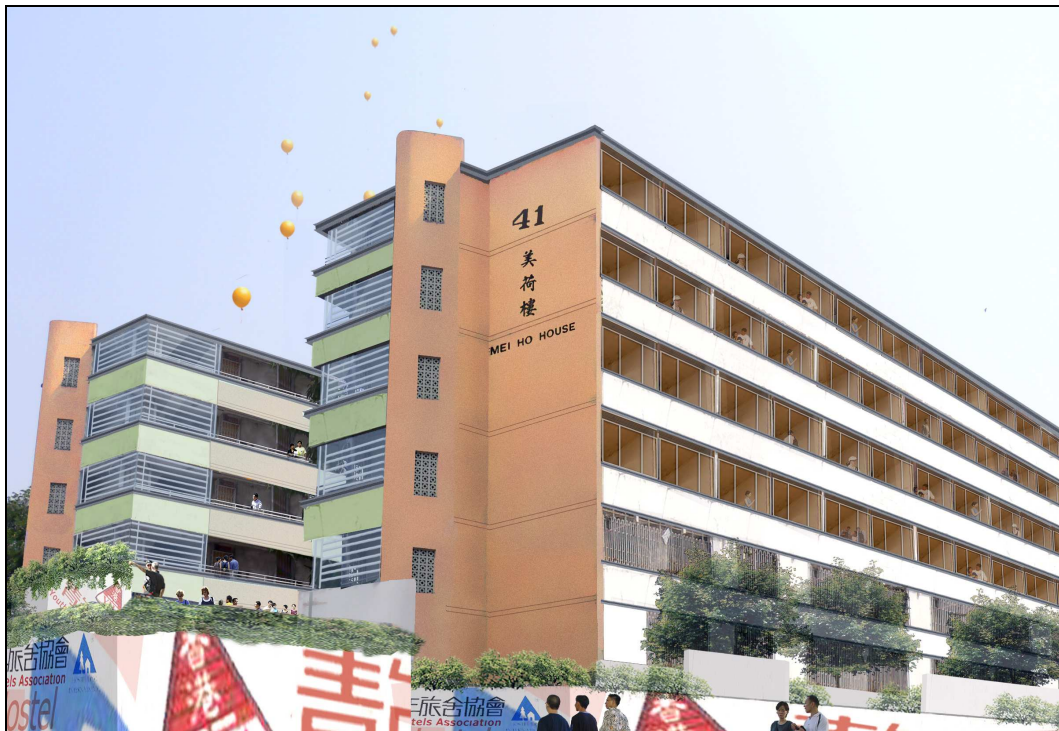
Drawing 4.1 – The façade design

- The later-added steel window grilles in the 1970s will be replaced by windows slightly set back from the external wall, such that the balcony will be enclosed as part of the interior space to increase the usable space of each unit.
- And the external walls and parapet walls will be painted with polyurethane texture paint to minimize the frequency of maintenance and to provide better protection to the existing old reinforced concrete in compare with the painting materials for low cost housing.
- A new colour scheme will be adopted.

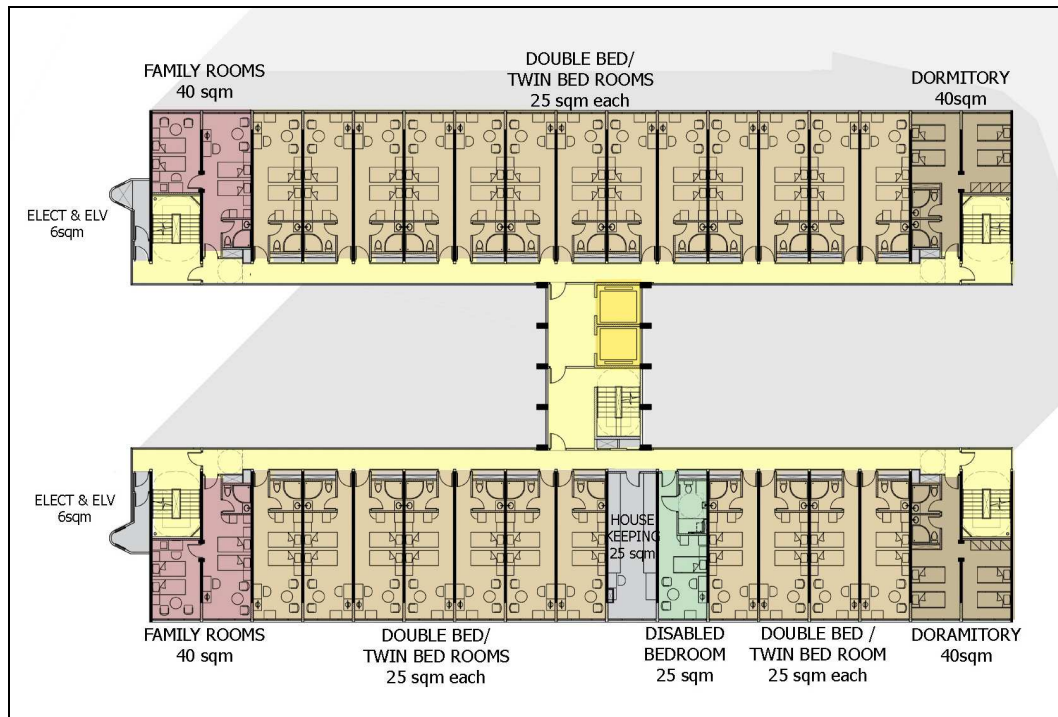
Drawing 4.16a – Third and fourth floor plan – proposed layout for adaptive re-use scheme

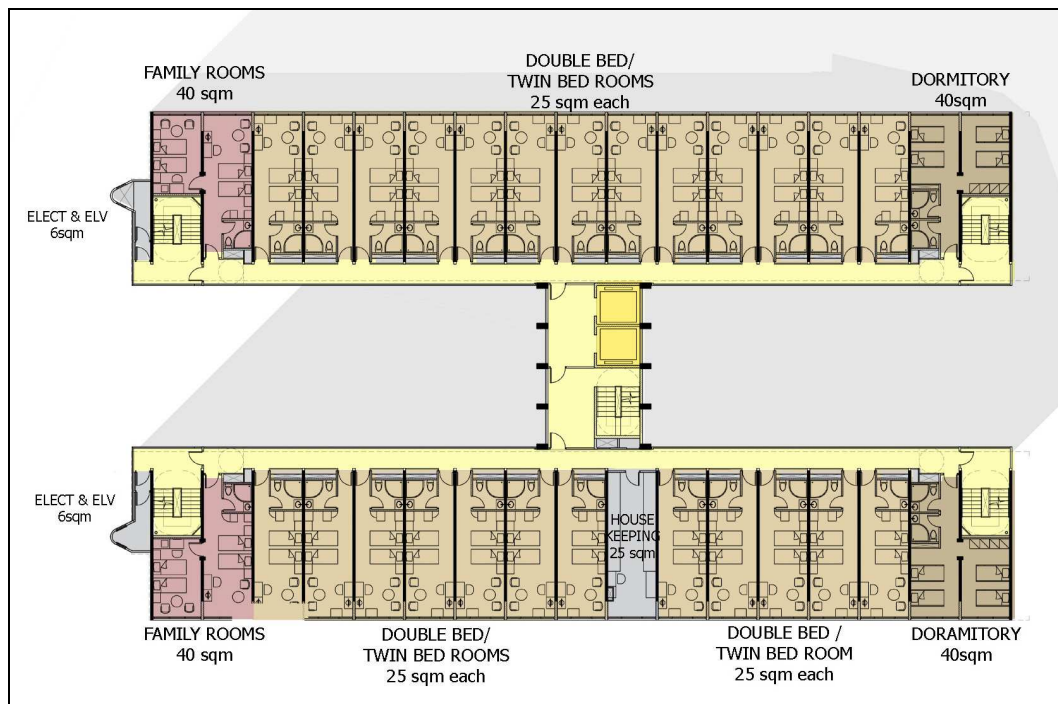
Drawing 4.17a – Fifth floor plan – proposed layout for adaptive re-use scheme

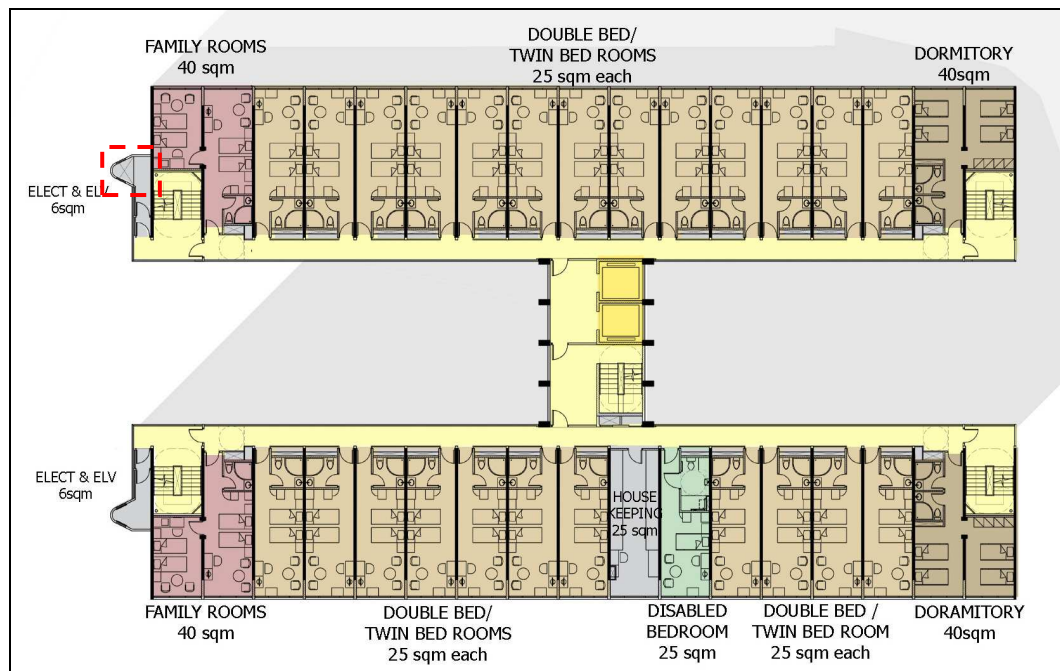
Drawing 4.18 – Third and fourth plan showing the proposed location of the dumbwaiter (outlined in red)

- A dumbwaiter to be installed inside the north refuse room.
- The dumbwaiter is essential for vertical transportation of daily necessities for the operation of the hostel.
- Openings on the floor slabs have to be formed as the shaft for the dumbwaiter.

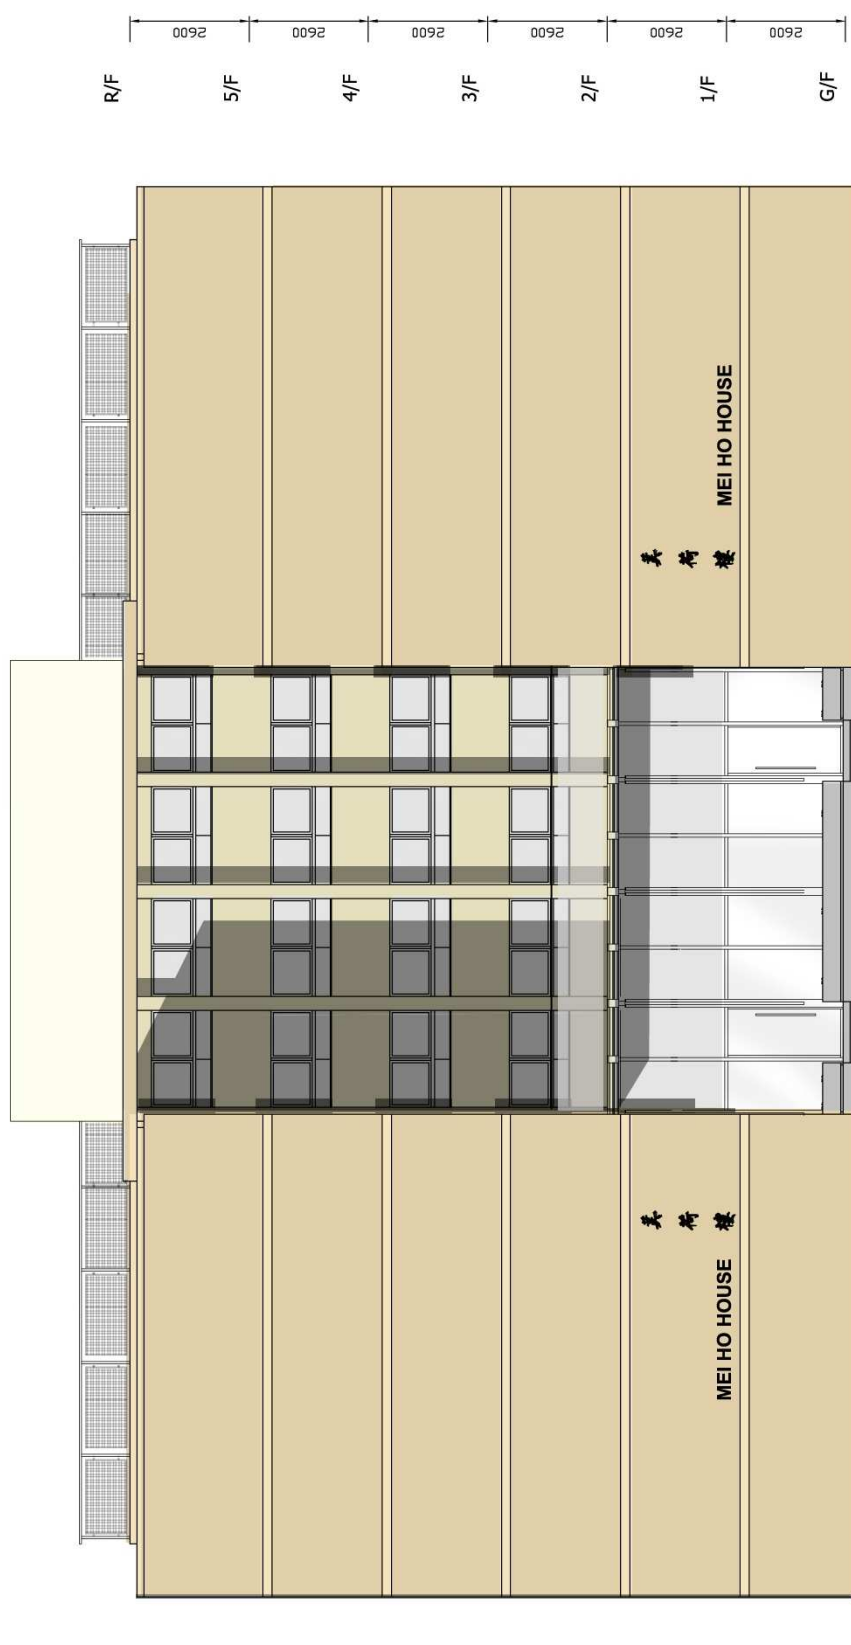
Façade (north-east elevation)
