Conservation Management Report

For Heritage Impact Assessment Submission

LCM & Associates Ltd. Conservation Architect . Heritage Consultant

SCAD-HK

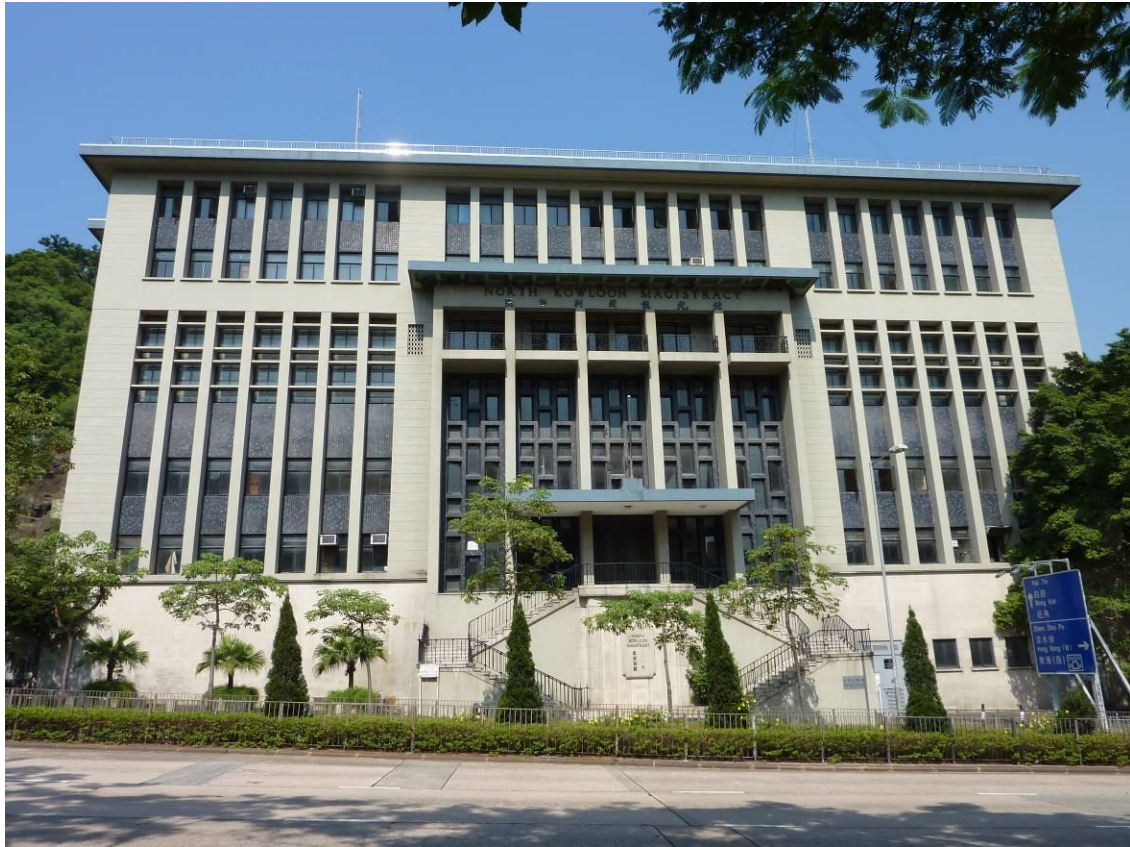
Fig. 7 North Kowloon Magistracy – Main Façade facing Tai Po Road

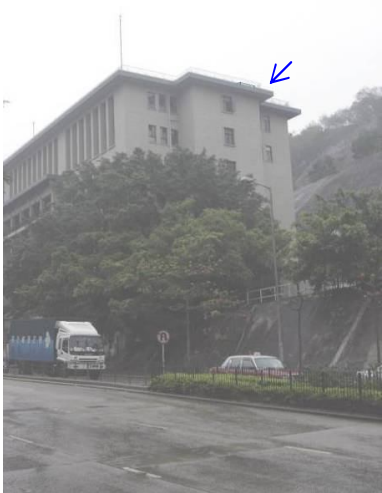
<p>New roof top hardly visible from Tai Po Road from a close distance</p>

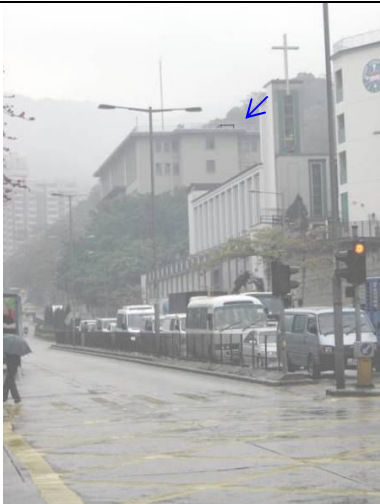
<p>New roof top only slightly visible when viewing from distance</p>			<p>subdue and low profile design compatible with but distinguishable from the existing surrounding building fabric, e.g., glass enclosure, to minimize potential visual impact when being viewed from distance.</p>	
10.4	<p>New structures for additions of F.S. & sprinkler tanks / pump rooms & water cooling towers</p>			<ul style="list-style-type: none"> New structure for housing the new water tanks, pump rooms & A/C outdoor condensers to be constructed outside the existing building should be allowed. <p>Justification:</p> <ul style="list-style-type: none"> Insufficient space available in the existing building and constraint of limited floor load for existing floor slabs and roof. 	Moderate
	<p>Location: open carpark opposite to the existing temporary structure</p>

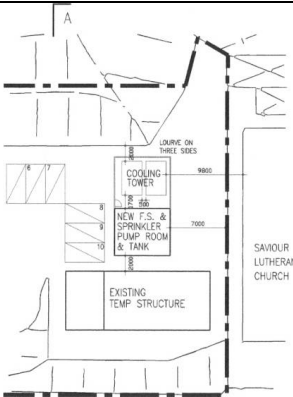
<p>Proposed location of new structures</p>

The existing floor loading conditions and physical constraints of the historical building restrict the location of water cooling towers, water tanks and plant rooms within the existing structure. It is proposed that a new structure housing the F.S. & Sprinkler water tanks, pump rooms and water cooling towers would have to be constructed in a less obstructive location in the open car park in the southeast corner and opposite the existing temporary structure. It is suggested that the new structure would be in subdued and low profile design to reduce any potential impact on the existing building.

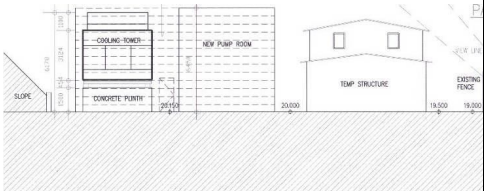
<p>Sketch elevation of proposed new structures to be screened off by metal louvre (dotted line)</p>
