**ST PAUL'S PRIMARY CATHOLIC SCHOOL
HAPPY VALLEY**

HERITAGE IMPACT ASSESSMENT

OCTOBER 2010

***McDougall & Vines
Conservation and Heritage Consultants***

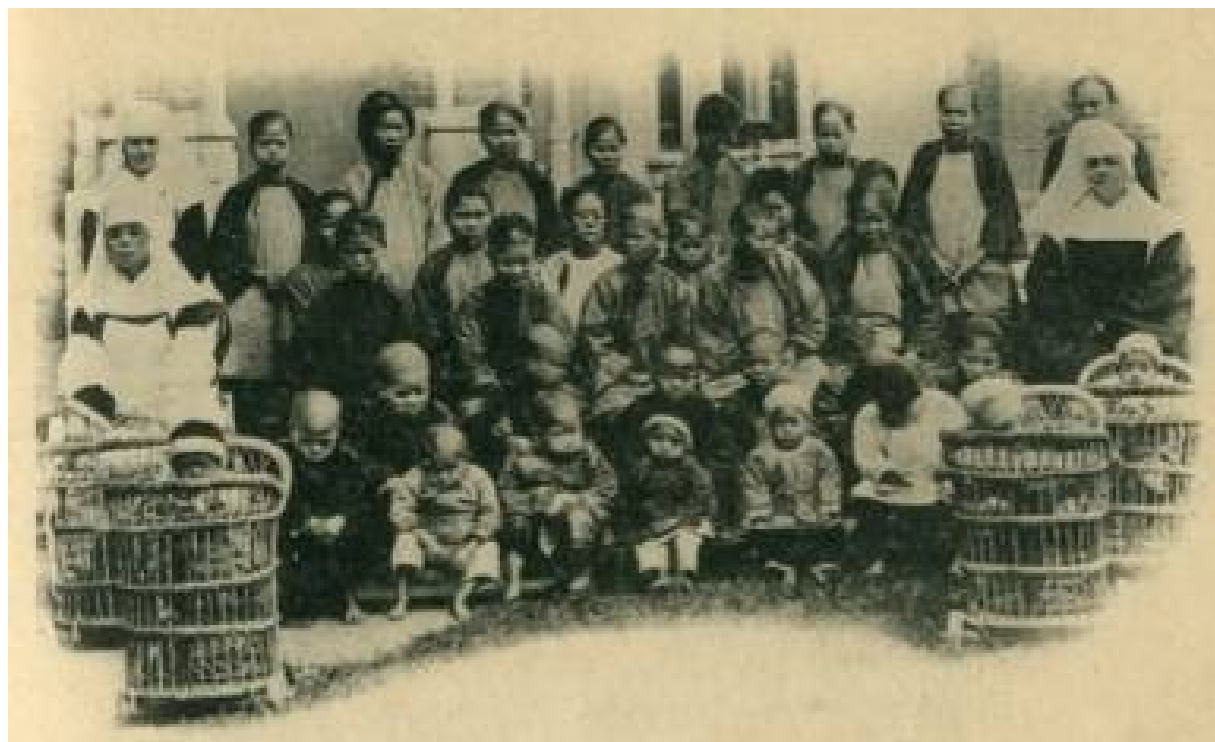
The brick columns of the arcaded eastern verandah can be seen in the background of this illustration from the pamphlet produced in 1910.

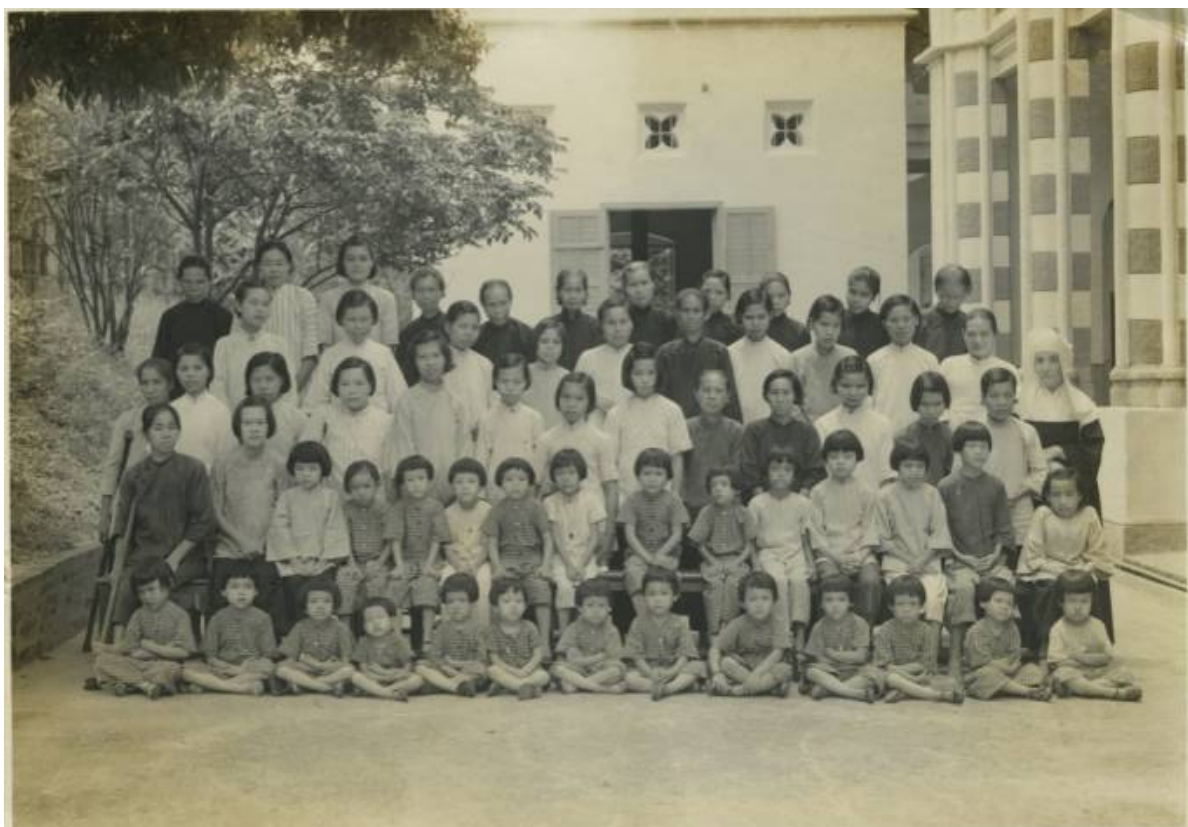
This photo is captioned 'Inmates of Le Calvaire c1940' and shows approximately 28 small girls, a number of older girls and adults, with one Sister. The original timber shutters and joinery to the windows of the Service Block are visible behind.

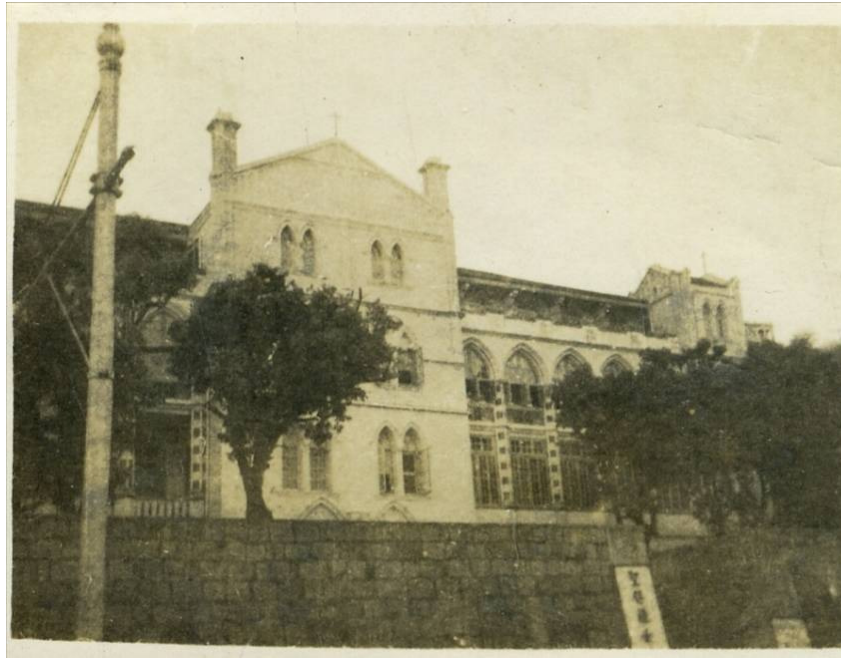
A post-World War 2 view of Le Calvaire from Wong Nai Chung Road after the front steps that breached the front granite retaining wall were installed. The school name is visible on the buttress.

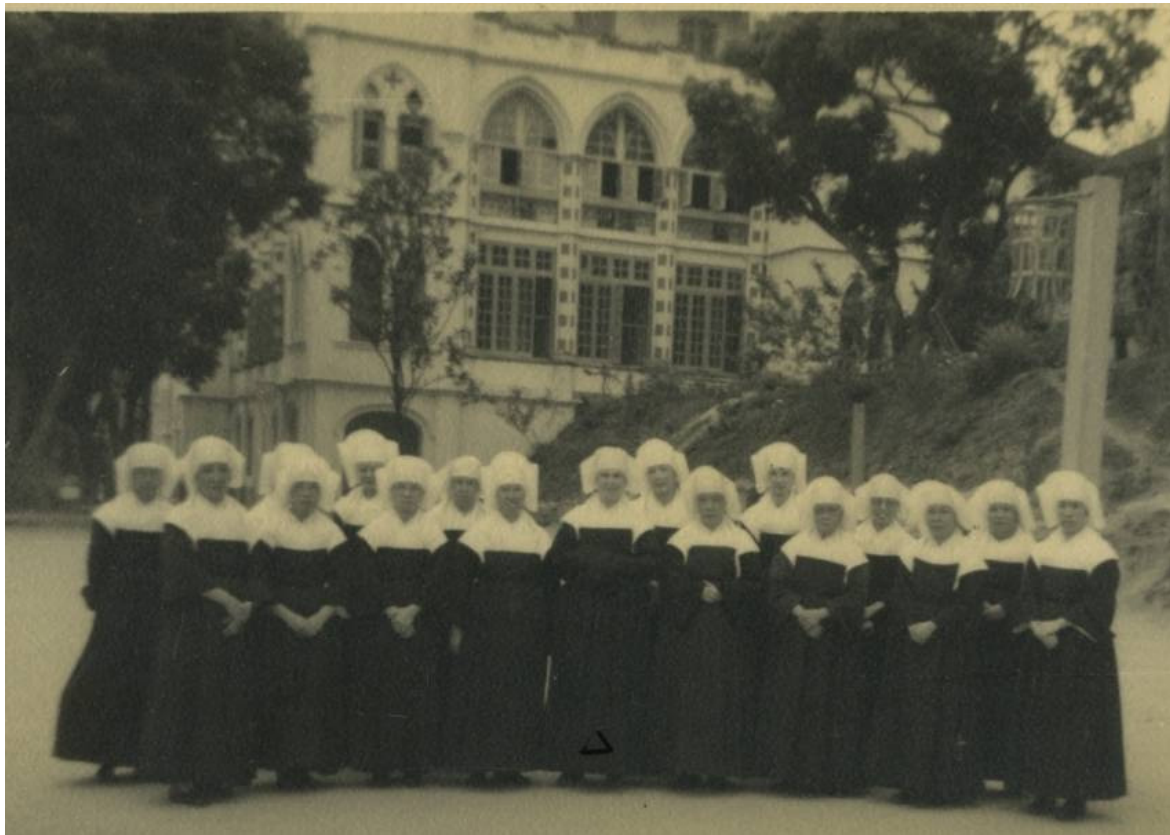
Sisters in 1945 in south garden – note the original shutters and screens in the arcaded verandahs

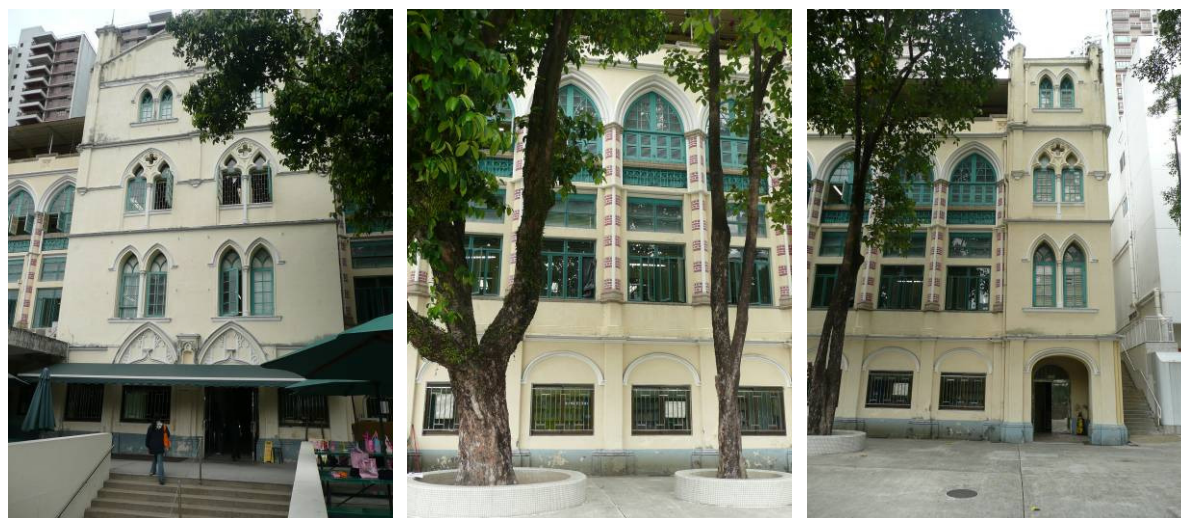
- Principal (Western) Elevation

The principal elevation is symmetrical and articulated into five main bays: two tower ends, two recessed arcaded bays and the central bay which is marked at each level by two paired Gothic arched windows with tracery, and the central entrance doors. The floors are delineated horizontally by granite string courses and moulding. The wall materials of the elevation are plastered and rendered brick, with the brick exposed only in bands on the attached pilasters of the two recessed bays at the ground floor level above the basement

The basement level is characterized by segmentally arched openings and the front access door which is visible in early photographs, with the Gothic arches and infilled tracery. The elevation has a granite plinth with rendered walls above. The northern end has had some later tiles applied and stainless steel grilles to windows, some arches have been filled in and new stainless steel doors installed to the main entrance at the top of the stairs. To the southern end all arches have been infilled and the area behind converted to rooms. The northern and southern store rooms are currently used as sports stores.

The top floor of this elevation has an open balcony, now roofed with corrugated iron, which was originally open, which links the end towers with the central bay. This has a stepped balustrade and quatrefoil detailing in panels below each of the five steps. The main roof is clad in terracotta pan and roll tiles, while the later verandah roof over the open balcony is in corrugated iron.

There is a large concrete canopy attached to the northern end of the ground floor of this principal elevation which provides sheltered playing space.

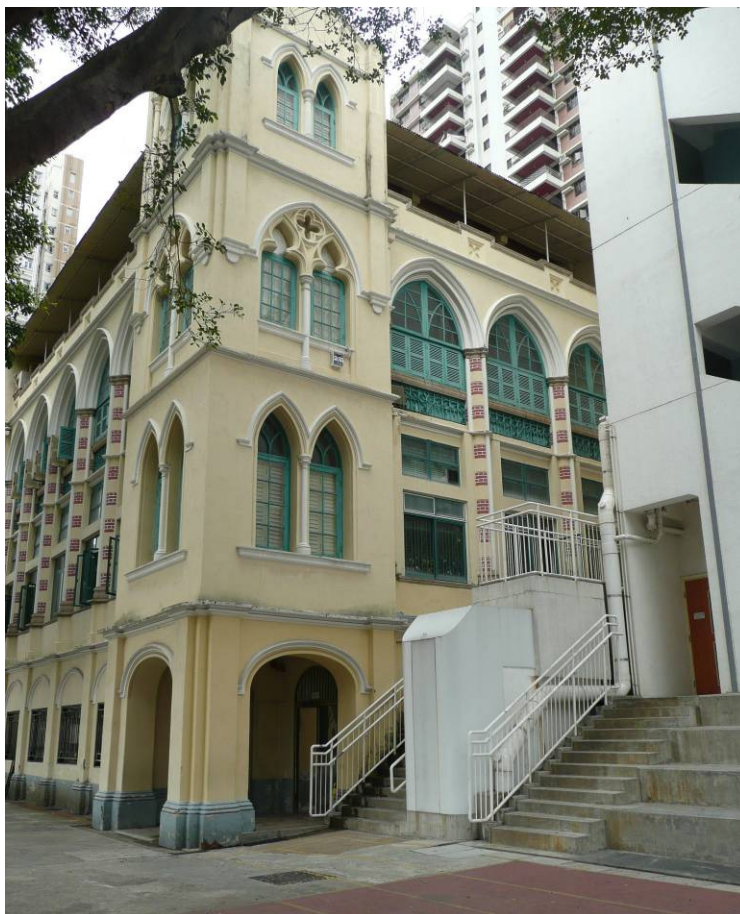
- **Southern Elevation**

This elevation is in three bays: a western projecting corner tower, a central three arched bay and a projecting rear tower which contains bathroom facilities on the ground and first floors. The detailing to this bay corresponds with that of the western main elevation, although much of it is obscured by its close adjacency to the Secondary School. Later aluminium framed sliding windows and hoppers have been installed in the ground floor windows; the upper windows are timber framed windows and have the same infill elements as the western elevation. In some places cast iron downpipes remain, as they were not replaced by PVC pipes in c1990. Where new windows have been installed in this elevation they have copied the original profile. In most places the granite has been painted. Much of the moulding which exists is in poor condition, with water penetration behind later paint surfaces.

The external stairs to the ground floor level obscure most of the southern elevation at basement level.

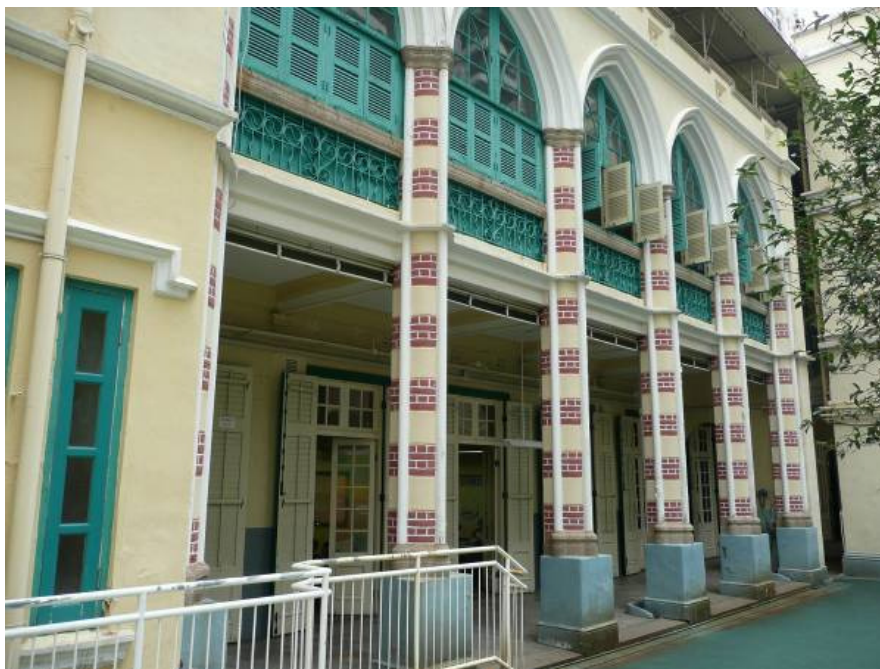
- **Eastern Elevation**

This elevation is the rear of the building and repeats the form and articulation into bays of the front elevation, although the lower arcade is open. The original shutters and French doors to the ground floor are visible between the arcades on this elevation. The two upper floors repeat the configuration of window infill and roofing over open balconies as for the western elevation; although because these columns are not attached they have flat backs (as per attached pilasters on the front elevation). The granite string courses and plinths to the columns have been painted. The main stair hall is accessed through double doors in the centre of this elevation. There is a system of steel beams (RSJs) which support the bridging links to the rear service block, and it should be noted that the floor level for the central floor of the rear block is higher than that of the main building. The walls of the arcaded ground floor section are painted brick and the north eastern corner tower includes bathroom facilities and associated cast iron pipework down the external walls. Tall timber windows off-set from the edge of the corner towers indicate the location of toilets.

There is no elevation at basement level on the eastern side as the building is excavated into the sloping site.

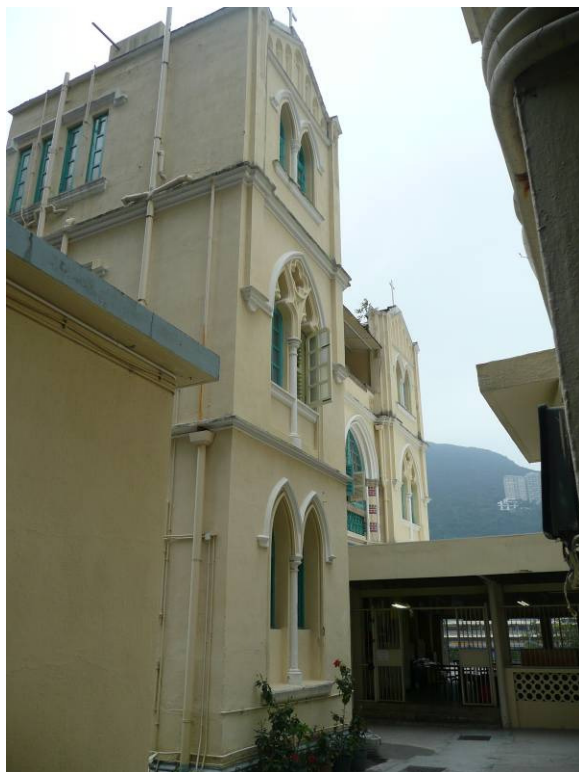
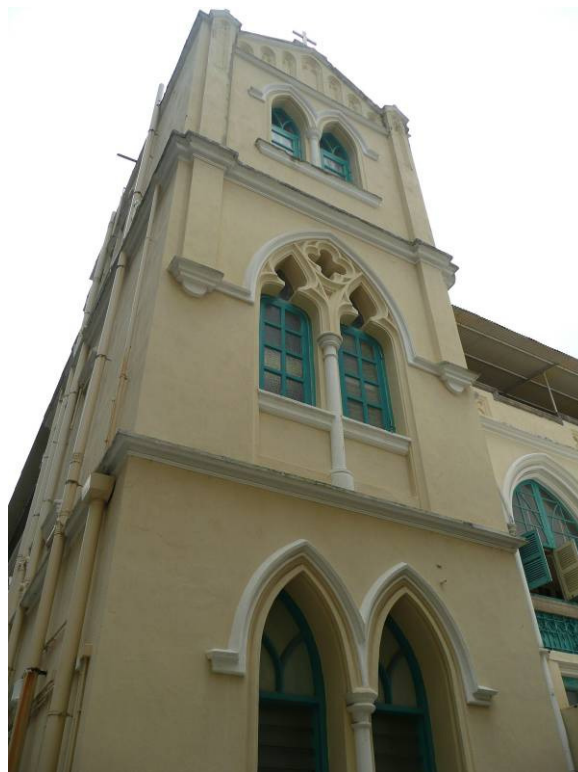
- Northern Elevation**

The design and detailing of the northern elevation repeats the southern elevation with a corner tower to the west, a recessed bay of arched windows and a balcony above, and a projecting tower to the east which contains bathroom facilities. This elevation is accessed at ground level, and additional structures have been attached to the original building to create an external covered area. All wall surfaces have been painted. A later door has been inserted at ground level to the eastern corner section. The original balustrading and timber shutters remain at first floor level. There is a variety of window treatment at the ground floor level to this elevation; metal framed and later sliding aluminium windows have been installed.

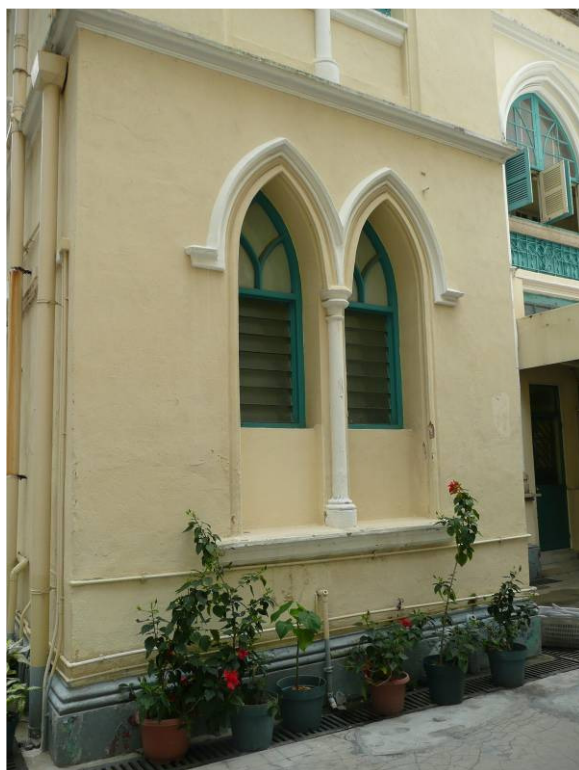
North east corner bay

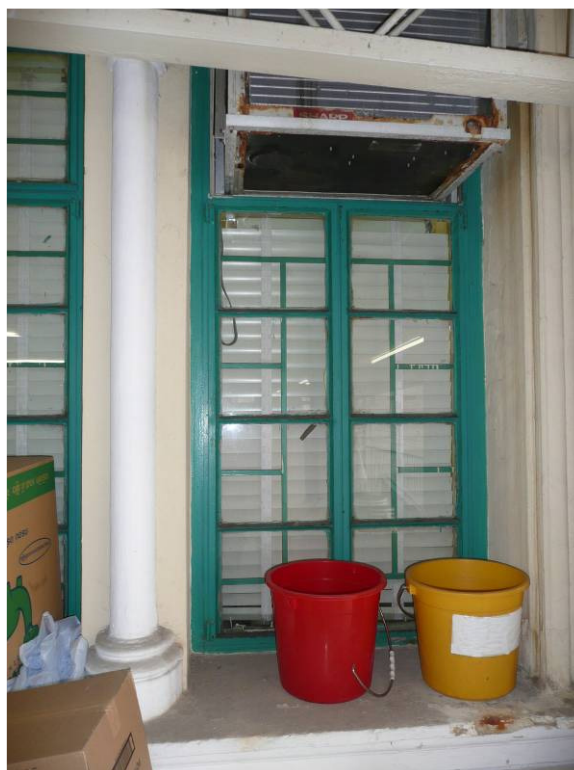
Metal windows under canopy

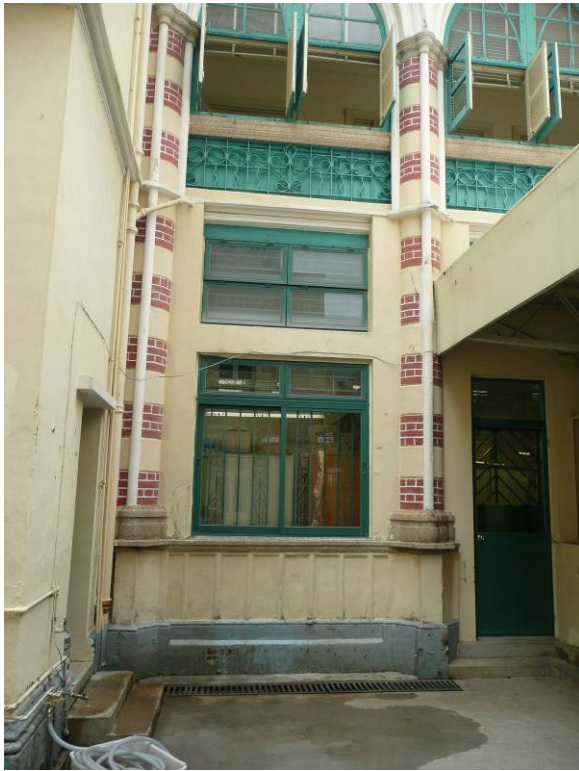
Central northern bay – lower level and top floors

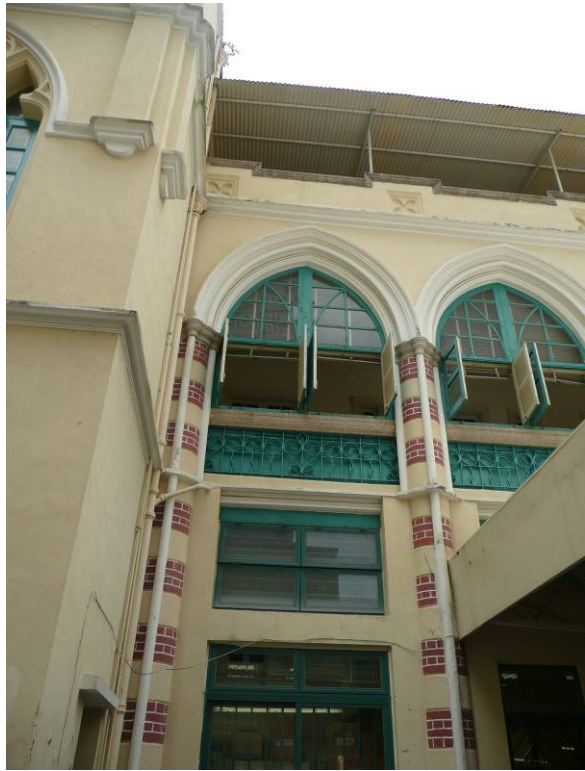
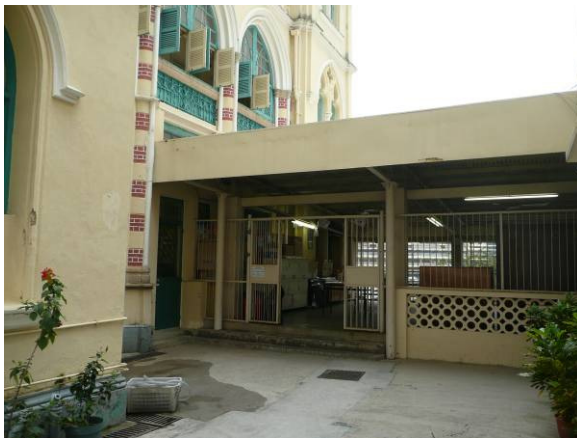
Canopy attached to northern elevation

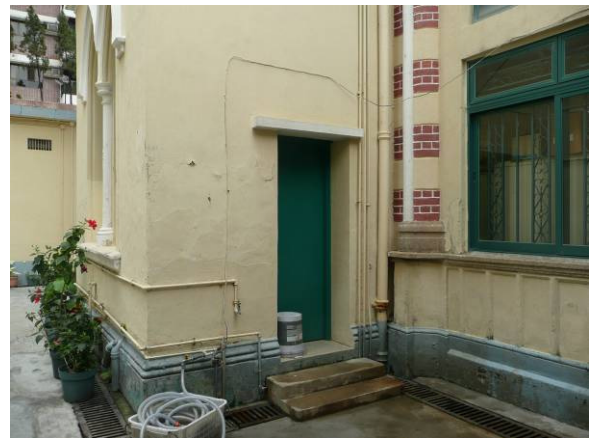
North east corner bay – external door

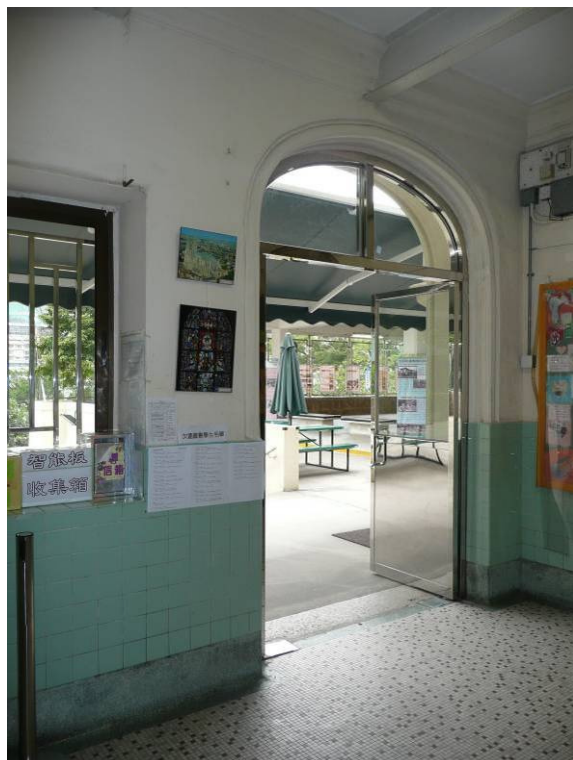
Basement level entrance lobby

The main entrance to the school is from Wong Nai Chung Road through the basement level and up a single flight of stairs to the ground floor. Metal entrance doors have been installed at the front elevation which was originally open. The timber entrance doors are located at the line of the interior wall of the basement level of the building. A large granite sill remains, but the floor has been retiled in small mosaics and the walls tiled to 1.2 metres high in green 100 x 100 glazed tiles. A number of RSJ's support the floor of the balconies above in the entrance hall and at the corner openings. The floor of the basement level (as far as can be determined) was originally stone tiles with granite sills, as is evident in the rest of the building.

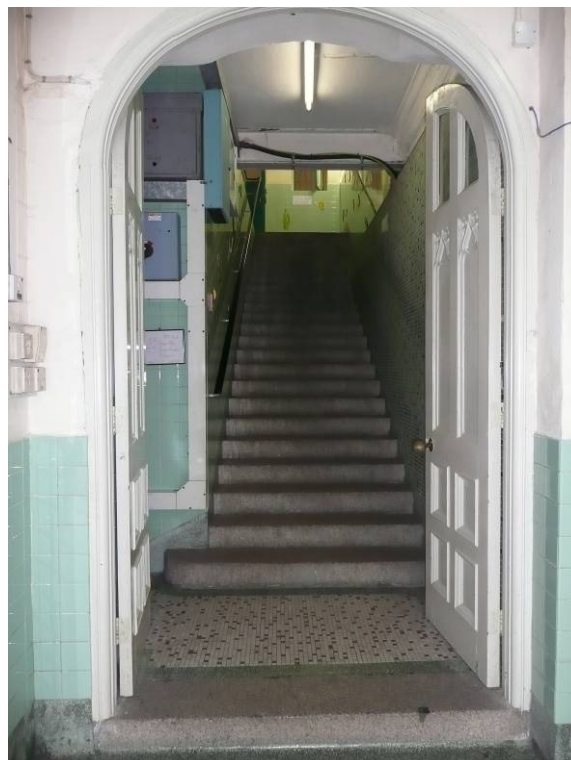
Stairs to ground floor

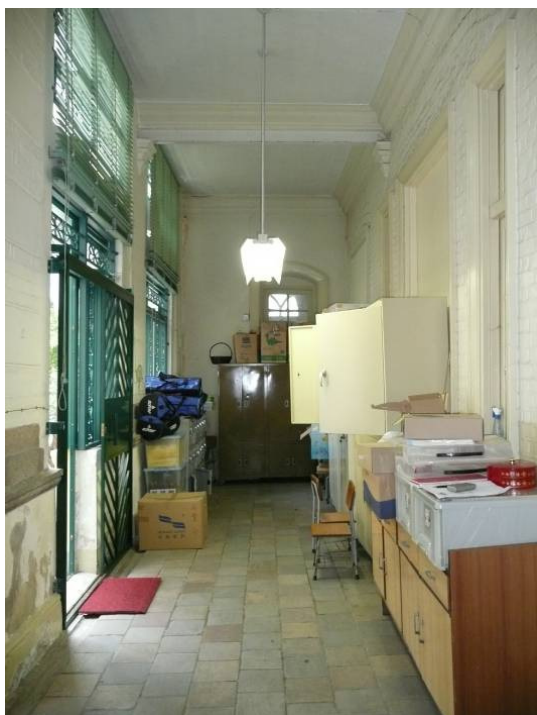
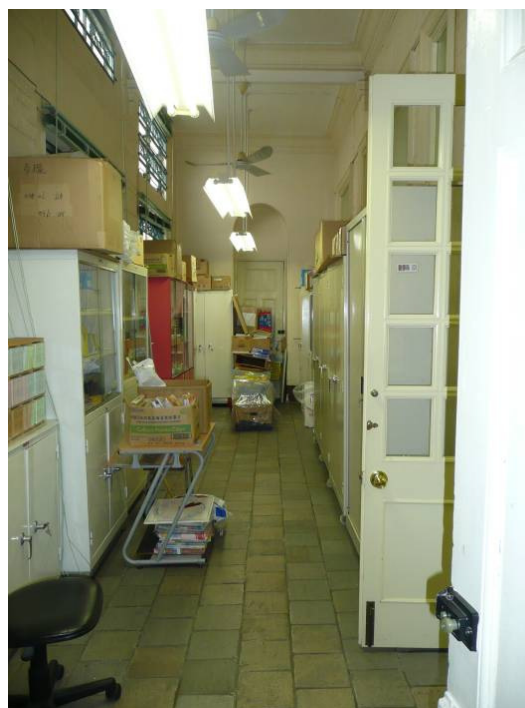
Typical Ground Floor corridors – infilled balconies. Note floor tiles

Along the south, west and north verandahs of the ground floor, a concrete framework has been installed above and below the granite balustrade. These enclosed verandahs were originally open, and the internal detail of the attached pilasters, brick and render banding is now painted. RSJs are installed at ceiling level, supported on corbelled brackets. The support corbels are missing in some places. The enclosed verandah on the southern side of the ground floor retains similar features to that on the northern side, the windows have been replaced, and the balustrade filled in. The granite base to the columns remains unpainted. The later aluminium window infills inside the concrete frame are clearly visible internally. The French doors opening to the rooms, which occupy the full width of the building, are half glazed with paneled lower sections. The fan lights are also multi-paned. Many of these doors are new joinery, made to match the original design, and installed between 1995 and 2000.

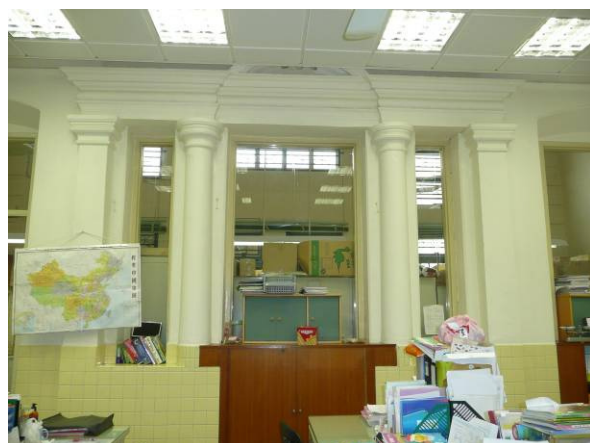
Decorative attached pilasters at north end of floor

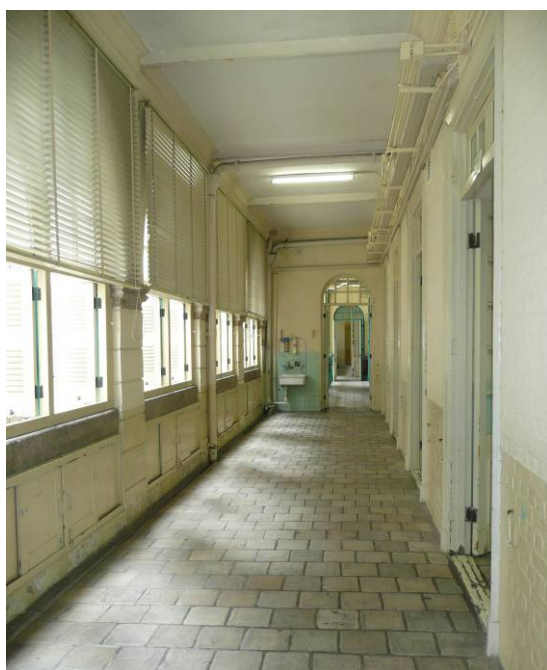
Typical First Floor Gallery (Eastern)

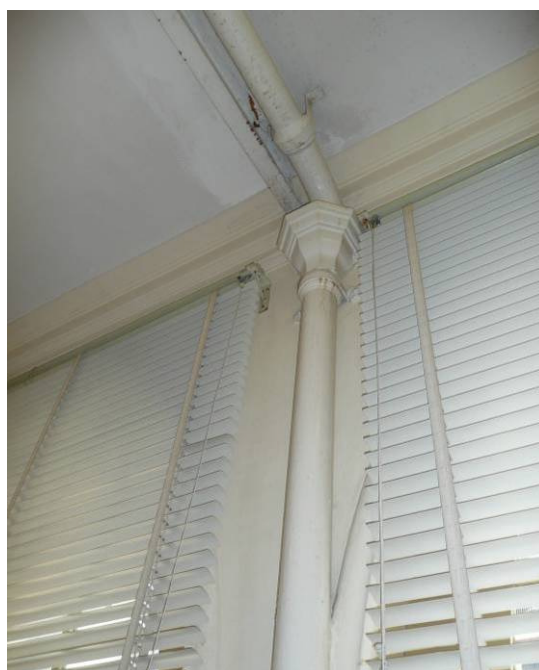
Internal drain pipe

The verandahs/balconies around this upper floor remain open and have been roofed with a later corrugated iron roof which extends the original pan and roll tiled roof. There are no shutters or screens above the masonry balustrade which retains its granite coping. The verandah floors and the internal rooms retain their original stone floor tiles. There are granite sills at each of the pairs of doors and an internal drain to the floor of the rooms, as well as one along the edge of the balcony.

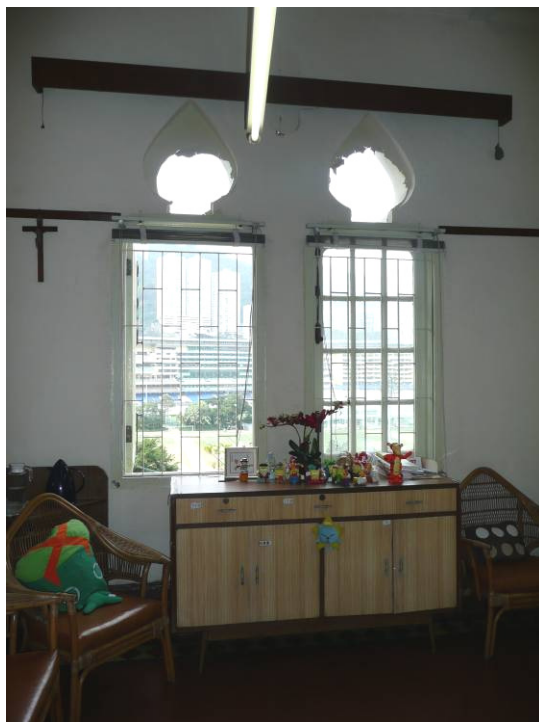
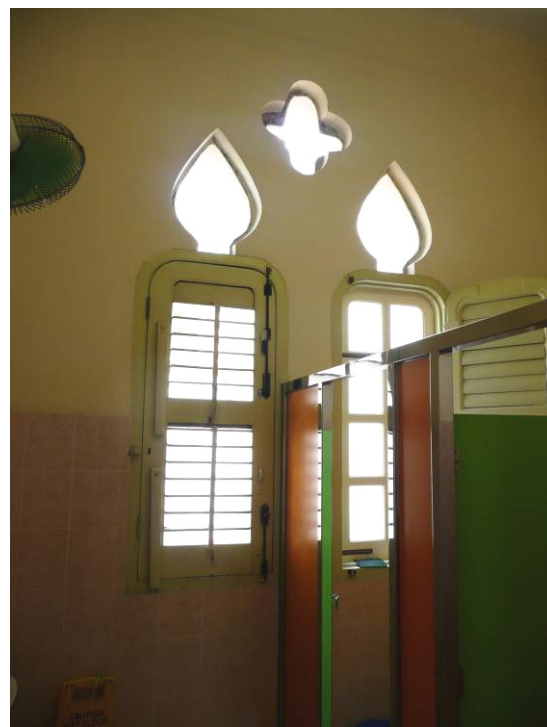
Window forms to rooms in central and end bays

The western corner rooms serve as storerooms, and retain original window shutters and fixed glazed decorative window elements above. Toilets are located in the eastern corner rooms

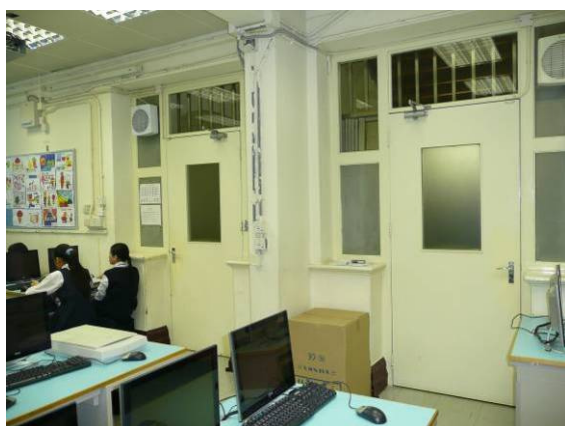
Removed wall nib retained in computer room

Pairs of French doors open from the three northern classrooms onto the verandah. Door joinery to the classrooms appears original and has only been replaced in a few places. Scratches to the paint indicate the original paint finish, which was a dark green in some places and in other places a typical Edwardian dark brown. It is possible this area was one space and later divided, as the cornice dentil line does not appear to follow the dividing walls.

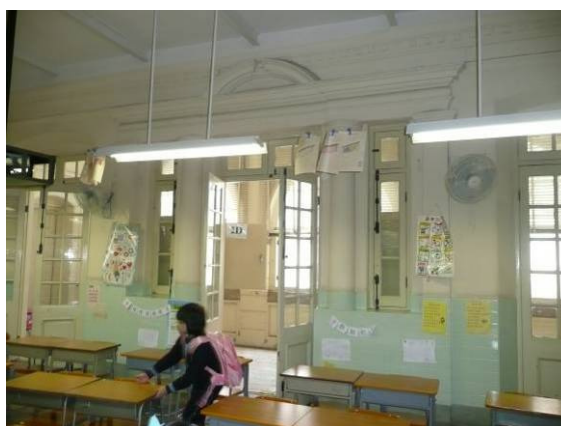
Pilaster detail to end wall

Both end walls of the first floor repeat the columned design seen in the same location on the ground floor.

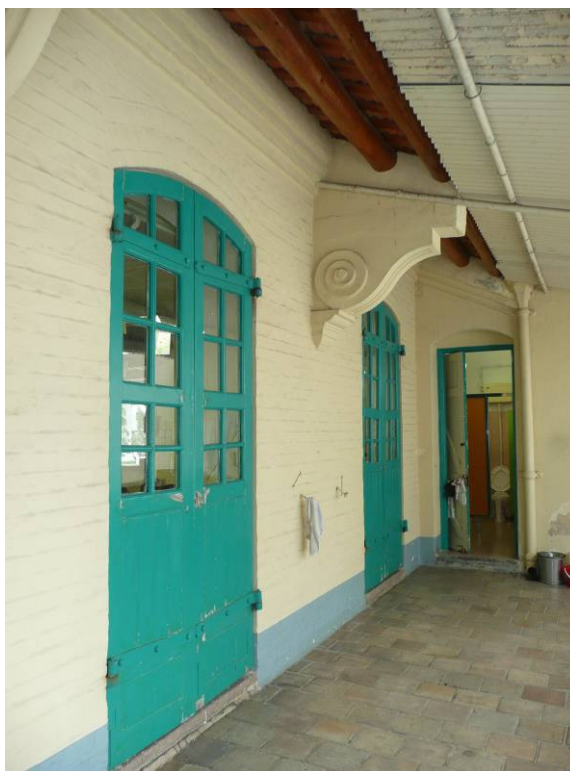
External doors to top balcony at northern end

The original eaves projections are supported by substantial decorative masonry brackets between each of the sets of French doors. The eaves also expose the original tiled roof construction.

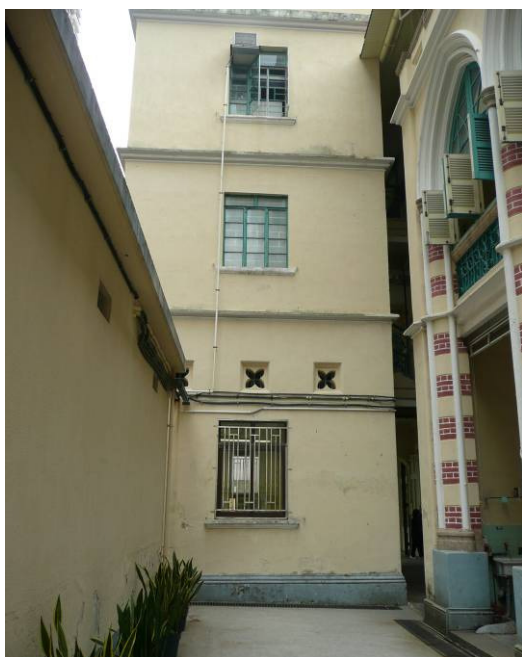
North Elevation

This simple rear block is set in line with the eastern elevation of the main building within a three metre gap in the rear verandah. It is three storeys high and of a utilitarian, plain design. Externally it retains rendered walls and plinth and quatrefoil piercings high in the walls, corresponding with the internal height of the ground floor room. All timber windows have been replaced with later casement hung metal or aluminium sliding windows. All floors have centrally located double entrance doors in the western elevation and the floors are linked by walkways to the main building. The steel beams (RSJs) supporting the links are held on simple quarter round corbels.

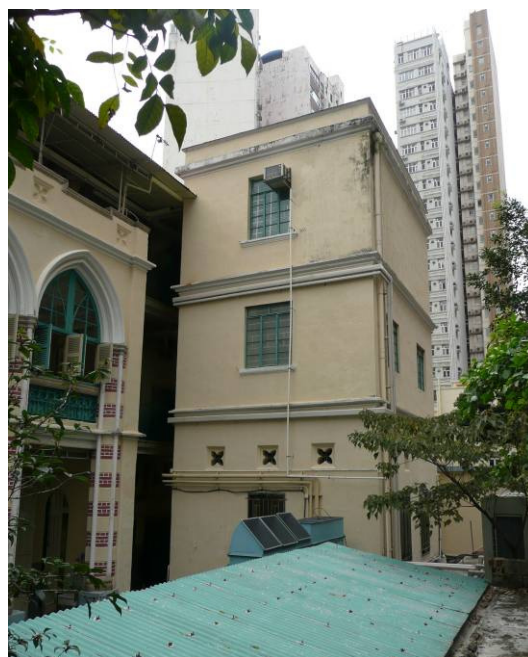
South Elevation

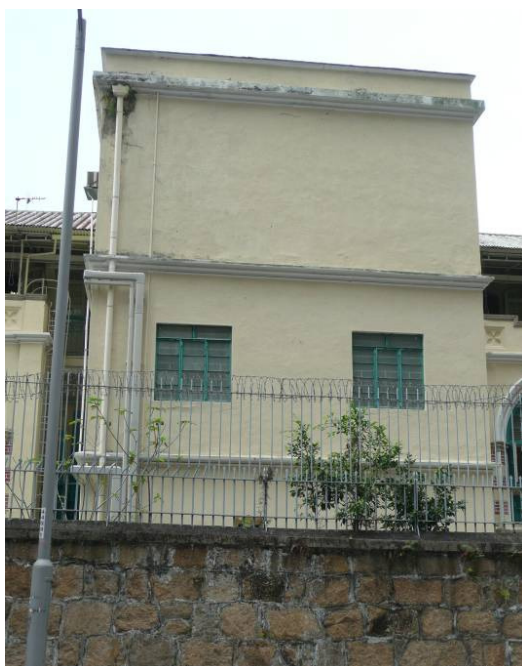
East Elevation – to Ventris Road

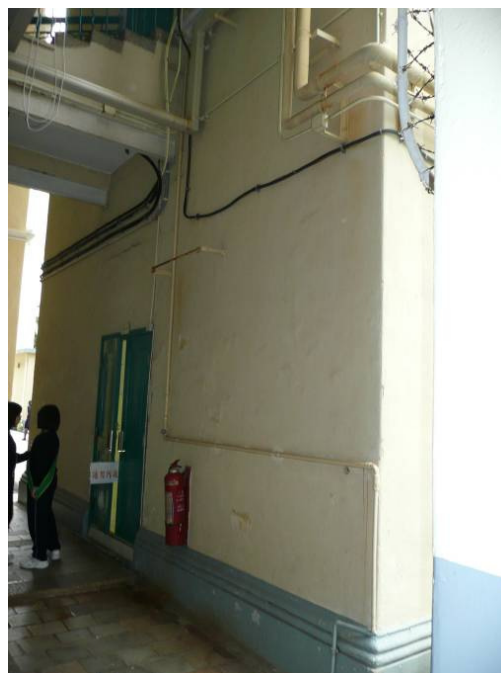
Ground Floor West Elevation

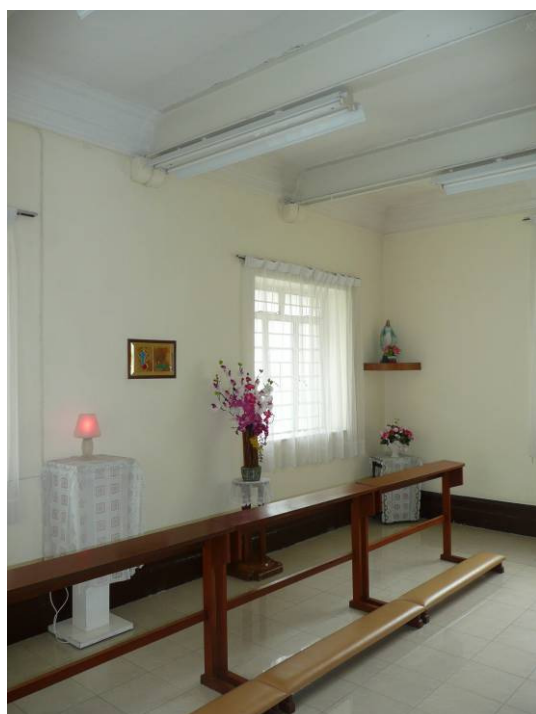
Chapel on First Floor

At the first floor level the service block contains a small chapel which is reached by five steps. This is a small room with a low ceiling due to the greater height of the ceiling in the room below. Original finishes are not able to be determined because these have all been replaced by later materials.

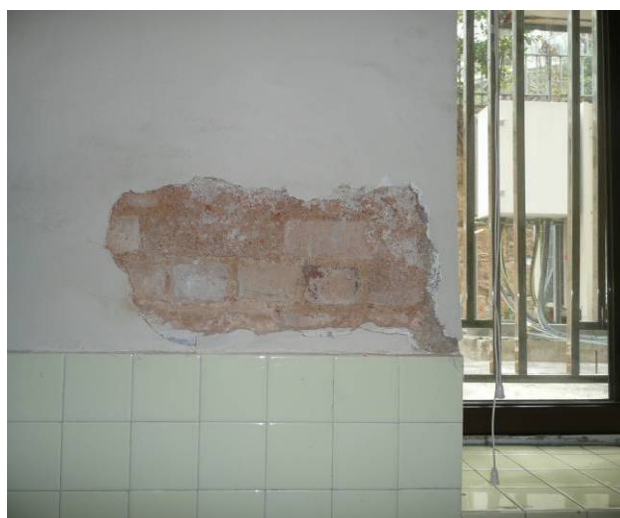
Evidence of original wall materials – Ground Floor

The interior of this small building is extremely simple. The walls are 400mm thick, with the windows recessed. The original timber window joinery has been replaced with aluminium. The ceiling height is higher than that of the corresponding floor of the main building and there are quatrefoil ventilating panels (now covered) reflecting this room's original use as a kitchen. Three substantial RSJs support the ceiling. The construction of this building is assumed to be brick and rubble as evidenced by the exposed section of the wall where the render has disintegrated. The original floor surface has been covered by 300mm square ceramic tiles. Deteriorating wall finishes above later tiling have exposed original brick construction in one section.

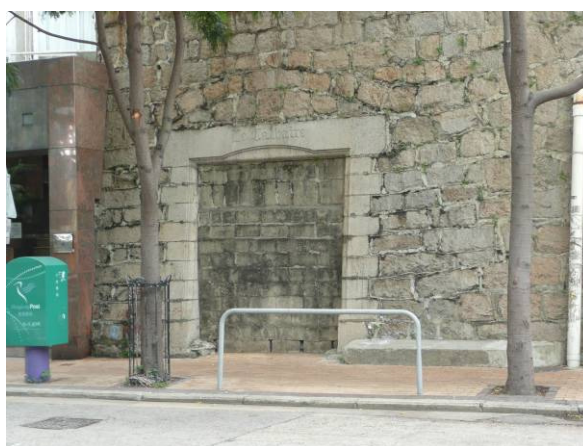
Original Entrance gateway

The massive granite retaining walls along Wong Nai Chung Road retain the evidence of their original gates and entrances to Le Calvaire at both the north and south end (refer original plan, page 10). These are an important part of the context of the place. The eastern walls on Ventris Road are less massive and serve only as a boundary wall, rather than a retaining wall, as this is on the uphill slope of the site.

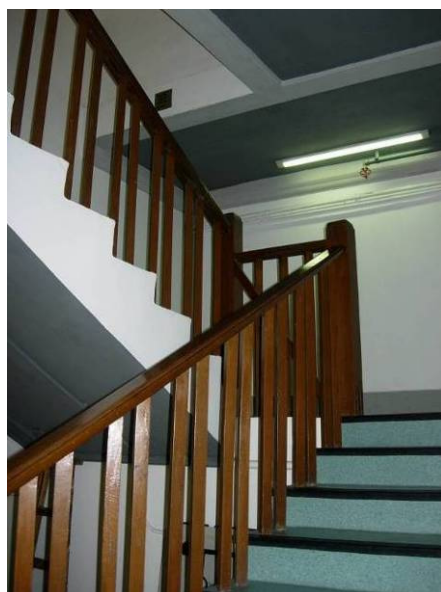
Timber balustrading to staircase in Eliot Hall HKU

The major internal changes can be seen in the central hall where the original timber staircase, assumed to be similar to the timber staircase in the Old Halls (student residential buildings) at Hong Kong University also designed by Leigh & Orange in 1903, was replaced by a concrete staircase with wrought iron balustrading.

Internally, the central staircase would have been similar in detail to those in the Old Halls at HKU. The scale and proportion are identical and the form of the balustrading could be assumed to be similar.

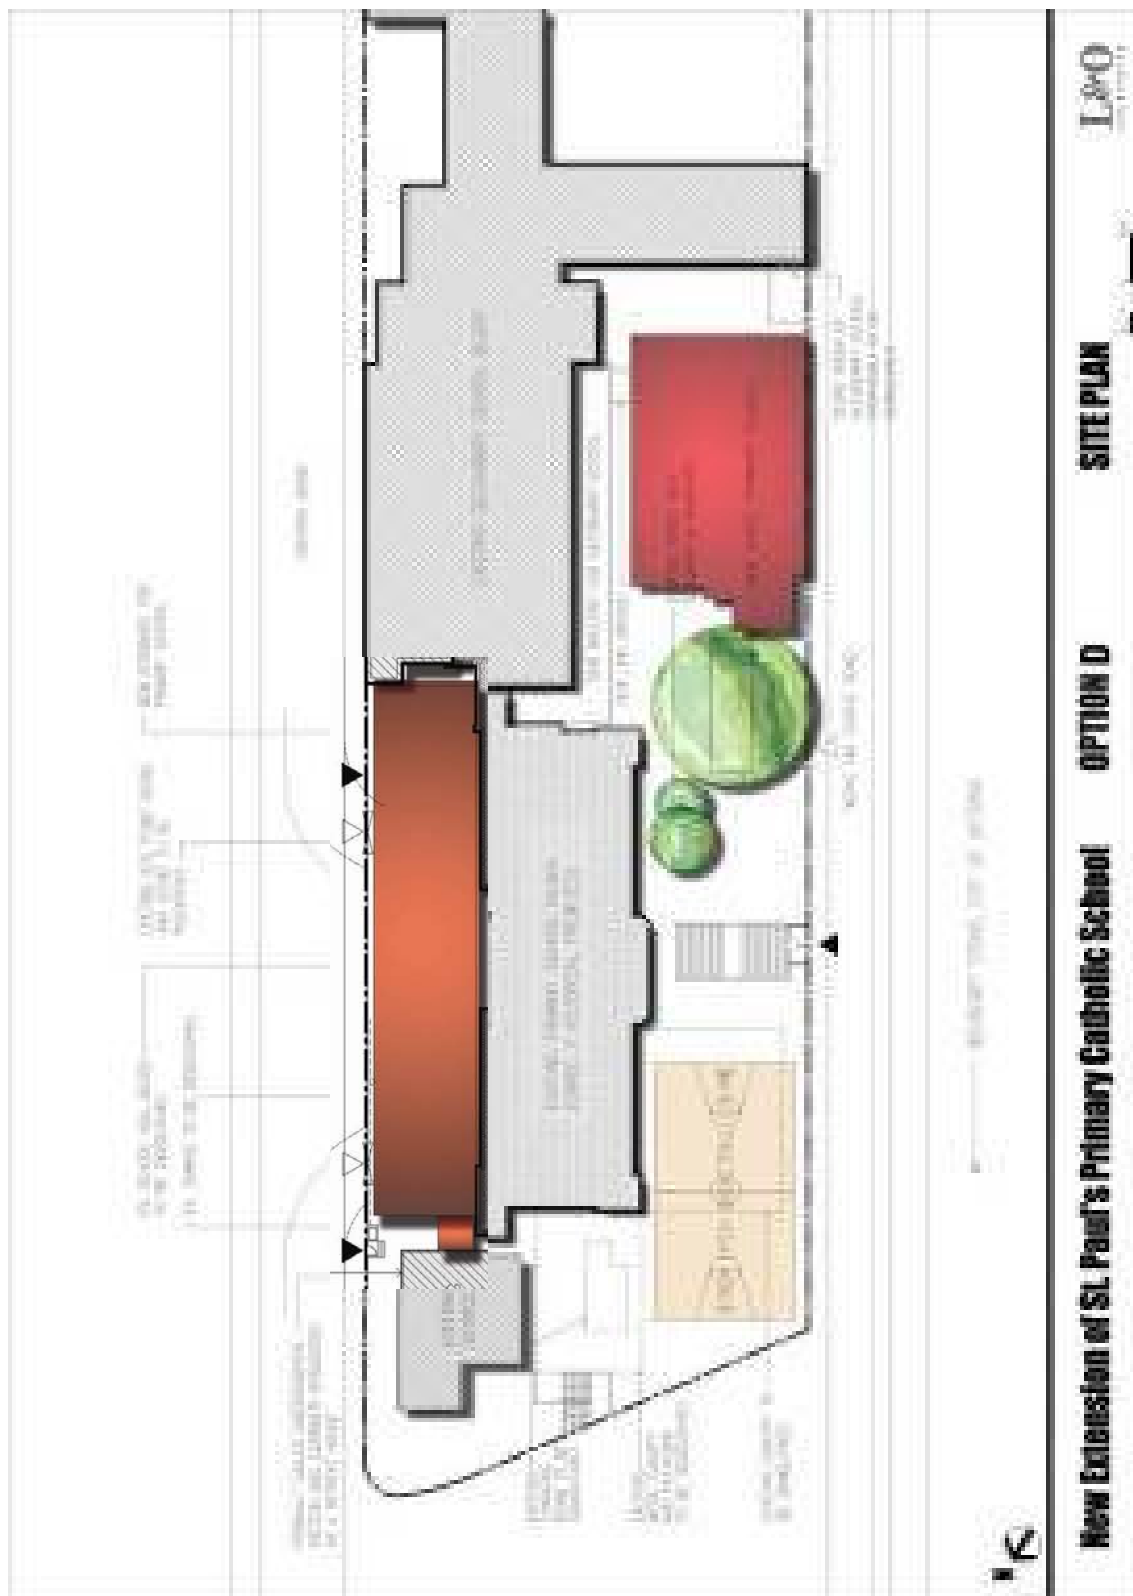
OPTION D
 Showing location of proposed Annexes A and B immediately to east and south west of existing school building

- **Option D** – combines Option C (Annex A) with the addition of a free standing four storey building (Annex B) constructed to the south west of the original building

This additional building, constructed over the playground of the existing secondary school, does not impact on the significant trees and is located sufficiently to the south so that it does not obscure the view of the front elevation of the historic building. However, it would also require unacceptable demolition of sections of the significant granite walls to Wong Nai Chung Road.

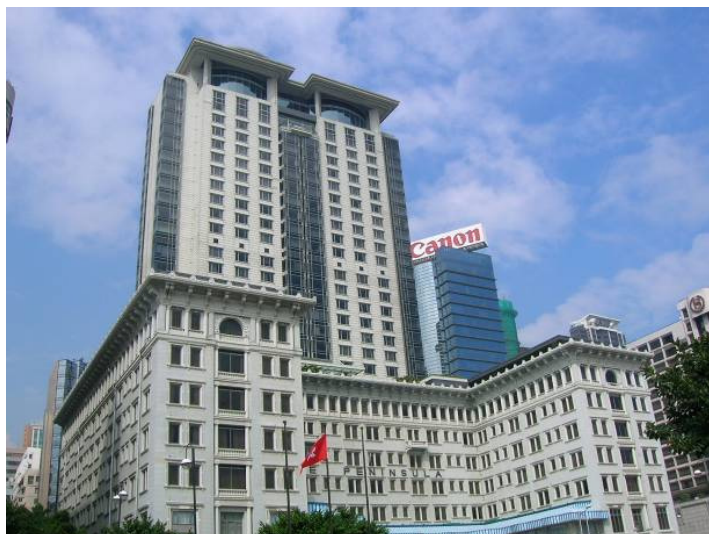
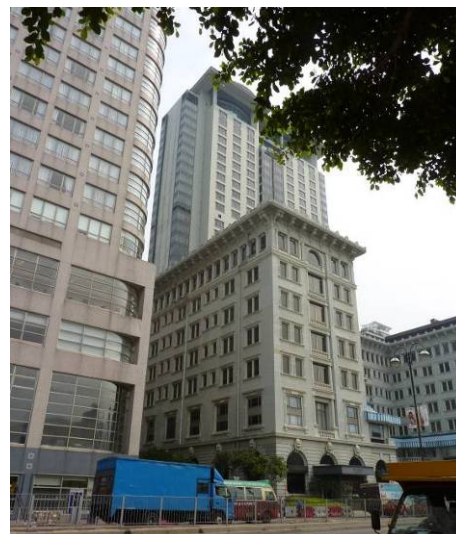
Peninsula Hotel, Kowloon

The original 1928 hotel building has been extended with a rear 30 storey section, constructed in 1994. This addition won a Hong Kong Institute of Architects award in 1995.

The option of building a multi-storied addition behind a low rise historic structure has been used successfully in a number of cases where the site area is limited but the development is considered necessary. The following are examples of this approach.

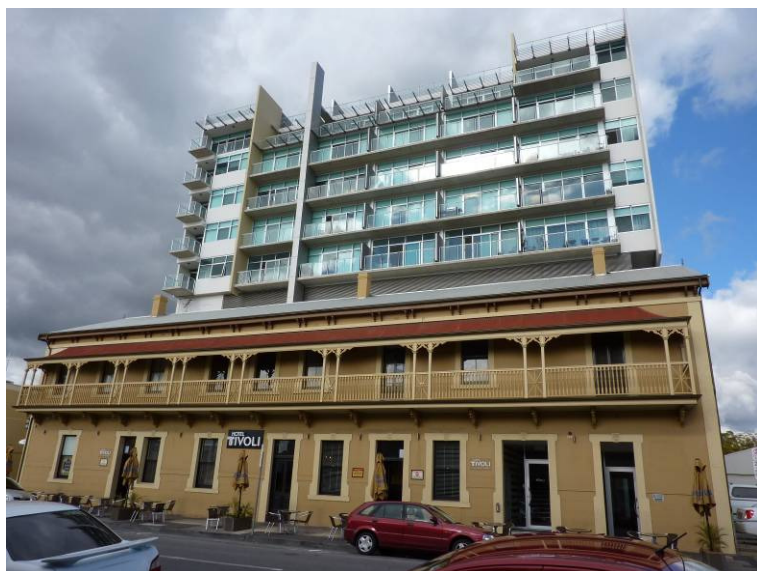
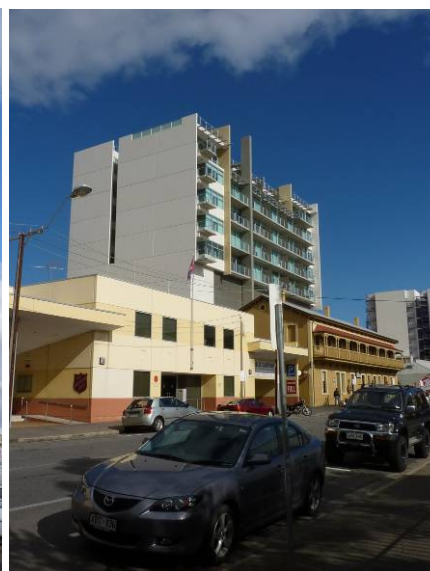
Tivoli Hotel, Adelaide, South Australia

The original Tivoli Hotel was constructed in 1850 and was extended a number of times with the frontage built in 1883-4. An apartment block was added to the rear of the two storey hotel in 2008. The building is located in a narrow street in the centre of Adelaide.

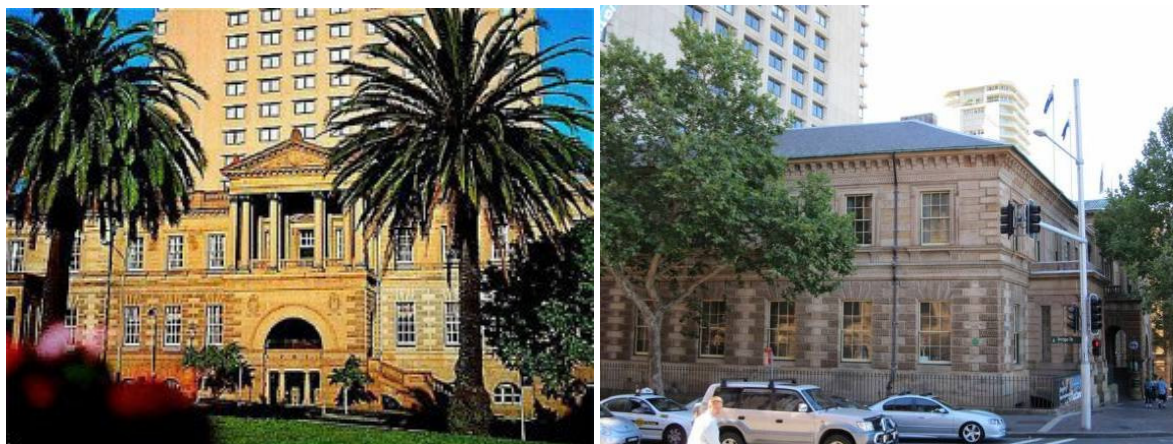
Intercontinental Hotel, Sydney, NSW

The former 1850s NSW Colonial Secretary's Office building, facing a small city park in downtown Sydney, was converted to a hotel in 1984, with a 30 storey accommodation tower constructed behind the early three storey sandstone structure.
