UNDERSTANDING

2 UNDERSTANDING

2.1 Ownership and Management

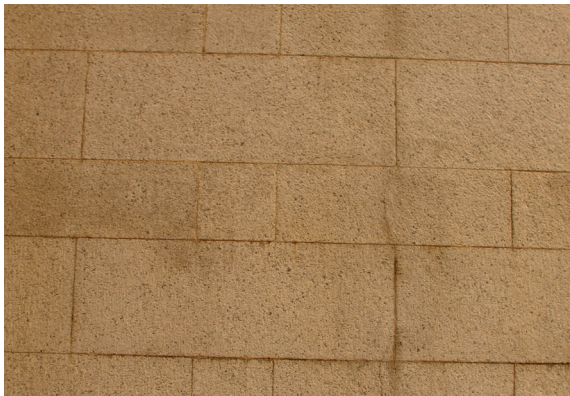
Granite cladding

Areas of granite cladding can be found to all the CGO buildings, although as an expensive material it tends to be used within the public areas of the site. It is laid in a variety of patterns, although the most prevalent type tends to be courses of alternate headers and stretchers followed by courses of larger stretchers.

There were historically a number of quarries within Hong Kong, as evidenced by place names such as *Stonecutter Island* and *Quarry Bay*. Originally the granite on the site came from Grampian Road Quarry, close to the old Kai Tak airport. When this closed a close match had to be found elsewhere; granite for the 2nd and 3rd phases possibly came from the Diamond Hill Quarry. The relative expense of the material is evidenced by the fact that it is replaced with ceramic tiling on the Main Wing Annexe extension, constructed c. 1989.

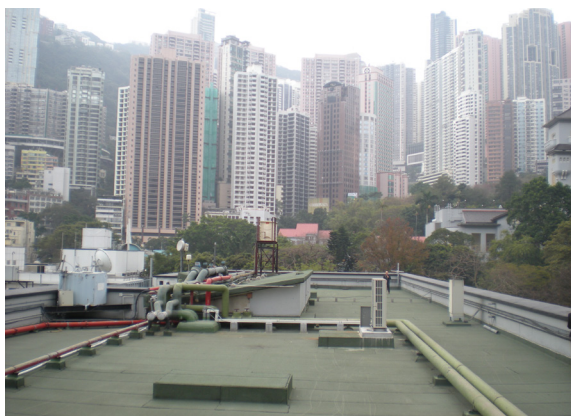
The roof of the Central Wing

There are various plant rooms on the roof, most of which are later additions. The roof surface is covered with green bituminous felt, with various gantries and walkways over, together with items of air conditioning plant, water tanks and steel framed enclosures clad with profiled metal sheet. The parapet upstand to the perimeter is 1.1 m high. Access to the roof of the original building is by a staircase over a parapet wall at the junction between the two phases of building. The top of the mono-pitched roof of the link between the Central and East Wings that contains the lift overruns is visible, the rest being concealed by the 7th floor extension.

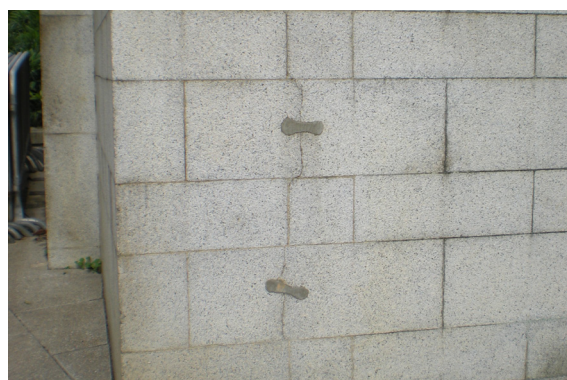
Cracks in the granite walling

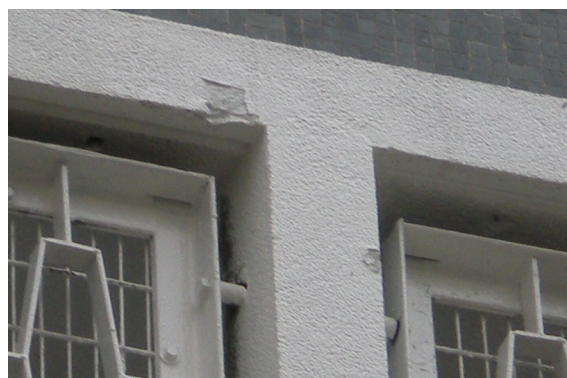
Spalling to the concrete of the Central Wing

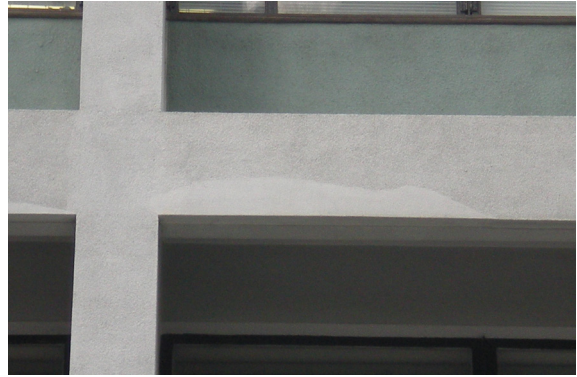
Concrete repairs to arrisses

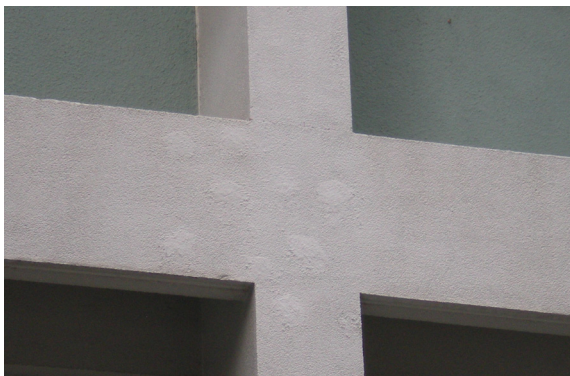
Concrete repairs on the West Wing

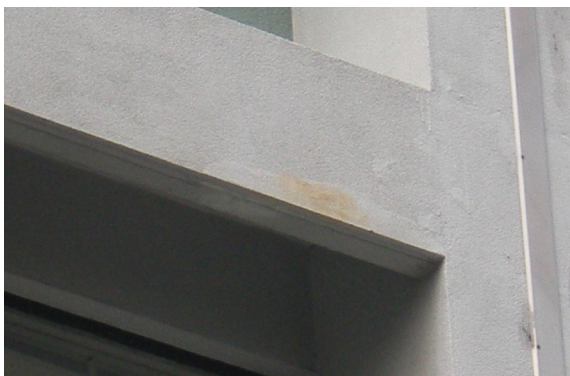
Staining on the West Wing

The design of the exposed frame, with deep horizontal ledges, means that the elevation is subject to staining to the front faces from water run-off. This is once again apparent despite the recent redecoration.

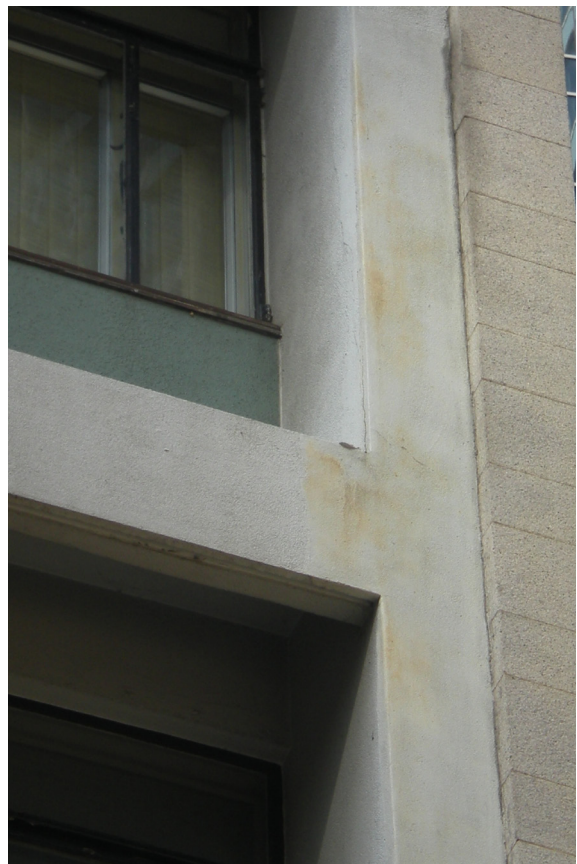
Staining on the West Wing

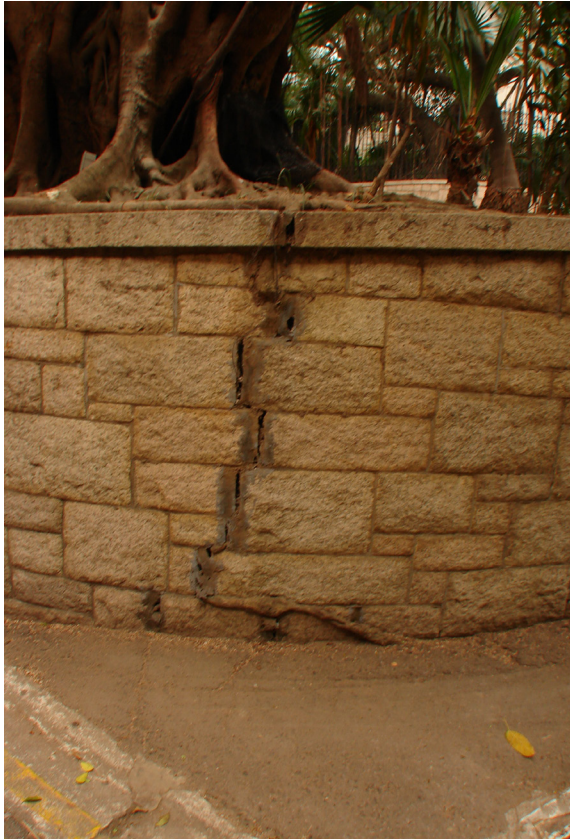
A large crack in a retaining wall for a flower bed

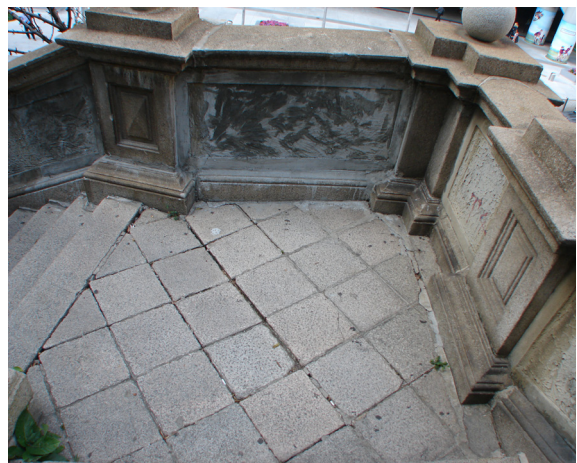
Concrete repairs and gaps in the paving of the Battery Path steps

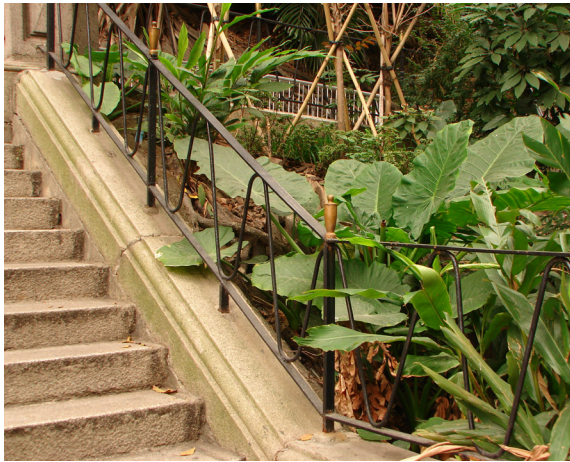
Wave pattern railings from the 1950s

There are two different designs of railings on and around the CGO site. The first is a waist height iron railing with wave pattern bars and gilded gold finials on each main upright. These railings were designed and installed when the CGO were constructed in the 1950s. Examples of this type of railing can be found along Battery Path and beside the northern driveway leading into the CGO Complex.

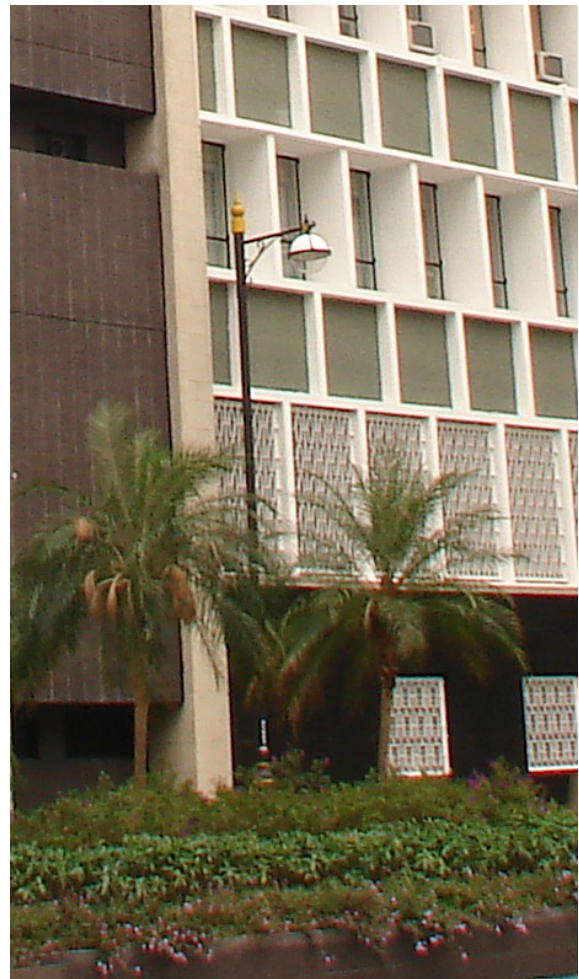
A lamp post outside the Central Wing

Within the compound is another lamp post outside the Central Wing which has a different design. The plain post is also topped by a gold finial but the globe shaped lamp hangs off to the side from a projecting bar which is supported by a decorative brace.
