大夫第

Tai Fu Tai Mansion

建築特色

Architectural Features

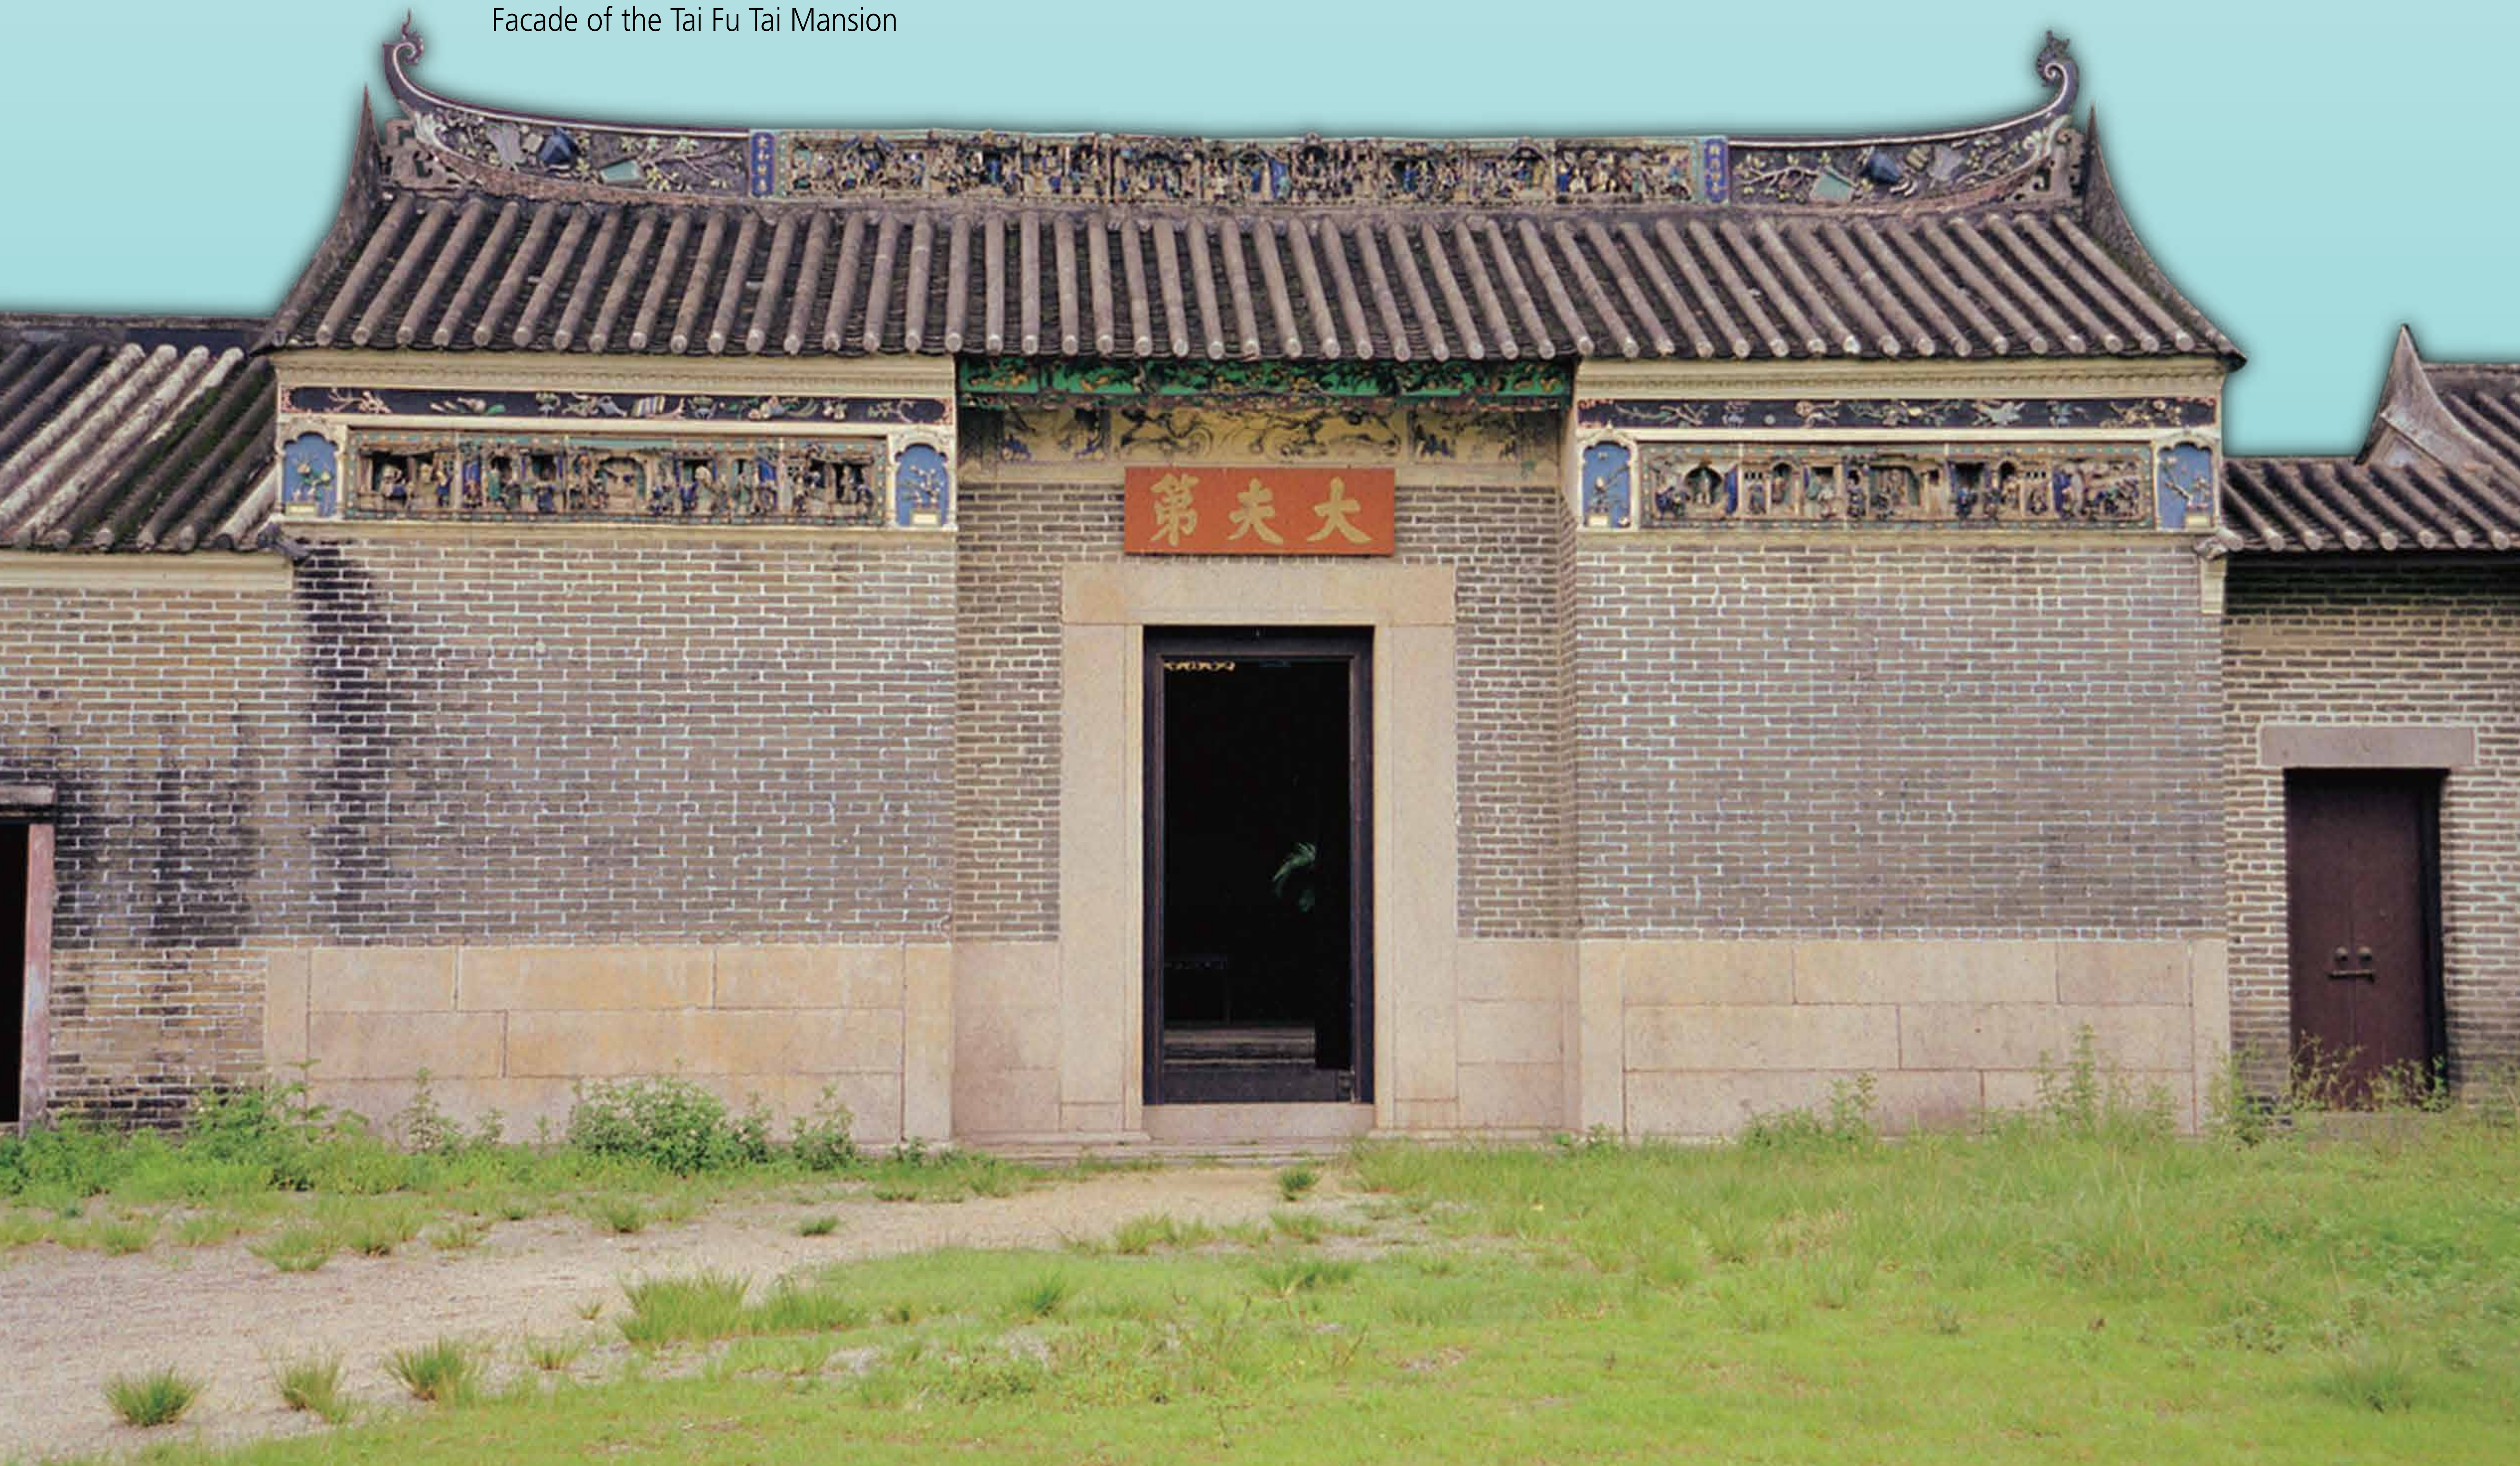
大夫第的正面
Facade of the Tai Fu Tai Mansion

大夫第正面青磚牆下方有花崗條石牆基，牆頭裝飾以陶塑及彩塑壁龕為主體。正門門框以花崗條石砌築，門楣高掛「大夫第」紅漆金字牌匾。船形正脊上精巧的人物陶塑是廣東佛山石灣文如壁窯燒製。

Tai Fu Tai Mansion is distinguished by its solemn granite-block base, green-brick walls and ceramic figurines and polychrome mouldings that embellish the niches. Above the recessed and granite-framed entrance is a red wooden board carved with the characters "Tai Fu Tai" ("the residence of the dafu") in gold. The boat-shaped main ridge above the entrance hall is also decorated with polychrome mouldings and exquisite ceramic figurines manufactured at the famous Wenrubi kiln at Shiwan in Foshan of Guangdong province.

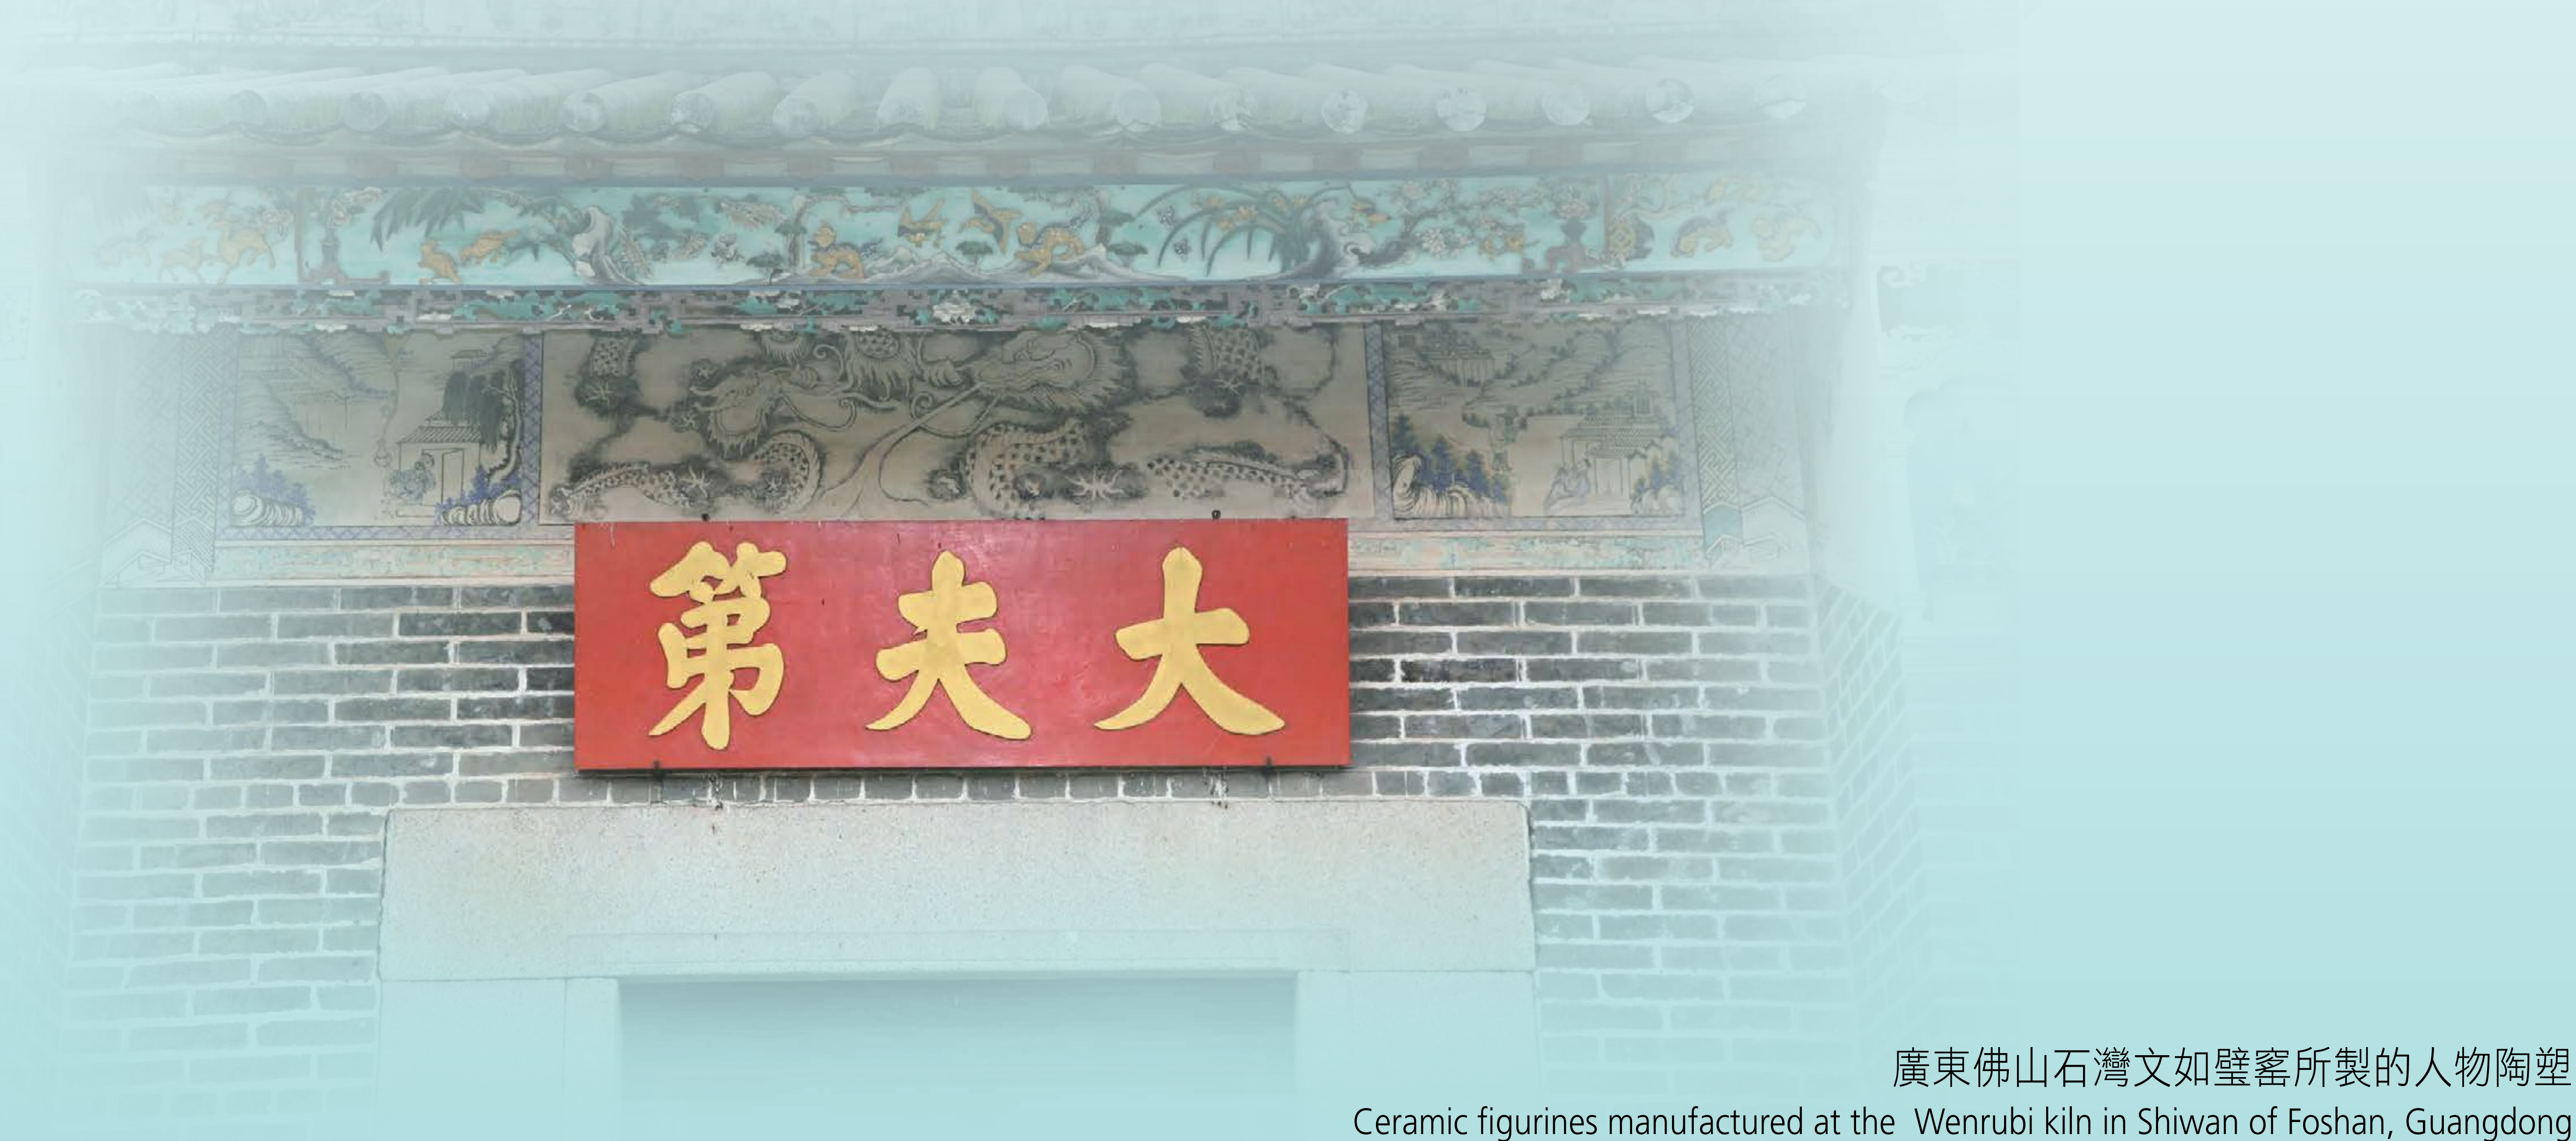
「大夫第」的紅漆金字牌匾
A red wooden board with golden characters "Tai Fu Tai"

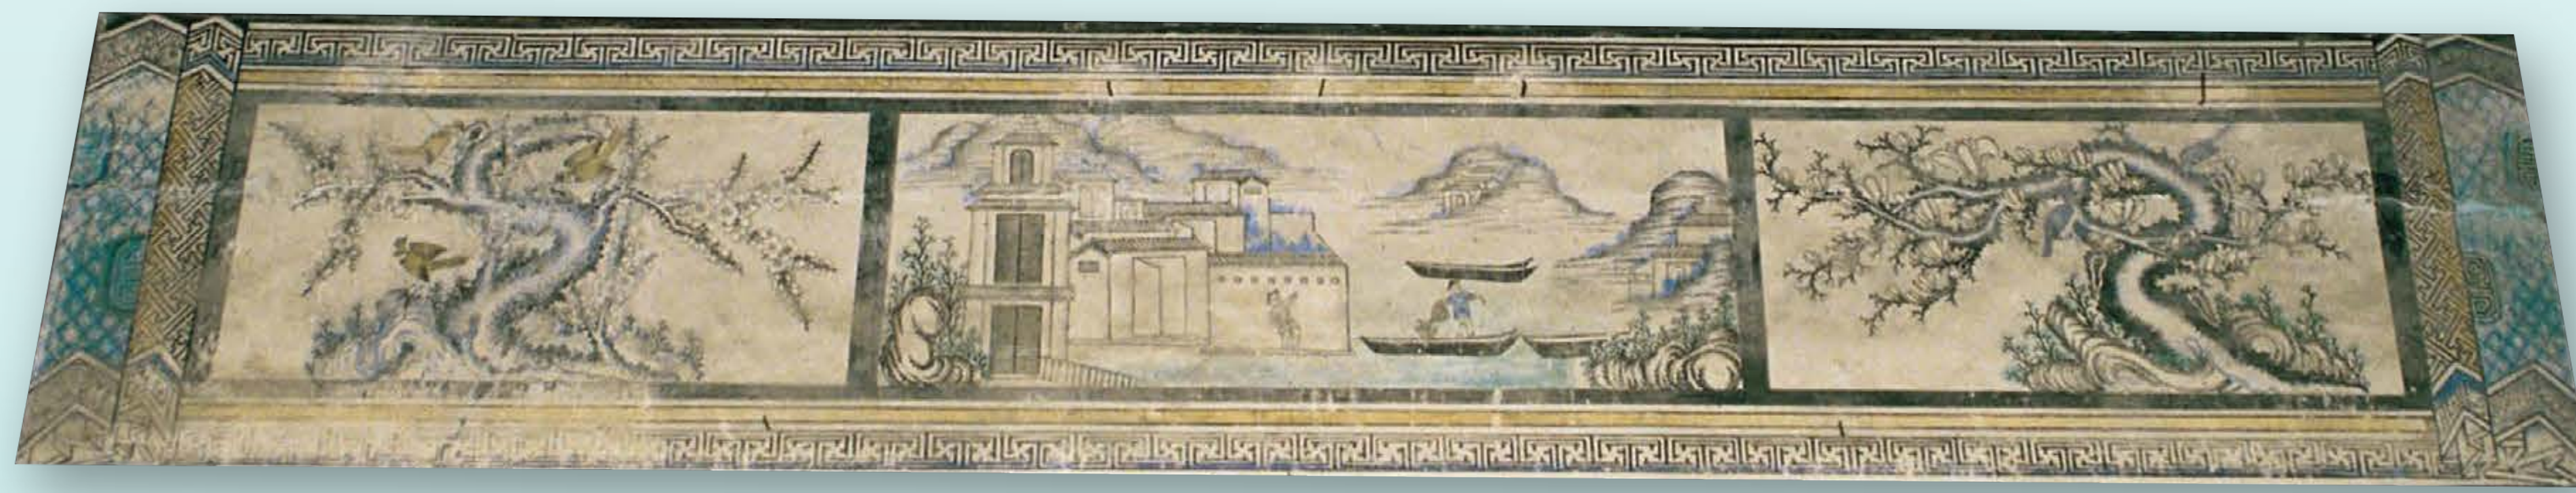
傳統中國壁畫
Traditional Chinese murals

整座建築飾有豐富的灰塑及彩塑、木刻及壁畫等，而大部分裝飾均刻畫中國吉祥圖案及繪畫，其中有梅、蘭、菊、竹、鹿、蝙蝠及麒麟等。屋內通道拱門上的彩繪玻璃和巴羅克式的花葉浮雕，顯示當時建築藝術受西方影響。

The whole building is elegantly decorated with fine monochrome and polychrome plaster mouldings, wood carvings and murals incorporating auspicious Chinese themes and images. Common Chinese motifs from the worlds of botany, zoology and ornithology feature strongly, including plum blossoms, orchids, chrysanthemums, bamboo, deer, bats and unicorns. In addition, the painted glass panes and the baroque flower and leafy plaster mouldings above the arched doorways are examples of decorative features that reflect the influence of Western culture on architecture of the period.

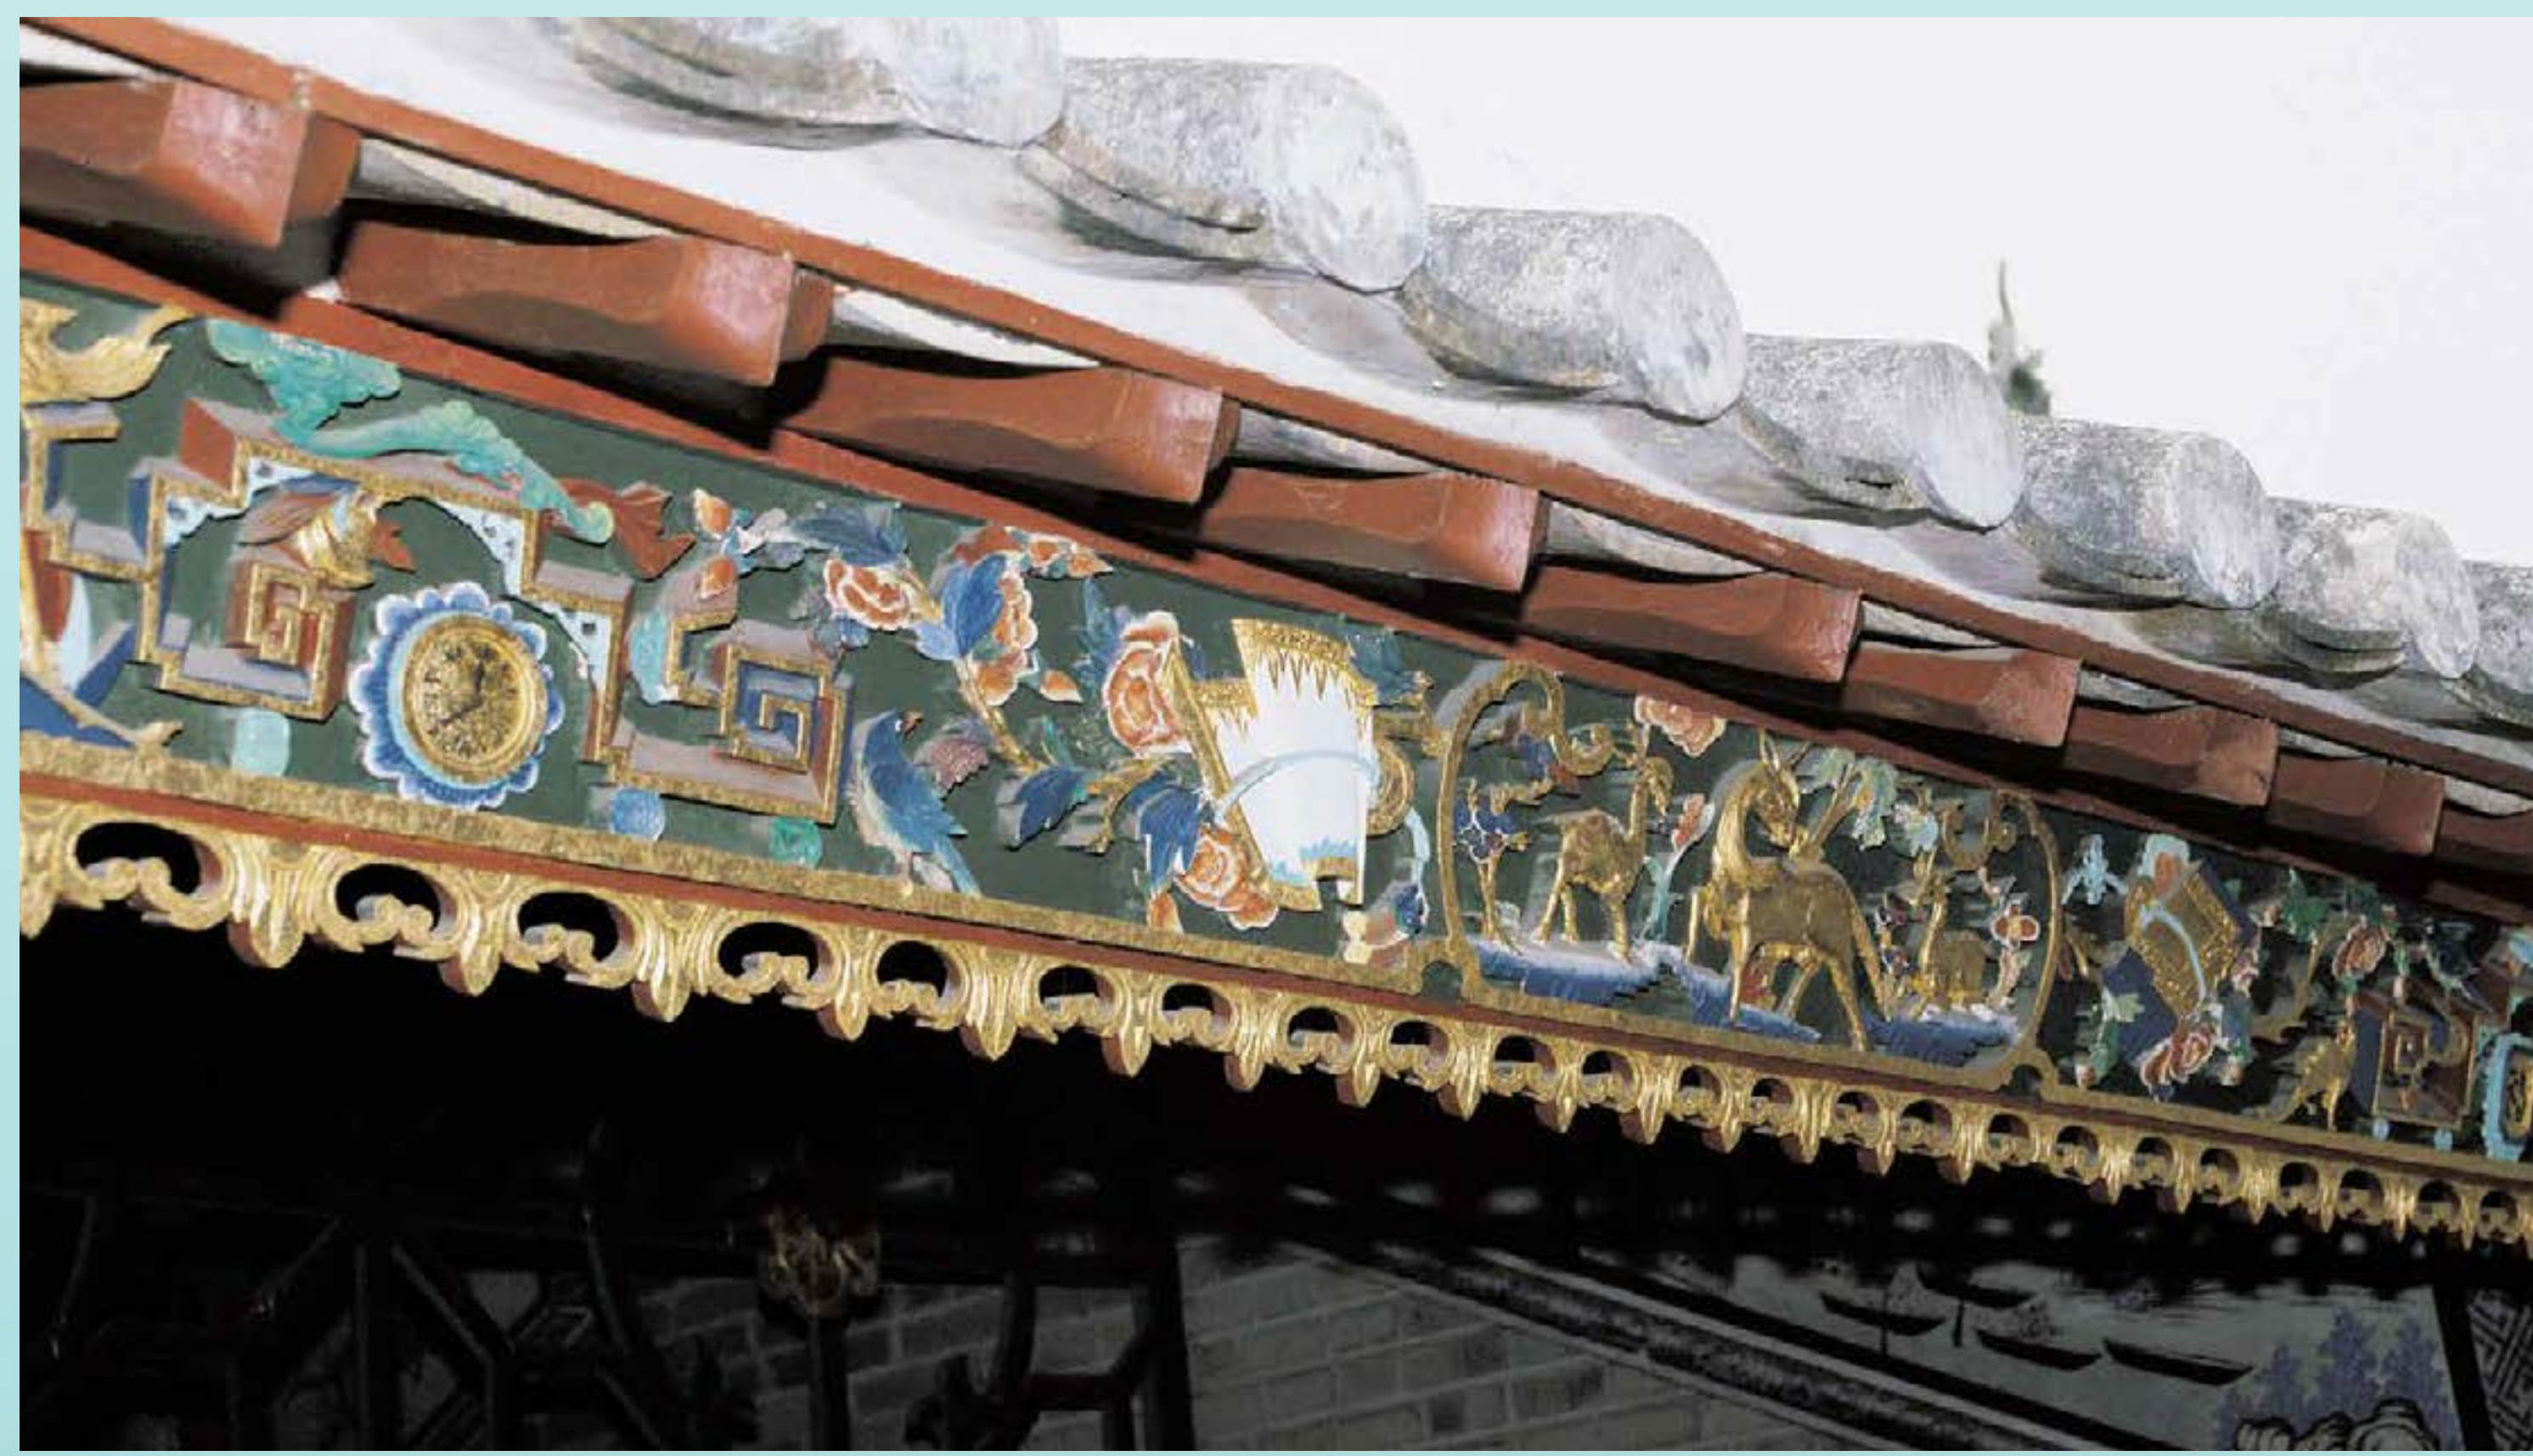
揉合中外吉祥圖案的木刻
Wood carvings blending with Western motifs and auspicious Chinese symbols

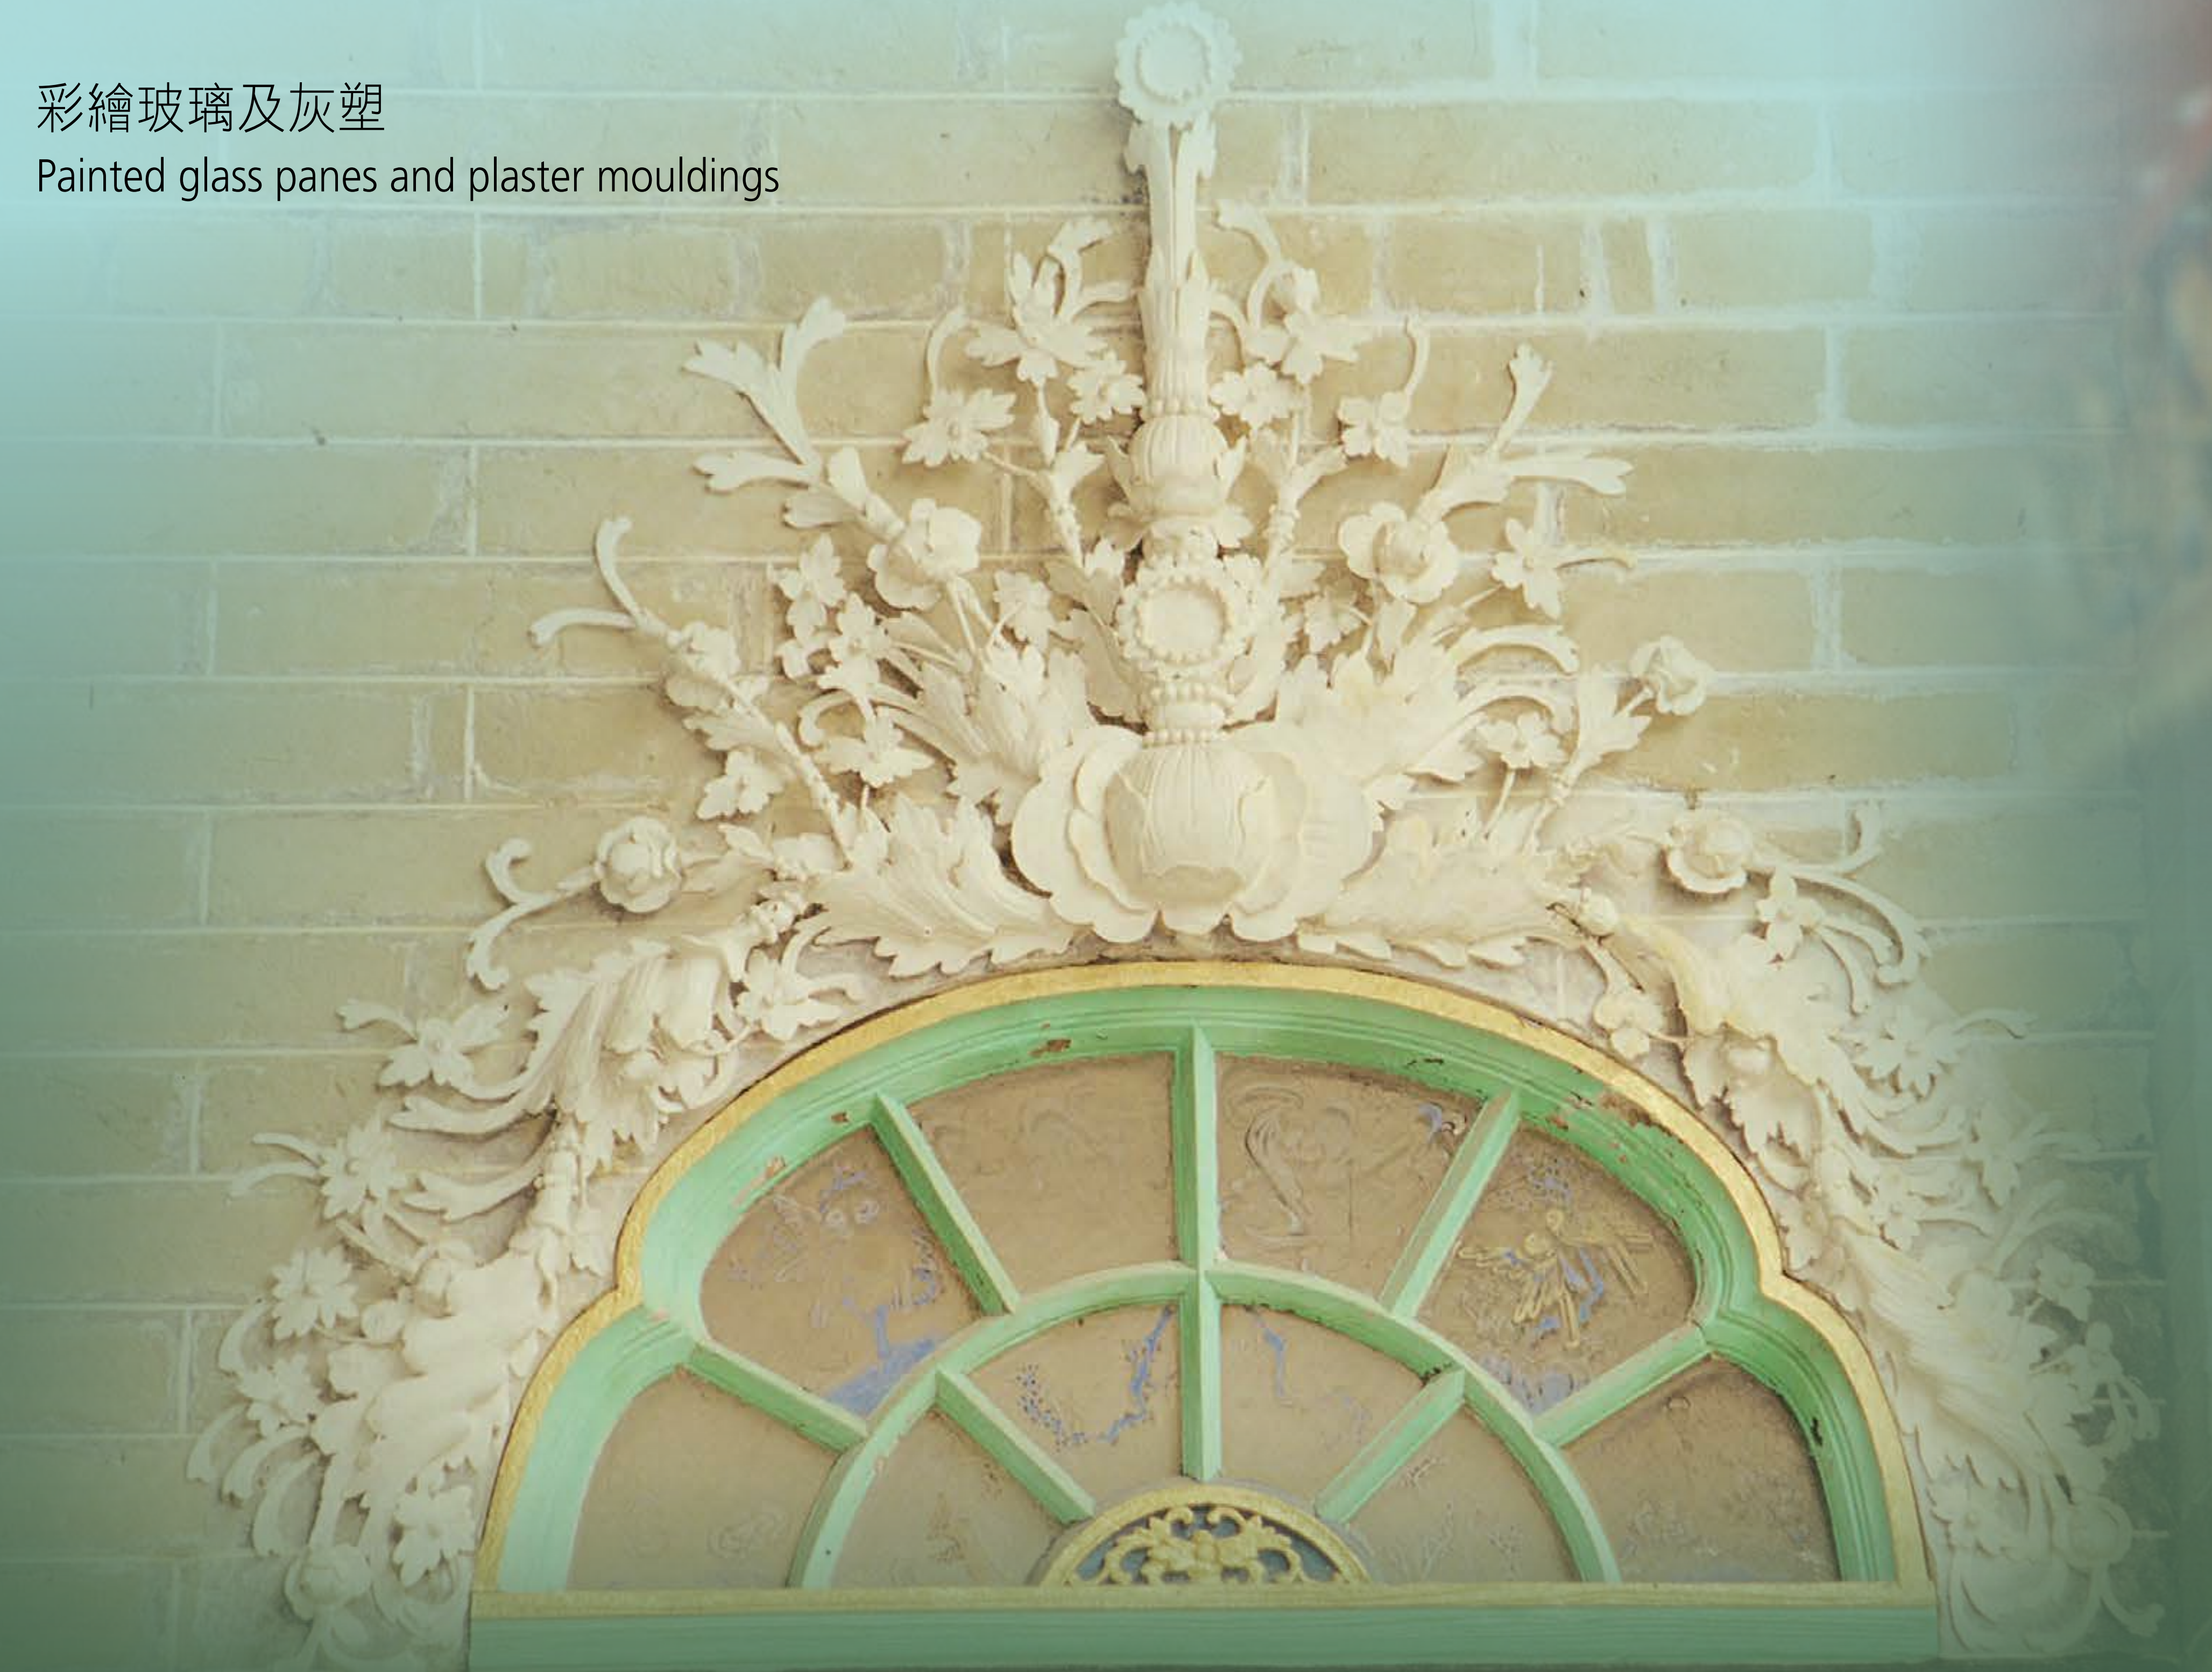
鯨魚形出水口
Water spout in the shape of a dragon fish

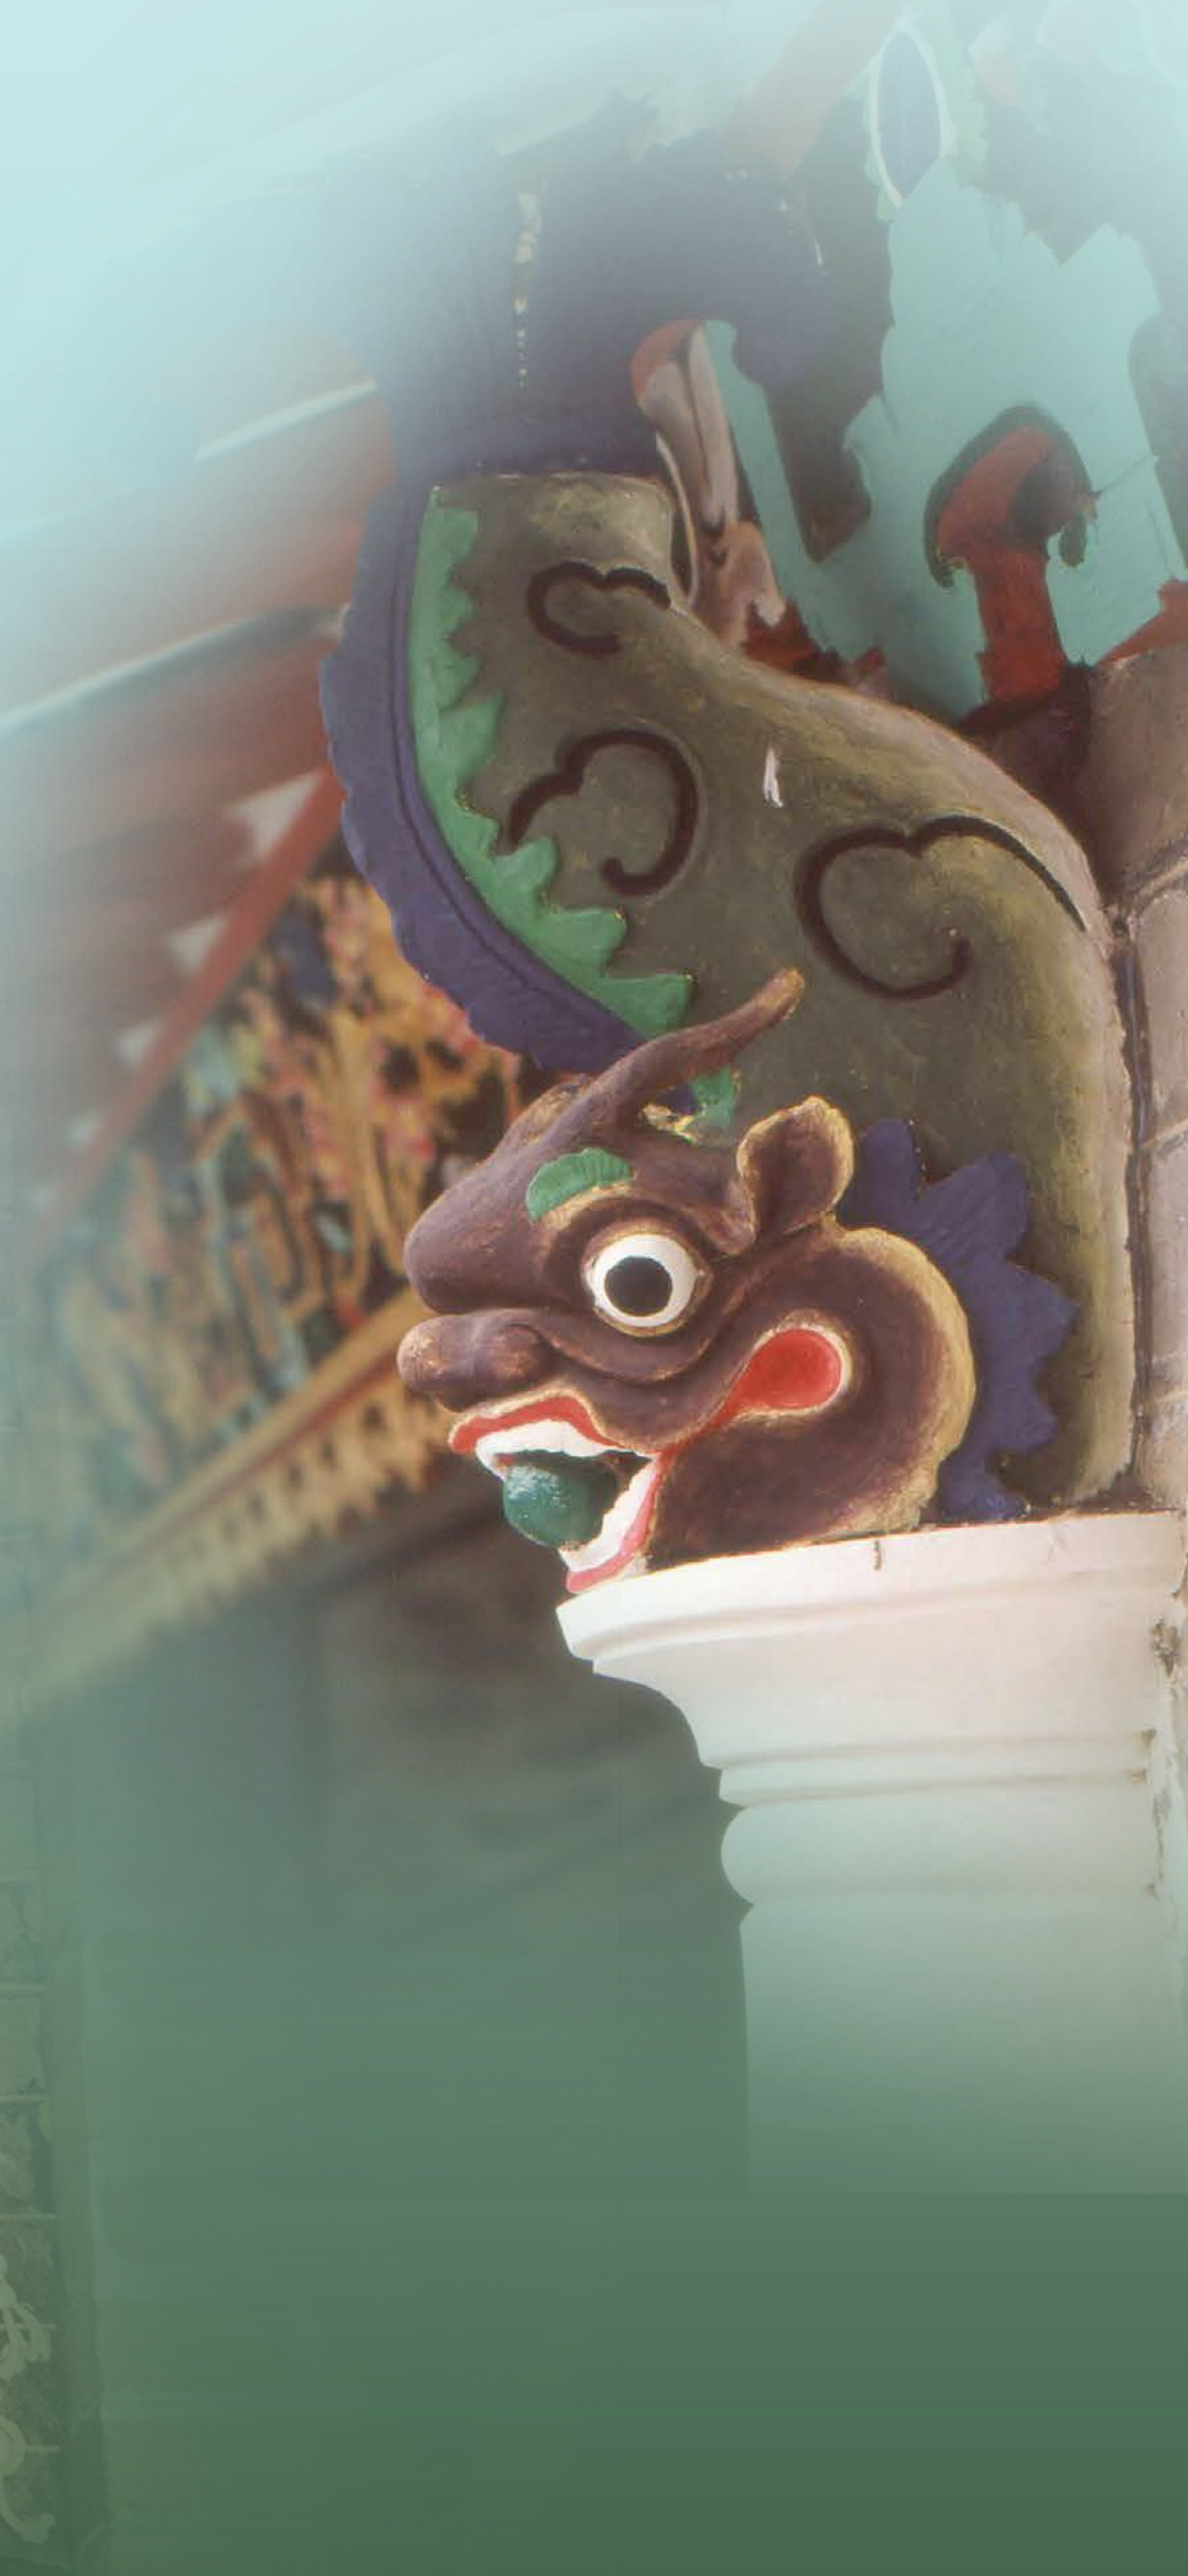
彩繪玻璃及灰塑
Painted glass panes and plaster mouldings

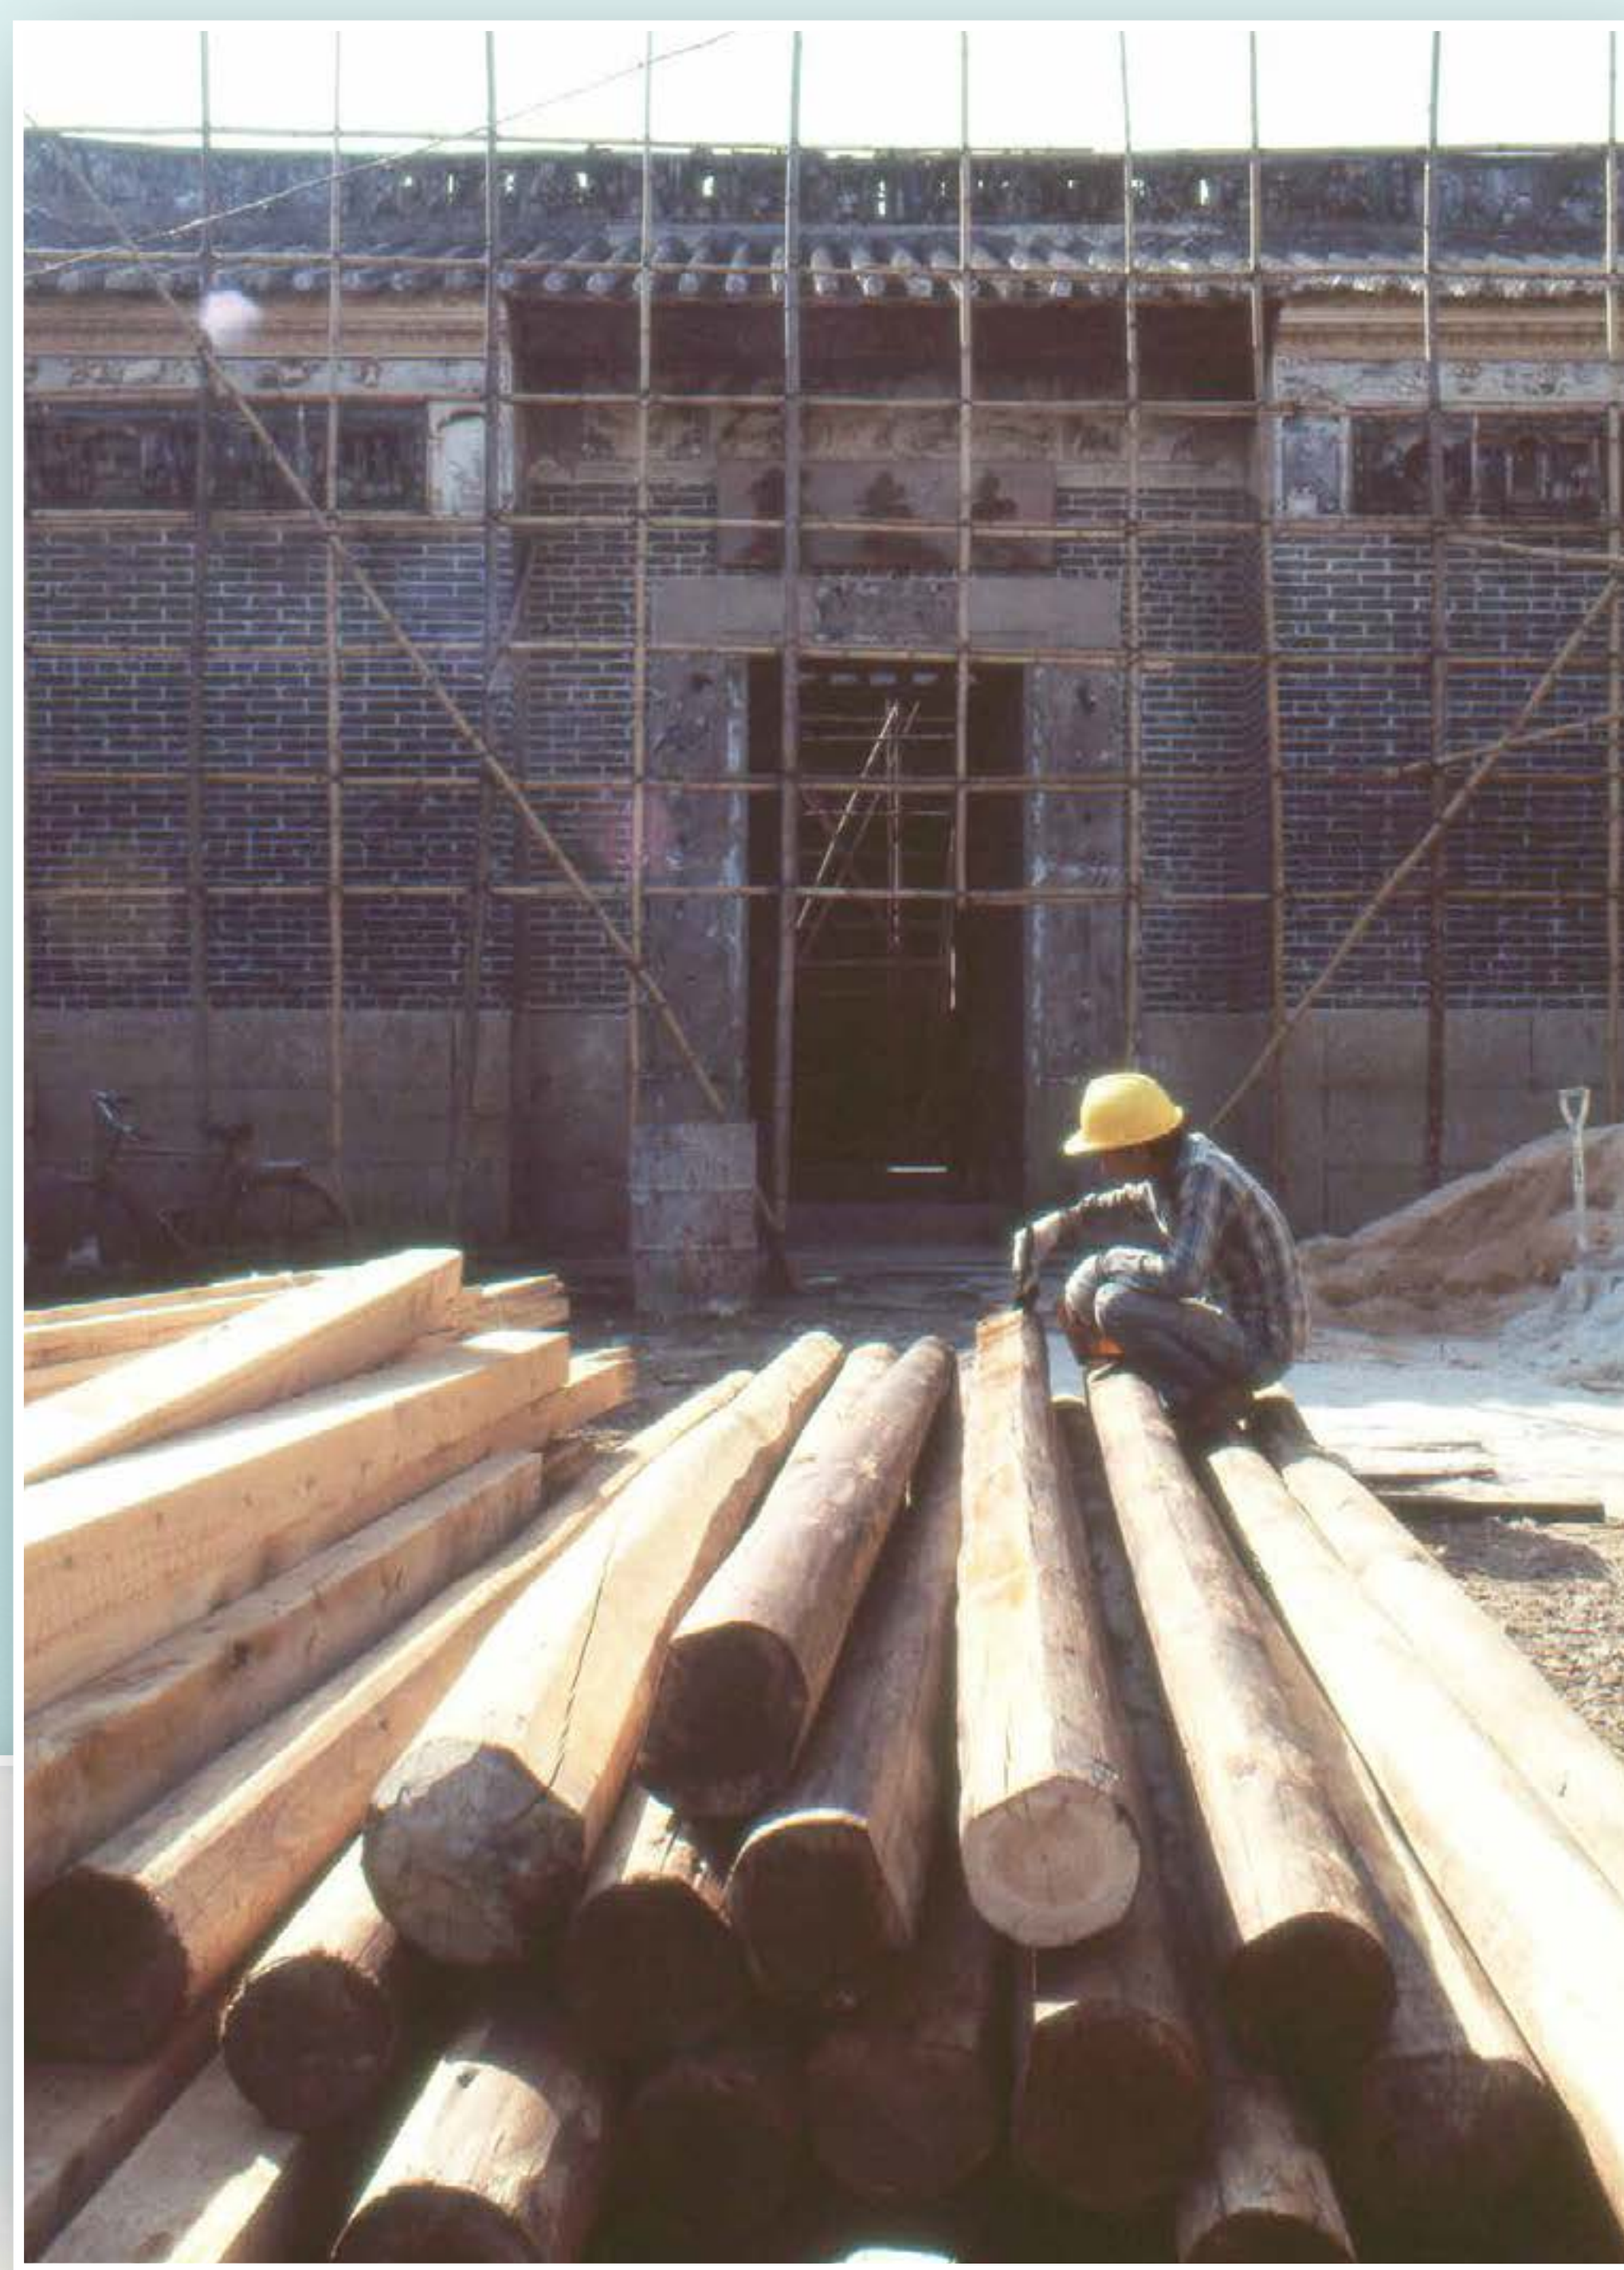
大夫第於1988年展開修復工程
Restoration work on Tai Fu Tai Mansion commenced in 1988

大夫第在文華章堂各司理的鼎力合作下，於1987年7月10日列為法定古蹟，並得到賽馬會慷慨捐款250萬元，以進行修復工程。這項修復工程在建築署及古物古蹟辦事處監督下，由本地建築公司的工匠負責施工。

With the co-operation and assistance of the managers of the Man Wah Cheung Tong, the building was declared as a monument on 10 July 1987. Funded by a generous donation of HK\$2.5 million from the Hong Kong Jockey Club, restoration work was conducted by the craftsmen of a local contractor under the supervision of the Architectural Services Department and the Antiquities and Monuments Office.
