大夫第

Tai Fu Tai Mansion

建築特色

Architectural Features

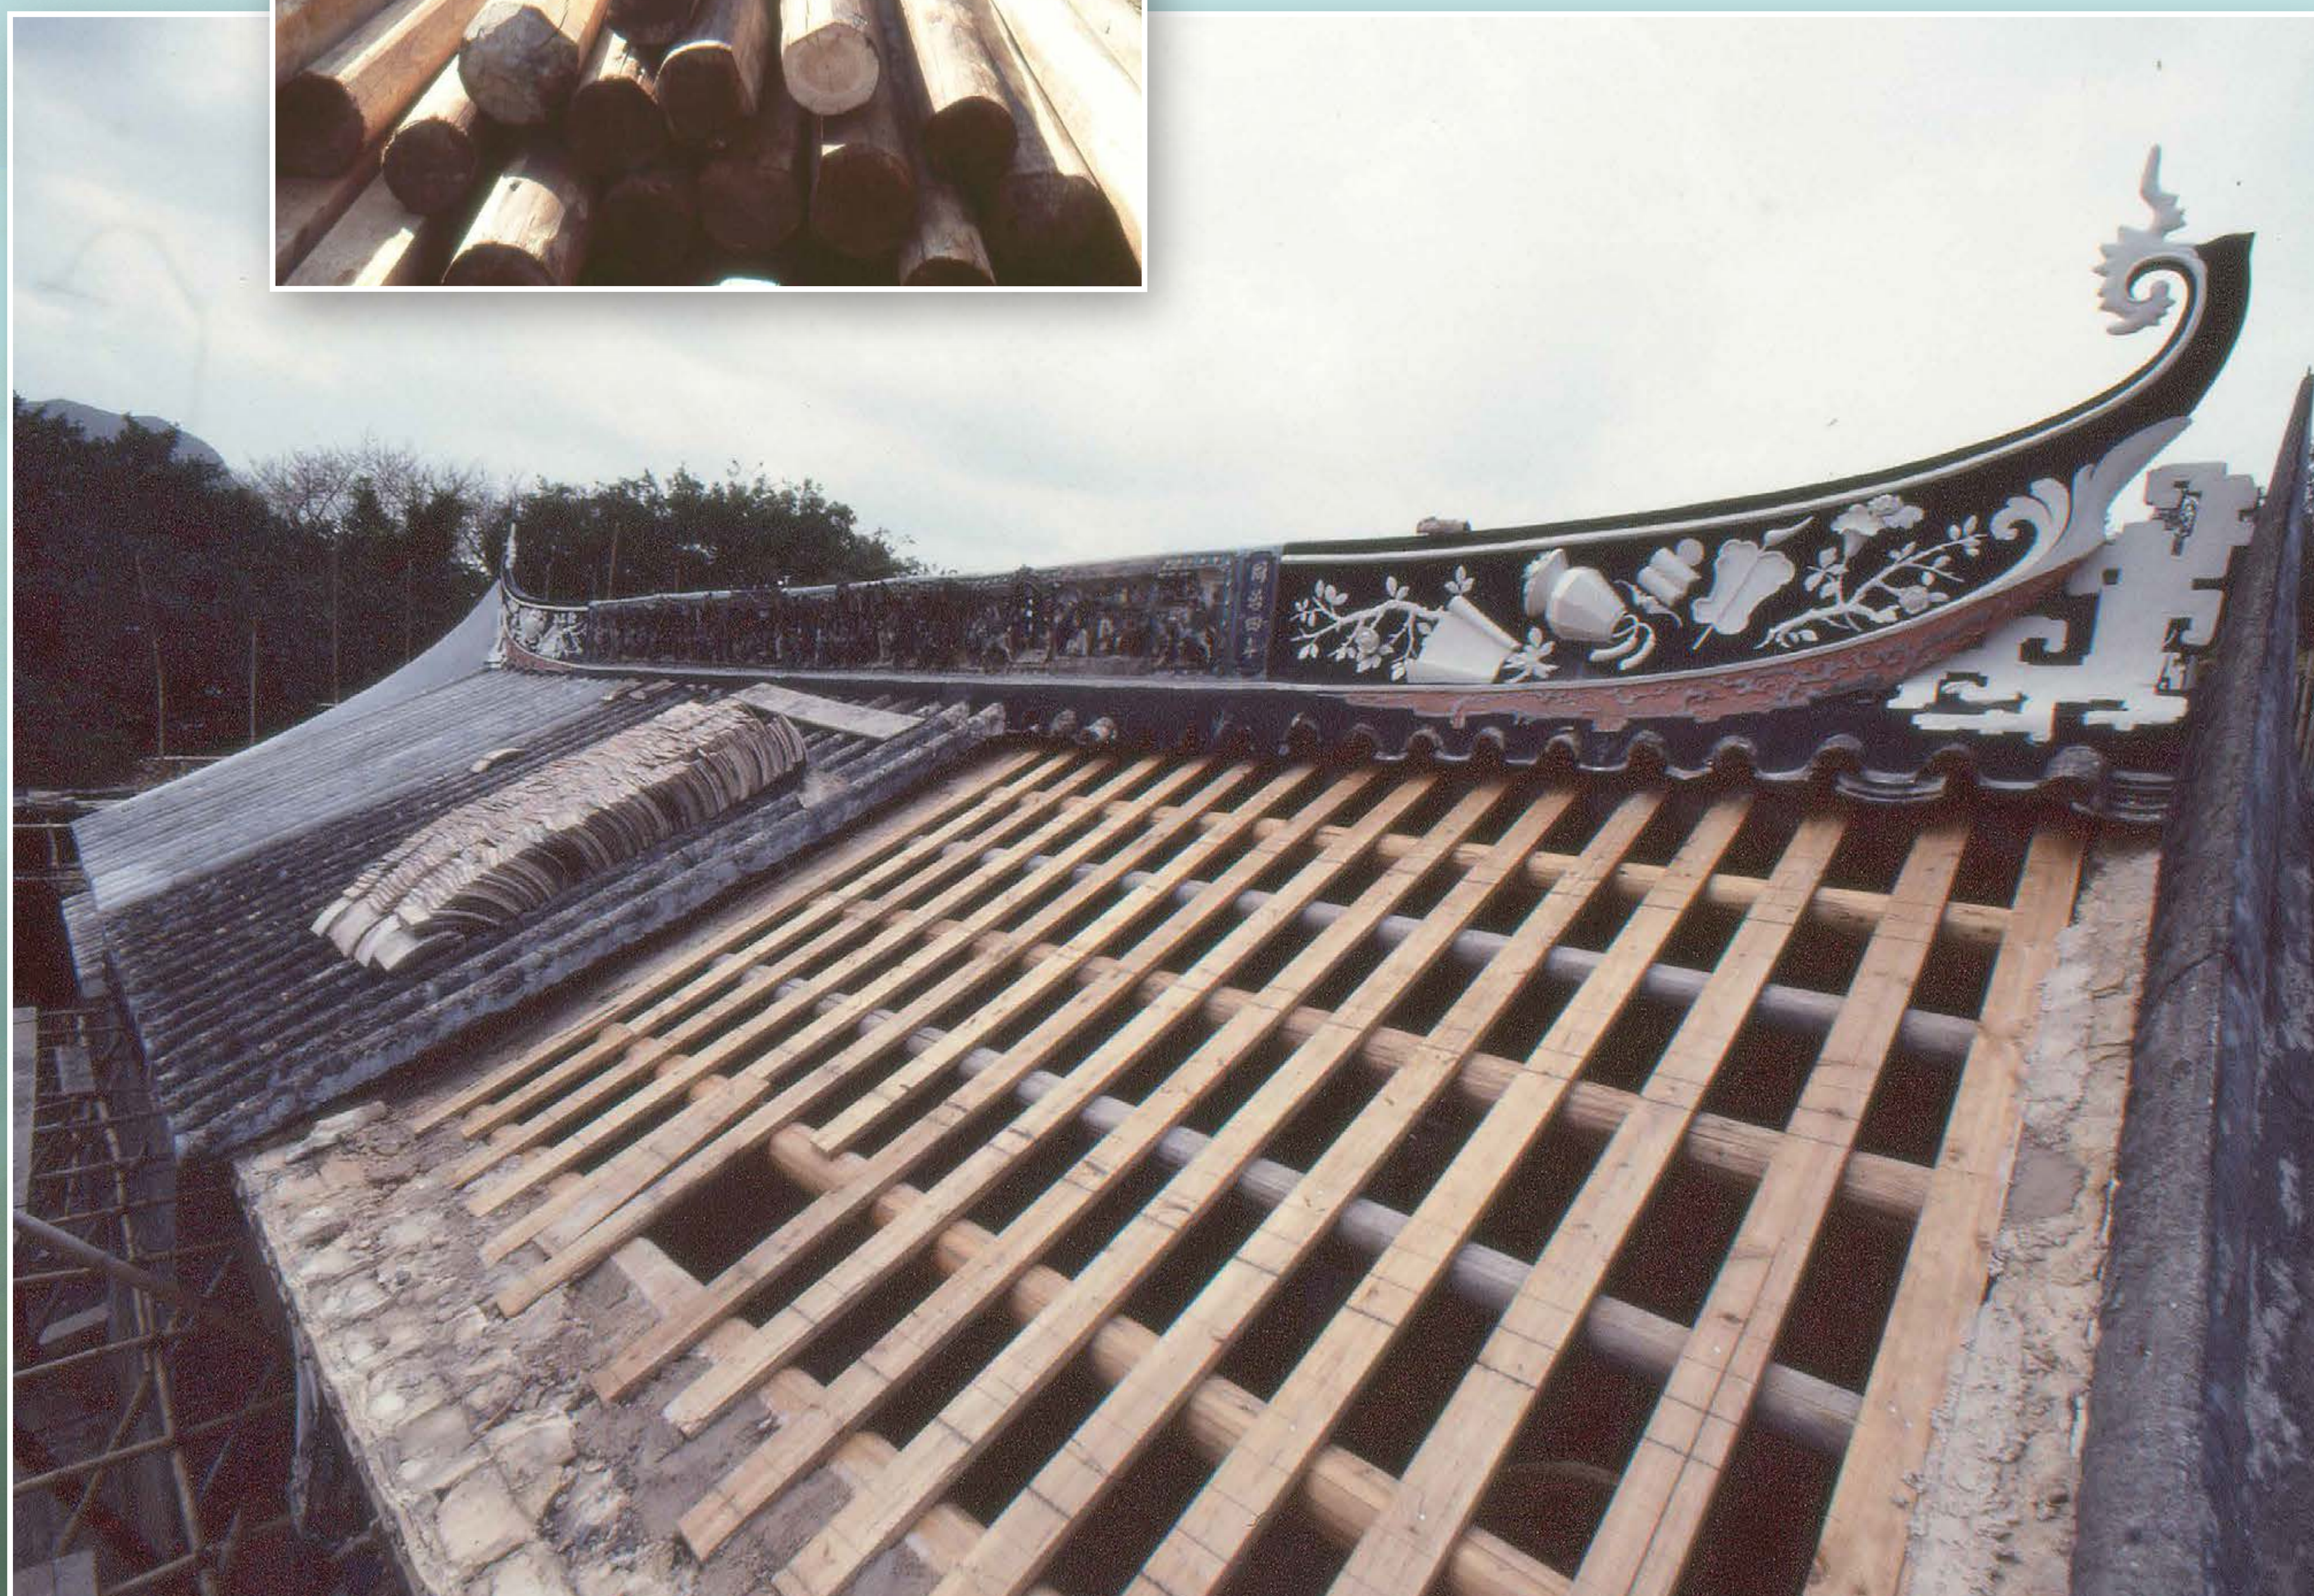
鋪砌天面瓦頂
Laying of roof tiles

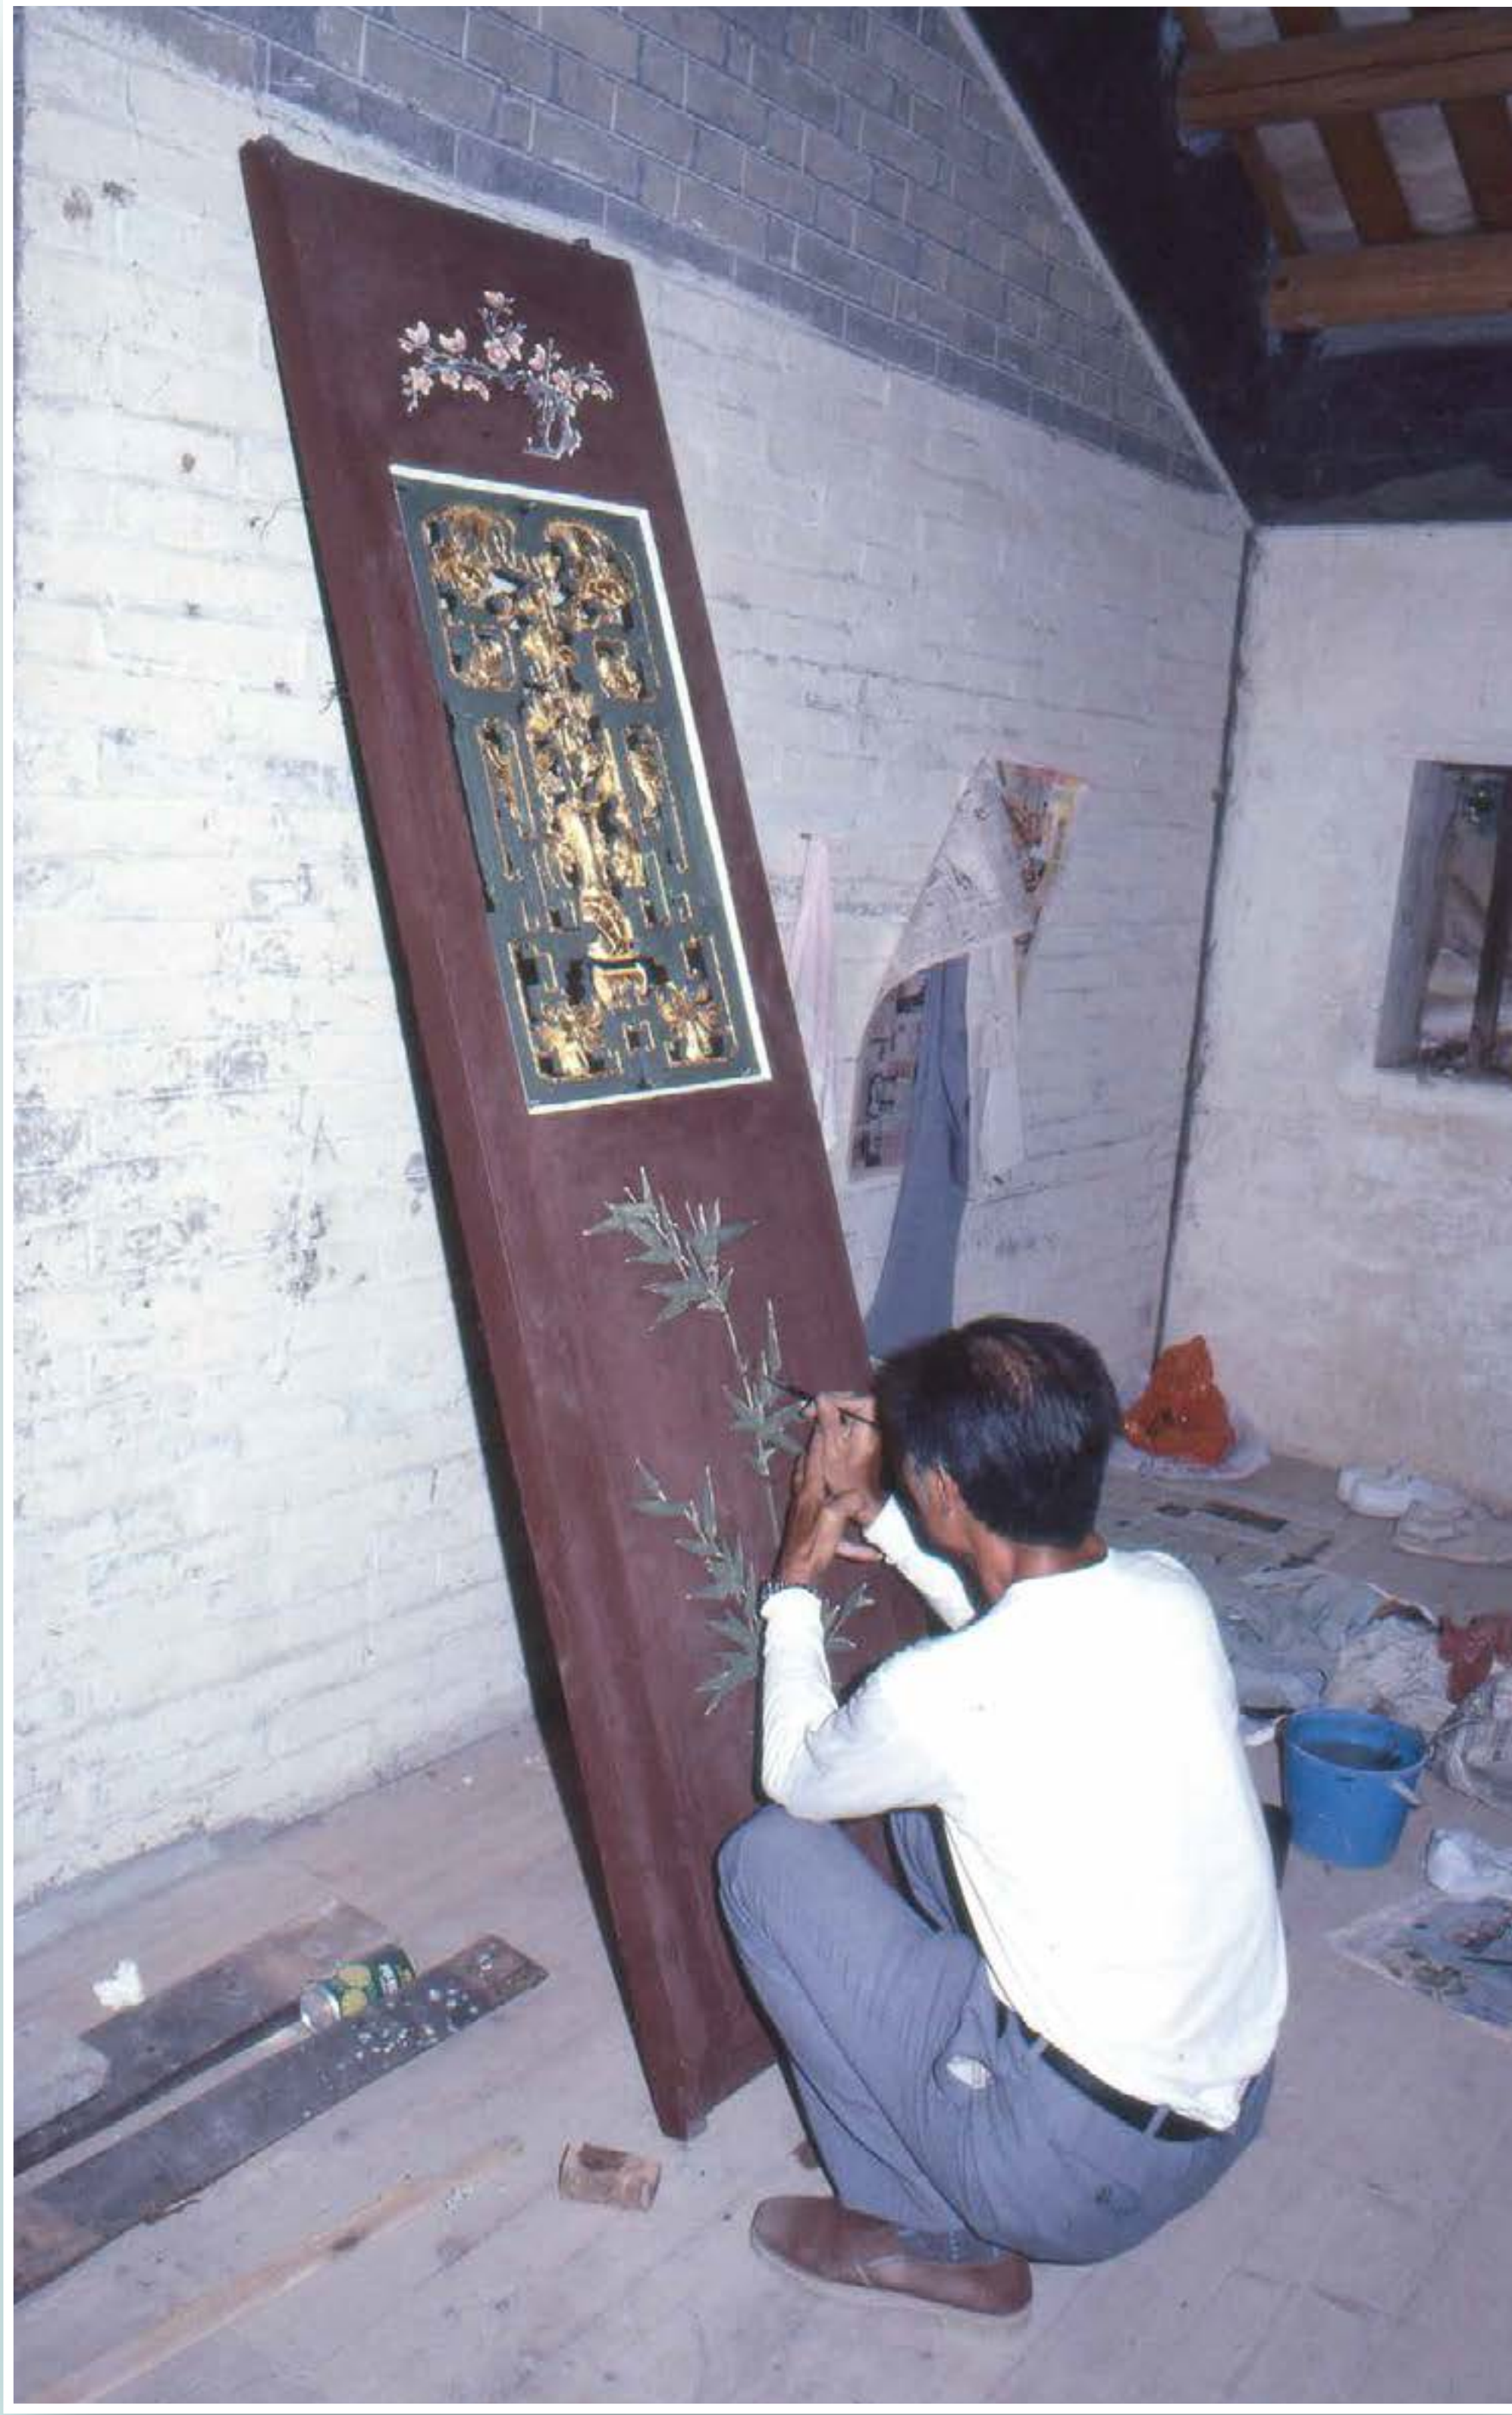
木屏風重新上色
Re-painting of carved wooden panel

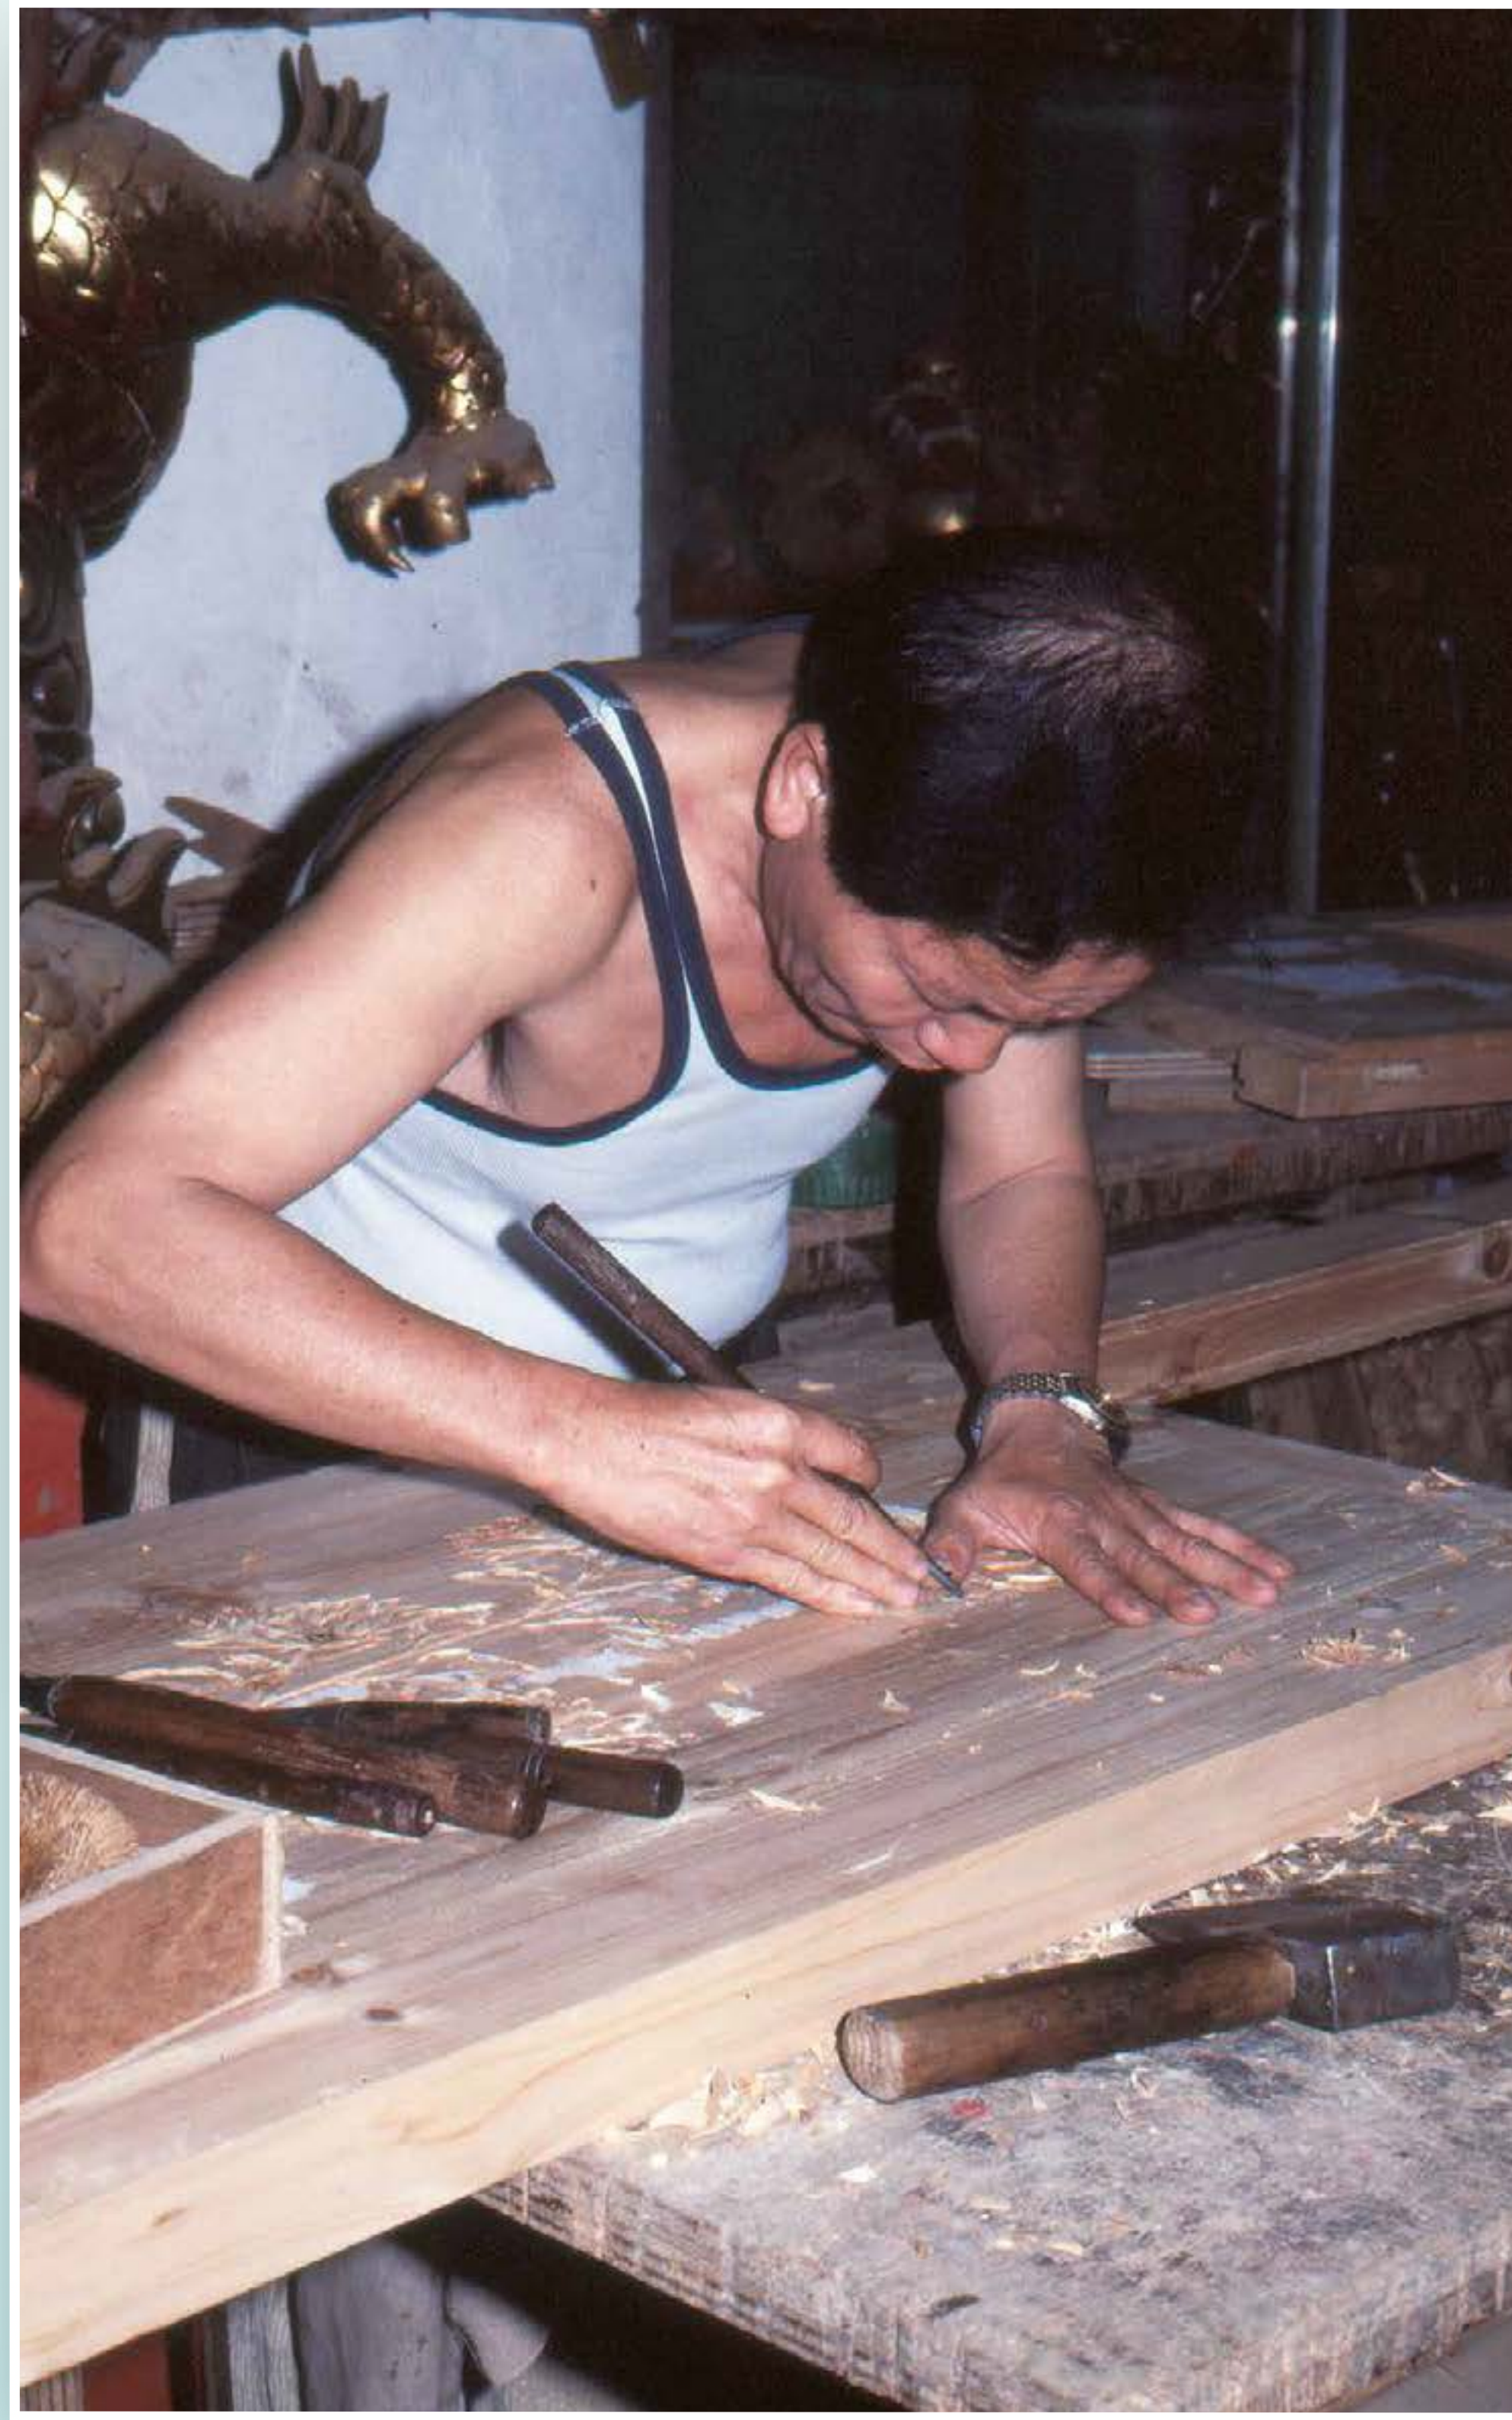
木匠復修屏風上的木刻
A wooden panel is restored by a craftsman.

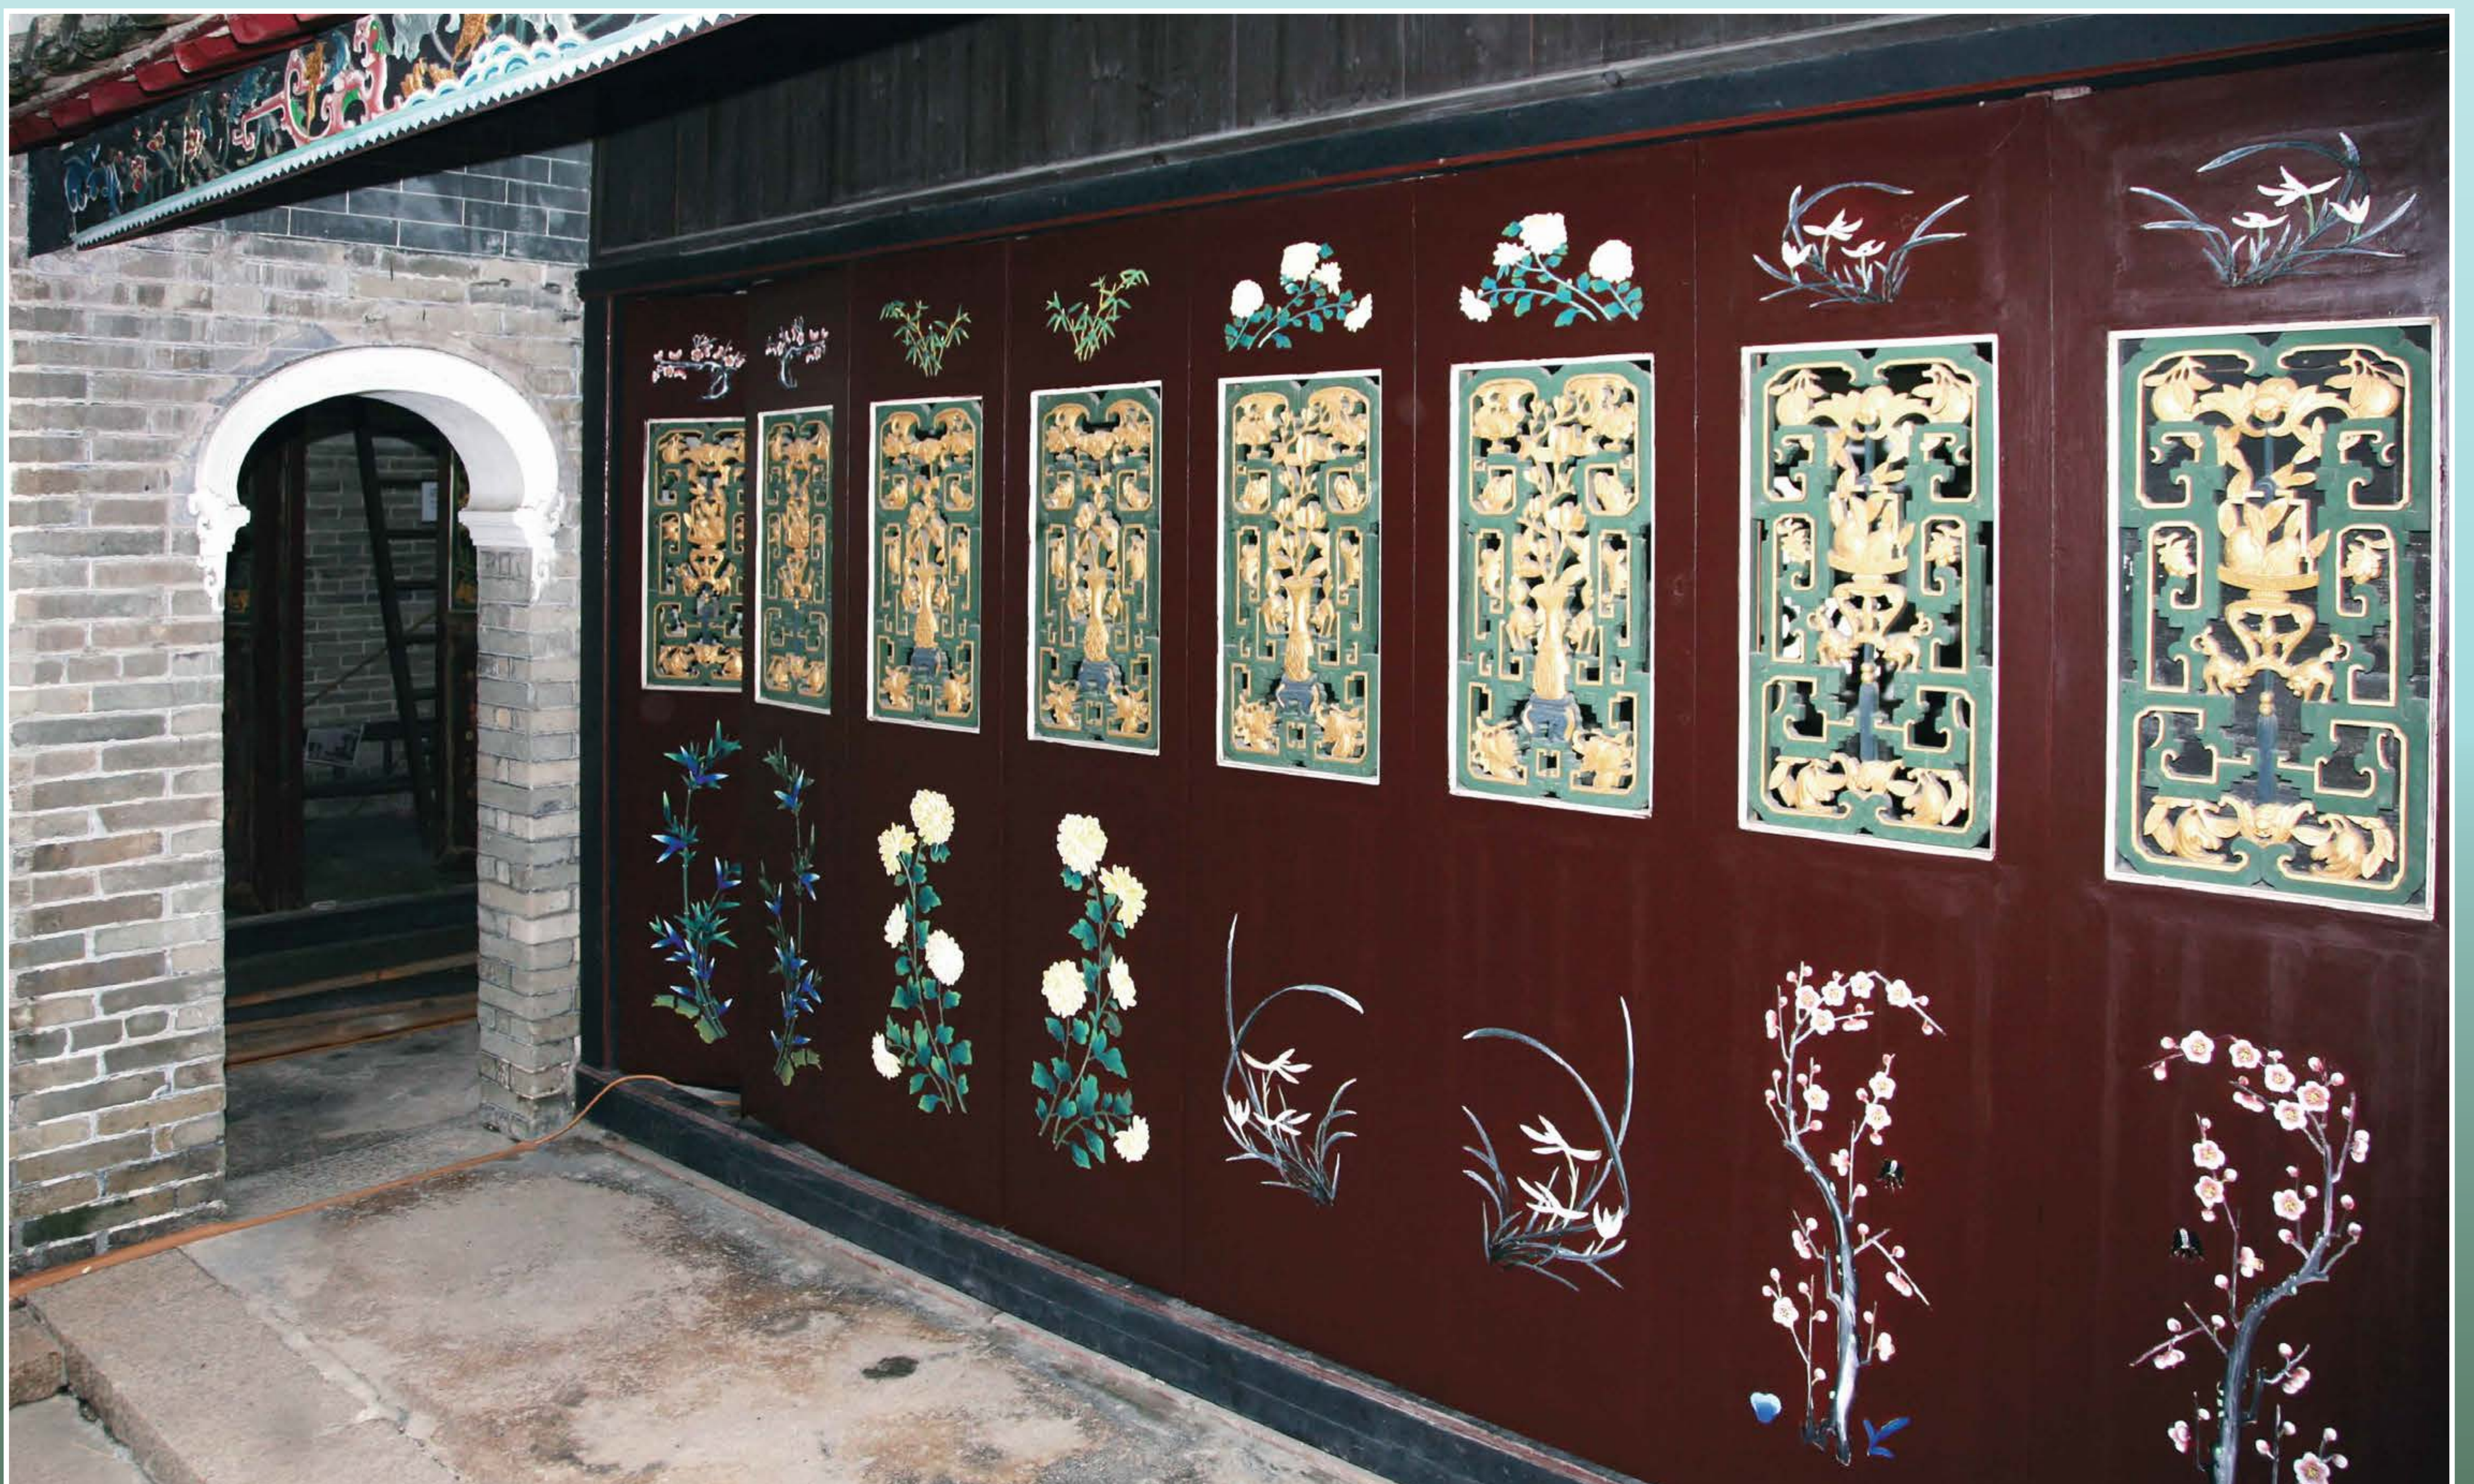
重修後的木屏風
Carved wooden panels after restoration

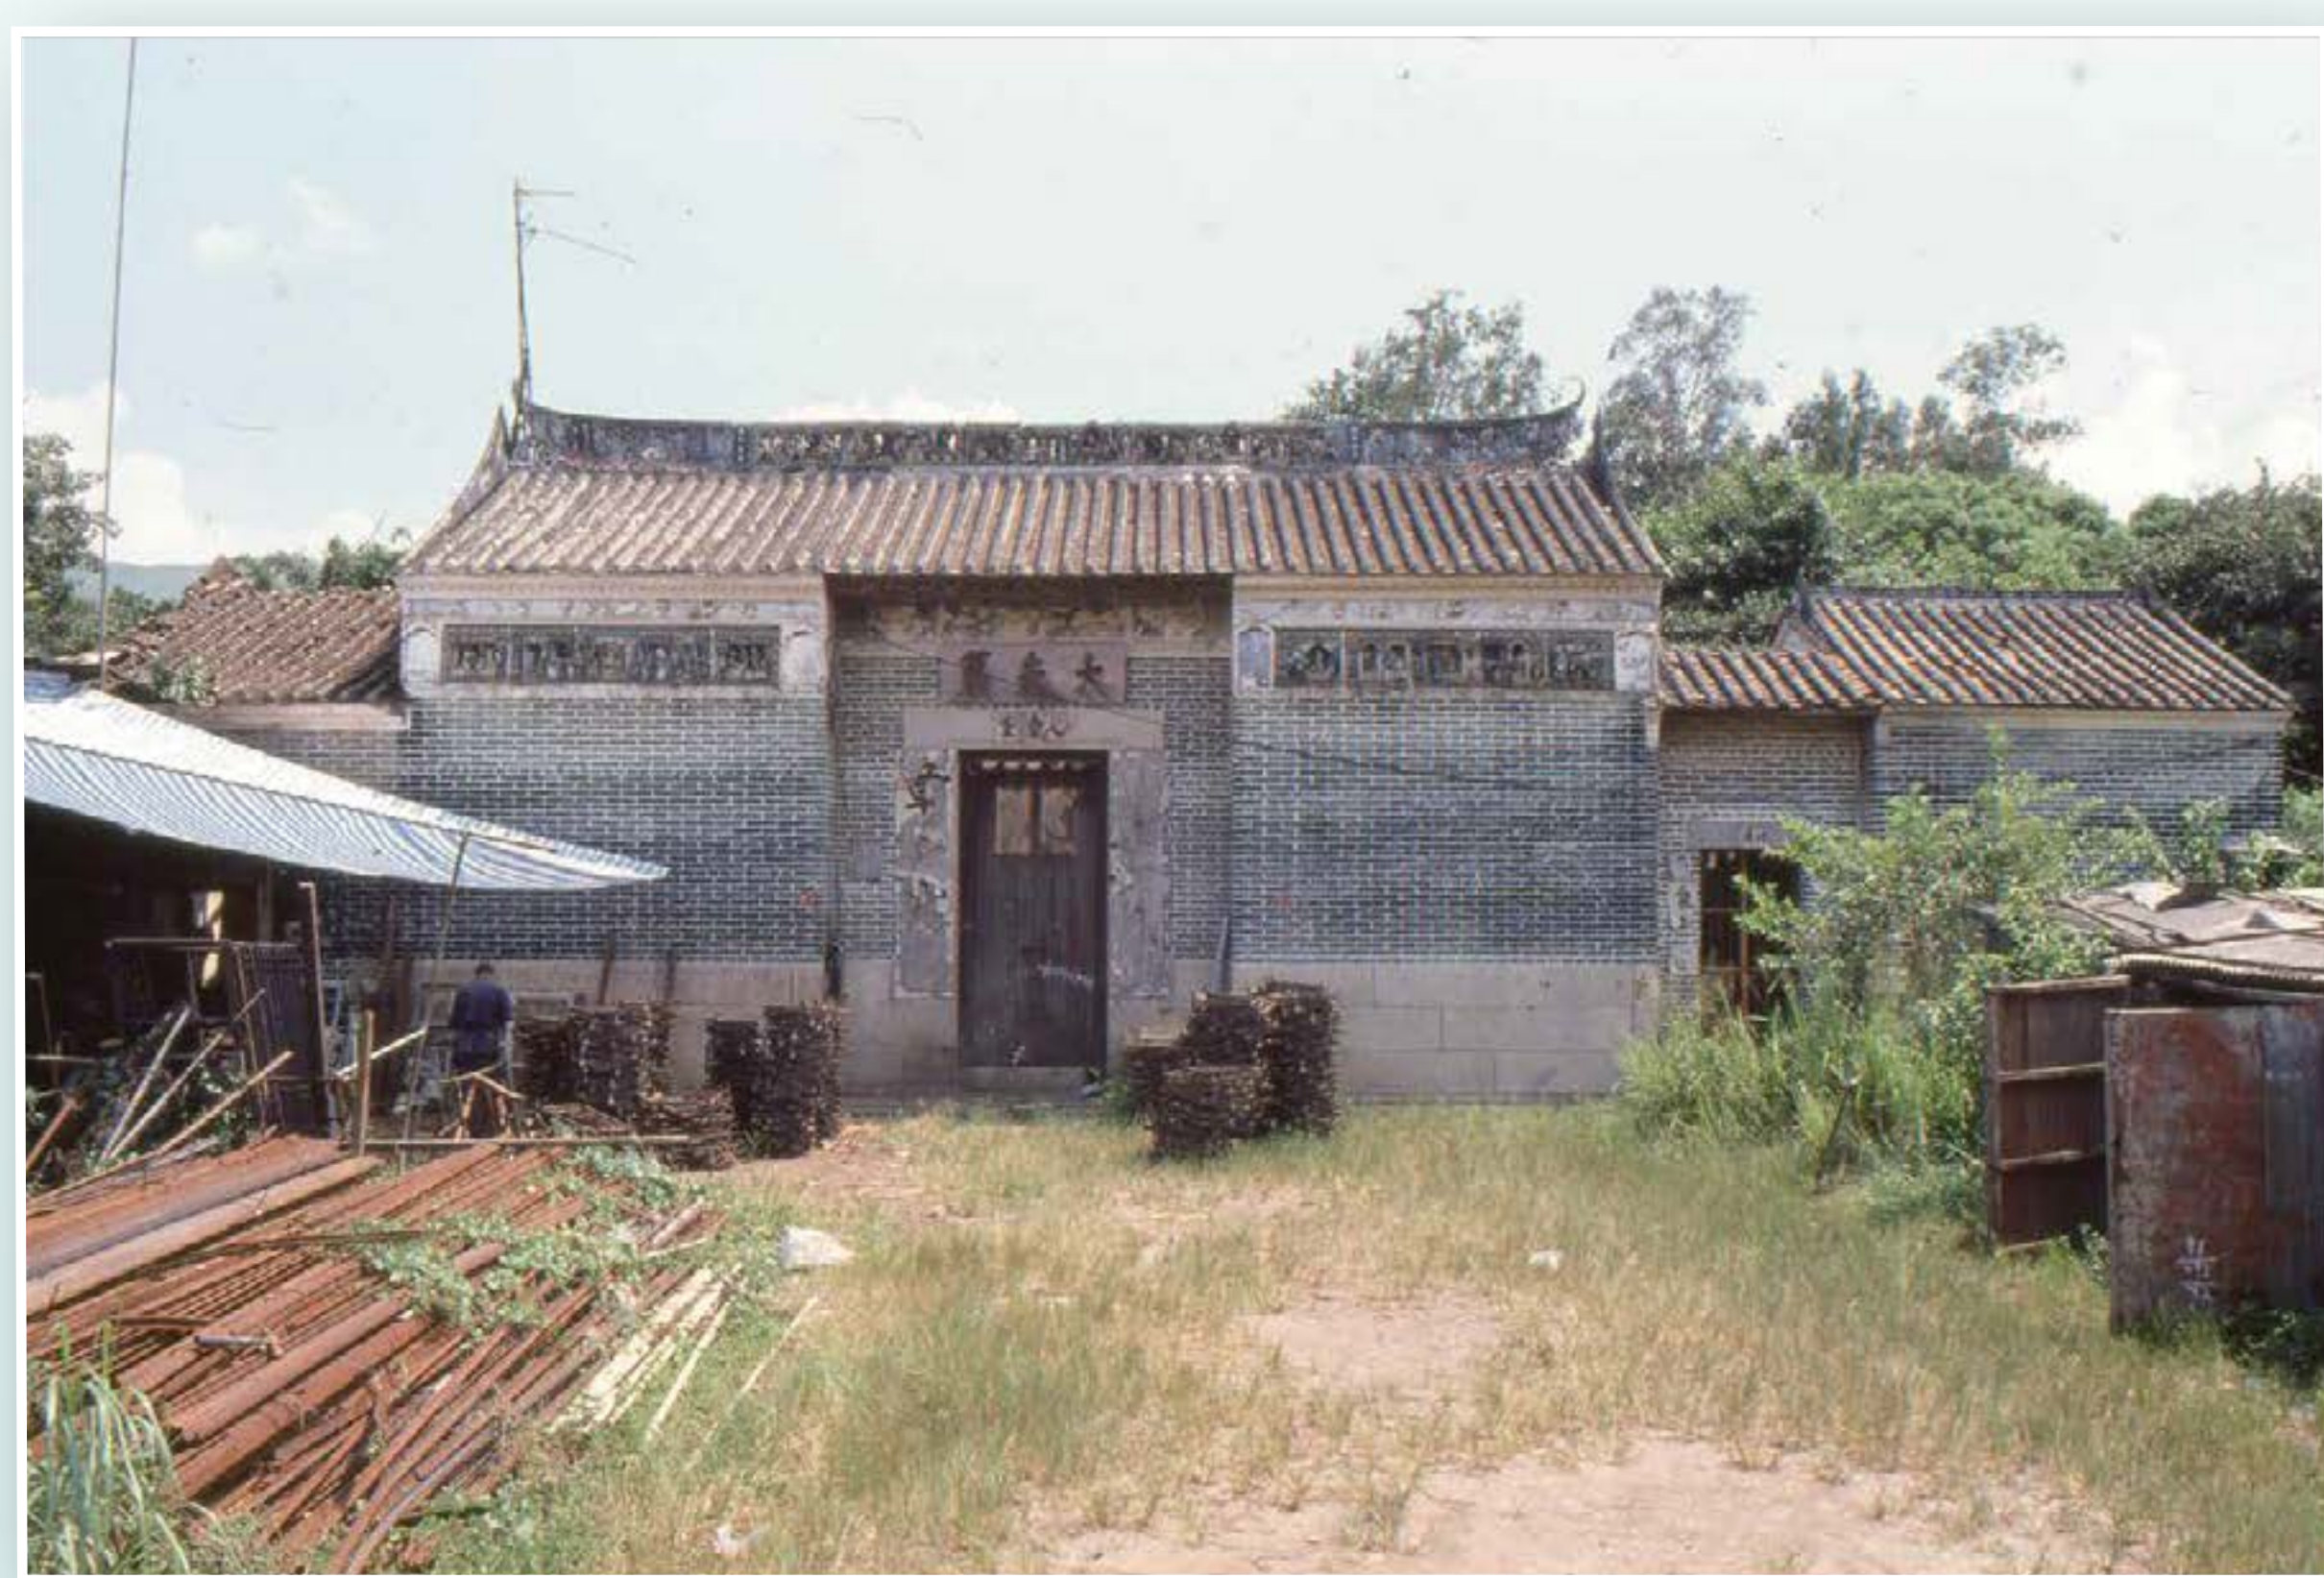
修復前的外貌
Facade before restoration

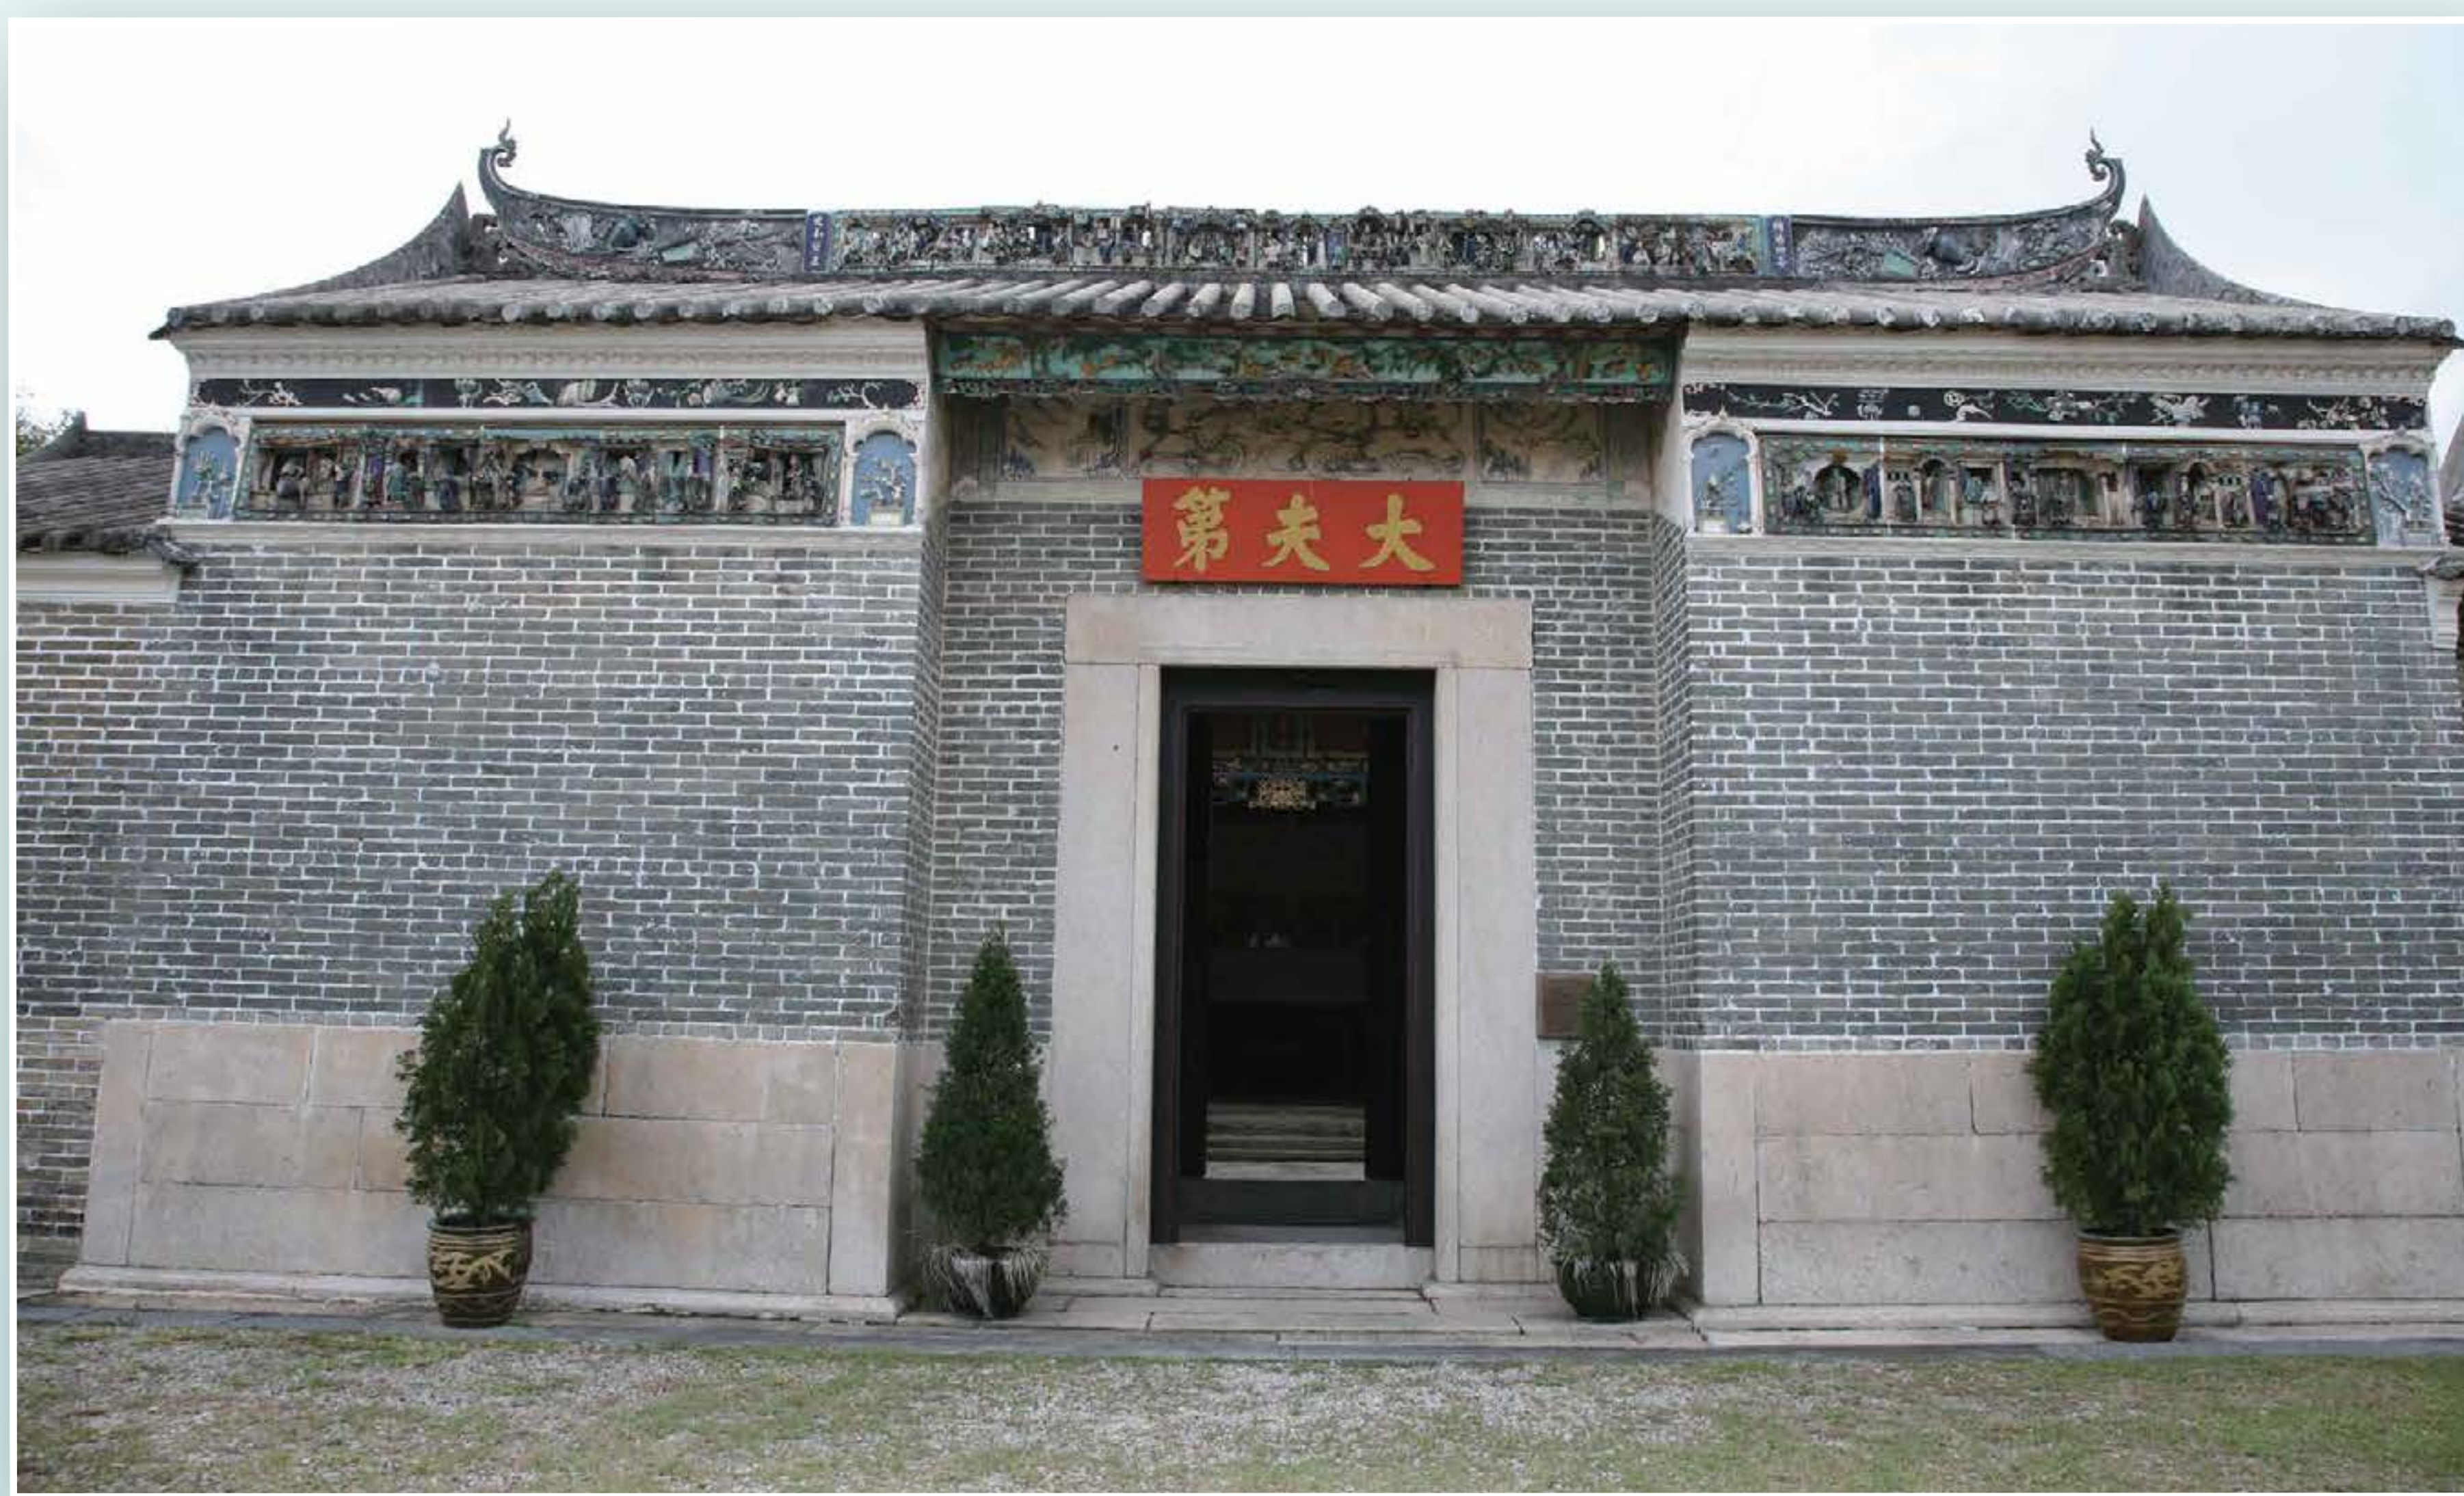
修復後的外貌
Facade after restoration
