大夫第

Tai Fu Tai Mansion

建築特色

Architectural Features

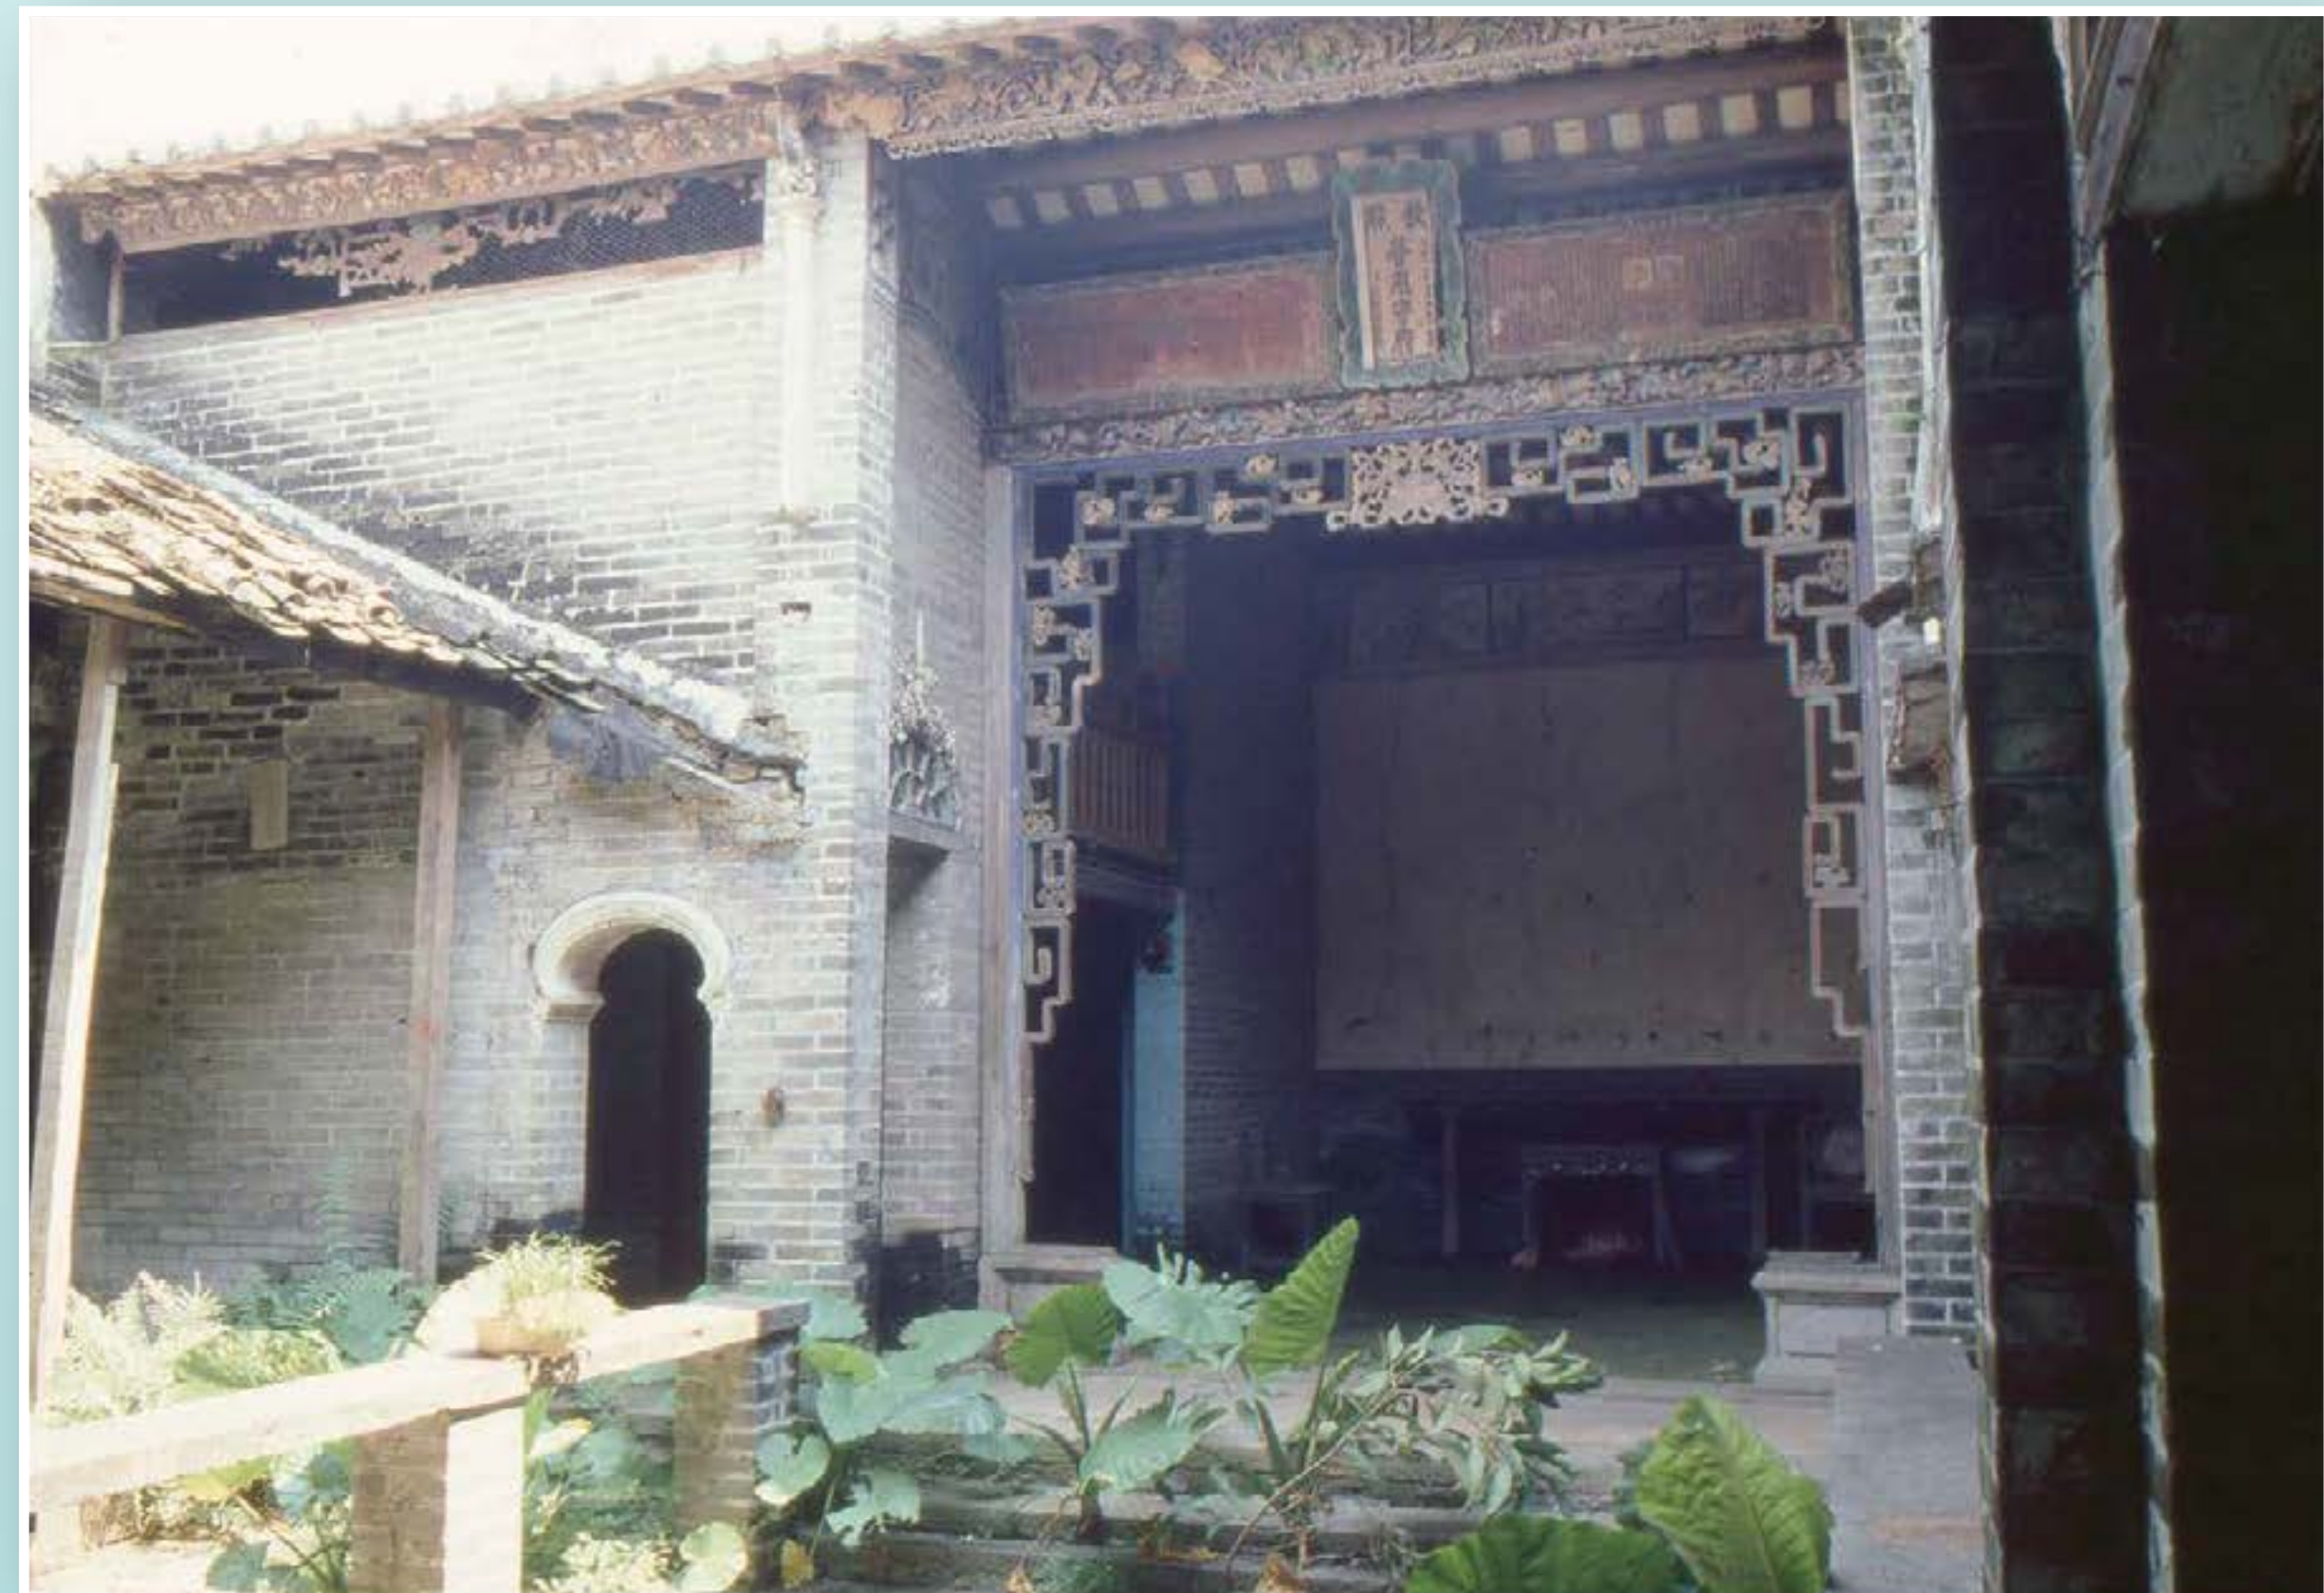
修復前的內貌
Interior view of the building before restoration

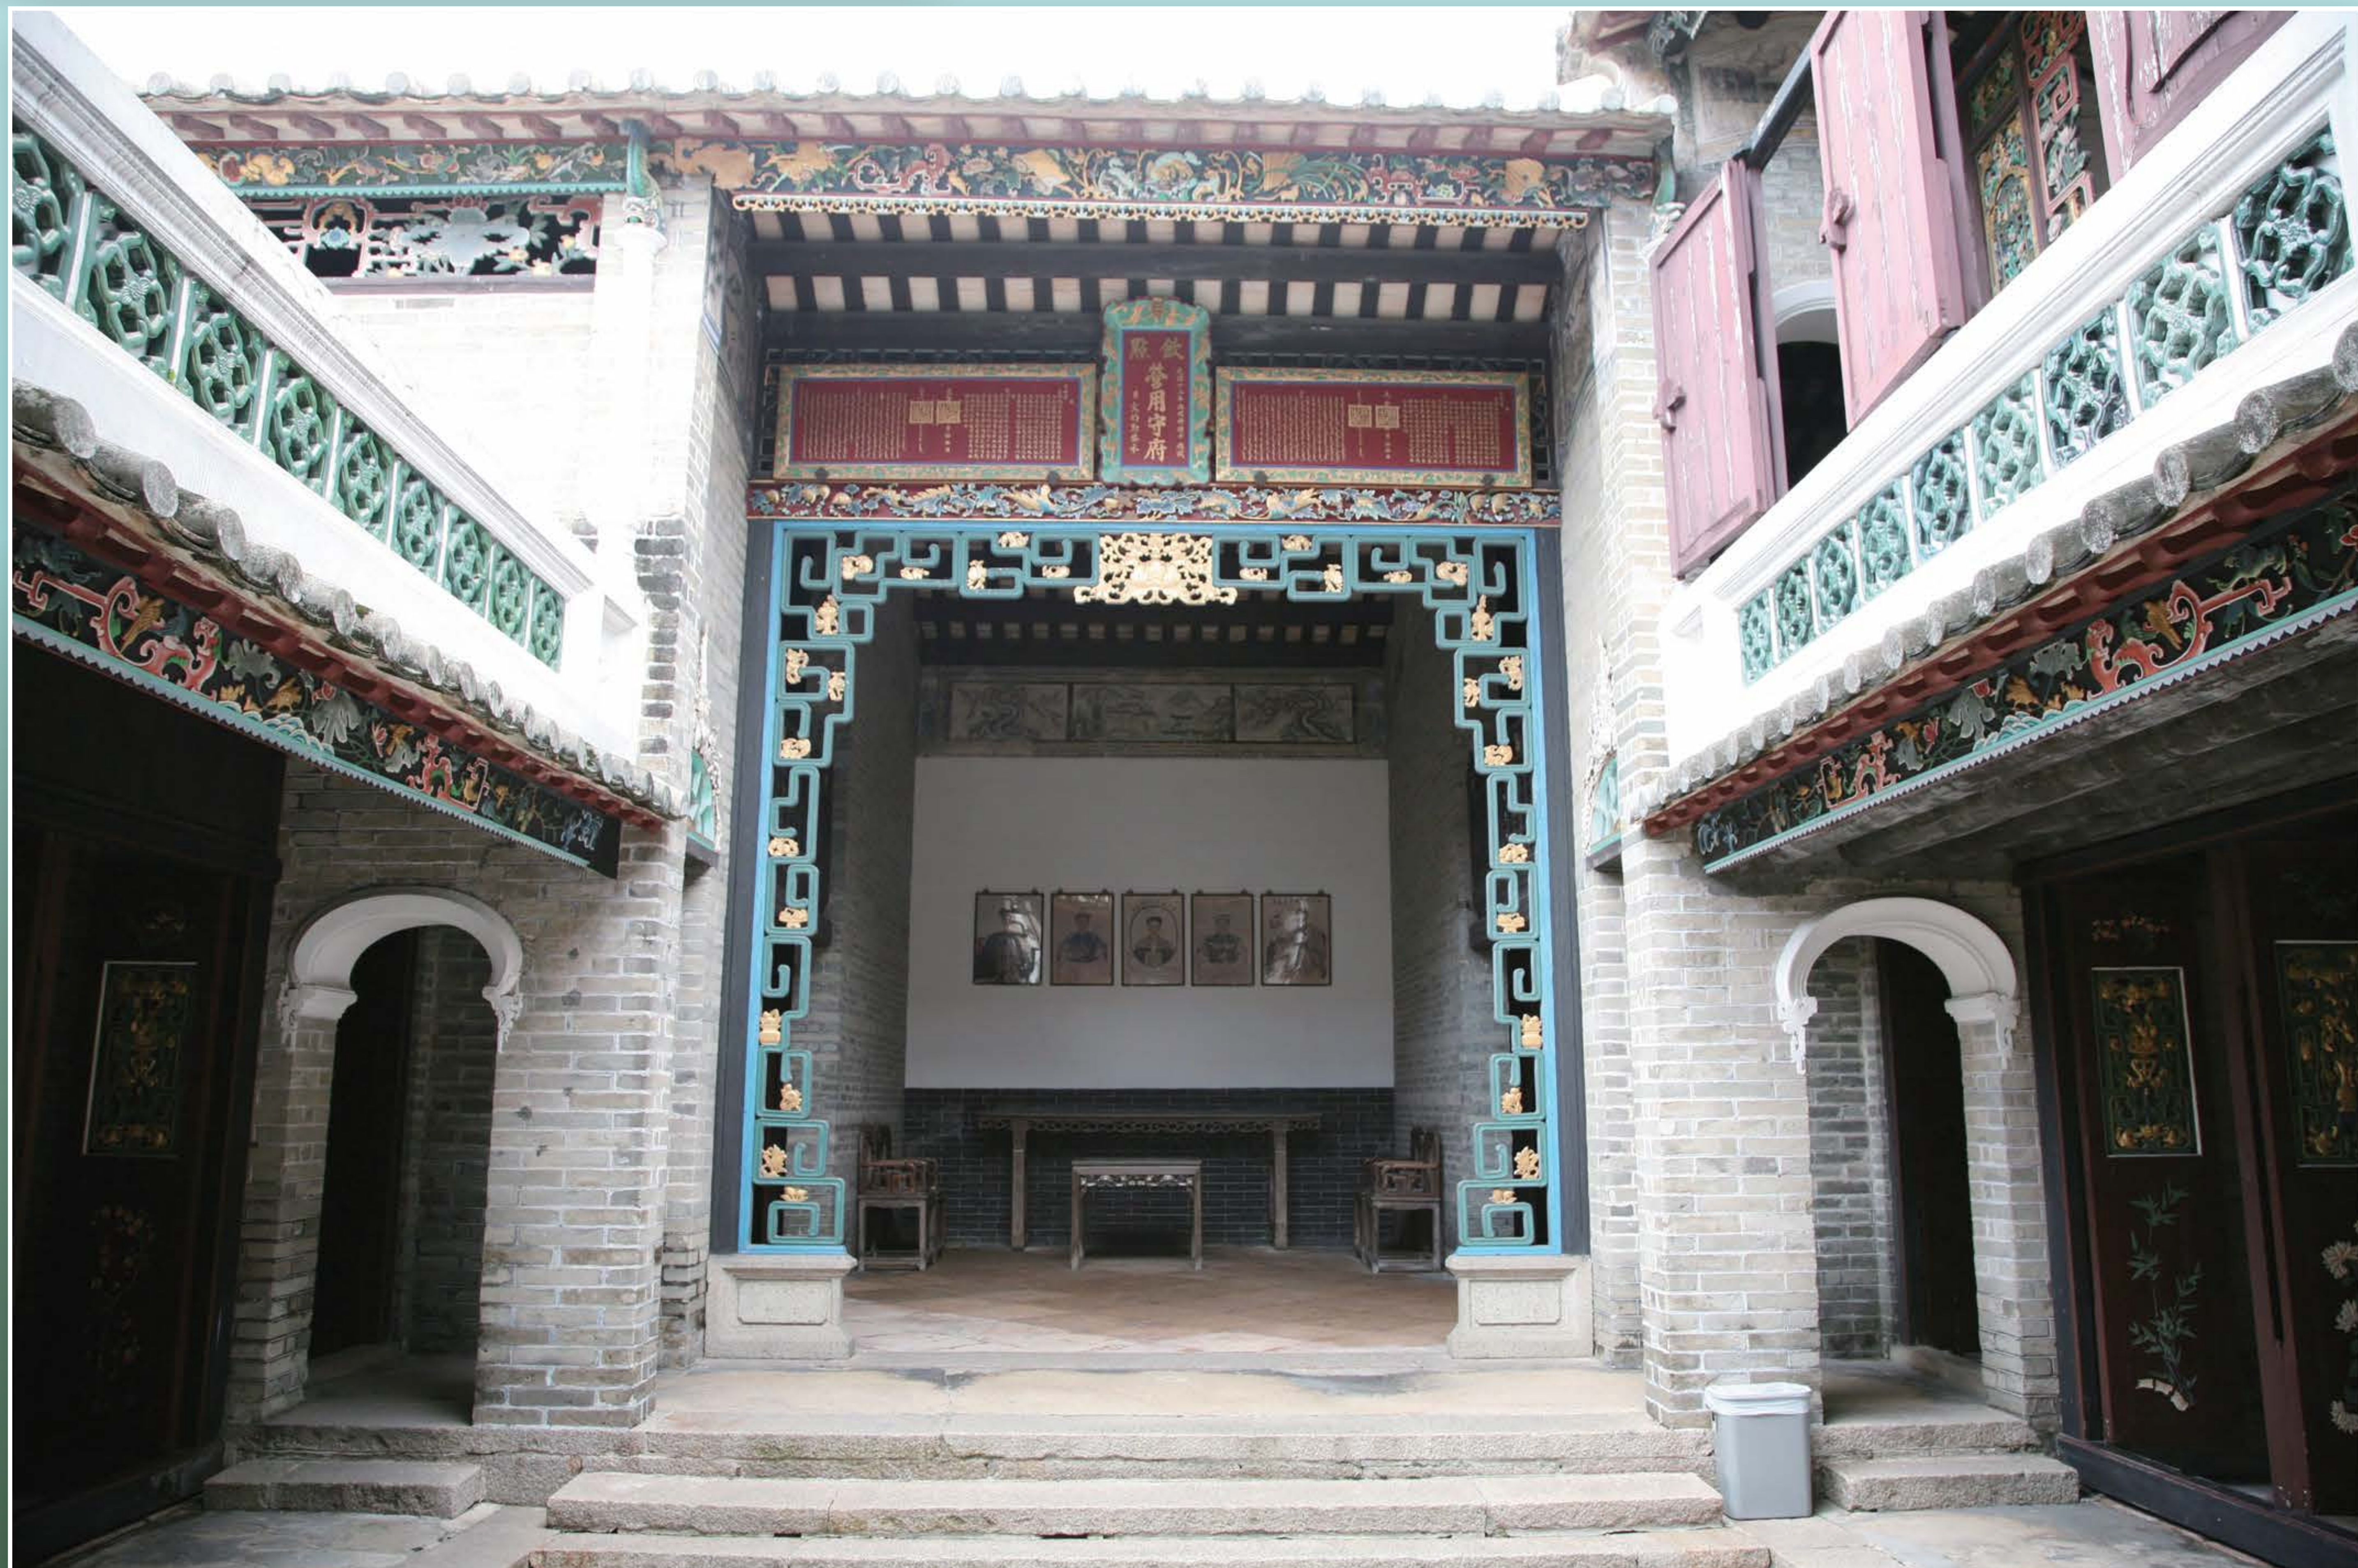
修復後的內貌
Interior view of the buildings after restoration
