SIGNIFICANCE

4.1 Assessment criteria for cultural significance

CONDITION

5.7 The Buildings: Condition

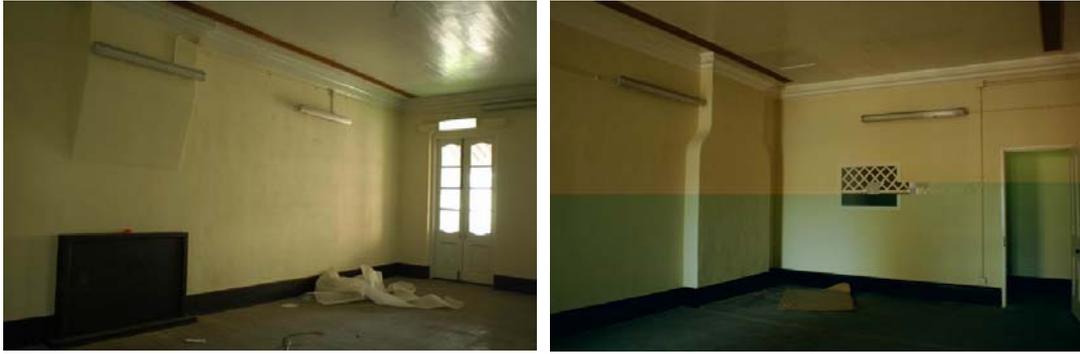
Fig. 459. Blocked fireplace at 1/F main building.

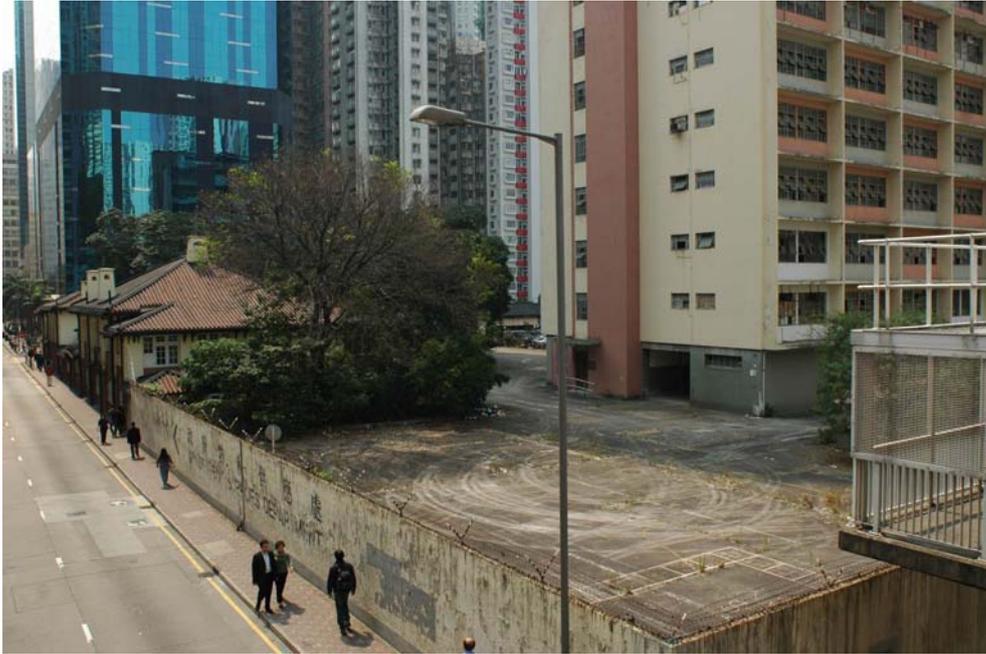
1. An old photo illustrates clearly the composition of the boundary wall, with the columns appeared to be of same style of as the columns found at the original entrance porch and exit between Annex A and B.
2. When design the new boundary wall for the historic site, current boundary wall can be replaced by the old design of boundary wall according to the old photos, using the same material and style. Or demolish the boundary fence wall which has no significance.

Fig. 468. The present boundary wall facing Electric Road.

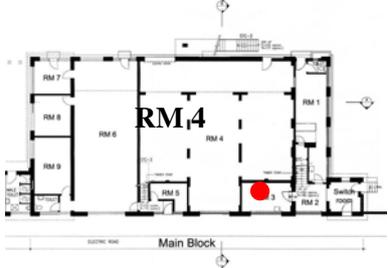
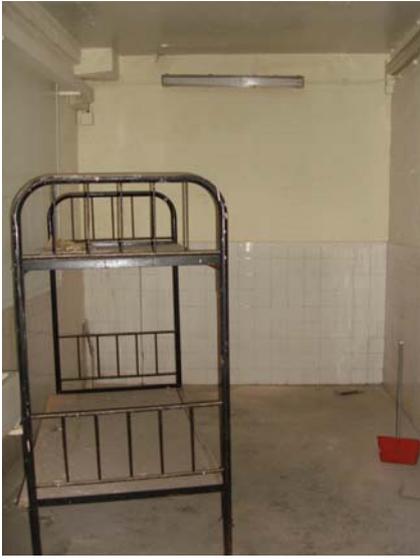
<p>Now used as store room, appears to be subdivided in RM 4, with the segmental archway infilled with brickworks for partitioning, and the segmental-headed windows were blocked up</p>	<p>Re-opened to connect with RM 4</p> <p>or</p> <p>Remained as it is</p> <p>Compatible for multi-functional uses with natural lighting</p> <p>or</p> <p>for storage</p> <p>It is compatible for multi-functional uses and the metal plates that cover the segmental-headed window facing Electric Road can be removed to provide natural lighting to this room</p>

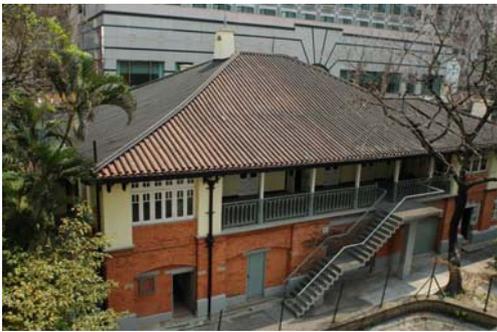
External façade – facing internal of the site		
Main Building		
Elements	Description and significance	Recommended treatment
<p>Gutter</p>

<p>Not original elements but of modern services upgrading for functional uses</p>	<p>Can be retained and repaired, or replaced if necessary</p>
<p>Infilled archways</p>

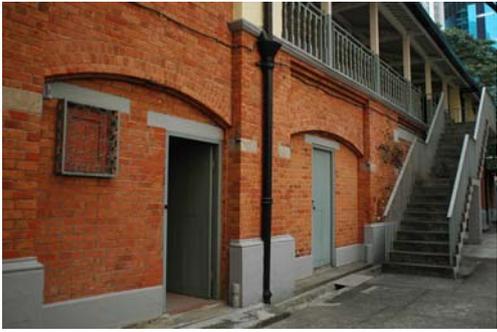
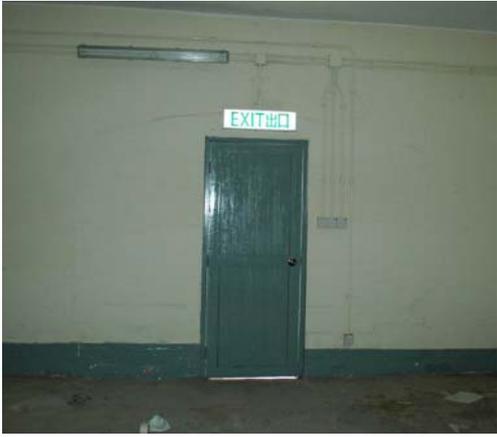
<p>Infilled archways on the existing archway at the central room of ground floor are later added of low significance.</p> <p>The original location of the two large panelled doors to the boat storage.</p>	<p>Can be re-opened and restored, and replaced by folded door or other sensible door design that can reveal the segmental-headed openings.</p>

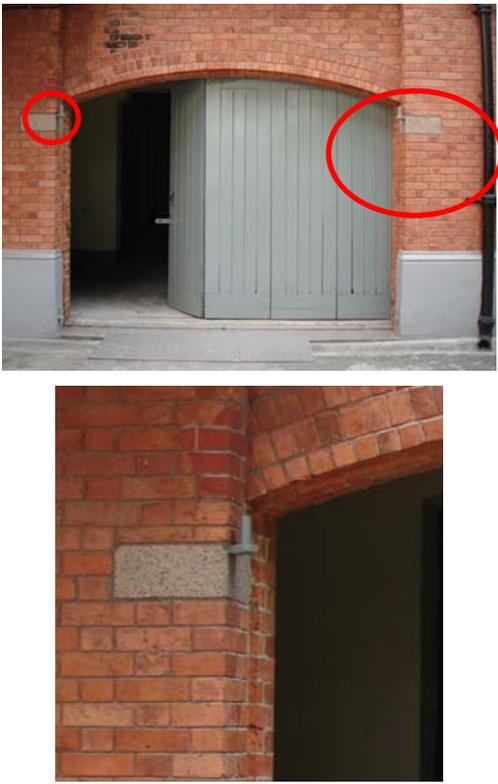
External façade – facing internal of the site		
Main Building		
Elements	Description and significance	Recommended treatment
<p>Iron pintles</p>

<p>Original gates to the store were removed, leaving only the iron pintles set in the granite which are significant for the interpretation of the original function of the room</p>	<p>Shall be retained in-situ for interpretation of the original function of the room</p>

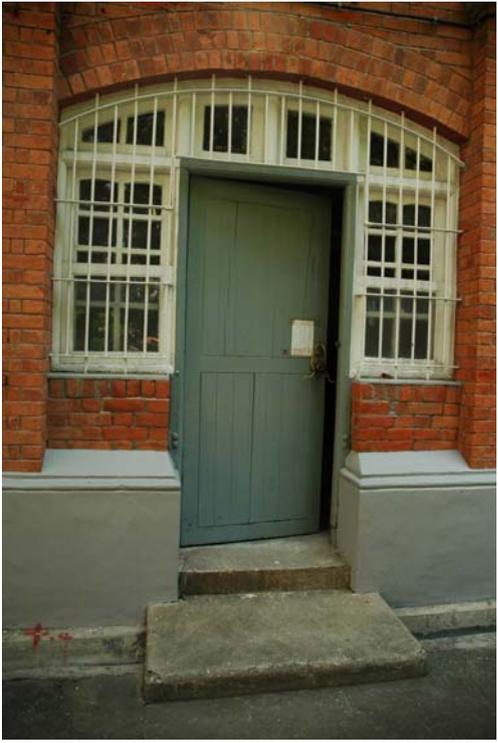
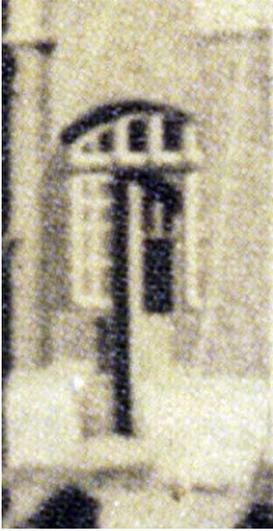
<p>The door was later altered but still of high degree of integrity, represents the essence of Arts and Crafts style – design combining windows and glazed doors</p>

<p>Can be replaced by door combined with glazing, making reference to the original design as shown in the old photo or the door design of this style.</p>

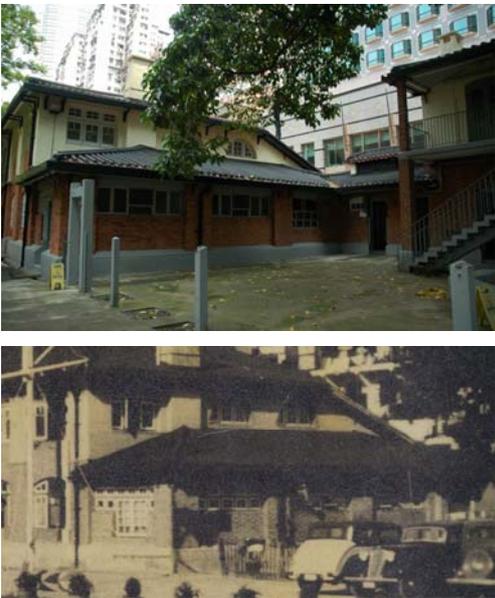
Elements	Description and significance	Recommended treatment
<p>Later replaced aluminium windows</p>

<p>The aluminium windows facing the small courtyard are obviously later added, and the window openings at RM 9 were enlarged which are originally the same size as the other two rooms</p>	<p>The window openings shall be restored to the same for the three rooms and replace the aluminium windows by timber windows based on the old photos</p>
<p>Later replacement by solid door</p>

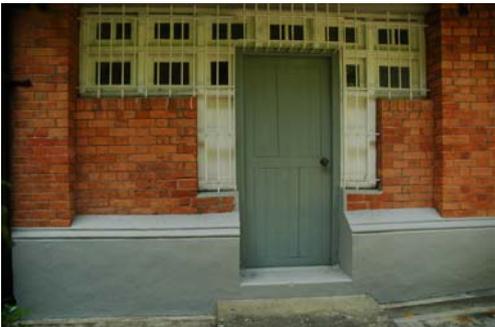
<p>The door was later altered according to the old photo but should respect the historical change and not necessary to restore to the original appearance</p>	<p>The door can be replaced by design combining windows and door, the essence of Arts and Crafts style.</p> <p>See also the recommended treatment of the door of Main Building</p>

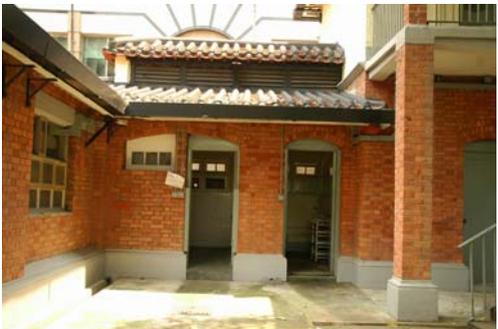
Elements	Description and significance	Recommended treatment
<p>Sub-divided arch opening</p>

<p>Sub-division of the arch into windows and door opening at existing male toilet</p>	<p>The window and door can be replaced by design that compatible with existing architectural design</p>
<p>Ventilated double roof</p>

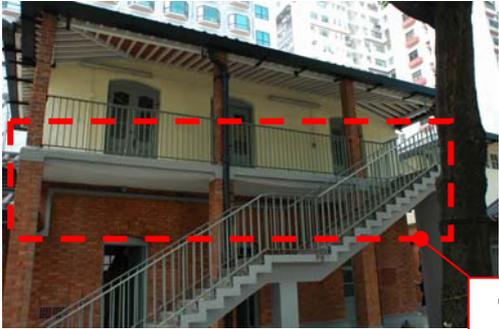
Elements	Description and significance	Recommended treatment
<p>External staircase</p>

<p>The external staircase together with the balustrade was obviously later addition, of no significance.</p> <p>Curved shaped beams underneath the concrete slab of first floor verandah represent simple design</p>	<p>Can be removed or replaced by sensible design that matches with the style of the building.</p> <p>The design of the replaced balustrade should match with the design of the balustrade at Main Building</p> <p>The curved shaped beam should be preserved</p>

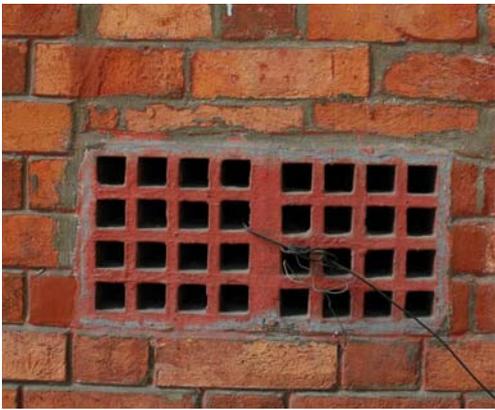
External façade – facing internal of the site		
Annex A		
Elements	Description and significance	Recommended treatment
Kitchen ventilation block

The ventilation block on the wall surface of the kitchen on ground floor represent the original use of the room and together with the chimney stack above the room and the smoke flue inside the room, contribute greatly the interpretation of the room previously used as cooking place.	Shall not be blocked or filled up.
Interior of the kitchen

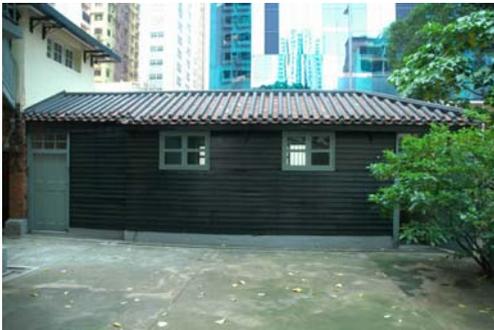
One storey linear block of Annex B facing courtyard

One-storey block - the wooden facing is new alteration

Elevation of the wooden facing can be altered to suit new adaptive design, sympathetic to the historic building in term of size, proportion, material and colour.

Preserve the double-layered roof of Chinese pan and roll tile.

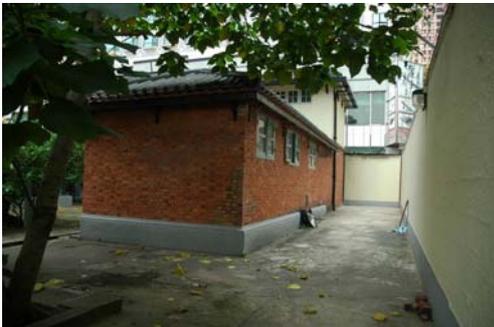
Rear window openings were added later which was evident by the cut bricks and no lintel or brick arch over

Timber windows can be replaced or altered with new design sympathetic to the historic building in term of size, proportion, material and colour.

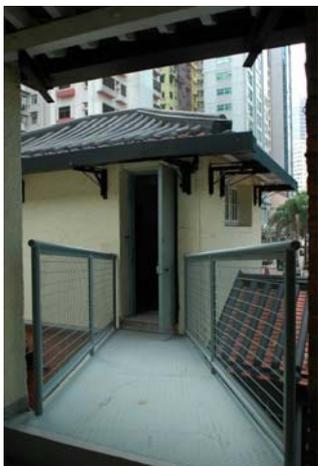
Linked bridge between Annex A and Annex B

The balustrade is later design

Can be replaced by the new balustrade match with the balustrade of 1/F at Annex A

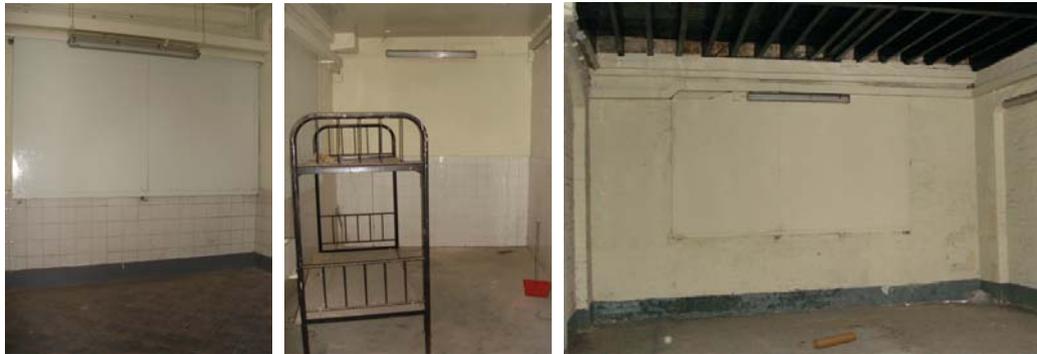
Windows facing Electric Road were blocked up – RM 2, RM 3 and RM 4 (left to right)

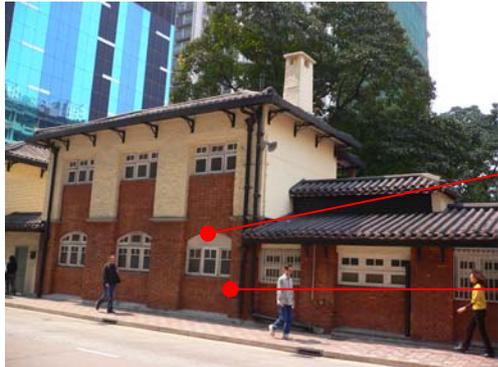
Elements	Description and significance	Recommended treatment
<p>Kitchen window was blocked</p>

<p>The top window beneath the segmental arch of the kitchen facing Electric Road was blocked up by metal plate.</p> <div data-bbox="710 1422 957 1512" style="border: 1px solid red; padding: 2px;">Kitchen window was blocked up</div> <div data-bbox="710 1534 957 1624" style="border: 1px solid red; padding: 2px;">Ventilation block on wall surface</div>	<p>The window can be restored, with the appearance making reference to the windows in the adjacent rooms.</p>
<p>Ventilation block on wall surface</p>

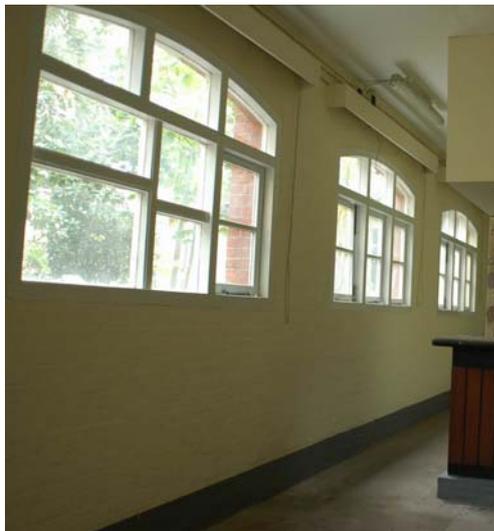
The timber windows at G/F were generally new without original round edged timber transom and mullion details, of lower significance than the window at 1/F.

Timber windows at G/F without round edged details are later added, with some irregular window replacement

Irregular timber window at G/F can be replaced, making reference to windows beside.

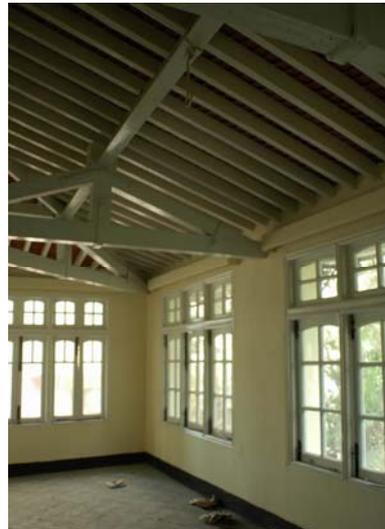
Timber frames at 1/F along the enclosed verandah have round edge details are authentic design of timber windows.

Timber windows at 1/F with round edged details are authentic design

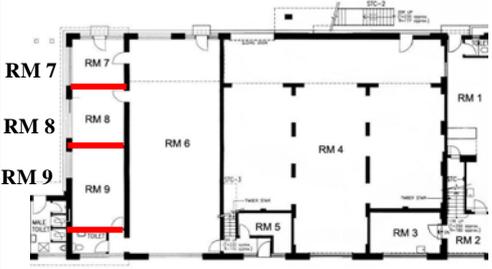
<p>Internal partitions between RM 7, RM 8 and RM 9 are later addition</p>	<p>Internal layout can be altered according to the new design for adaptive re-use</p>
<p>Authentic segmental archway (3nos)</p>

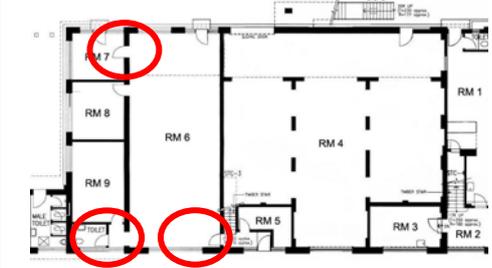
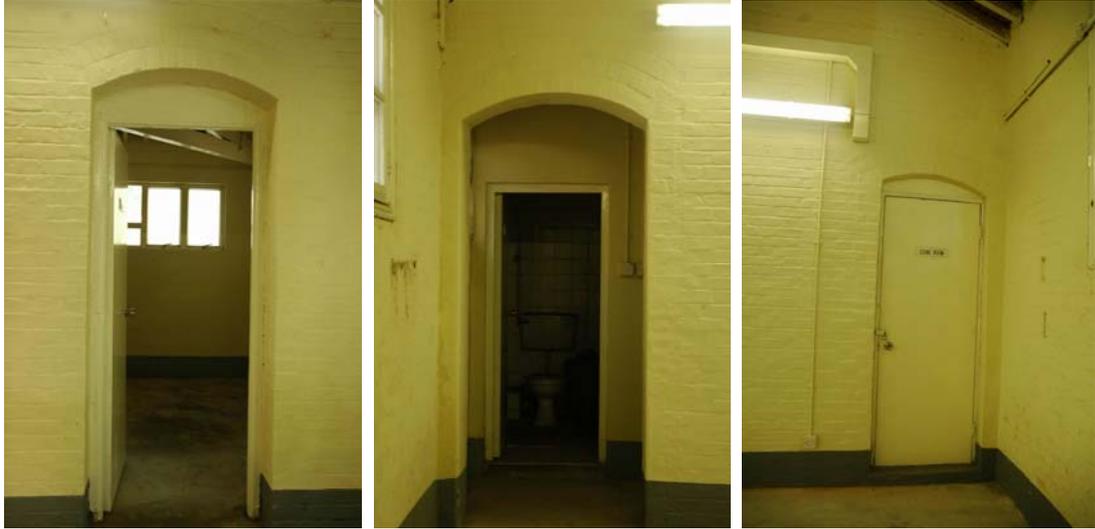
<p>The archway to RM 7 and the toilet beside RM 9, and to the adjoining staircases are authentic</p> <p>Existing door not match with the archway.</p>	<p>The mis-match doors should be replaced by new doors that fit the archway or re-open them for passage</p> <p>In case of blocking any segmental archway or door, the segmental arch openings should be infilled with a recess wall to make a blind arch</p>
<p>Authentic segmental archway at RM 7 (left), to the toilet (middle) and beside the staircase (right)</p>

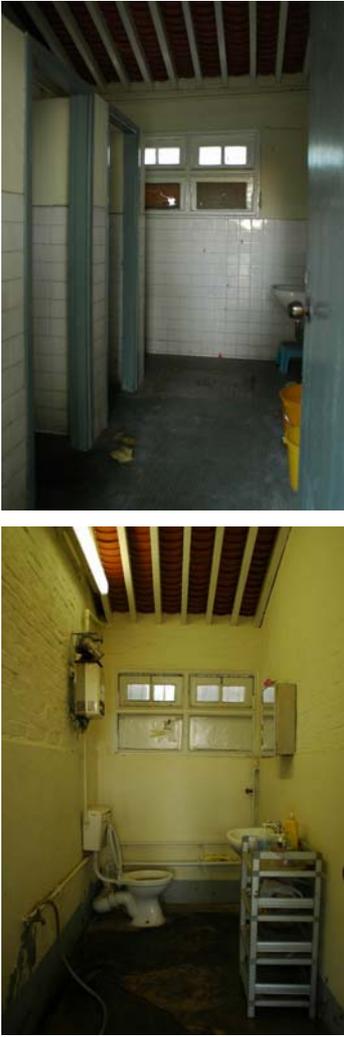
<p>The interior toilet partitions, wall and floor finishes were later altered.</p>	<p>Can be altered by new sympathetic design</p>

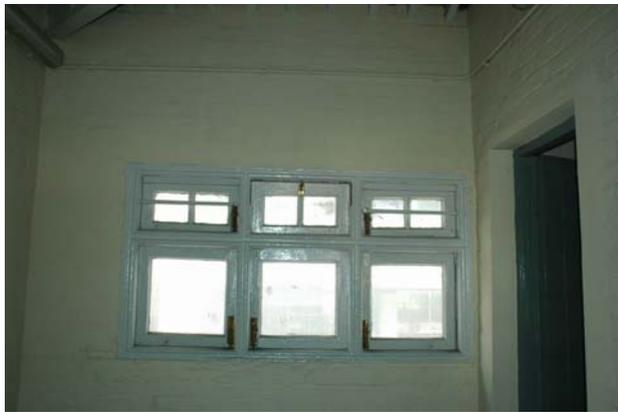
<p>Partition of low significance</p> <p>Timber windows with rounded edged frames are authentic design</p>	<p>The interior partitions can be altered to suit new layout provided that the appearance of the windows and doors will not be affect , i.e. new partition walls shall not block verandah doors/external windows</p> <p>Chimney stack at RM 21 shall not be removed</p> <p>Timber windows with rounded edged frames shall be retained and repaired</p>

<p>Timber windows with rounded edge timber frames</p>

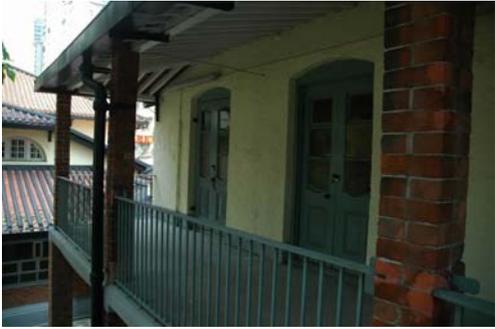
Elements	Description and significance	Recommended treatment
<p data-bbox="178 376 667 443">Authentic double leave door with segmental glazing</p>

<p data-bbox="703 376 1005 443">Authentic door appearance with segmental glazing</p>	<p data-bbox="1027 376 1324 560">Unless it is technical feasible without excessive damage the doors, the two doors with flat glazing are not necessary to restore to original appearance</p>

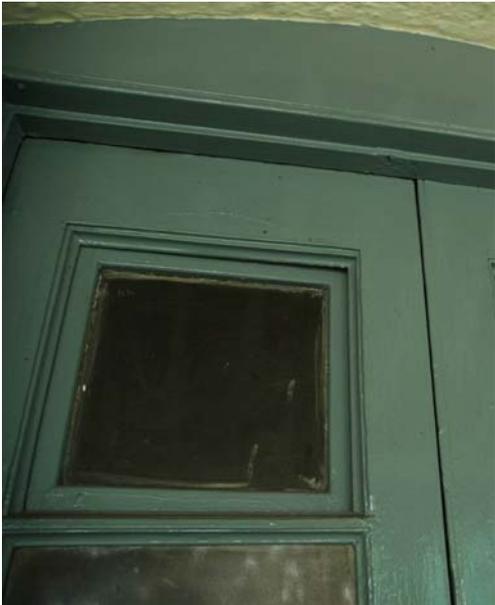
<p data-bbox="178 1196 638 1232">Top glazing was converted to flat glazing</p>

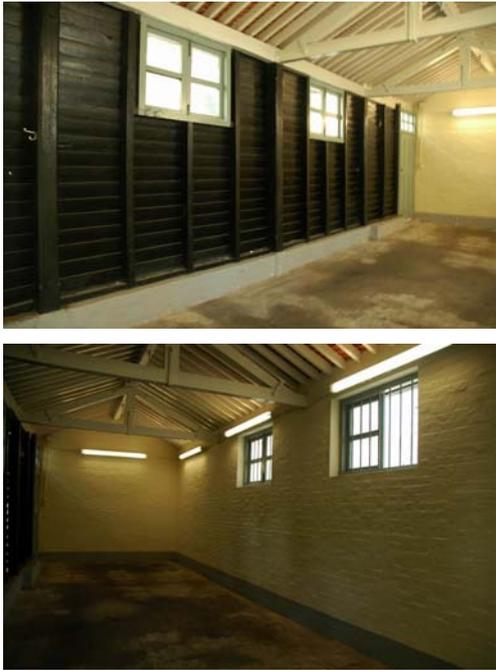
Interior of the Annex B		
Elements	Description and significance	Recommended treatment
<p>Interior with one side of timber louvre surfacing and the other three walls are of brick materials</p>

<p>See also the façade of Annex B</p> <p>The interior space is characterized by the exposed timber roof truss supporting the pitch roof.</p>	<p>The interior can be refinished provided that the timber roof truss, and the roof structure will not be affected</p>

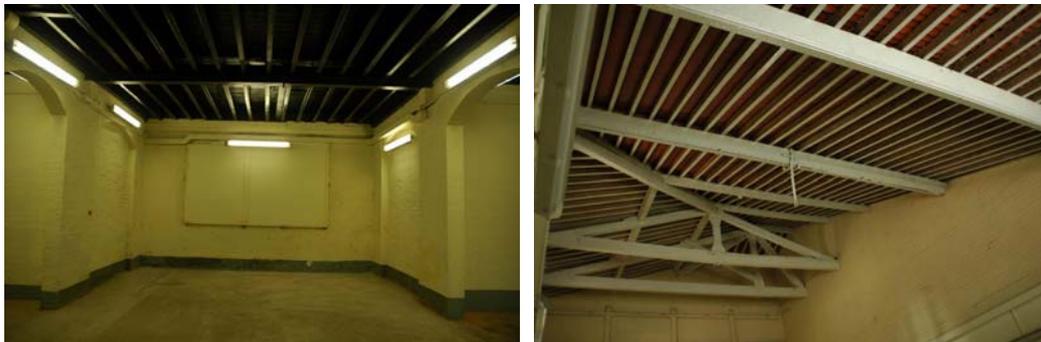
Fig. 477. Timber floor and roof structures

All timber members, including the timber roof structural framing system, timber floors, staircases and all other timber members of each part of existing man-made structure such as window and door frames, door panels, skirting, built in wardrobes, decorative panels and all other wooden built-ins.

1. Carry out a thorough termite inspection to identify termite problem as well as fungi decay by recognizing the areas and extent of termite infestation, if any
2. Modern paint system that is acrylic based would have a detrimental effect on wood should not be used.
3. The film-forming finishes would block the wood and prevent a moisture exchanges resulting the wood to rot.
4. If such paint is found on the timber members, it should be removed before any restoration and repair work.
5. The removal of old finish should be carried out or advised by specialists.

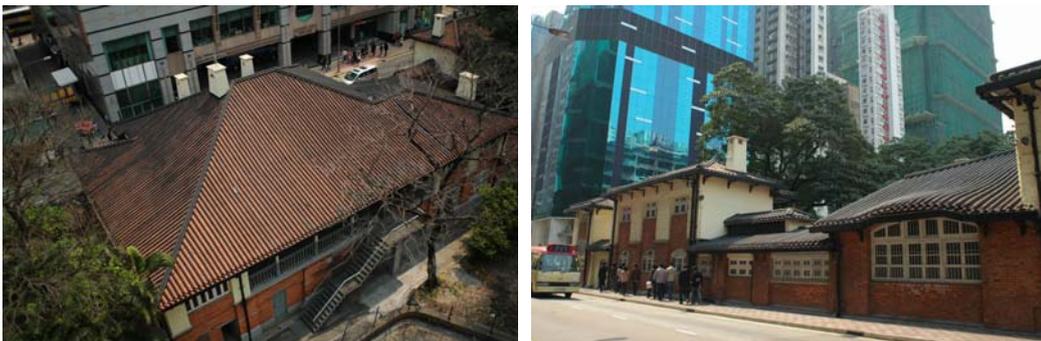
Fig. 479. Multiple roof forms finished with double-layered pan and rendered roll tiles.

Roof form, colour, material, appearance, roof height and projection, finished with double-layered pan and rendered roll tiles

1. Keep the natural red colour of the original clay roof tiles, with “wu-yin” finish on top of the rendering to the roll tiles.
2. Replace defected roof tiles by new roof tiles of the same and install new insulation and waterproofing layers.

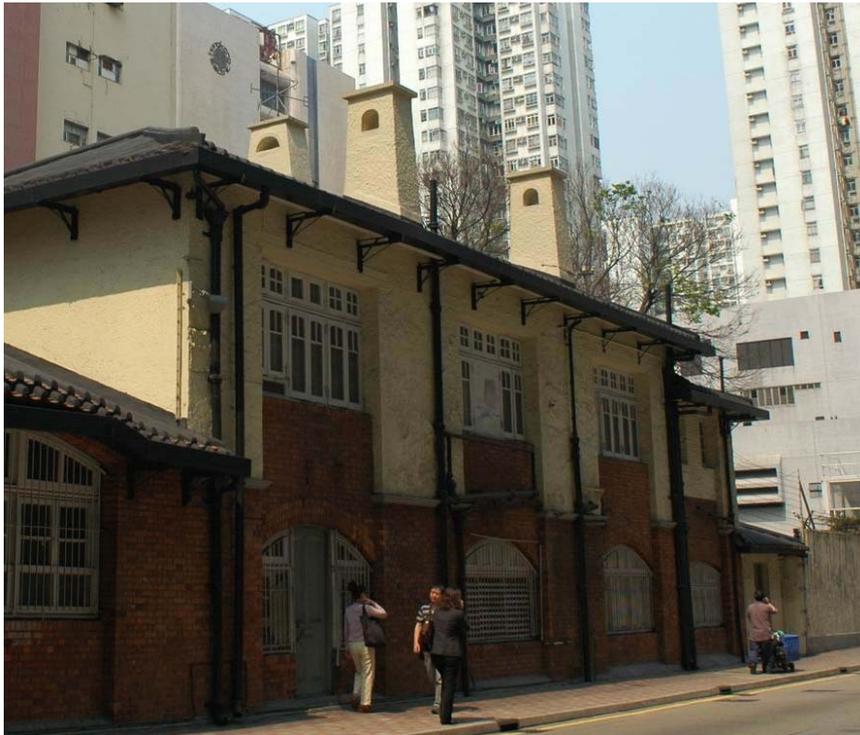
Fig. 480. Multiple roof forms finished with double-layered pan and rendered roll tiles.

Prominent chimney stack with semi-circular archway vent openings.

1. Many of the semi-circular archway vent openings were filled up. They can be made weather tight, but filled up by a recess infill to make the semi-circular blind arch identifiable from the appearance.

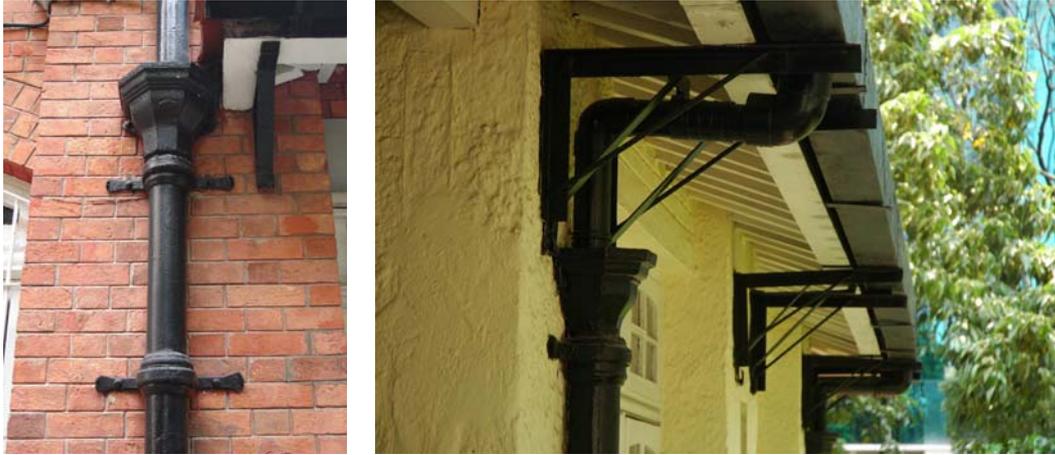
Fig. 481. Existing cast iron downpipes with hopper head of earlier period.

1. Existing cast iron downpipes with hopper heads and two eyes mild steel fixing brackets are believed to be from an earlier period either the time when it was used as the clubhouse or when it was converted into a staff quarter during 1930s. They should be repaired and reused as far as

possible. If beyond repair, the replica hopper shall be of the same size, design, detail and material.

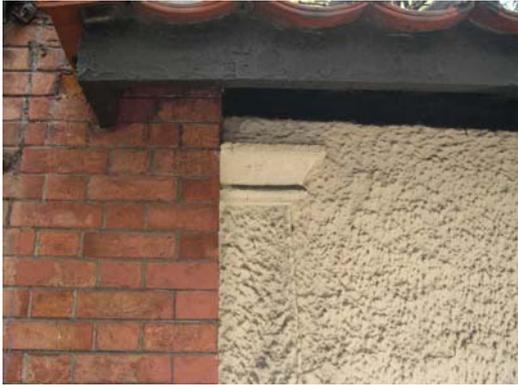
Column capital buried in the wall.
5.

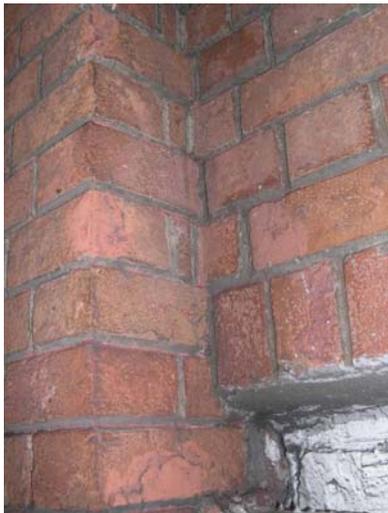
Irregular bonding of underwindow panels into columns suggests a later addition.
6.

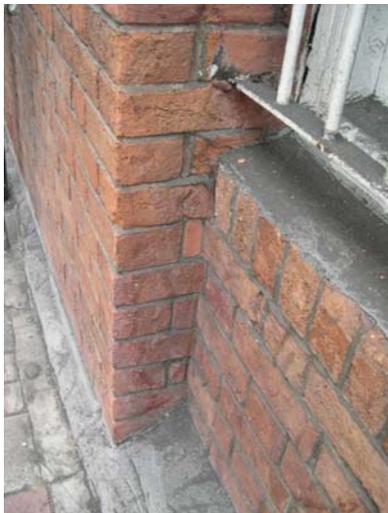
The course of brick on edge forming the cill and irregular brickwork of the inserted underwindow panel.
7.

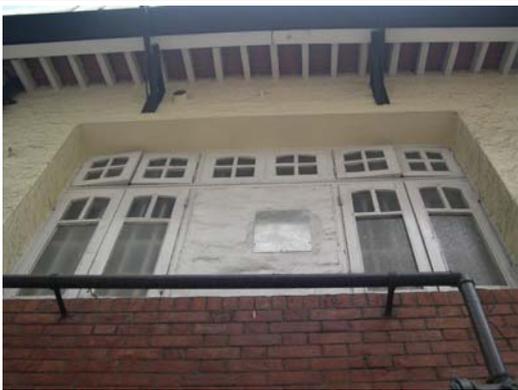
Infilling of upper windows with solid wall.

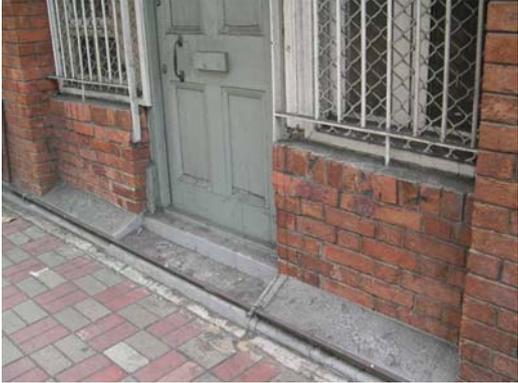
<p>Rendered step and inserted underwindow panel suggest the panel is new.</p>
9.

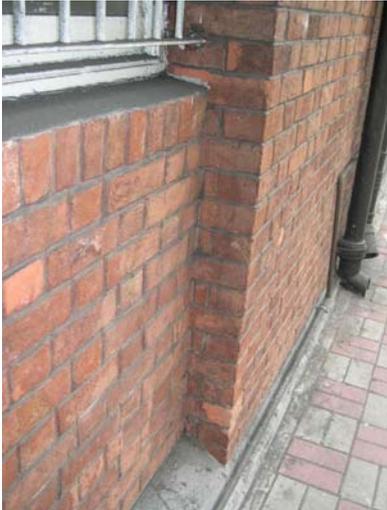
<p>Similarly the lack of symmetrical bonding and the queen closers to the bond suggest new work.</p>
10.

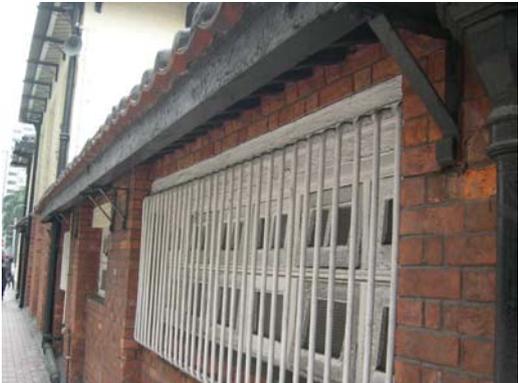
<p>Timber eaves board with curved end brackets, a concrete lintel over the window. The bars are an addition.</p>
11.

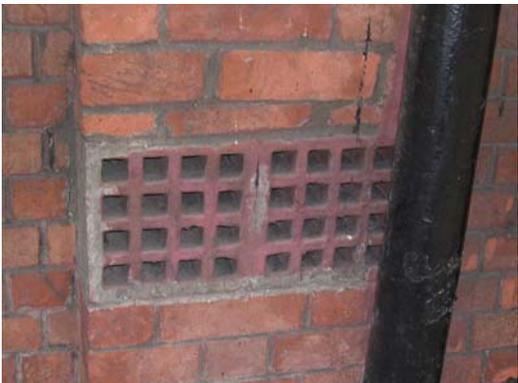
<p>New air-bricks to give ventilation to the kitchen cooking shelf.</p>

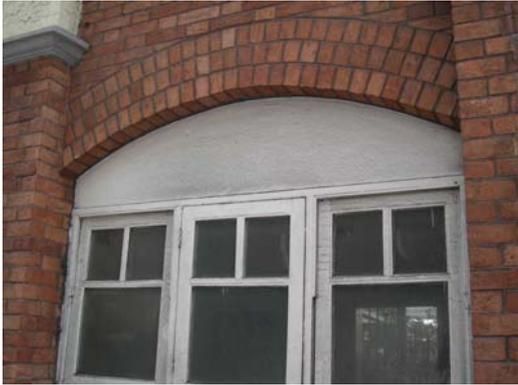
New window frames not fitted to the shape of the brick arch.
13.

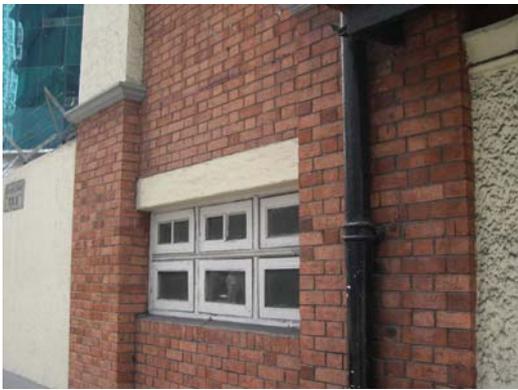
Heavy concrete lintel over smaller window with new frame.
15.

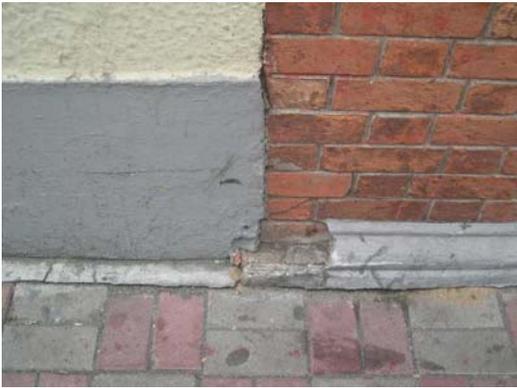
Plinth broken.

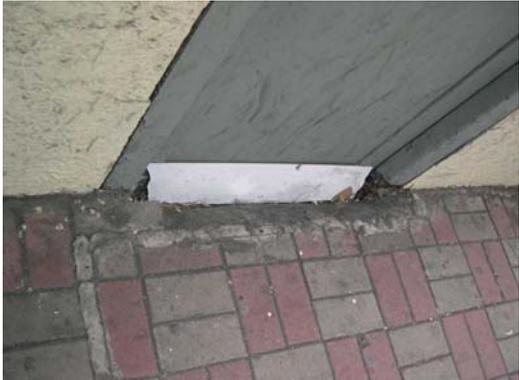
Door opening now situated below pavement level.
25.

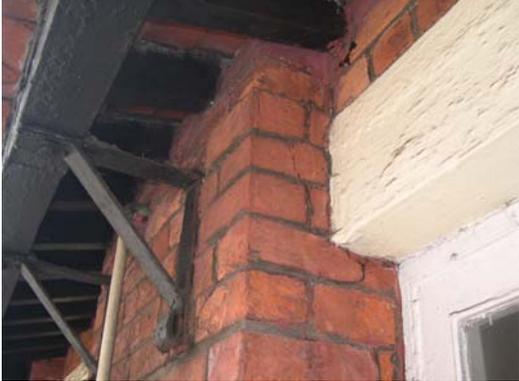
Hairline cracks to the brick wall under the eaves.
27.

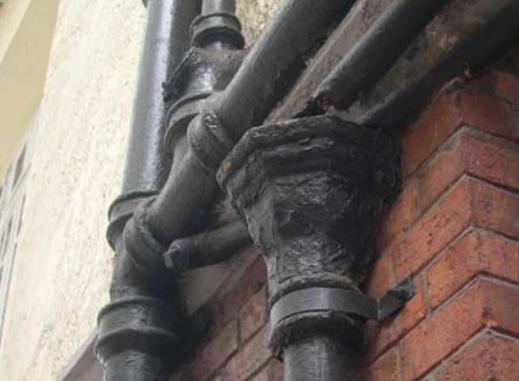
Broken drainage pipes.

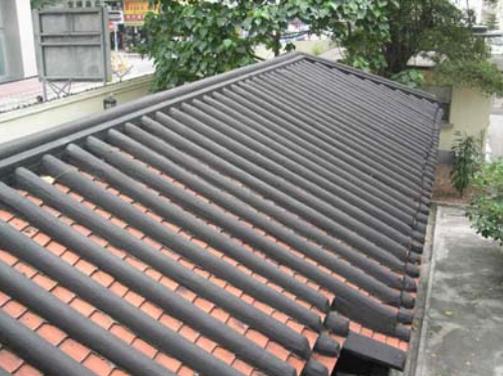
30.

A close-up photograph of the tiled roof of the timber building. The tiles are dark grey with red accents, arranged in a traditional pattern.	The roof to the timber fronted building.

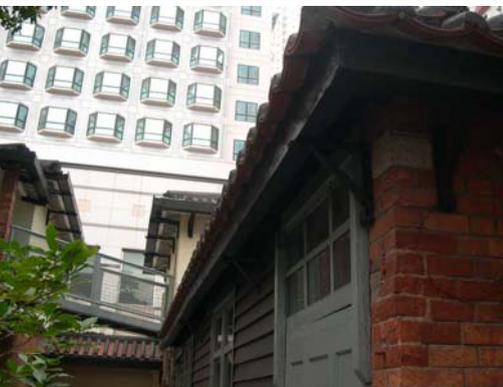
31.

A photograph showing the eaves and gutter bracket detail of the building. The brickwork is visible, along with a wooden door and a window. A modern building with many windows is in the background.	Eaves and gutter bracket detail.

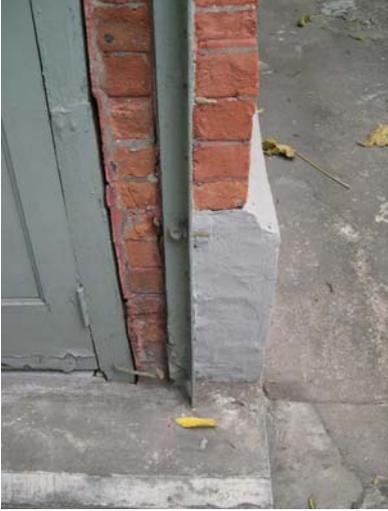
32.

The oversized plinth and old security frame to reveal.
33.

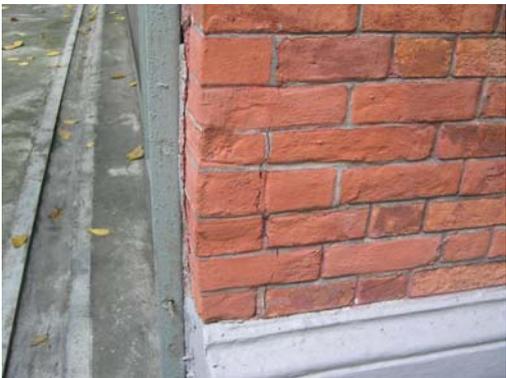
Hairline crack and surface repairs to the brick.
34.

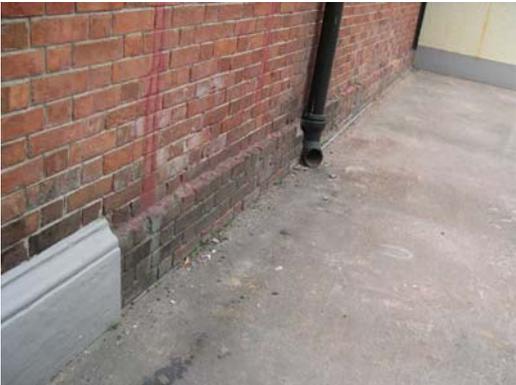
The original haunched brickwork and the new plinth
35.

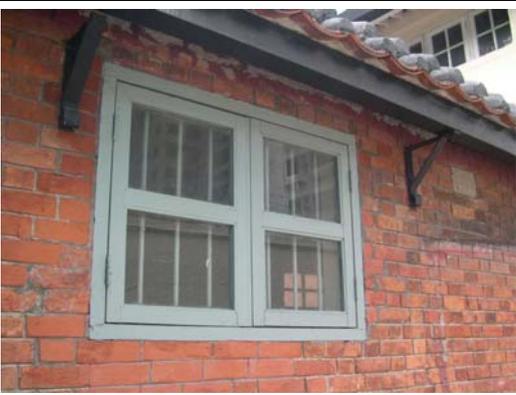
The new rear window openings with the cut bricks and no lintel or brick arch over, note position of granite pad stone.

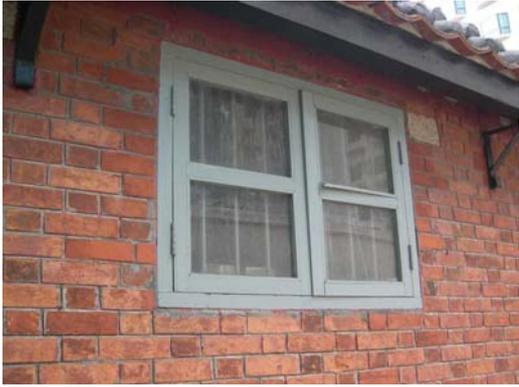
36.

The granite block for the truss pad stone at irregular spacing compared with the window.
37.

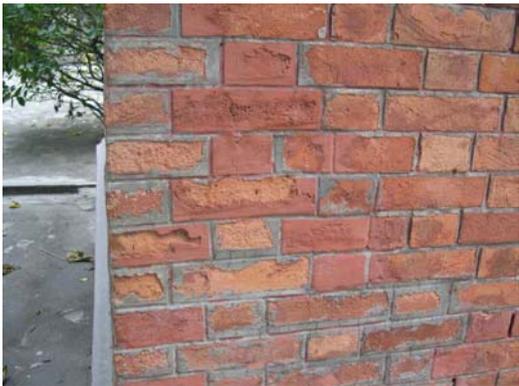
Repairs to the degraded bricks at the NW corner of the building.
38.

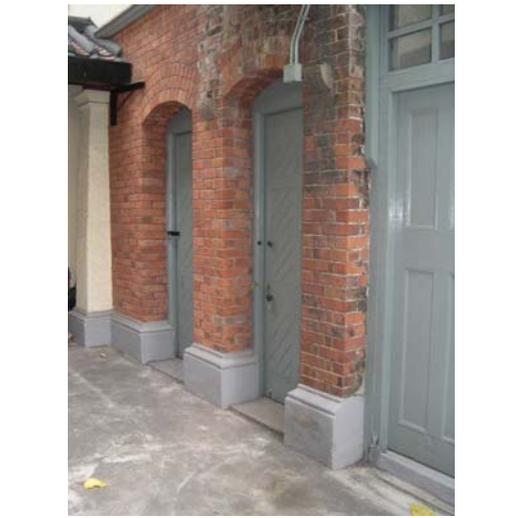
Brick arch door openings with framed ledged and diagonally paneled doors.
39.

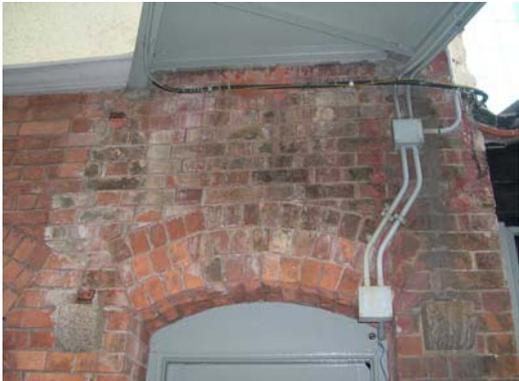
The pad stones for the original bridge or covered walkway.

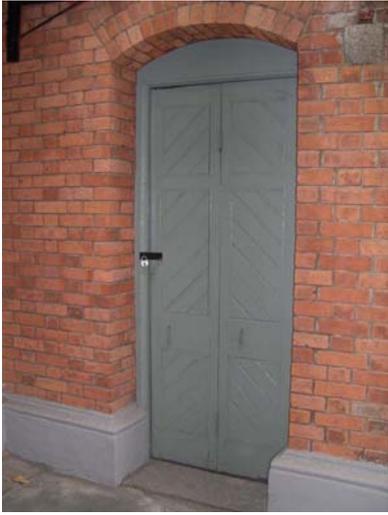
40.

The framed, ledged and diagonal doors.
41.

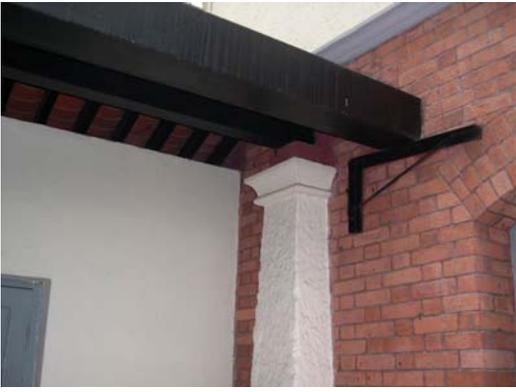
Tapered column to inside of entrance with box gutter and new bracket.
42.

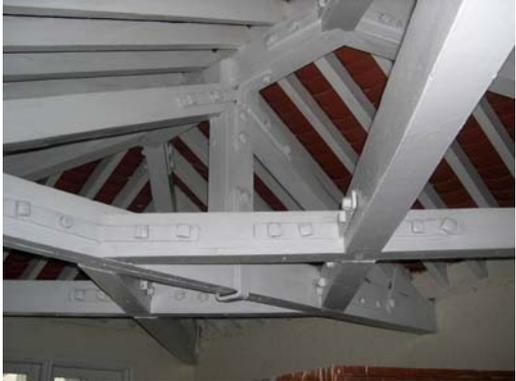
The king post roof of the 2-storey corner building.
43.

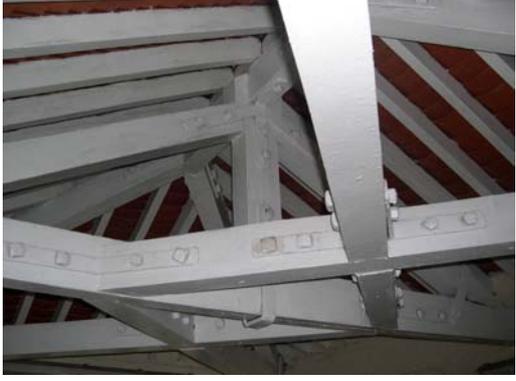
Iron brackets / ties to the joints.

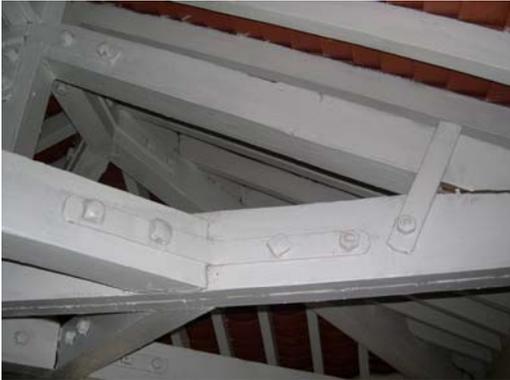
44.

The dogs and tie iron for the roof construction.
45.

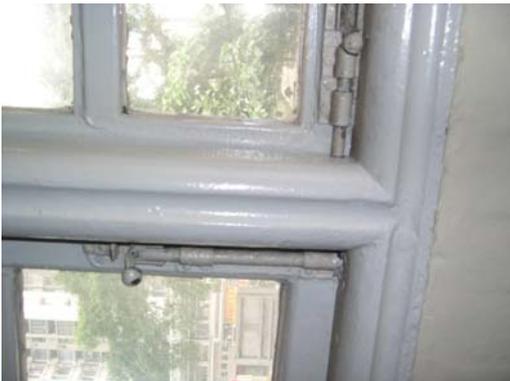
Convex window frame details.
46.

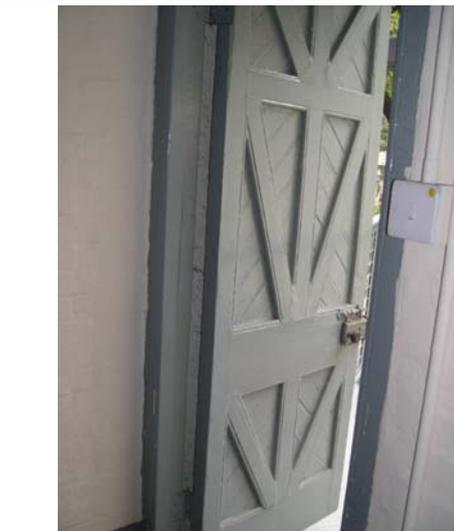
Framed, ledged and braced doors with diagonal planking.
47.

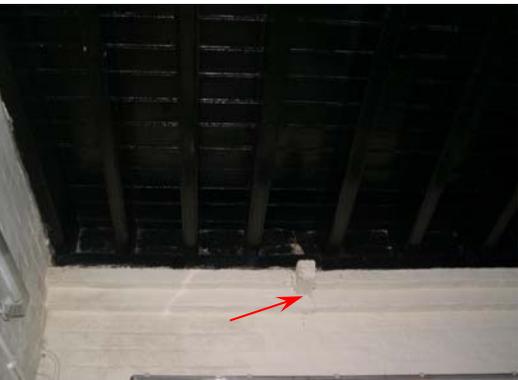
Hairline crack above and below the corbel.

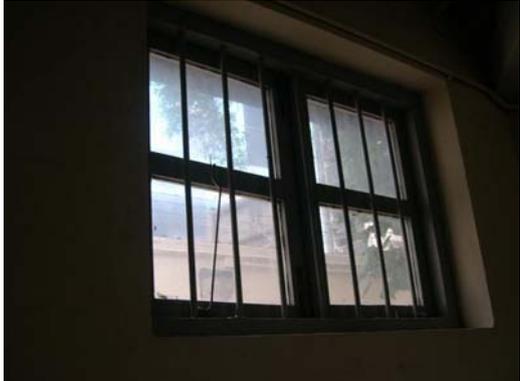
A photograph showing a close-up of a new window with a dark frame and multiple panes, set into a light-colored wall. The view is from the interior of the building, looking out through the window.	The internal view of the new windows to the rear wall.

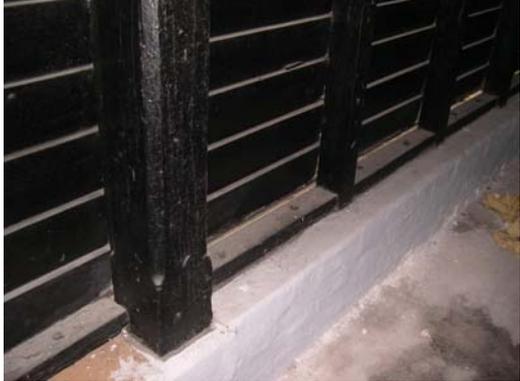
49.

A photograph showing a close-up of a dark timber column and a horizontal timber panel. The column has a chamfered corner, and the panel is a new addition. The background shows more of the timber structure.	The chamfered corners to the columns are not continued in the new timber panels.

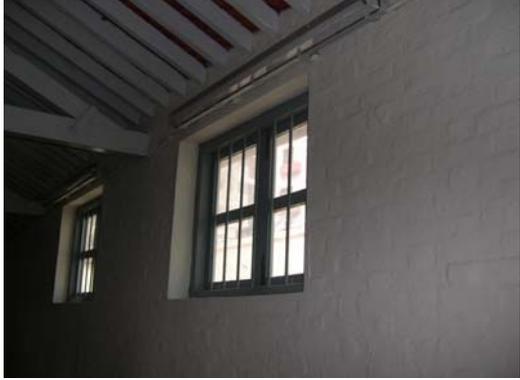
50.

A photograph showing a rear wall with two new window openings. The wall is light-colored and has a simple, rectangular design. The windows have dark frames and multiple panes.	The rear wall with new window openings.

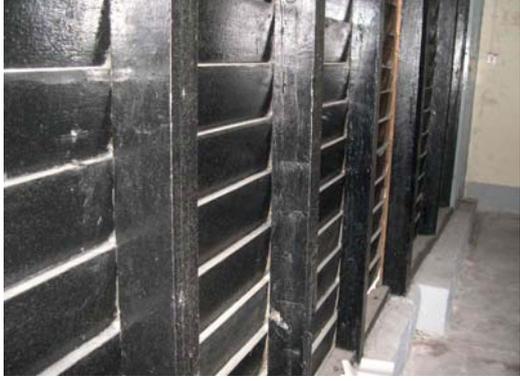
51.

A photograph showing a new front enclosure made of dark timber. It features vertical columns and horizontal panels, similar to the structure shown in photo 49. The enclosure is set against a light-colored wall.	The new front enclosure.

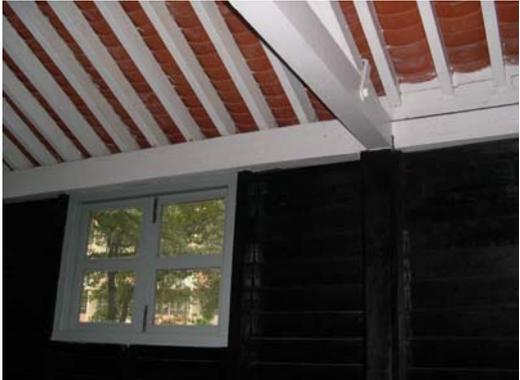
52.

The original timber eaves beam.
53.

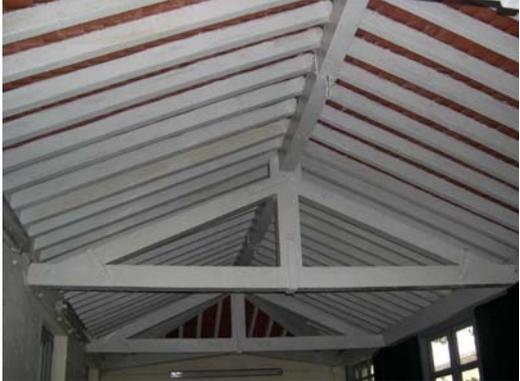
The king post roof truss construction.

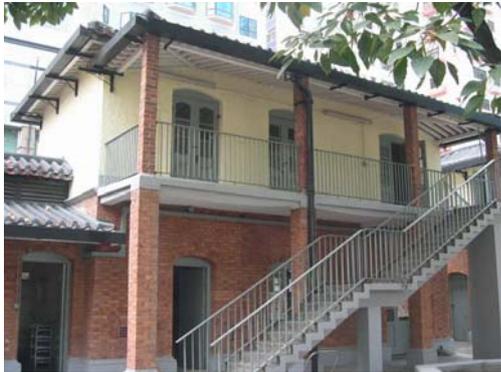
General view of Annex A.
55.

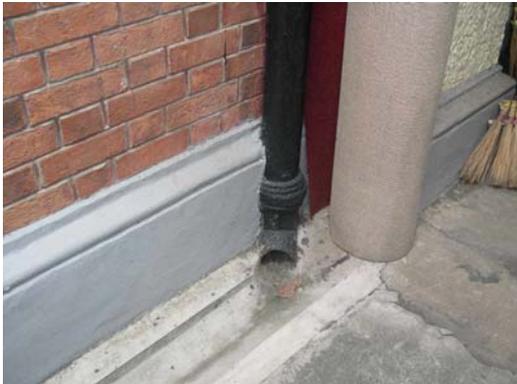
The drainpipes partially buried in the new plinth.
56.

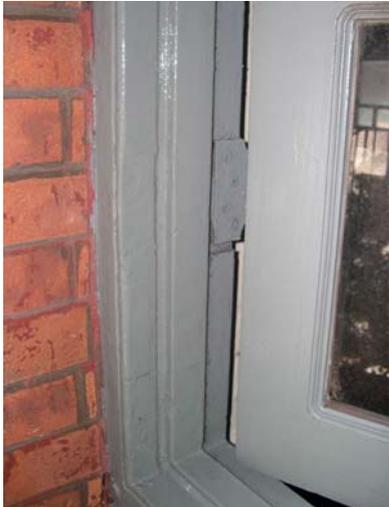
The original door hinge recesses visible next to the re-hung inward opening window.

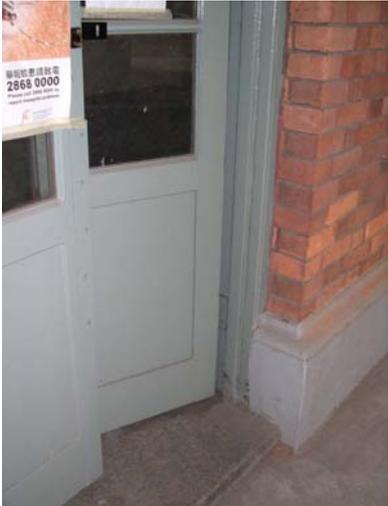
The new inward opening doors.
58.

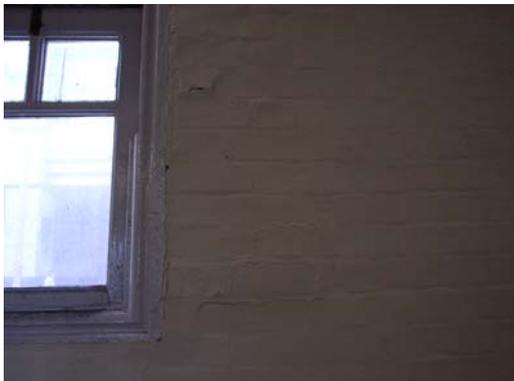
Hairline cracks on wall next to windows.
59.

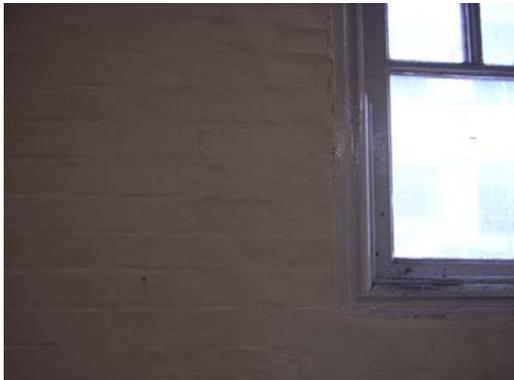
Hairline cracks on wall next to windows.
60.

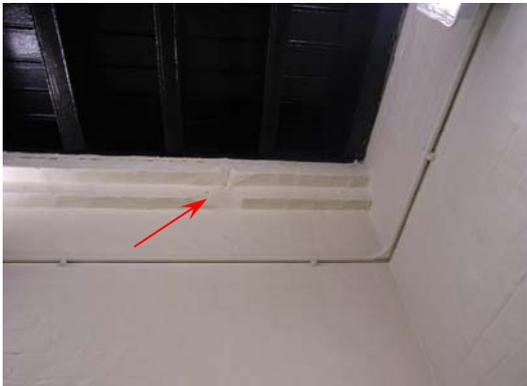
Part of the corbel is missing.

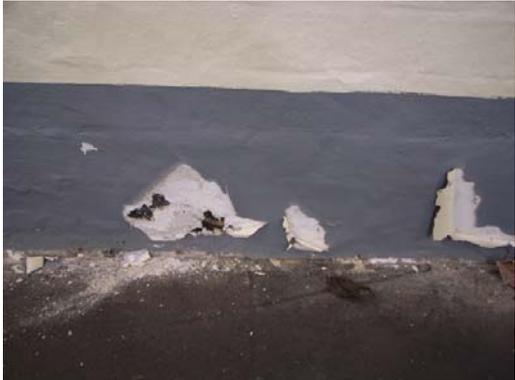
Paint at wall bases peeling off.
62.
