SIGNIFICANCE

4.1 Assessment criteria for cultural significance

CONDITION

5.7 The Buildings: Condition

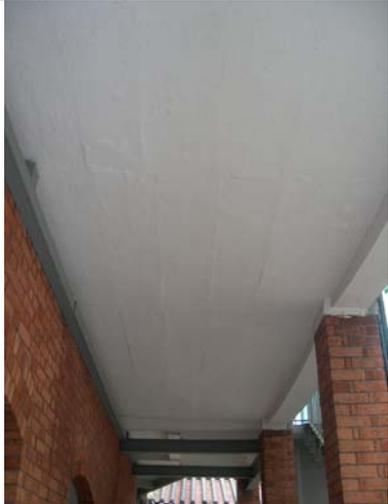
63.

Concrete slab forming the Office building verandah.

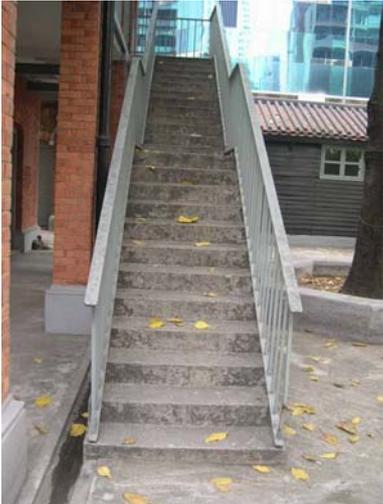
64.

The new concrete staircase.
65.

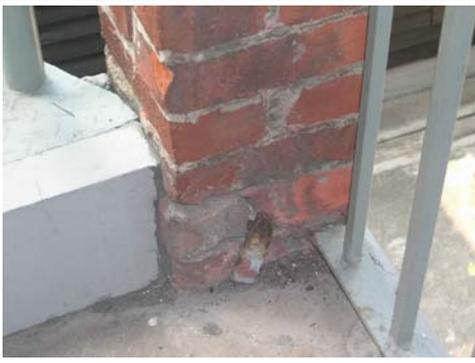
68.

Brickwork at the column base was broken.
69.

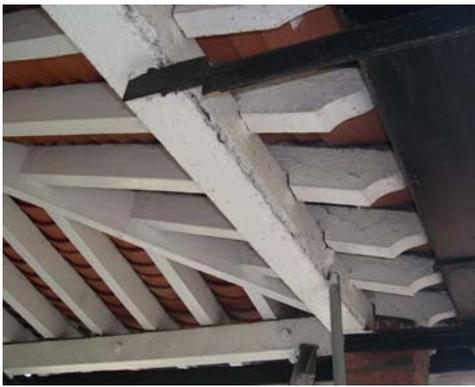
Corner detail of verandah roof with rafters, eaves beam and gutter brackets.
70.

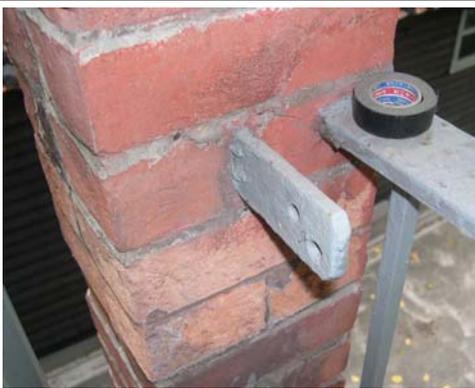
New handrail with original connection.
71.

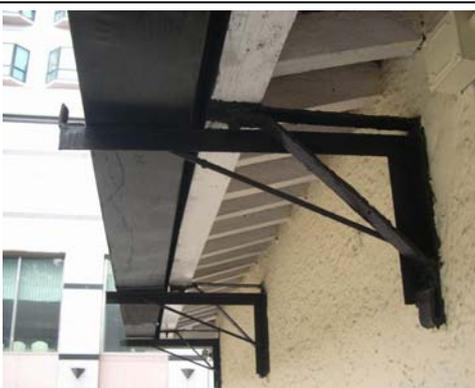
The gutter and eaves brackets. The old brackets have the hooped bottom for another bracket to hold the original (half round) gutters.

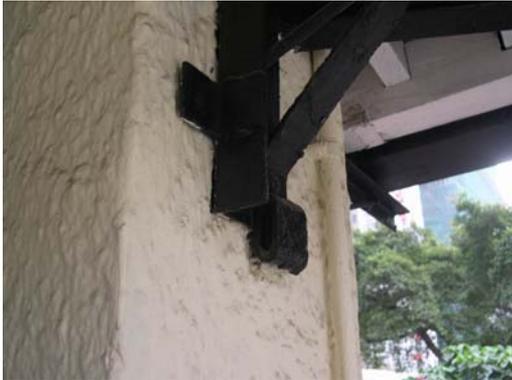
72.

The hooped bottom of the bracket.
73.

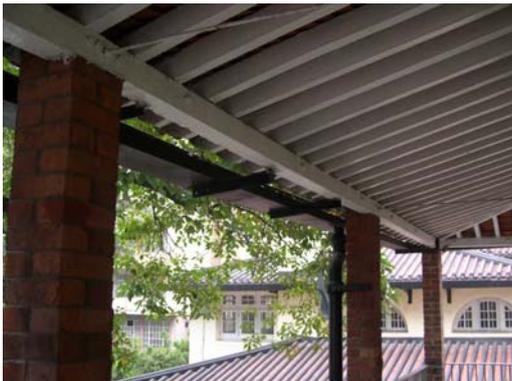
The verandah roof of the Office building.
74.

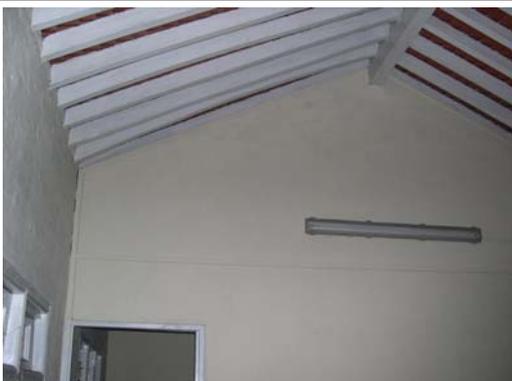
The hip detail.
75.

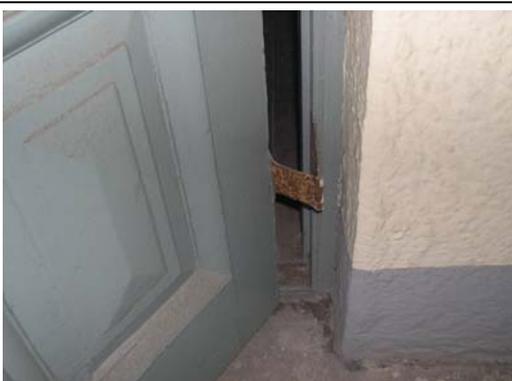
76.

Parliament hinges to the doors.

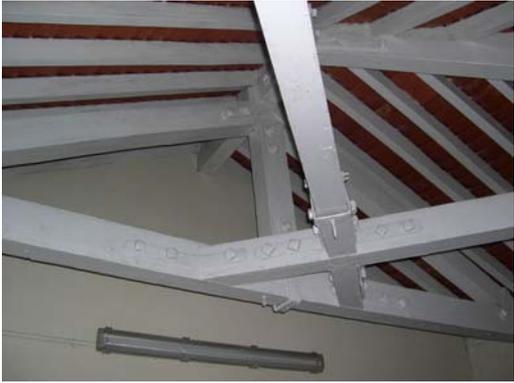
Diagonal ties to the king post roof.
77.

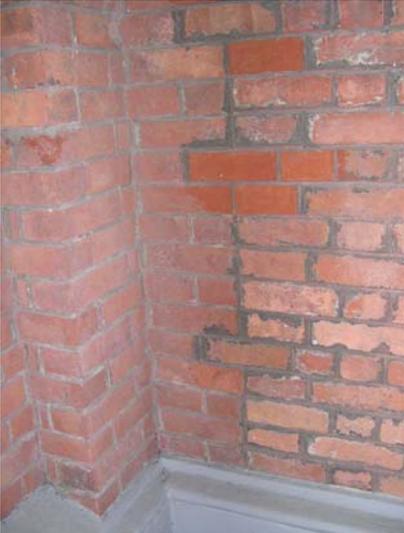
The toothed bond of the new kitchen underwindow panel.
78.

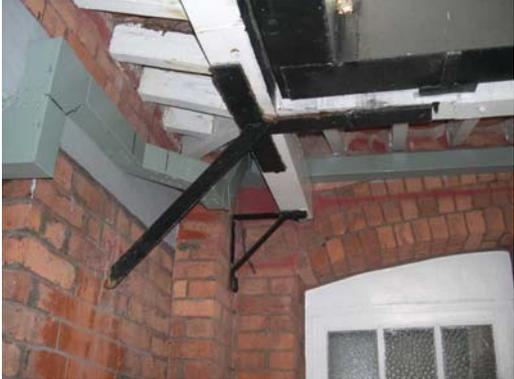
Eaves gutter brackets and braced beam support.
79.

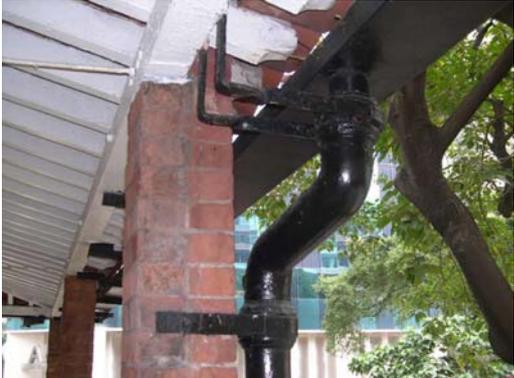
Gutter/down pipe tie backs to the verandah column.

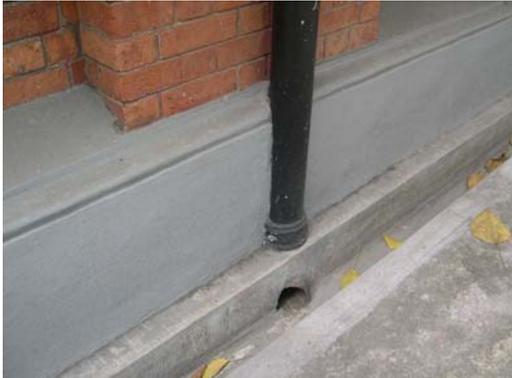
Downpipe embedded in the new plinth discharges to the surface channel.
-----	---	--

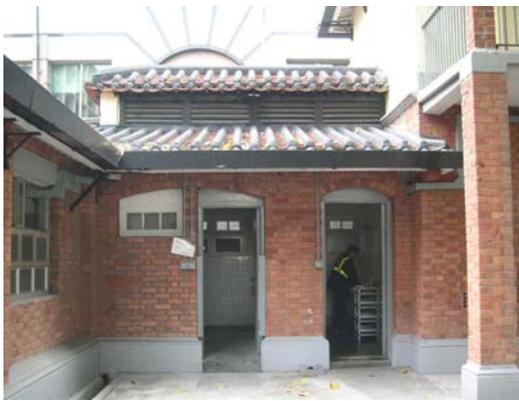
General view of the toilets.
82.

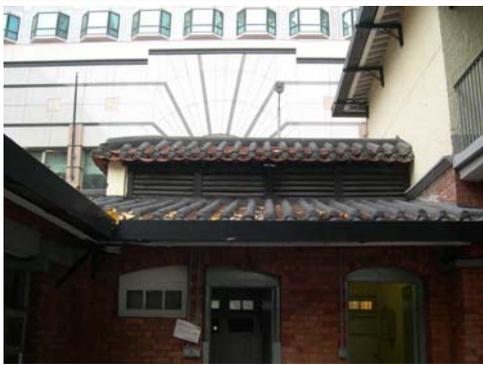
The ventilated double roof over the kitchen toilet block.
83.

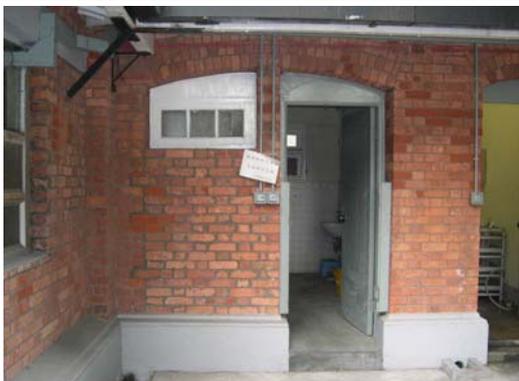
The original arch sub-divided to form the new kitchen. Note the toothed bonding of the new under-window panel.

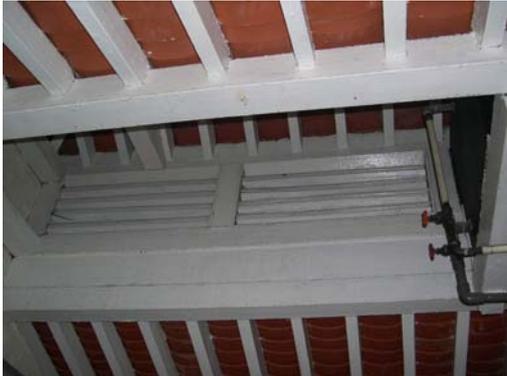
The louvered double roof for ventilation and drying.
85.

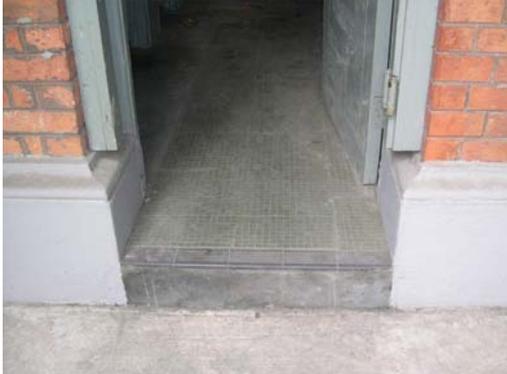
The new toilet door and floor.
86.

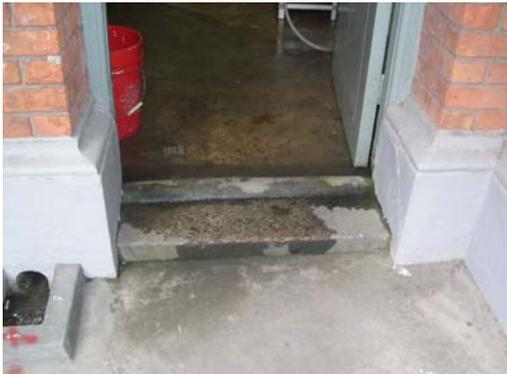
The original type of granite floors.
87.

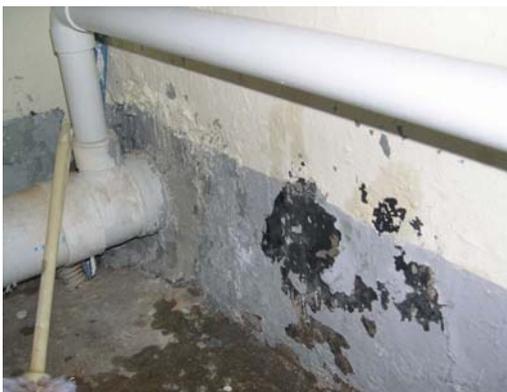
Dampness at the wall bases.

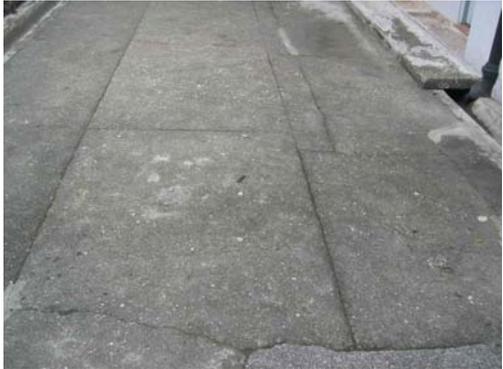
Hairline and minor cracks to the hard landscaping indicates differential settlement.
90.

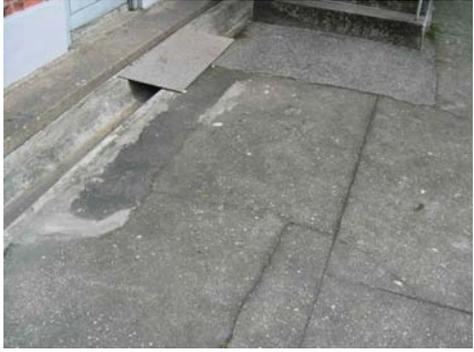
Hairline and minor cracks to the hard landscaping.
91.

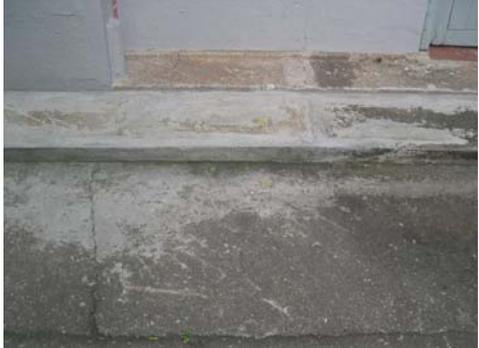
Hairline cracks to the paving and granite step.

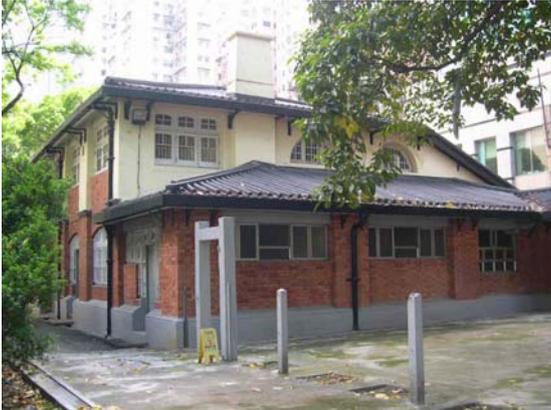
General view of the main building.
93.

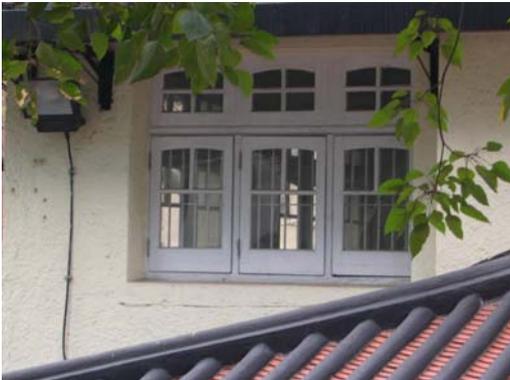
Square window to the cockloft of the Clubhouse building.
94.

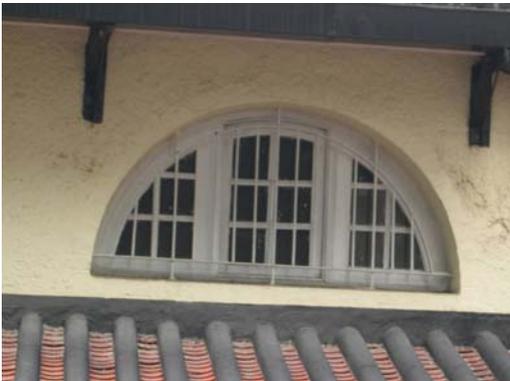
Half round windows of the west end of the Clubhouse building, note the fair-faced brick arch now painted.
95.

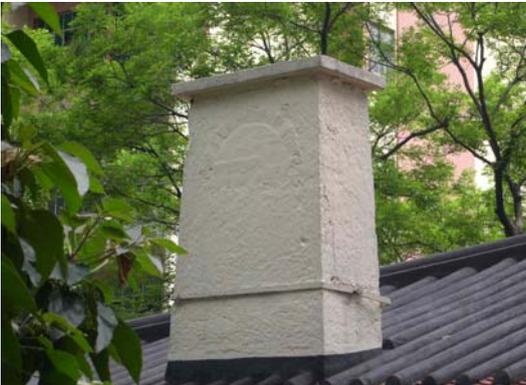
Chimney of the Main Building was blocked.

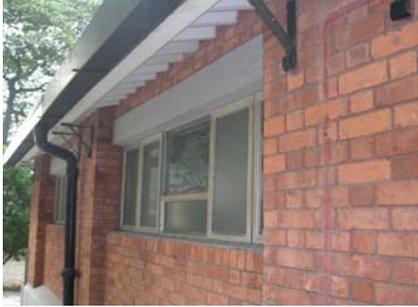
Side wall of the Clubhouse extension with concrete lintels, the looped brackets and new box gutters.
97.

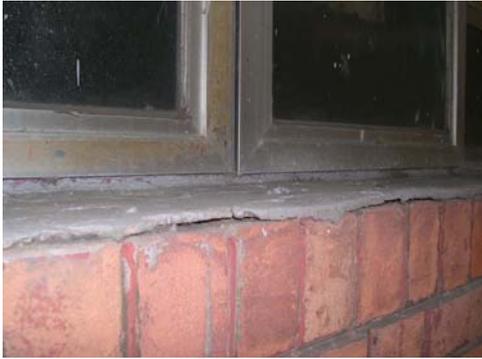
De-bonded cement sand window cills.
98.

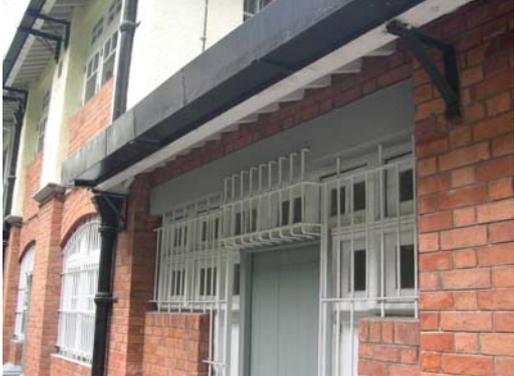
Concrete lintel to the Clubhouse extension with the brick arch of the older building.
99.

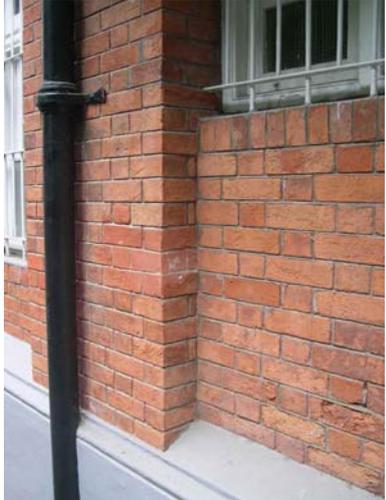
The infill under window panels, new plinth and missing cill.

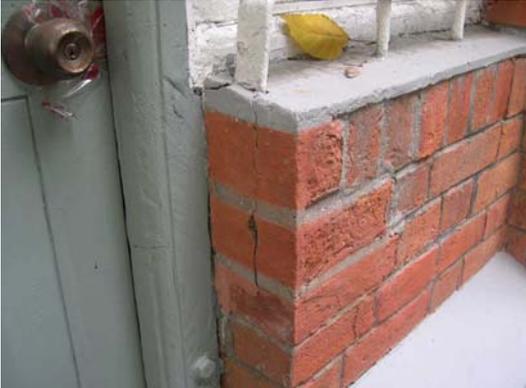
<p>Hairline crack to the brick next to door opening.</p>
103.

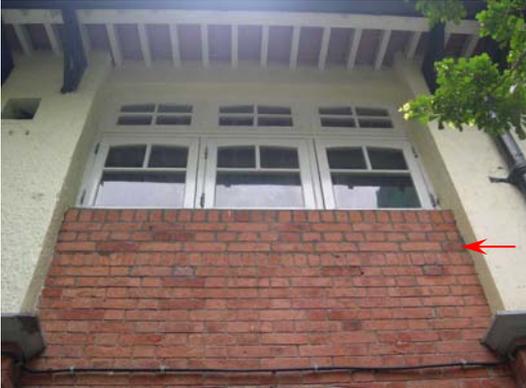
<p>The row of headers 5 courses down indicates the original window opening was larger.</p>

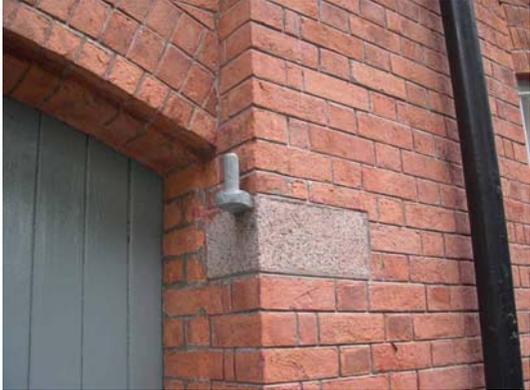
Granite blocks built in to take the pintle for the gates to the boat store.
105.

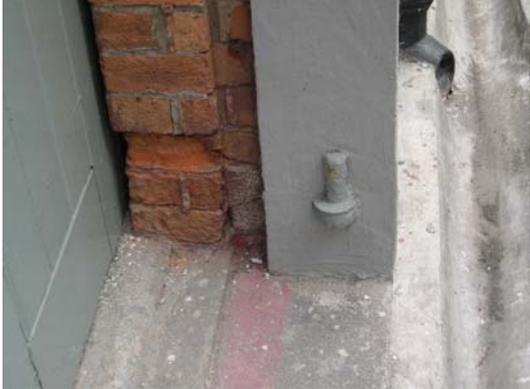
Lower pintle to the boatstore.
106.

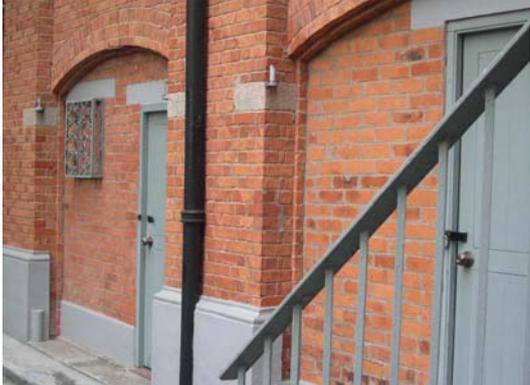
Infill panels under the arched brickwork, the new plinth and new staircase handrail.

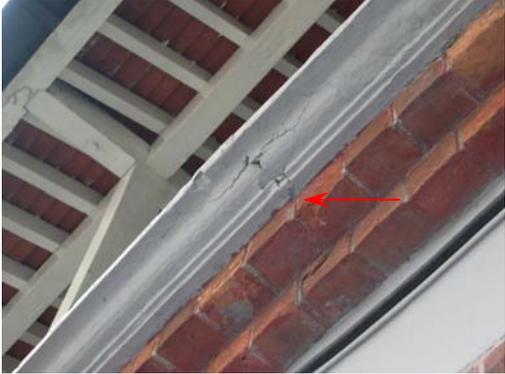
Hairline crack to the corbel to the verandah.
110.

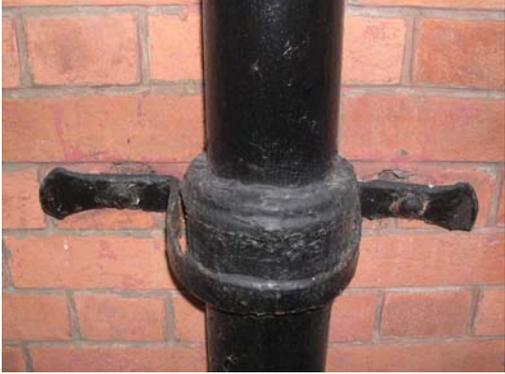
Loose pipe brackets.
111.

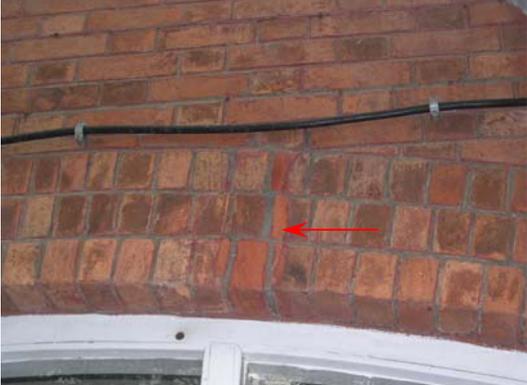
A crack to the NE corner window arch and making good in sand/cement render.

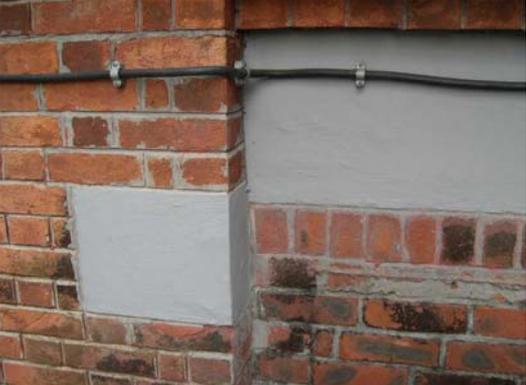
Cement finishing to the bricked in infill panel.
114.

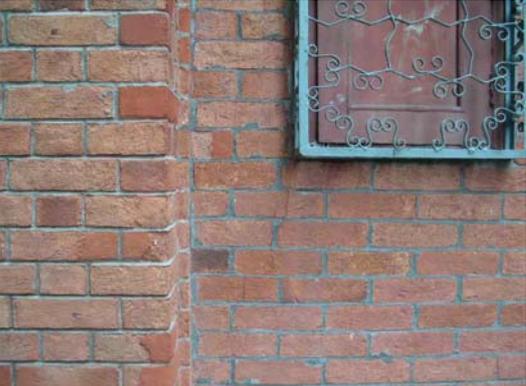
<p>Hairline cracks stepping down from the corner of the window to the column.</p> <p>Brick repairs to the columns and the toothed bonding of the newer infill panels.</p>
115.

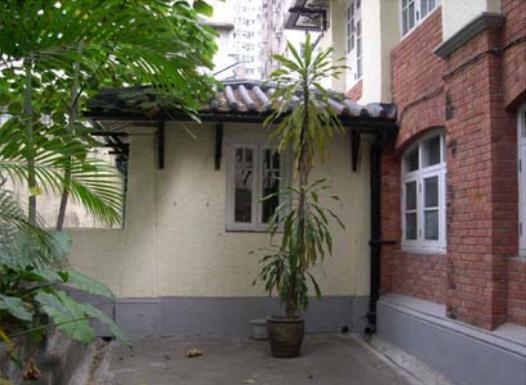
The new walls to the east entrance porch.

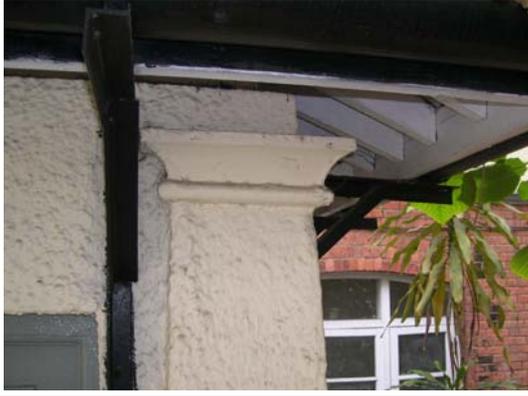
The columns now built in to the walls.

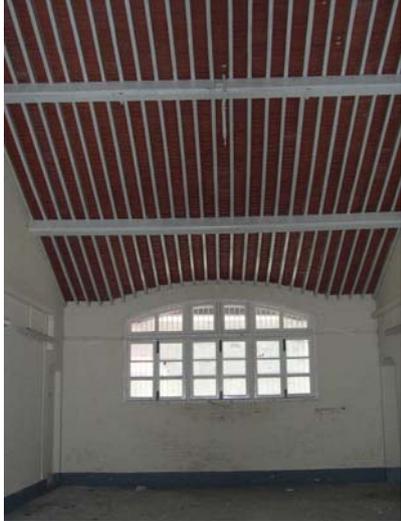
The wide roof span with no eaves ties.
118.

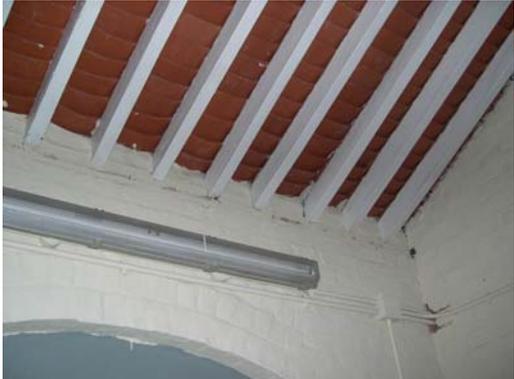
128.

<p>A photograph of a roof showing new red tiles. The tiles are laid over a wooden beam (eaves board), and the infill between the tiles is visible. A silver downspout is also visible on the wall below the roofline.</p>	The new roof tiles showing the infill at the eaves over the eaves board.

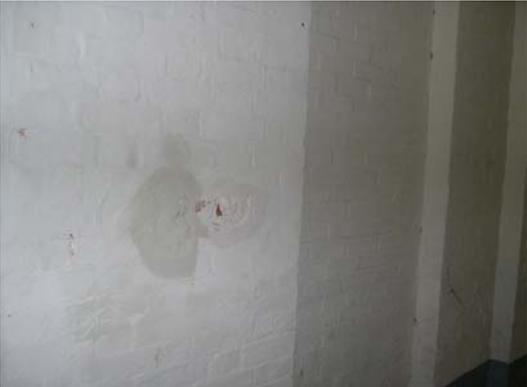
Dampness on the wall
131.

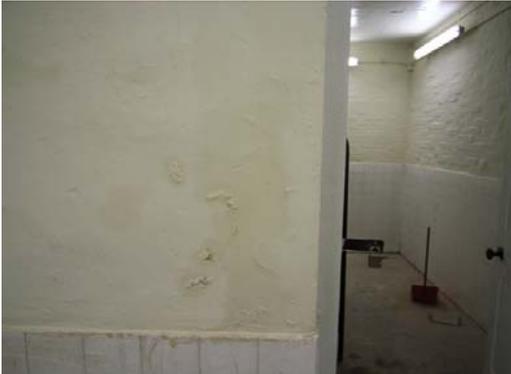
Dampness on wall.
142.

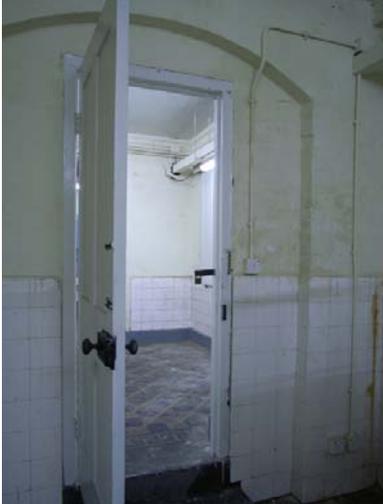
Dampness on wall, new door opening in infill panel.
143.

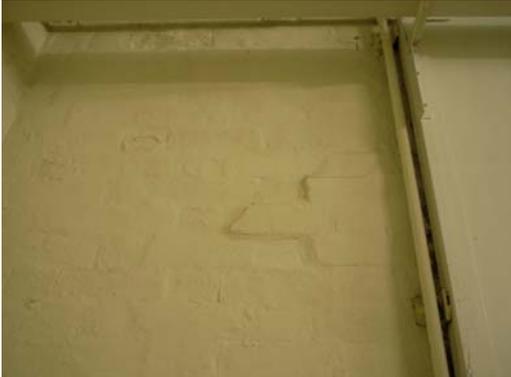
144.

De-bonded brickwork.

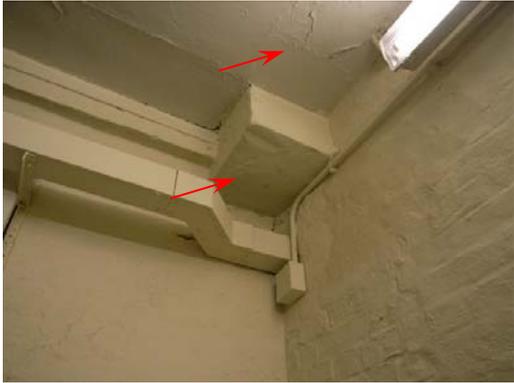
Hairline crack to the corbel and hairline crack to the ceiling soffit.
145.

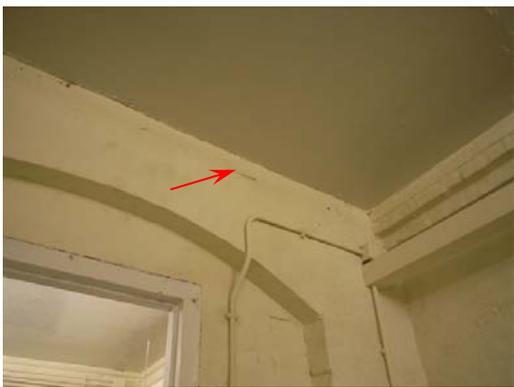
Hairline cracks above the arch.
146.

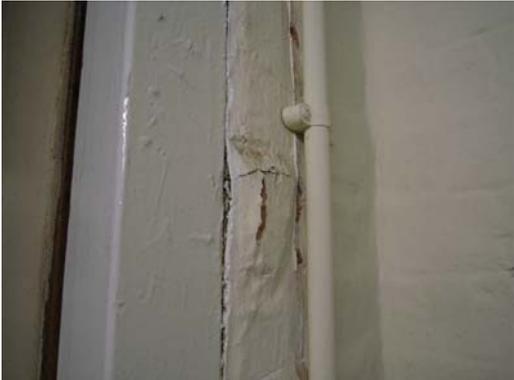
Degraded brick behind the G/F Bar counter
149.

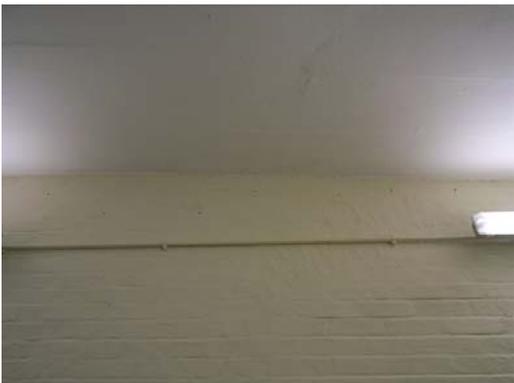
Hairline cracks to the brick under the ceiling.
150.

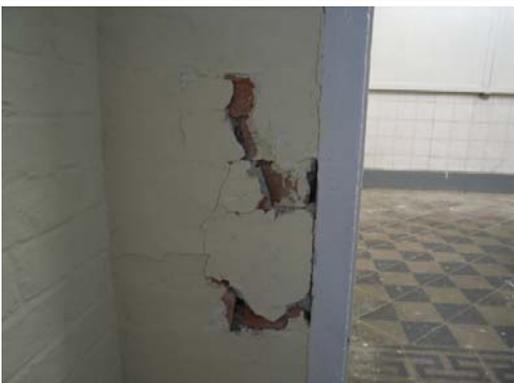
Minor degradation to brickwork.
151.

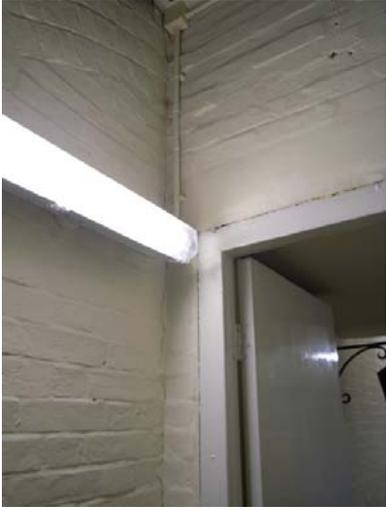
152.

Cracks at the junction of brick wall.

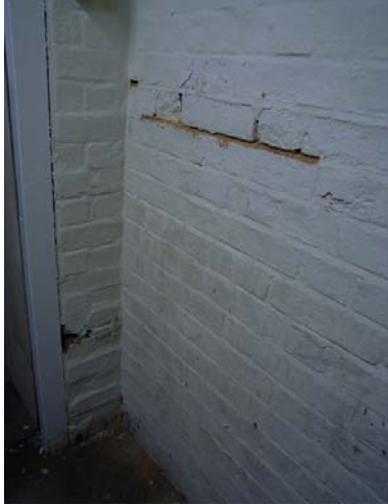
Degraded brickwork, surface becomes powdery.
153.

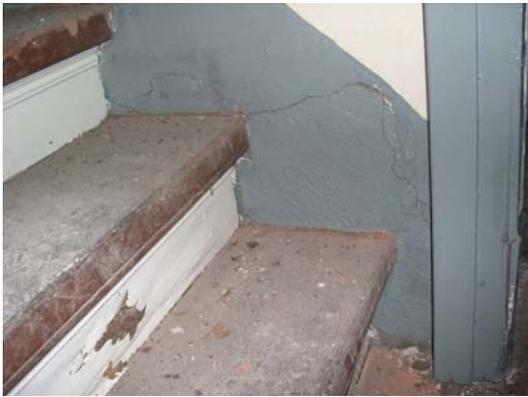
De-bonded plastering to the brick wall.
East entrance/Switch Room		
155.

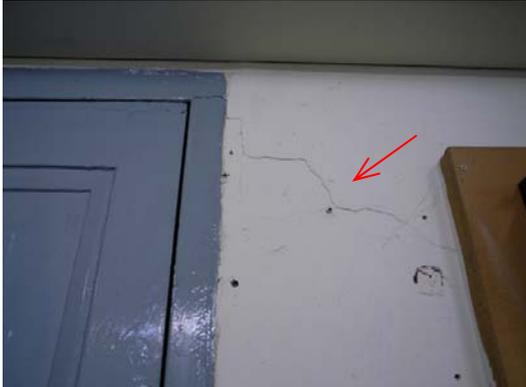
Hairline crack to brick wall
162.

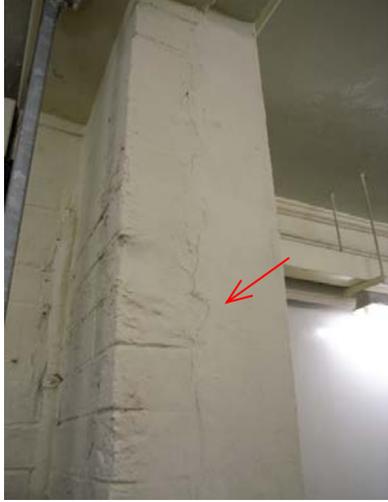
Hairline crack to the brick column.

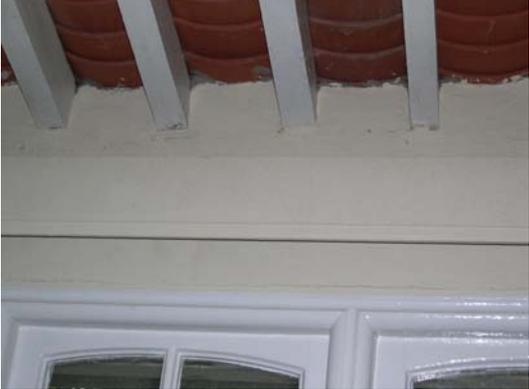
179.

Eaves infilled restricting air flow.

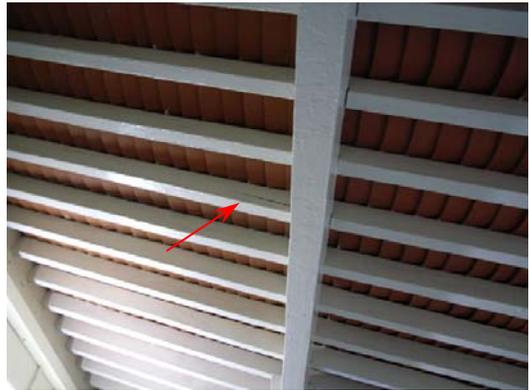
Split on the batten.
181.

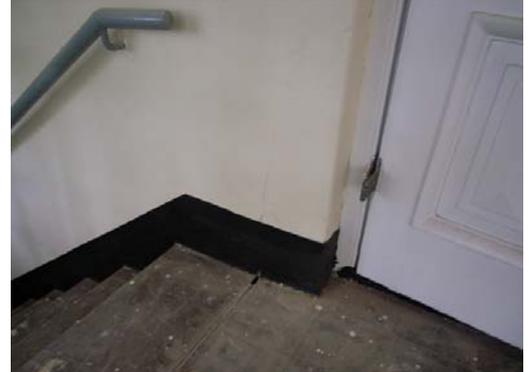
183.

Hairline crack to the bottom of the wall.

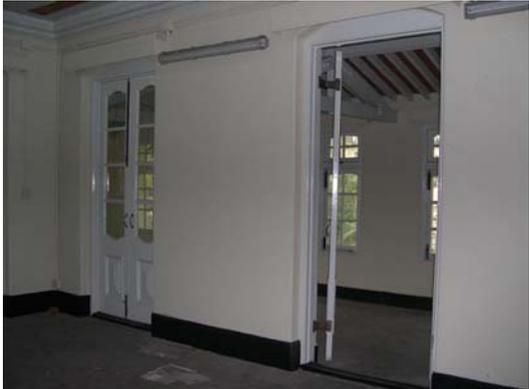
Doors to the verandah suggest it was originally open or louvered.
185.

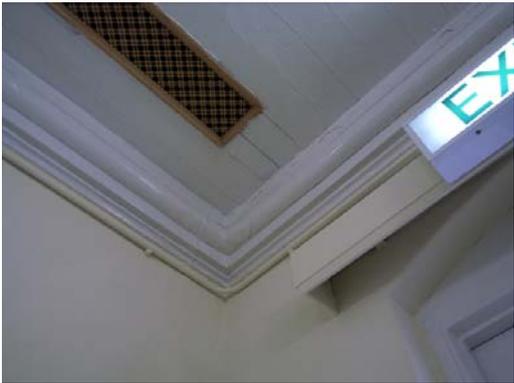
Hairline crack to the molding.
186.

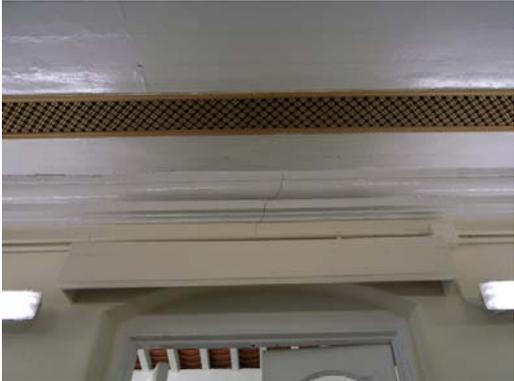
187.

The ventilated "cool" roof, hairline crack to the molding.

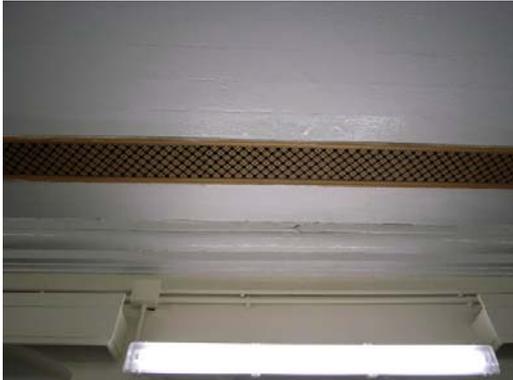
Hairline cracks to the moldings.
188.

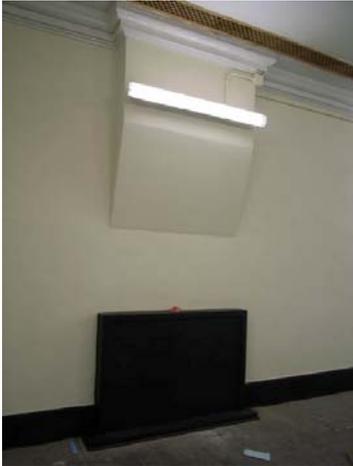
The fireplace was block up.
