CONSERVATION MANAGEMENT PLAN AND HERITAGE IMPACT ASSESSMENT

24 FEBRUARY 2015

RENOVATION WORKS FOR THE WEST WING OF THE FORMER CENTRAL
GOVERNMENT OFFICES - 8AB114

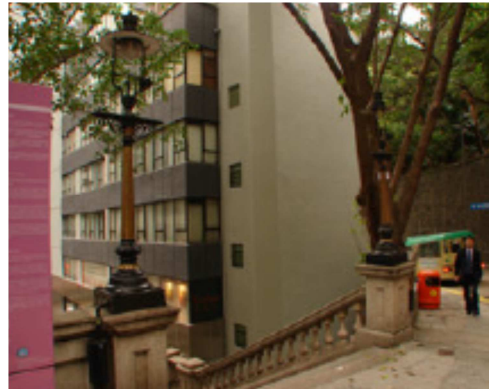
Repairs to the steps have been carried out at various times. At least one of the stone balls has been replaced, and the workmanship is to a high standard. A large section of the east retaining wall has also been removed, though sections of the pointing have broken away. Other repairs, such as to the cement plaster panels, have not been carried out to a high standard and there are other areas, such as the widening gaps between the paving stones, where repairs are needed.

Fig.33: The Duddell Street steps and gas lamps

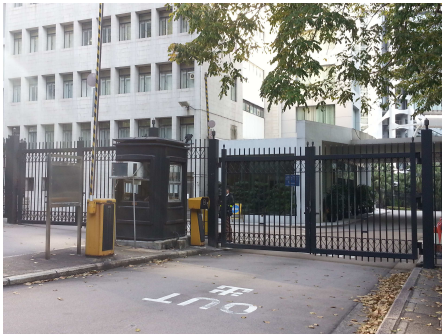
Fences and gates (modern)	Intrusive	Adverse impact on setting of the building
1.7

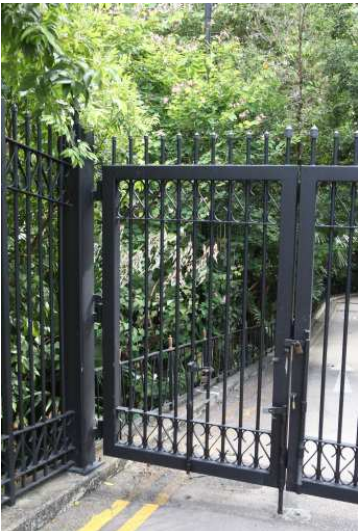
Railings (modern) at top of escarpment	Intrusive	Adverse impact on setting of the site

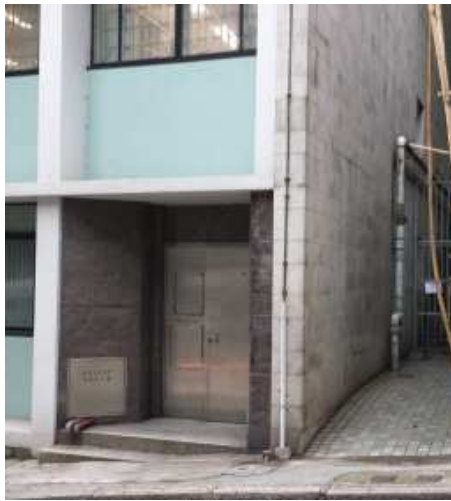
E&M services	Intrusive	Ad hoc additions without regard to impacts arising

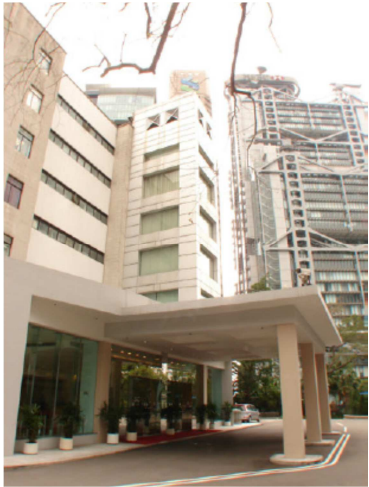
East lift tower and entrance	Intrusive	Restricts views north-south between Central and West Wings

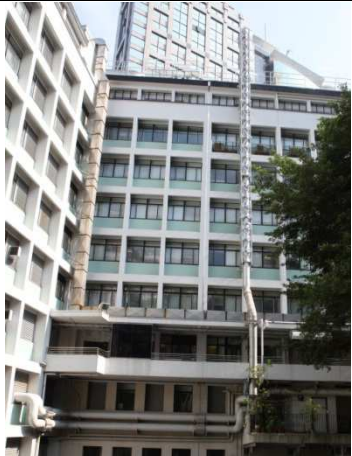
Services pipelines and chimney on south elevation	Intrusive	Intrudes on architectural quality of the exterior
3.0	INTERIORS			
3.1

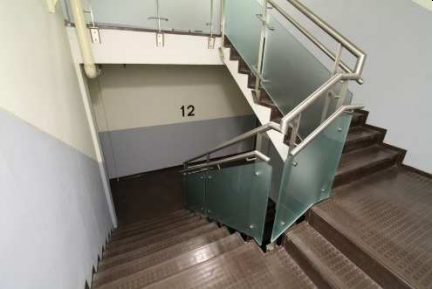
Staircase at East end Block	Intrusive	Have been altered significantly, including replacement of the balustrades and finishes of the steps.
3.4	 	Lift lobbies	Low	Retain fragments of the original materials but substantially altered

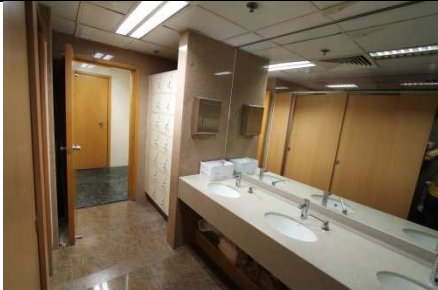
Toilets	Low	Located in their original positons but substantially altered in previous refitting
3.6
