# **Archaeological Watching Brief for South Island Line (East) for MTR Corporation Ltd.**

**Final Watching Brief Report**

**ARCHAEOLOGICAL ASSESSMENTS LTD.  
September 2013**

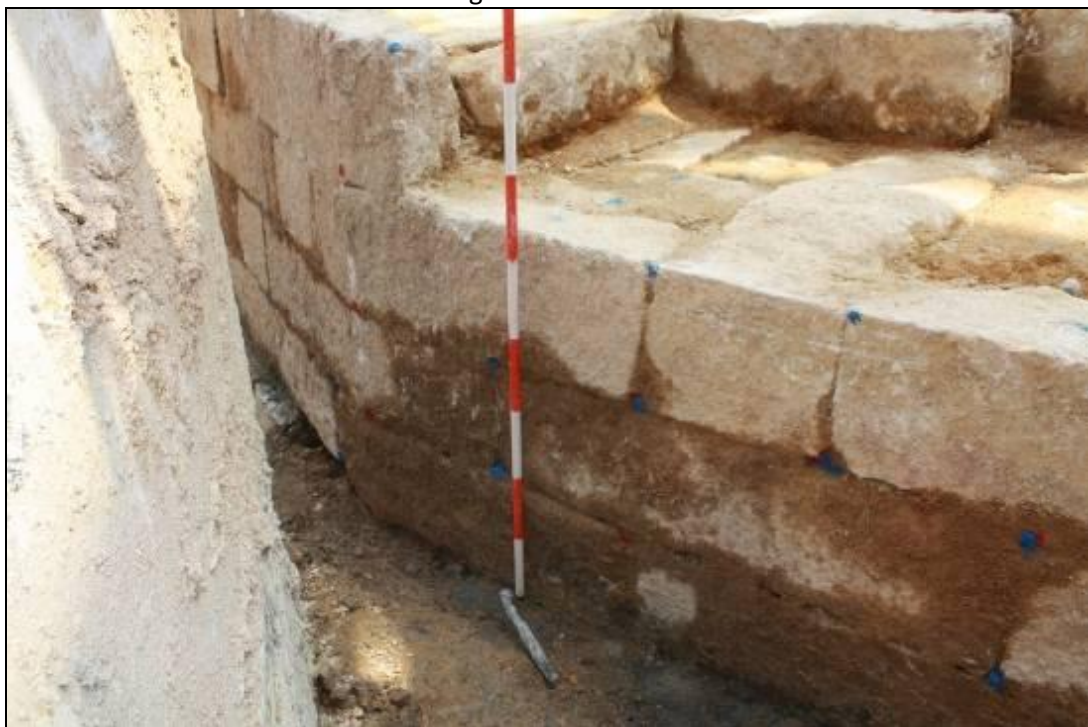
Plate 6b View of the seawall fragment: bend at western end

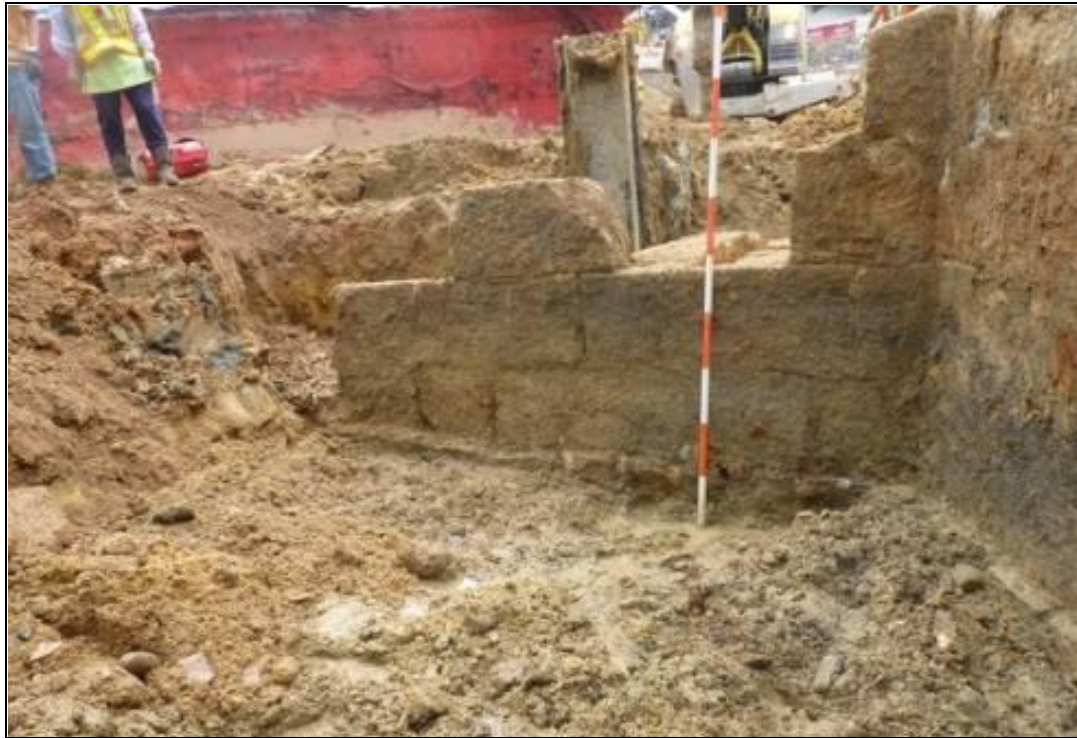
Plate 6c View of the seawall fragment: bend at eastern end frontal view; notice sheetpile for electric substation in background

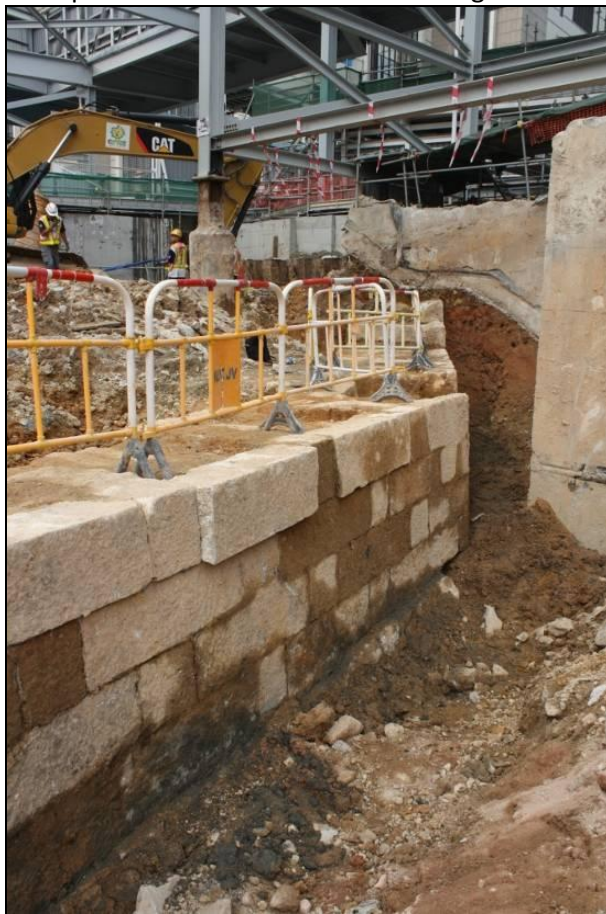
Plate 6d View of the seawall fragment: view of seawall to west; concrete structure on the right of photo is MTRC's entrance 'E'

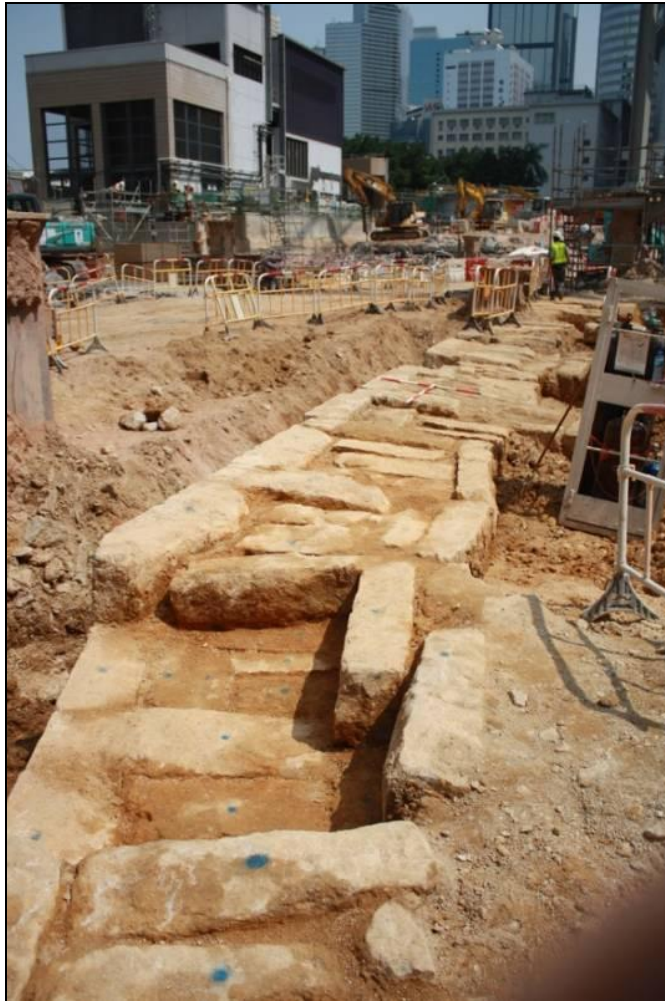
Plate 6 e View of the seawall fragment: top view of row '4' towards east

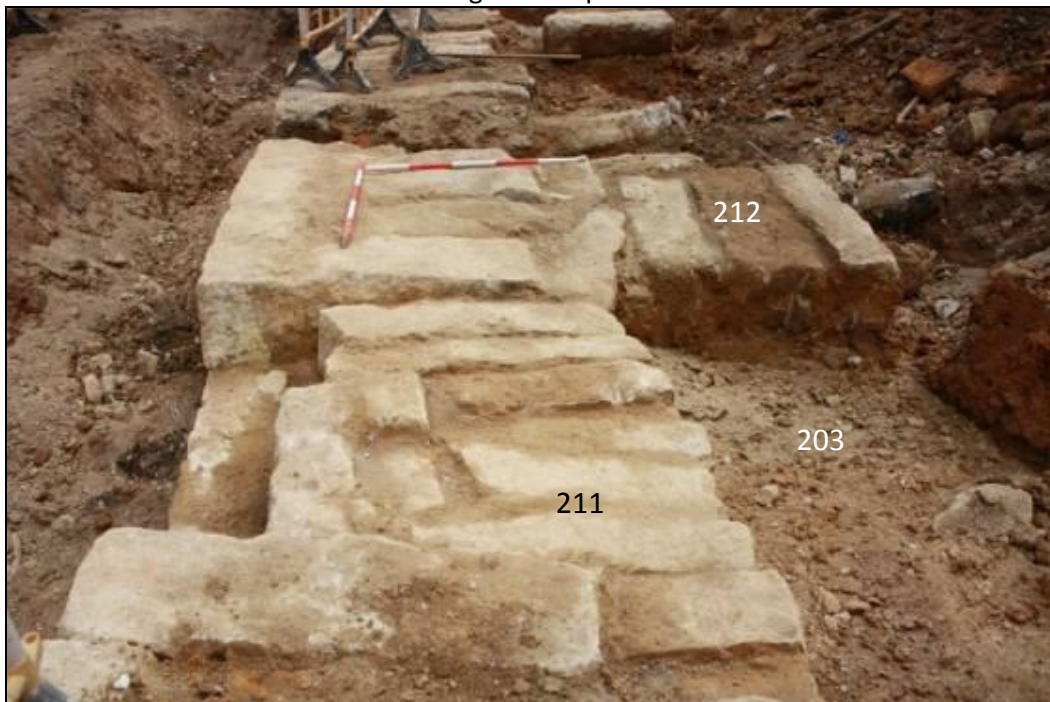
Plate 6f View of the seawall fragment: detail view of buttress backing the south of the seawall

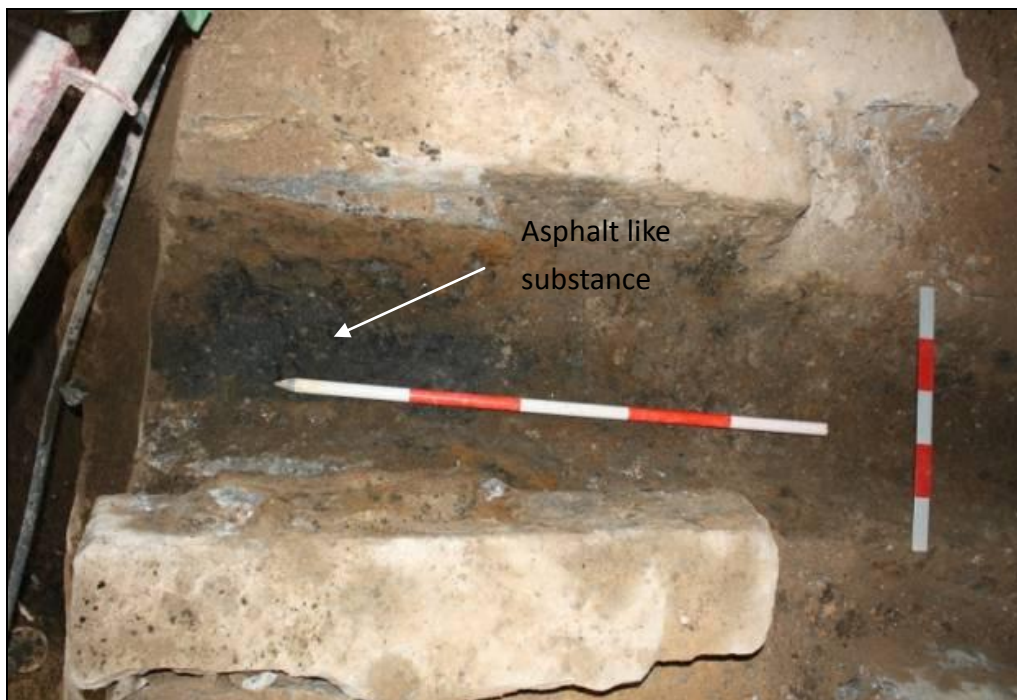
Plate 8c Inside of stone drain, notice black asphalt substance inside

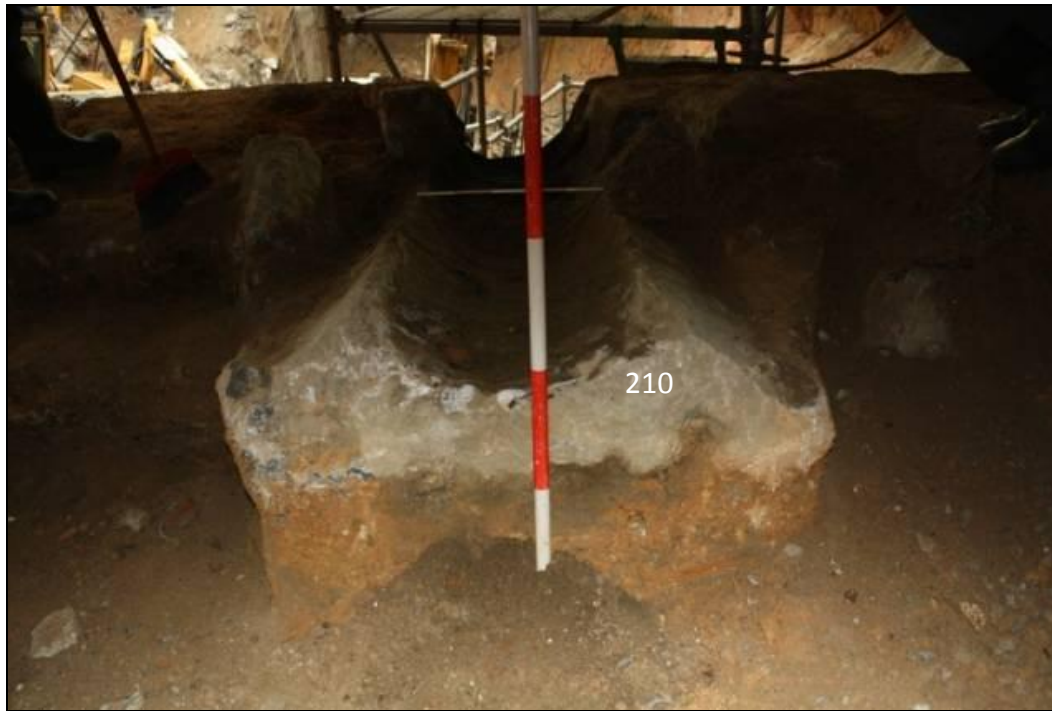
Plate 8d Rear of stone drain set onto soils, context 208

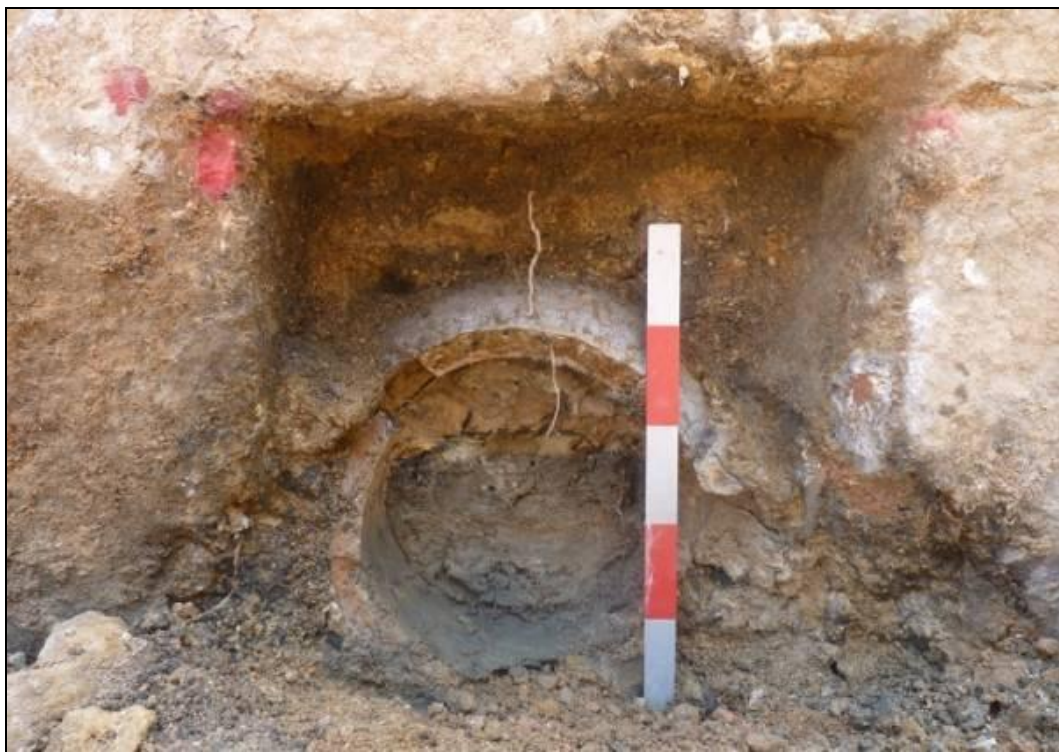
Plate 9c Ceramic drain, context 205; north facing section

**Context 205:** Context 205 is a ceramic drainpipe (PLATE 9c) found on top of context 210 (PLATE 8a), a stone drain pipe mentioned below. The pipe was located within the seawall and was intact when found. It had a diameter of 50cm. The inside had a series of soils but

A circular outlet (context 210) was recorded at level of 'row 2' and part of 'row 3' (PLATE 8a). A circular outlet had been cut in granite. The hole measured around 85cm in diameter. It is assumed that the drain broke and was reinforced with concrete during which part of the foundation stones were removed and replaced by a large natural stone capped by concrete (PLATE 8b). During another (?) modification the top of the old sewage stone drain was cut (PLATE 8a) and a grey glazed ceramic pipe (context 205) was placed on top of the old stone drain (PLATE 9c-d).

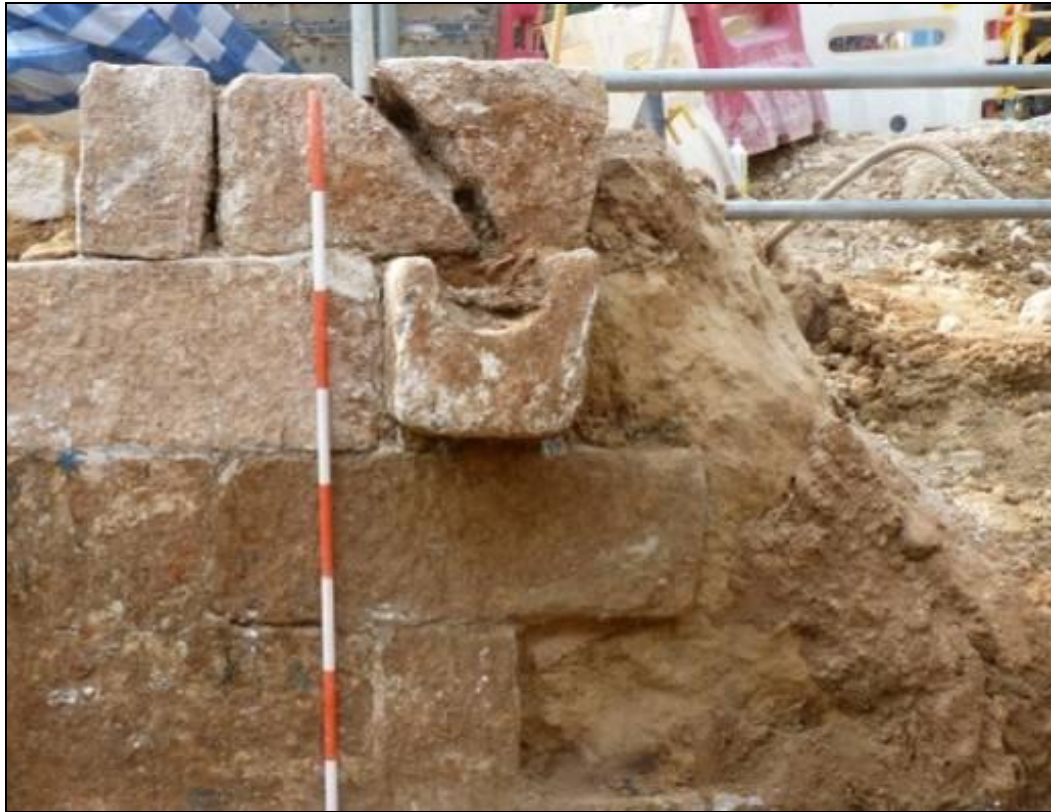
Plate 10 Stone run-off channel at row '7'; north facing section

A single run-off channel cut out in the granite at 'row 7' was also recorded. The channel continued inside the seawall fragment but no formal inlet was noticed (PLATE 10).

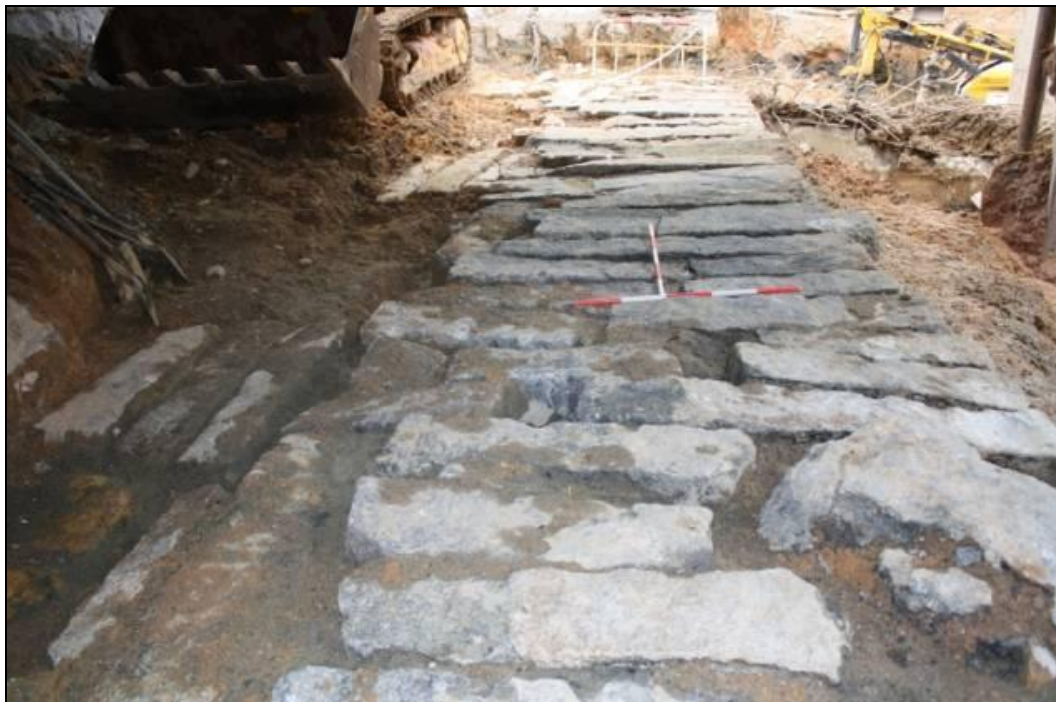
Plate 12e Seawall foundation: view of top of foundation looking west, notice buttress at rear

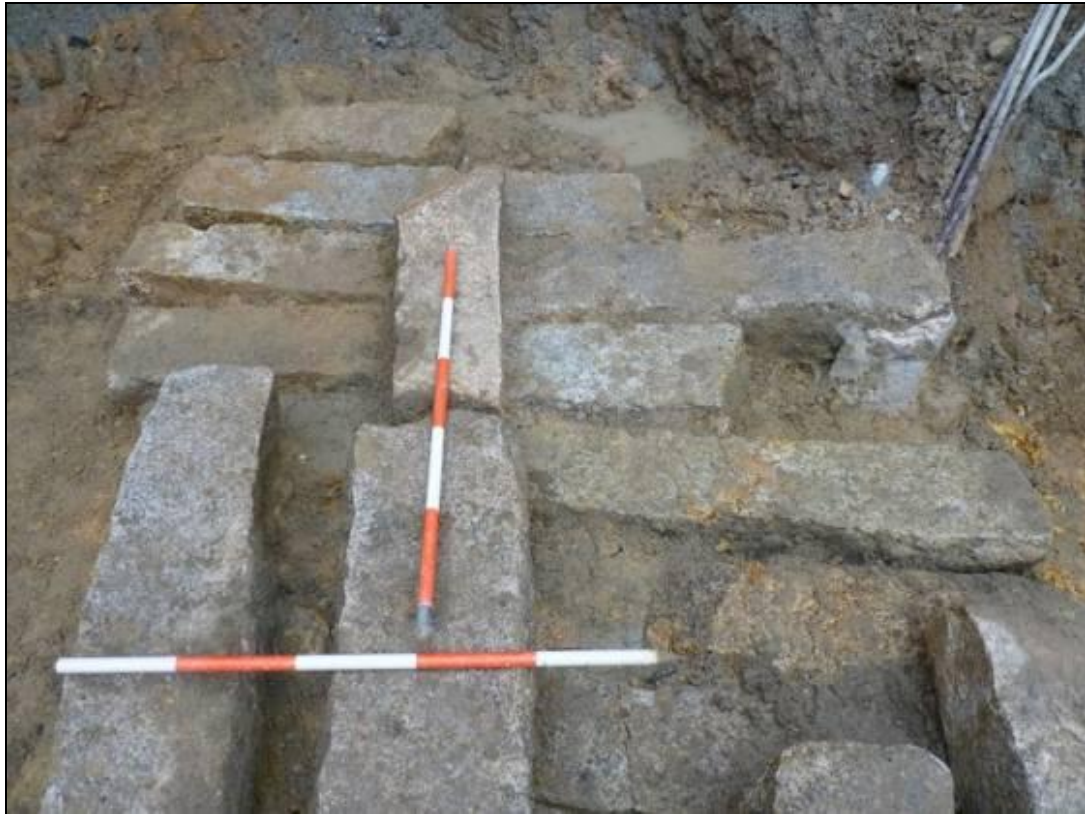
Plate 12j Seawall foundation: a simple bond

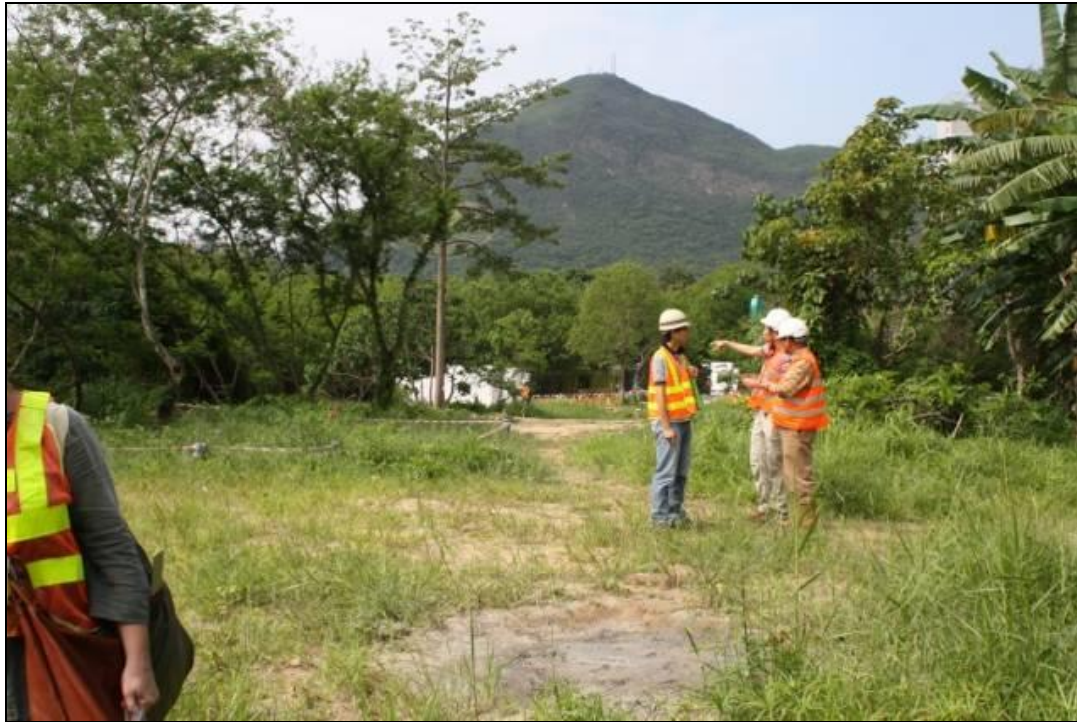
Plate 14a View of initial AWB visit to 902; view of flat area, looking south

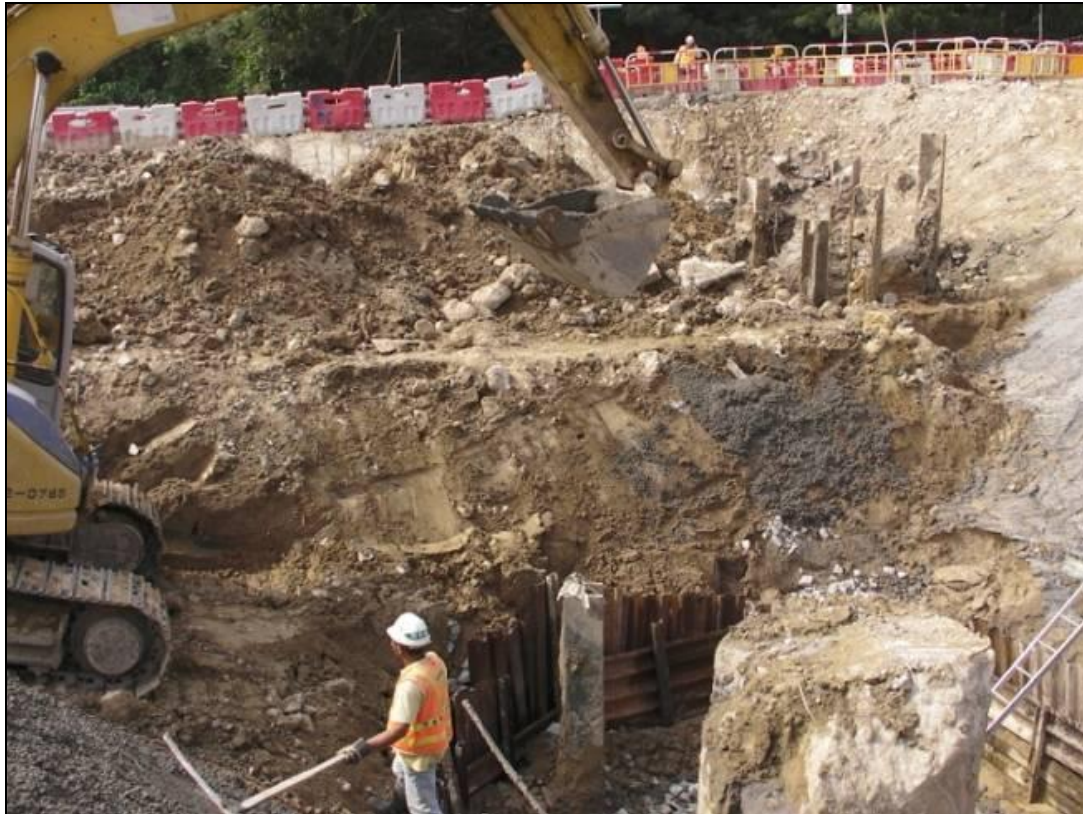
Excavations within the flat area were relatively shallow at the start of the AWB programme with relocation of trees and site formation. The shallow soil profiles indicated that the site was previously levelled and the upper layer was artificial. Further existing impact which had not been identifiable at desk-based stage was recorded in form of sheet piling at the base of the foot hills (PLATE 15).

Plate 15 Sheet piling of previous development at base of hill slope

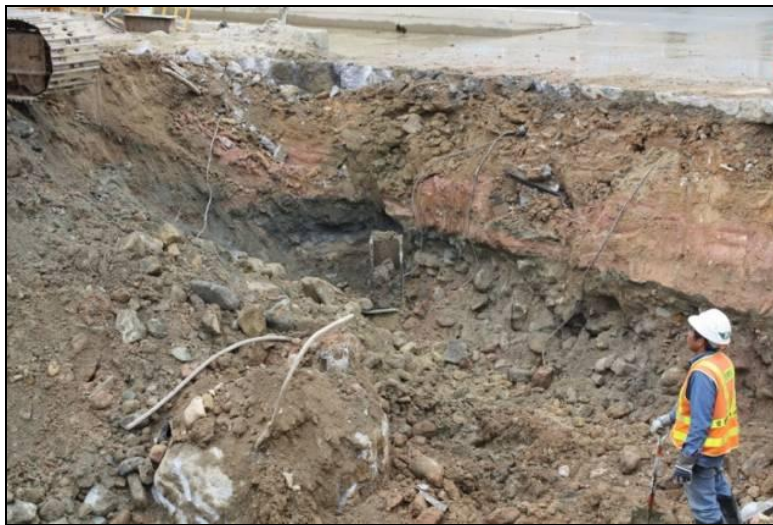
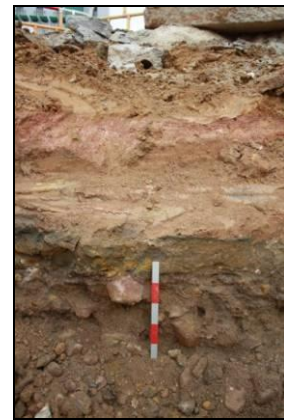
Plate 16 Area of finds: fill layers overlaying alluvial/fluvial deposit with lots of rounded and semi rounded cobbles.

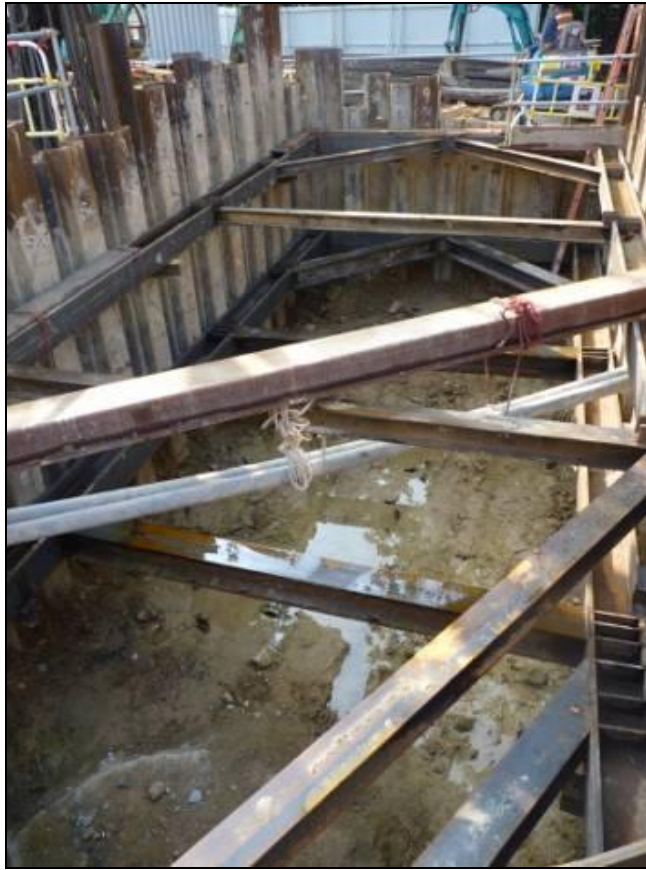
During the construction phase the exact location of Pier B4 (FIGURE 3) proved to affect an artificially raised area located immediately adjacent to a sparse woodland area to the west of the village. The pile cap excavations impacted around 2m of original soil deposit (PLATE 17). The soil consisted of well weathered alluvial sterile sands.

Plate 17a View of pile cap excavations at Site 10, Pier B4, looking west

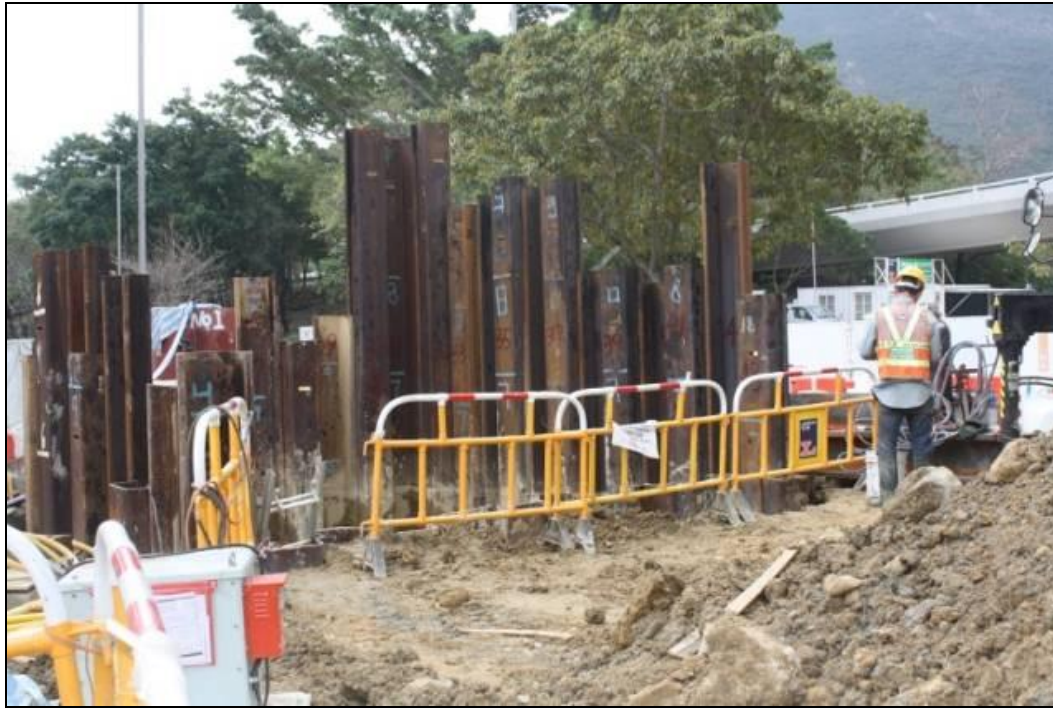
Pier B5 (FIGURE 3) was located within a traffic island and the area had recently been dug by water services department. The stratigraphy consisted of fill deposit overlaying well weathered alluvial soils. The alluvium was noted during the pile cap excavations at a depth of approximately 1.5-2 metres below the surface (PLATE 18).

Plate 18a View of pile cap excavation area and soils at Site 10, Pier B5

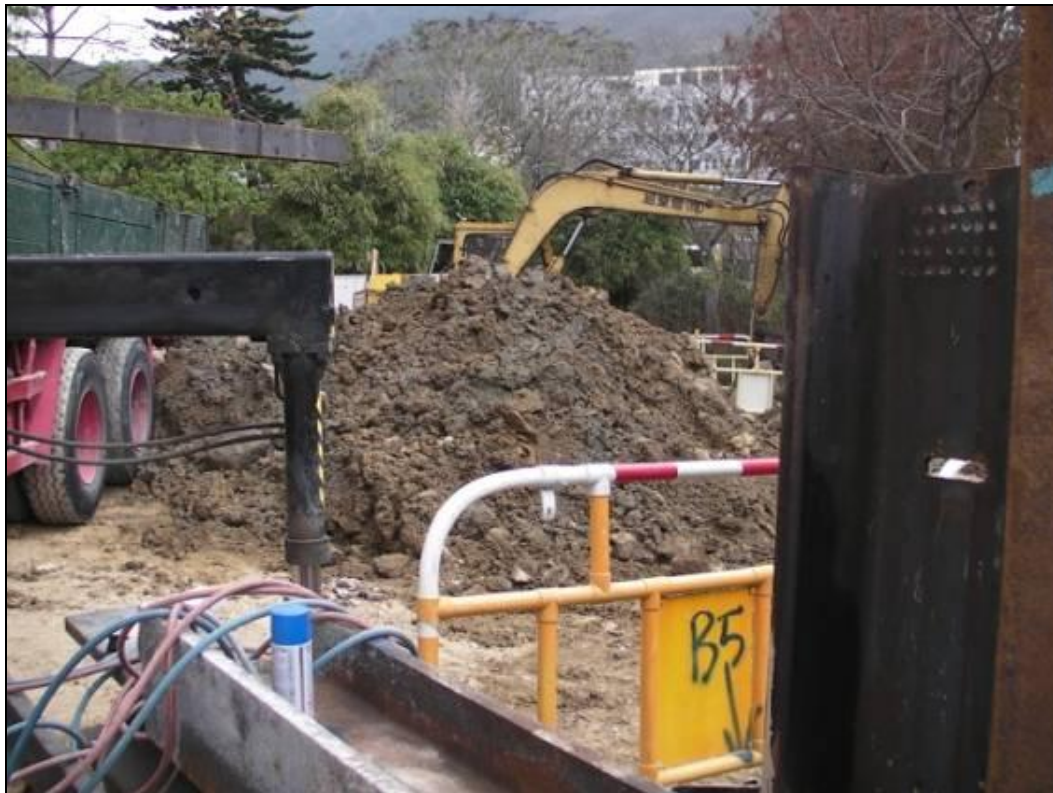
Plate 18b View of pile cap excavation area and soils at Site 10, Pier B5; looking north

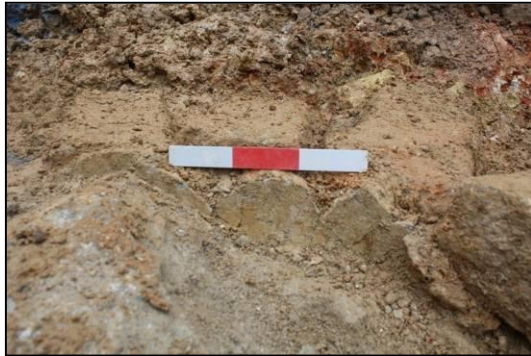
The mortar: The mortar was applied to the inner structure of the well. The mortar was made up of 3 layers, of which the inner 'layer' was pinkish while the outer layers were white. The mortar seemed to have been applied in a single event and there were no signs of maintenance. The thickness of the mortar ranged between 2 to 4cm. Samples were taken but have not been analysed.

Detail of mortar on the inside of the well

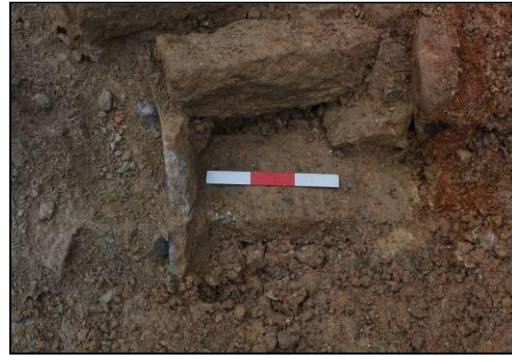
View of the mortar lining the granite blocks of the well

The wet mortar had been pushed into the cracks between the cut stones (PLATE 2a) and smoothed on the inside of the well. It can be presumed that it was utilized to seal the well and prevent contamination. The mortar did not continue to the bottom of the well but ended at approximately 0.7m from the bottom of the well which coincided with the end of the concrete infill (co.102) mentioned below. It assumed that this level was the original waterlevel mark.
