Archaeological Watching Brief for MTRC West Island Line

Final Watching Brief Report

**ARCHAEOLOGICAL ASSESSMENTS LTD.
September 2013**

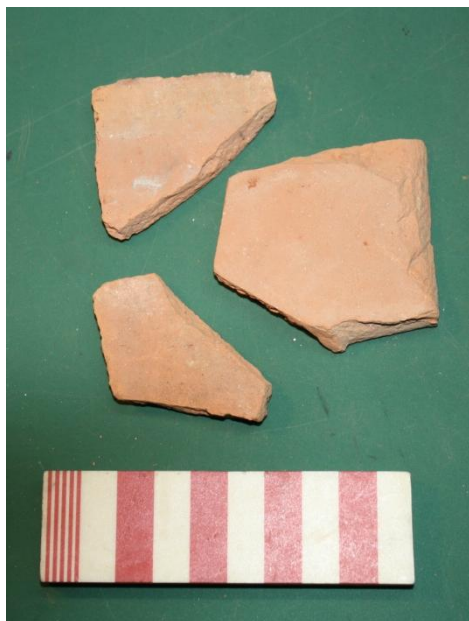
Plate 11.B.21 Photograph showing 3 tile fragments, undiagnostic in date, found within the foundation cut (104) for wall foundation 103.

The foundation trench for the wall [104] cut into pre-existing CDG fill [105] and had an east-west orientation. Apart from three undiagnostic red tile fragments (probably 20th-century in date) (Plate 11.B.21) within the foundation cut no other dateable material was noticed.

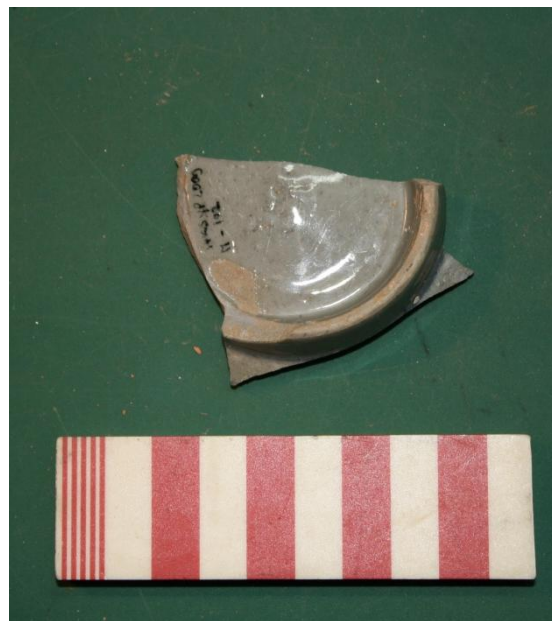
Plate 11.B.22 Photograph showing a provincial porcelain base sherd dated late 19th-century to 20th-century

The continuation of wall foundation [**WF103**] was noted in the Northwest corner of Site M (703) and it extended for some 11m west of where it was first discovered. During removal of hardcore layer [**102**], which sealed the wall foundation [**WF103**], a base sherd of late 19th-century to 20th-century provincial porcelain (Plate 11.B.22) was recovered.

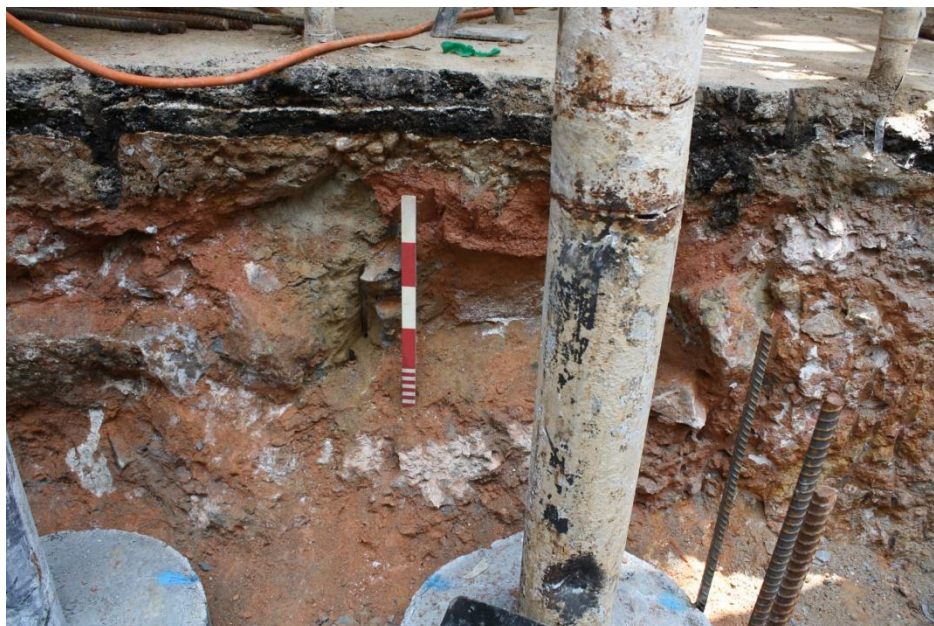
Plate 11.B.34 Photograph showing WF125; view of west facing elevation

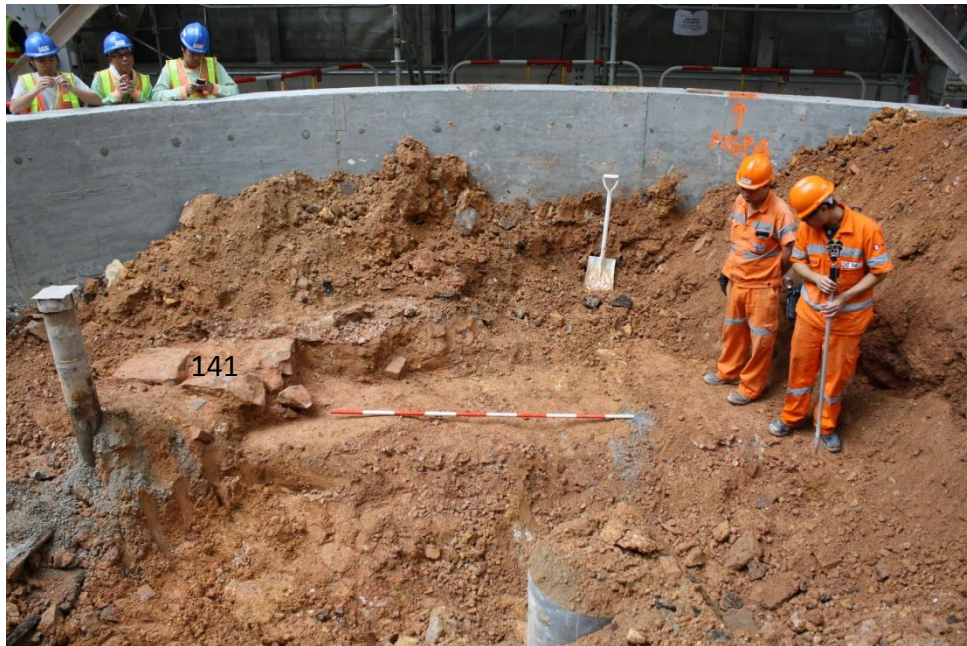
Plate 11.B.35 Photograph of WF 141; view looking east

The remains of a granite wall foundation and brick manhole [**WF141** and **MH142**] were first unearthed in the **Northwest corner** of the spoil basin area. The two lengths of granite wall foundation [**WF141**] were uncovered – one E-W orientated foundation at the western edge of the spoil basin and another 5m-long E-W orientated example, appeared to be the continuation of the one found the previous day. Few artefacts were found in the CDG fill (**140**) surrounding the structures (Plate 12.A.1); the finds consist of Qing to early modern materials. **MH142** is a more recent manhole structure.

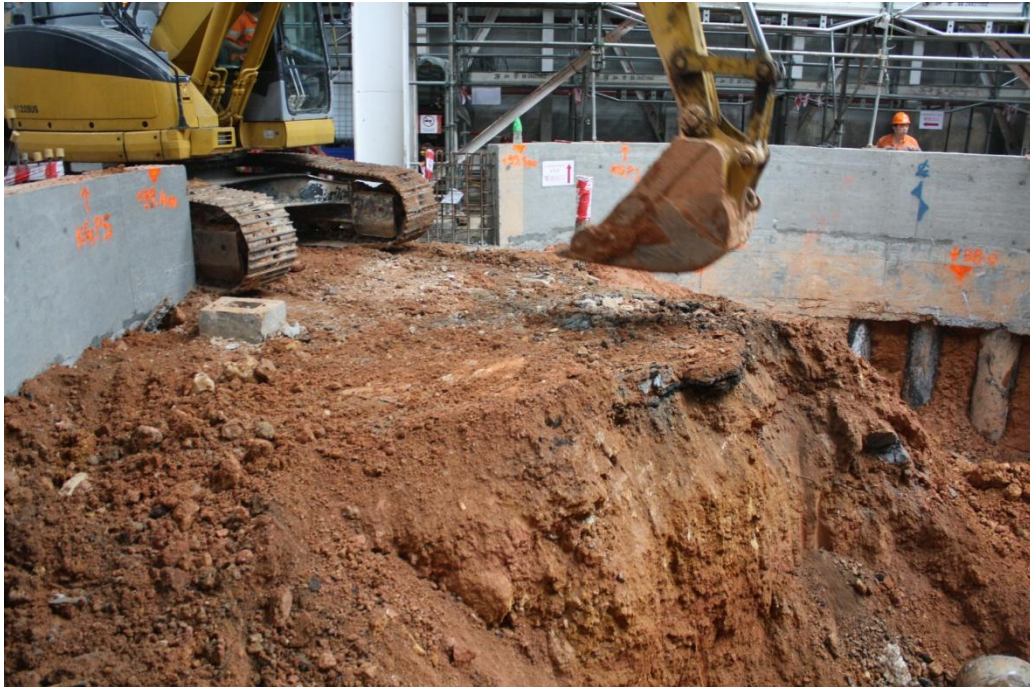
Plate 11.B.37 Photograph of the stratigraphy within the shaft as it is being excavated; view looking west

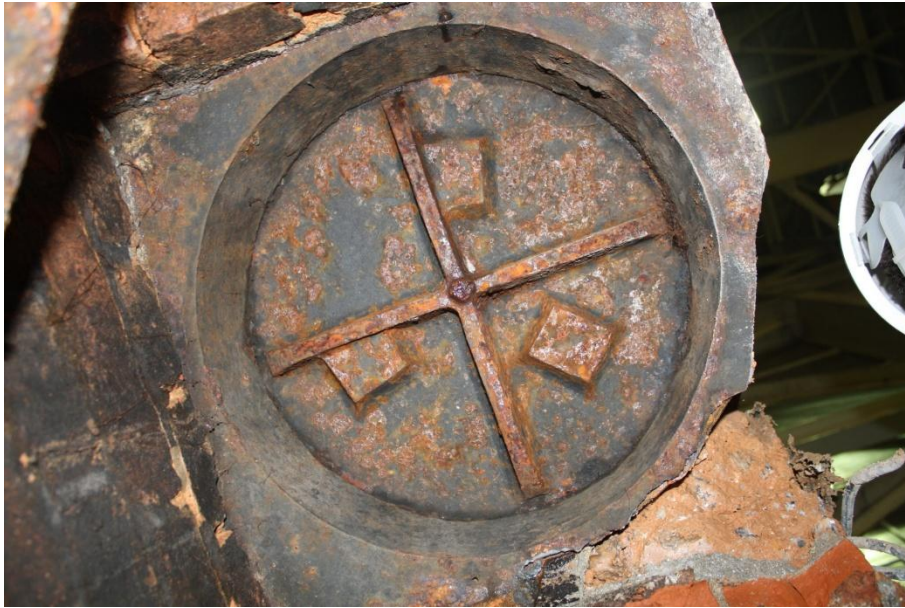
Plate 11.B.39 Photograph of the manhole cover of MH142

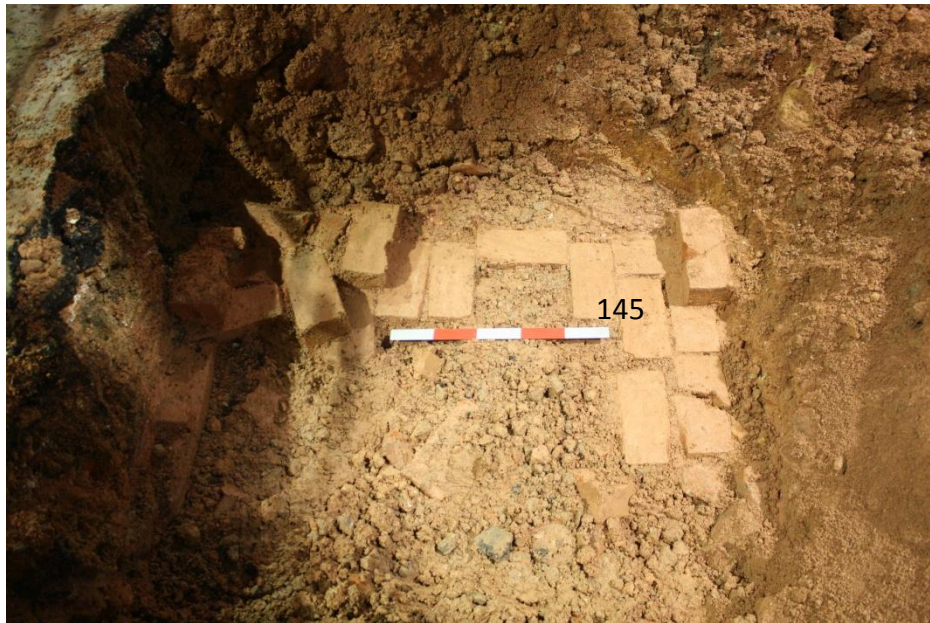
Plate 11.B.41 Photograph of brick foundation 145

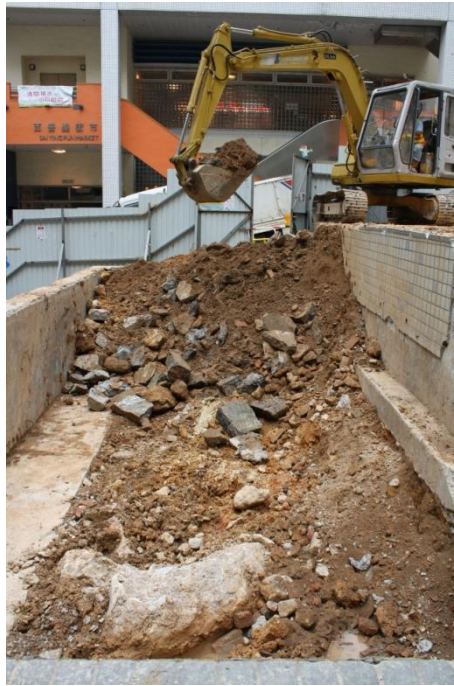
Plate 11.B.44 Photograph showing the deep sequence of disturbance at Site M2; view looking east
