Antiquities and Monuments Office

Study on Old Trails in Hong Kong - Final Study Report

February 2014

Study on Old Trails in Hong Kong: *Final Study Report*

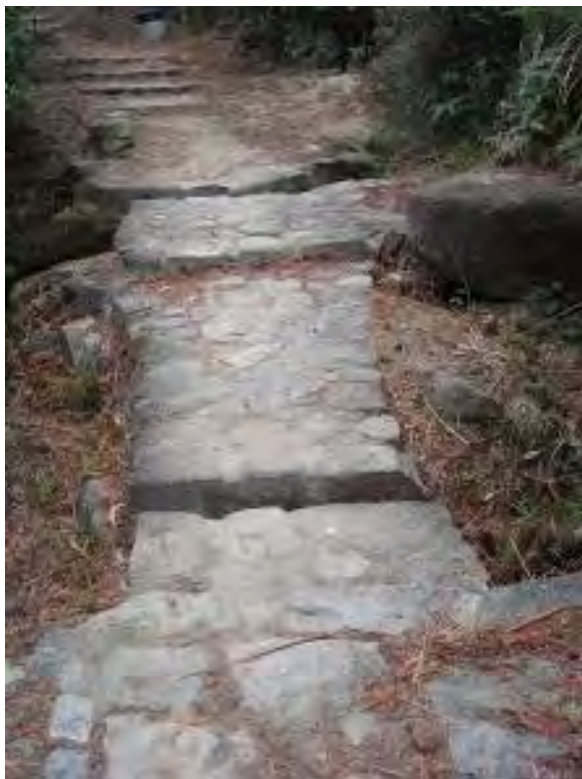
A reworked section with flat surfaced at Tai Lam Chung-Shap Pat Heung Trackway

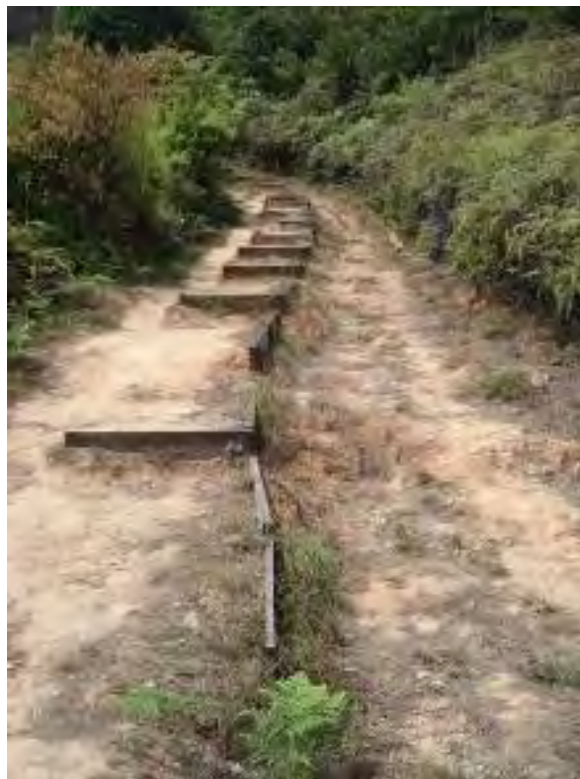
A reworked section with timber boards for reinforcement at Hok Tau Reservoir-Cheung Uk Boulder Trackway

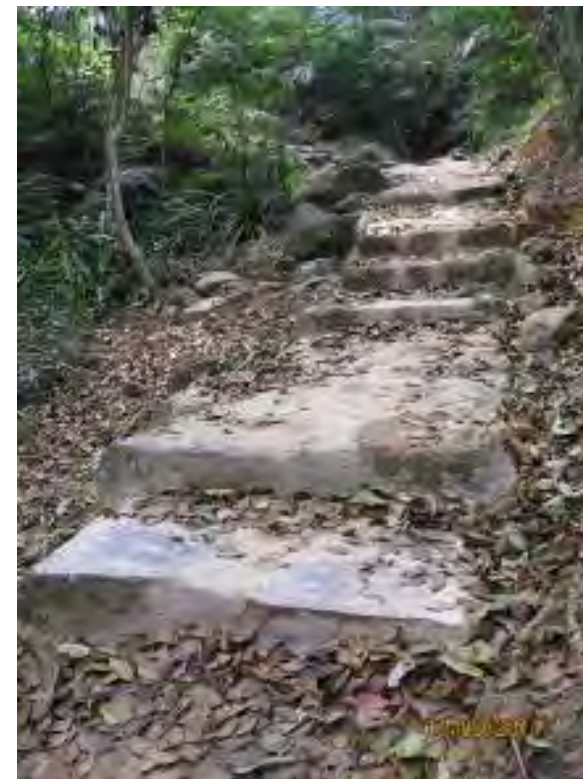
A reworked section at Pak Kong-Mui Tsz Lam Trackway

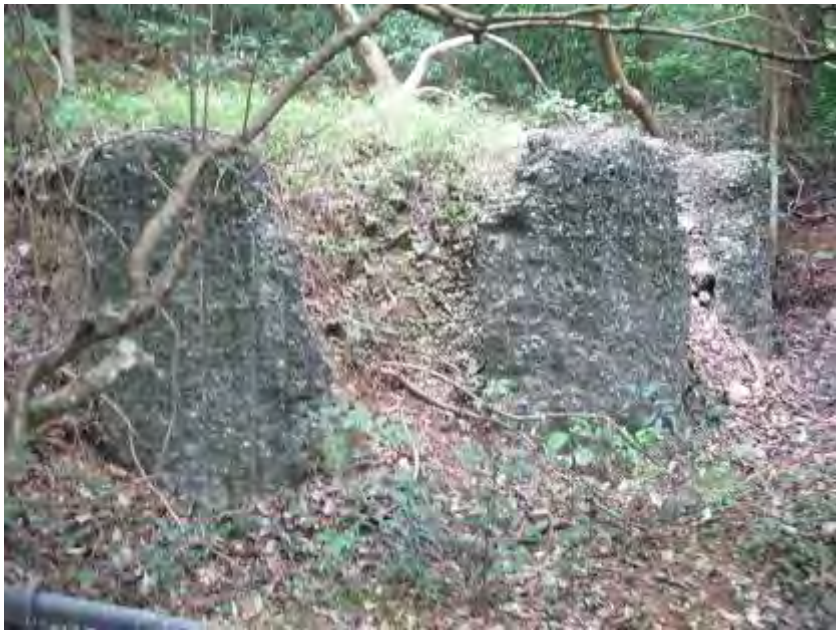
<p>Destroyed pillbox structure</p>

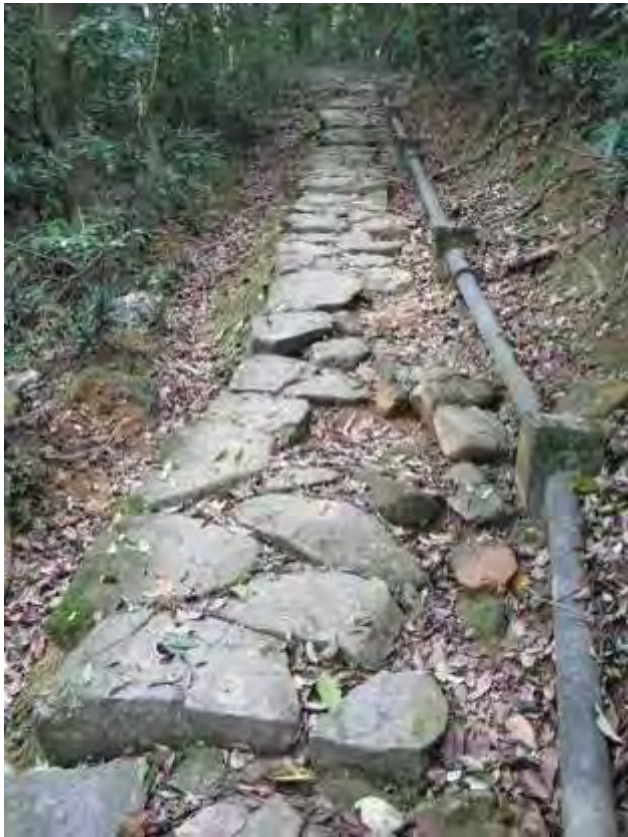
Photo Reference No.	Photographic Records	Photo Reference No.	Photographic Records
4

<p>A section with some loose boulders where repair work may be required. (view B to A)</p>		(Blank)

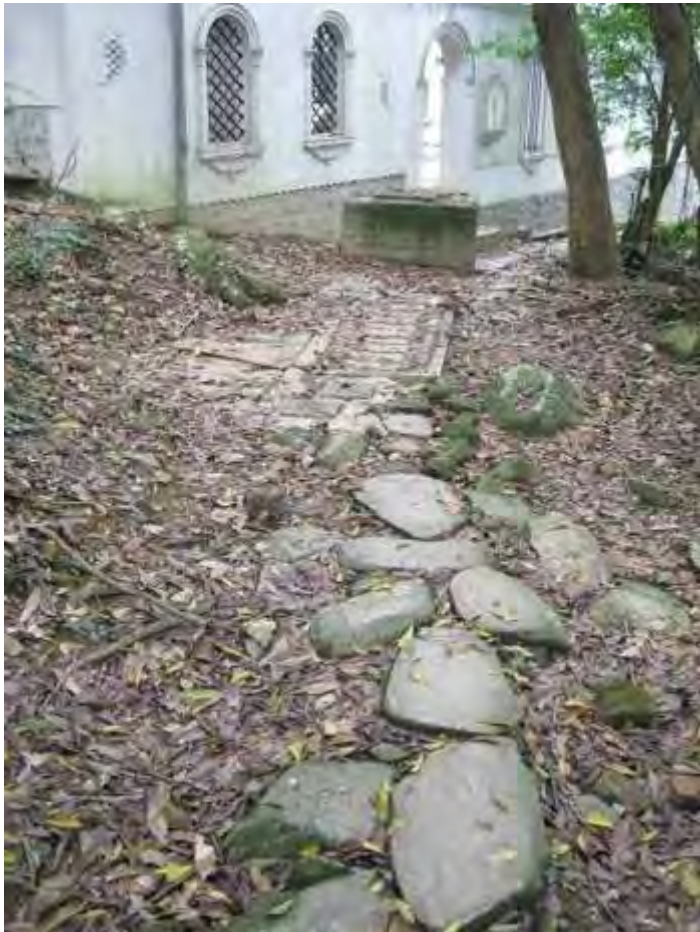
Photo Reference No.	Photographic Records	Photo Reference No.	Photographic Records
7

<p>Previous utilities construction work destroyed part of the boulder section. (view A to B)</p>	7

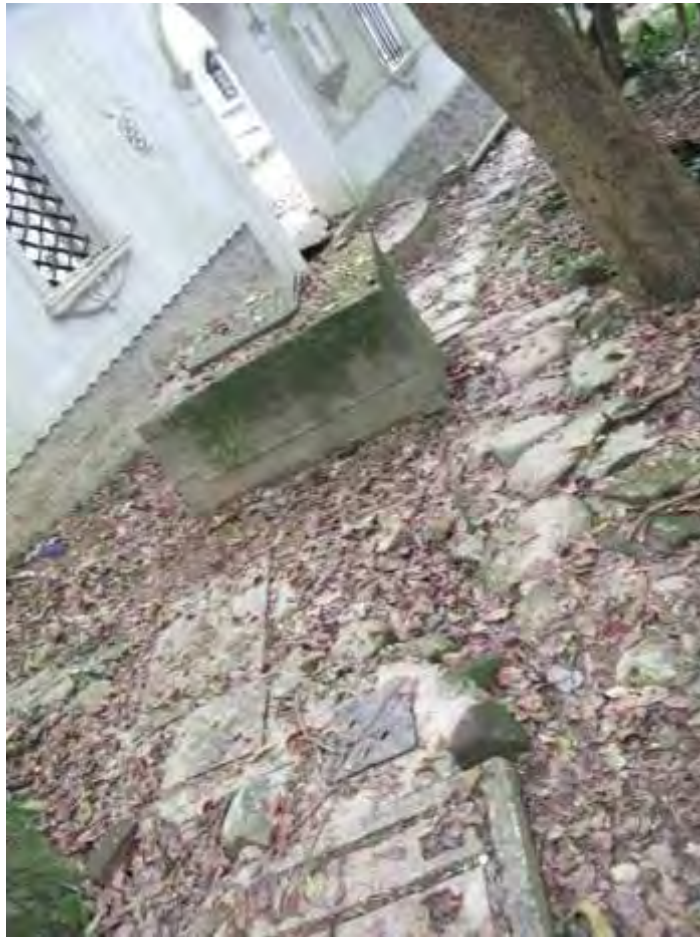
<p>Close up view of the destroyed part of the boulder section. (view A to B)</p>

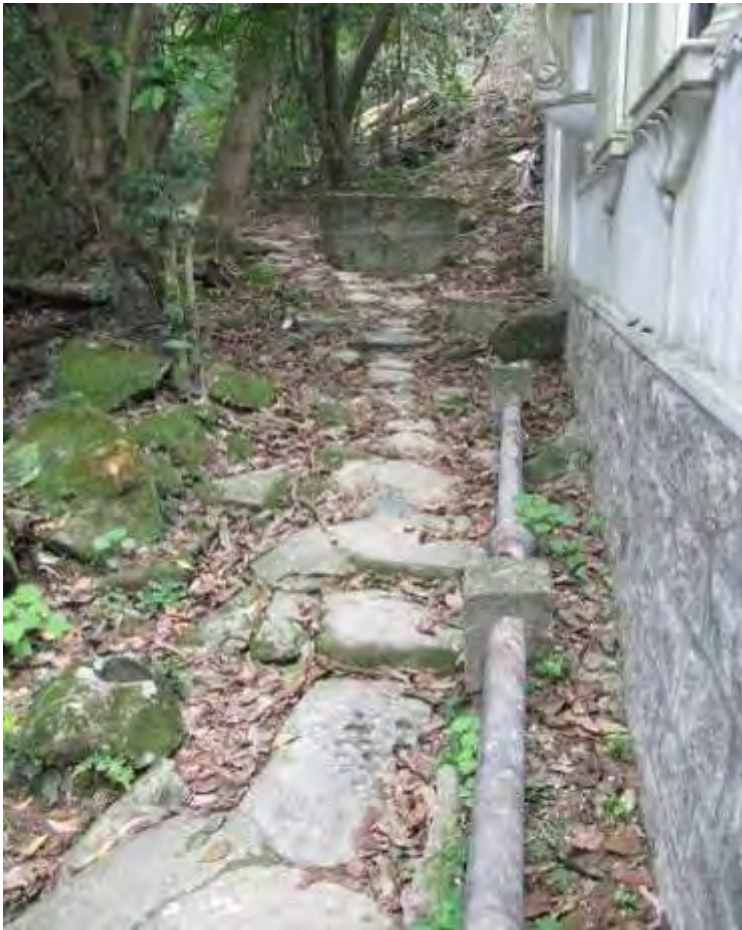
Photo Reference No.	Photographic Records	Photo Reference No.	Photographic Records
8

<p>General view of the boulder section toward the manhole along the section. (view B to A)</p>		(Blank)

Photo Reference No.	Photographic Records
F1	  <p data-bbox="309 911 2069 986">General view of the boundary wall of a western style building next to the boulder section. Window openings are in western style. The manhole as shown in the picture destroyed a section of the footpath.</p>

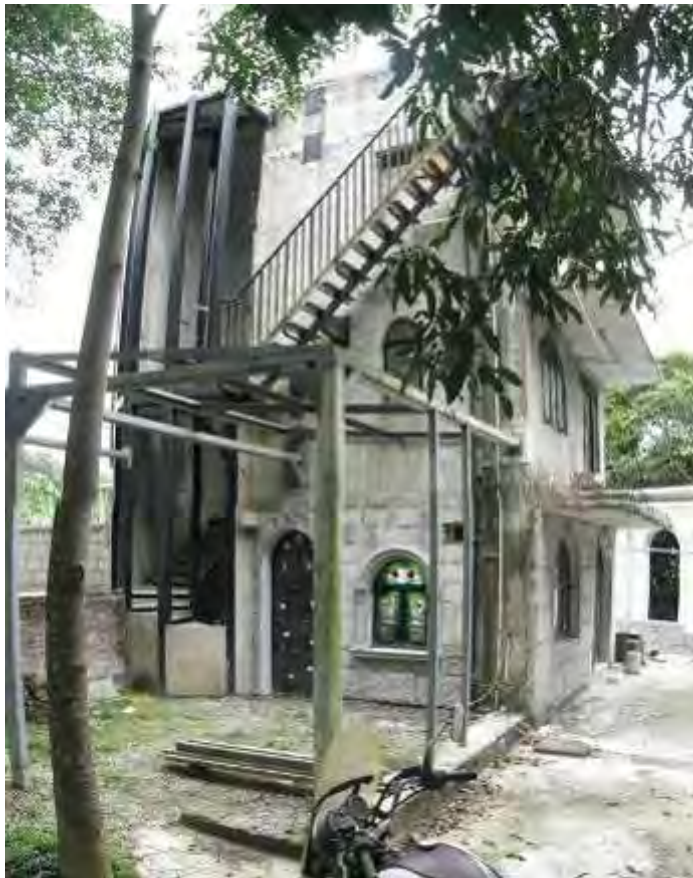
<p>General view of the building. Half the building has been demolished - the remaining building is supported by metal beams and columns. The building has art nouveau designed leadlight windows and arches.</p>

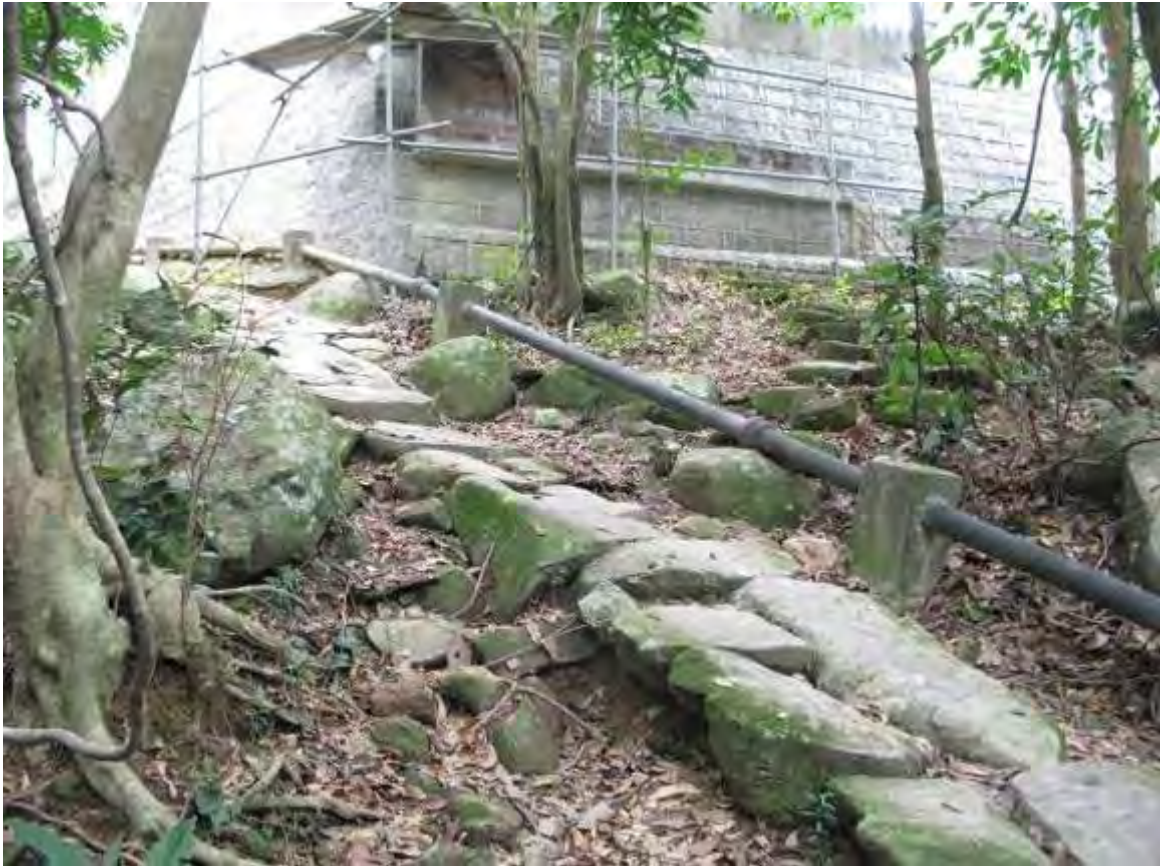
<p data-bbox="692 1177 1686 1214">View from the boulder section towards the east corner of the boundary wall.</p>

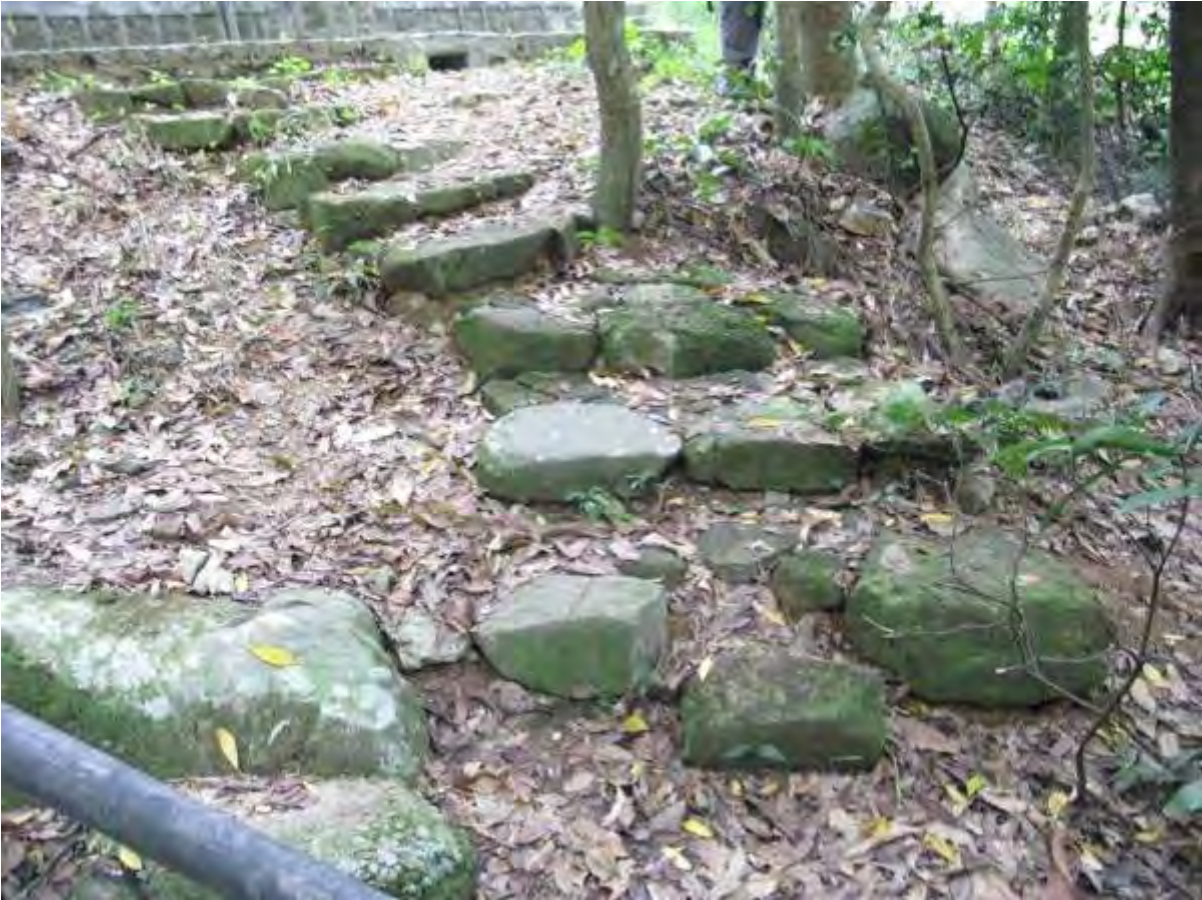
<p data-bbox="719 1246 1659 1283">Boulder steps leading to the edge of the northeast facing boundary wall.</p>

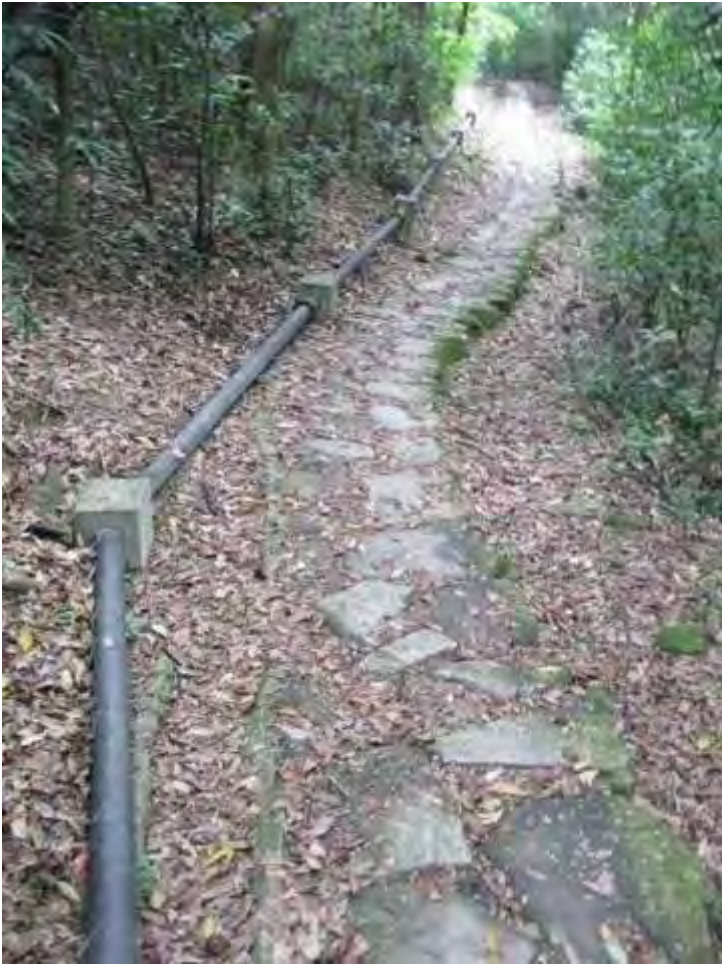
<p>Typical view of this boulder section. (view A to B)</p>		(Blank)

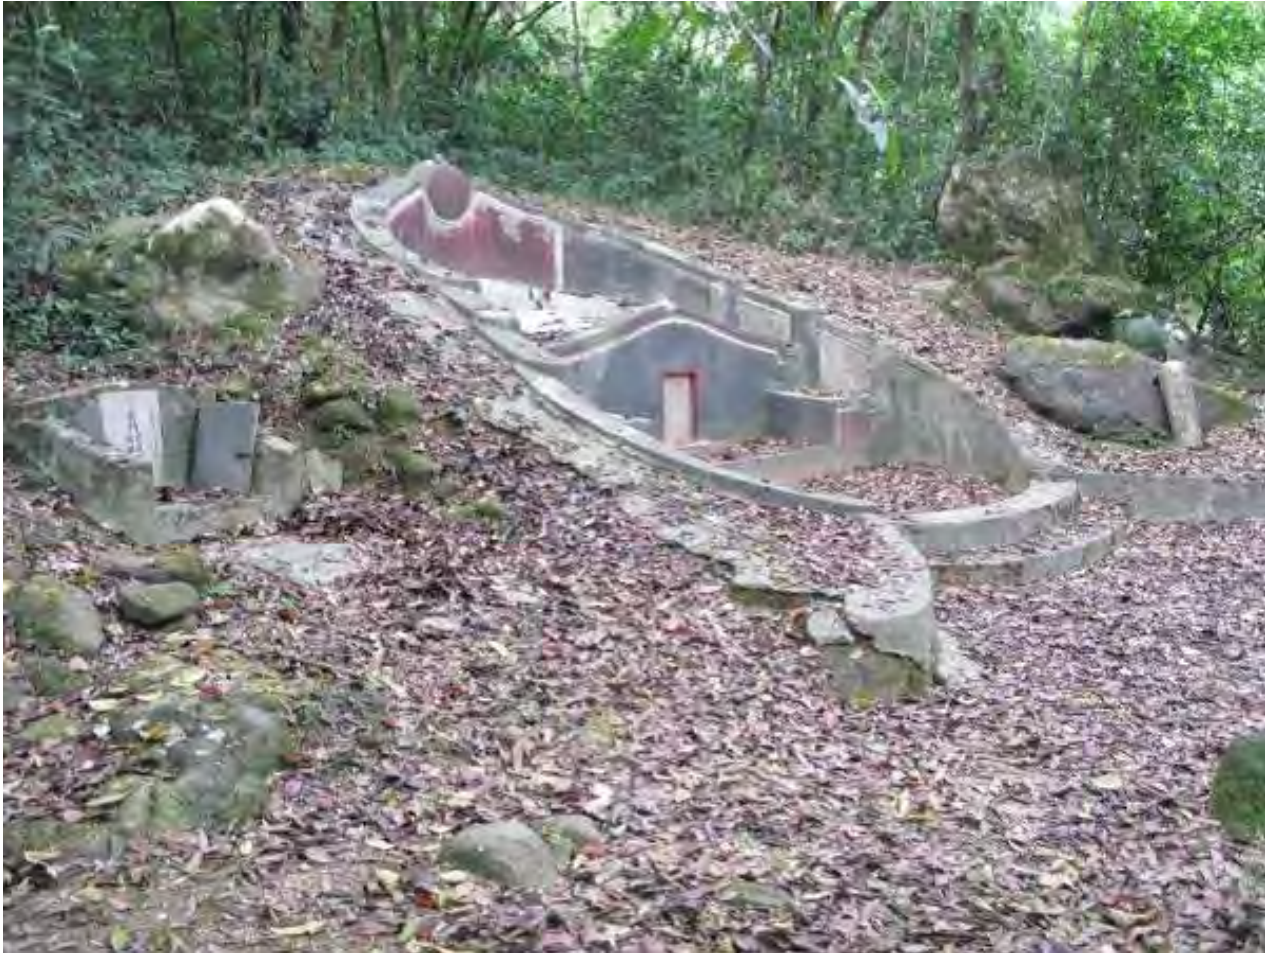
<p data-bbox="542 1230 1834 1264">General view of graves identified adjacent to the boulder section. The graves are northeast facing.</p>

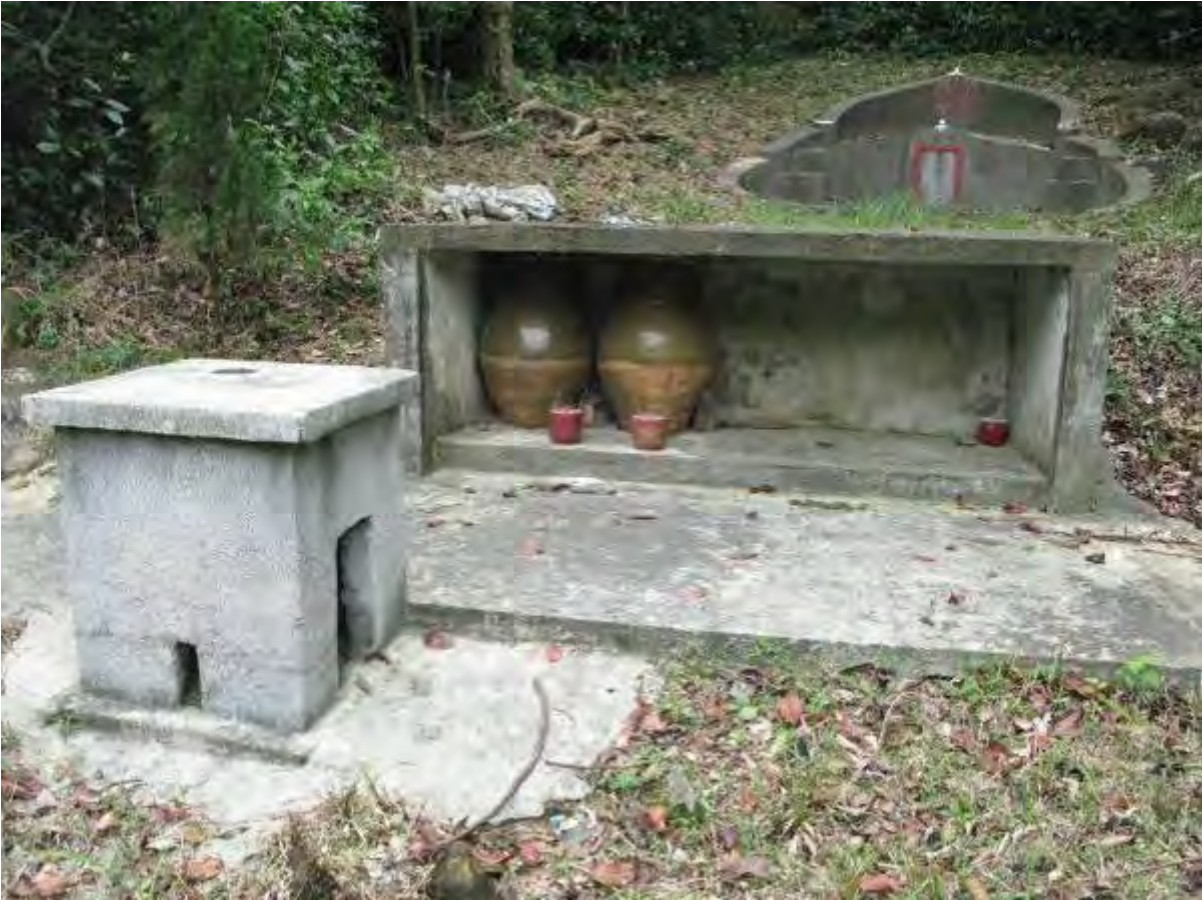
<p data-bbox="465 1246 1912 1283">General view of grave and urn identified adjacent to the boulder section. The grave/urns are northeast facing.</p>

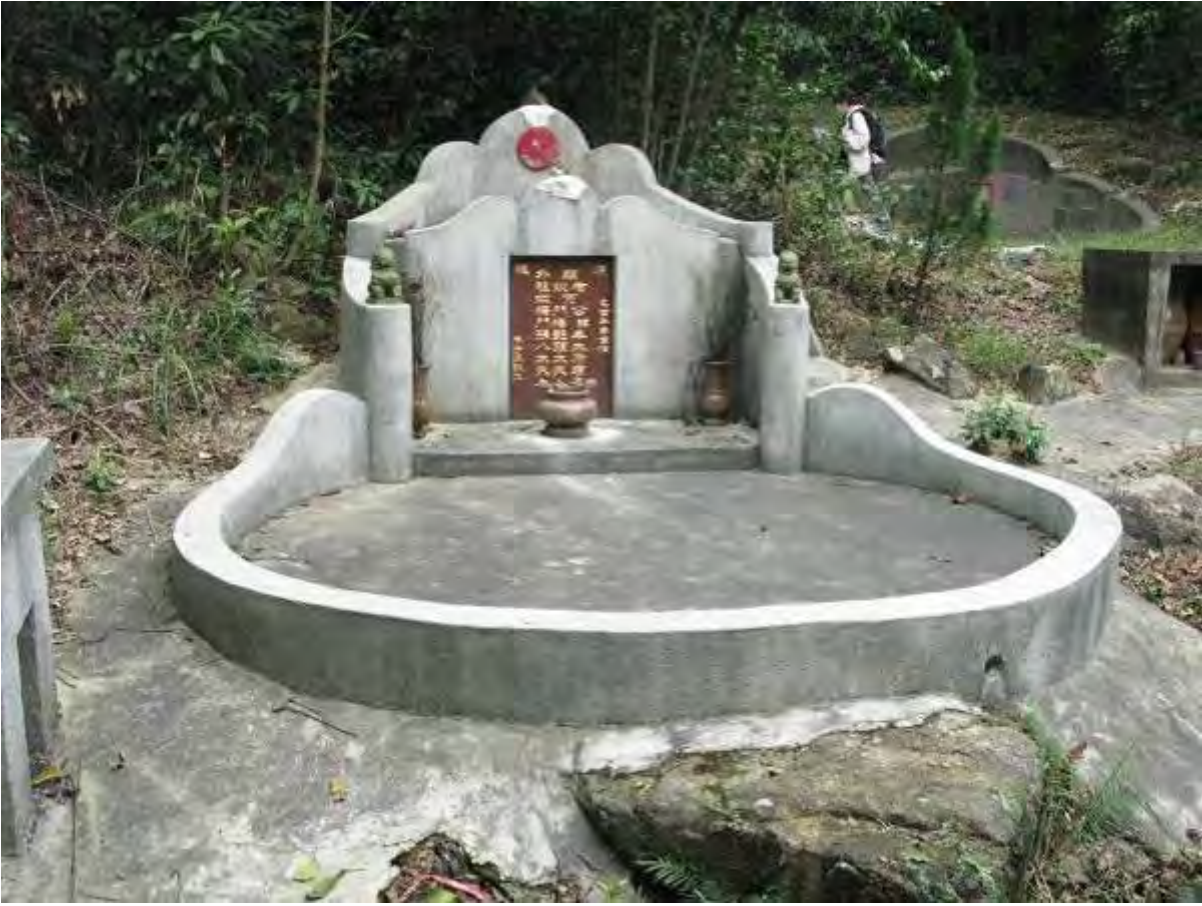
<p data-bbox="568 1177 1812 1214">General view of grave identified adjacent to the boulder section. The grave is northeast facing.</p>

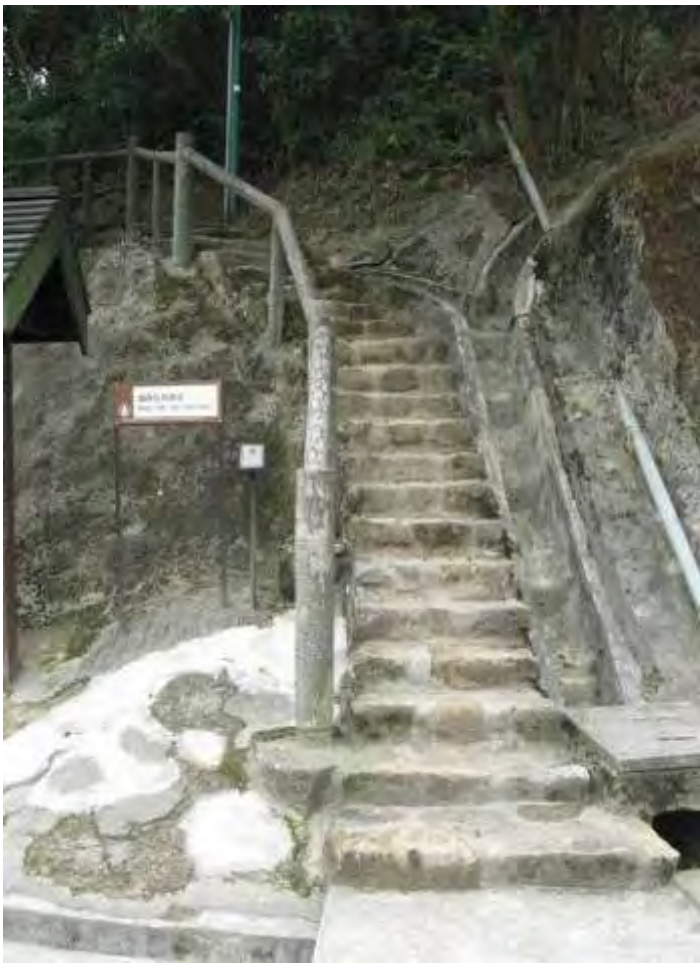
<p>Entrance/Exit steps toward the boulder section constructed by AFCD to/from Tai Lam Wu Road (大藍湖路). (view B to A)</p>		(Blank)

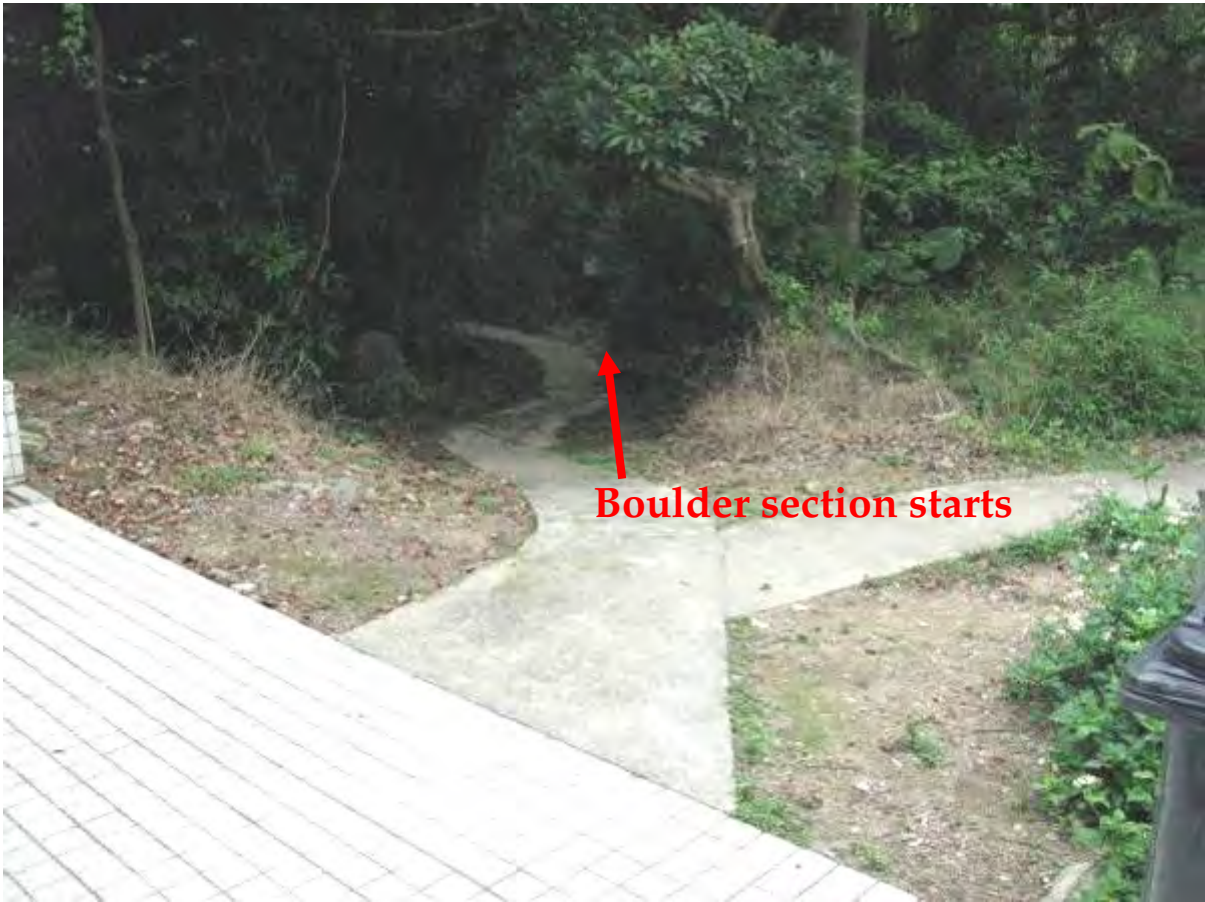
<p data-bbox="593 1220 1794 1257">Entrance/Exit from a pavilion by the Tai Lam Wu Road to the boulder section. (view A to B)</p>

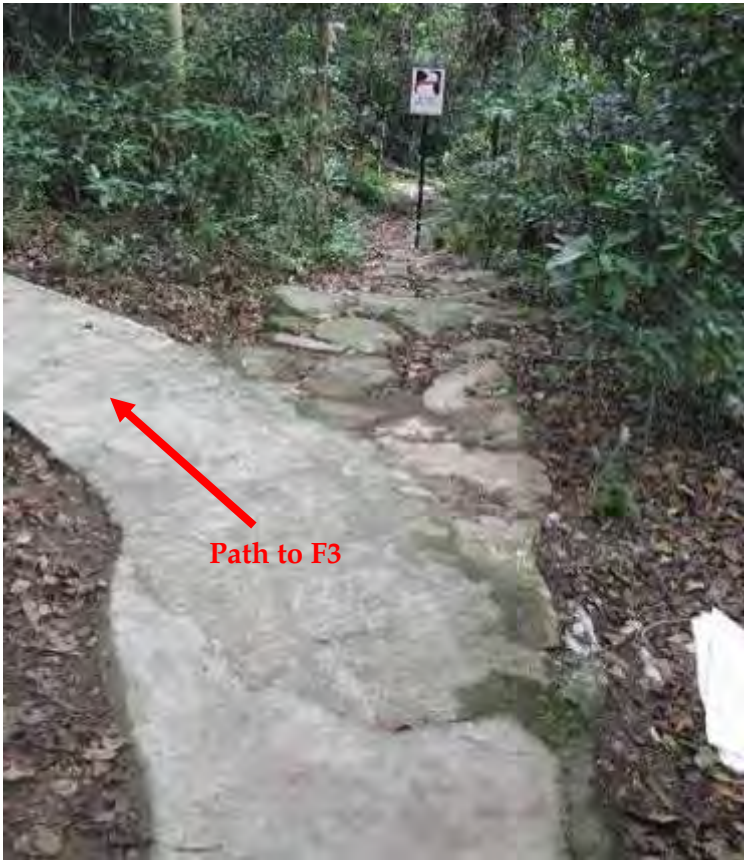
<p>Boulder section partly covered by a concrete path leading to F3. A warning sign "Road Closed" has been erected to discourage access to this boulder section. (view A to B)</p>	F3

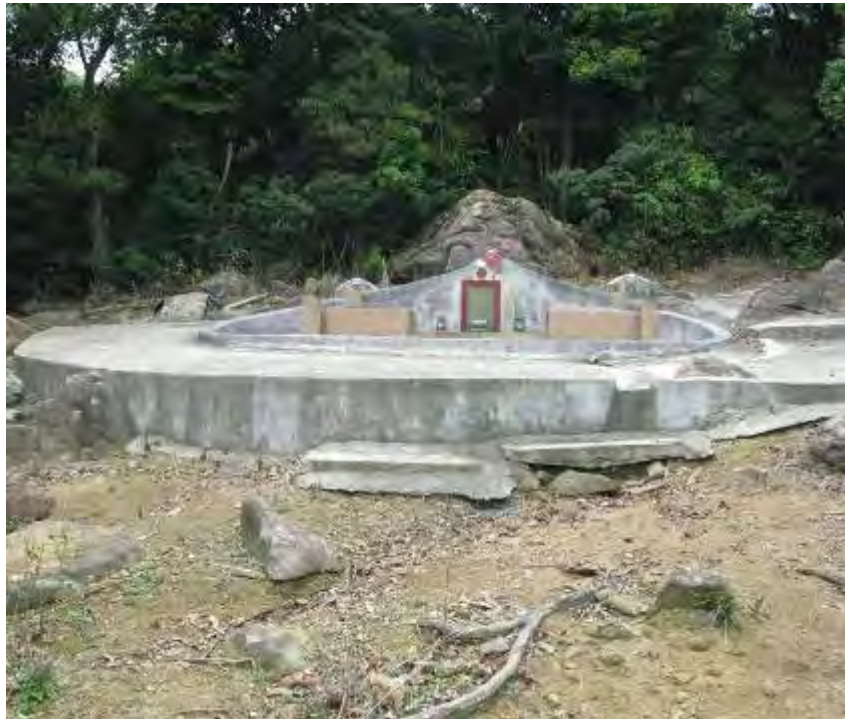
<p>General view of grave identified adjacent to the boulder section. The grave is east facing.</p>

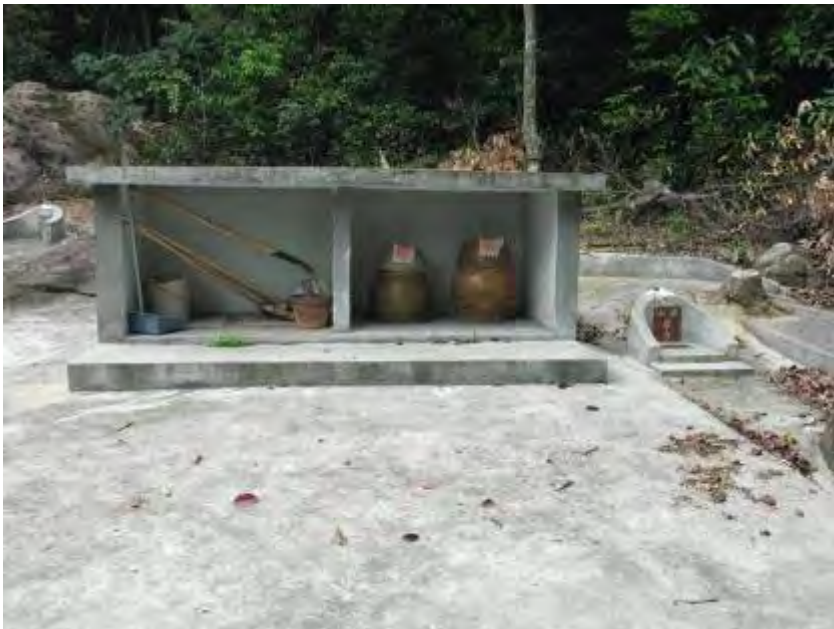
<p>General view of urn identified adjacent to the boulder section. The urn is east facing.</p>	14

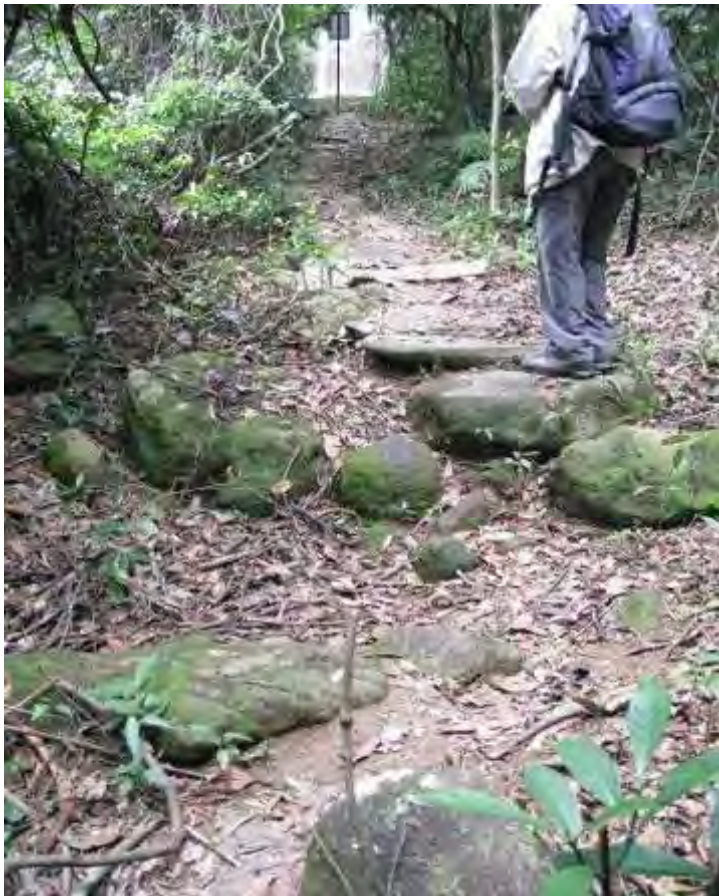
<p>Boulder section (viewing back to Tai Lam Wu Road from the boulder path, view B to A)</p>

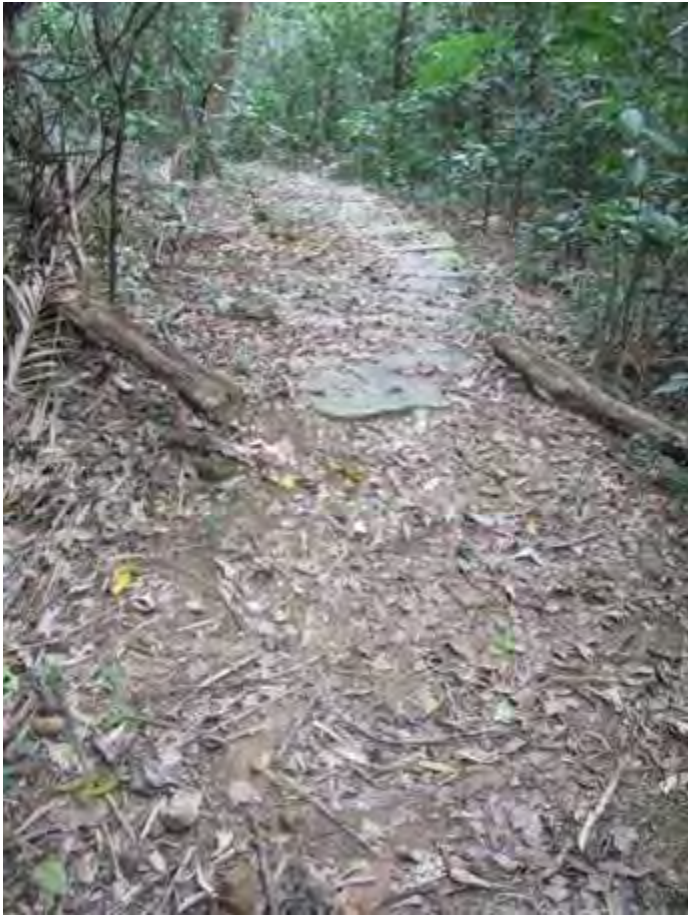
<p>Occasional short section without stone (probably destroyed). (view A to B)</p>	16

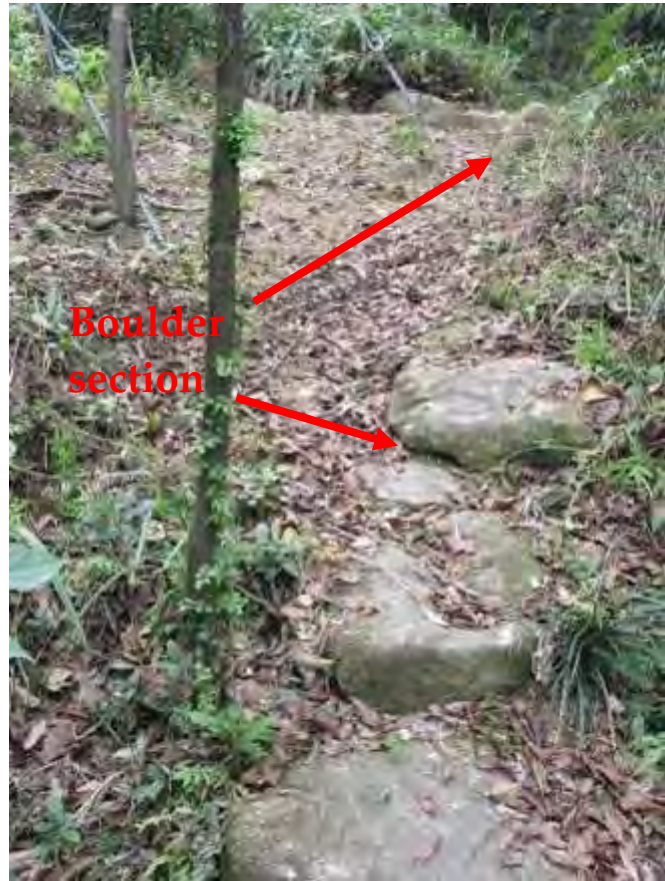
<p>Damaged part of the boulder section probably due to the construction of a cable tower supporting overhead electric cables. (view B to A)</p>

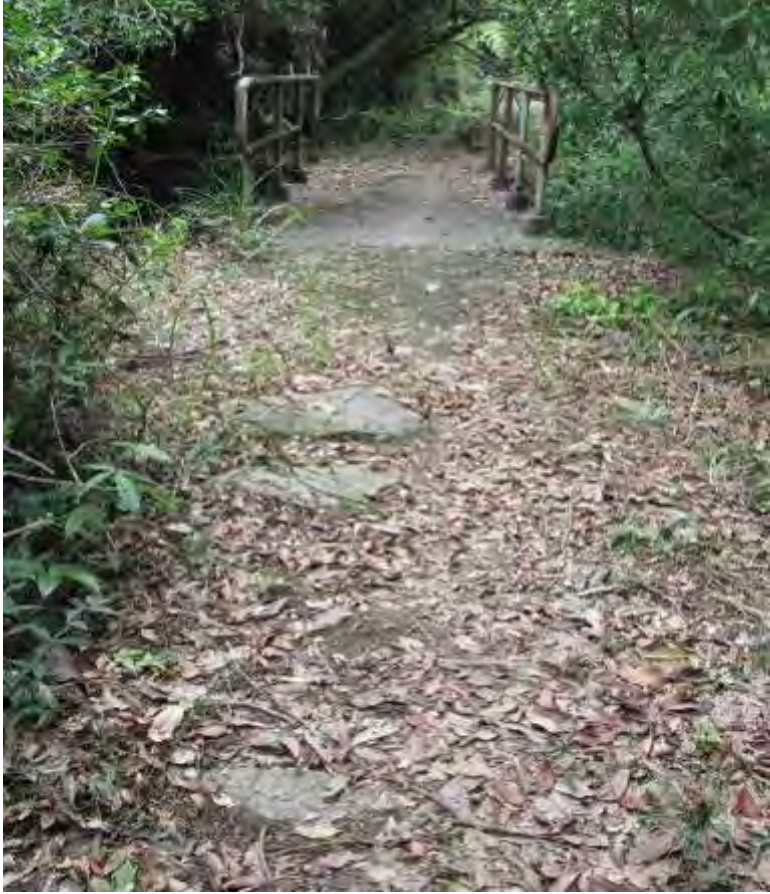
<p>Concrete built bridge with stone blocks supports. (view before crossing the bridge, view A to B)</p>		Blank.

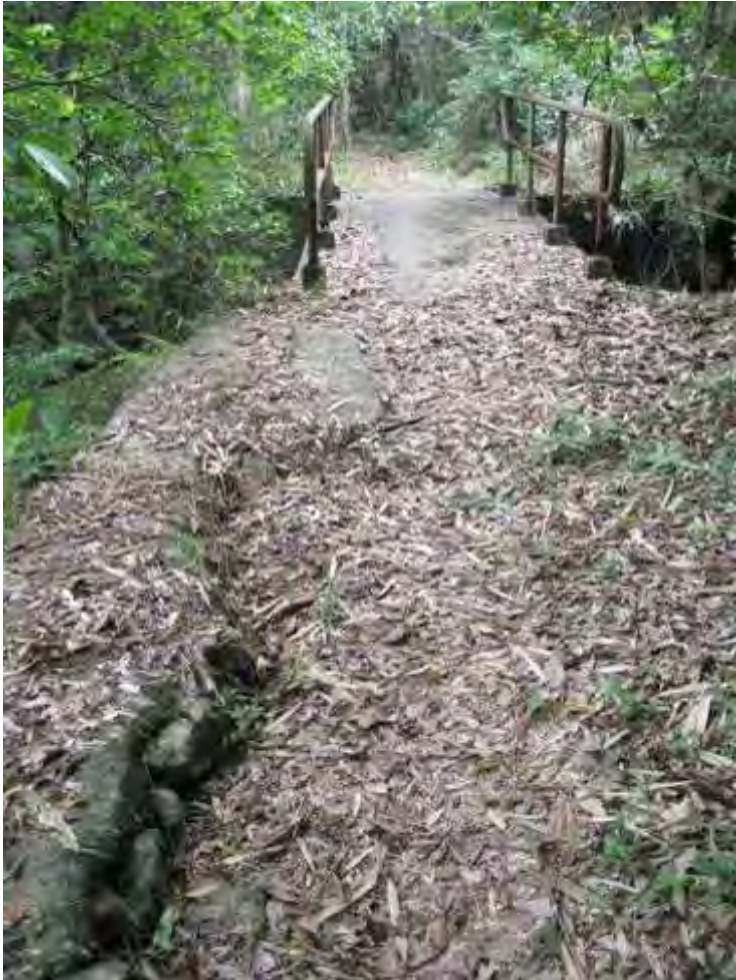
<p>View towards a modern bridge (F4), view B to A.</p>	18

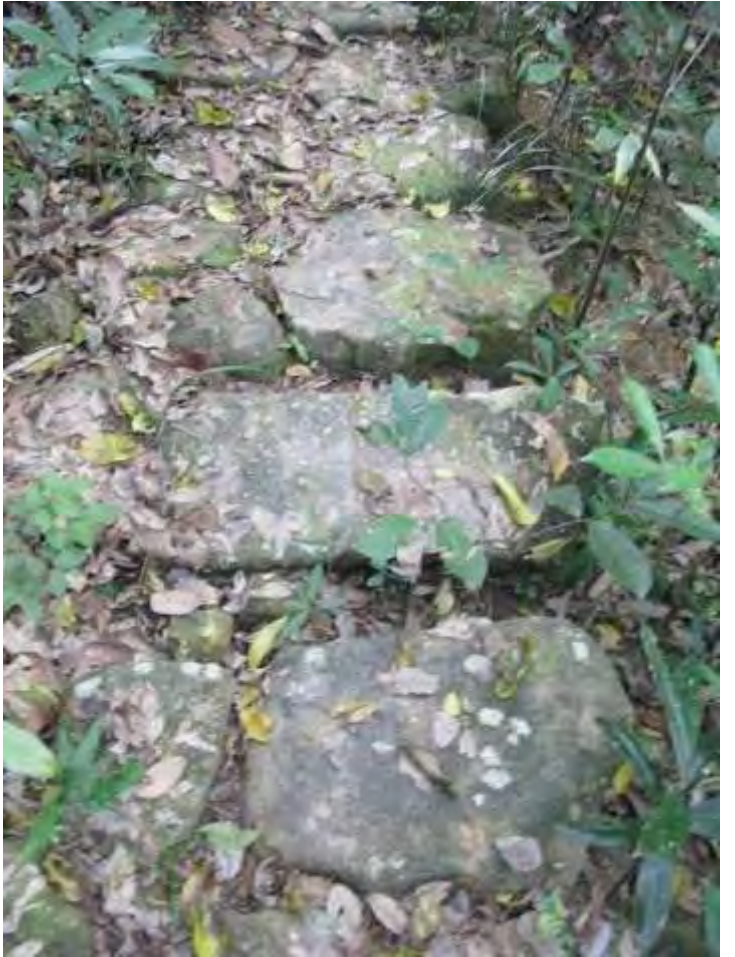
<p>Typical boulder section view in this section.</p>

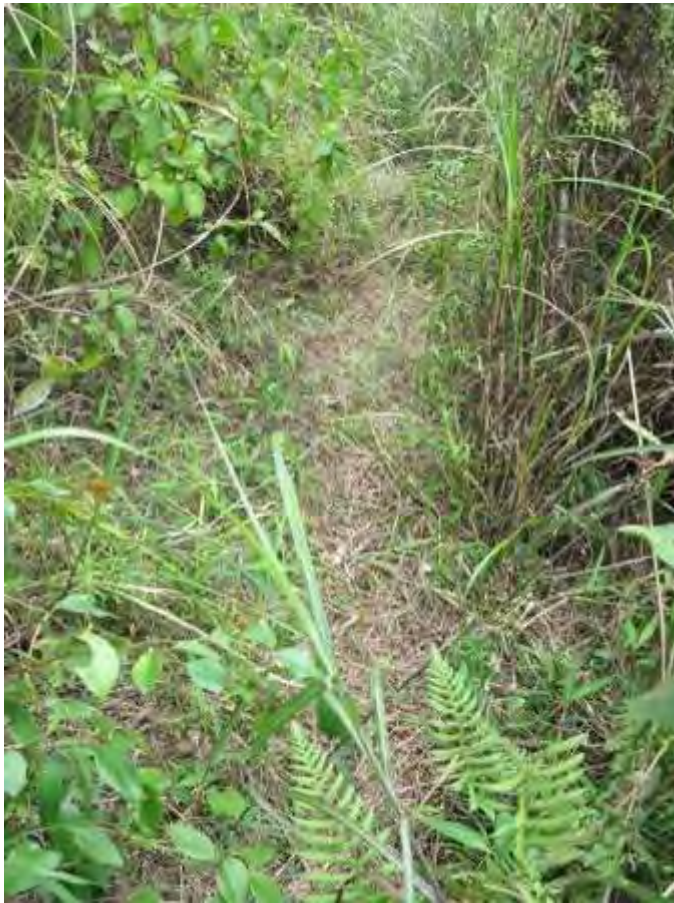
<p>Typical boulder section view in this section mostly covered by abundant vegetation.</p>

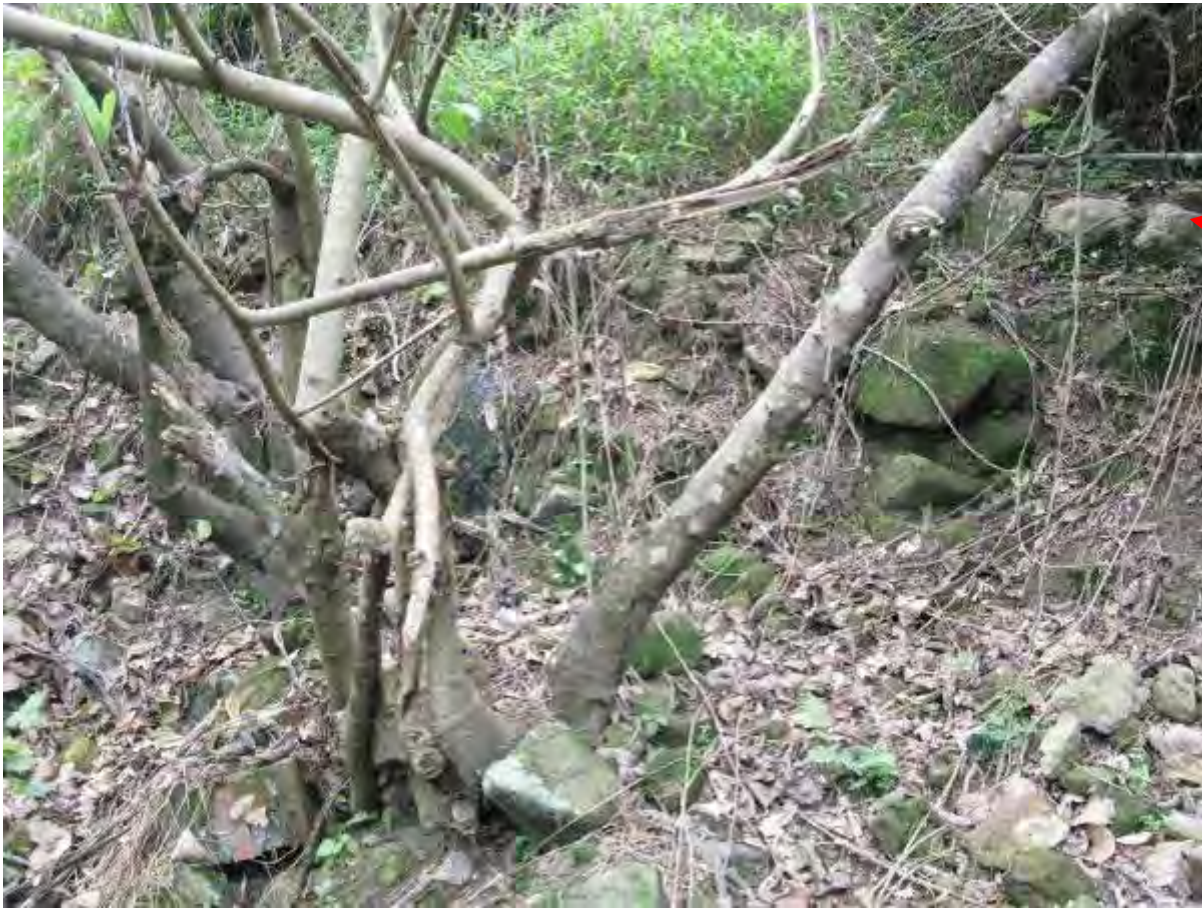
</div> <p data-bbox="1955 523 2116 619">Boulder section</p> <p data-bbox="288 1225 2092 1302">This boulder section is heavily covered by overgrown vegetation where walking on the footpath was not possible. Surveyors need to find alternative route adjacent to the footpath to pass through this section. (View from east to west toward the boulder section).</p>

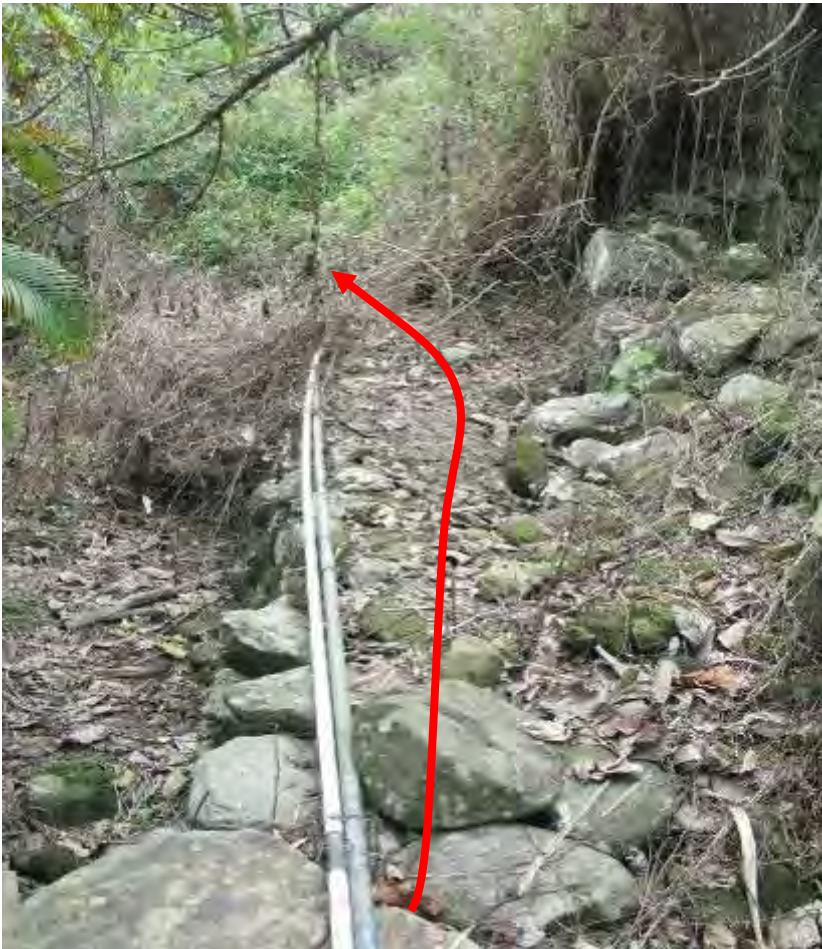
<p>Boulder section with utilities running on top and covered with abundant vegetation. (View B to A).</p>		(Blank)
