Antiquities and Monuments Office

Study on Old Trails in Hong Kong - Final Study Report

February 2014

Study on Old Trails in Hong Kong: *Final Study Report*

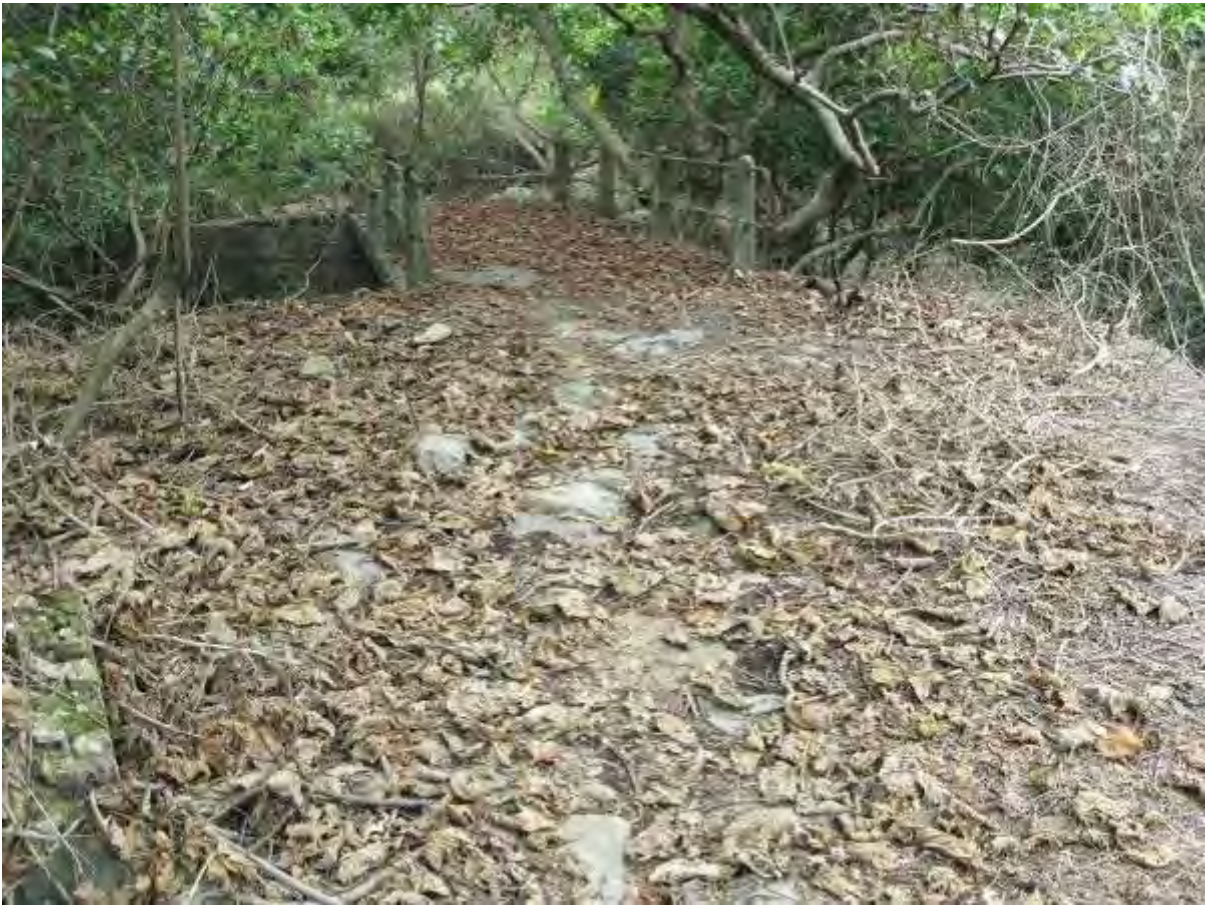
<p data-bbox="412 1177 1960 1214">Concrete surfaced bridge with stone blocks supports. (View before crossing the first bridge with railings, view A to B)</p>

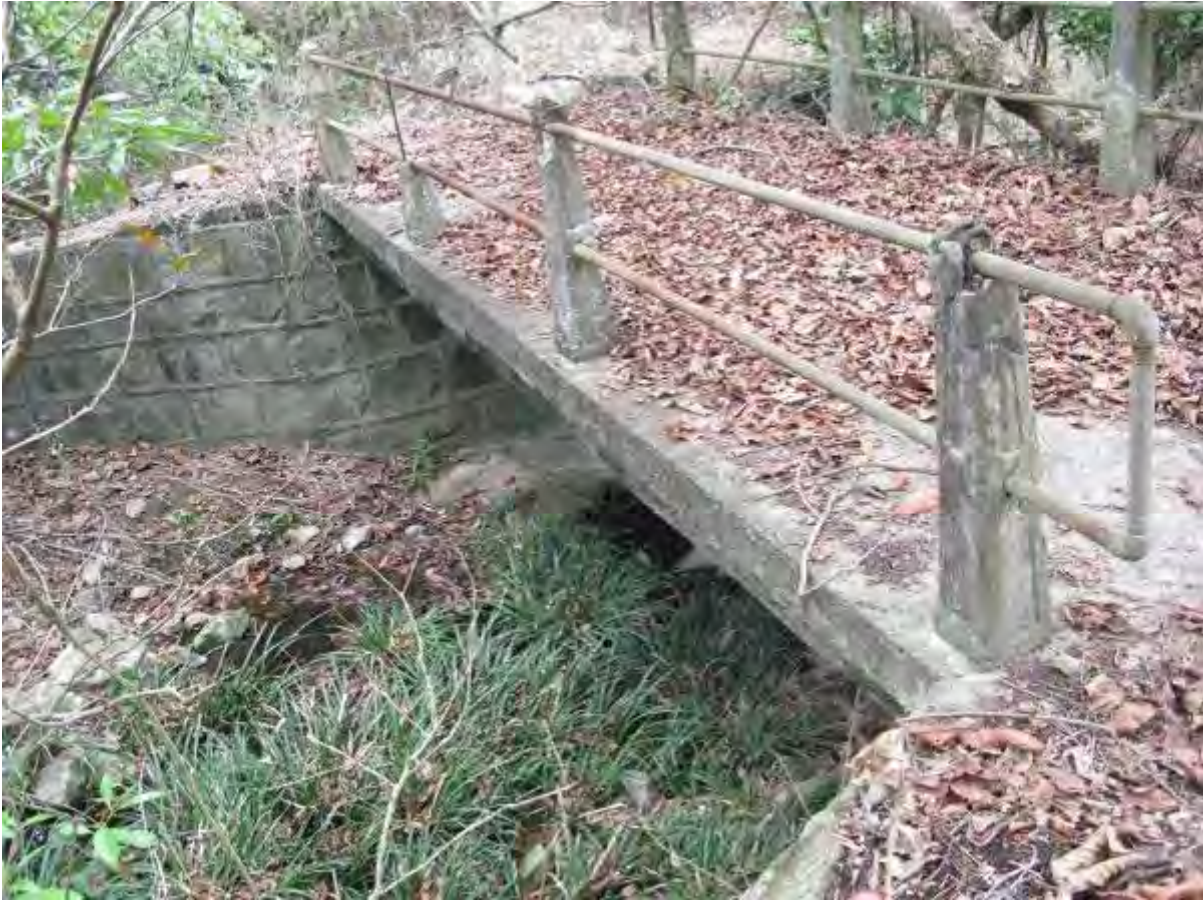
<p data-bbox="546 1246 1825 1283">View showing stone blocks supporting the bridge. (View before crossing the bridge, view A to B)</p>

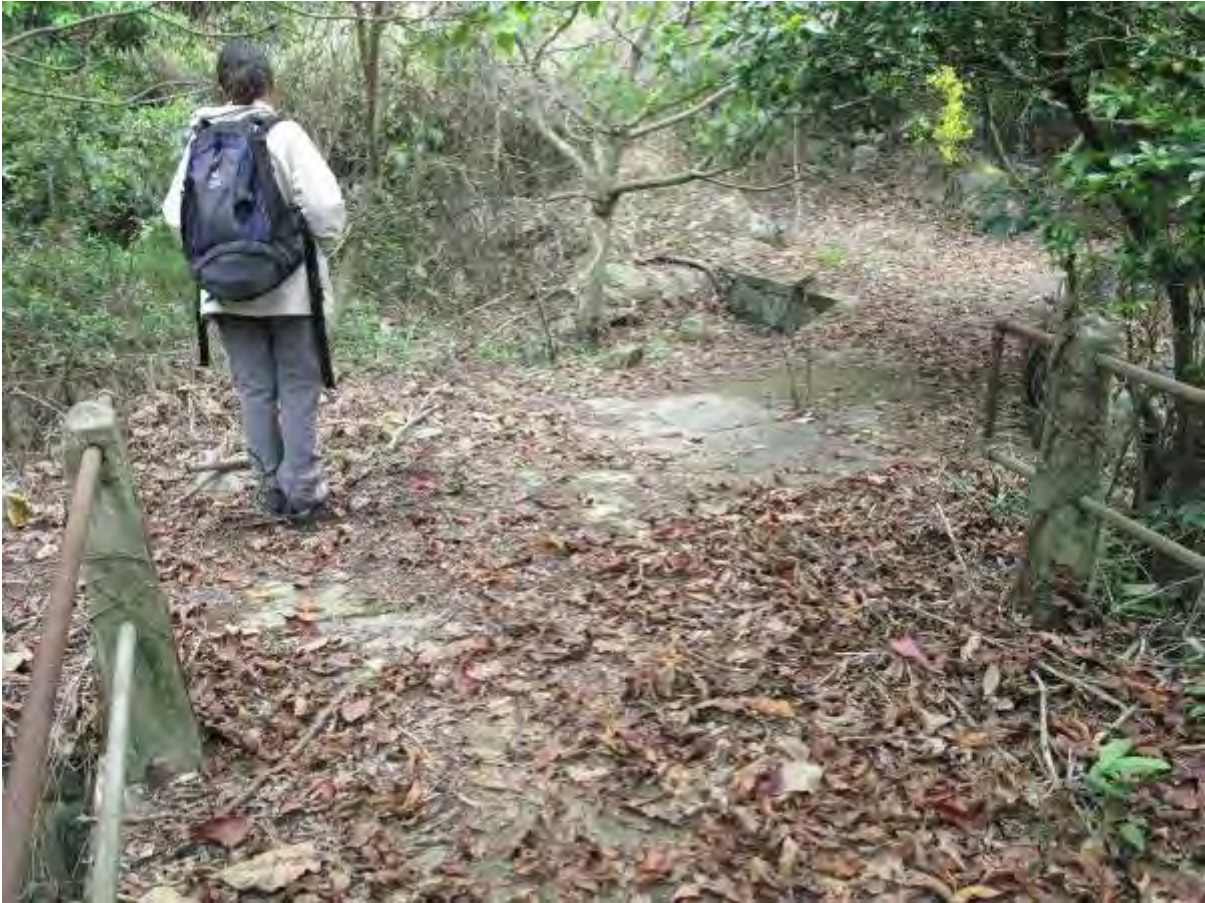
<p data-bbox="271 1177 2101 1252">Ground surface mostly covered with abundant dry leaves after crossing the bridge with railings and reached another bridge without railings. (View A to B)</p>

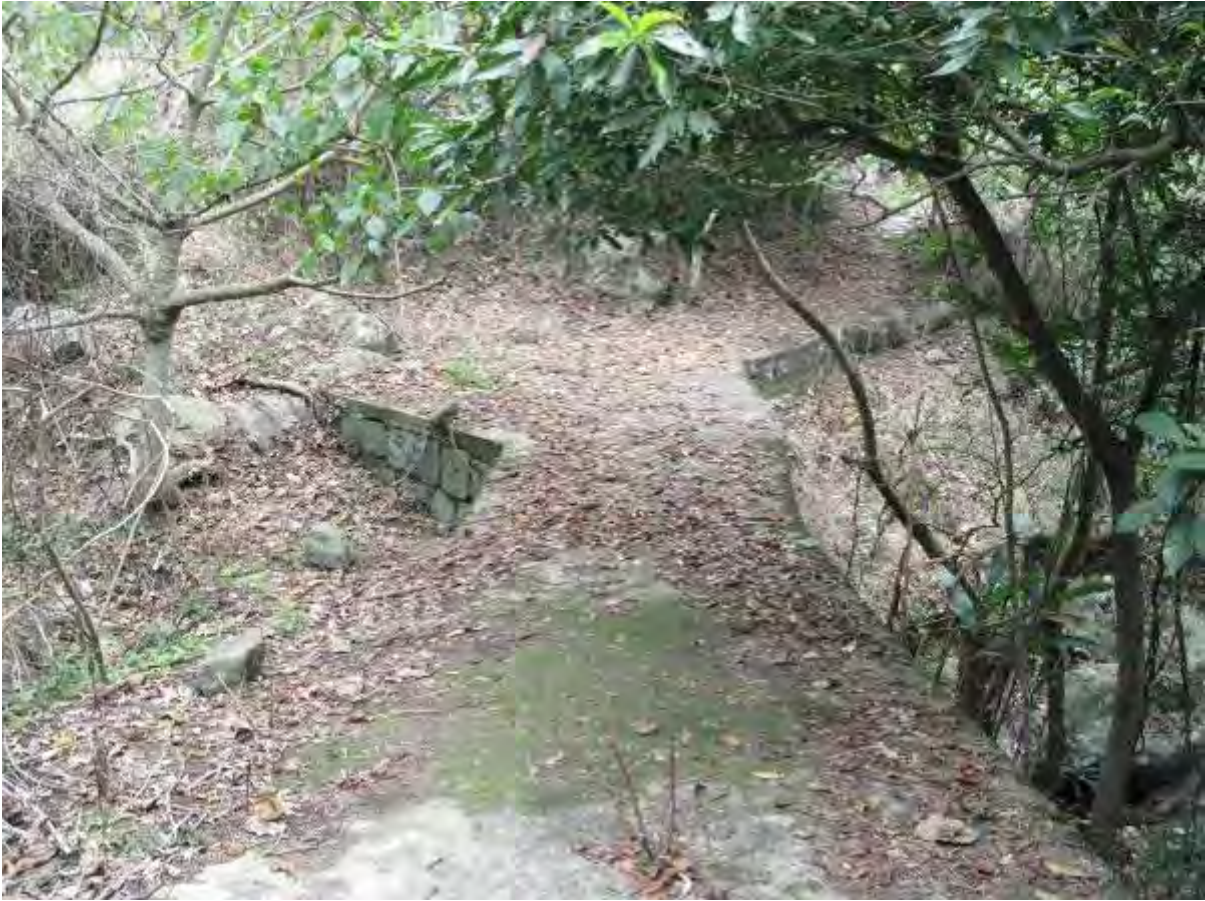
<p data-bbox="763 1174 1610 1209">General view of the second bridge without railings. (view A to B)</p>

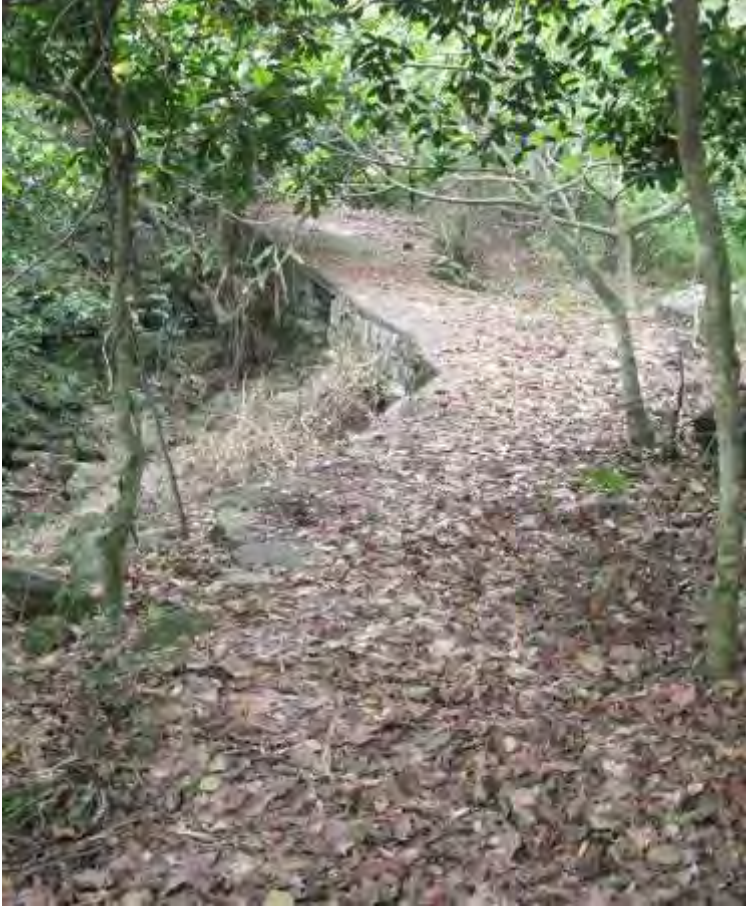
<p>View after bridge crossing. Boulders covered with abundant dry leaves (view B to A).</p>	25

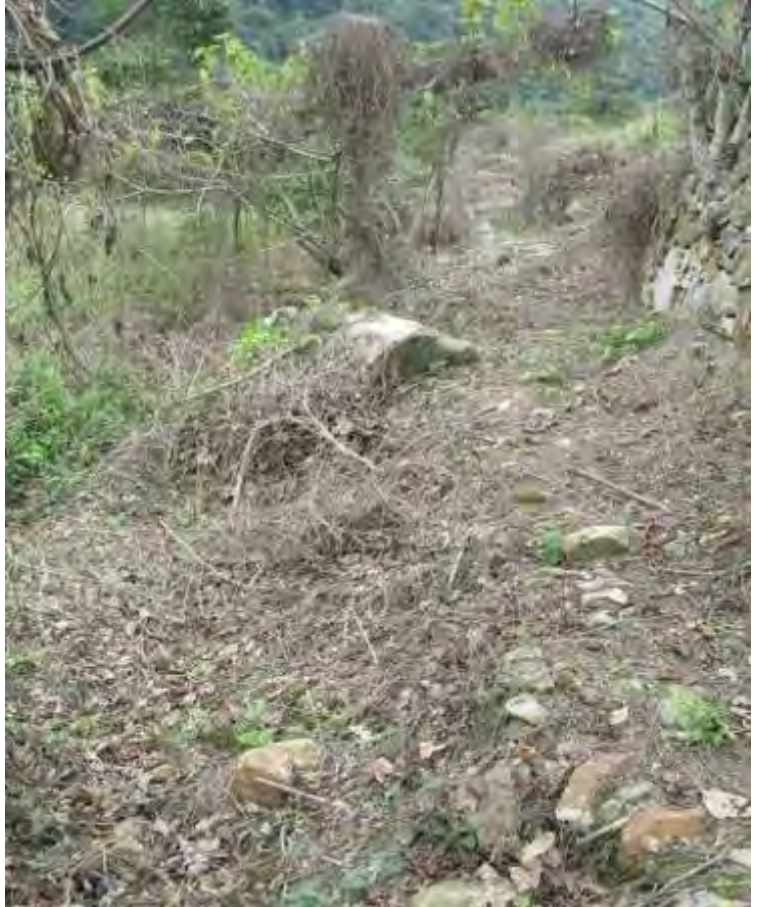
<p>View of the boulder section. Boulders covered with abundant dry leaves and branches (view B to A).</p>

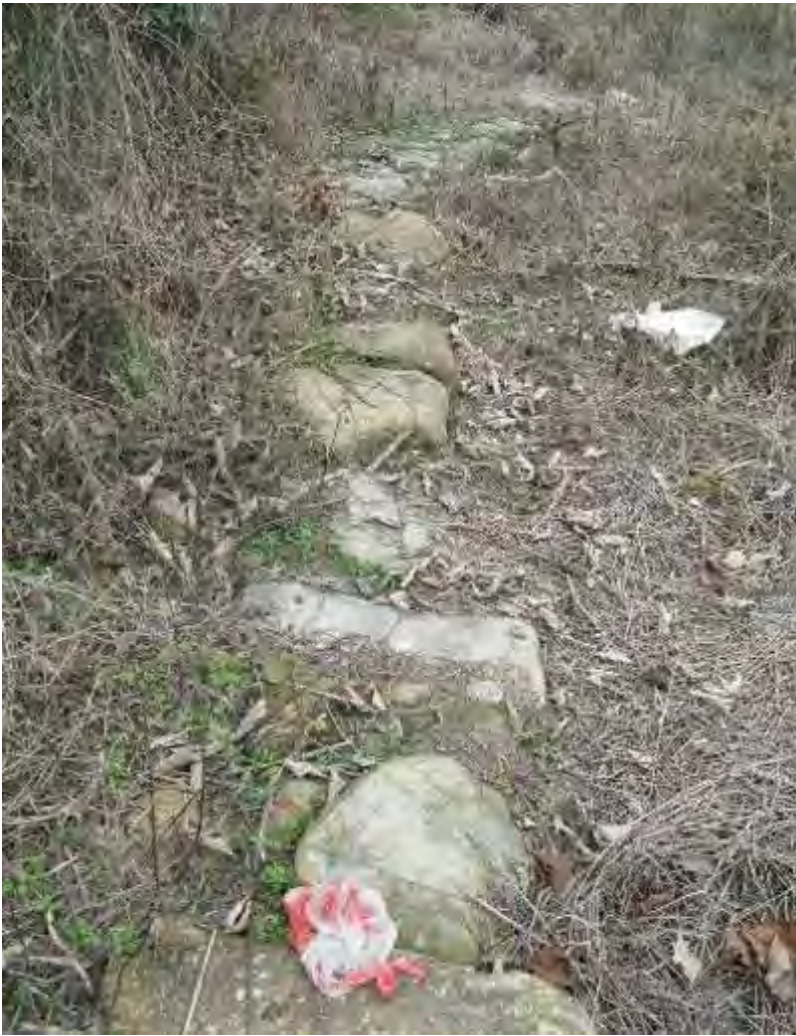
<p>Typical view along this boulder section. (View A to B).</p>		(Blank)

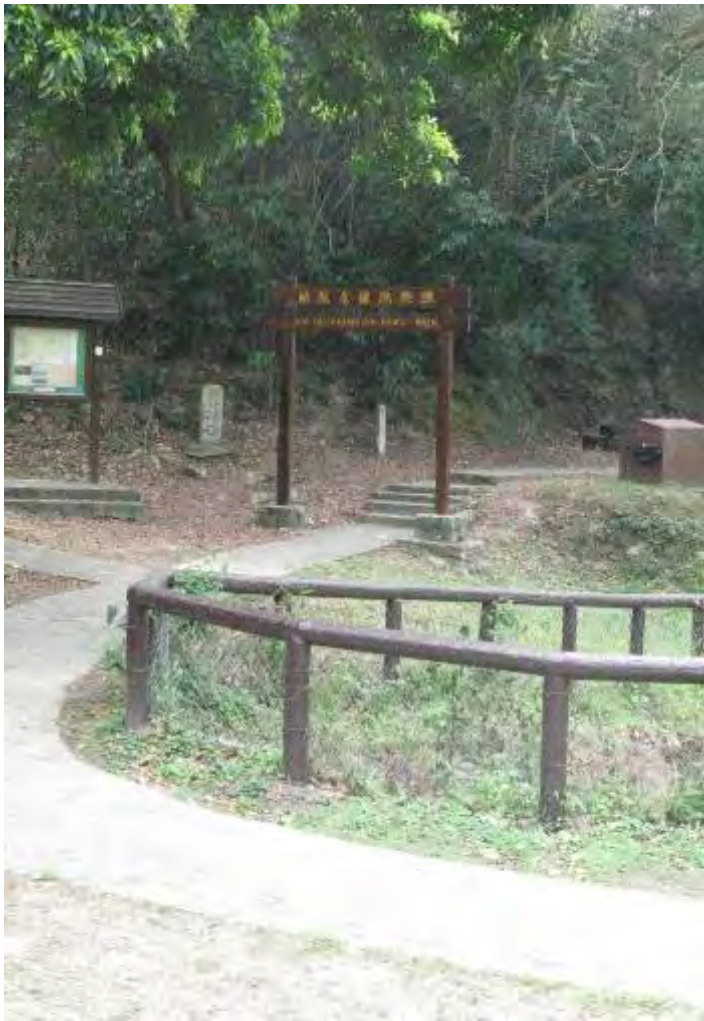
<p>The entrance of the Hok Tau Reservoir Family Walk starting from a barbecue area. (View to A)</p>	1

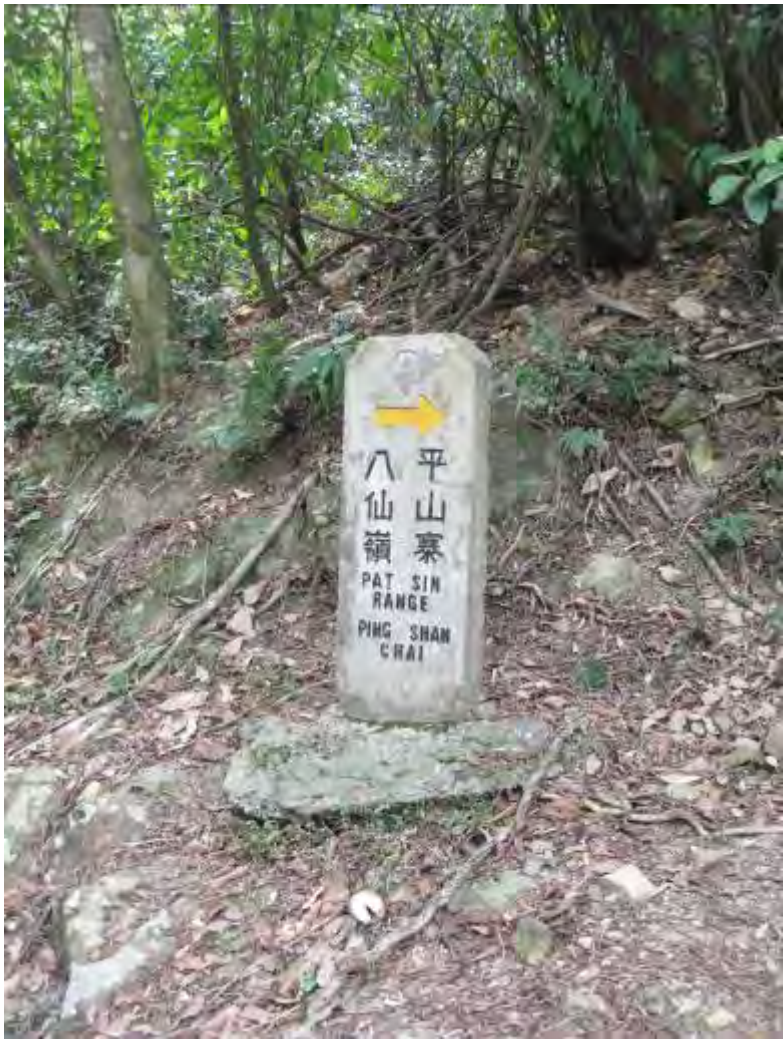
<p>AFCD trail direction sign showing the direction to Pat Sin Range and Ping Shan Chai.</p>

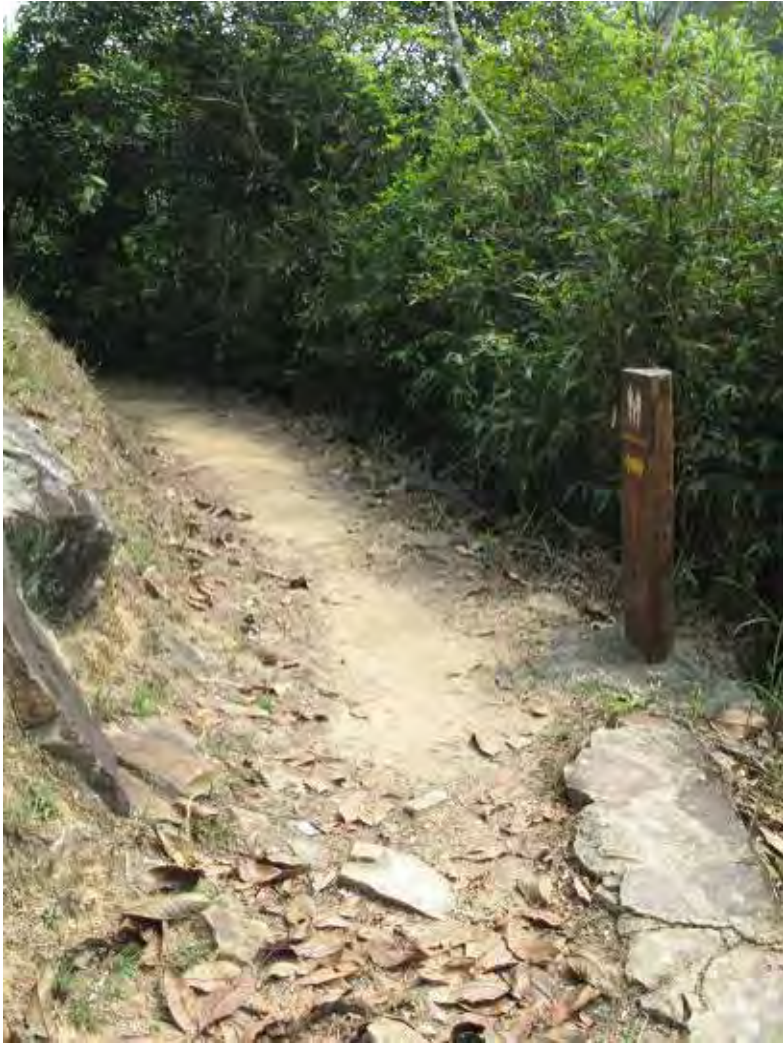
<p>End of concrete footpath, mud section start. (View A to B)</p>	From A to 3

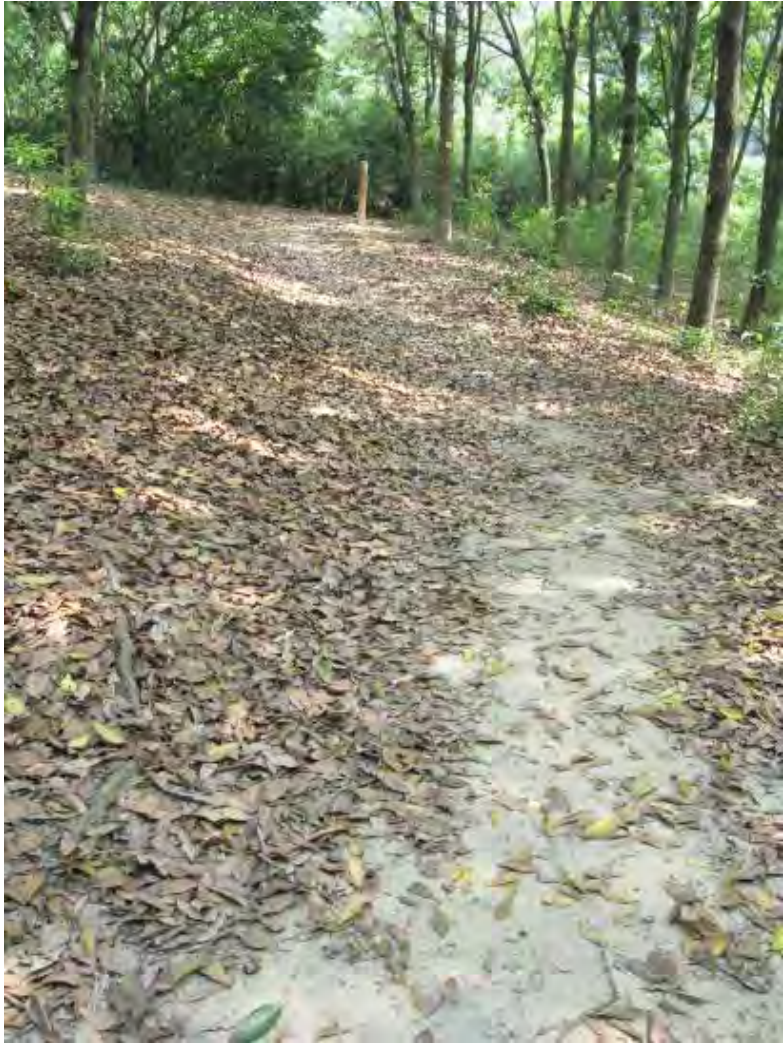
<p>Mud section. (View A to B)</p>

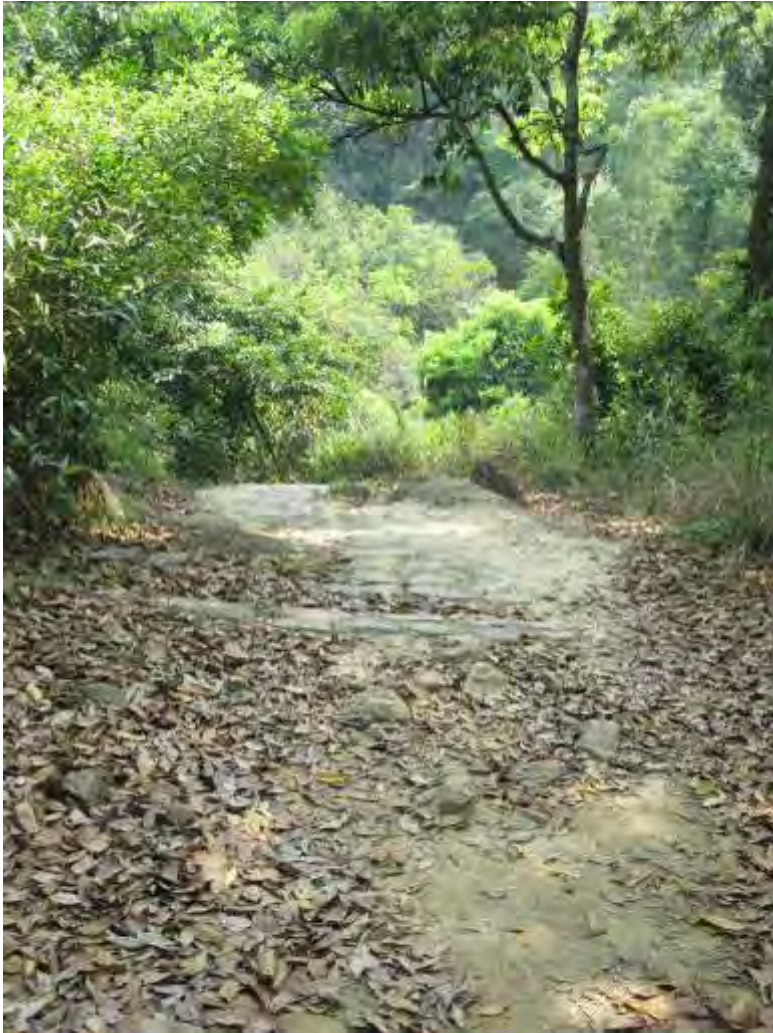
<p>End of mud section, reworked section (boulders and concrete) start. (View A to B)</p>	3

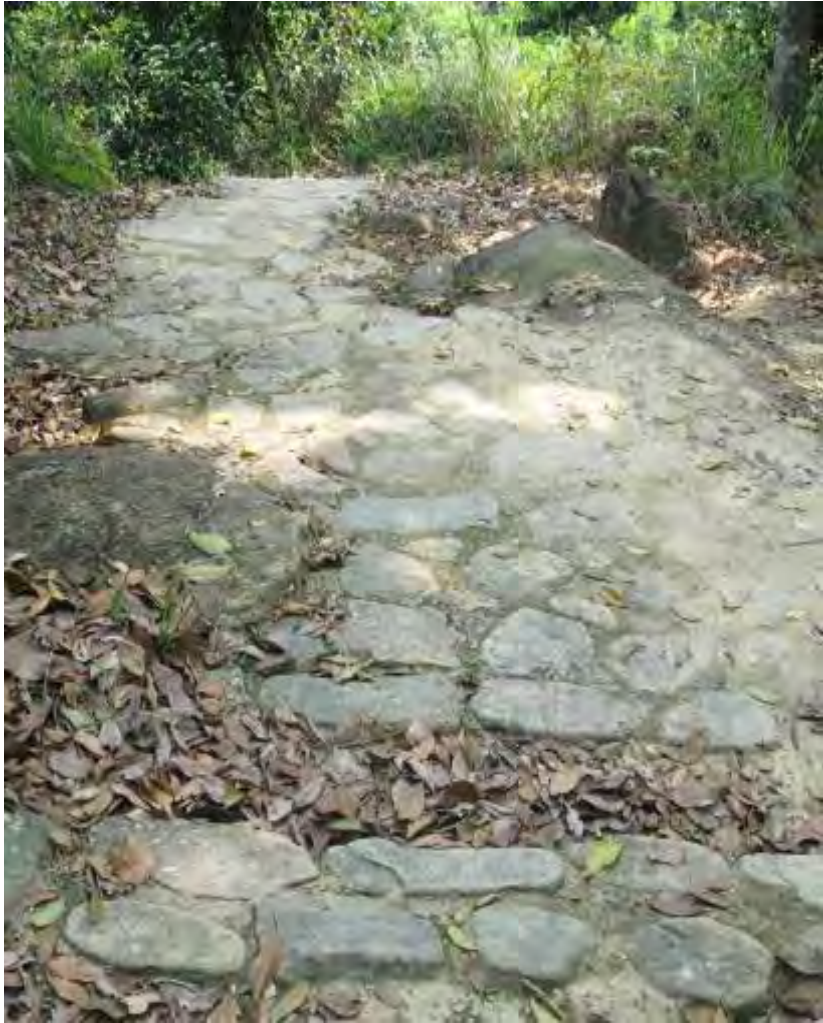
<p>Reworked section (boulders and concrete) (view A to B)</p>

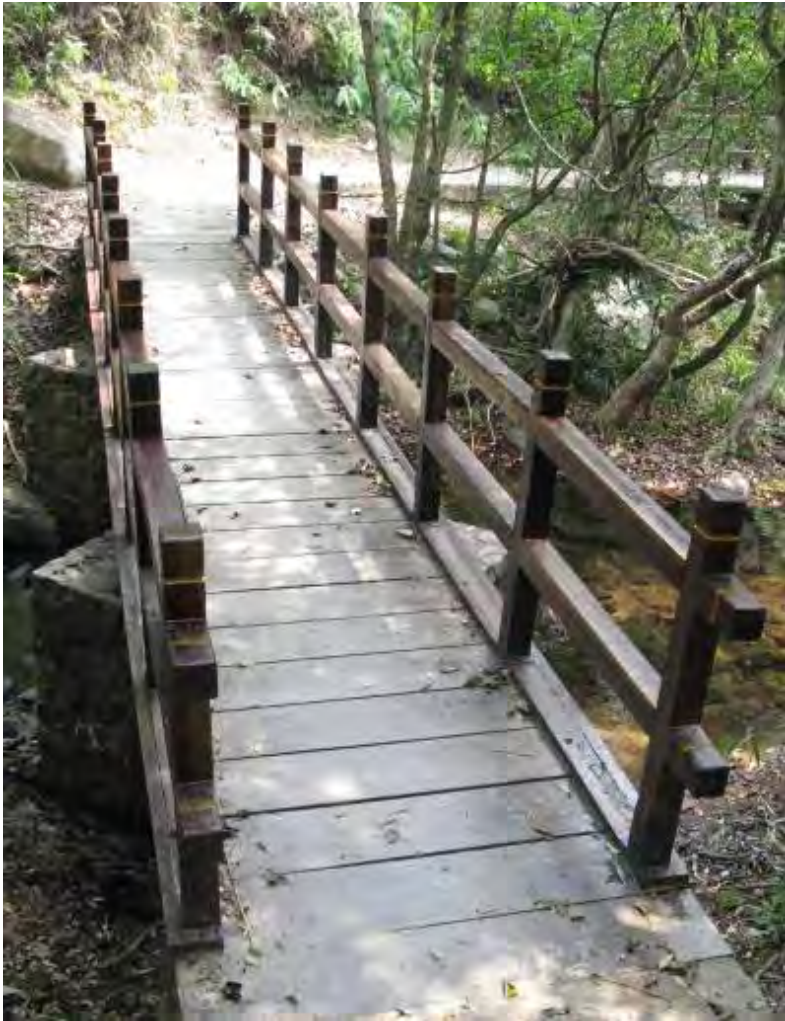
<p>Modern wooden bridge with concrete and stones bases (view A to B)</p>	F1

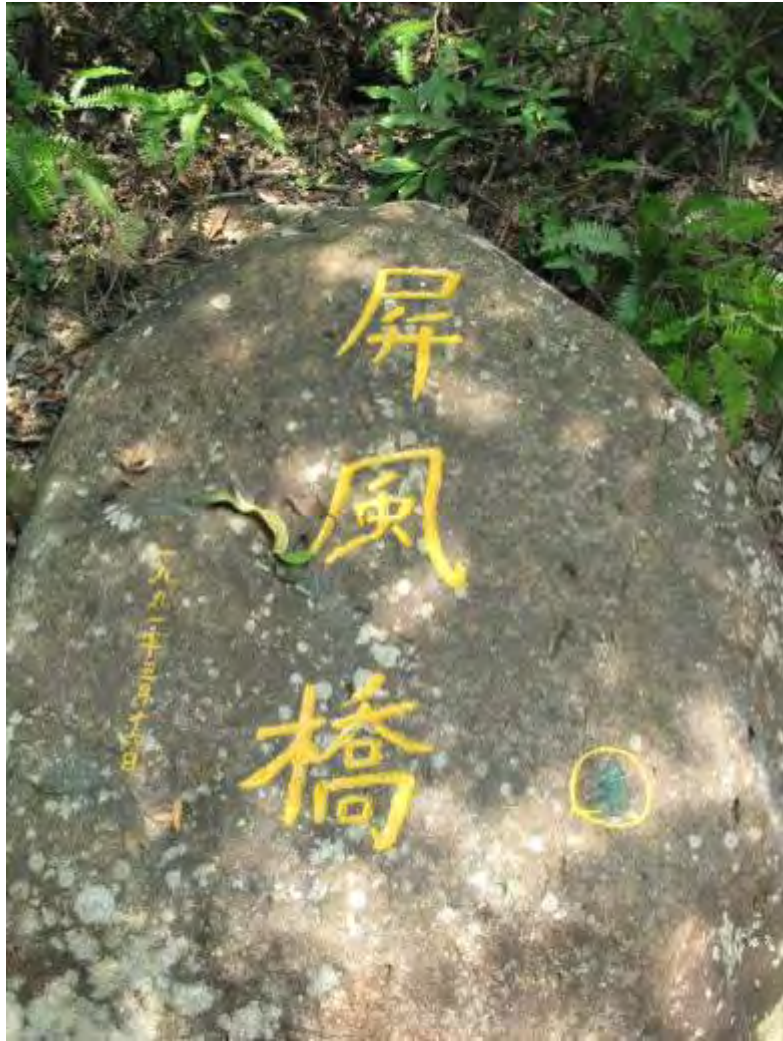
<p>A stone inscription indicating the name of the bridge as “Ping Fung Bridge” (屏風橋) marked by AFCD in 1991.</p>

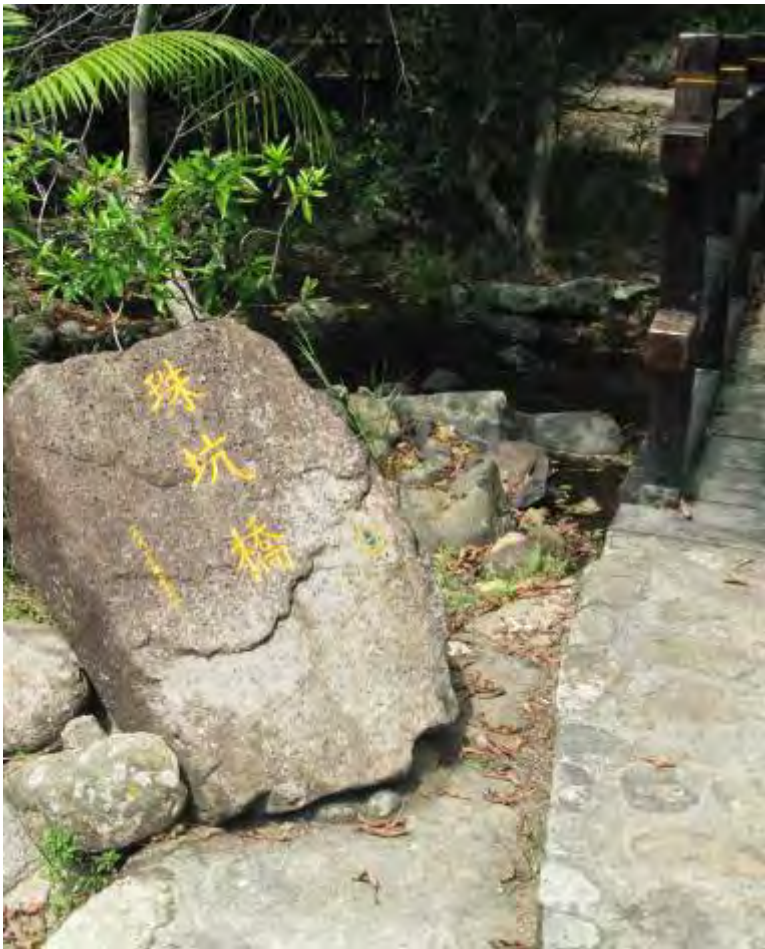
<p>A stone inscription indicating the name of the bridge as “Zhu Hang Bridge” (珠坑橋) marked by AFCD in 1991.</p>

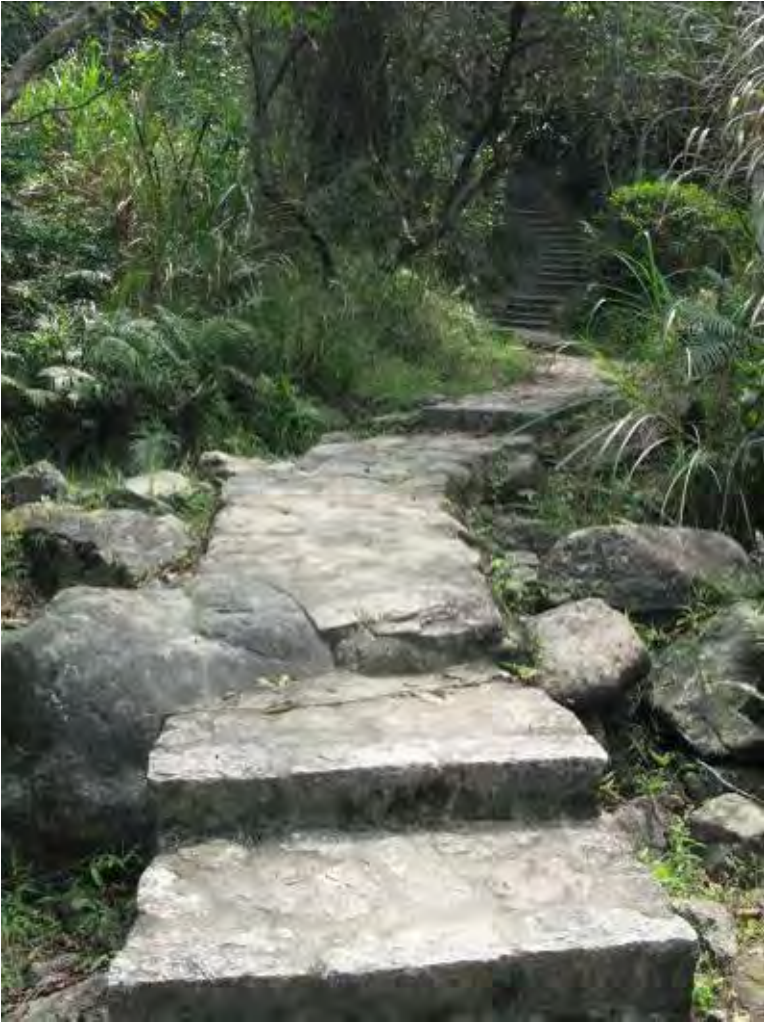
<p>Steps of reworked section (boulder and concrete). (view A to B)</p>	From 4 to 5

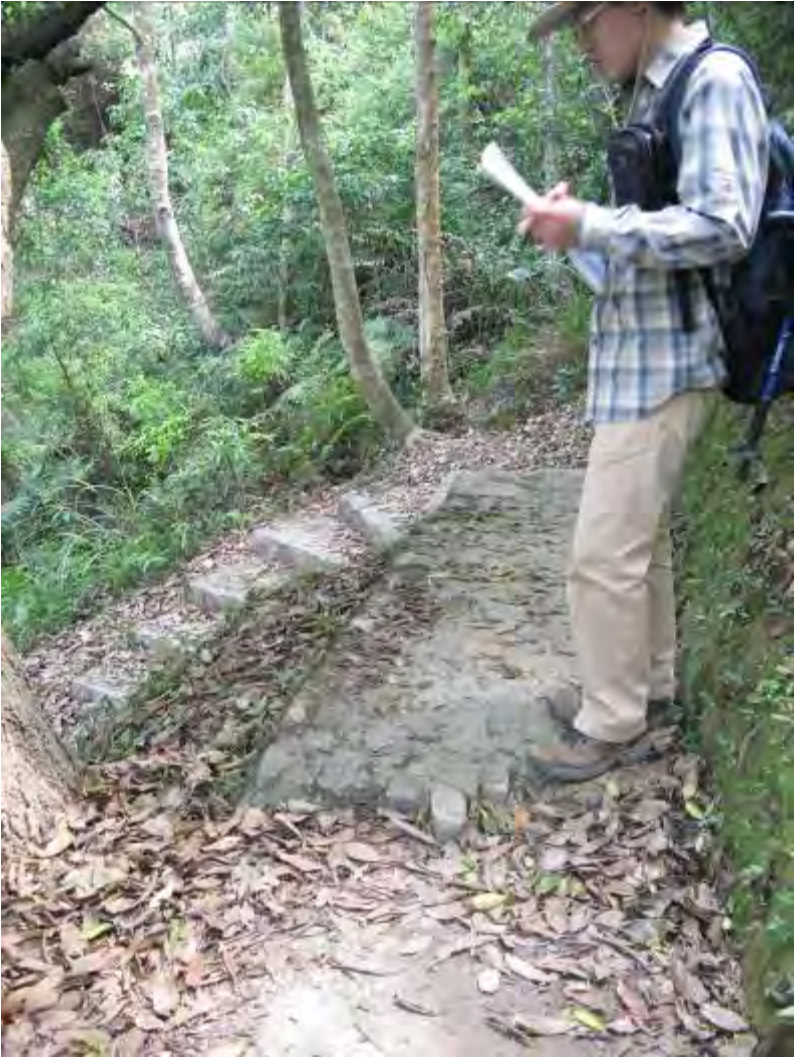
<p>Steps of reworked section appear occasionally along the zigzag mud surface footpath. (view A to B)</p>

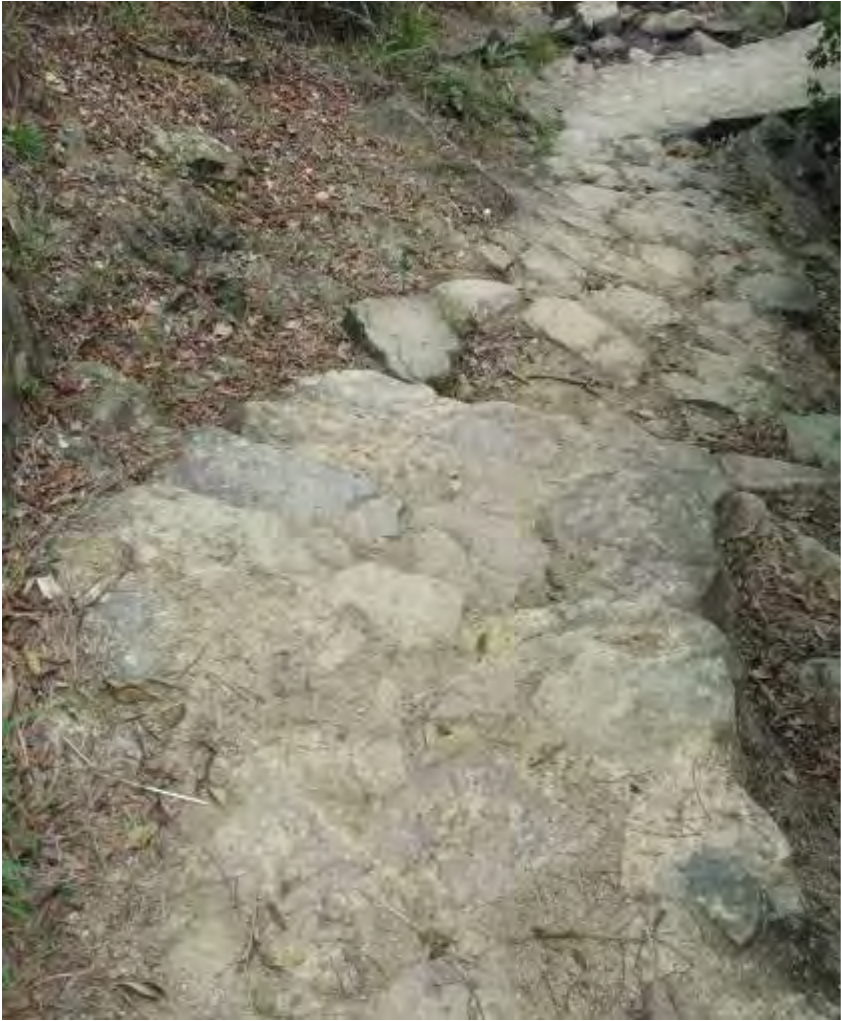
<p>Steps constructed with boulders and concrete. (View A to B)</p>	8

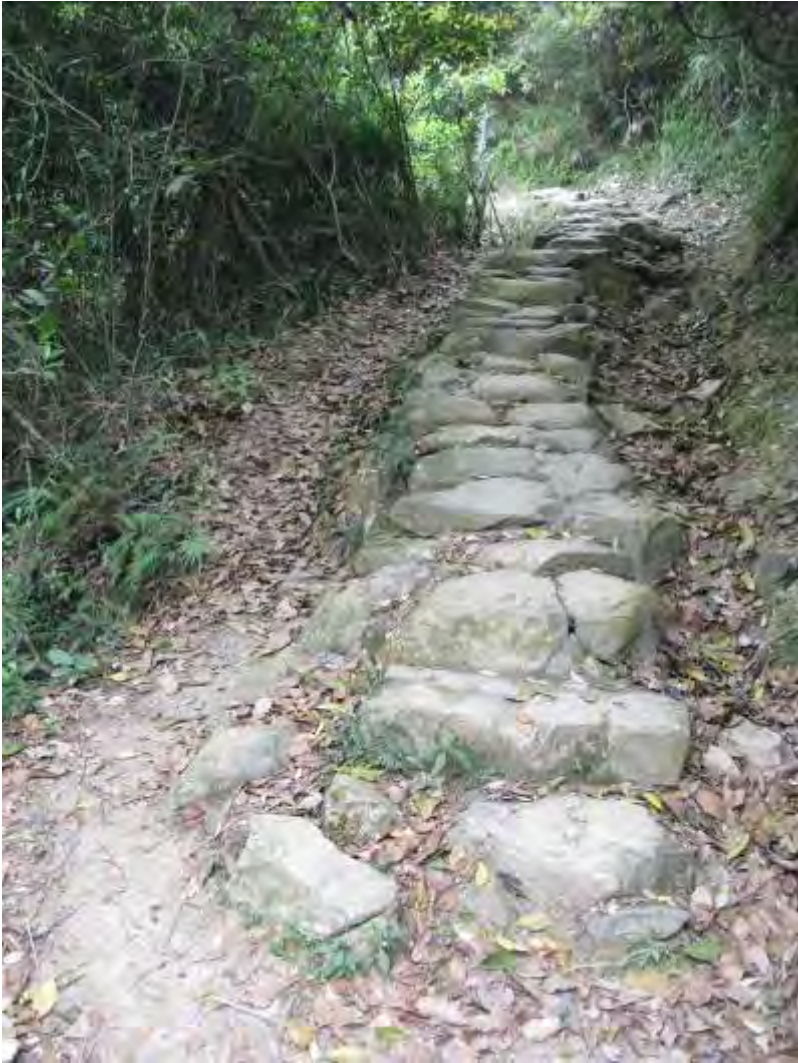
<p>Boulder steps. (View A to B)</p>	From 9 to 10

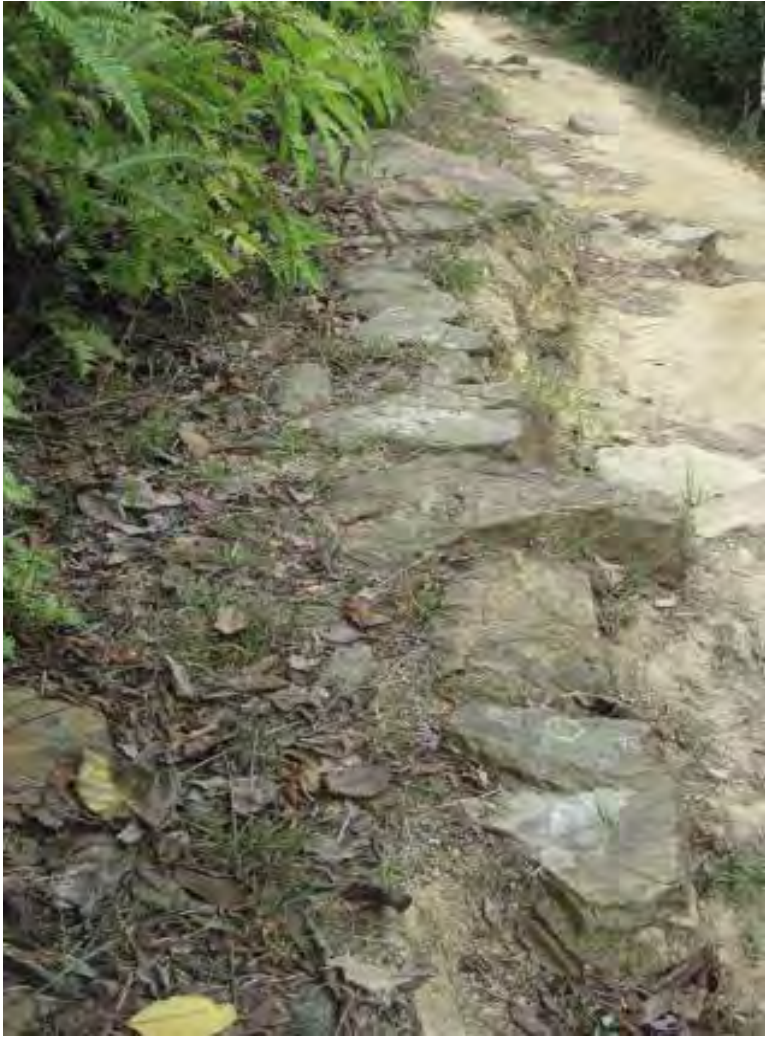
<p>Boulder section partial covered by hillside vegetation. (View B to A)</p>

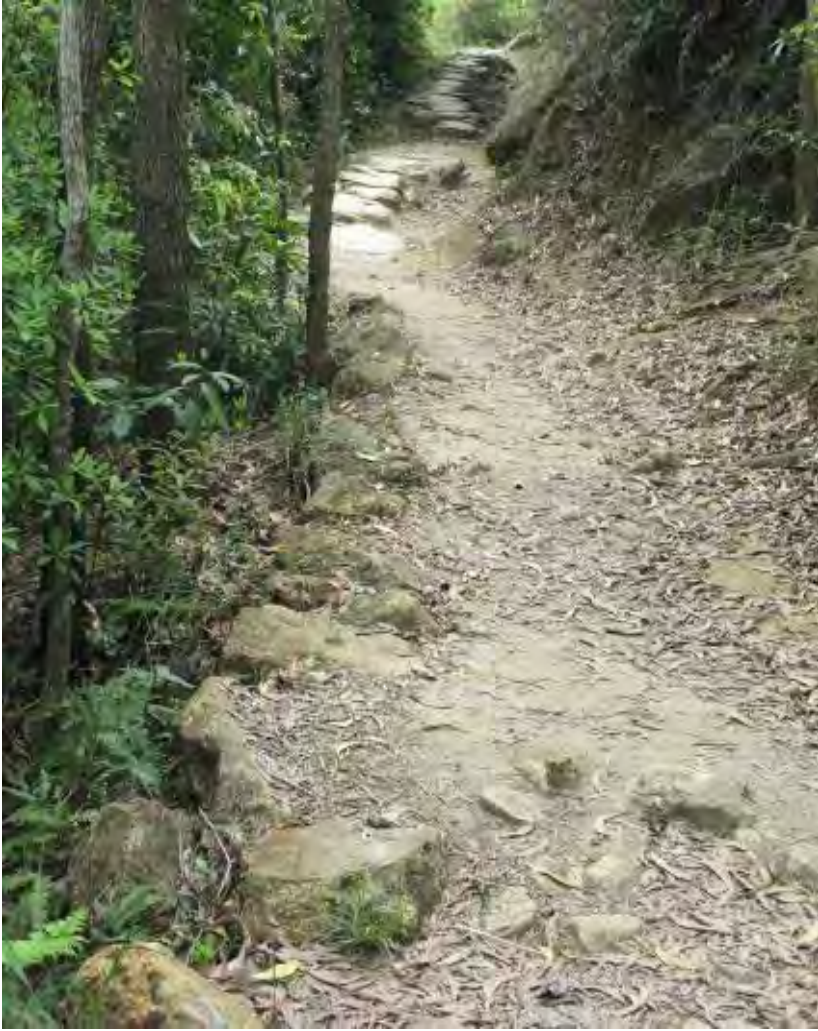
<p>Boulders are found placed at the edge of the footpath. (View A to B)</p>	14

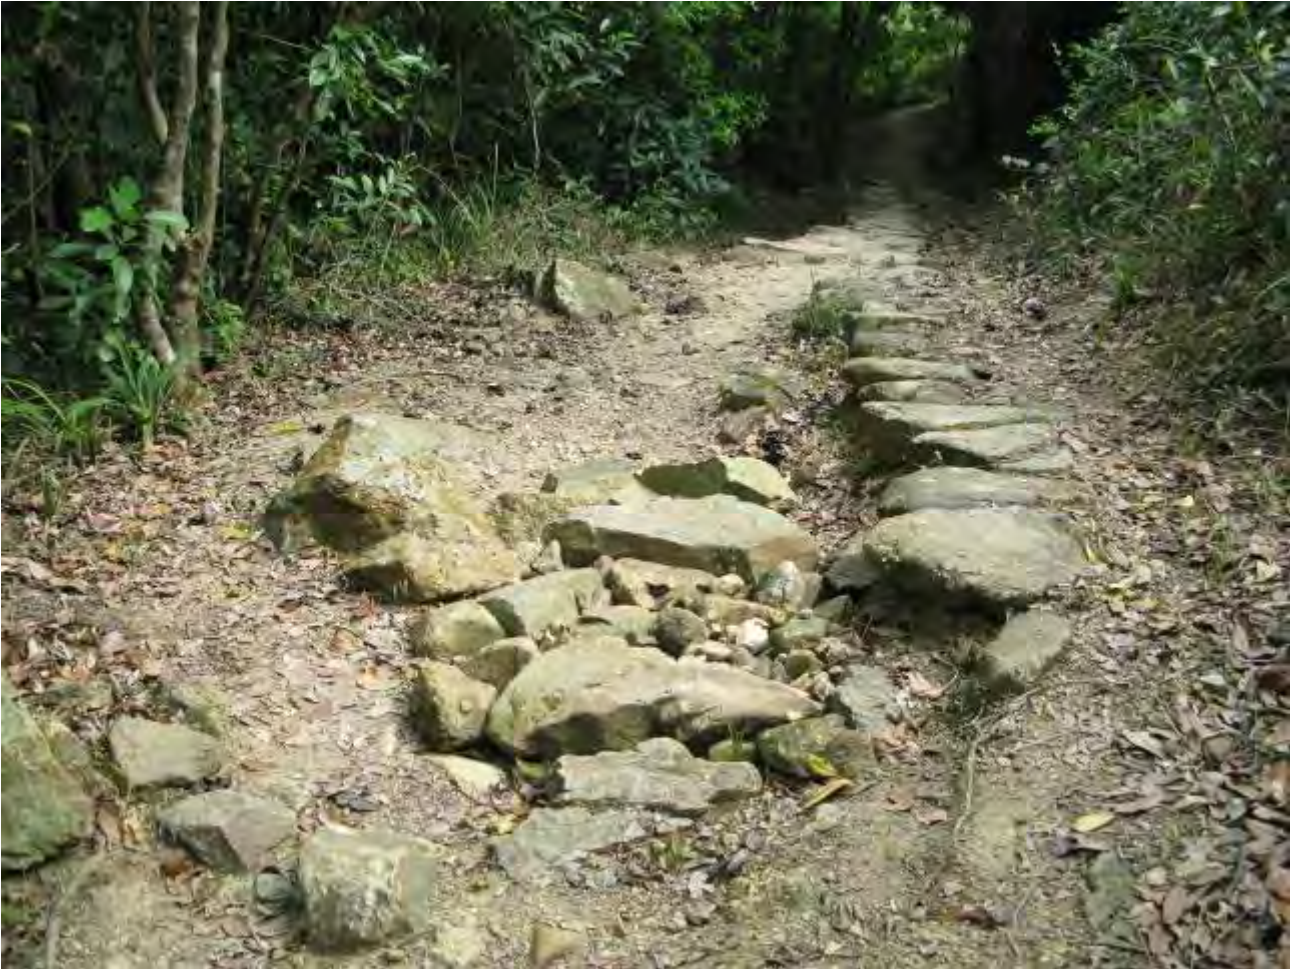
Photo Reference No.	Photographic Records
18

<p data-bbox="757 1241 1639 1278">A significantly disturbed location of boulder section. (View A to B)</p>

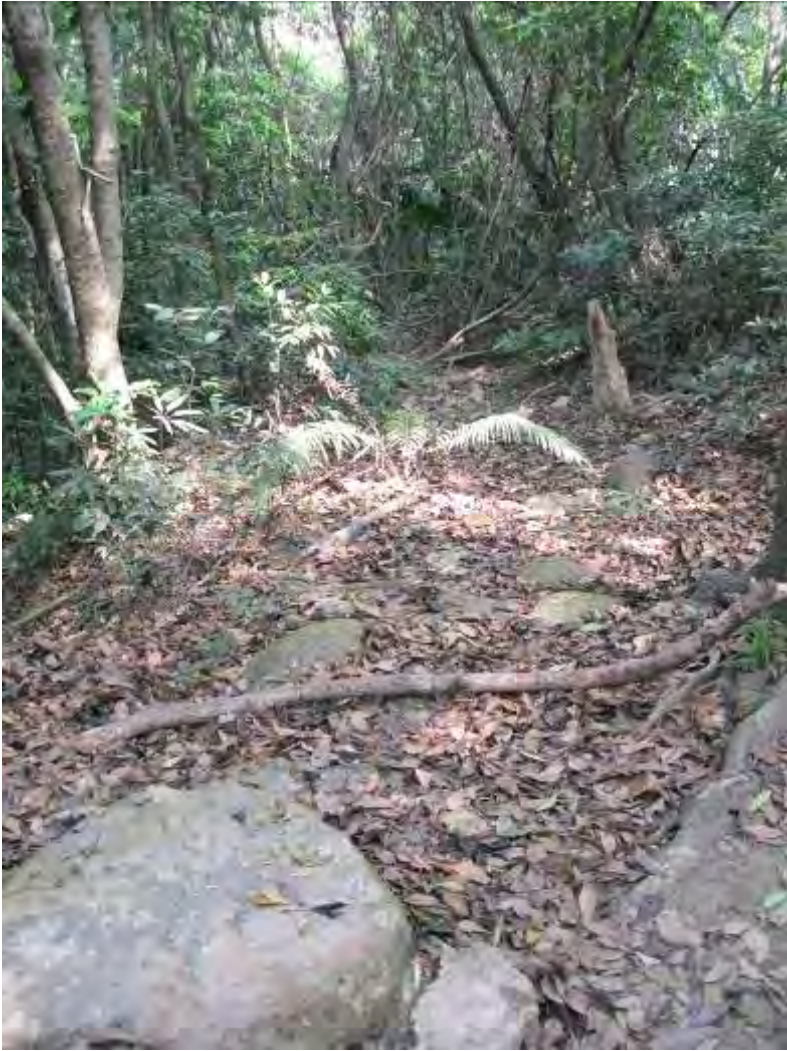
<p>Looking downward of the boulder section at B. Thick vegetation covering the boulder path. (View B to F6)</p>	F5

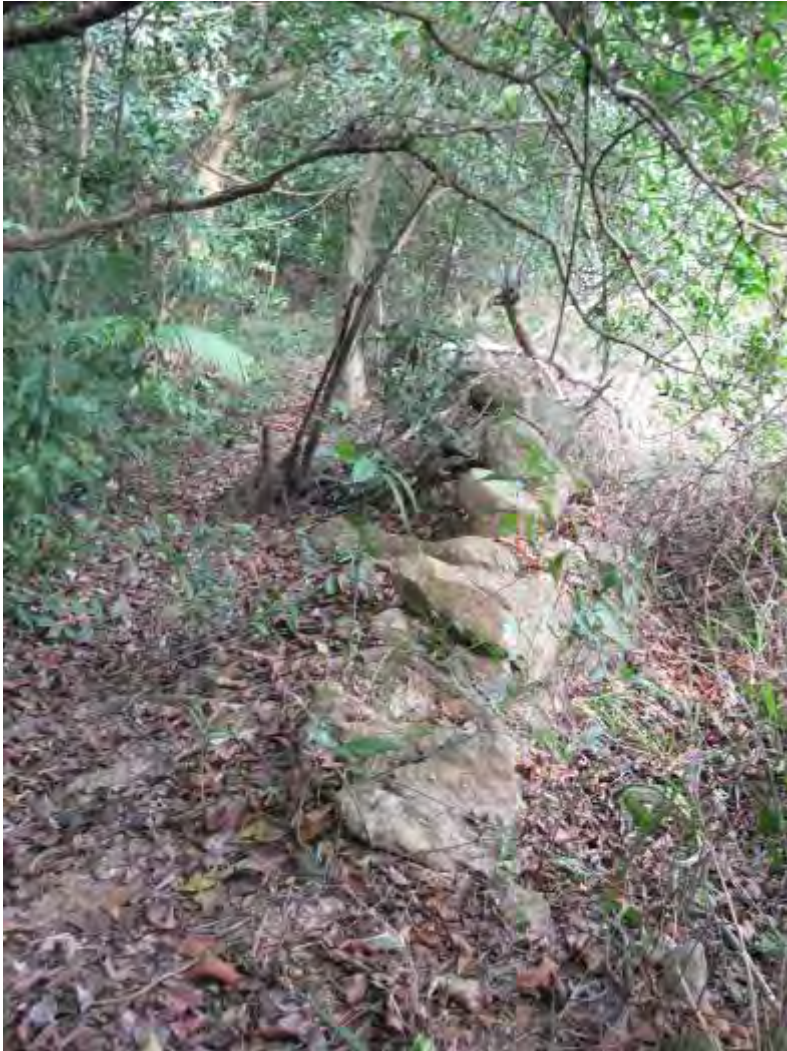
<p>Remains of boulder constructed wall. (View B to F6)</p>
