Antiquities and Monuments Office

Study on Old Trails in Hong Kong - Final Study Report

February 2014

Study on Old Trails in Hong Kong: *Final Study Report*

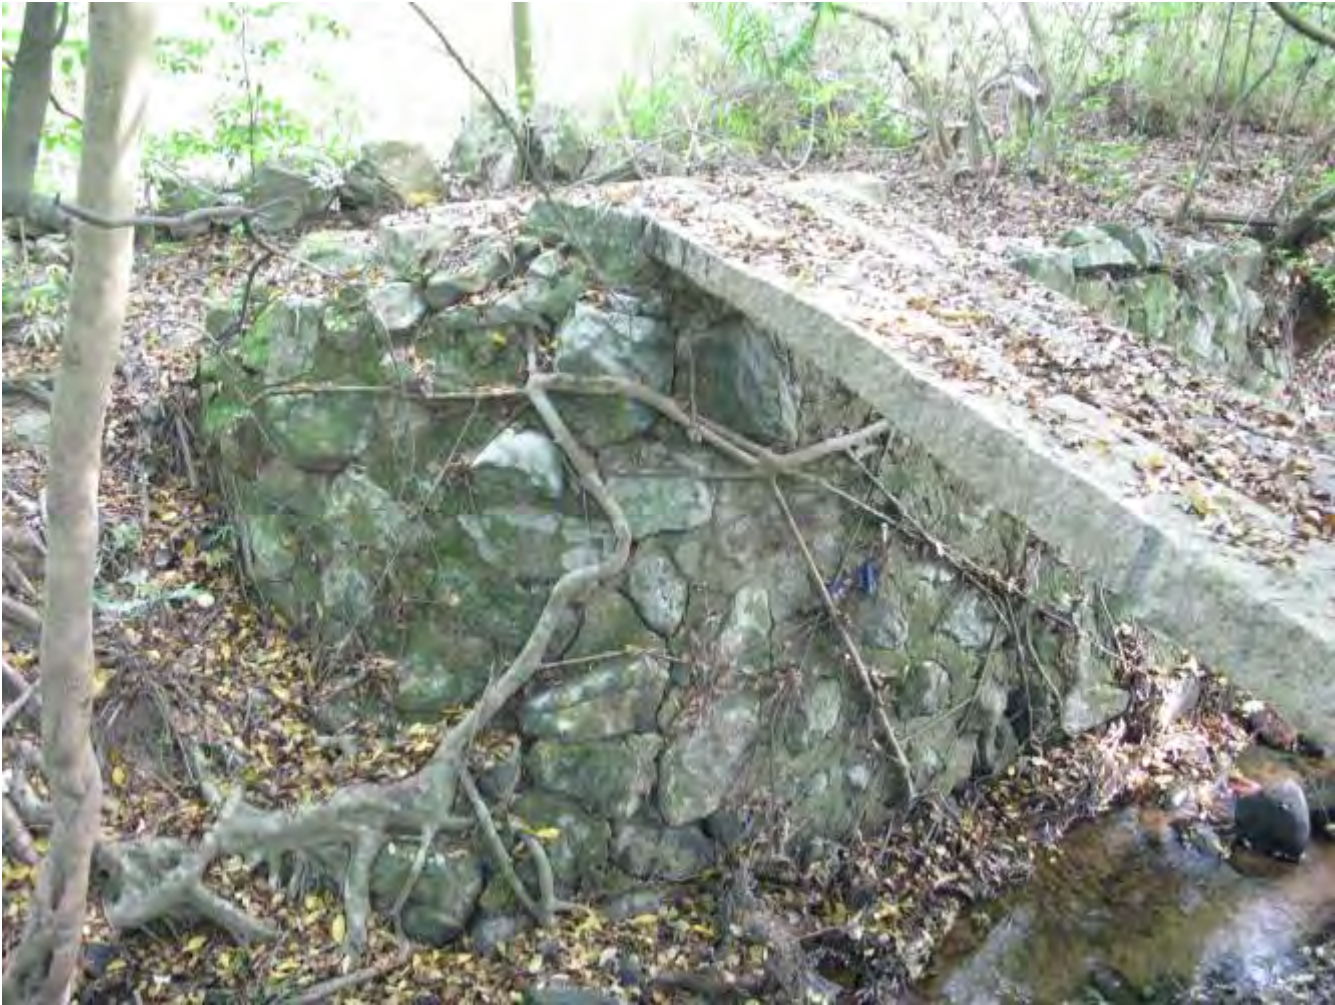
<p data-bbox="488 1278 1904 1313">Foundation of the east end of the bridge was constructed with boulders and concrete. (View north to south)</p>

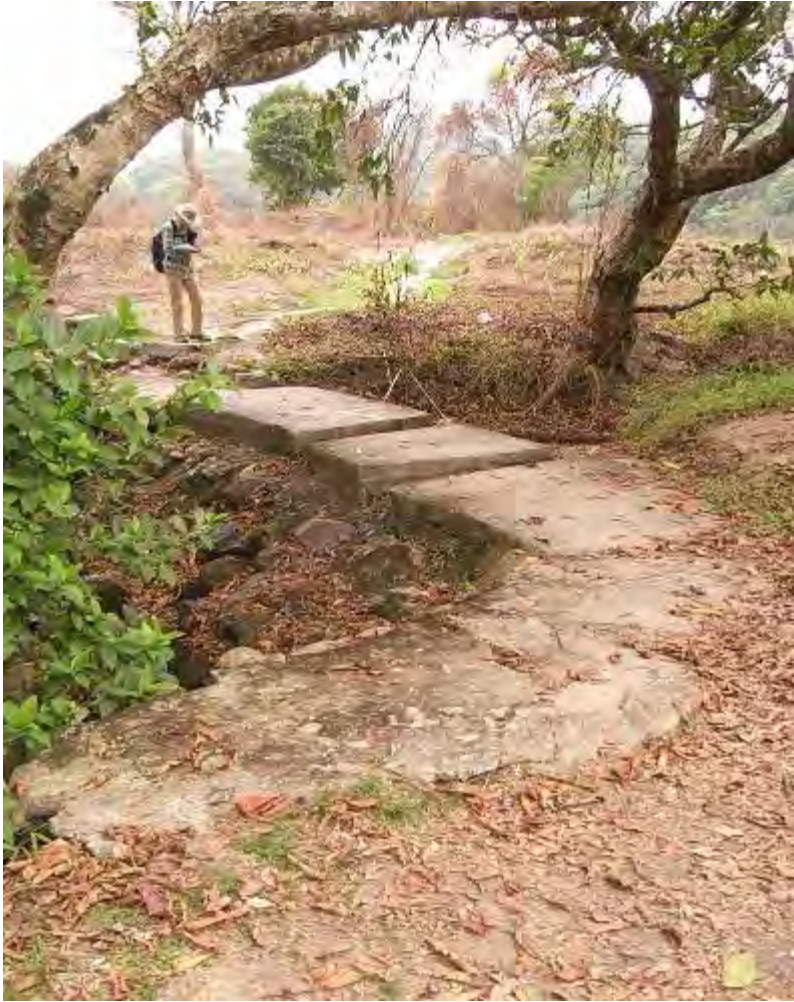
<p>Reworked section for stream crossing. Boulders are covered by concrete. (View B to C)</p>	F7

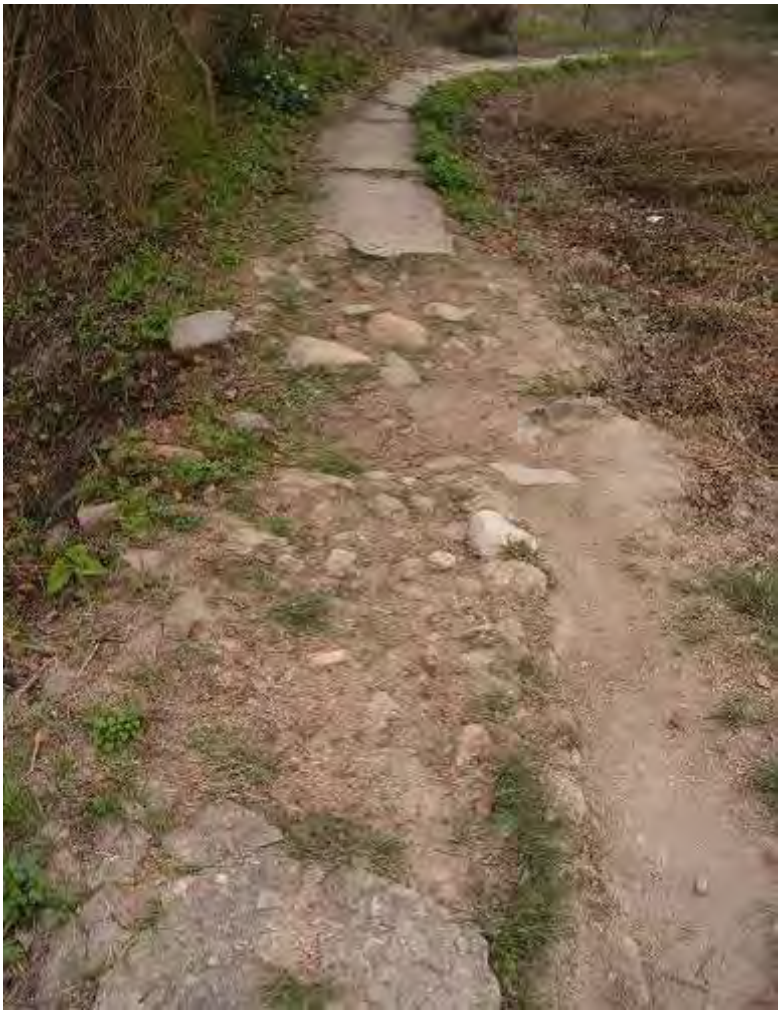
<p>Boulders covered by concrete layer in this reworked section. (View C to D)</p>

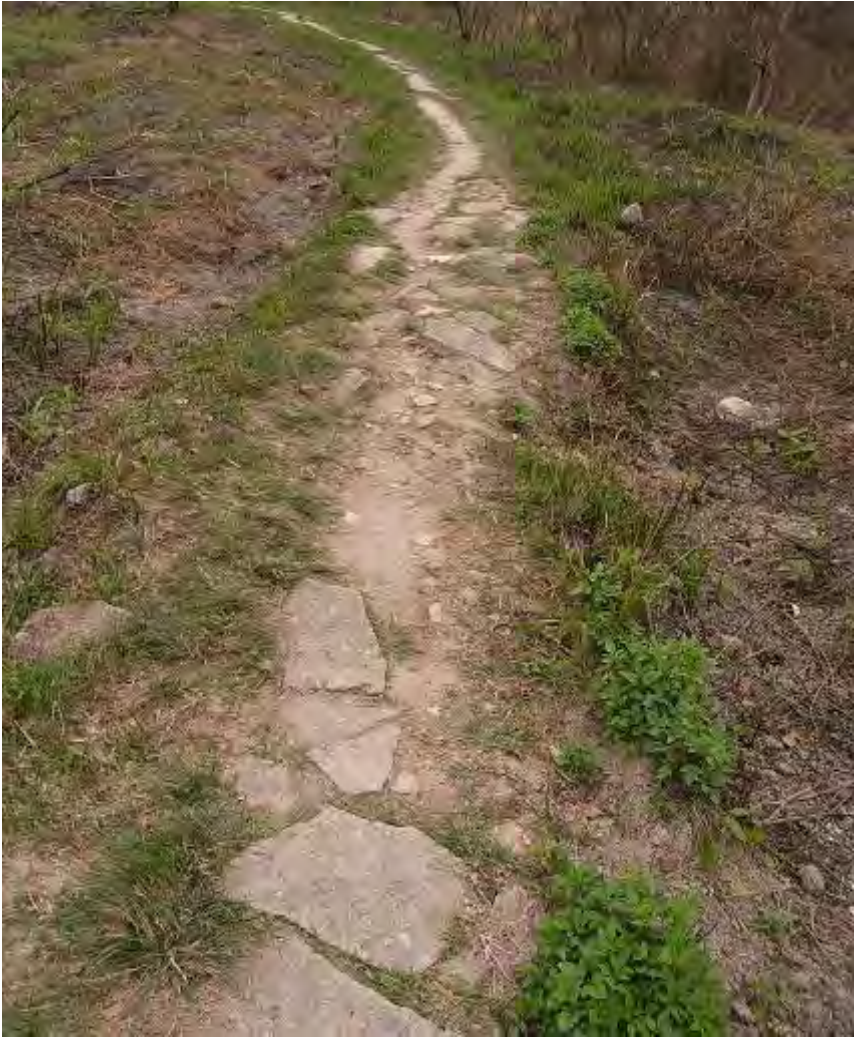
<p>Concrete surface layer is thin and eroded to expose the original boulder footpath. (View C to D)</p>	From C to 21

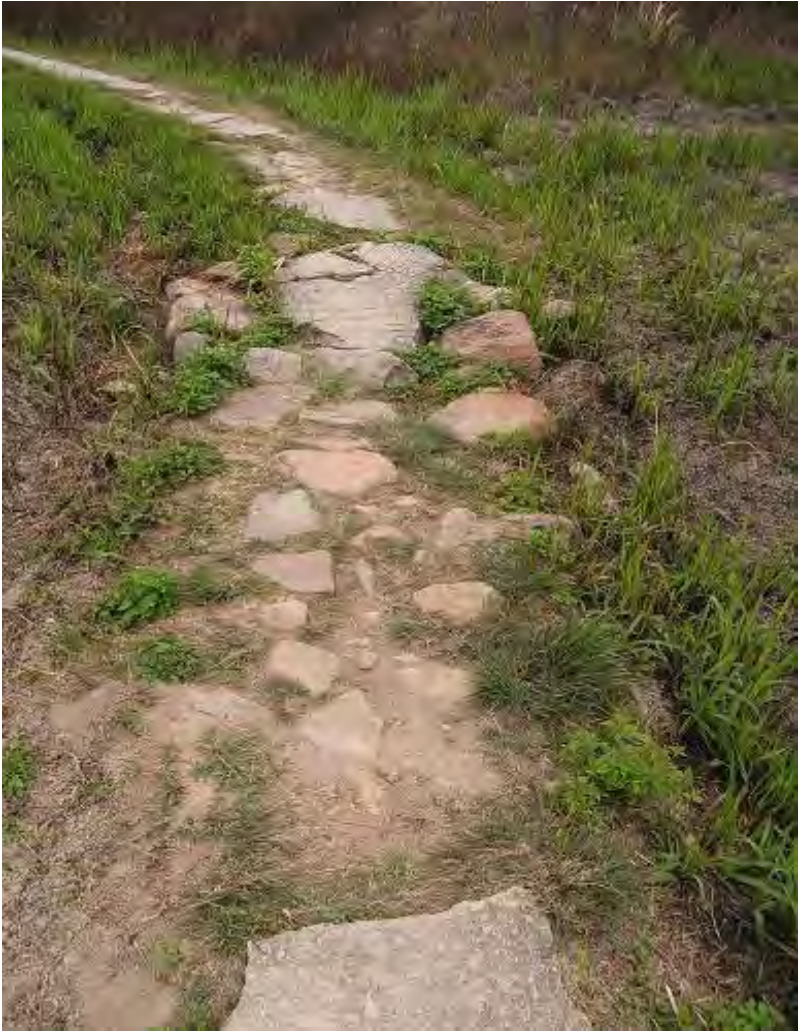
<p>Boulders exposed. (View C to D)</p>

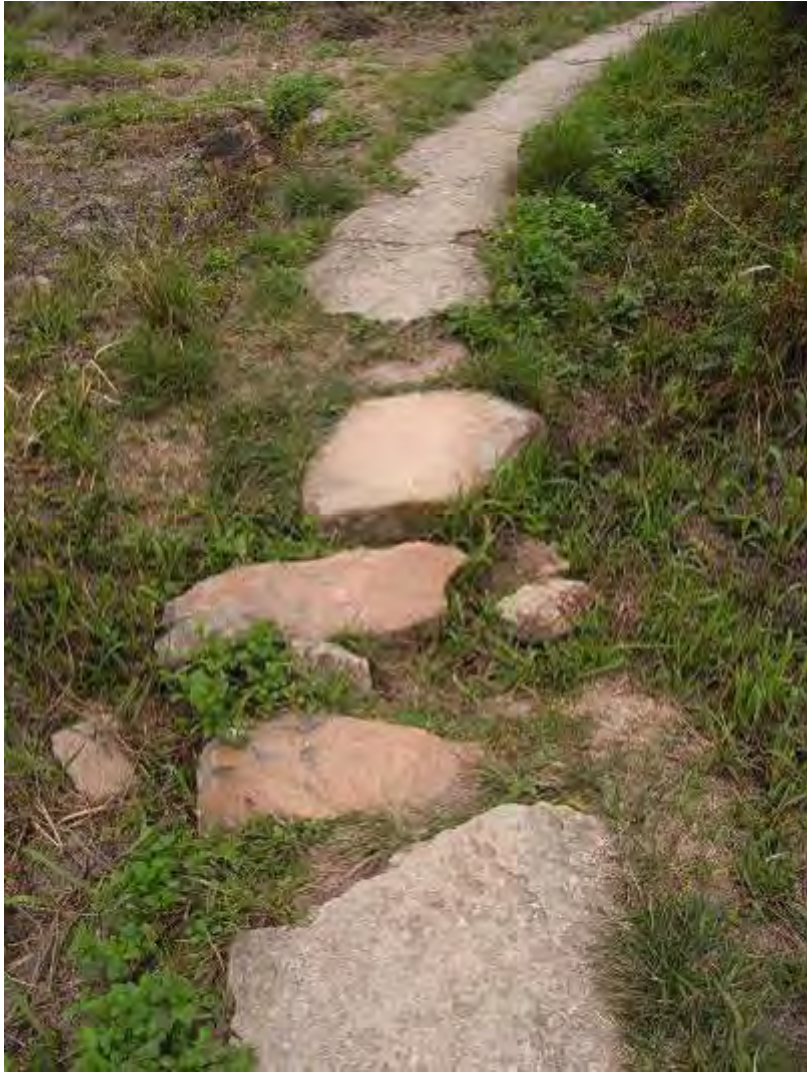
<p>Boulders exposed. (View C to D)</p>	21

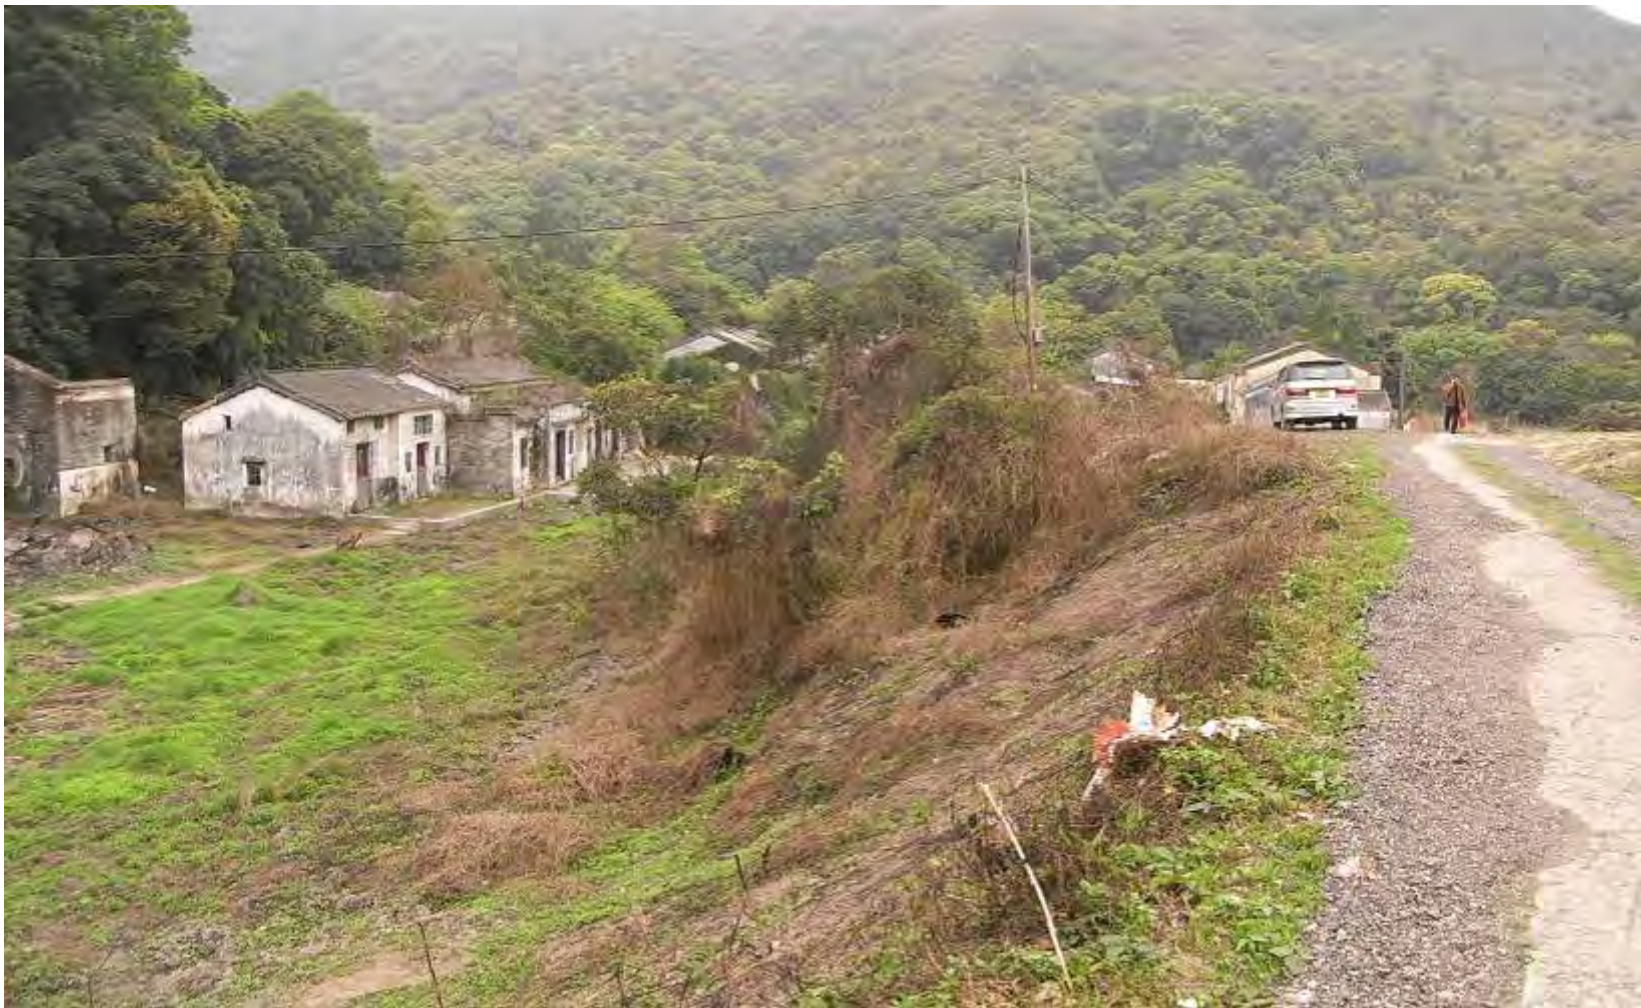
Photo Reference No.	Photographic Records
25

<p data-bbox="499 1278 1888 1313">The landscape has been modified by modern road construction (right of the photo). (View south to north)</p>

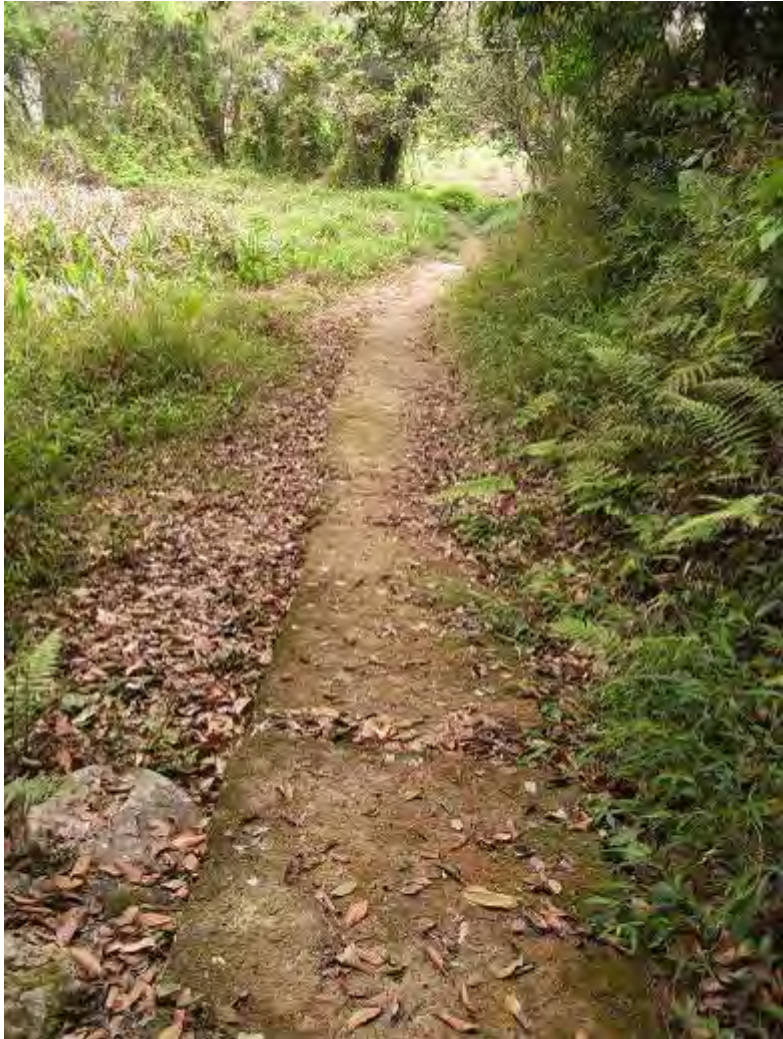
<p>Concrete after boulder steps. (View south to north)</p>

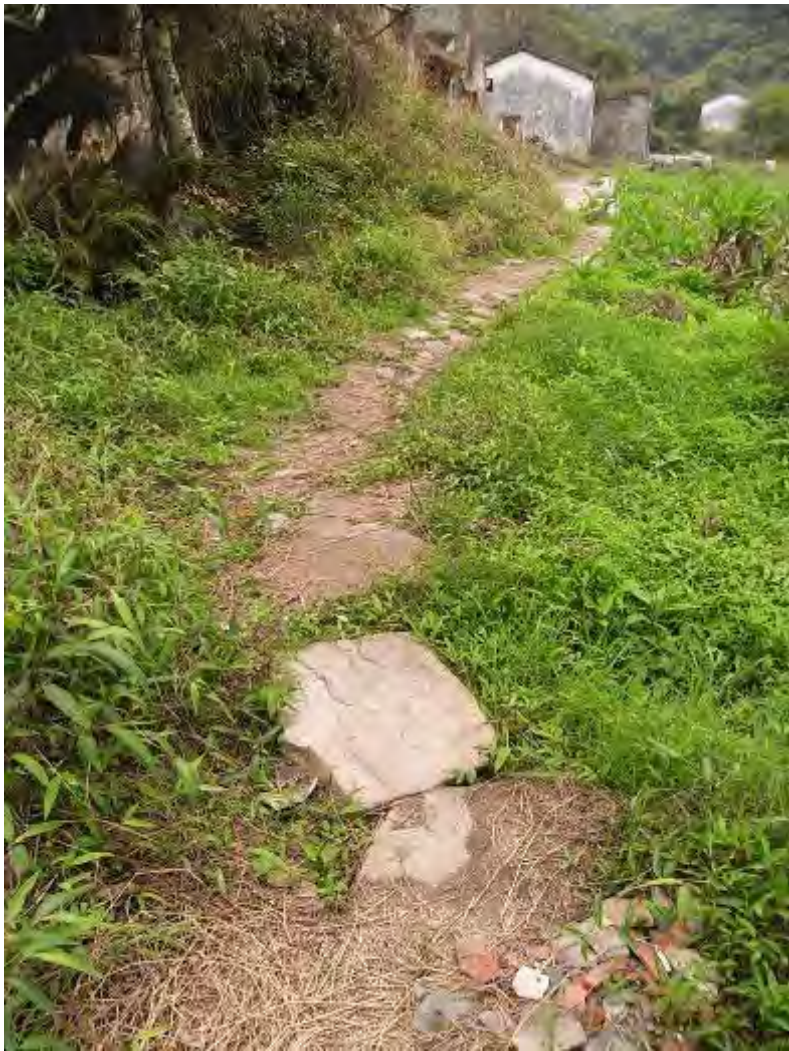
<p>Path leading to the village of Cheung Uk with boulders. (View east to west)</p>	29

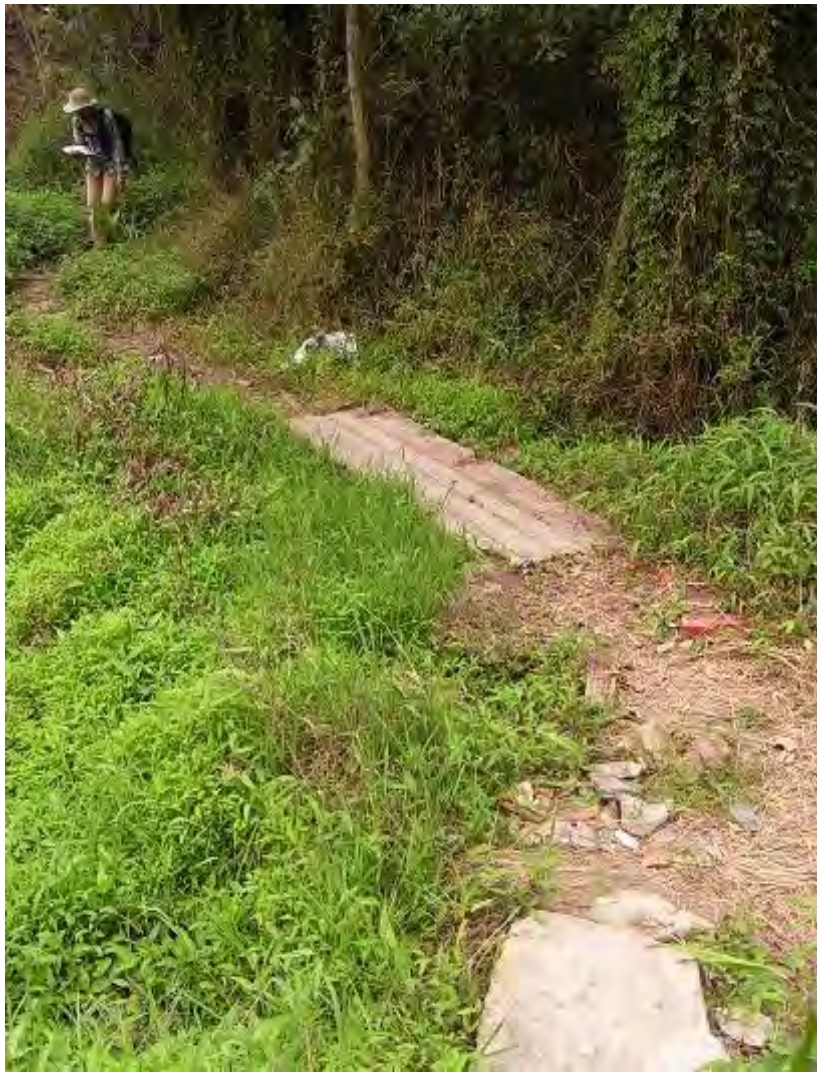
<p>A wooden bridge. (View west to east)</p>

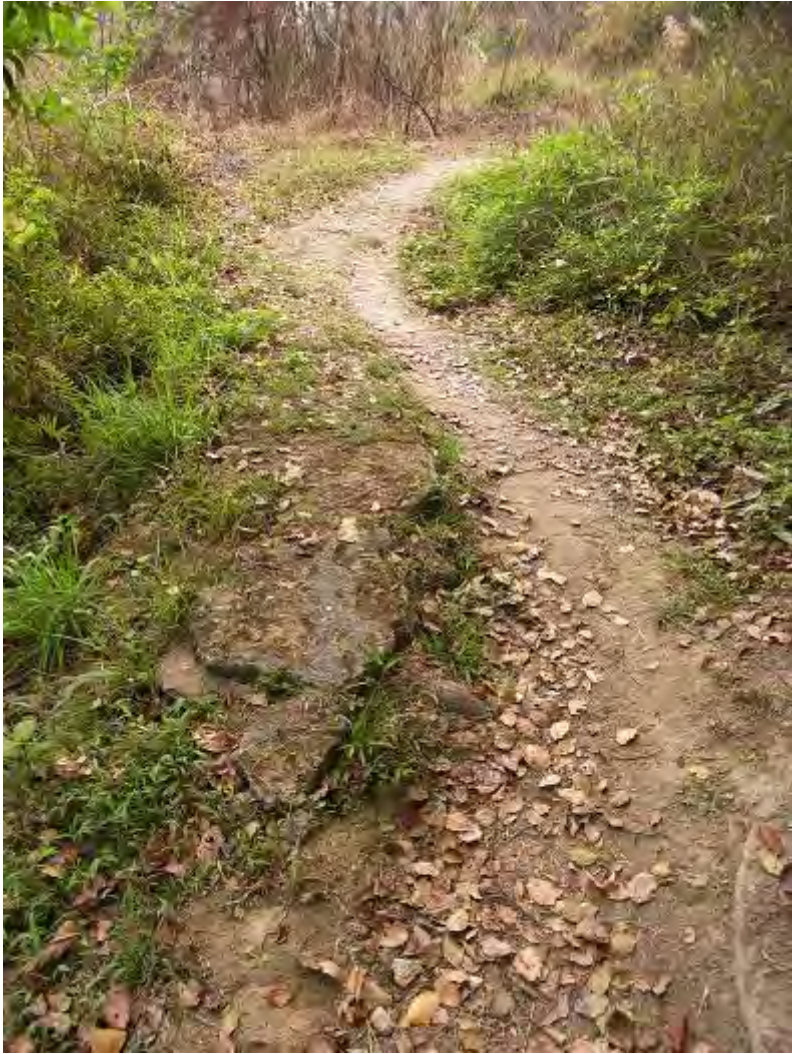
<p>Concrete reworked section. (View C to E)</p>		(Blank)

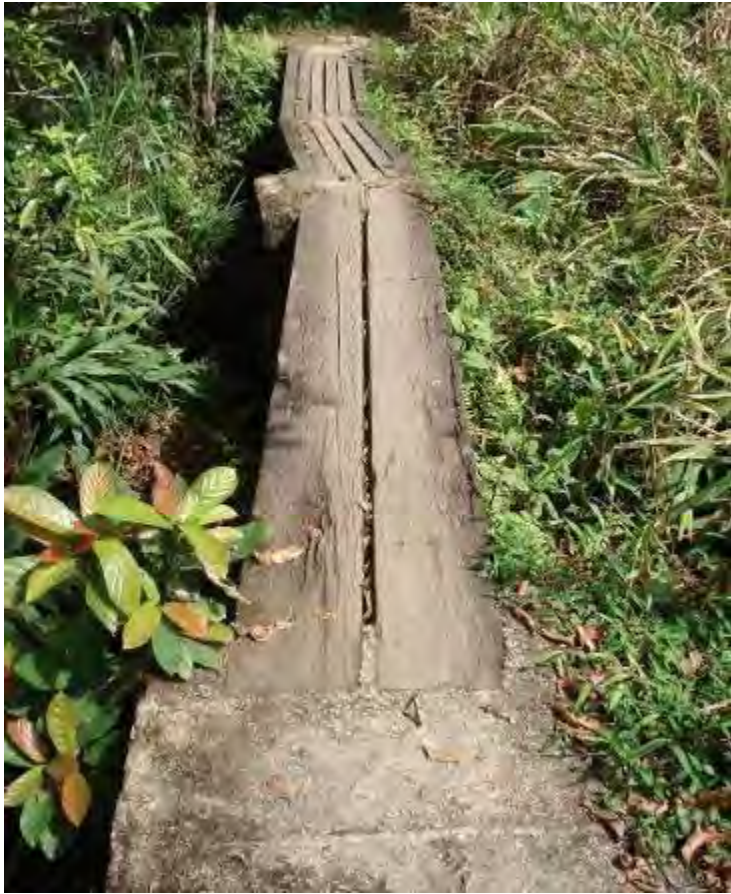
<p>Six narrow wooden planks have been used to continue the crossing to another support and then six more planks continue to the other side. Wooden planks would have been much easier to transport to here but would not last very long in the damp environment. (View C to E)</p>	F11

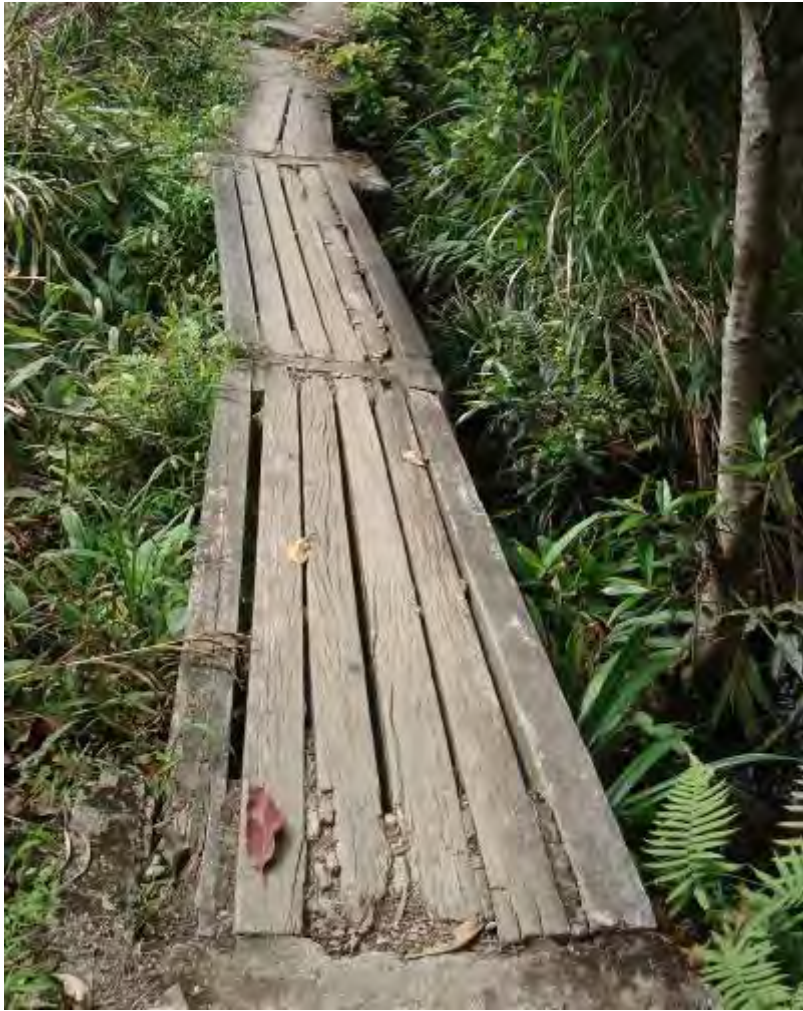
<p>The wooden plank bridge with concrete supports. (View E to C)</p>

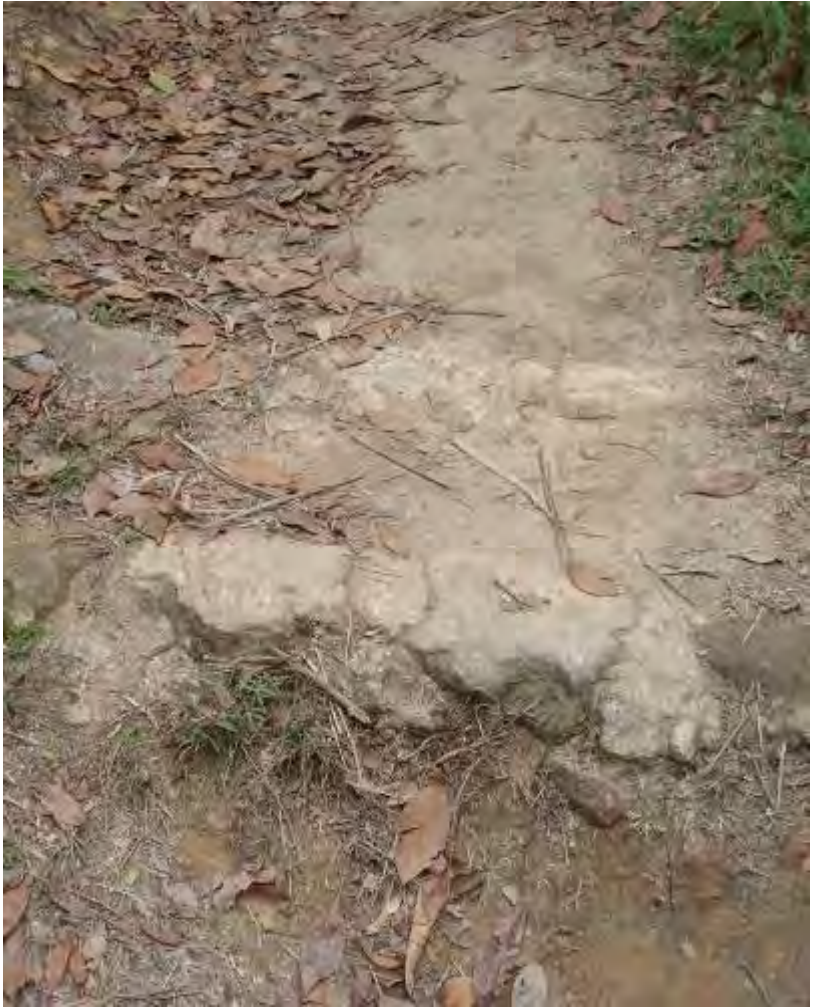
<p>Boulder and concrete built drain. (View C to E)</p>

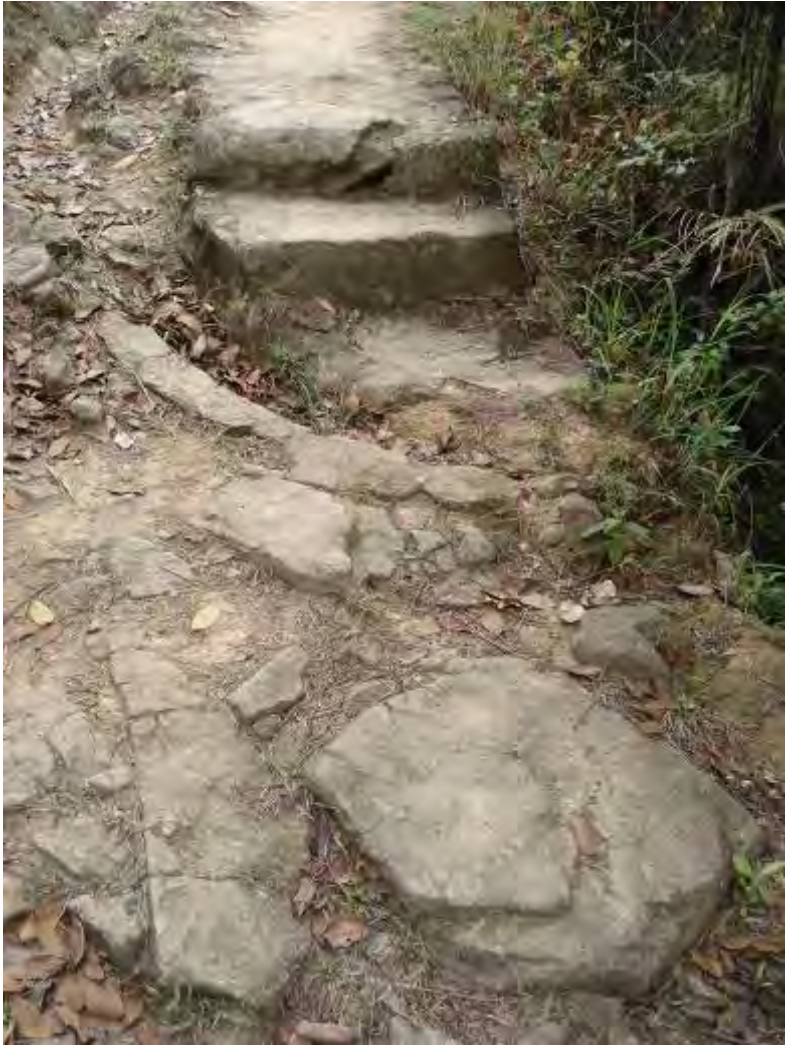
<p>Boulders and concrete reworked path and steps. (View C to E)</p>	32

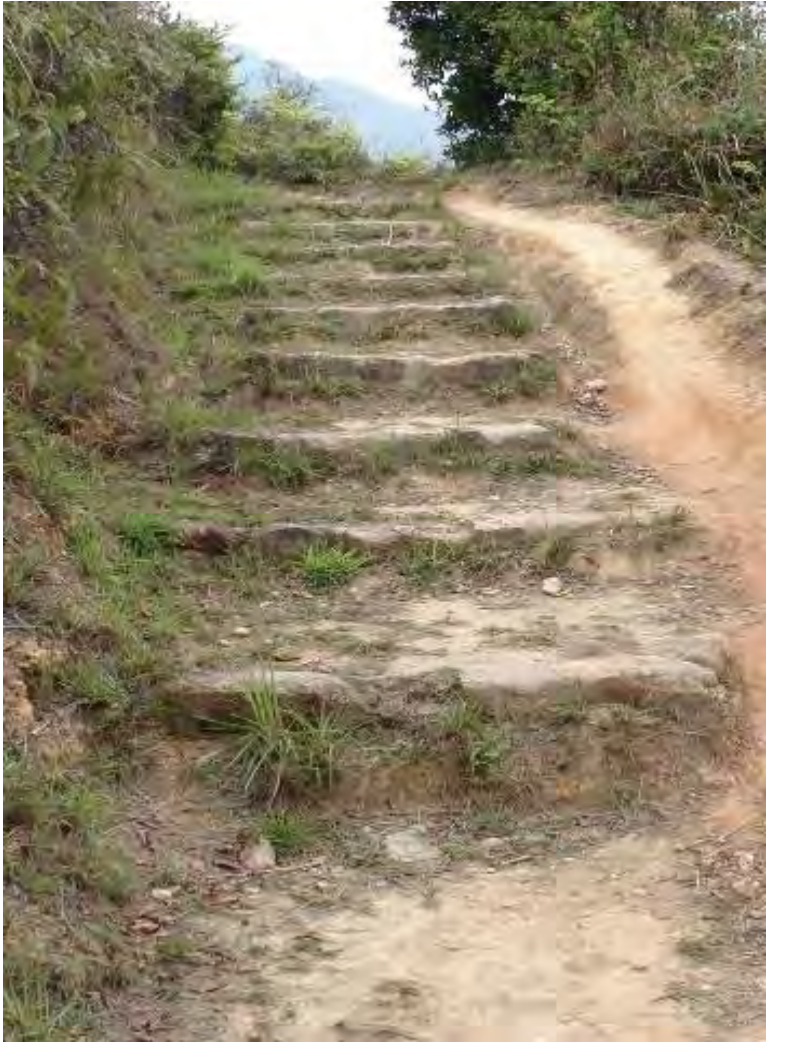
<p>Boulders, mud and concrete reworked steps. (View C to E)</p>

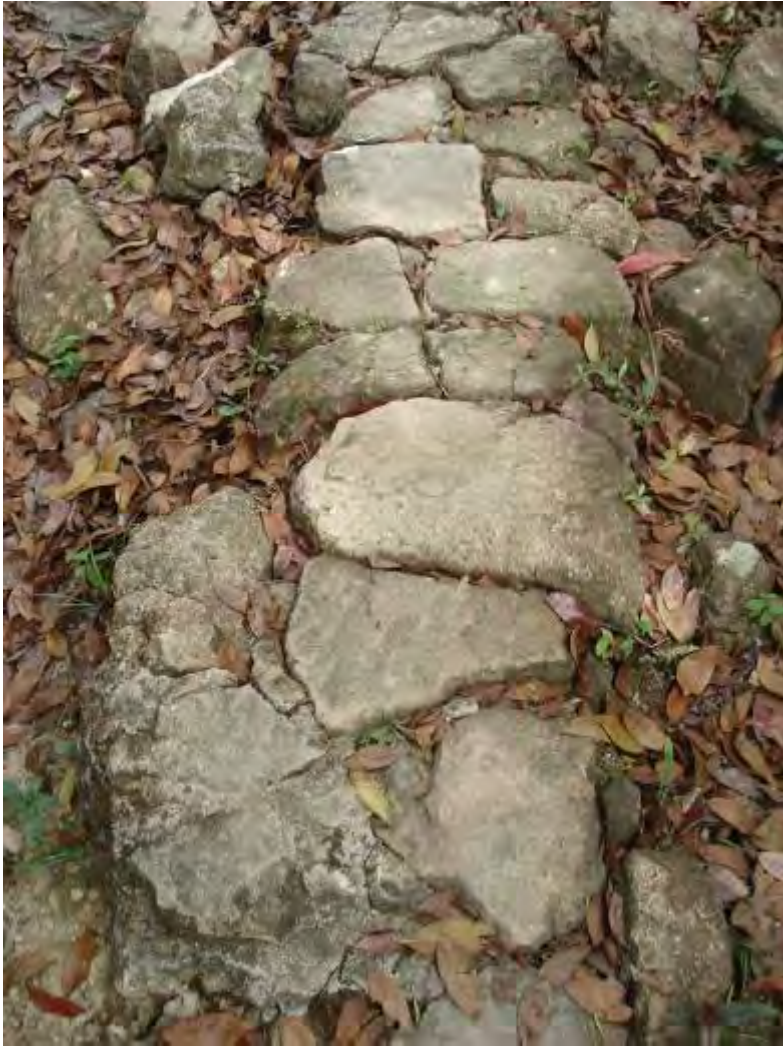
<p>Close-up of steps. (View C to E)</p>	35

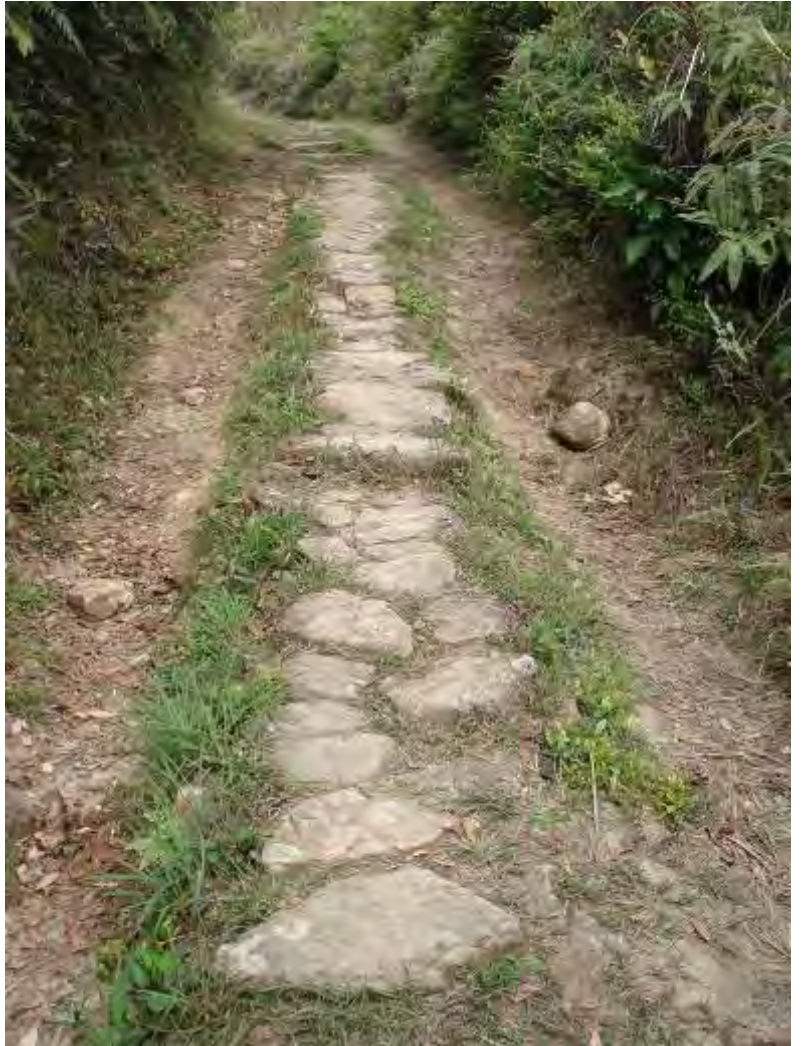
<p>Boulder section with mud path on both sides. (View C to E)</p>

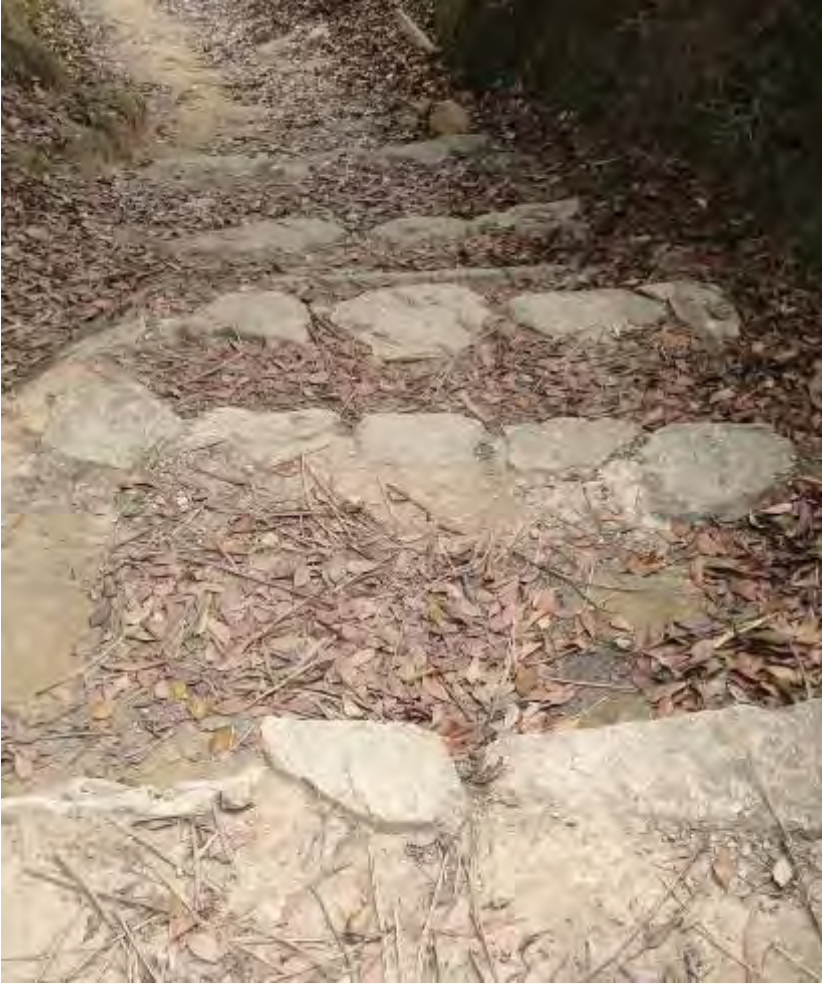
<p>Mud steps reinforced by boulders. (View C to E)</p>	40

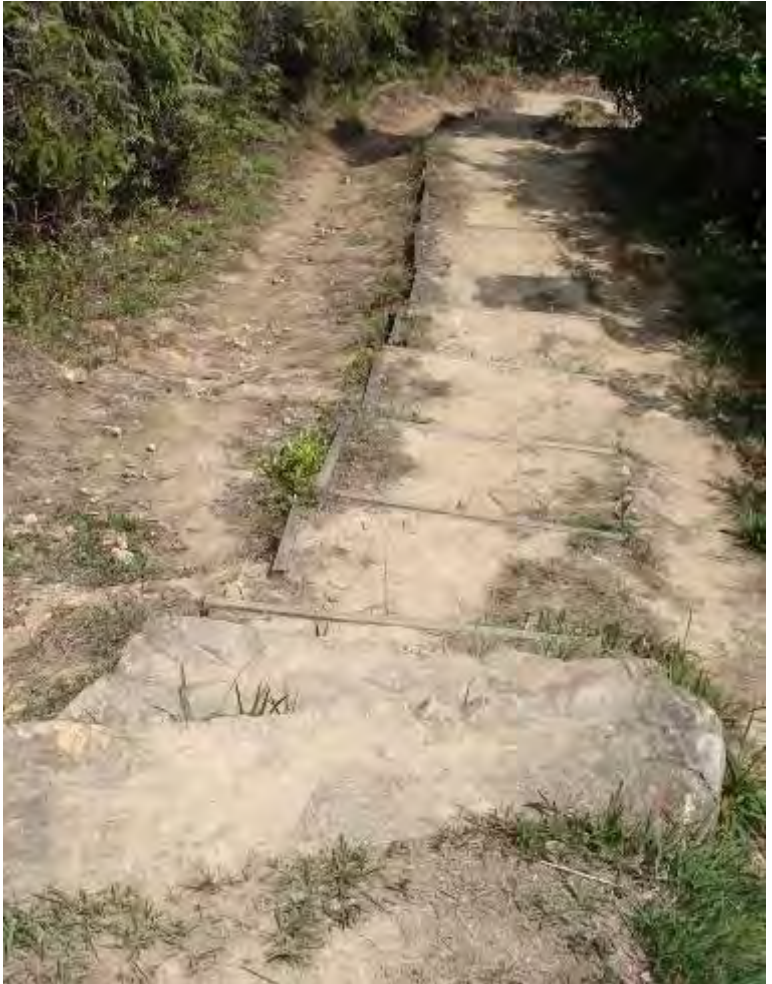
<p>Mud steps reinforced by wooden boards and occasional boulder and concrete steps. (View C to E)</p>

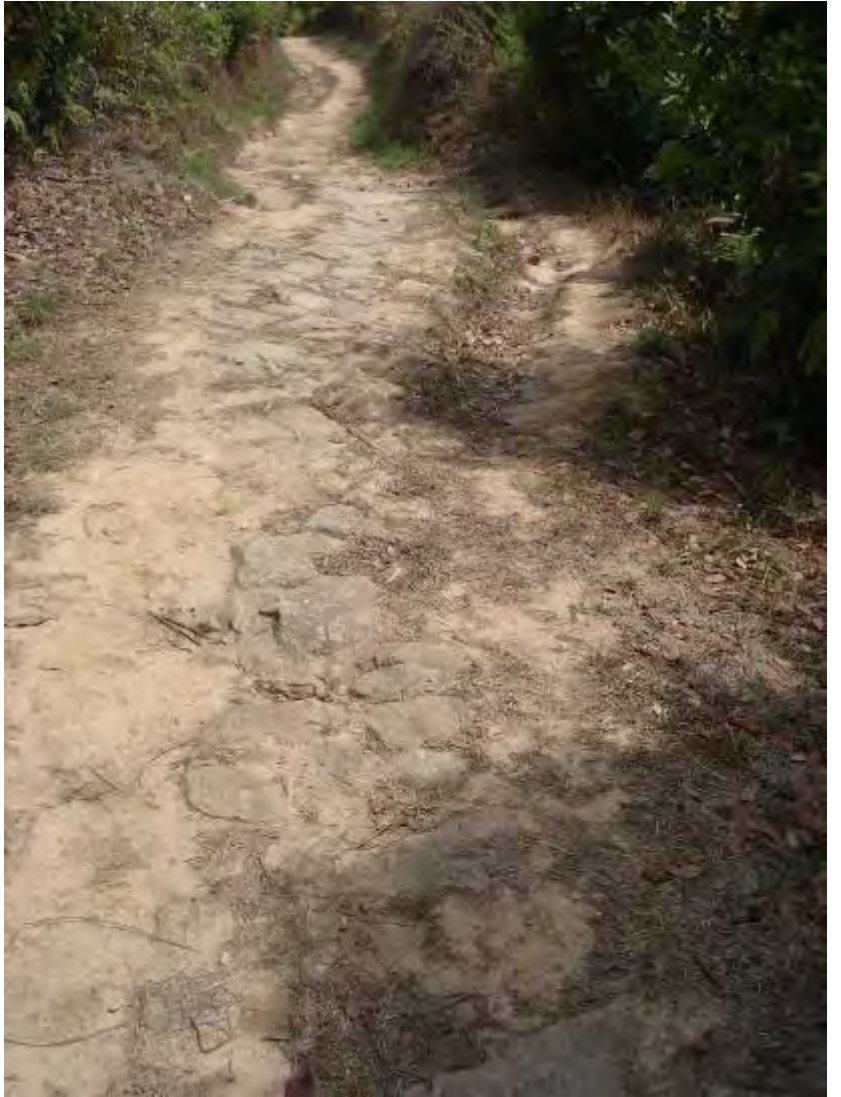
<p>Boulder section appears. (View C to E)</p>

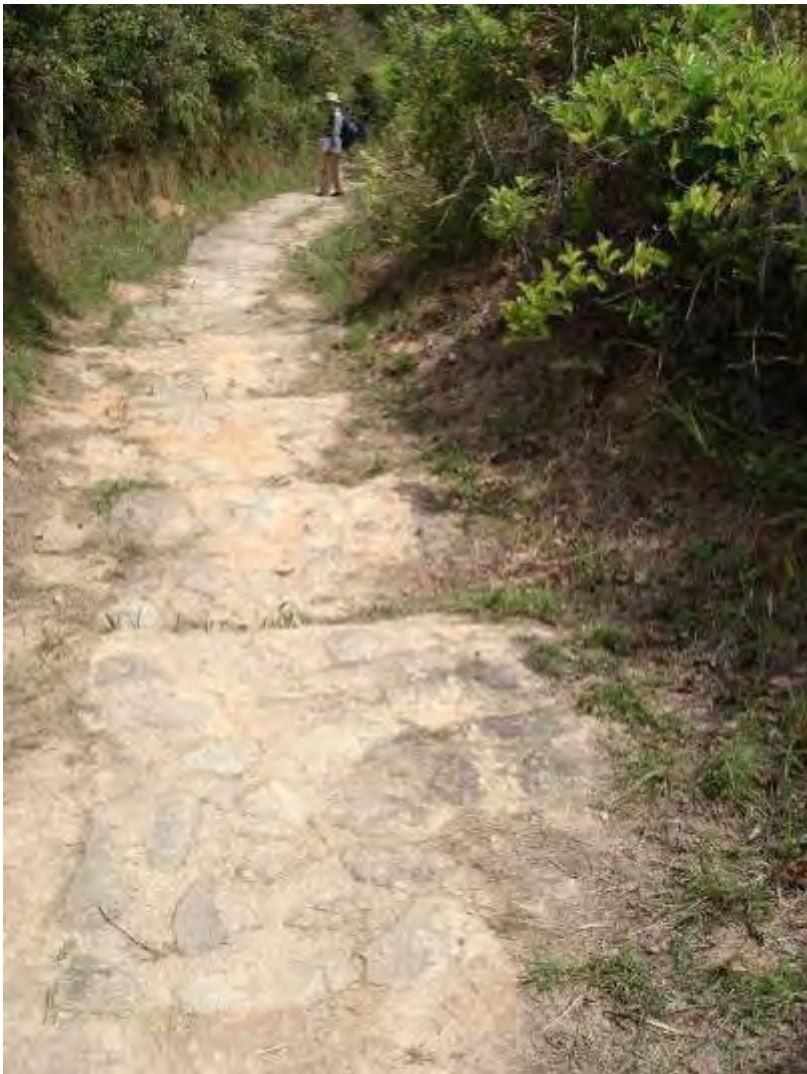
<p>Boulder and concrete reworked section. (View C to E)</p>	F13

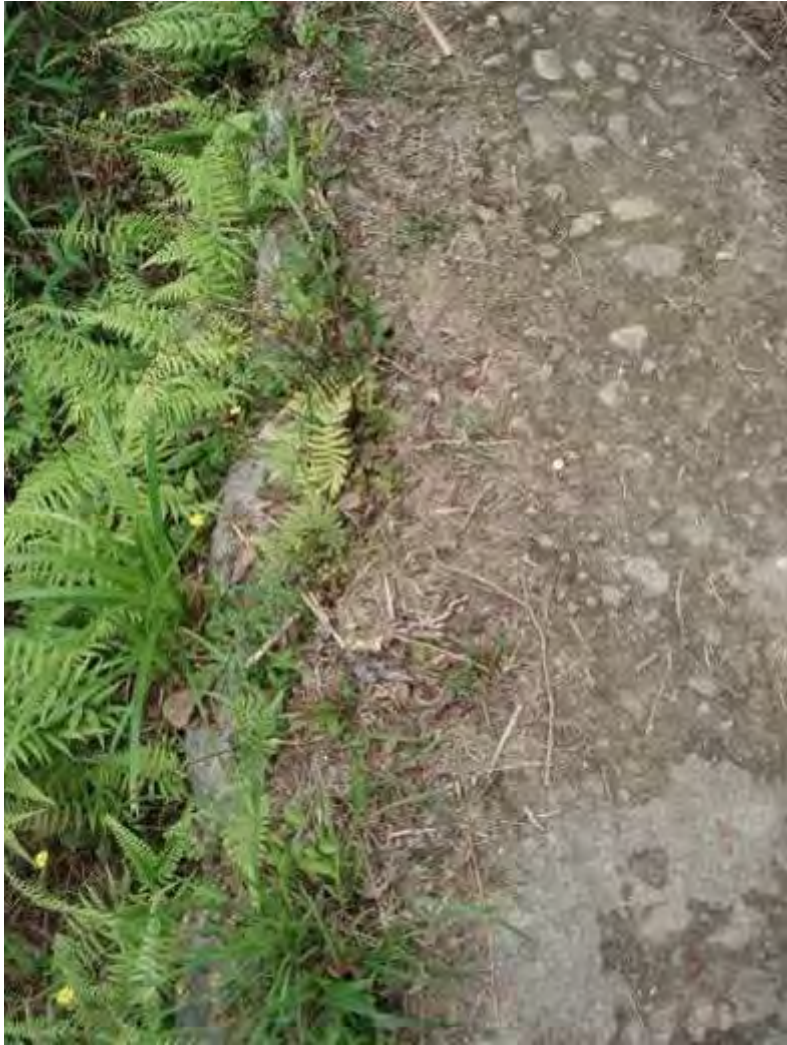
<p>Reworked section with concrete covering the boulders. (View C to E)</p>	45

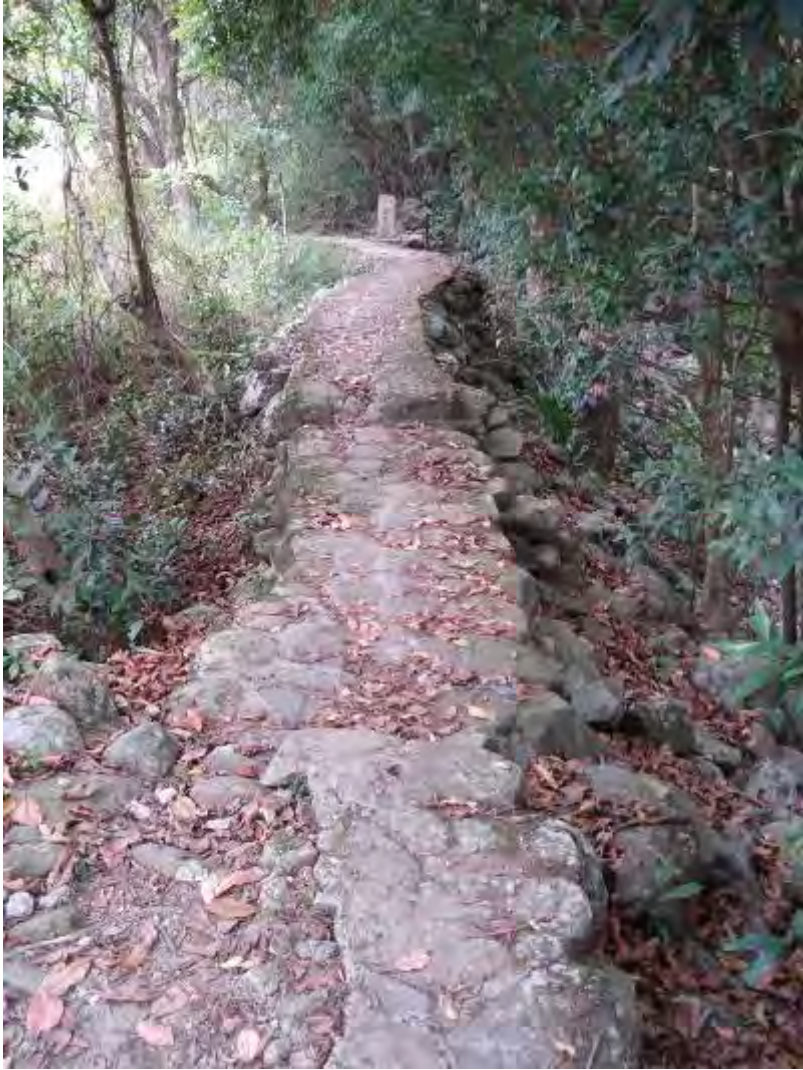
<p data-bbox="322 1347 1055 1378">Boulders and concrete reworked section. (View C to E)</p>	F14

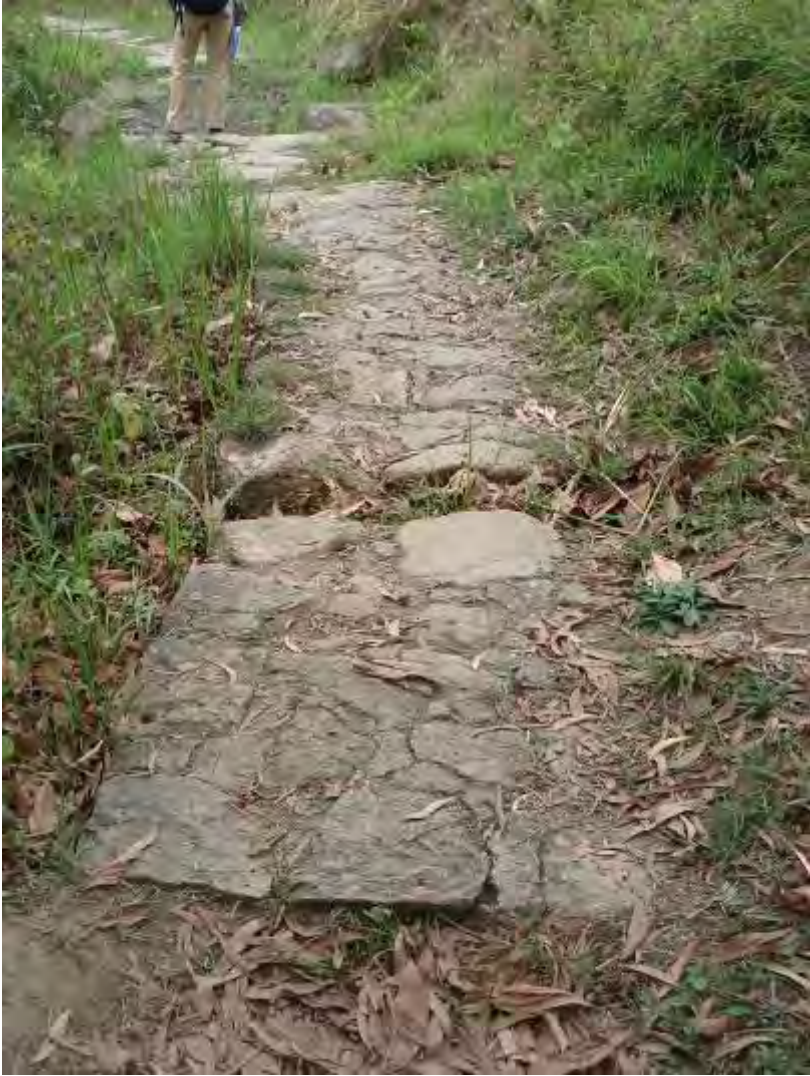
<p>Boulders and concrete reworked section. (View C to E)</p>	48
