Antiquities and Monuments Office

Study on Old Trails in Hong Kong - Final Study Report

February 2014

Study on Old Trails in Hong Kong: *Final Study Report*

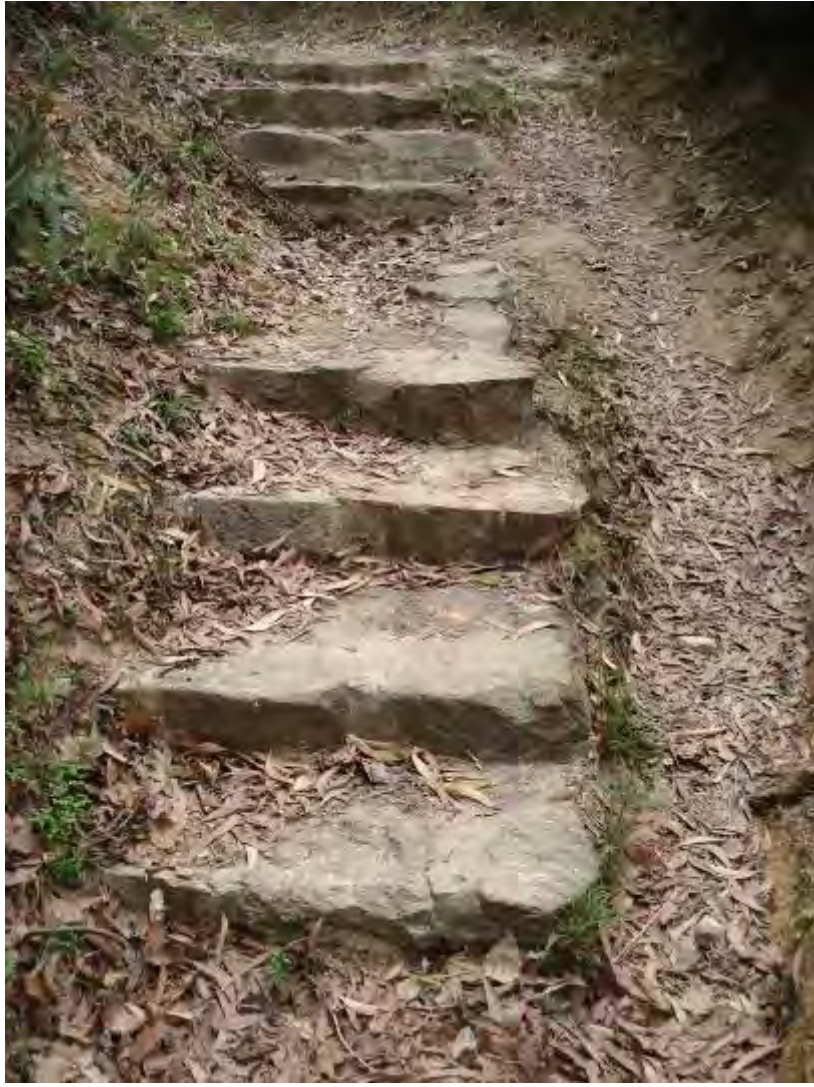
<p>Boulders and concrete reworked section. (View E to C)</p>

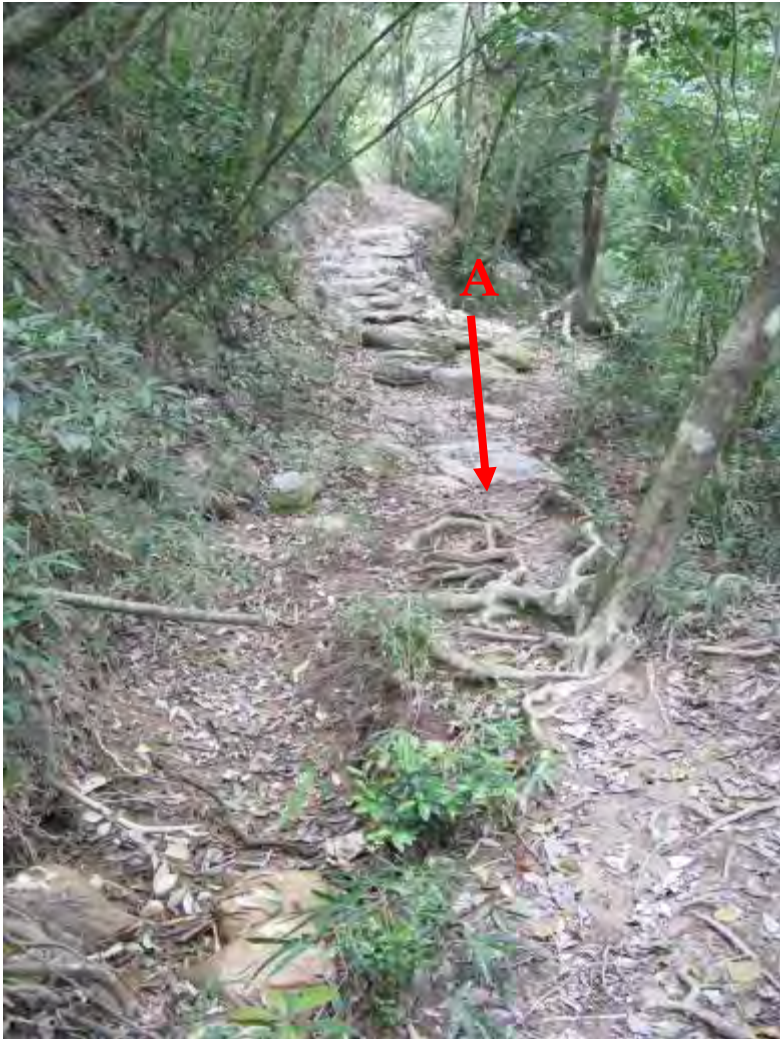
<p>Start point A. (view A to B)</p>	F1

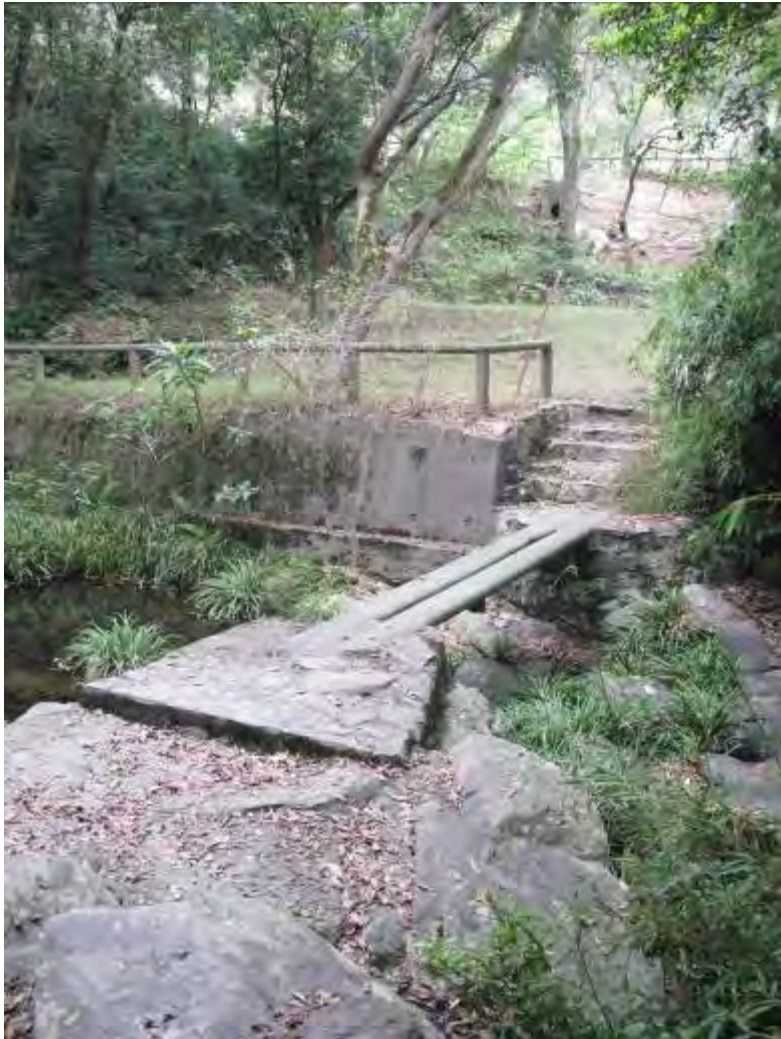
<p>A two stone slabs bridge</p>

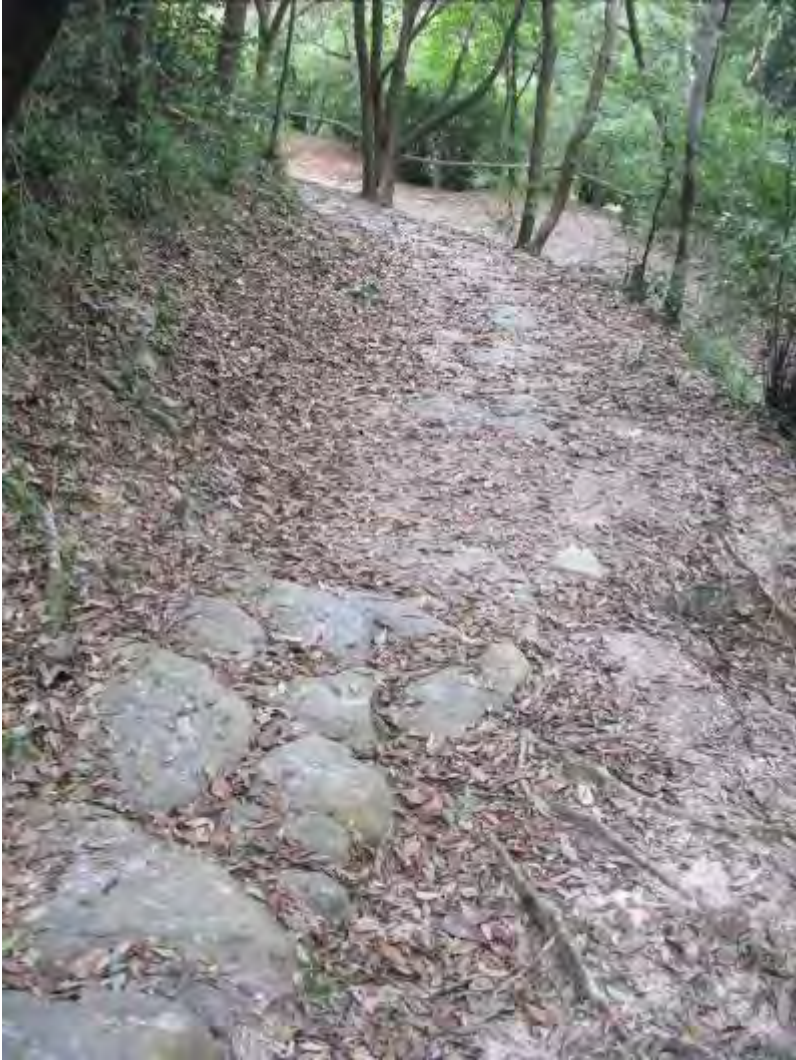
Photo Reference No.	Photographic Records	Photo Reference No.	Photographic Records
1

<p>Typical view of the boulder section (covered with abundant dry leaves). (View A to B)</p>	2

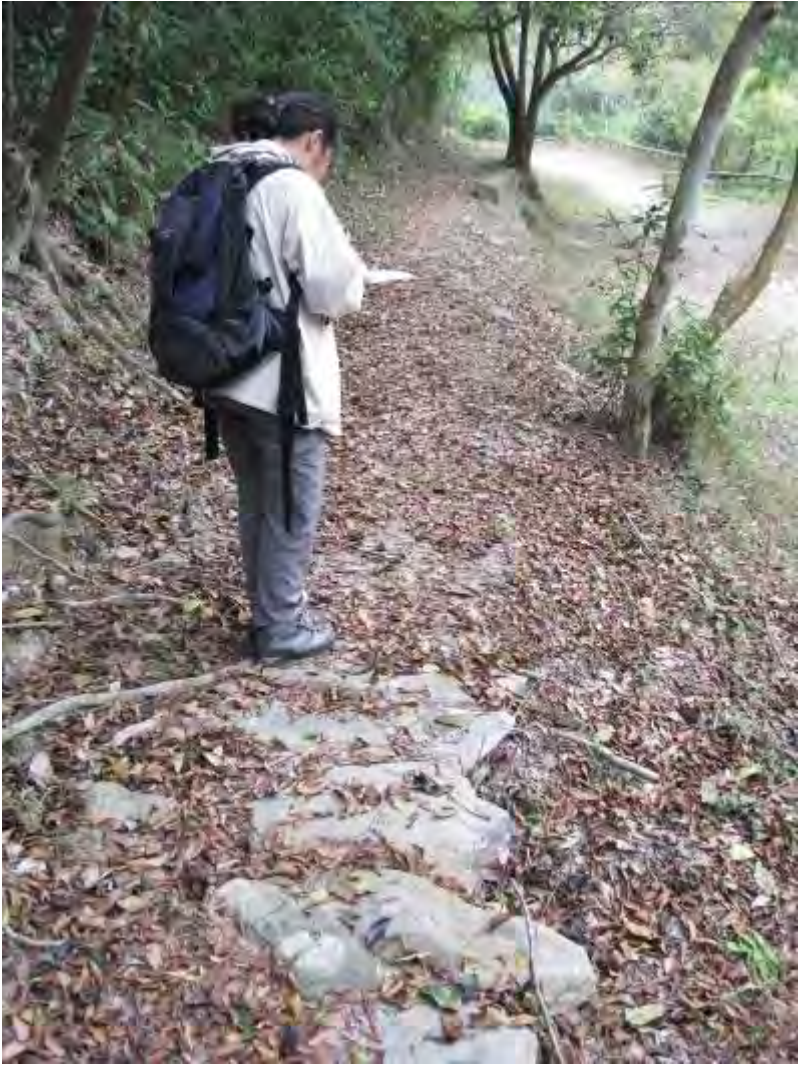
<p>Typical view of the boulder section. (View A to B)</p>

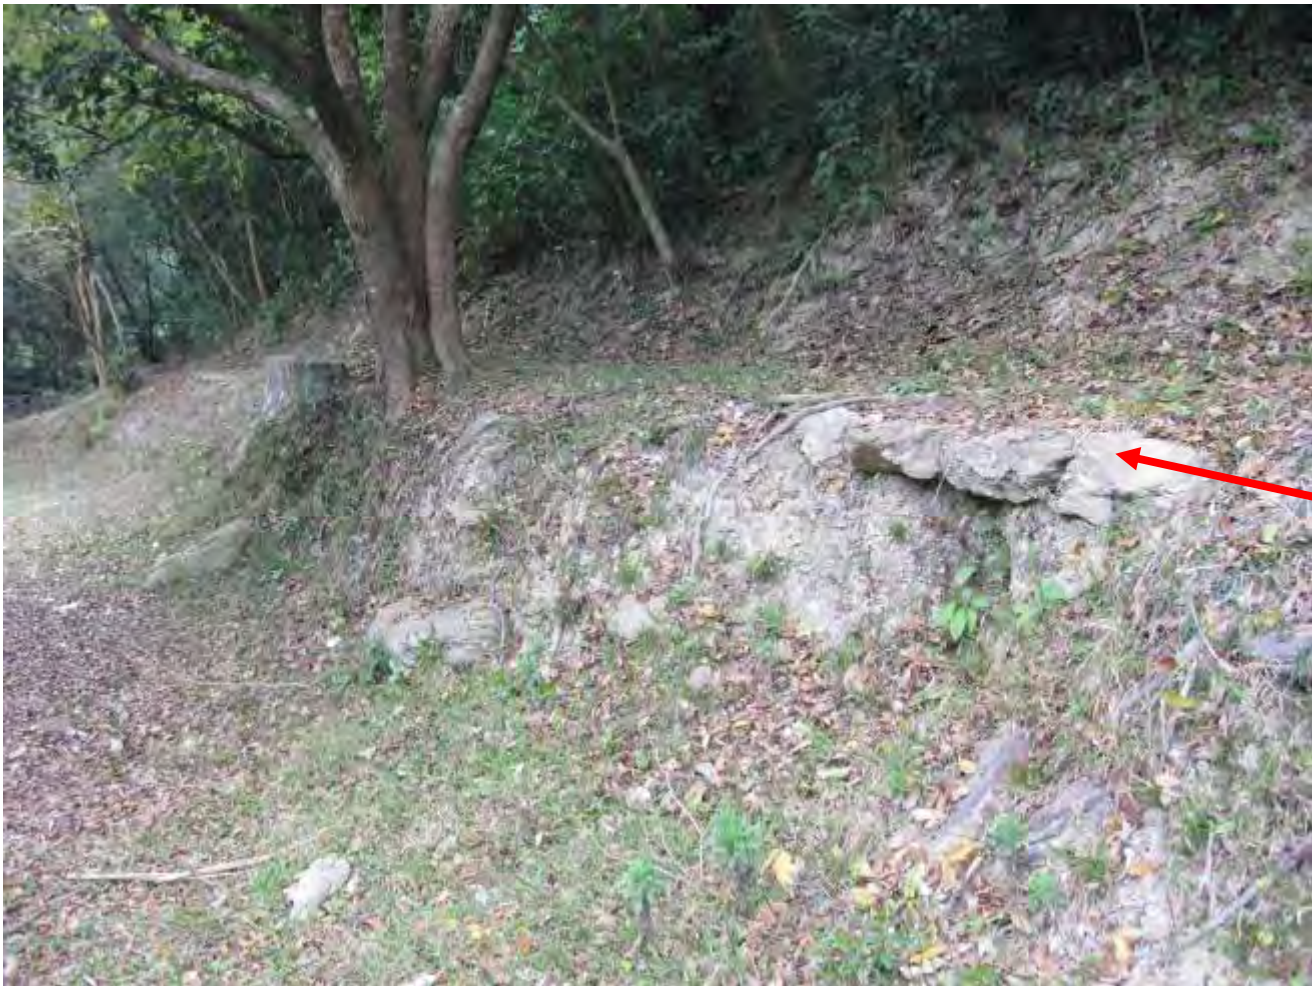
Photo Reference No.	Photographic Records
3

<p data-bbox="1966 842 2083 951">Boulder footpath surface</p> <p data-bbox="779 1299 1603 1331">Cross section view of the boulder section. (View south to north)</p>

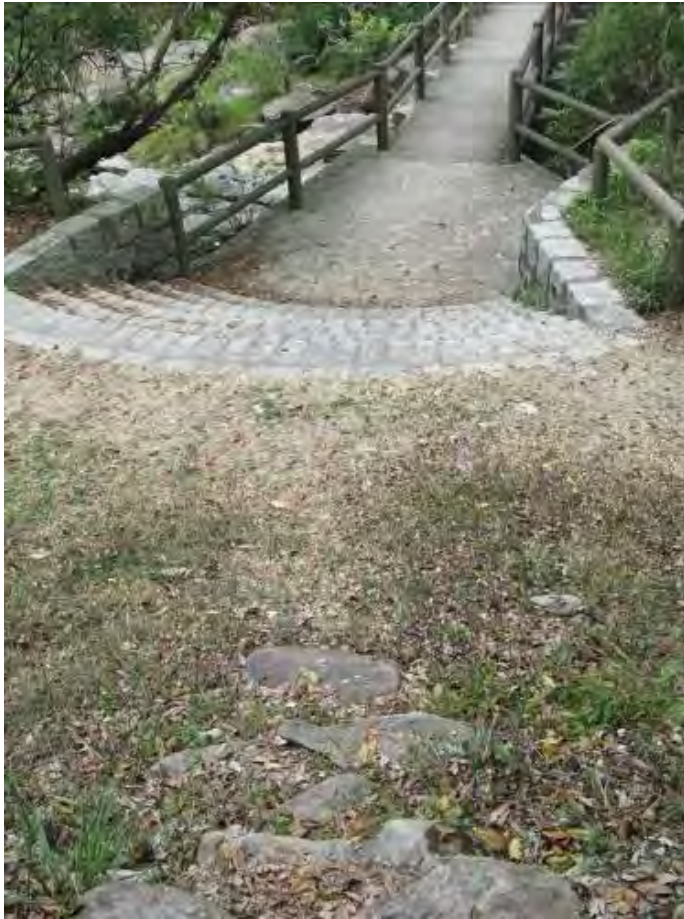
Photo Reference No.	Photographic Records	Photo Reference No.	Photographic Records
4

<p>After crossing a footbridge and reaching the modern steps, the boulder footpath is in front of you. (View from boulder footpath to the footbridge).</p>	5

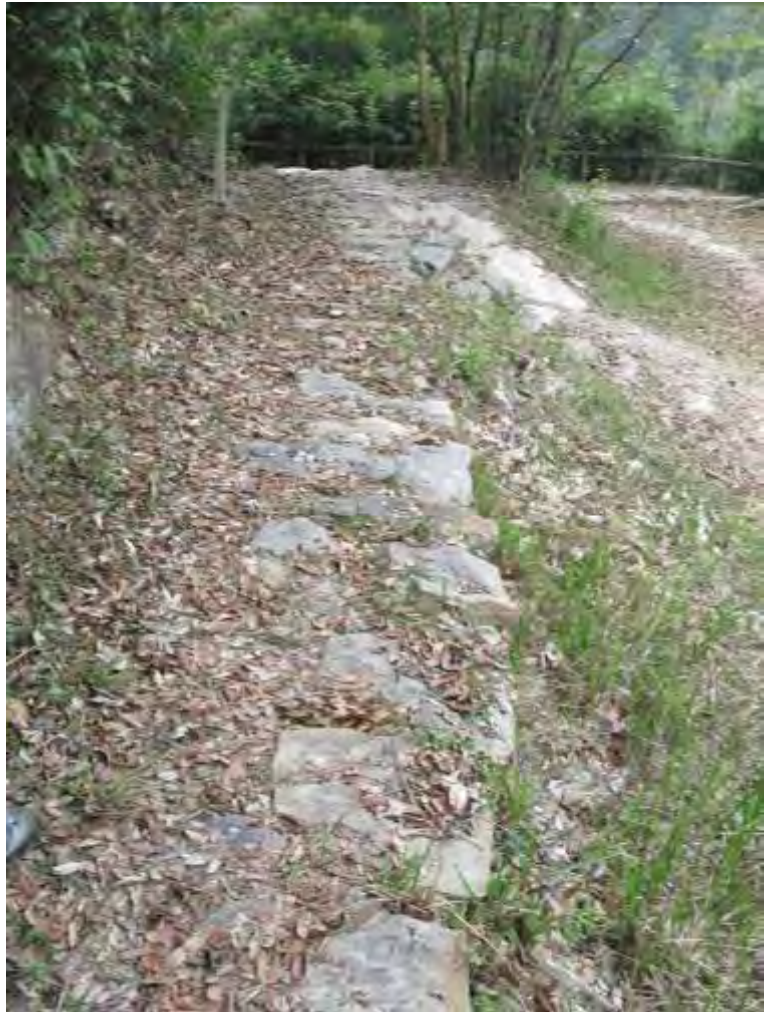
<p>Typical view of boulder section. (View from A to B)</p>

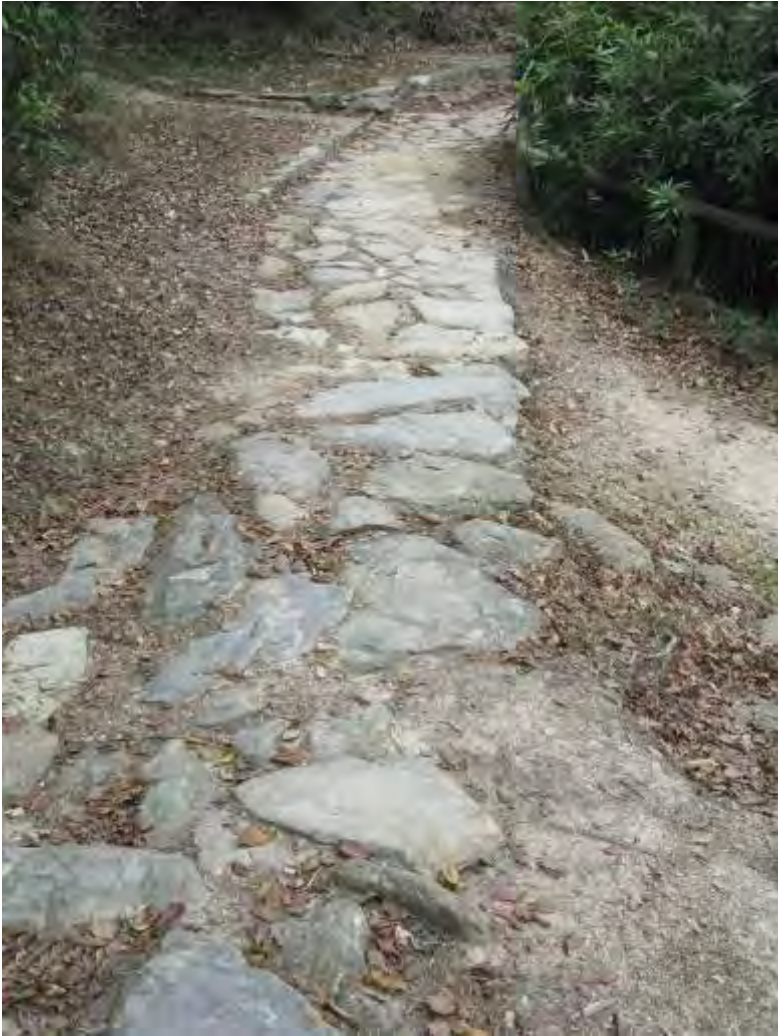
Photo Reference No.	Photographic Records	Photo Reference No.	Photographic Records
6

<p>Typical view of boulder section. (View from A to B)</p>		(Blank)

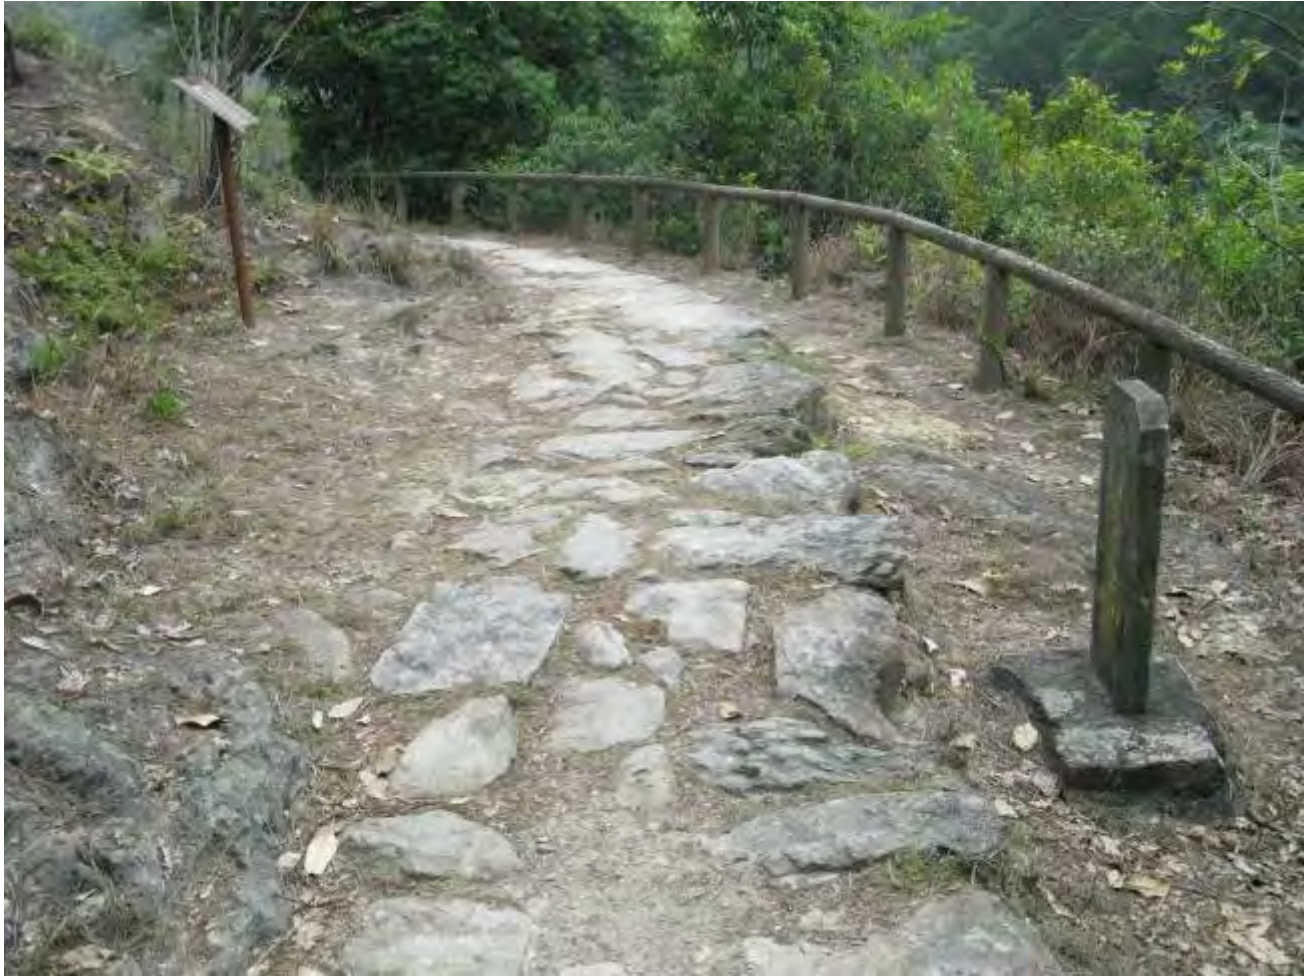
Photo Reference No.	Photographic Records
8

<p data-bbox="815 1251 1561 1286">General view of the boulder footpath. (View from A to B)</p>

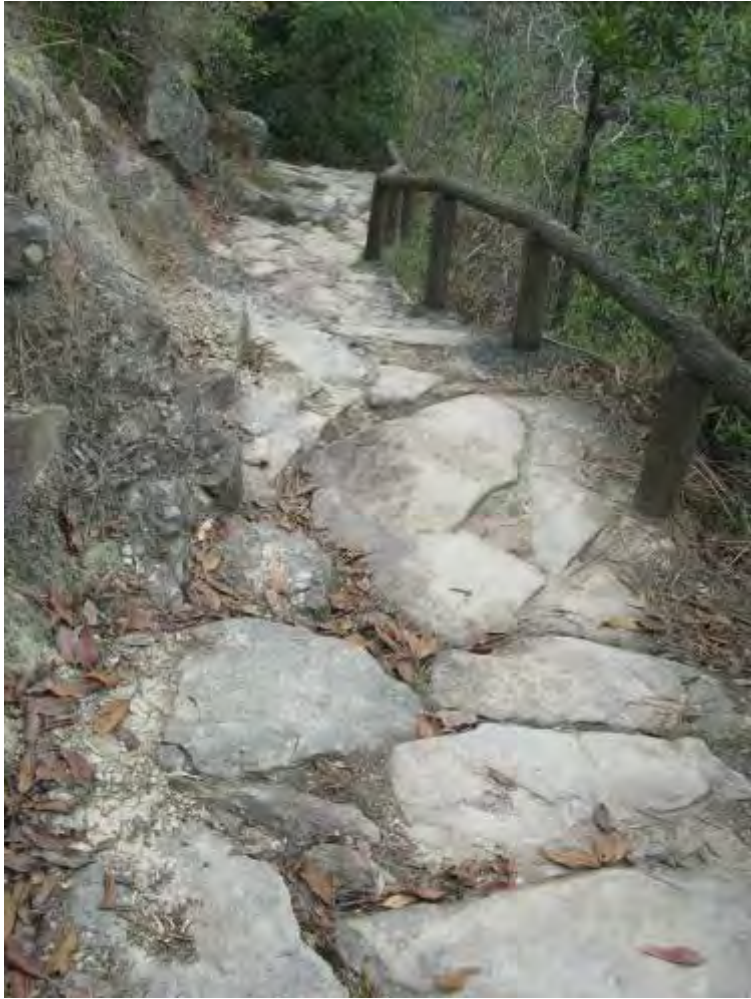
<p>General view of the boulder section. (View from A to B)</p>

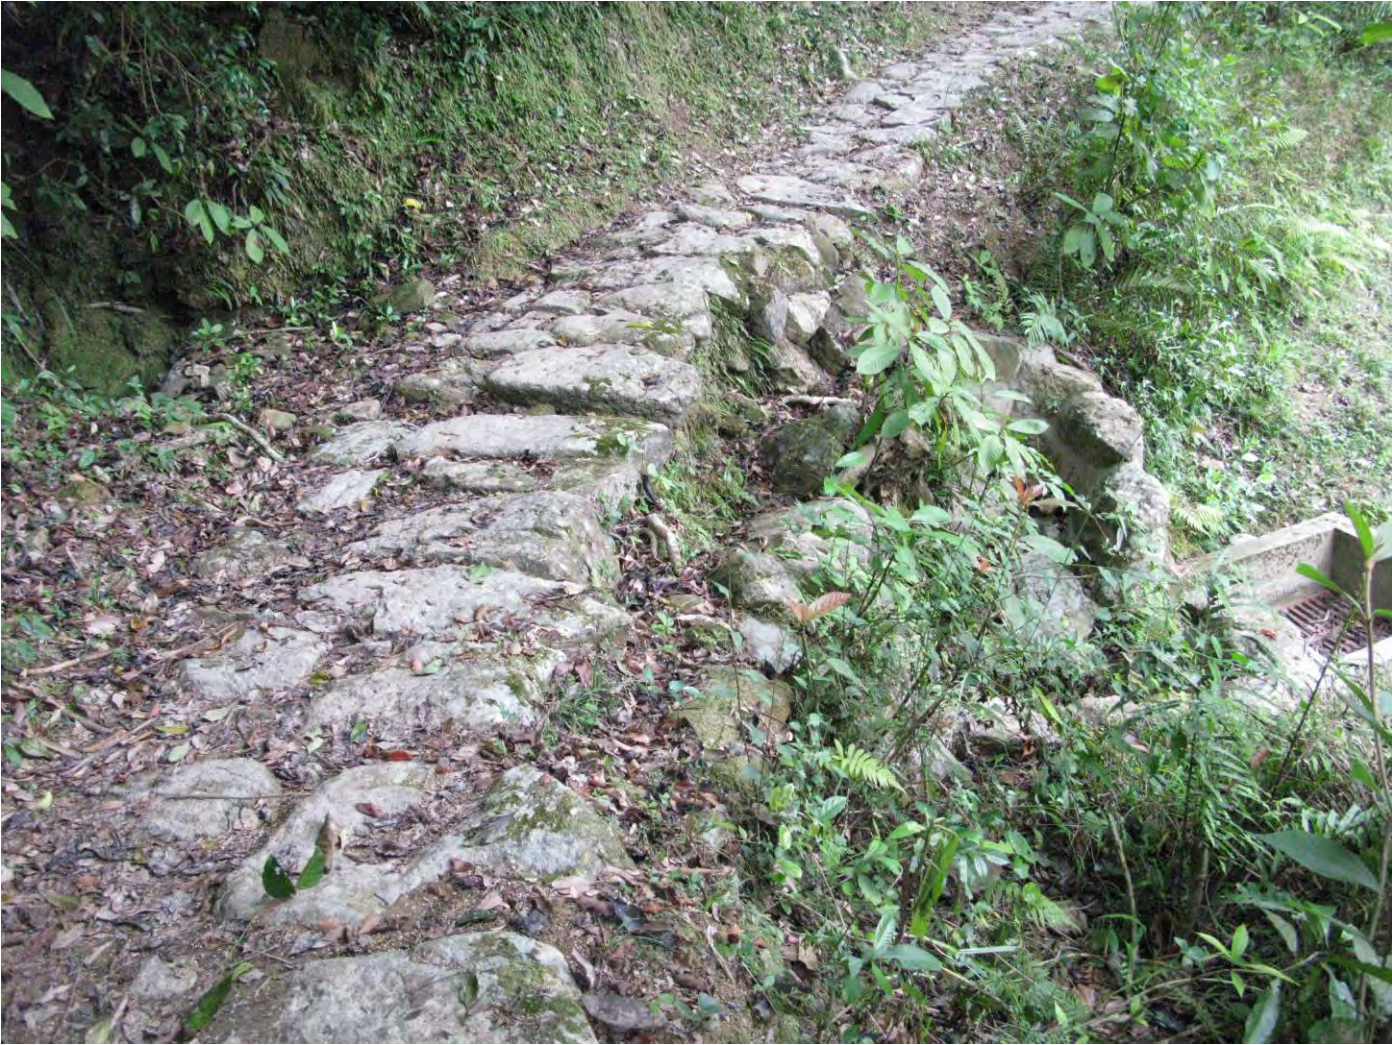
Photo Reference No.	Photographic Records
11

<p data-bbox="862 1321 1516 1353">General view of the boulder section. (View A to B)</p>

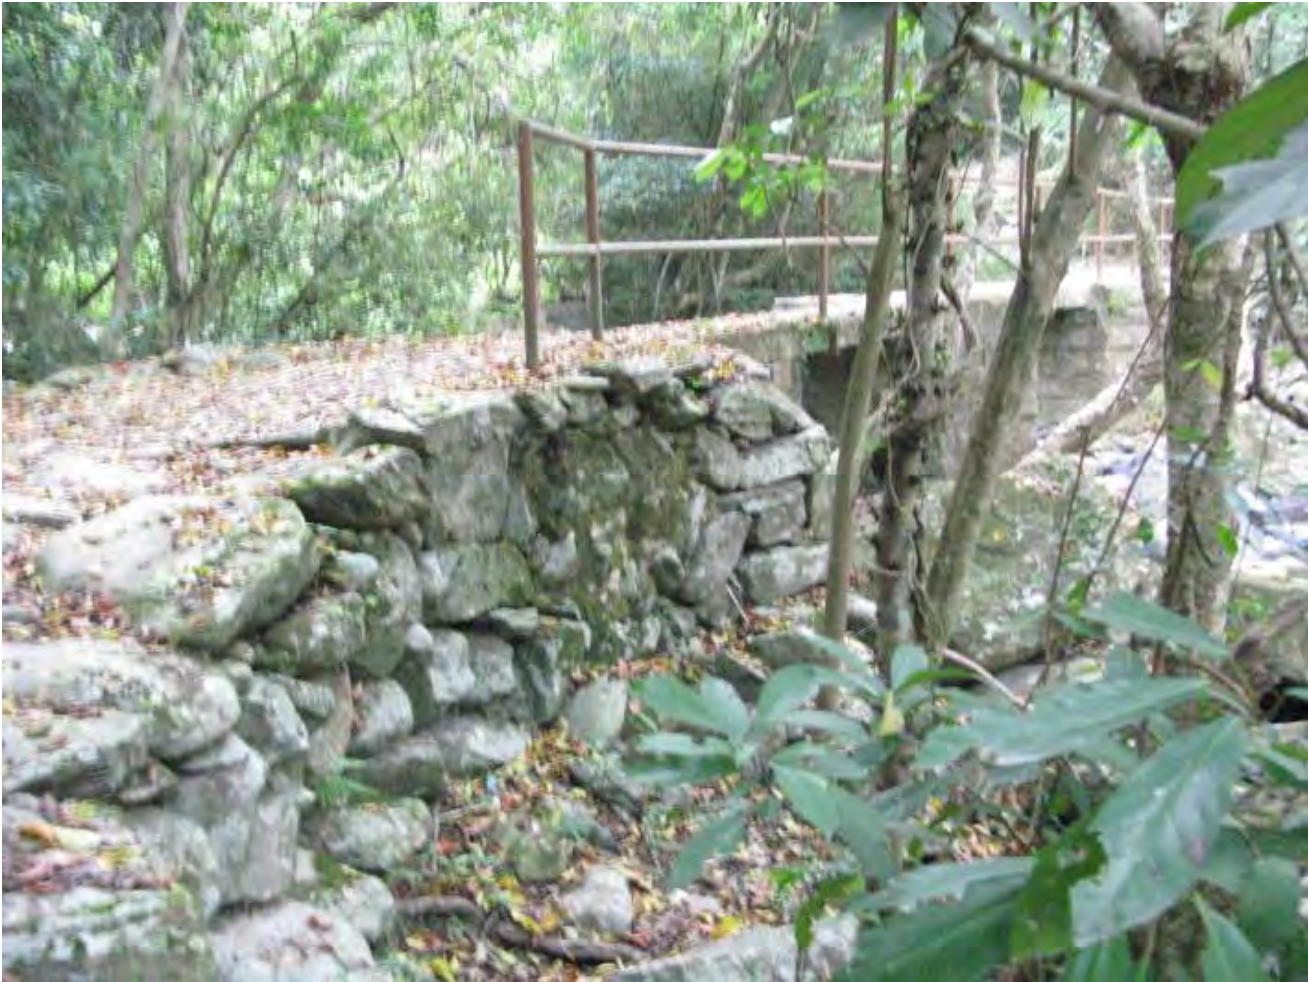
Photo Reference No.	Photographic Records
13

<p data-bbox="875 1257 1503 1294">General view of a bridge crossing. (View A to B)</p>

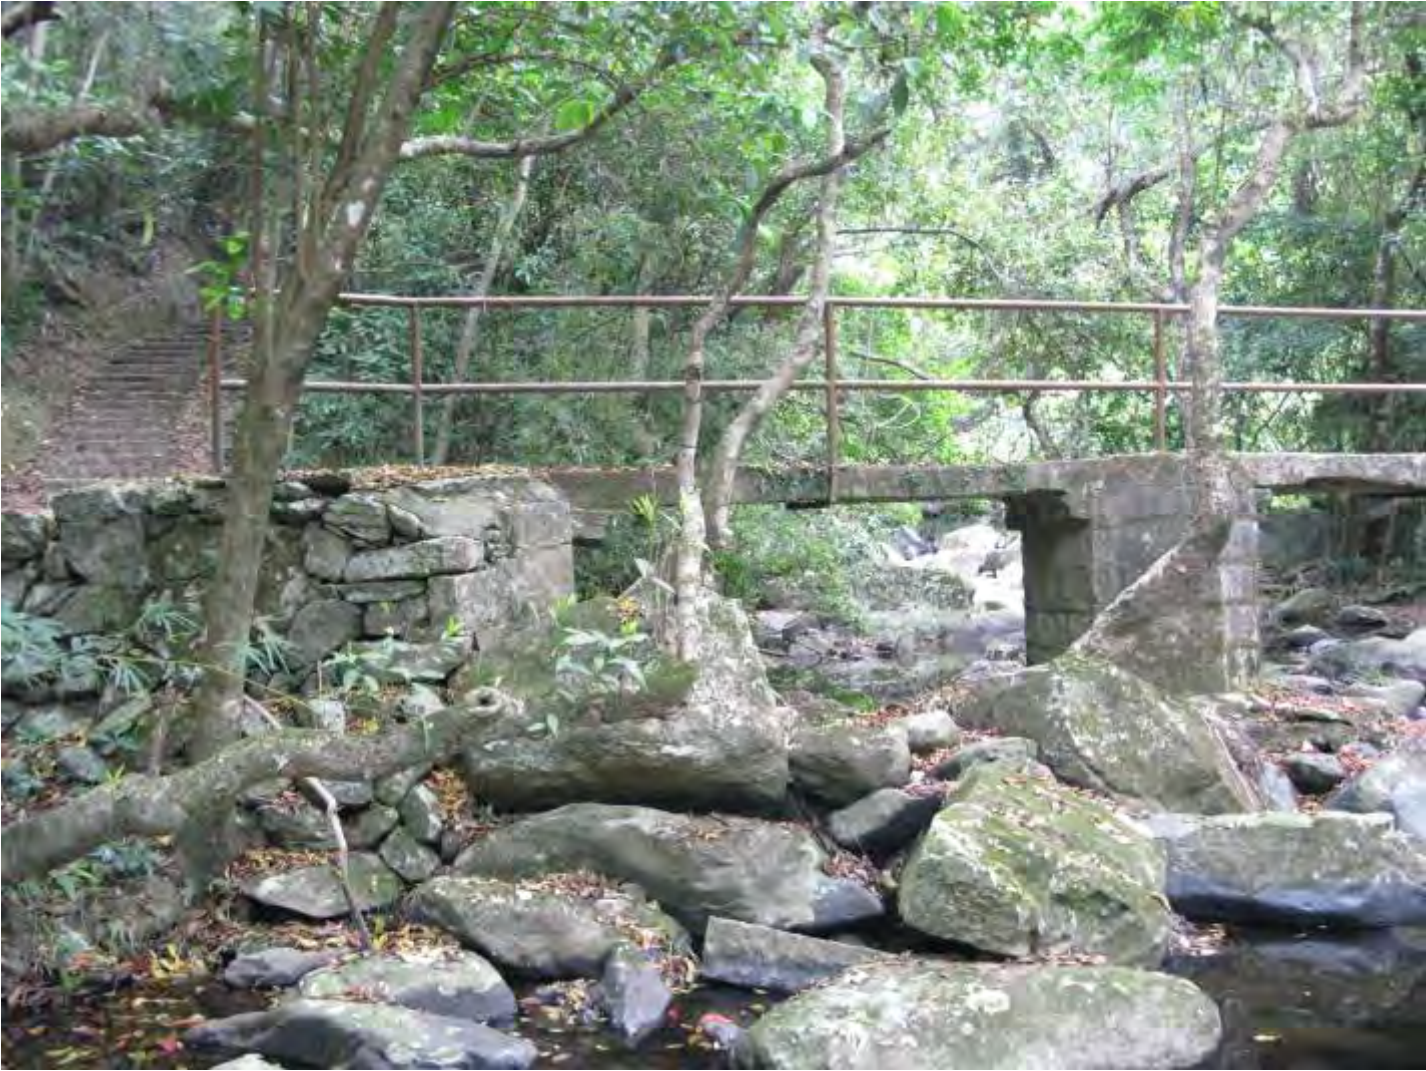
Photo Reference No.	Photographic Records
F2

<p data-bbox="853 1345 1525 1380">Section view of the Bridge. (View from west to east)</p>

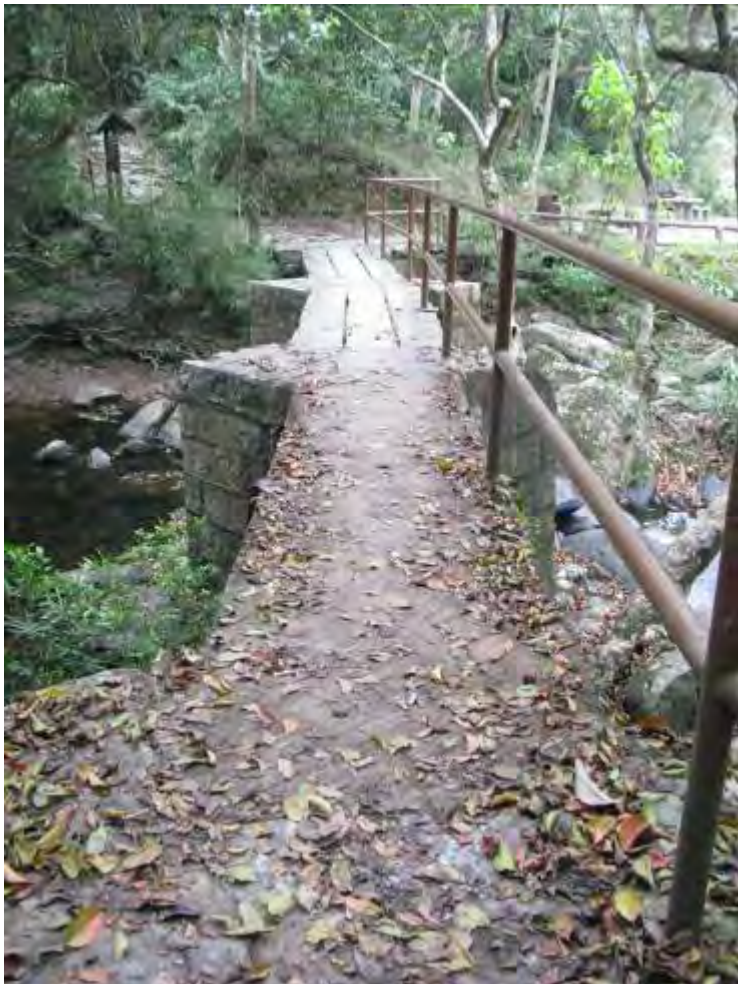
<p>First part of the bridge is concrete paved. (View A to B)</p>	F2

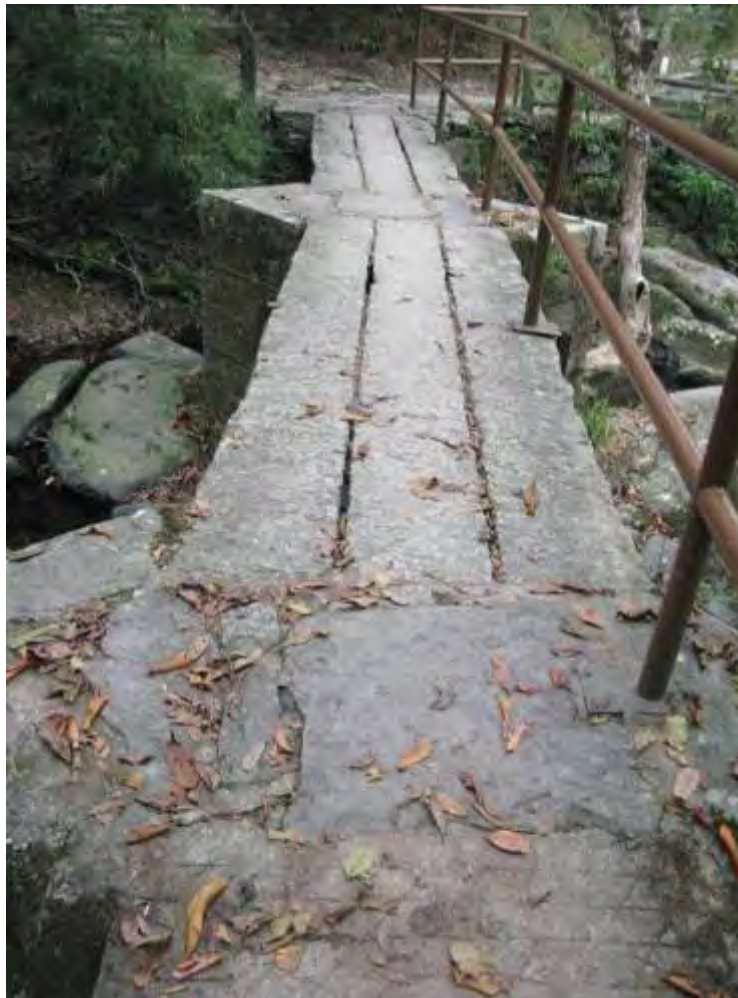
<p>Stone bases supporting the first and second part of the bridge. Second part is paved with 3 granite slabs. (View A to B)</p>

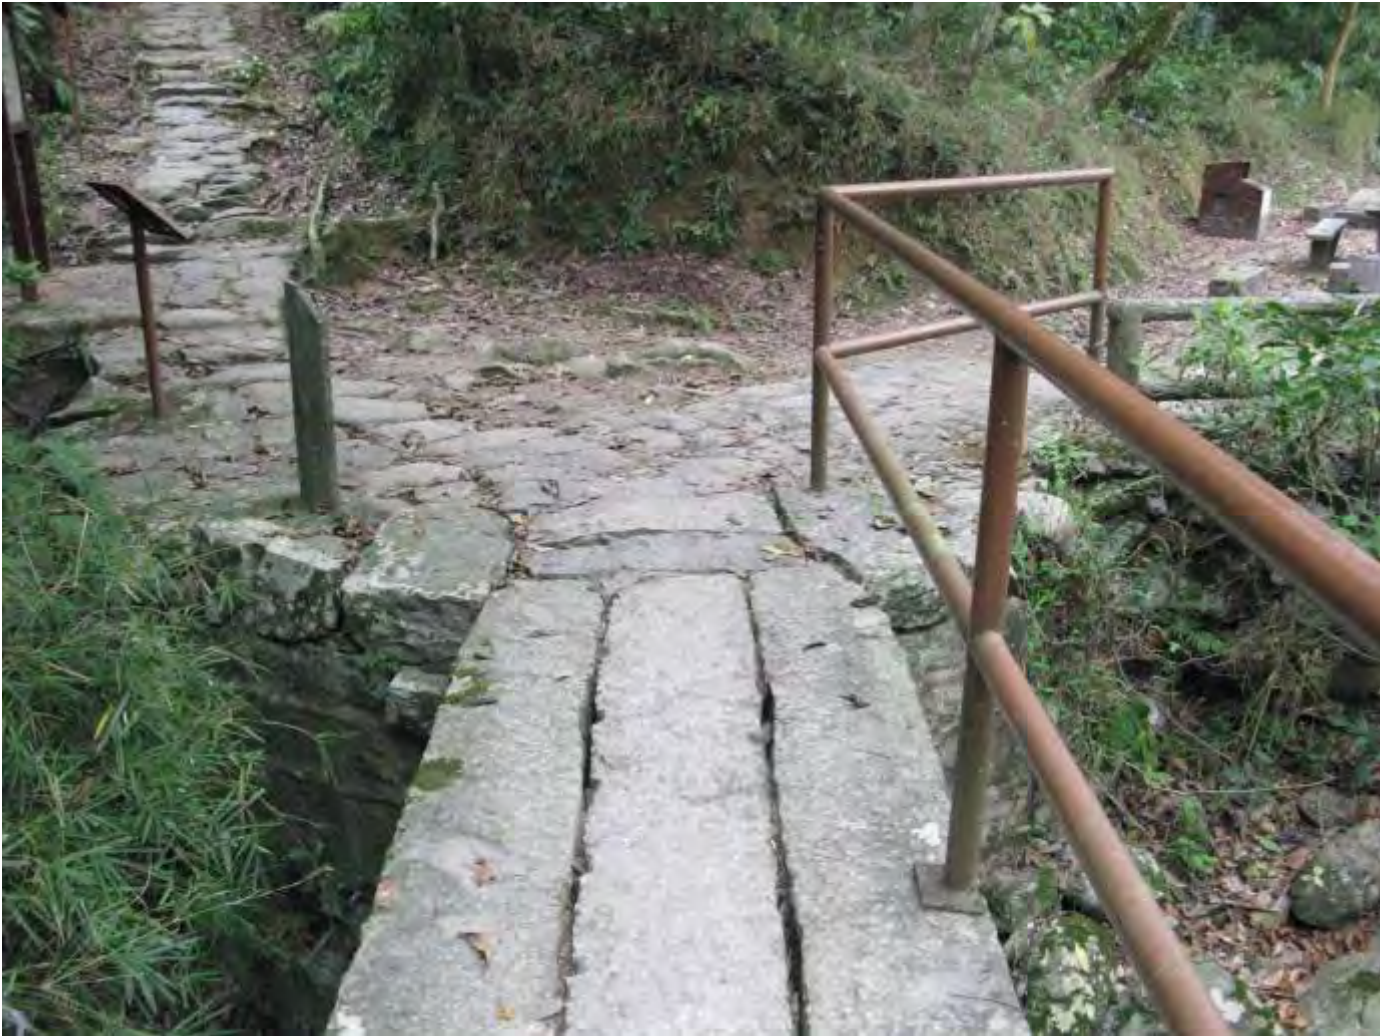
Photo Reference No.	Photographic Records
F2

<p data-bbox="813 1353 1563 1393">Third part is paved with three granite slabs. (View A to B)</p>

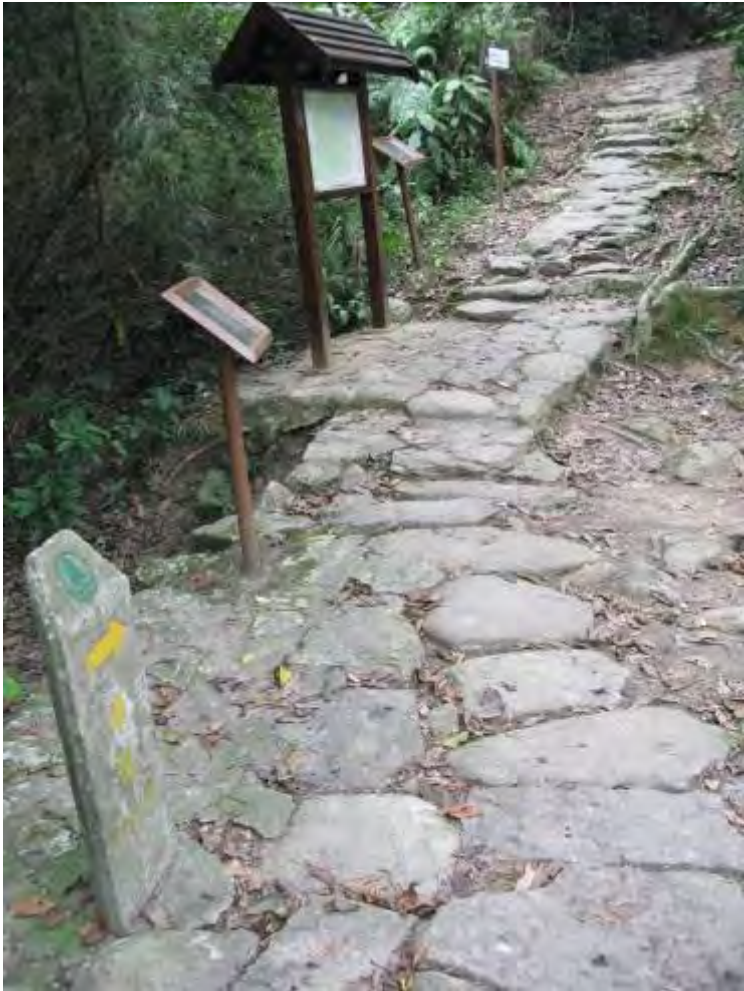
<p>Boulder path after bridge crossing showing a section reworked by AFCD. (View A to B)</p>	15

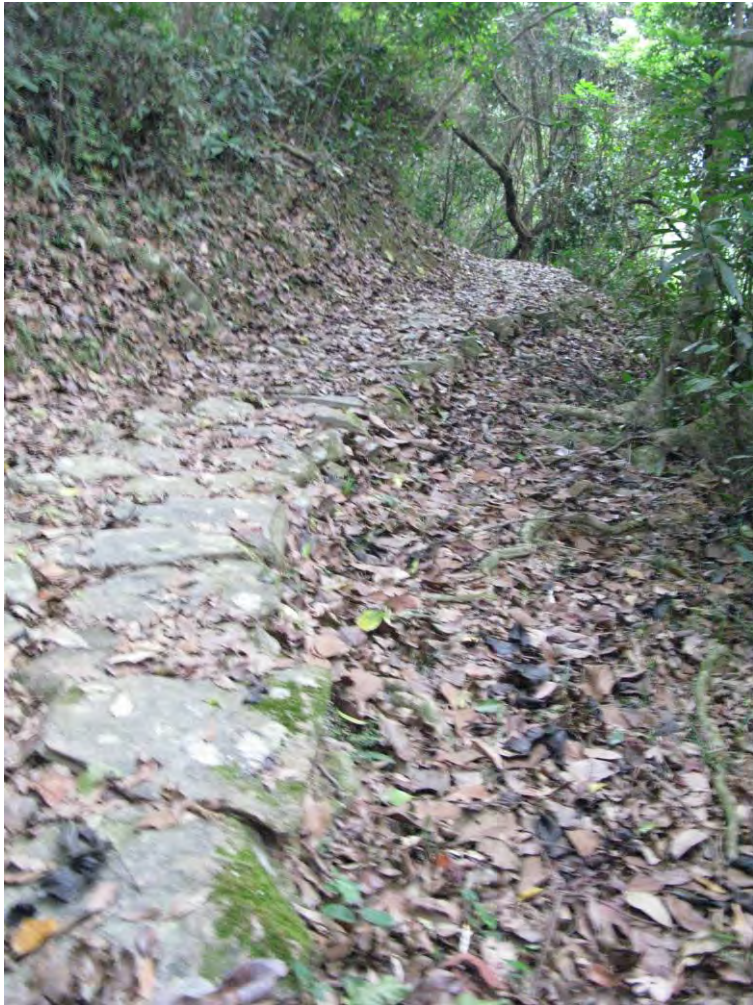
<p>General view covered with abundant dry leaves. (View A to B)</p>

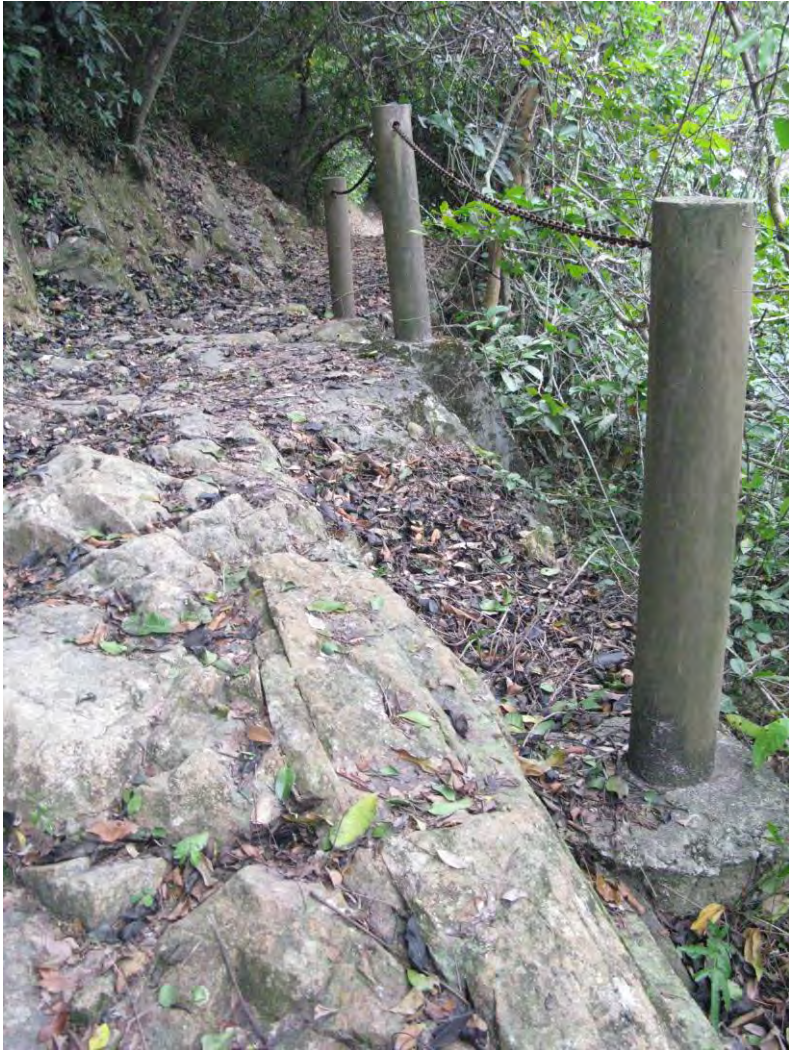
<p>A section with railing. (View A to B)</p>	17

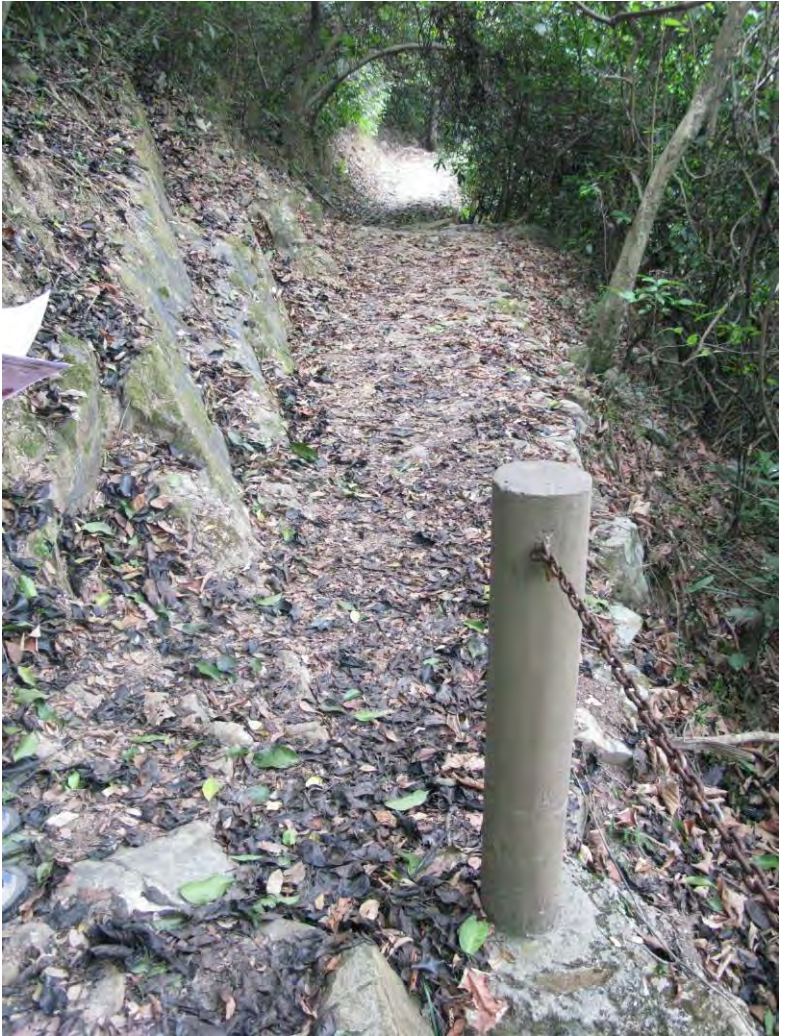
<p>End of railing. (View A to B)</p>

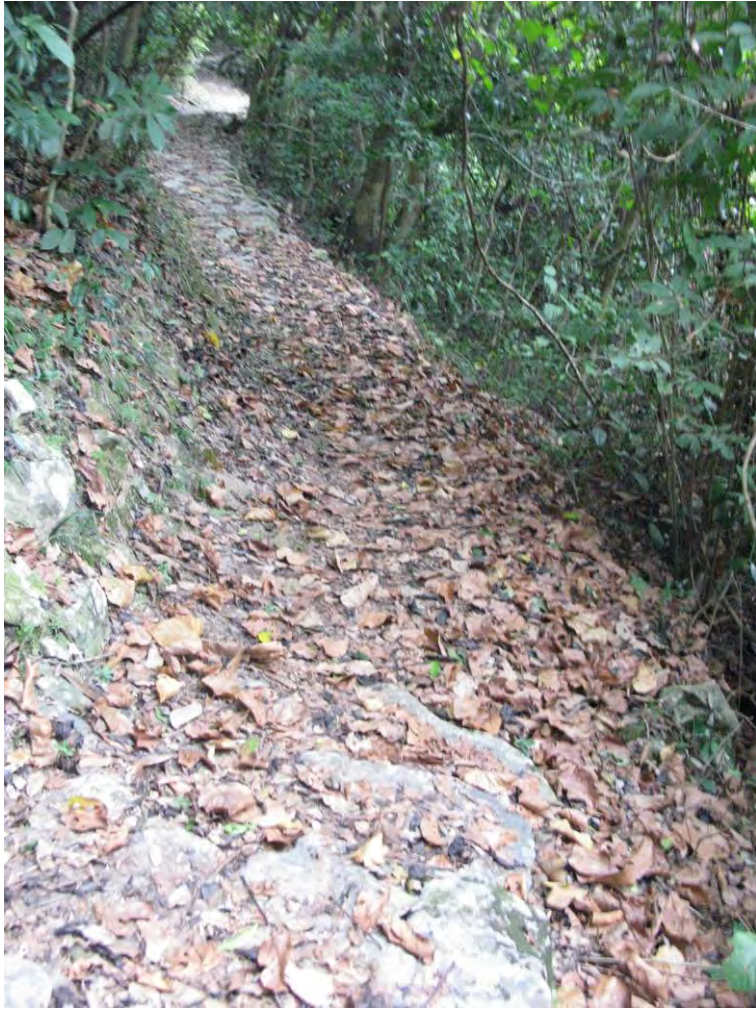
<p>General view covered with abundant dry leaves. (View A to B)</p>		(Blank)

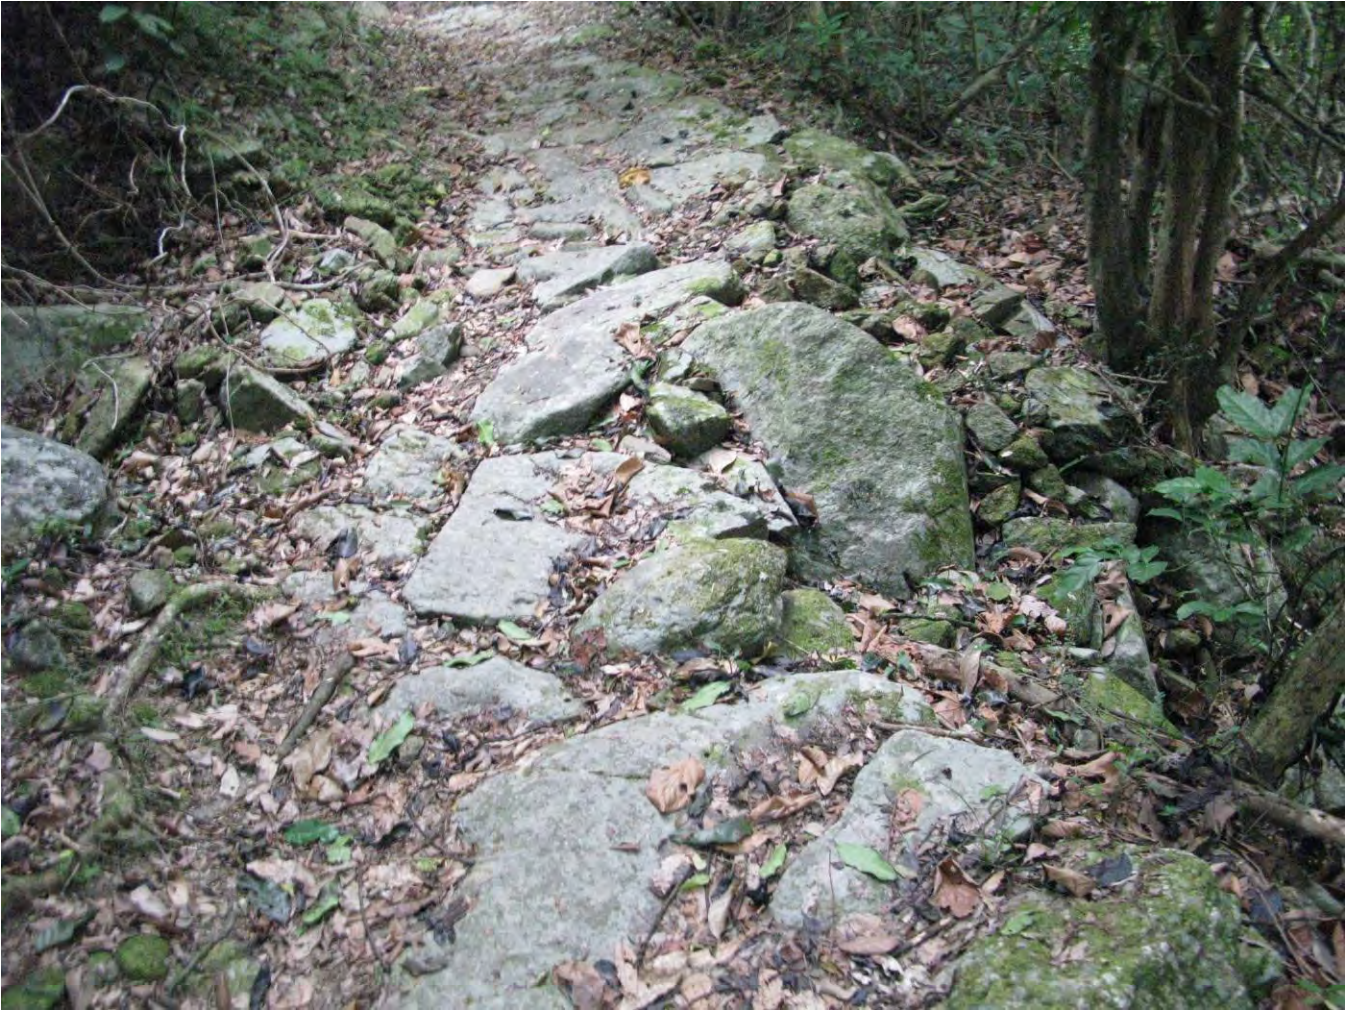
Photo Reference No.	Photographic Records
19

<p data-bbox="882 1286 1503 1321">General view of the boulder path. (View A to B)</p>
