Antiquities and Monuments Office

Study on Old Trails in Hong Kong - Final Study Report

February 2014

Study on Old Trails in Hong Kong: *Final Study Report*

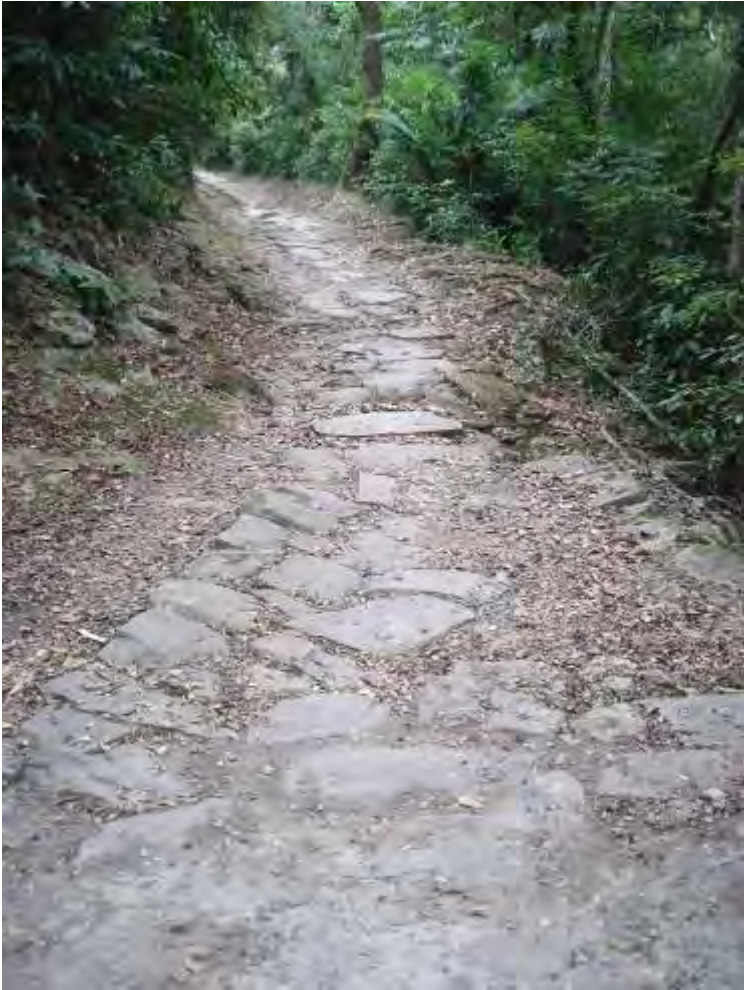
<p>Start with boulder section. (View C to D)</p>	From C to F5

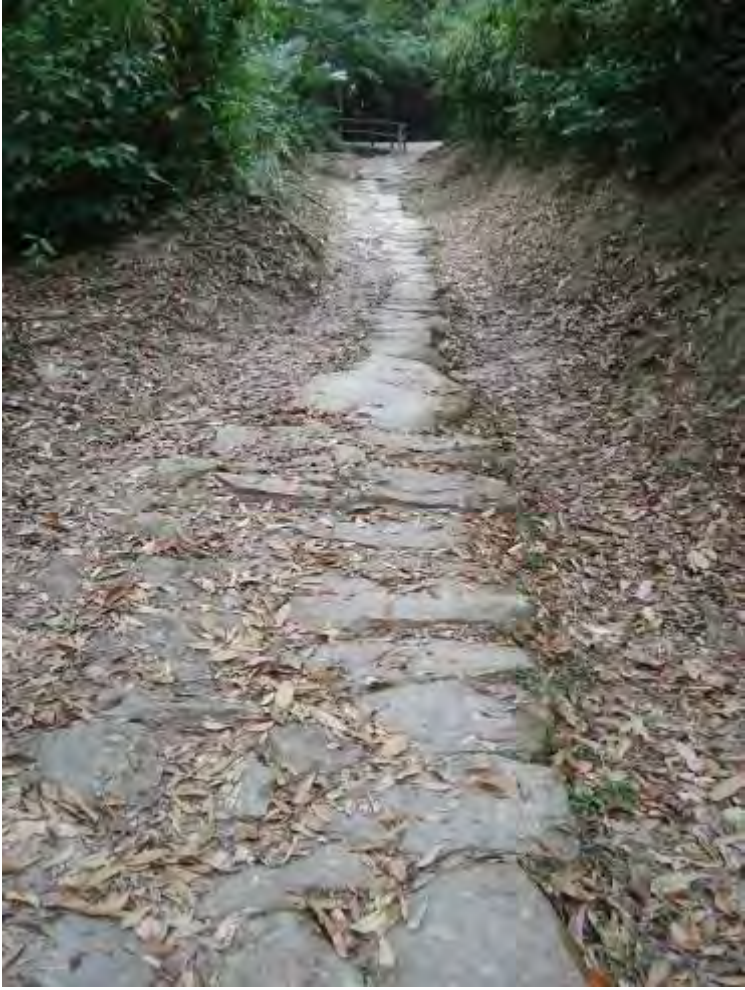
<p>Boulder section. (View D to C)</p>

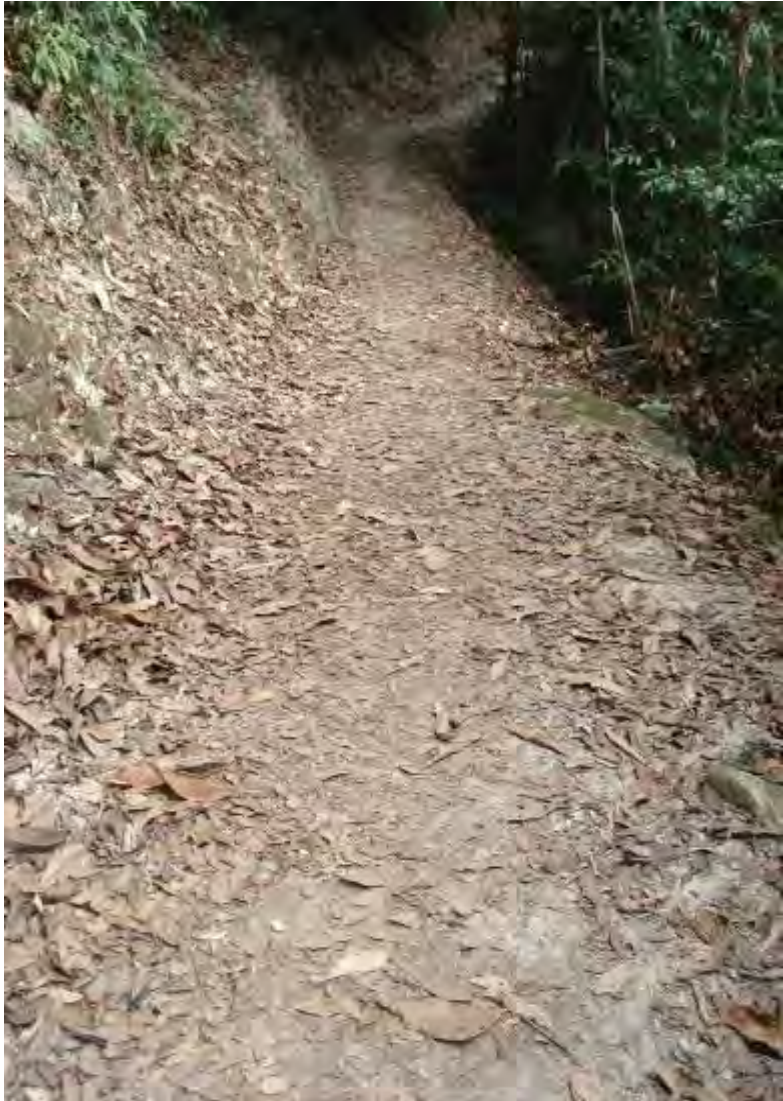
<p>Concrete reworked section. (View C to D)</p>

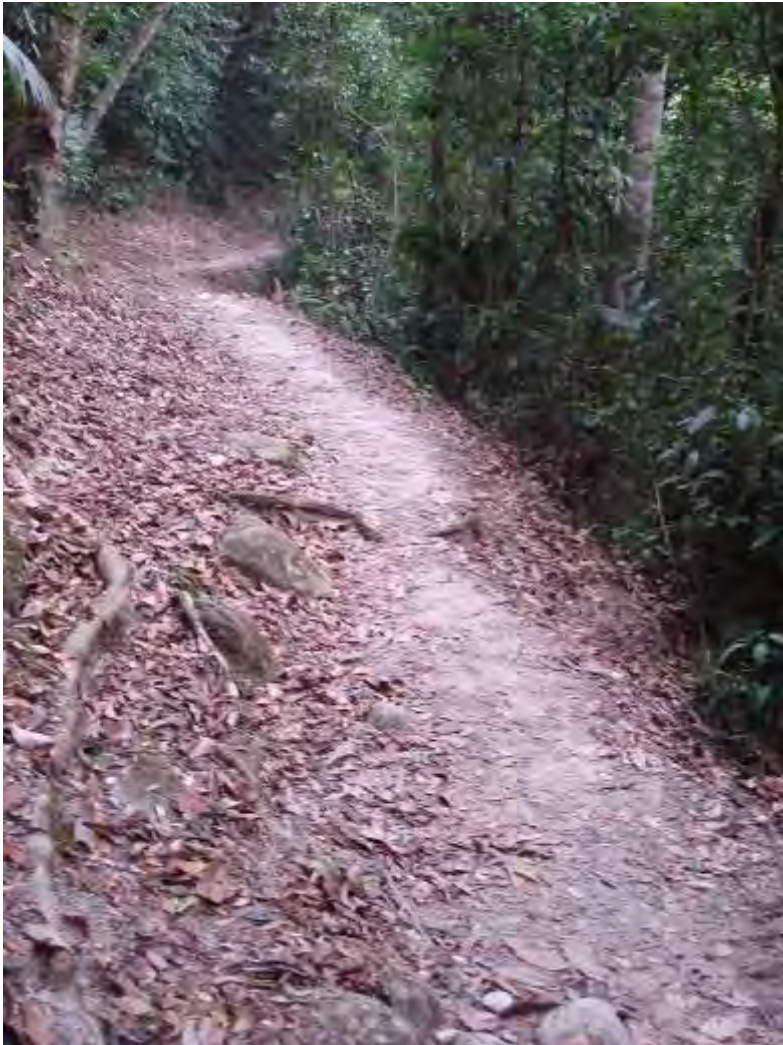
<p>Mud section. (View C to D)</p>	From 21 to 22

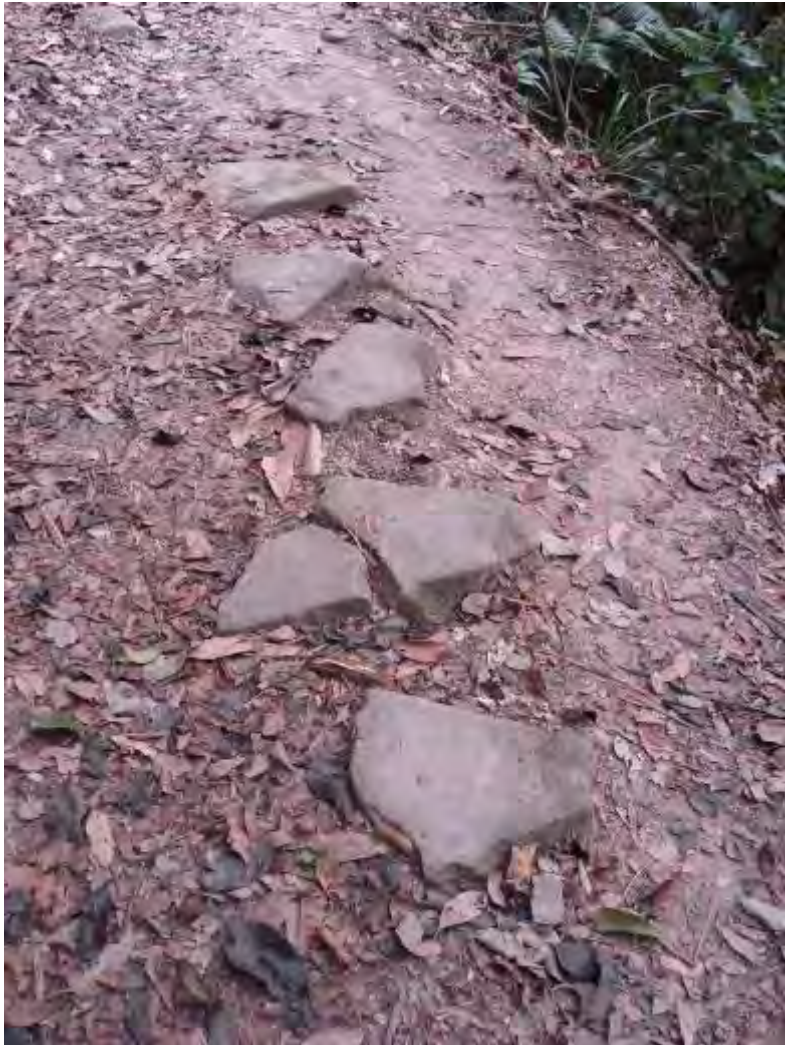
<p>Occasional boulders along mud section. (View C to D)</p>

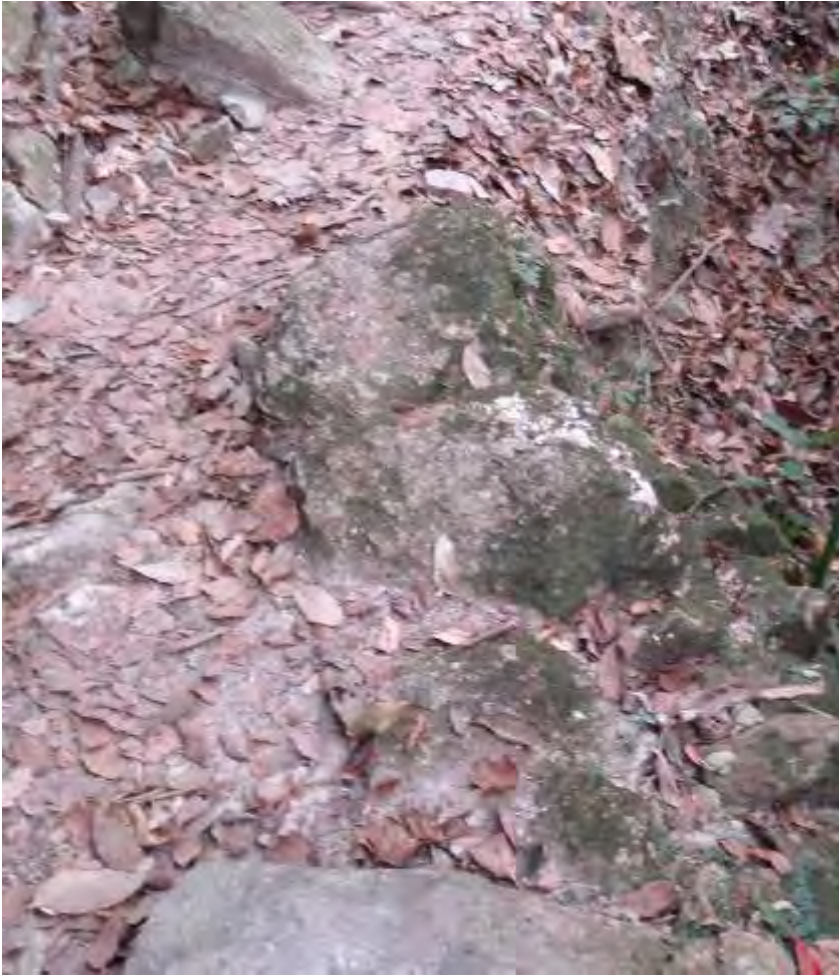
<p>Boulders at the edge of the footpath. (View C to D)</p>	From 21 to 22

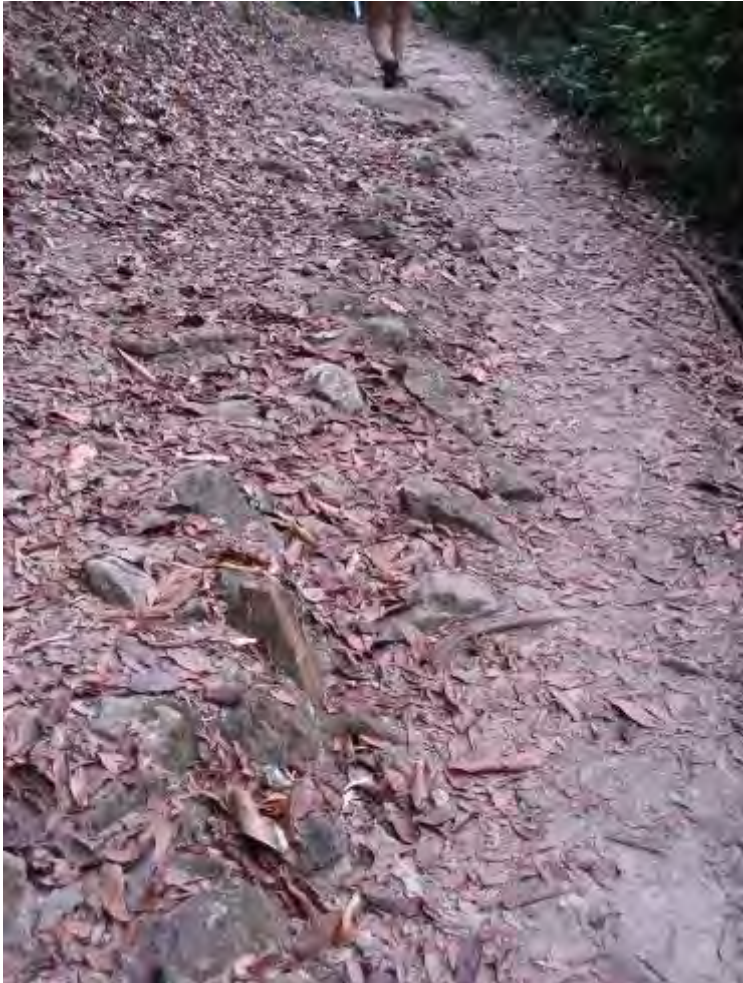
<p>Boulders along the footpath. (View C to D)</p>

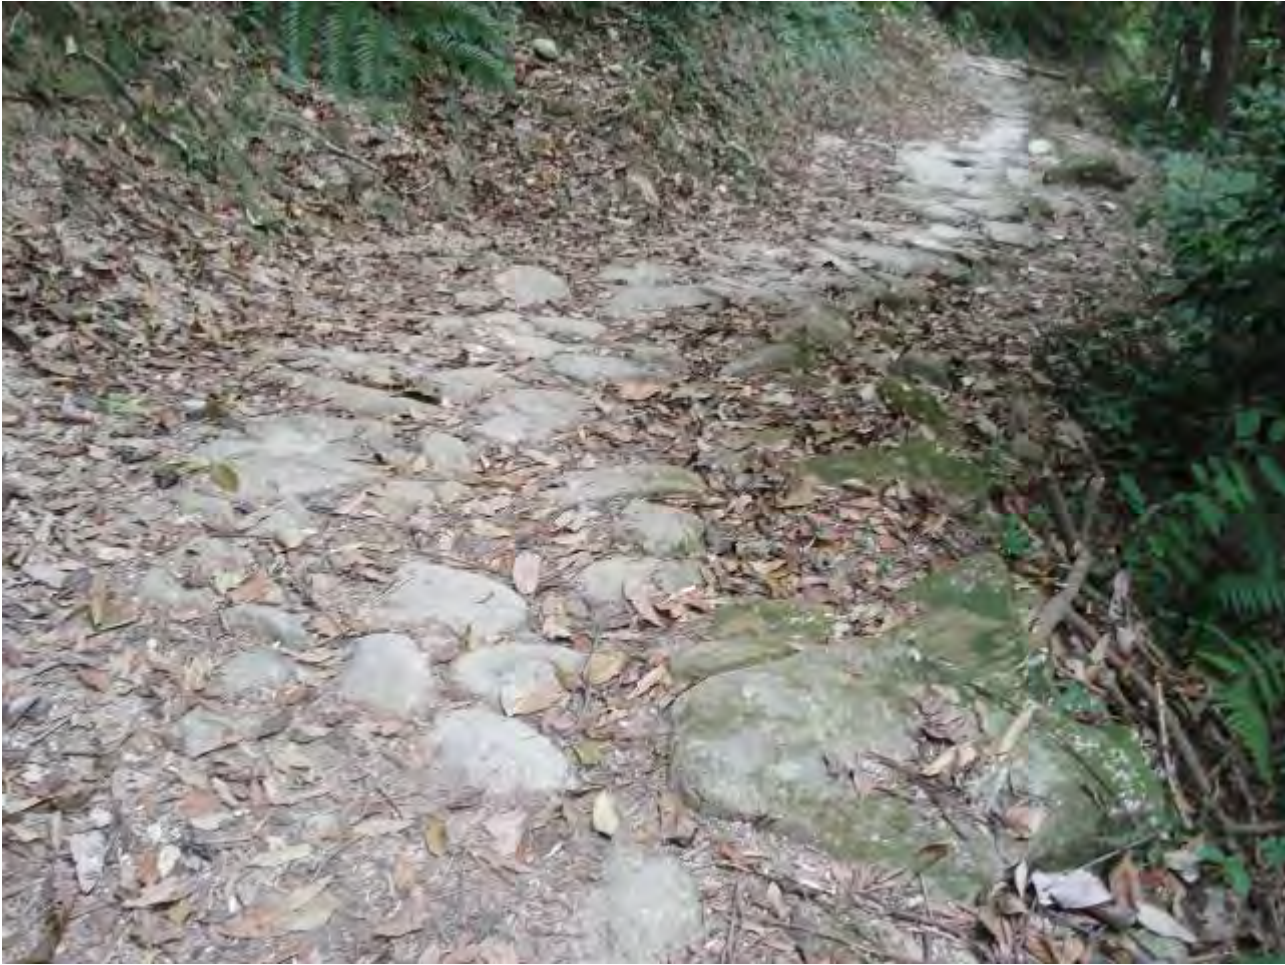
Photo Reference No.	Photographic Records
22

<p data-bbox="994 1241 1413 1278">Boulder section. (View C to D)</p>

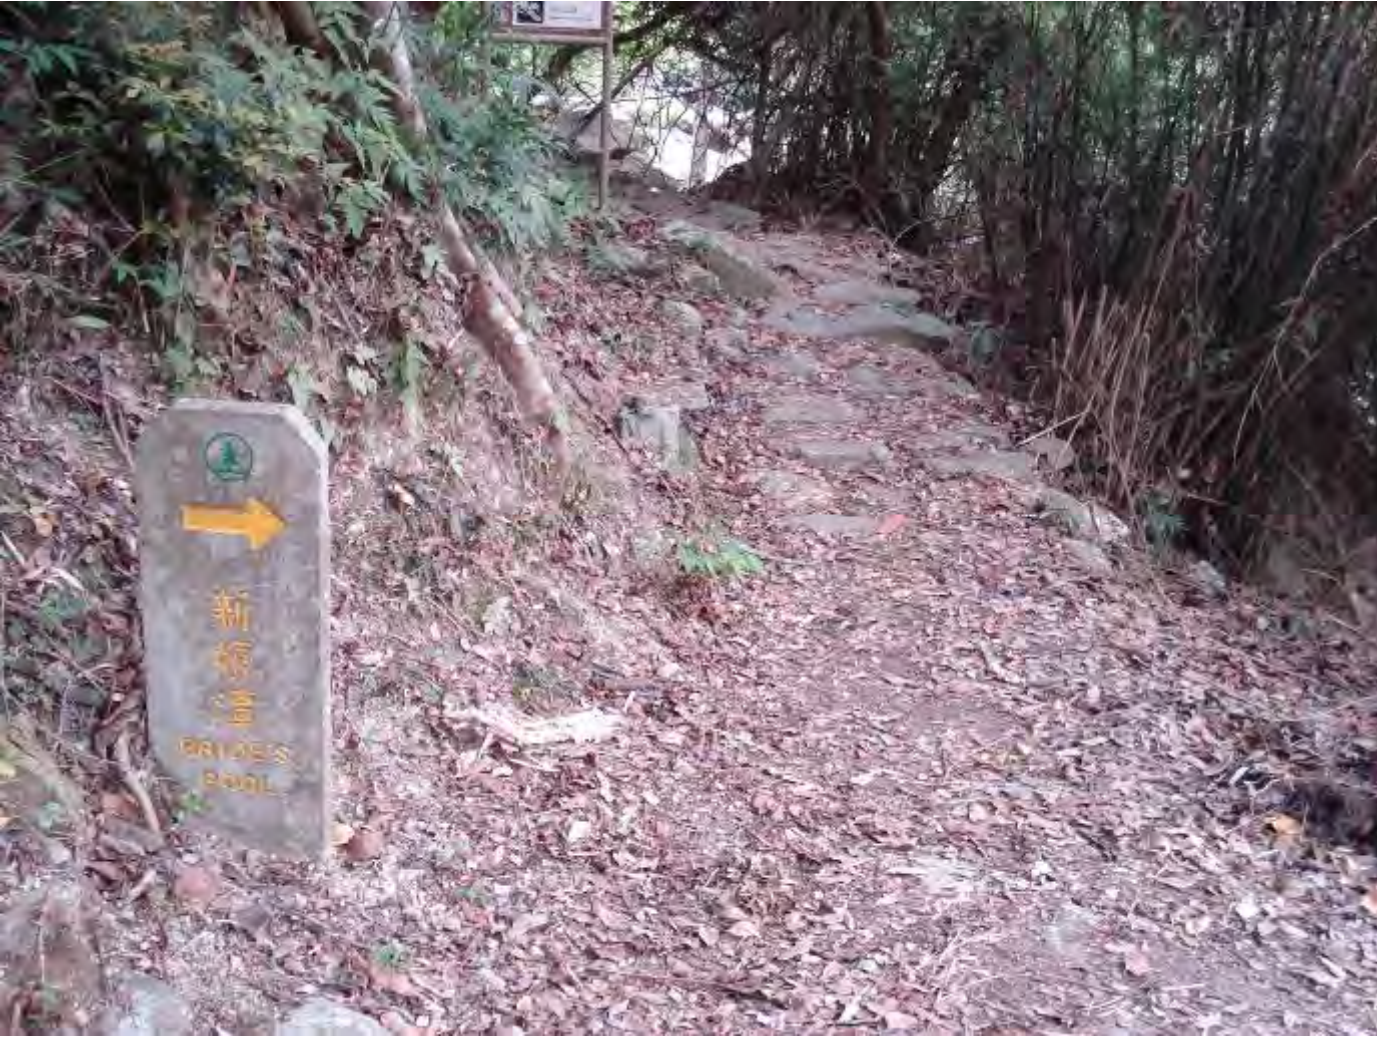
Photo Reference No.	Photographic Records
E

<p data-bbox="324 1313 2072 1385">Another starting point (E) of this Trackway, the Trackway begins with boulder section. Note the direction sign shows the direction to Bride's Pool. (View E to F)</p>

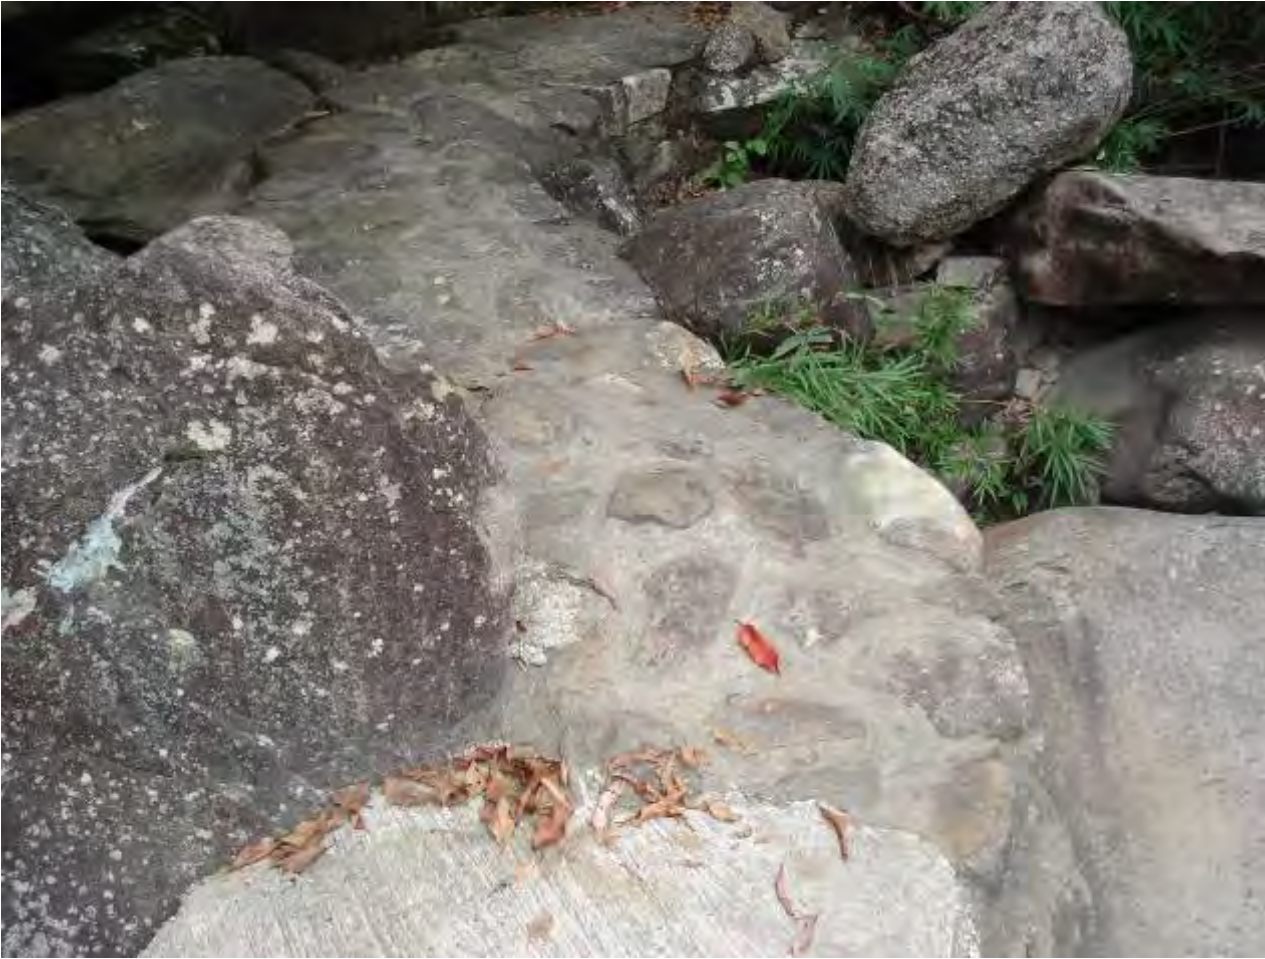
Photo Reference No.	Photographic Records
26

<p data-bbox="618 1233 1776 1270">Stones embedded concrete reworked section leading to a stream crossing. (View E to F)</p>

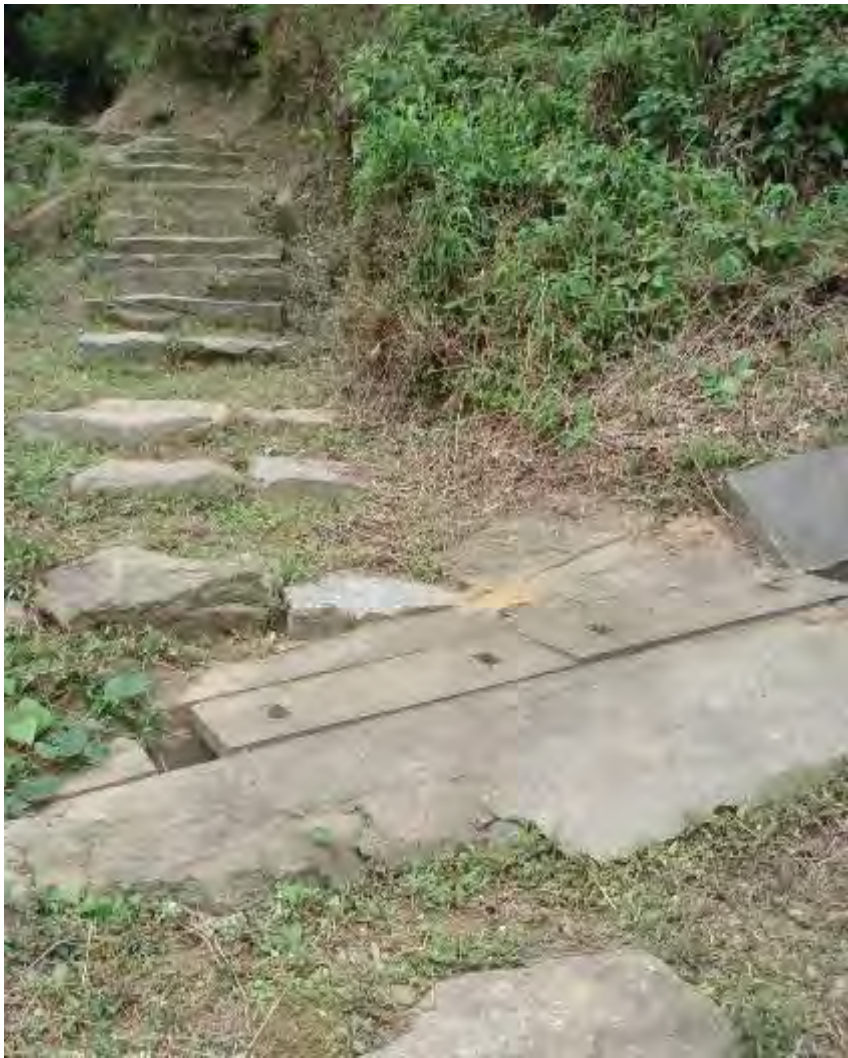
<p>Modern drain intrusion across the boulder section. (View A to B)</p>	1

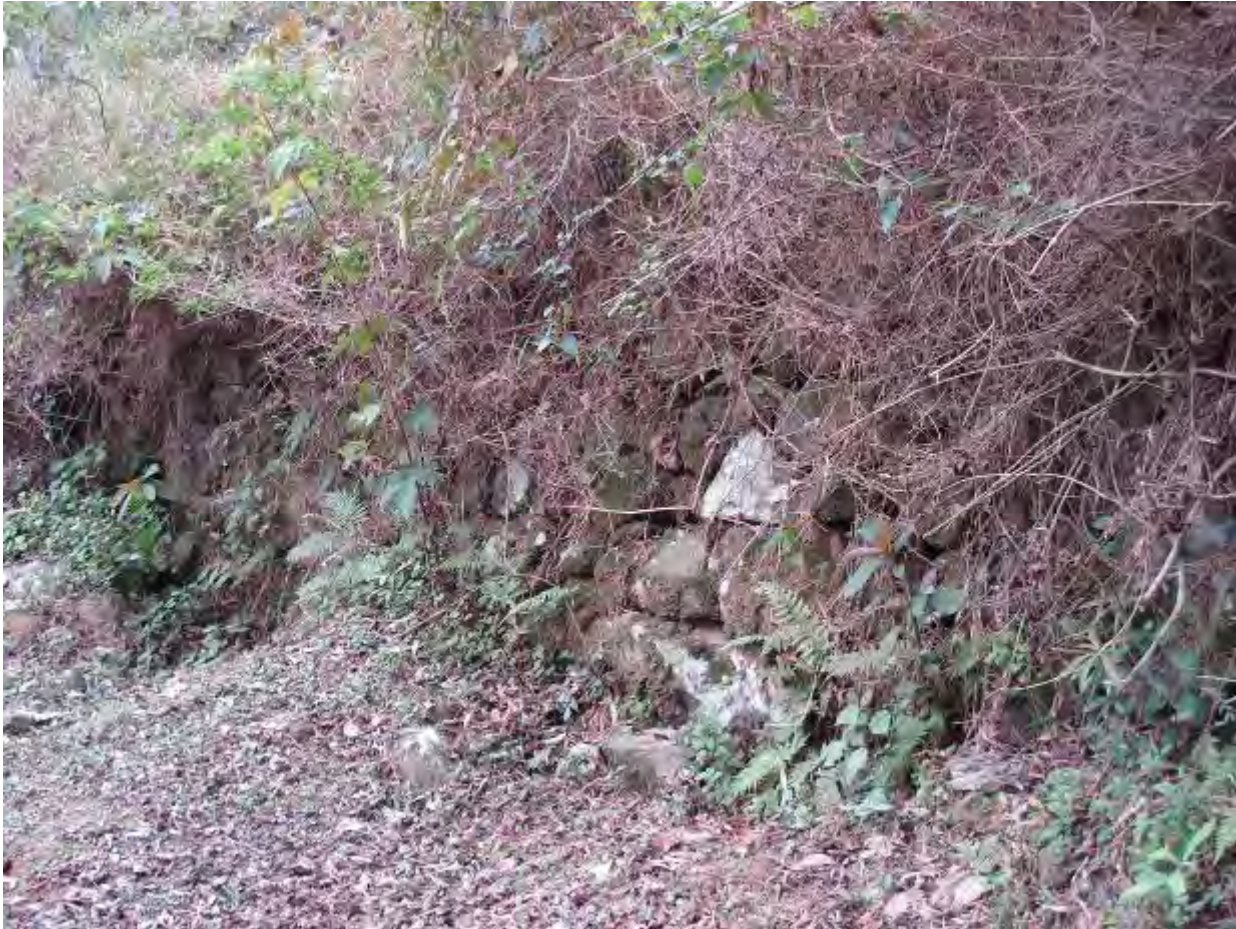
Photo Reference No.	Photographic Records
F2

<p data-bbox="741 1185 1637 1222">Boulder retaining wall observed west of the footpath. (View A to B)</p>

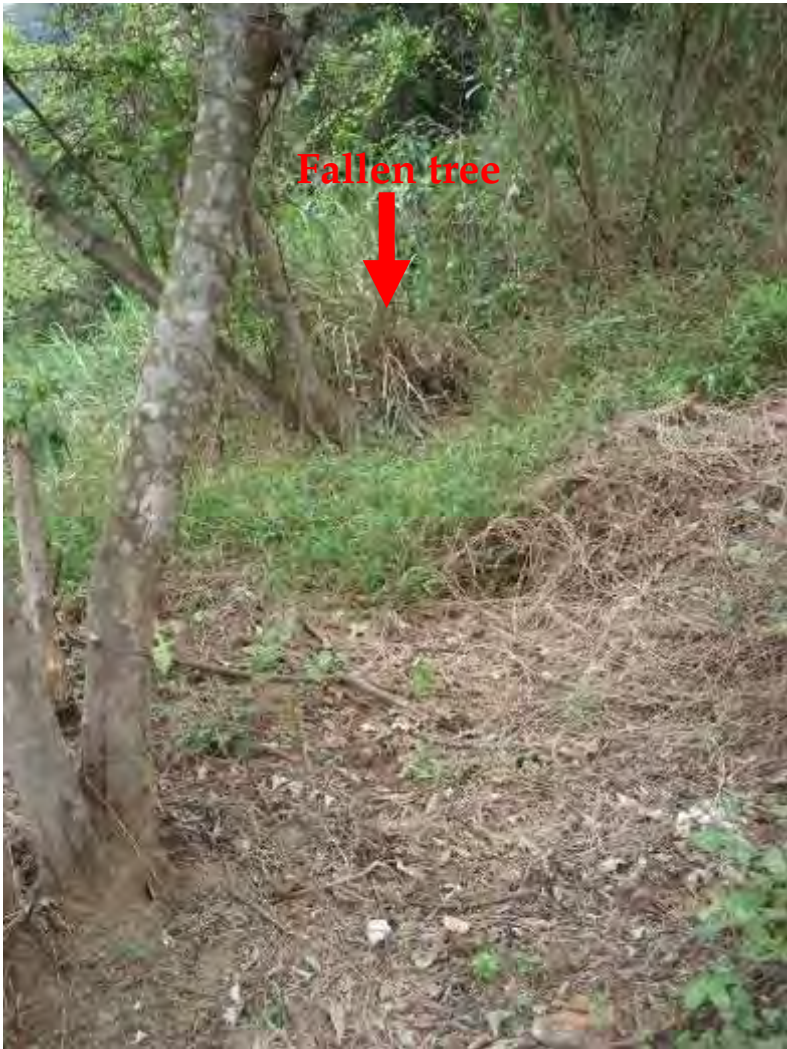
<p>Footpath blocked by fallen tree and thick vegetation. The Trackway is no longer identifiable beyond this point. (View A to B)</p>	7

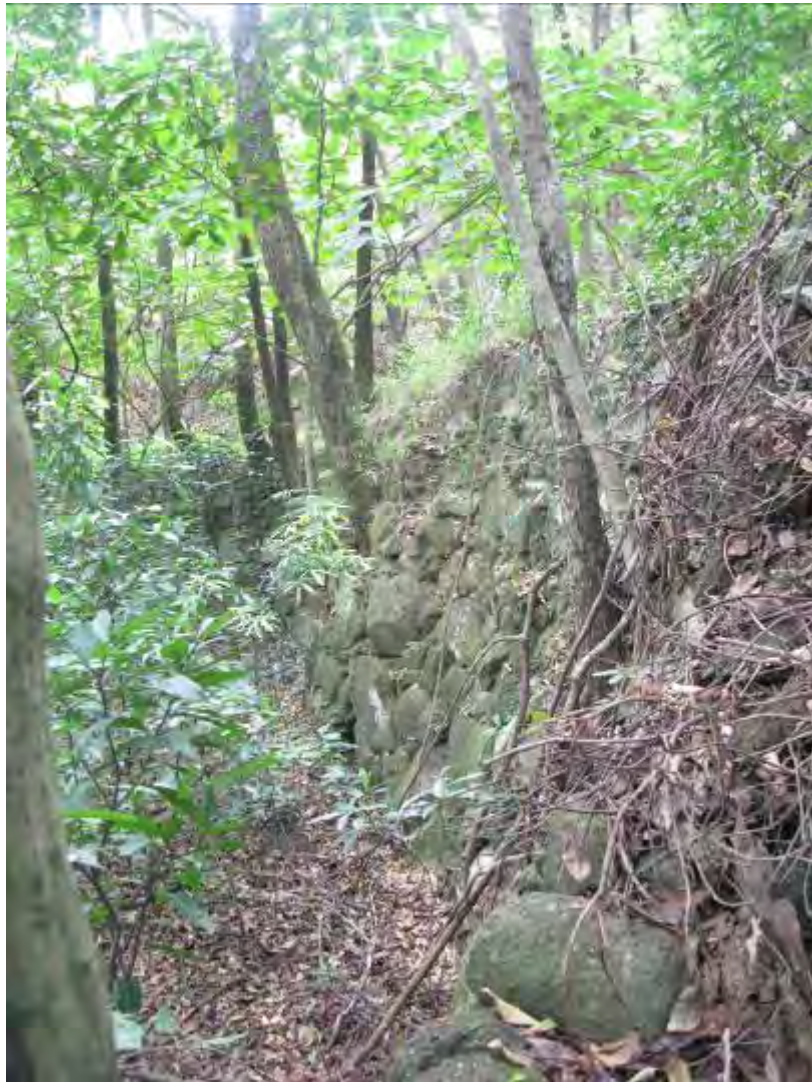
<p>Boulders retaining wall south of Point C. Possible remains of abandoned terraced fields. (View C to south)</p>

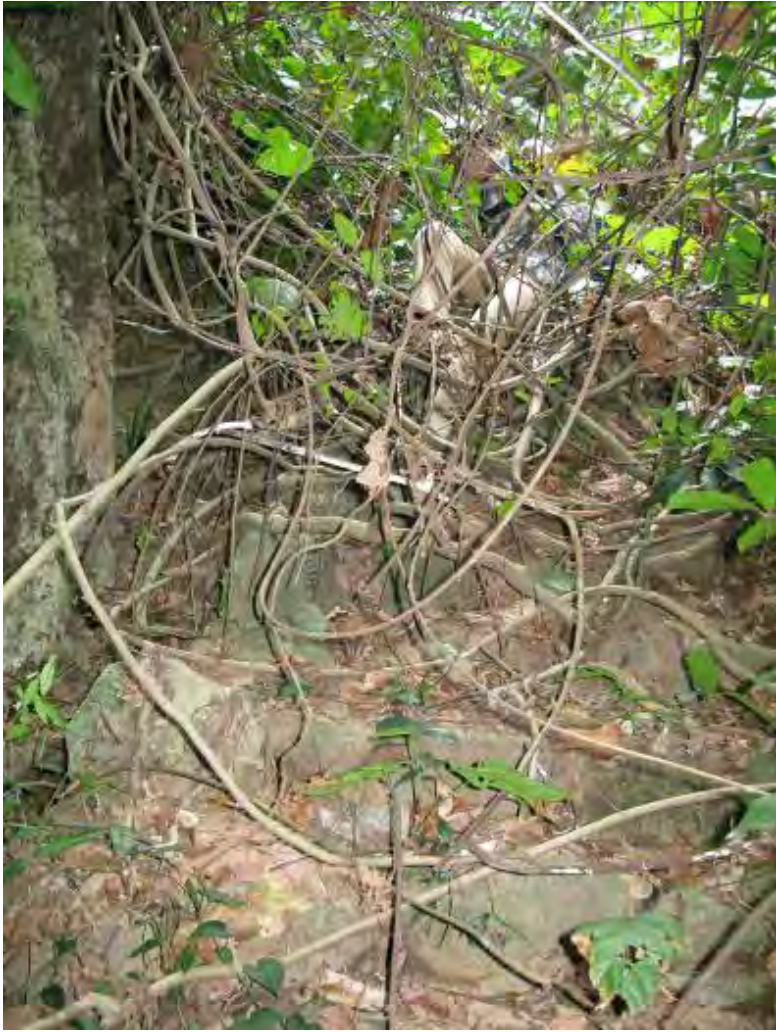
<p>Boulder steps identified in mud section. The vegetation makes the trackway impassable. It was not possible to go beyond this point. (View D to C)</p>		(Blank)

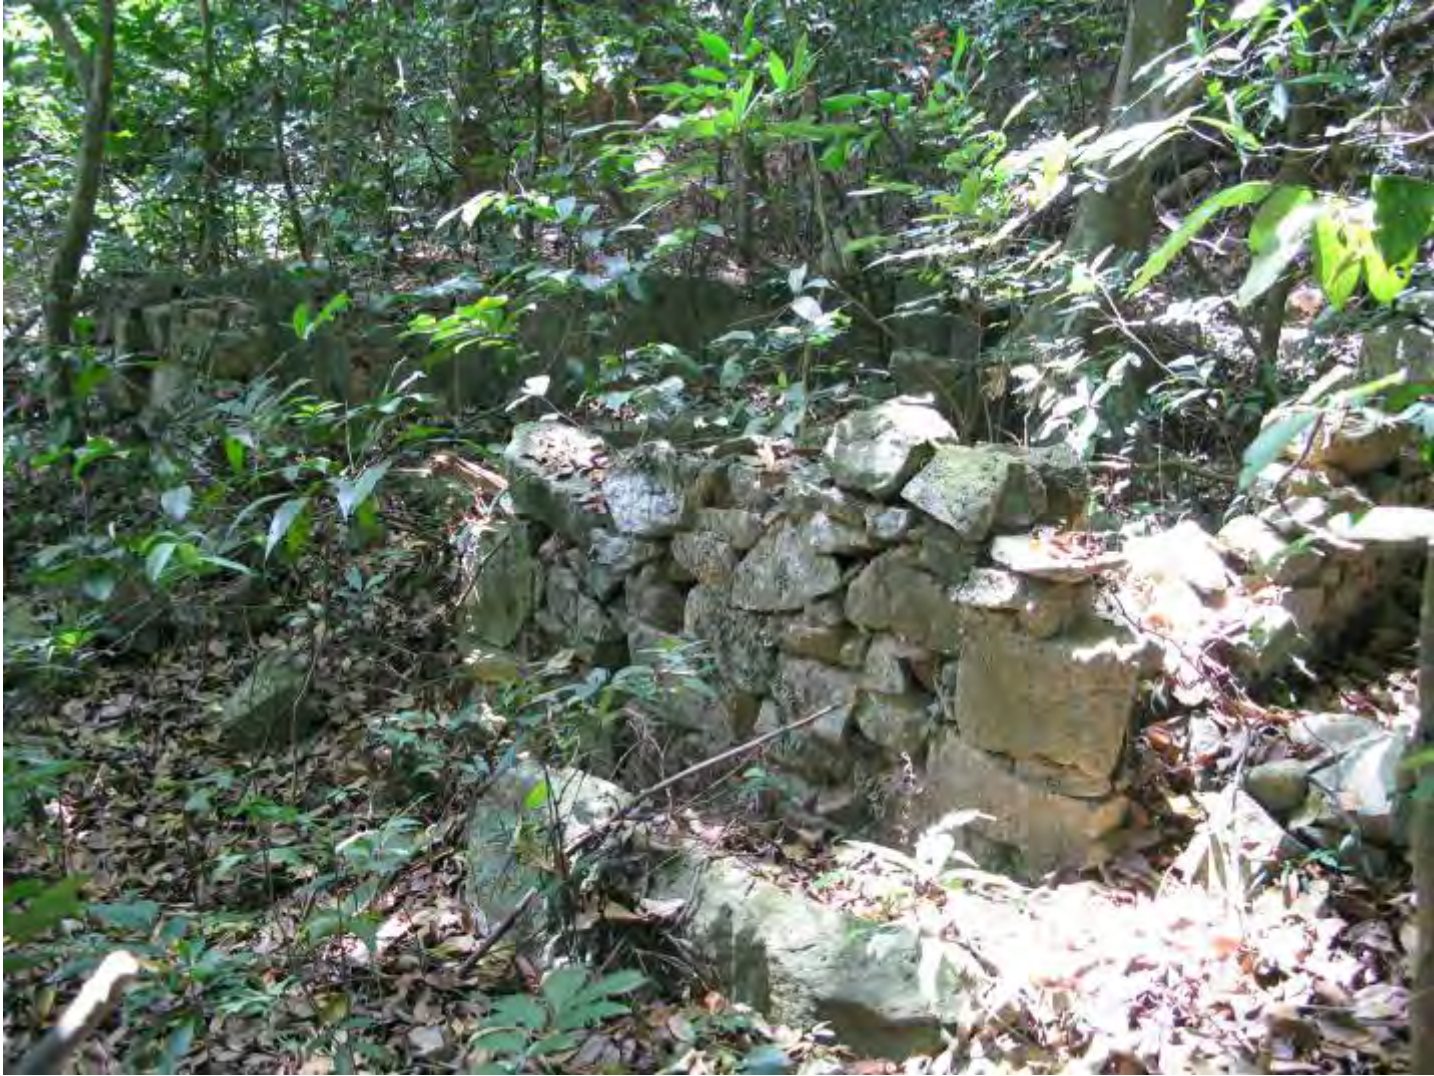
Photo Reference No.	Photographic Records
F7

<p data-bbox="741 1331 1637 1362">Ruins with stone foundations south of Point 10. (View east to west)</p>

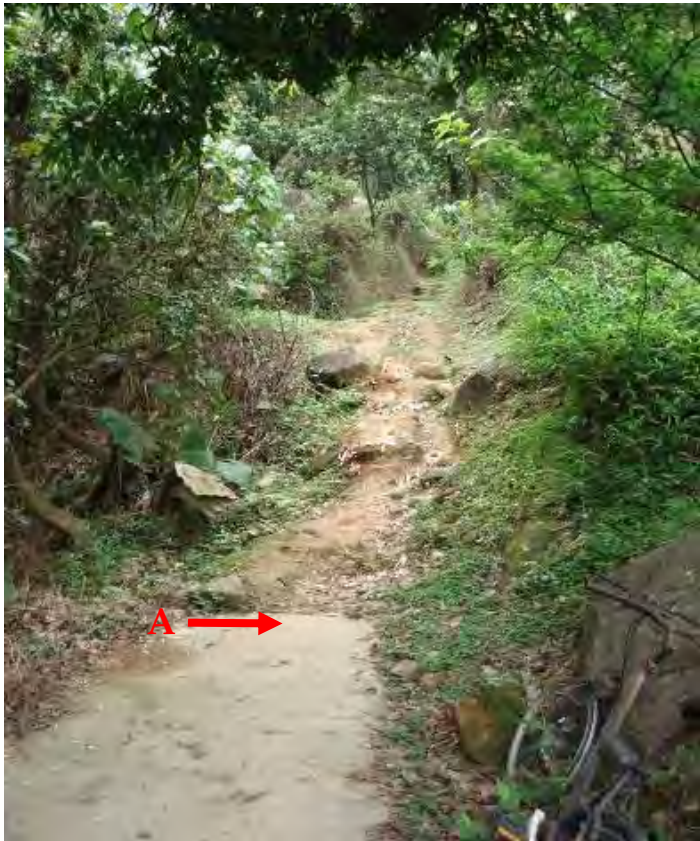
<p>This photo shows the entrance of the Wun Yiu Trackway starting from the Sheung Wun Yiu village (上碗窑村) in Tai Po. (View A to B)</p>	From A To 1

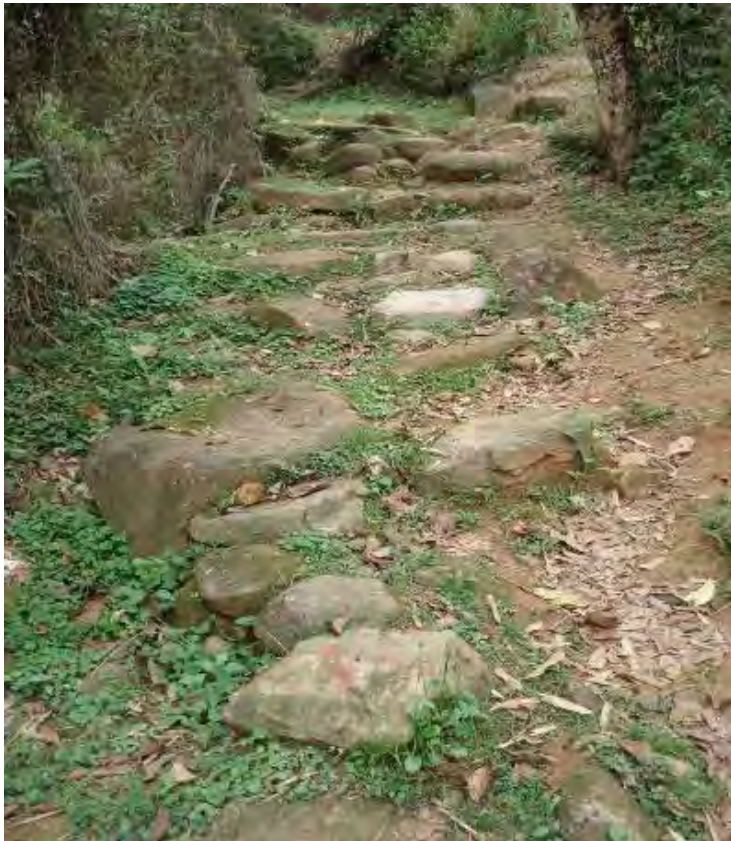
<p>The boulders at the beginning of the Wun Yiu Trackway appear to be original. One can see the boulders are in different shapes and sizes. (View A to B)</p>

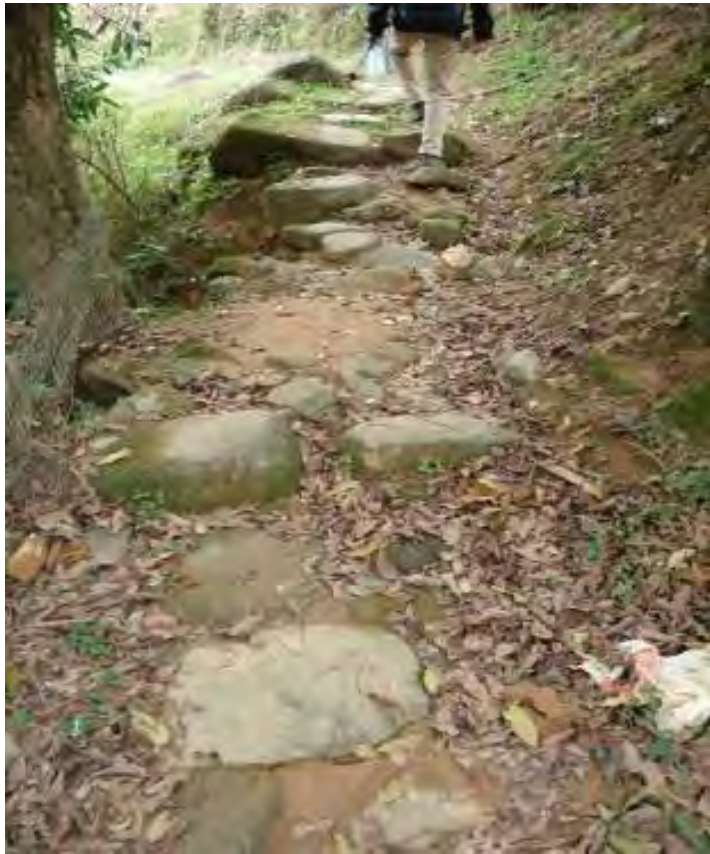
<p>On top of this photo shows the end of the first boulder section of this Trackway. From there onward is the mud section. (View A to B)</p>

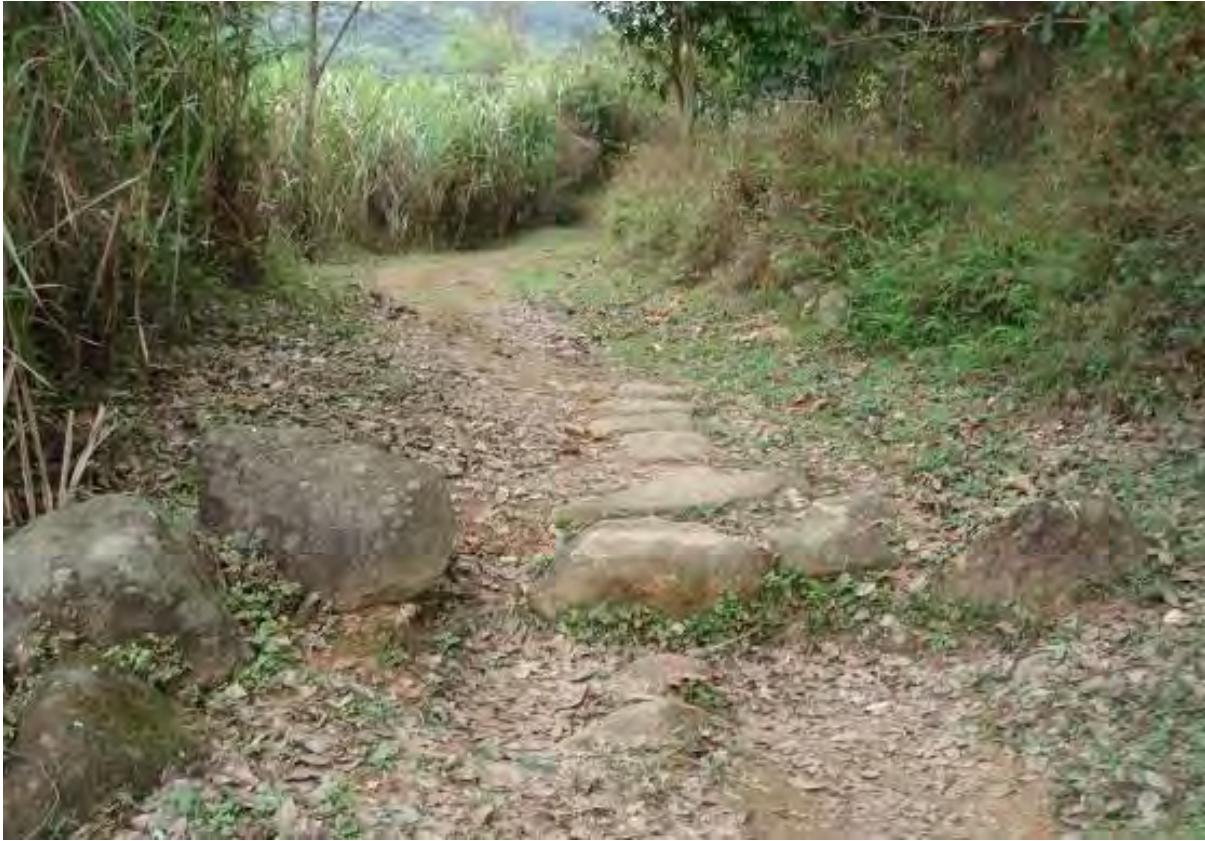
<p data-bbox="835 1246 1570 1278">A number of boulders on the mud section. (View A to B)</p>

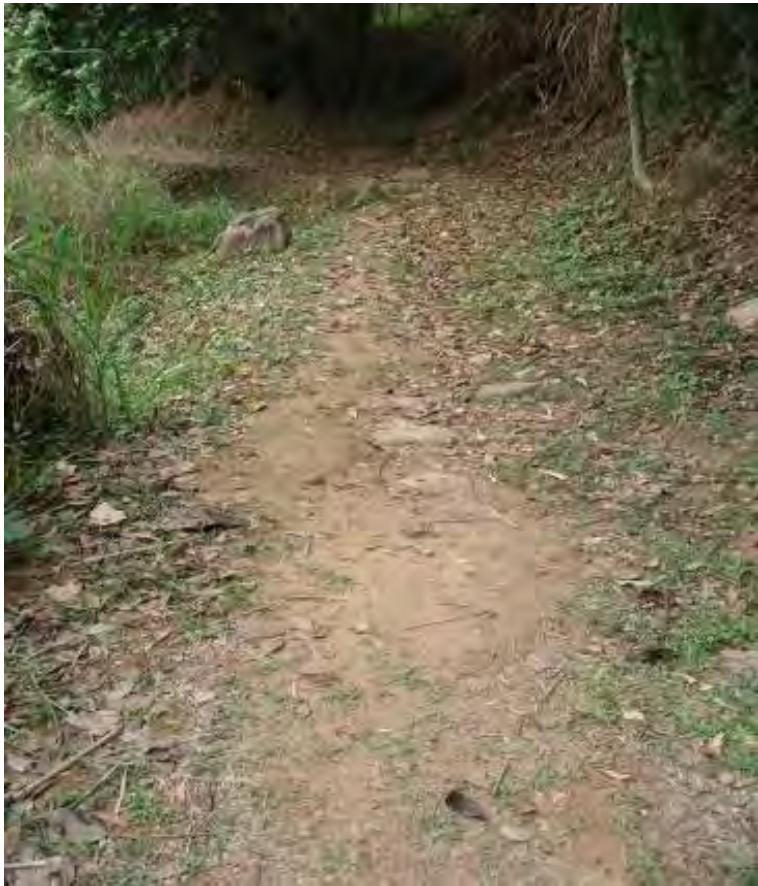
<p>Mud section with abundant fallen leaves and vegetation. (View A to B)</p>	5

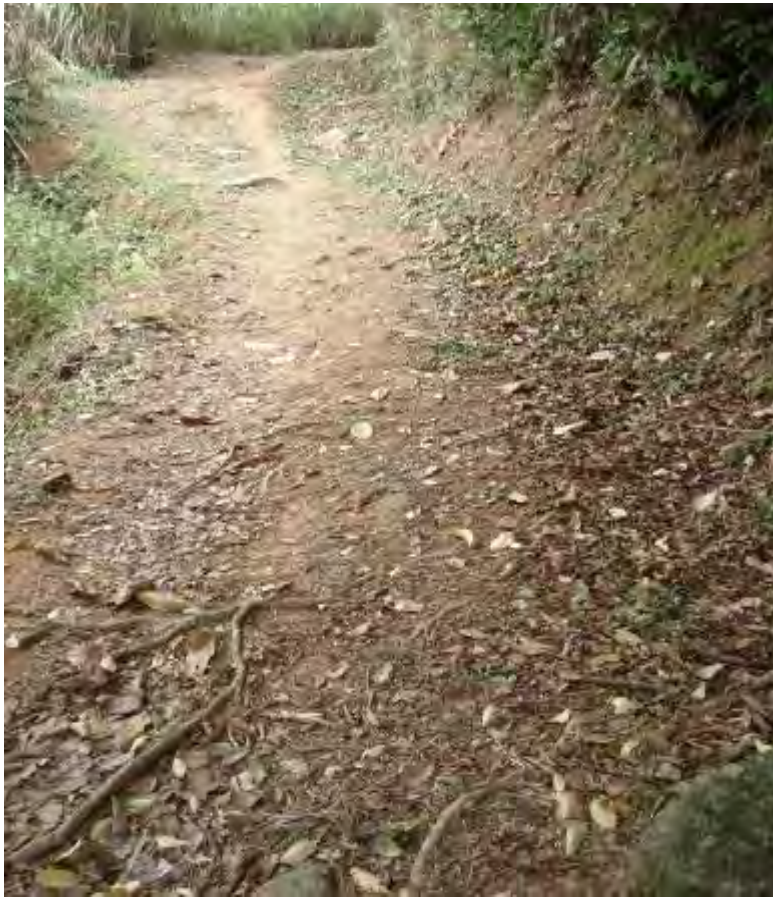
<p>Mud section with occasional tree roots emerging from the section. (View A to B)</p>

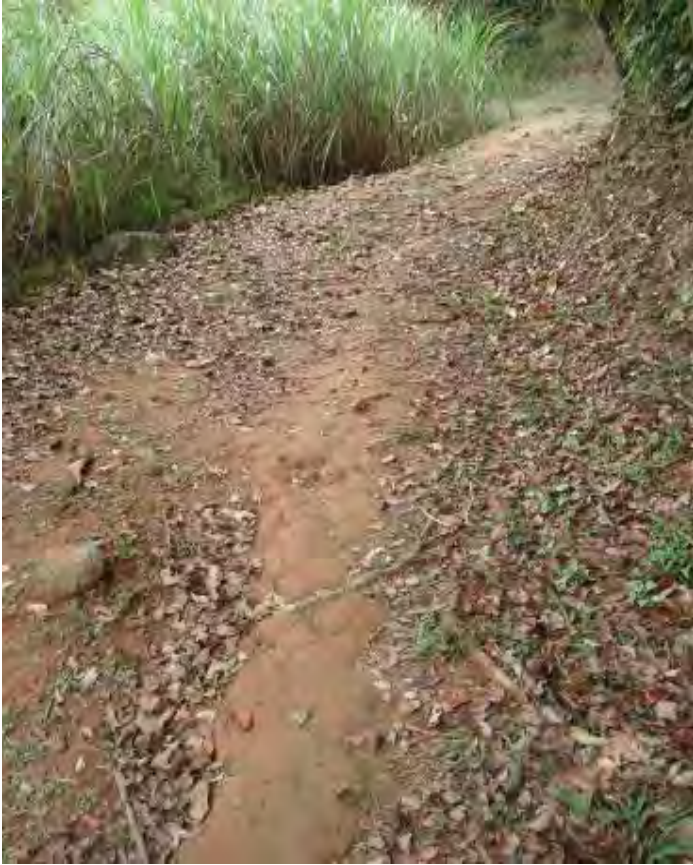
<p>Mud section with fallen leaves covering the footpath and overgrown shrubs adjacent to the footpath. (View A to B)</p>		(Blank)

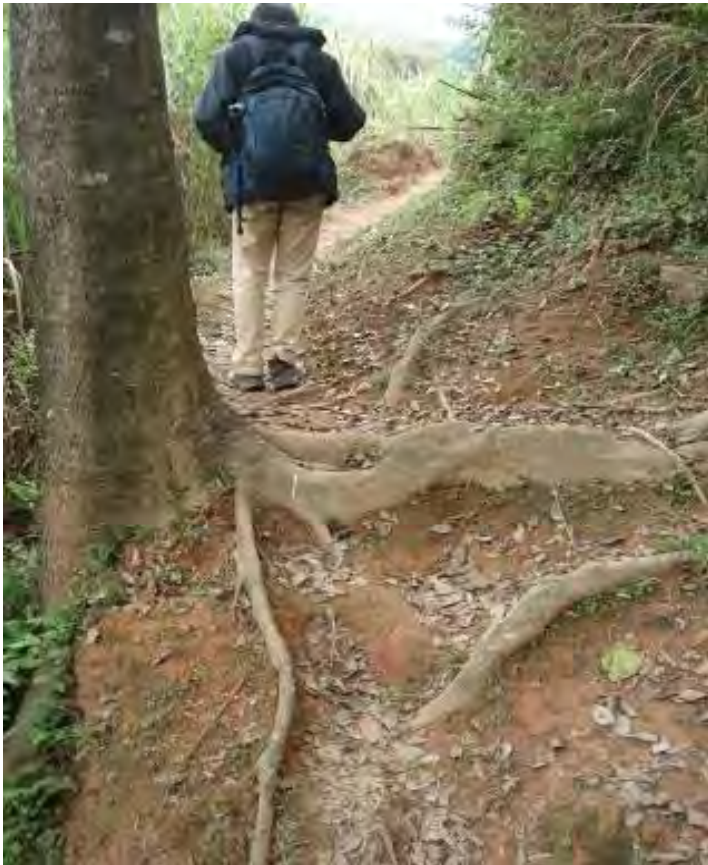
<p>A big tree was found situated in the middle of the footpath and its buttress roots emerging from beneath the footpath. (View A to B)</p>	8

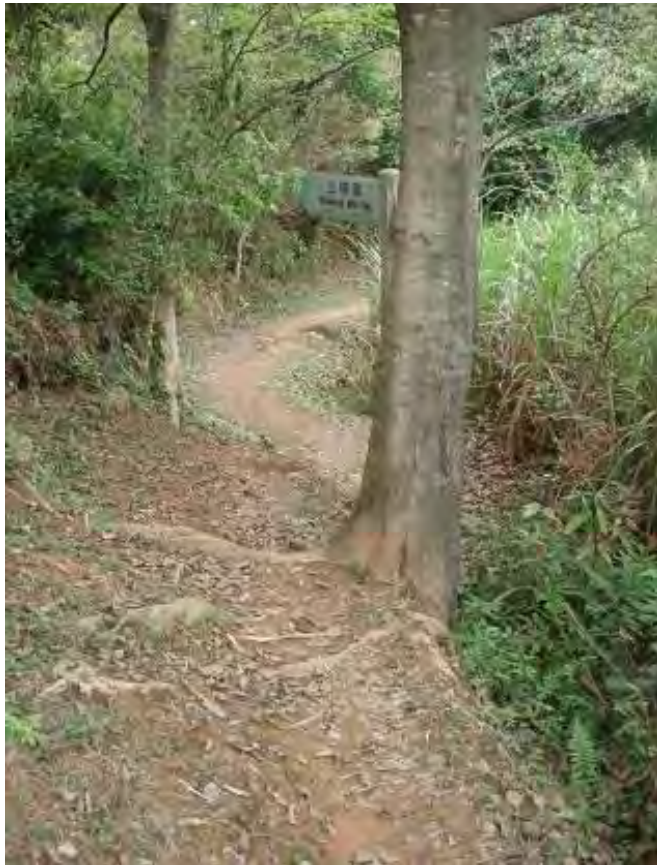
<p>A big tree was found situated in the middle of the footpath and its buttress roots emerging from beneath the footpath. (View B to A)</p>

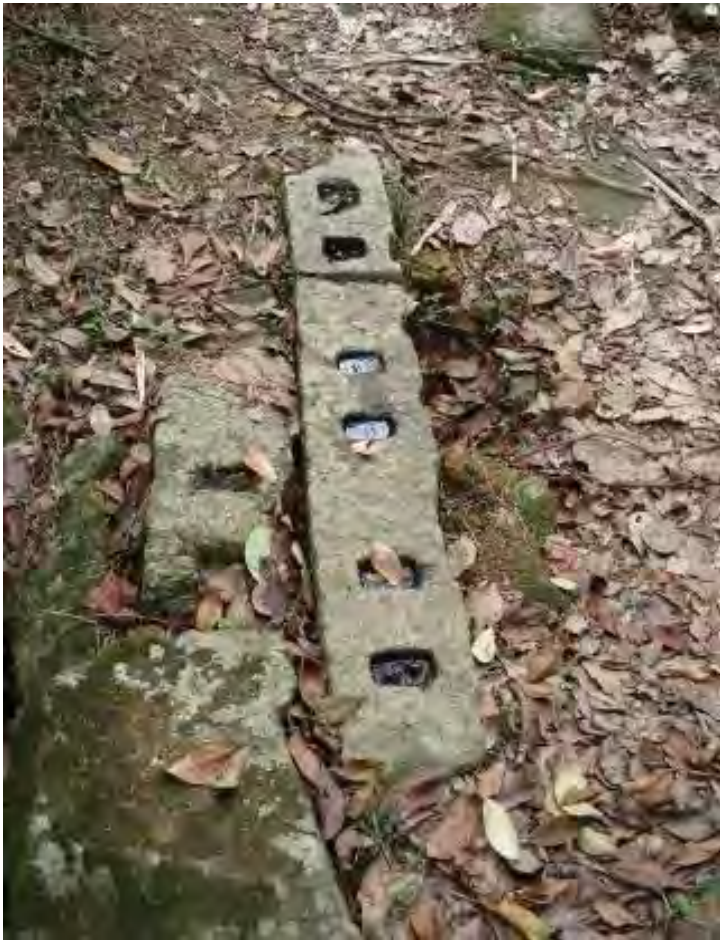
<p>A close up view of the granite water gate observed at bottom of the flight of boulder steps. (View A to B)</p>	From 11 to 12
