Antiquities and Monuments Office

Study on Old Trails in Hong Kong - Final Study Report

February 2014

Study on Old Trails in Hong Kong: *Final Study Report*

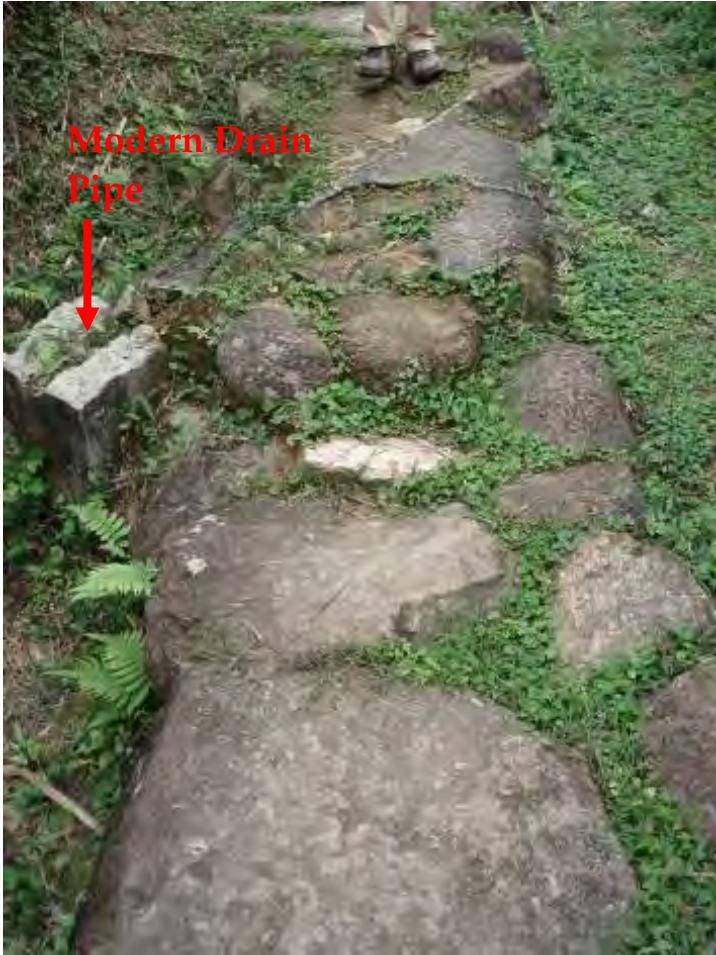
<p>Modern drain pipe was found next to the boulders. (View A to B)</p>		(Blank)

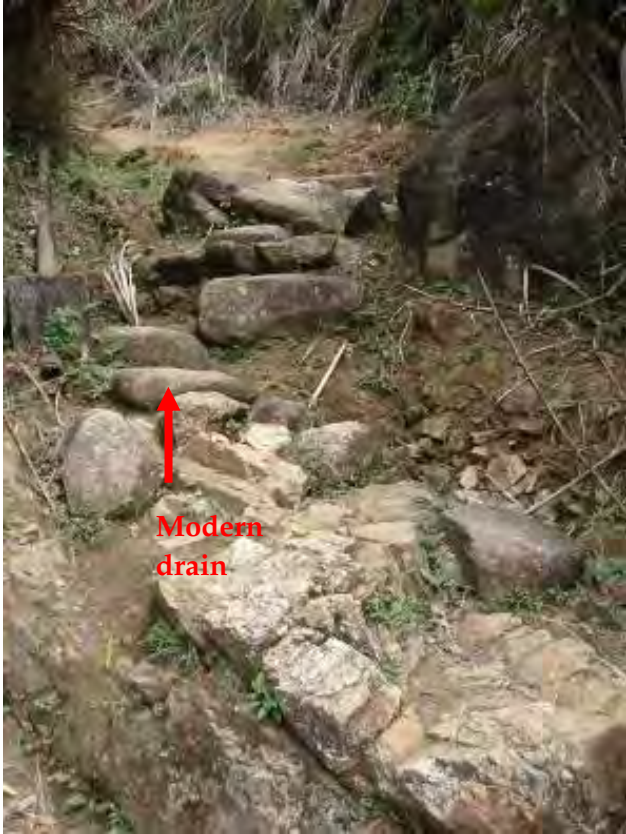
<p>Modern intrusion work can be seen on the boulder path; a modern drain was also observed adjacent to the boulder steps. (View A to B)</p>	15

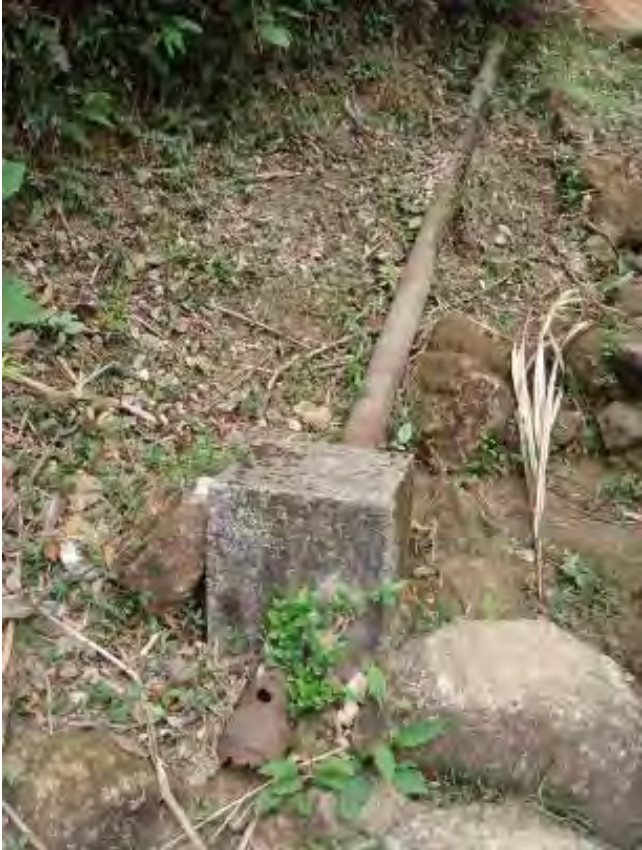
<p>A close up view of the modern drain. (View A to B)</p>

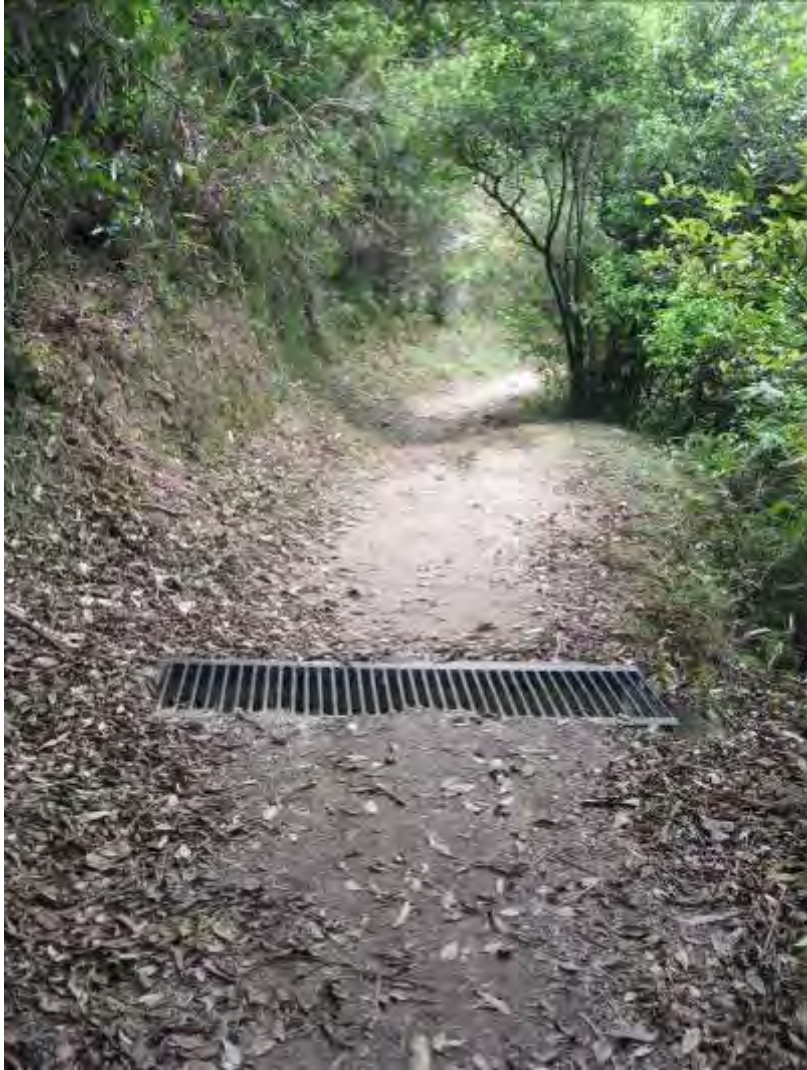
<p>Modern drain of the footpath. (View A to B)</p>		(Blank)

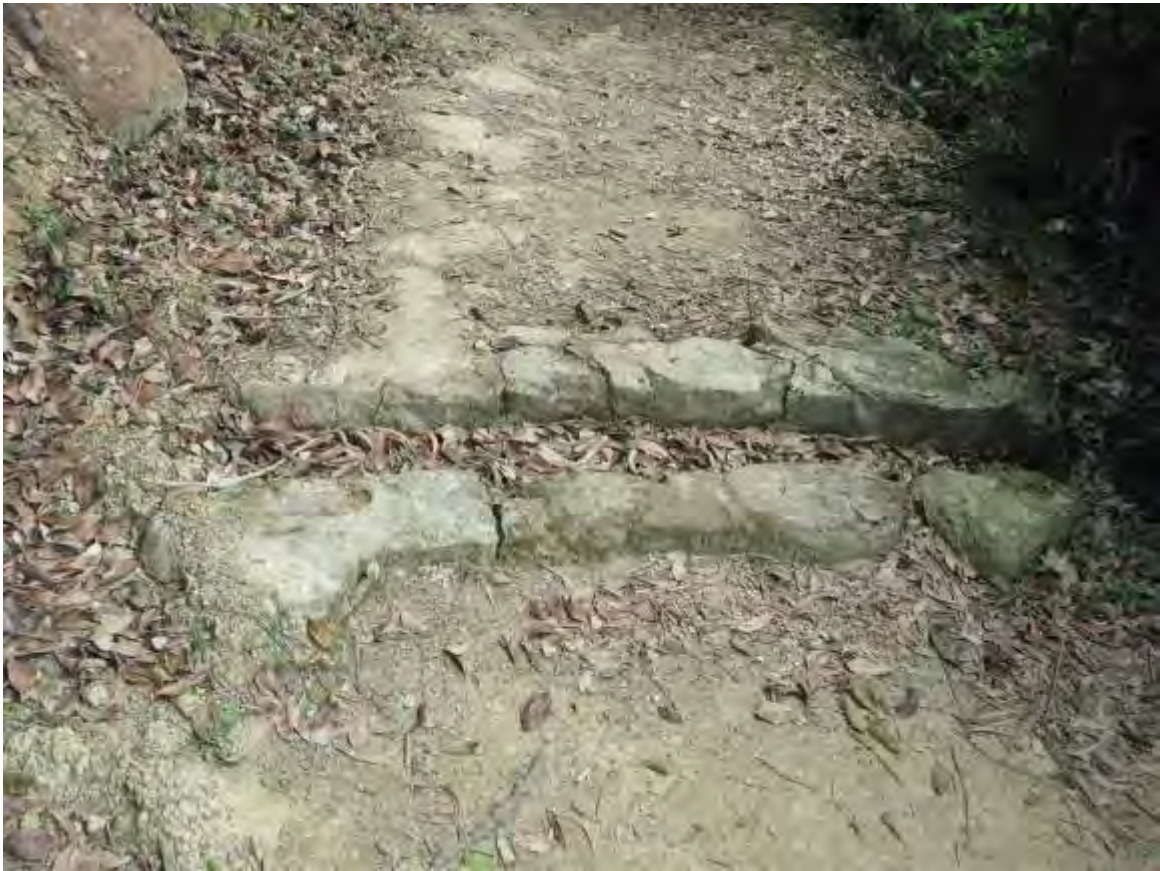
<p data-bbox="772 1161 1588 1201">Typical stone drain observed along the footpath. (View A to B)</p>

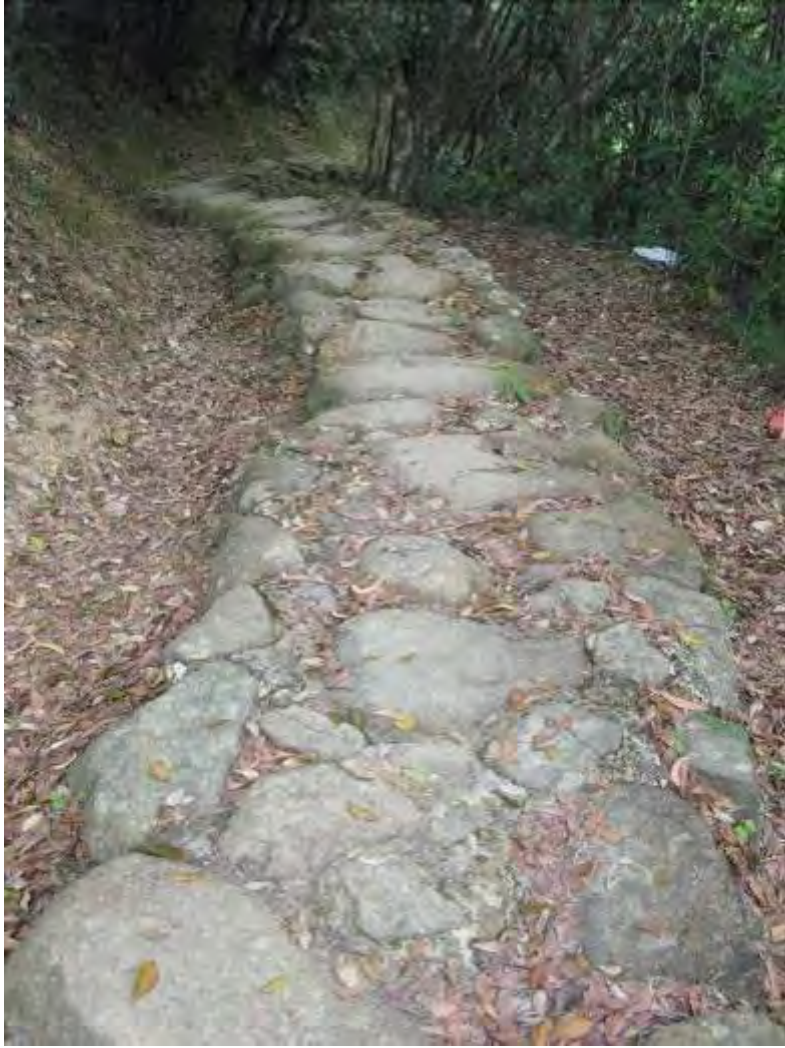
<p>Well arranged boulder section on a slope. (View A to B)</p>	5

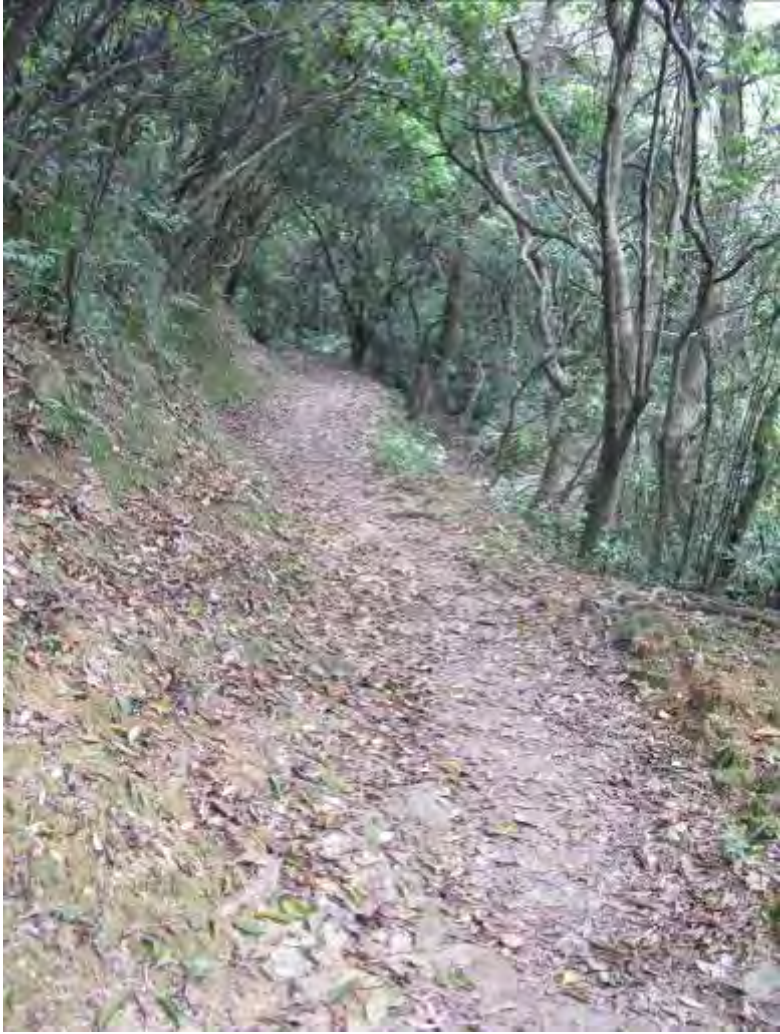
<p>Mud section after the boulder section. (View A to B)</p>

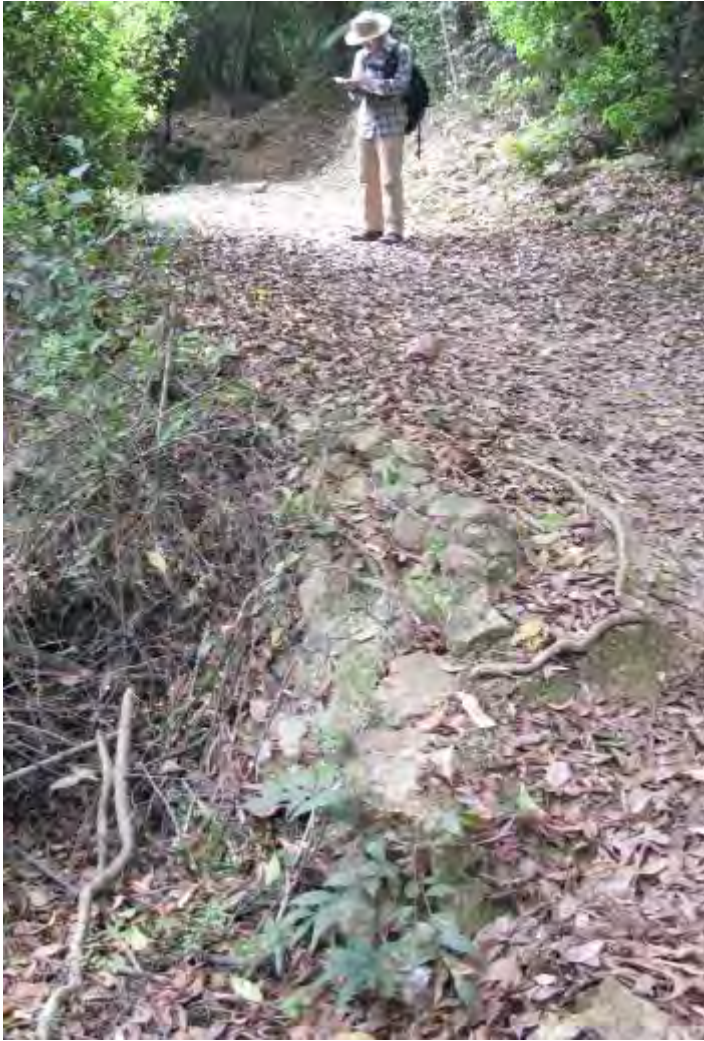
<p>Boulder built retaining wall on the edge of the footpath. (View B to A)</p>	7

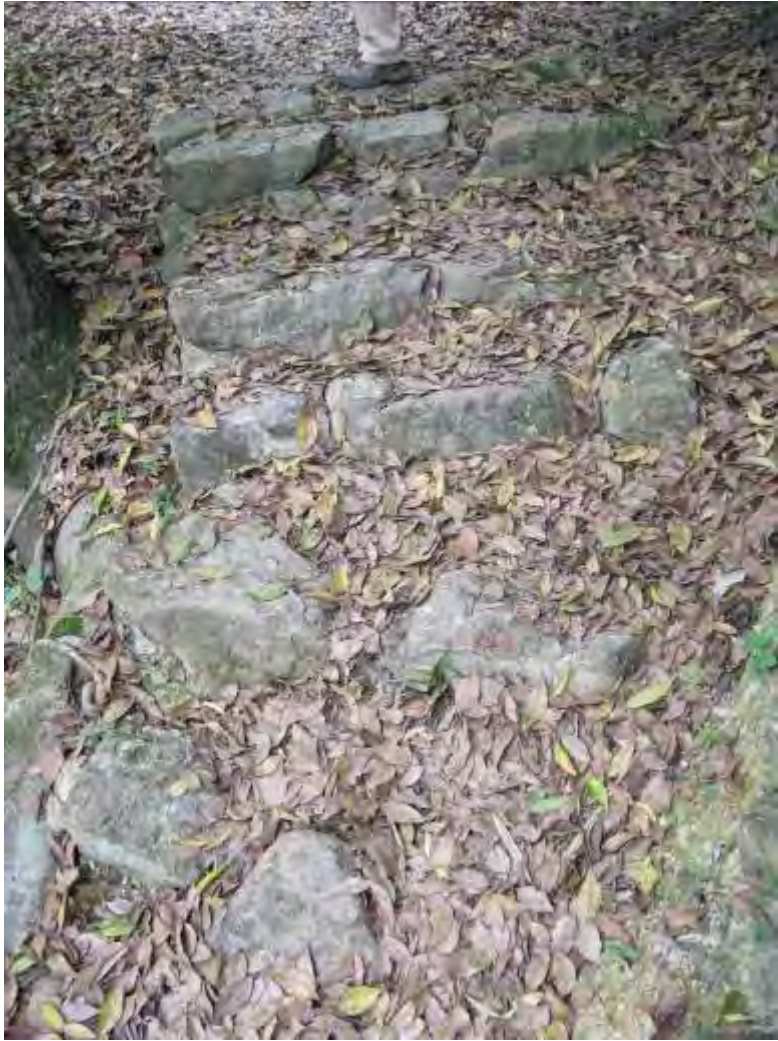
<p>Boulder steps (View B to A)</p>

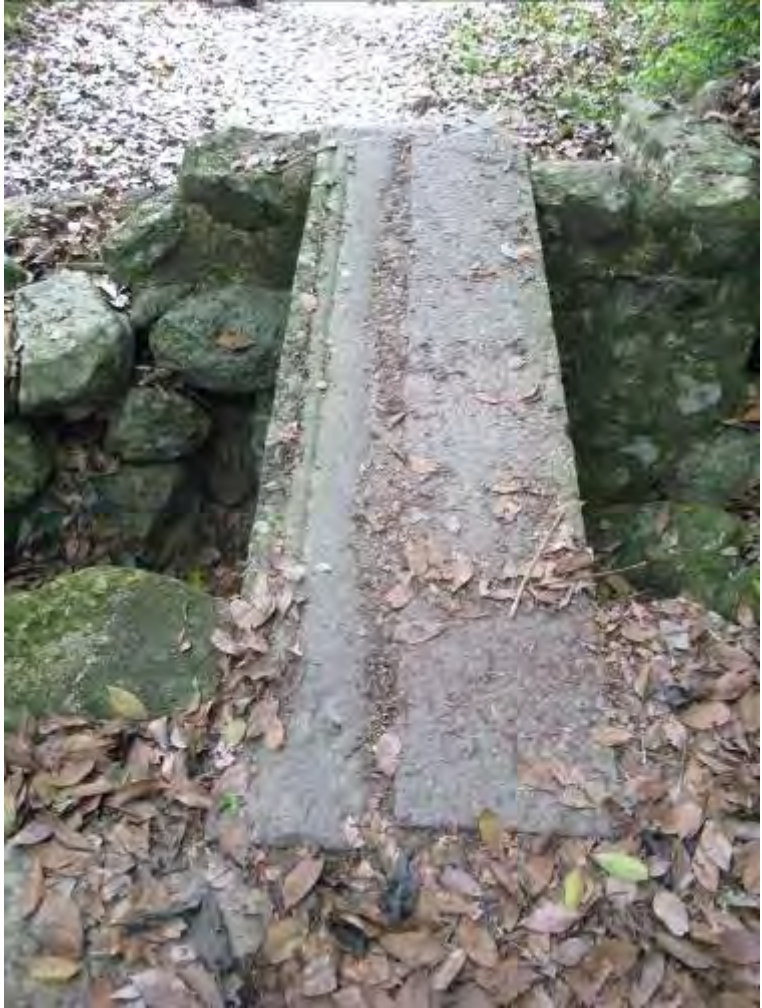
<p>Granite slab bridge for stream crossing. The granite slab at the right appears to be from reused building material. (View B to A)</p>

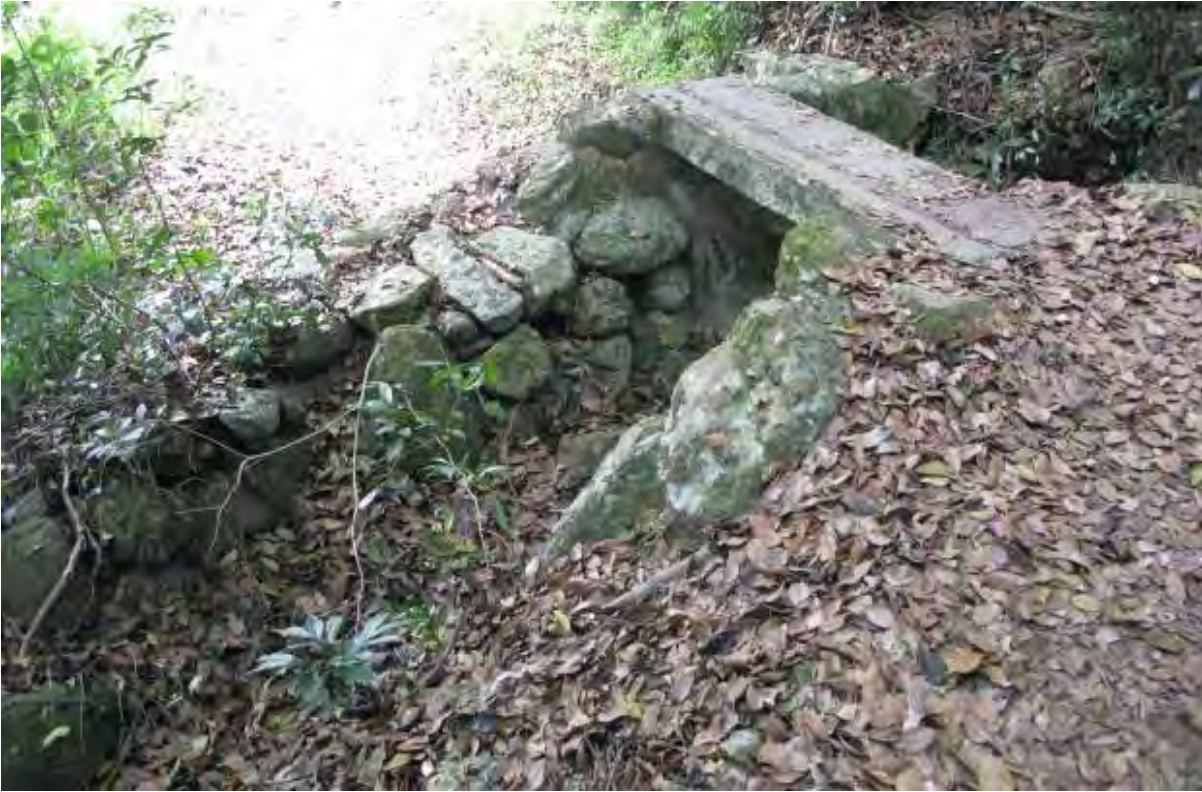
<p data-bbox="591 1043 1789 1082">General view of the granite slab bridge showing the foundation of the bridge. (View B to A)</p>

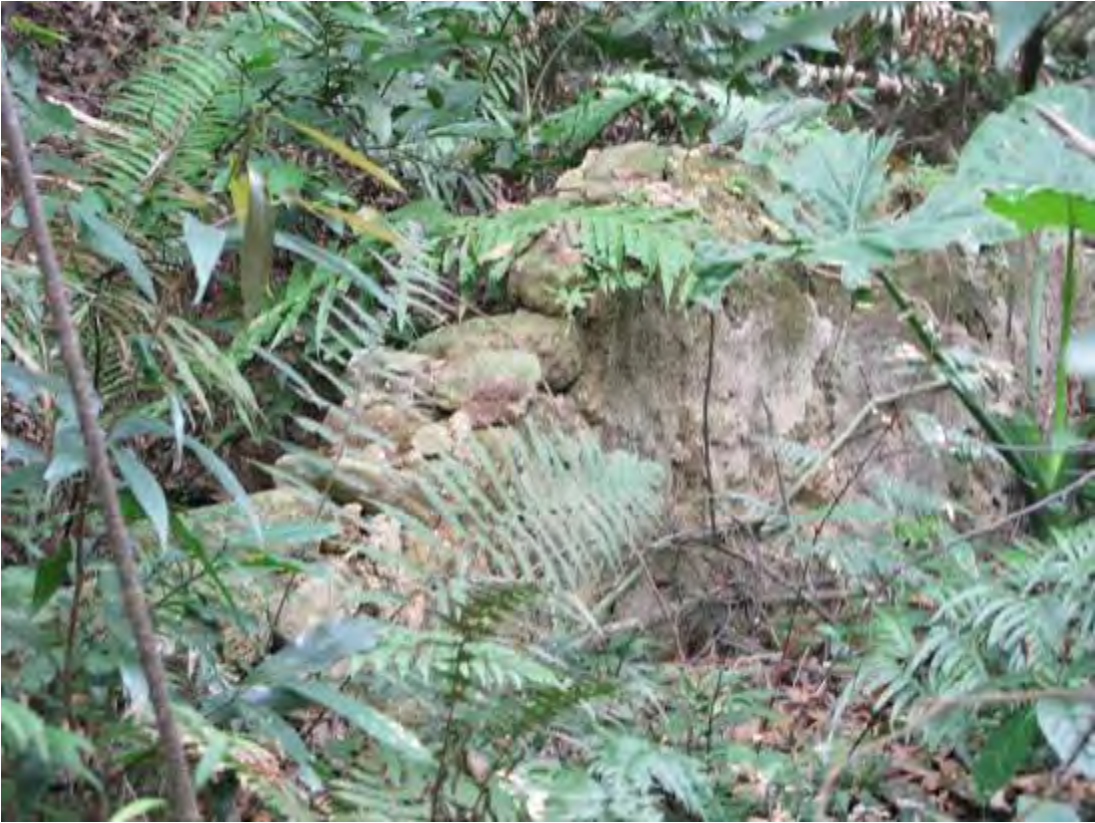
<p data-bbox="555 1077 1825 1114">Ruin west of the footpath with remaining stone wall of approximately 1 m high. (View from east).</p>

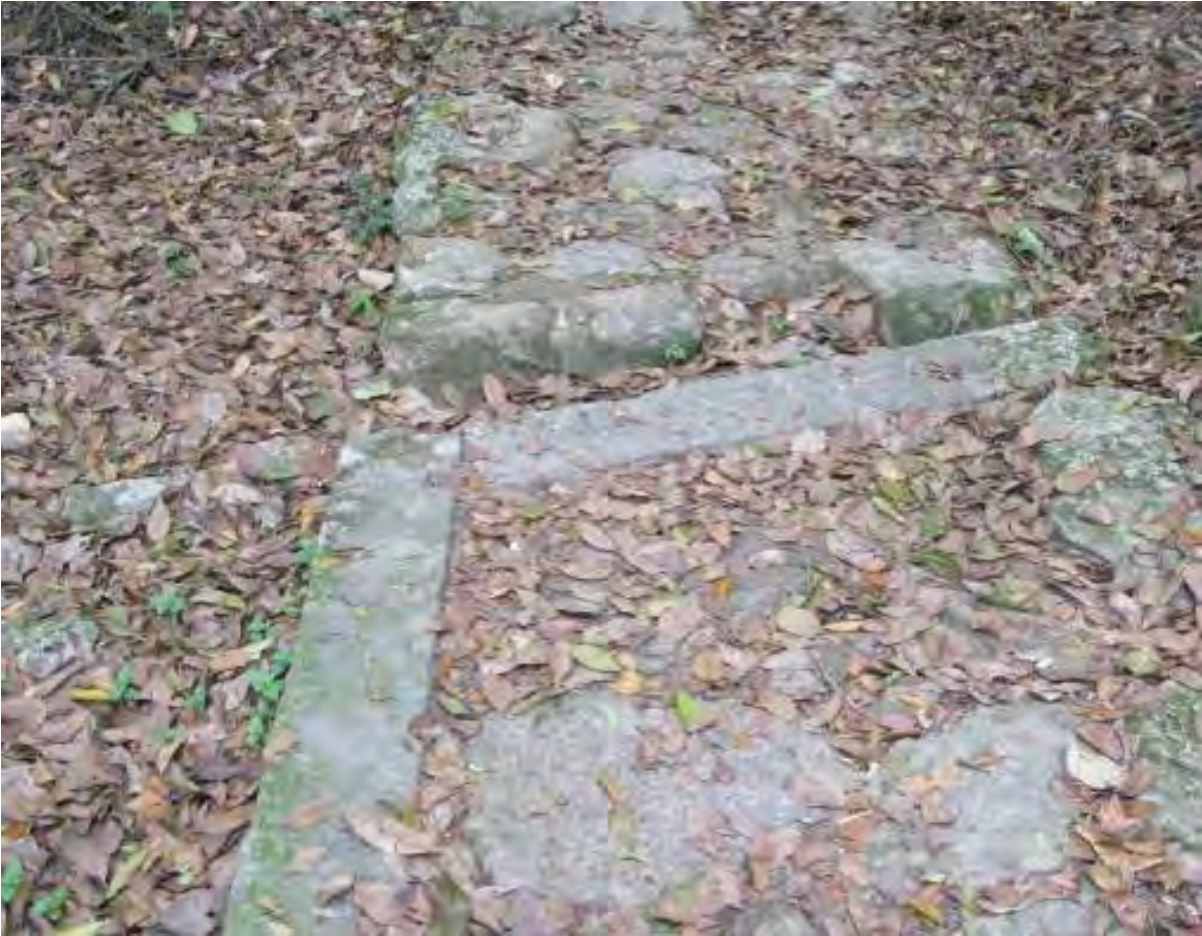
<p data-bbox="573 1190 1807 1225">Stone drain made with two rectangular blocks (probably building waste reused). (View B to A)</p>

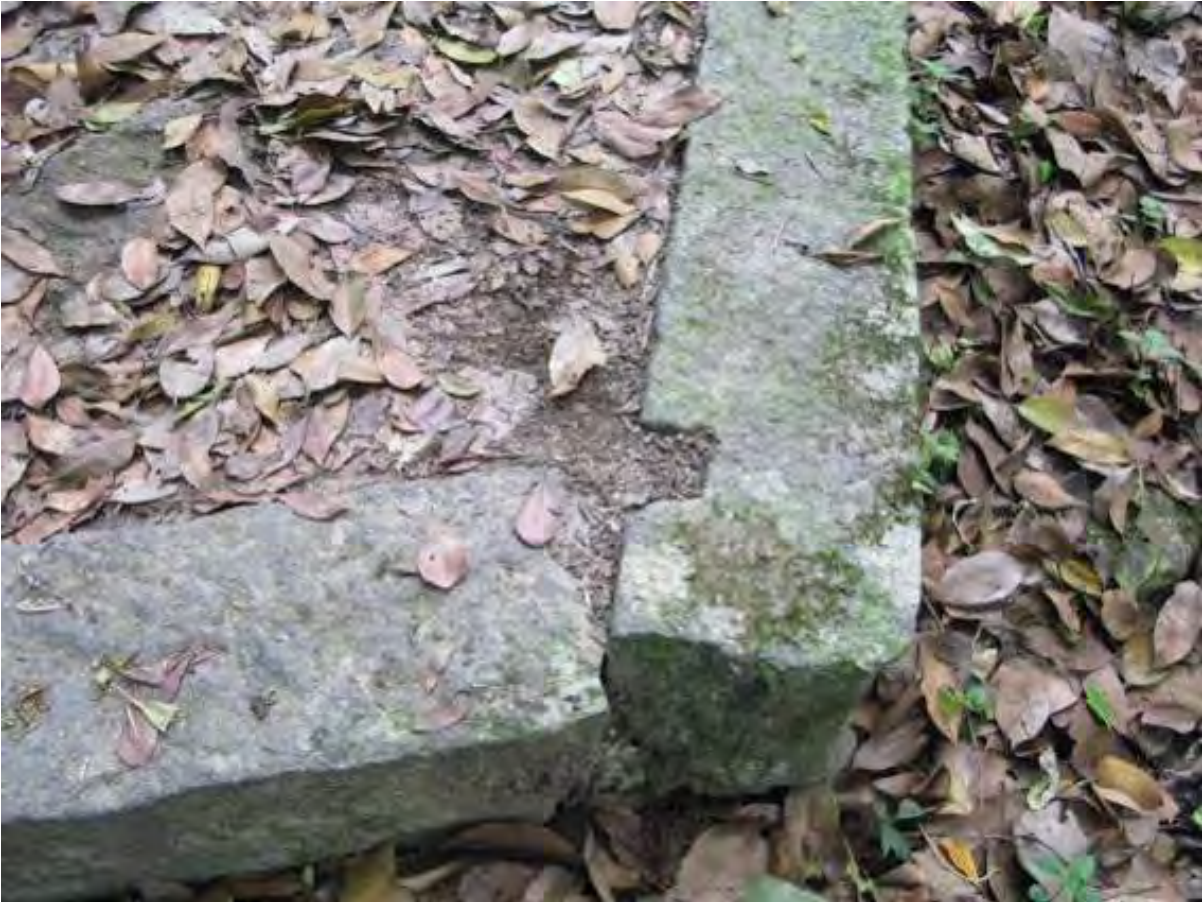
<p data-bbox="629 1158 1749 1193">Close up of the corner of stone drain. Probably building waste reused. (View A to B)</p>

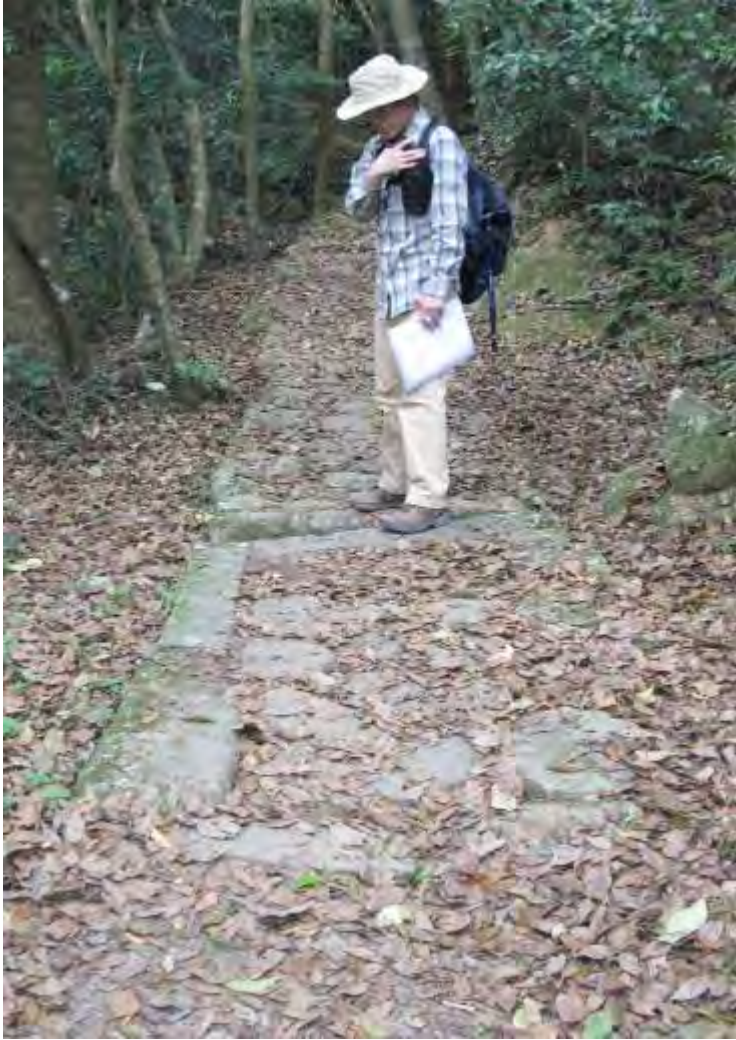
<p>End of the boulder section. (View B to A)</p>	10

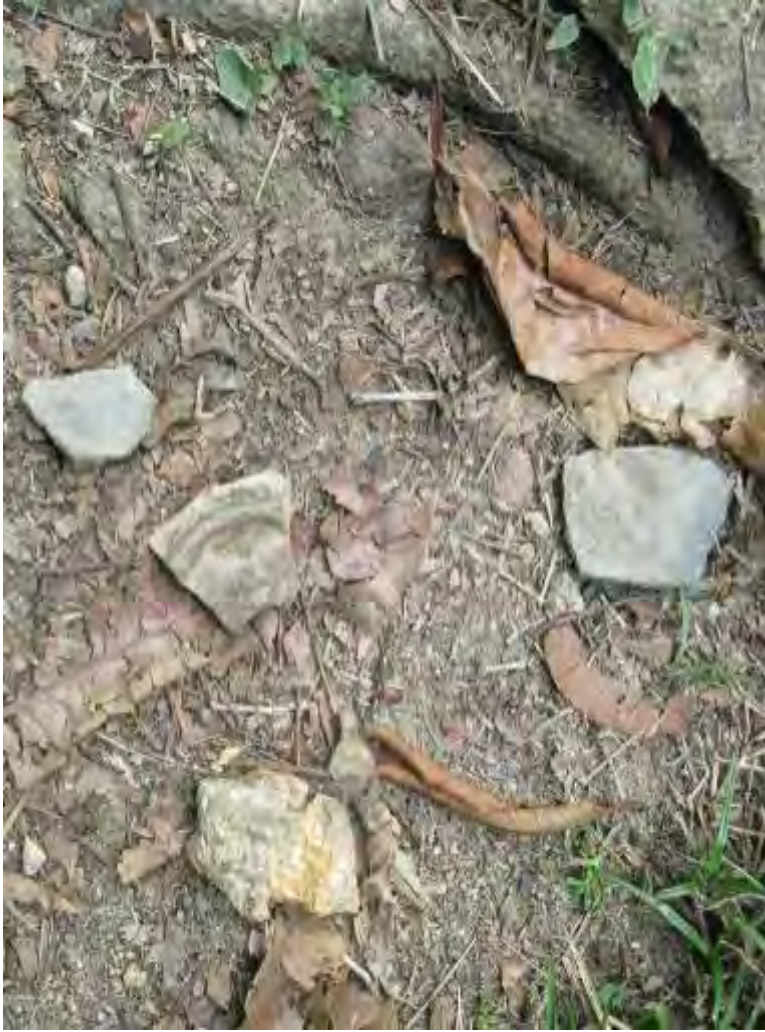
<p>Ceramic shards identified at the footpath</p>

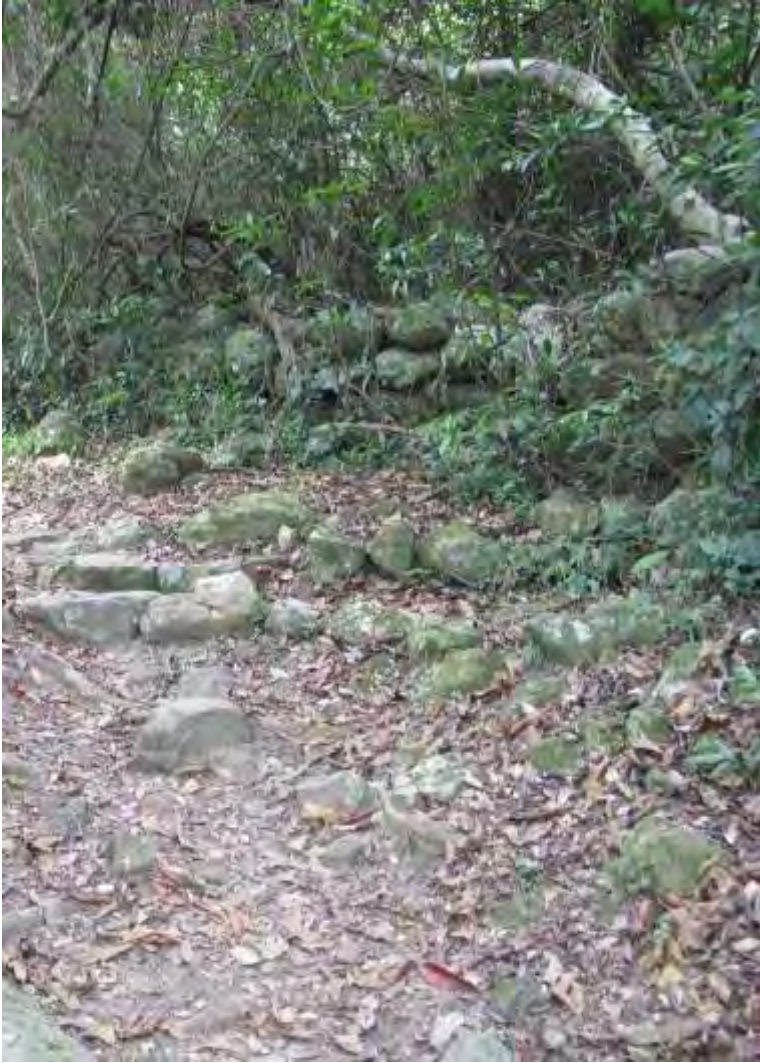
<p>Possible ruin or retaining wall west of the footpath. (View B to A)</p>	11

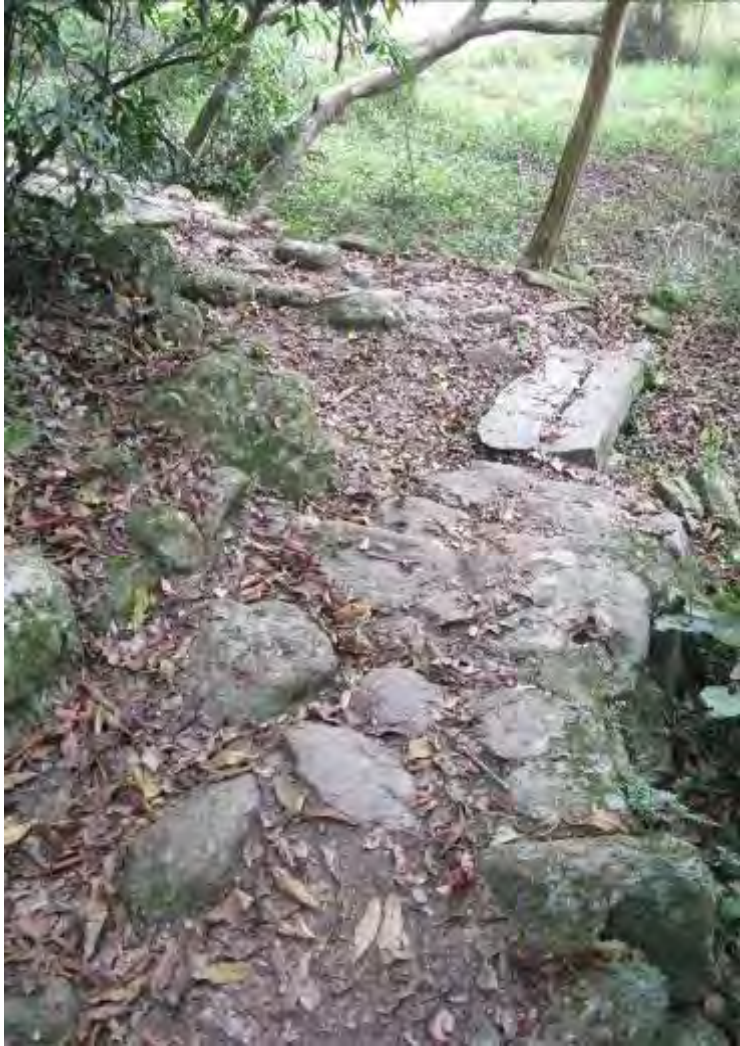
<p>Boulder steps leading to a granite slab bridge. (View A to B)</p>

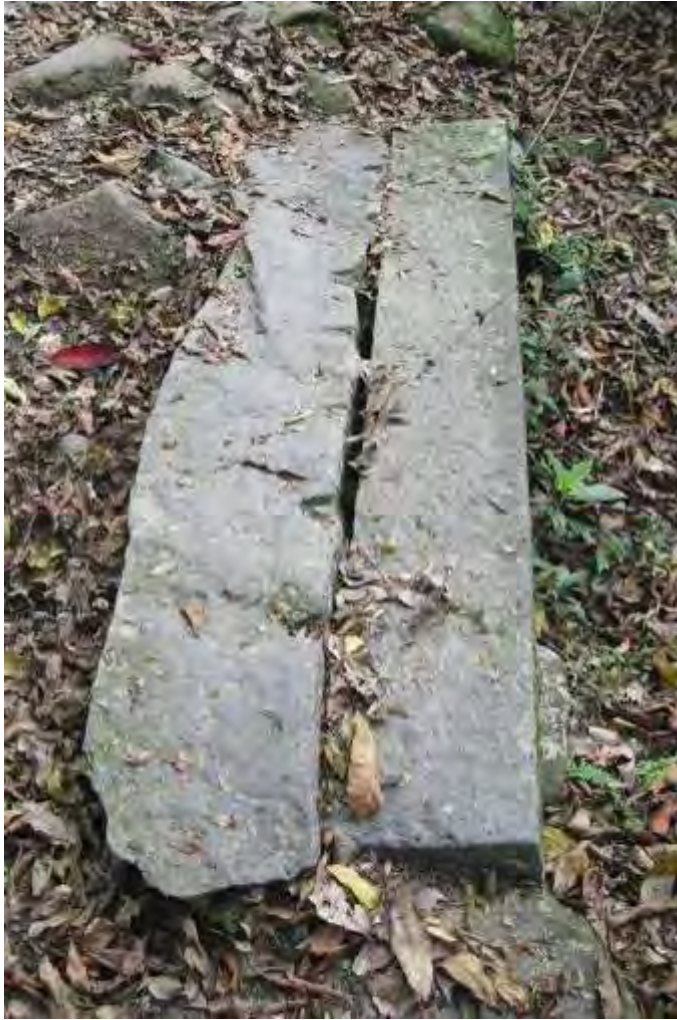
<p>Granite slab bridge crossing a dried stream course. (View A to B)</p>	12

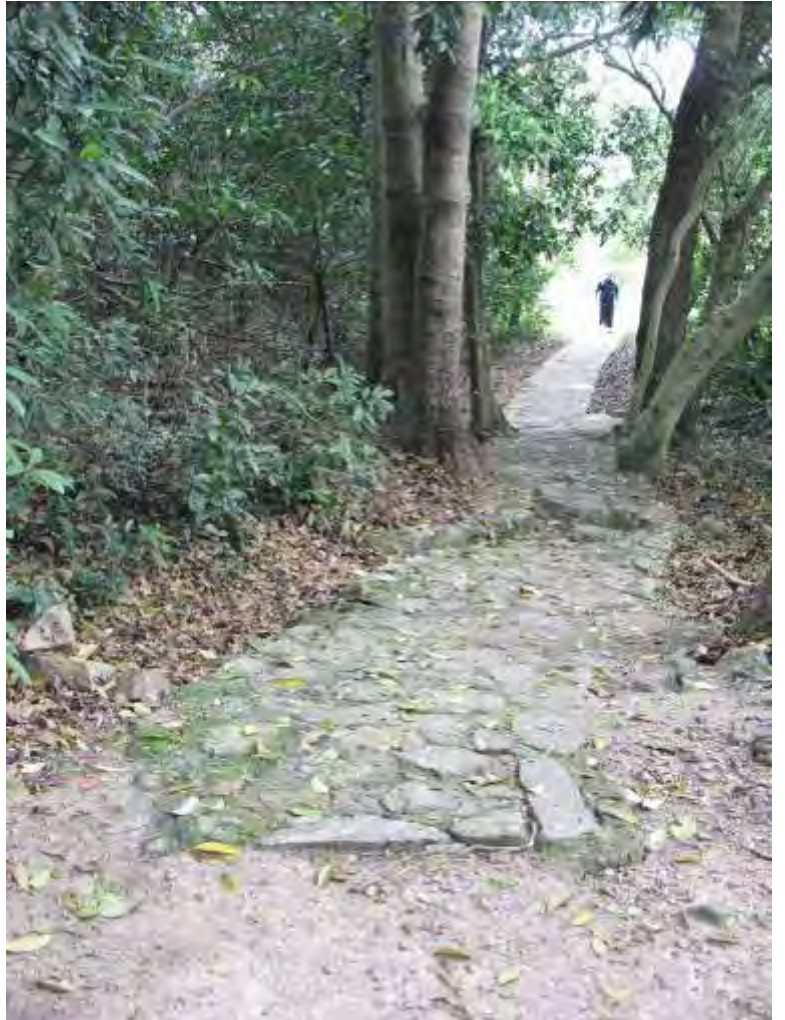
<p>End of mud section, boulder and concrete section appear. (View A to B)</p>

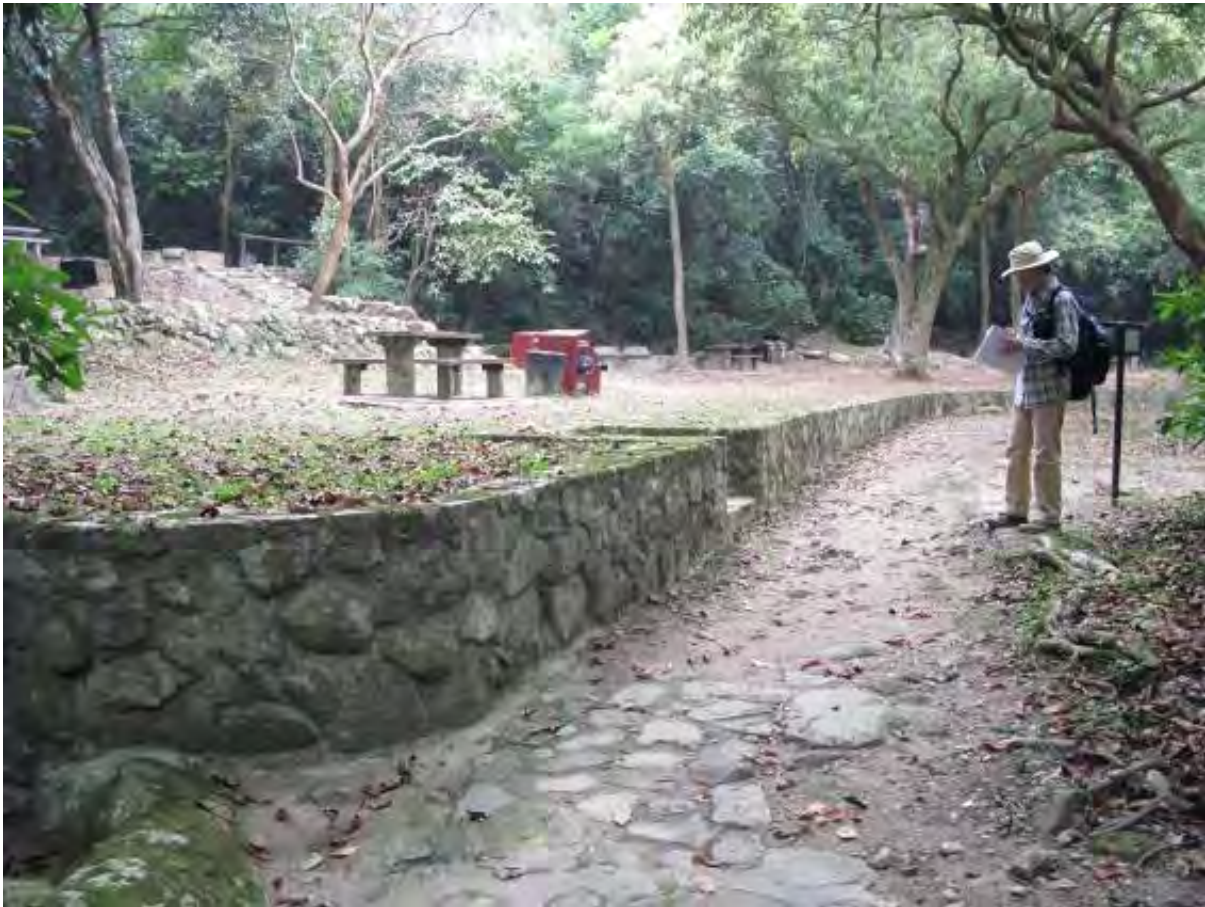
<p data-bbox="748 1201 1659 1236">Boulder and concrete section leading to a barbecue area. (View A to B)</p>

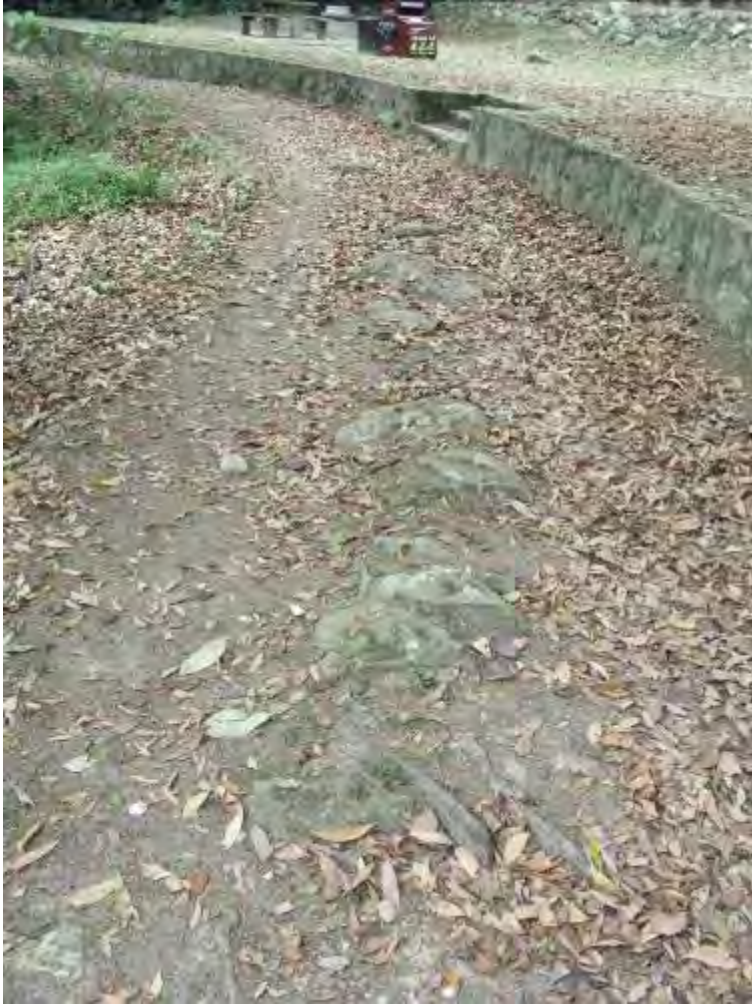
<p>Mud section outside the barbecue area. A boulder paved alignment is observed. (View B to A)</p>	15

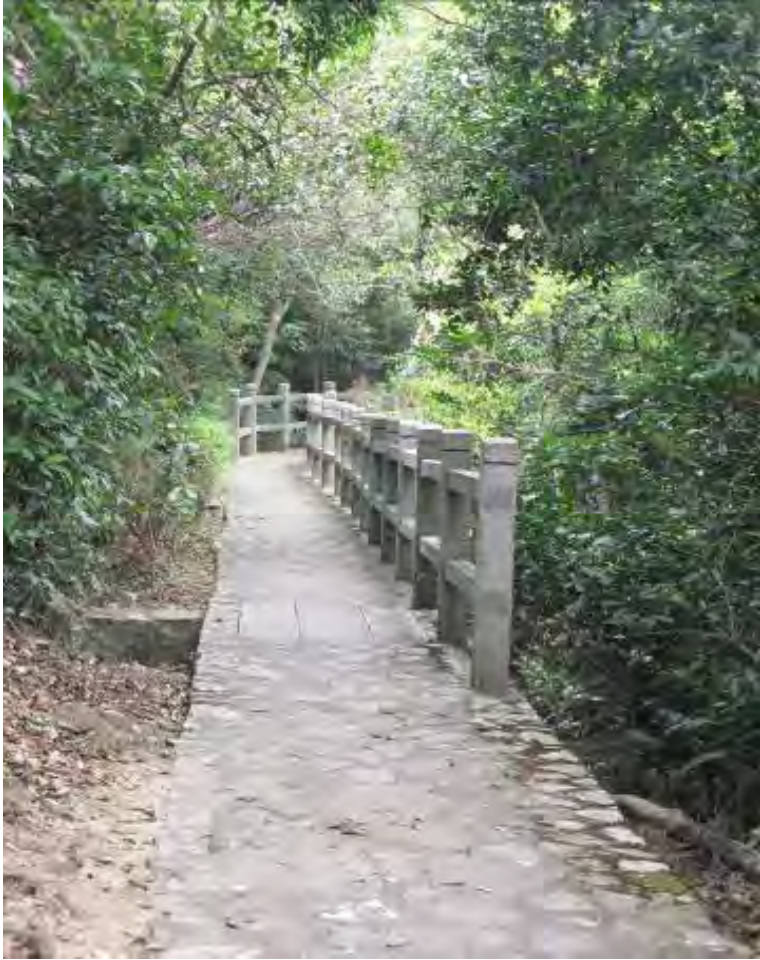
<p>Handrail erected in later period. Note the stone blocks placed parallel to each other. (View A to B)</p>	16

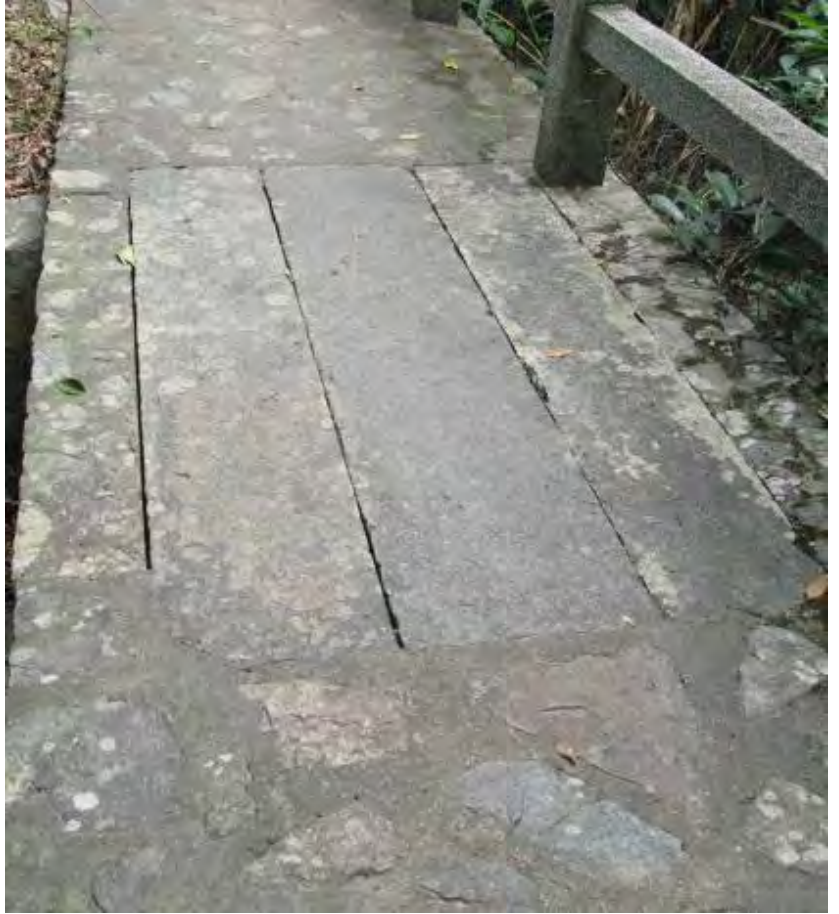
<p>Close-up of stone slabs placed parallel to each other over stream course. They are possibly granite slabs belong to the original old footpath being repaired. (View A to B)</p>

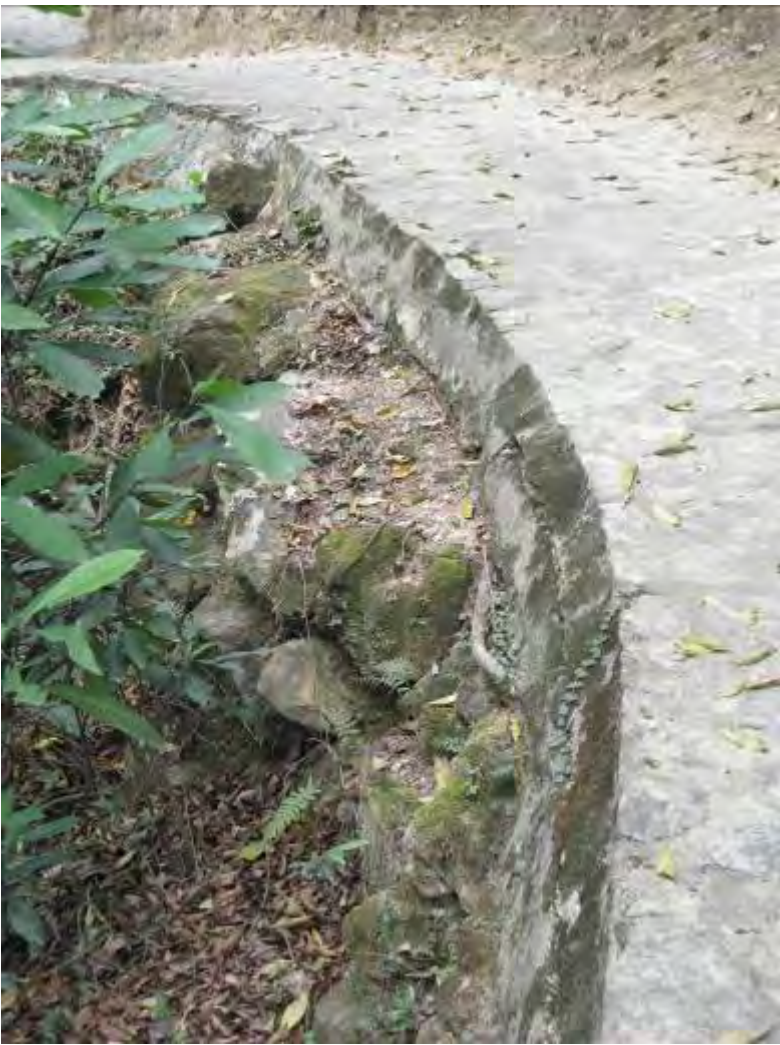
<p>Boulder of old footpath possible covered by boulder and concrete section constructed in a later period. (View A to B)</p>

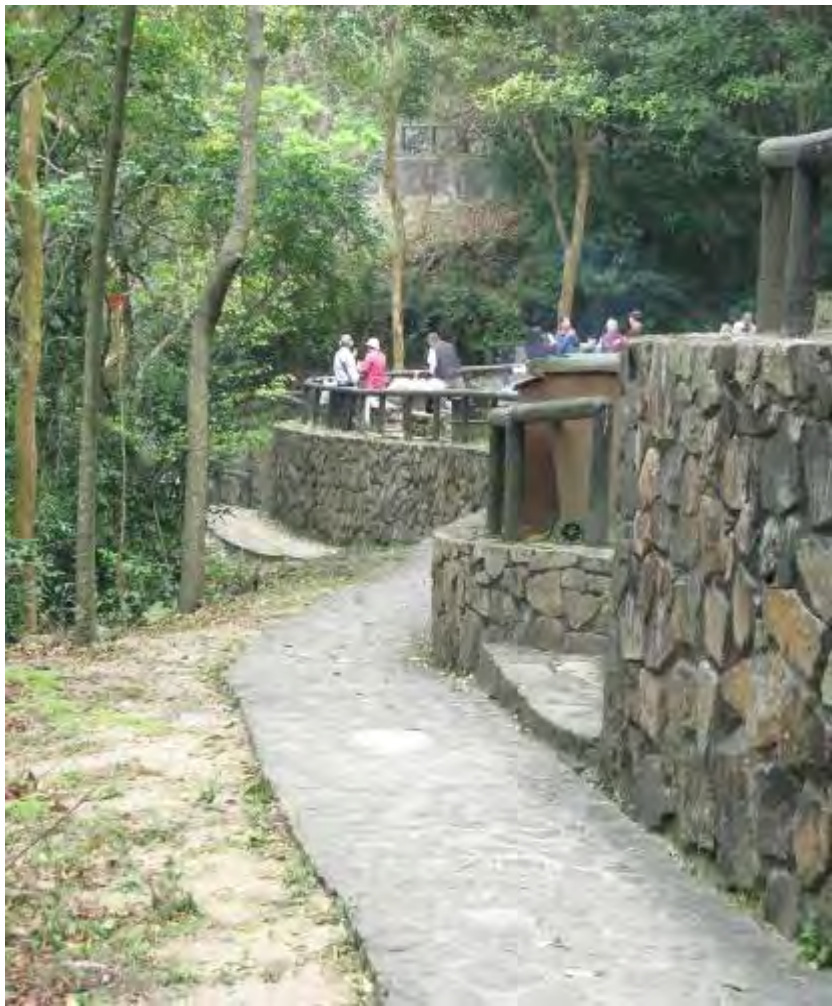
<p>Stone paved concrete section leading to a barbecue area. Note possible boulders of original old footpath no longer observable. Material evidence of the old footpath ended at the barbecue area. (View A to B)</p>	18

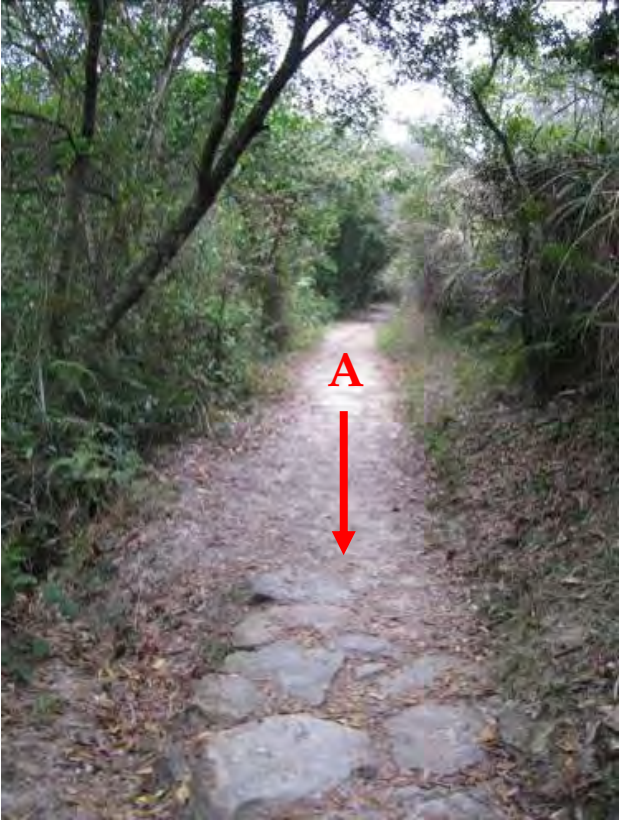
<p>Flat footpath inlaid with boulders which is covered with fallen leaves. (View B to A)</p>		(Blank)

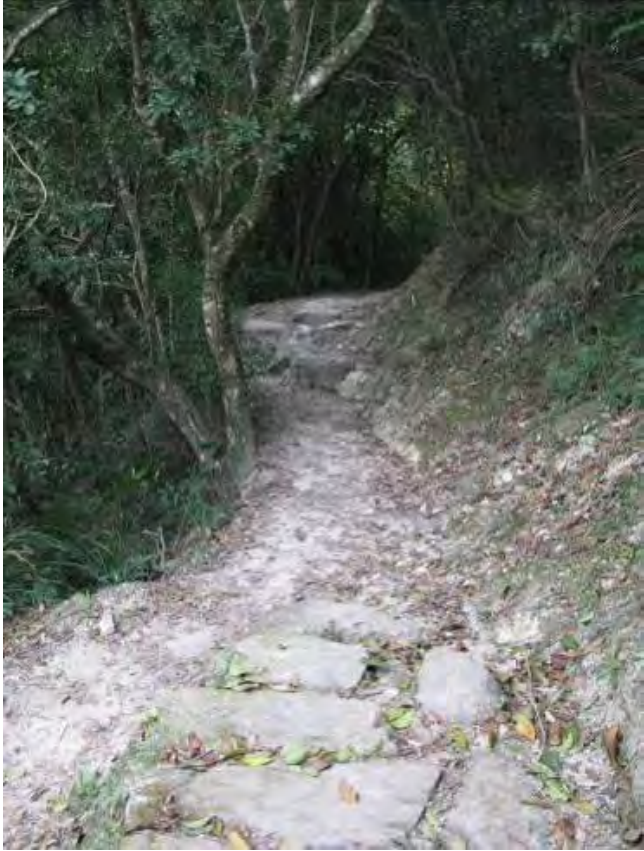
<p>Slightly sloping upwards boulder section with a part of no boulders. (View B to A)</p>		(Blank)
