Antiquities and Monuments Office

Study on Old Trails in Hong Kong - Final Study Report

February 2014

Study on Old Trails in Hong Kong: *Final Study Report*

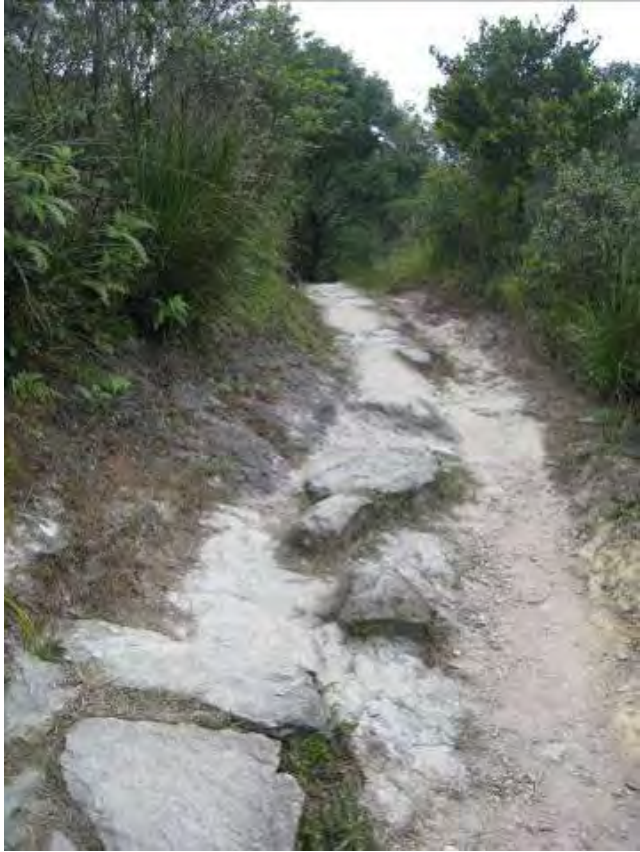
<p>Widened footpath with an elevated footpath on one side inlaid boulder and concrete. (View B to A)</p>		(Blank)

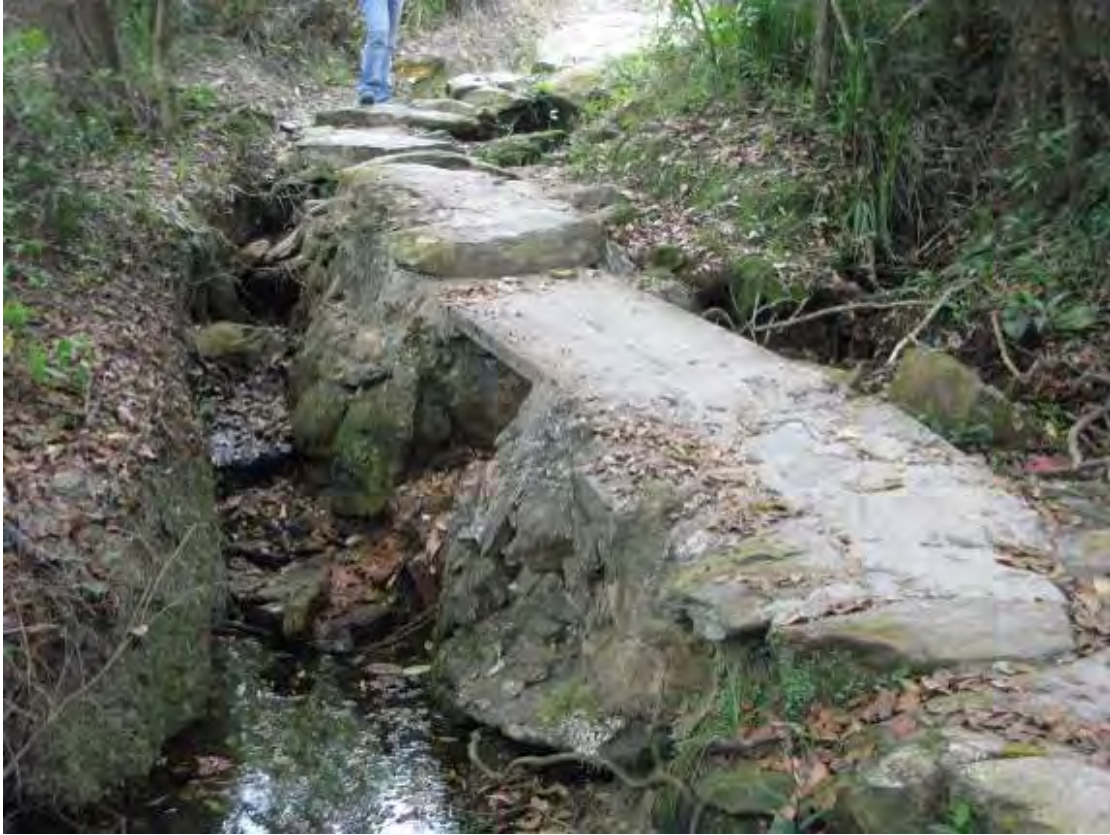
<p data-bbox="293 1198 2085 1270">Closer view of the concrete bridge where the footpath on either side of the bridge are further stabilized by boulders in-filled with concrete. (View B to A)</p>

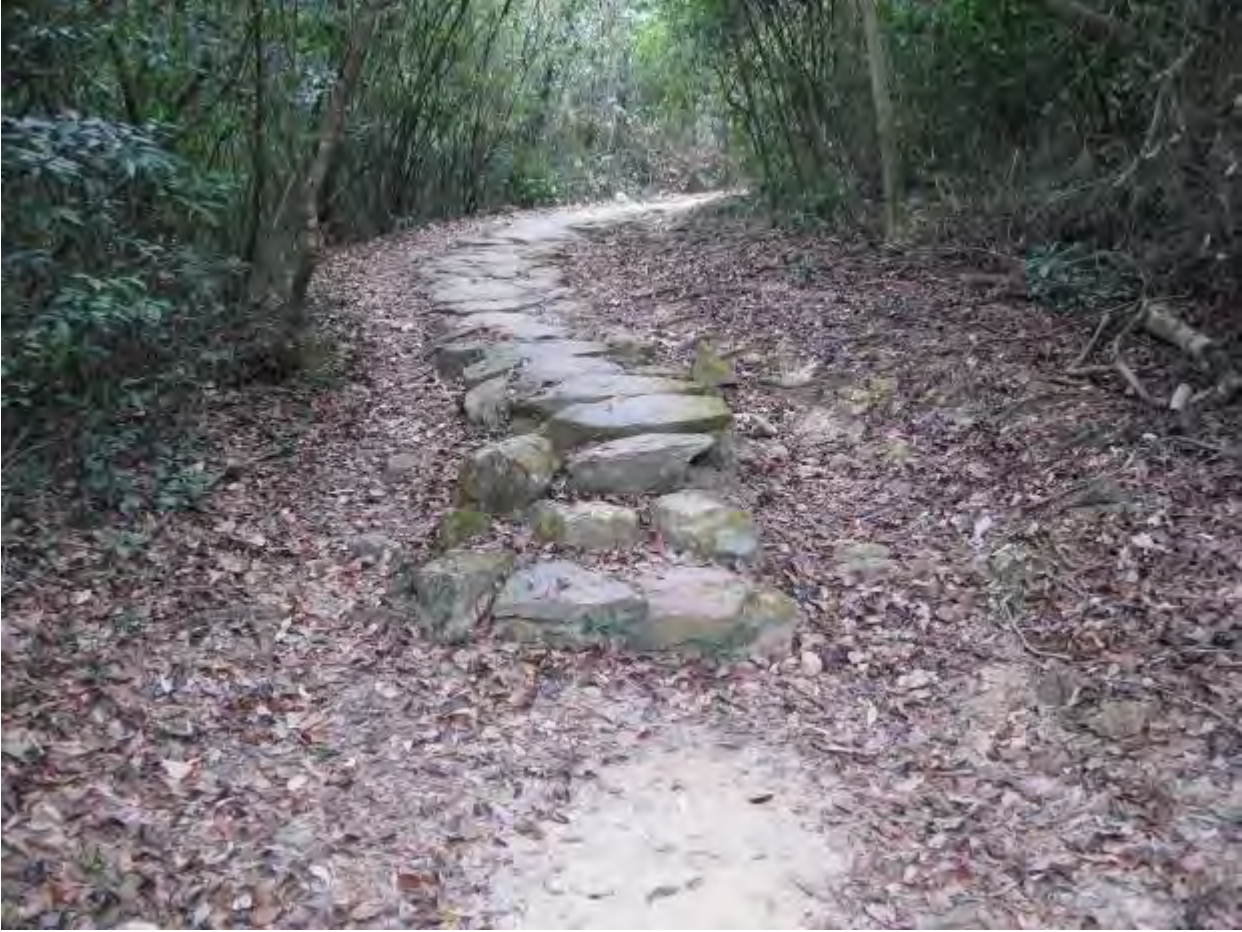
<p data-bbox="757 1294 1624 1327">The boulder section starts and the mud section ends. (View B to A)</p>

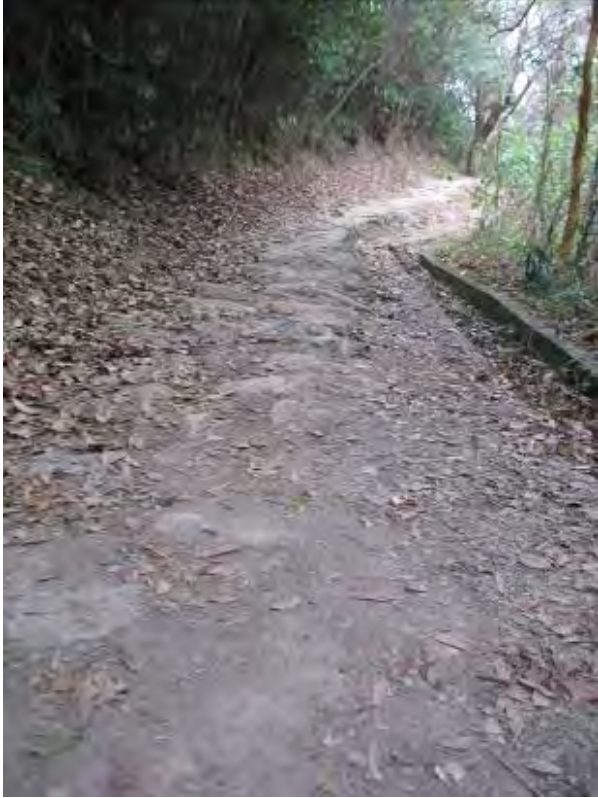
<p>Boulder section that fades out by a covering of mud and fallen leaves. A modern drain can be seen on one side of the footpath. (View B to A)</p>		(Blank)

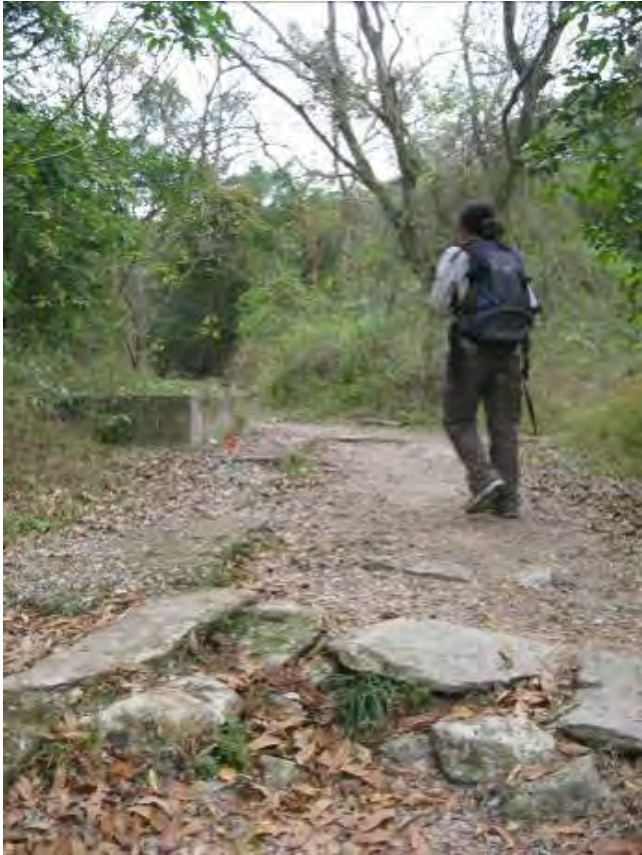
<p>Mud section with occasional boulder. A modern concrete structure can be seen on the left hand side. (View B to A)</p>		(Blank)

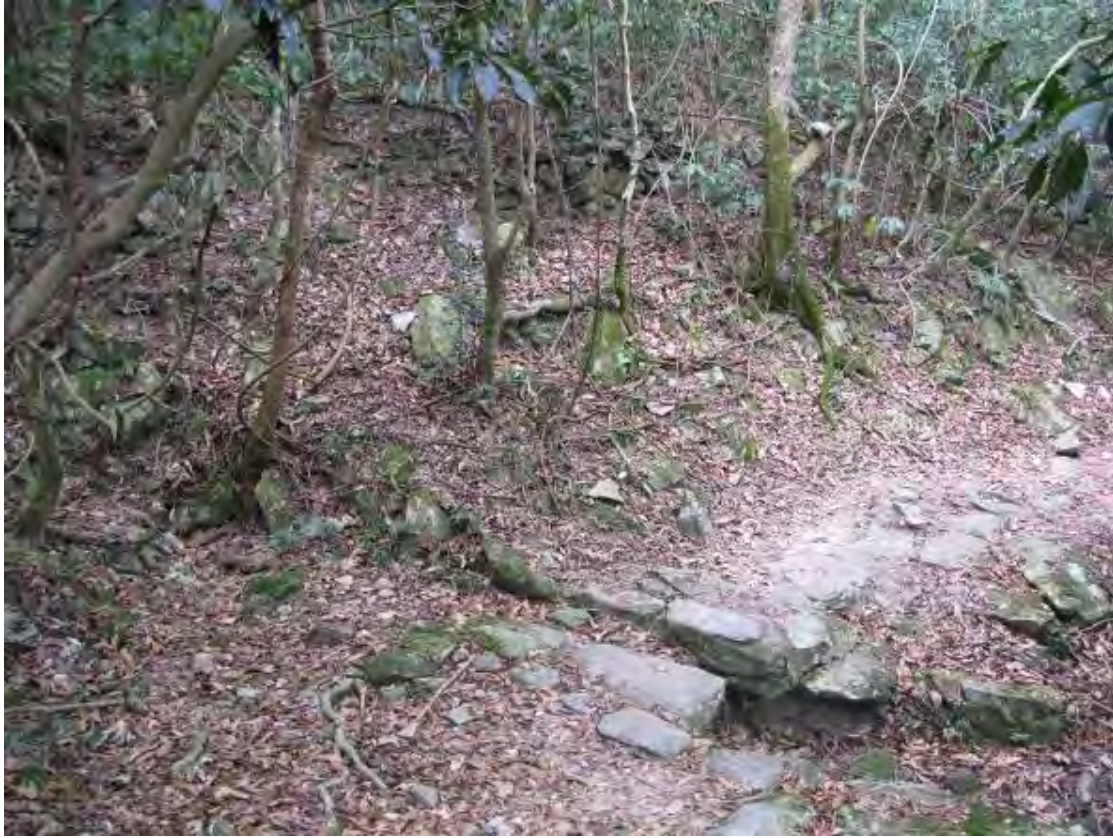
<p data-bbox="645 1246 1731 1279">A dry stream course across the boulder path with in-filled concrete. (View A to B)</p>

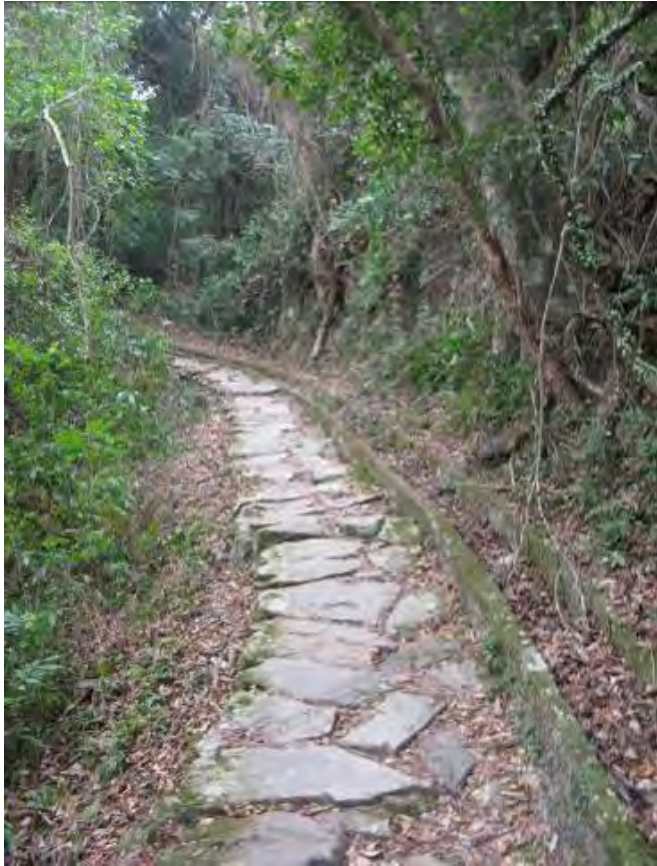
<p>Boulder section with concrete drain channel filled with fallen leaves. (View B to A)</p>		(Blank)

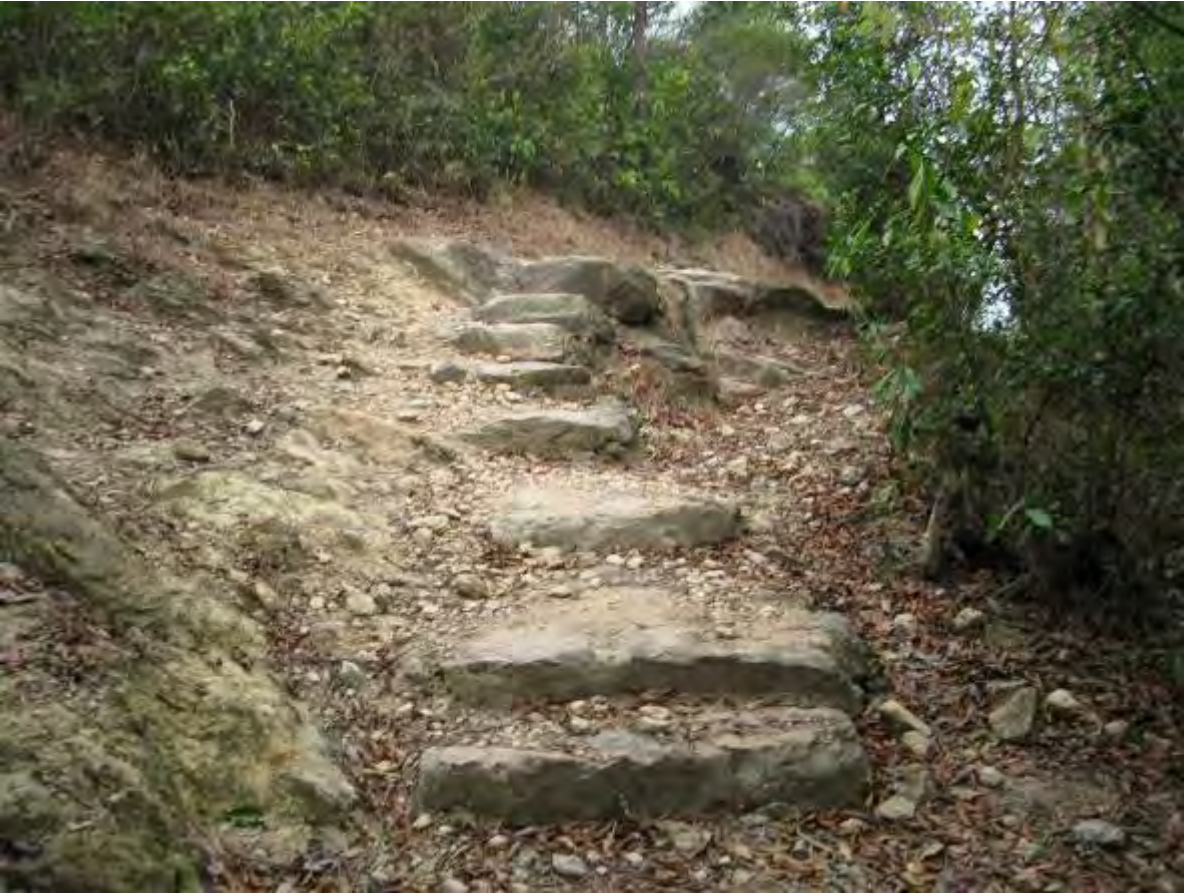
Photo Reference No.	Photographic Records
15

<p data-bbox="680 1252 1700 1289">Occasional short section of boulder steps along the mud section. (View B to A)</p>

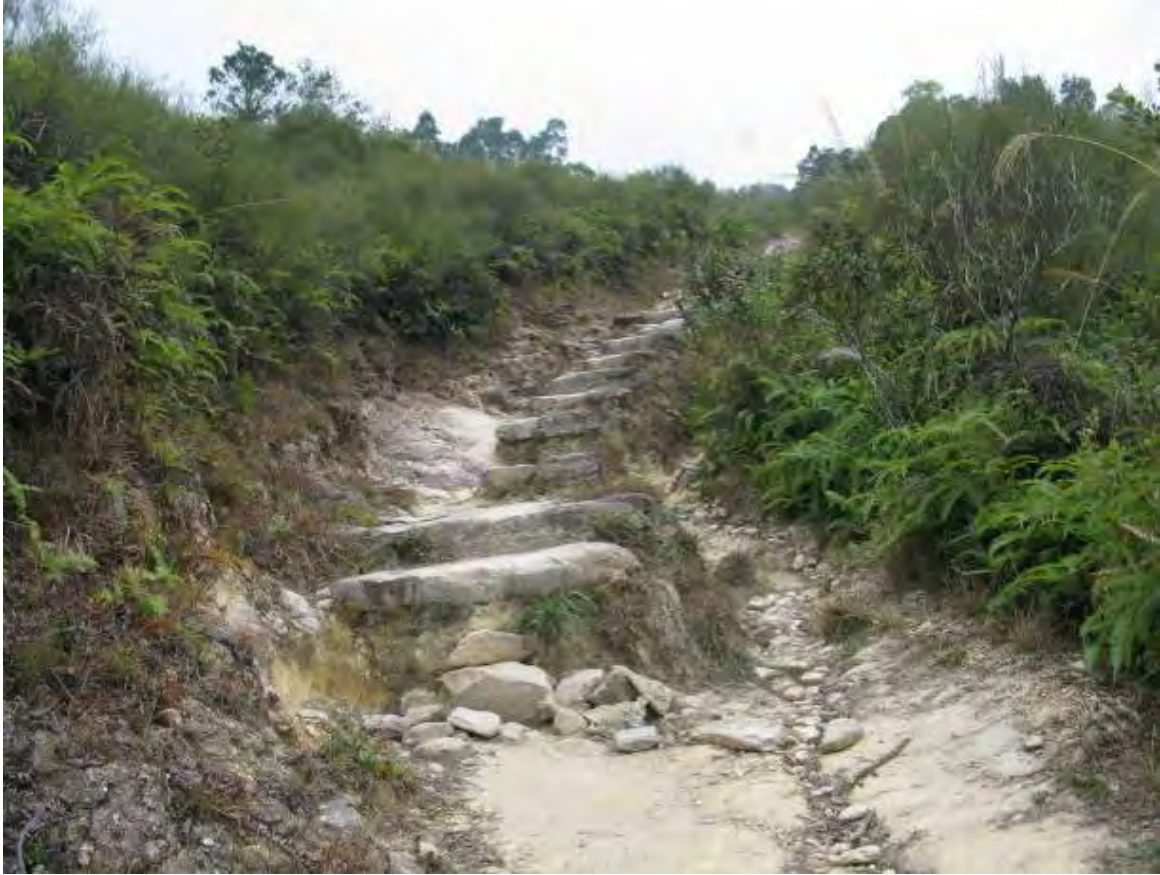
Photo Reference No.	Photographic Records
16

<p data-bbox="271 1278 2107 1350">Occasional short section of boulder steps along the mud section. Signs of concrete work can be seen along the boulder steps to stabilise them. (View B to A)</p>

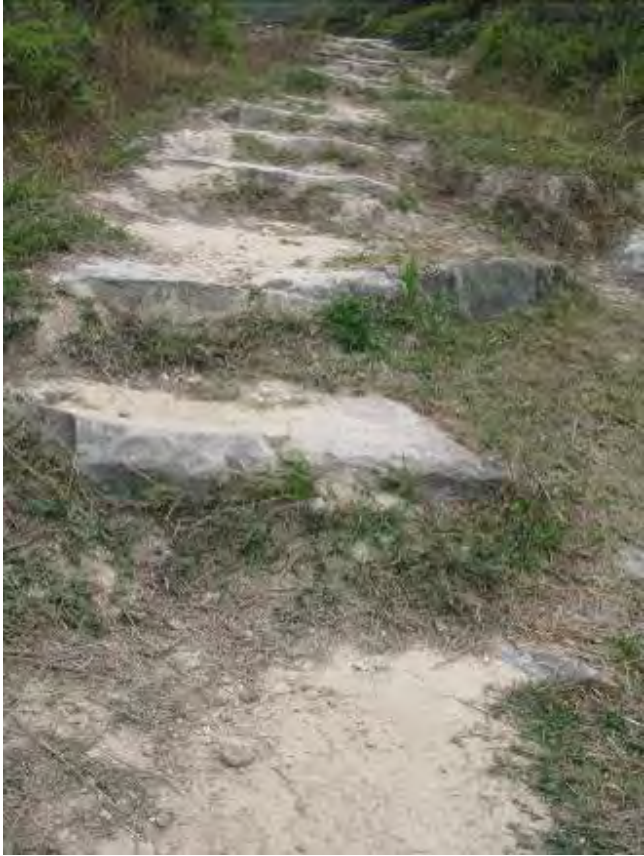
Photo Reference No.	Photographic Records	Photo Reference No.	Photographic Records
19

<p>Boulder steps on mud section heading downhill. (View B to A)</p>		(Blank)

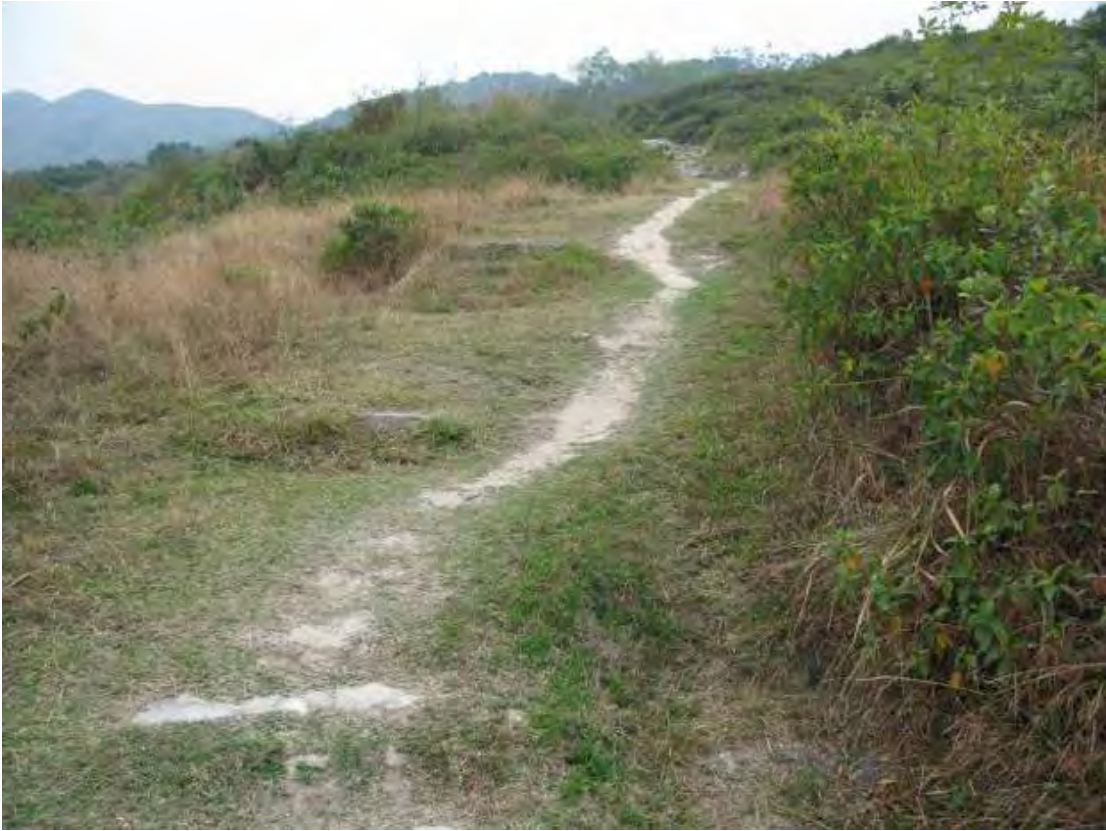
Photo Reference No.	Photographic Records
B

<p data-bbox="611 1230 1767 1267">This photo shows the end of the concrete path and start of the mud section. (View B to A)</p>

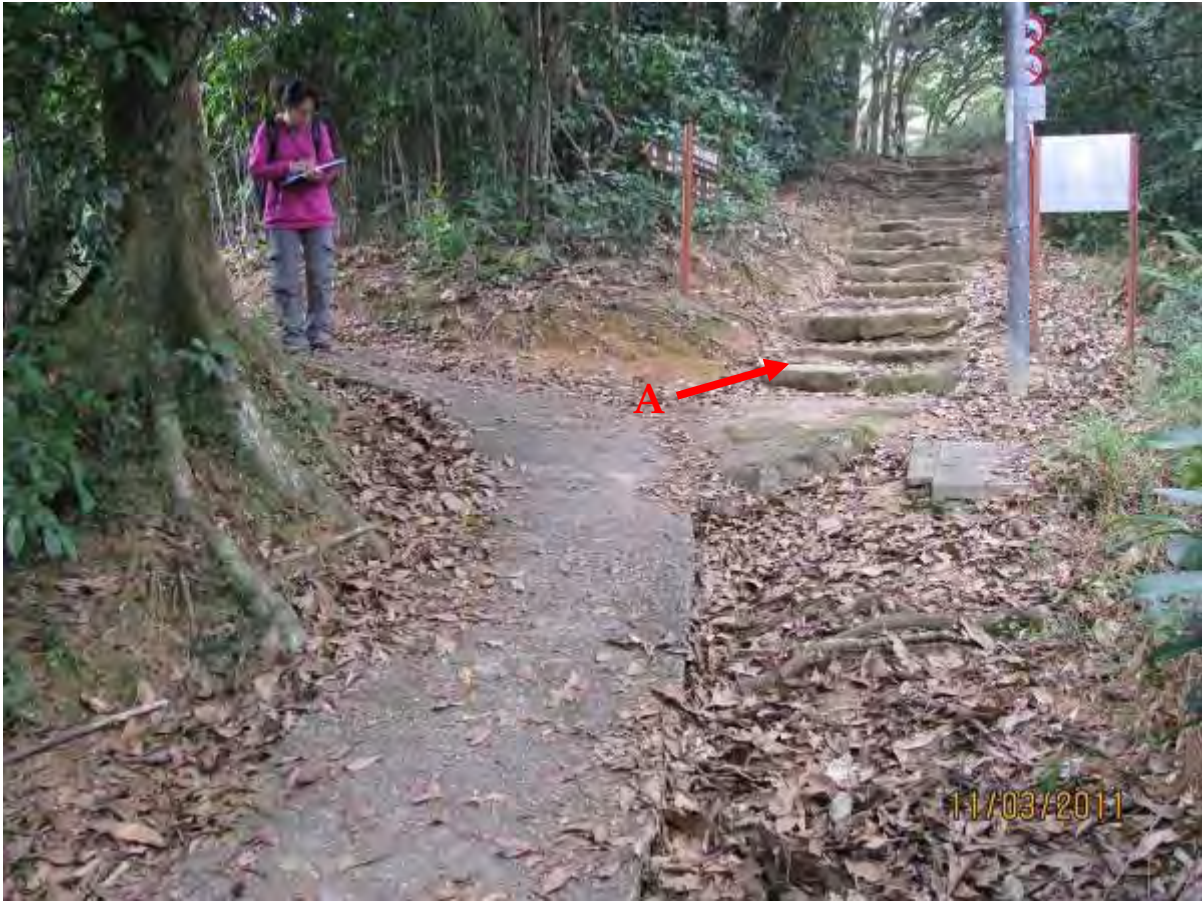
Photo Reference No.	Photographic Records
A

<p data-bbox="987 1174 1391 1209">Starting point A. (View A to B)</p>

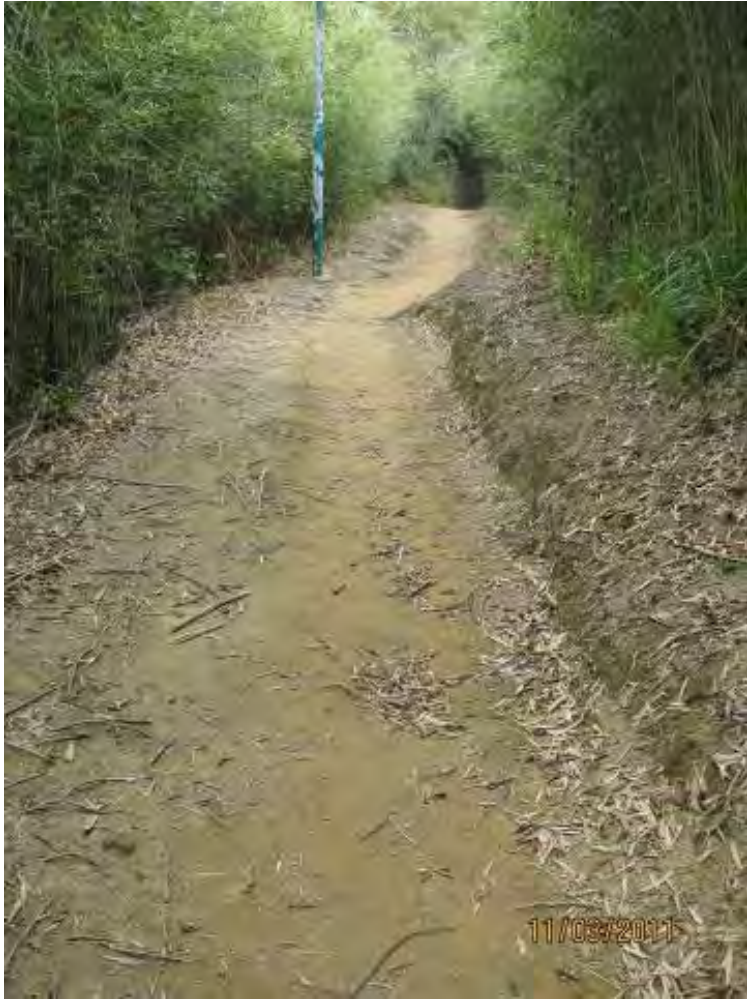
<p>Typical view of mud section. (View B to A)</p>

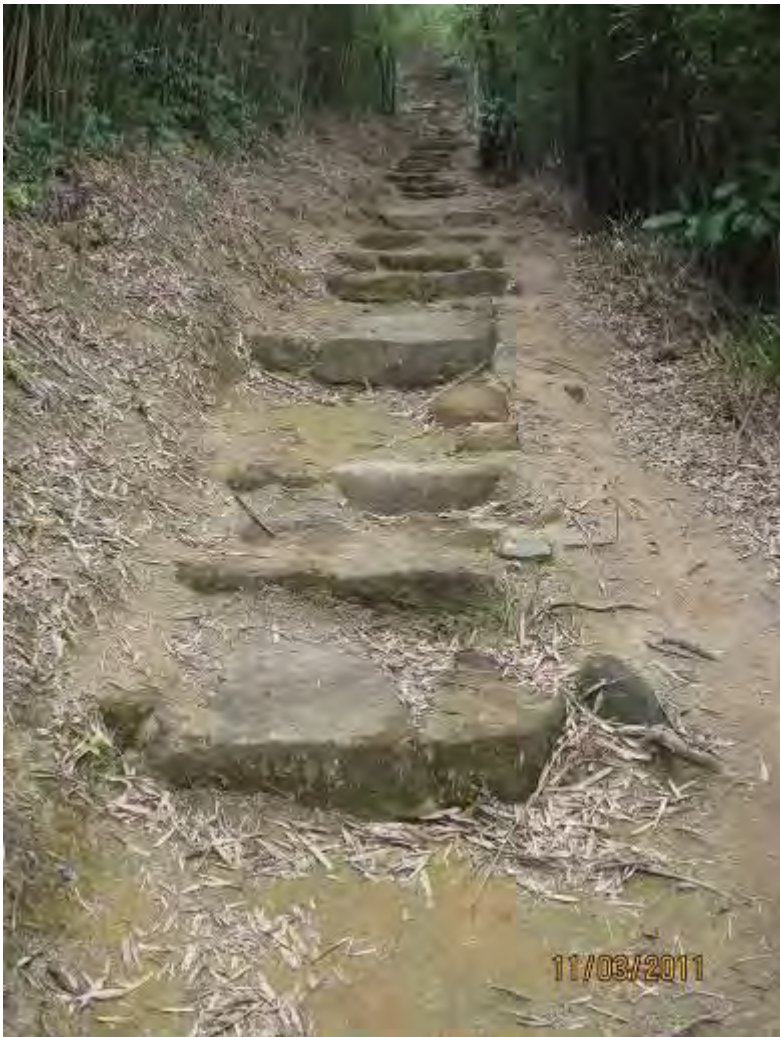
<p>Boulder section starts. (View A to B)</p>	4

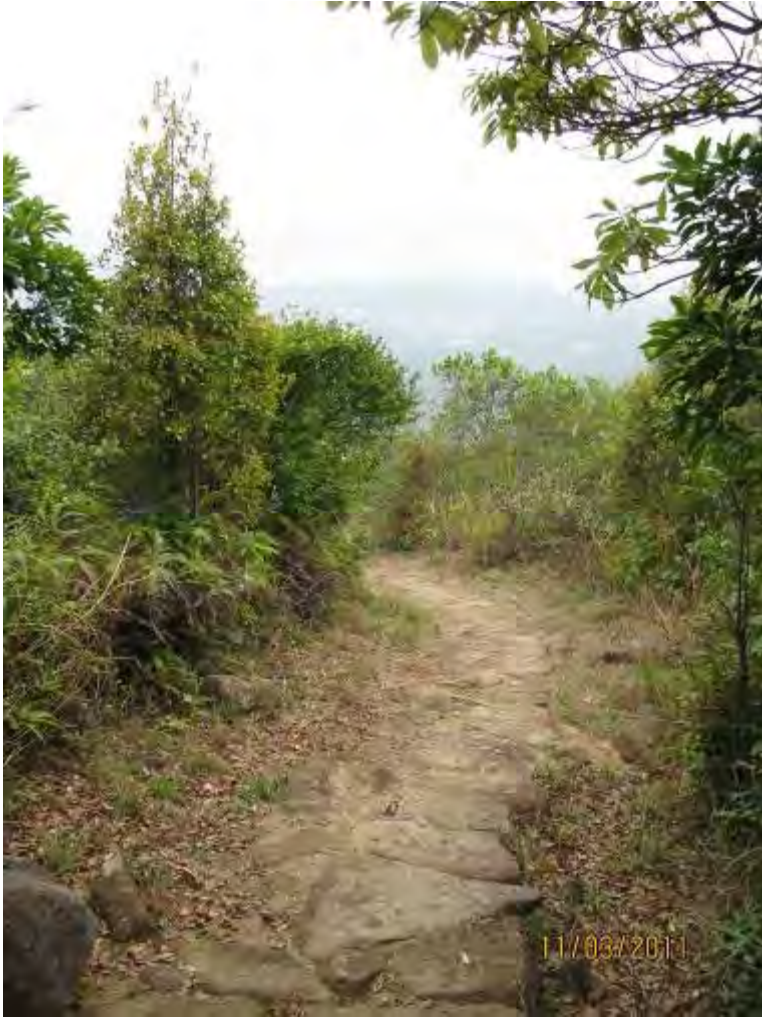
Photo Reference No.	Photographic Records	Photo Reference No.	Photographic Records
5

<p>Typical boulder section view along this section. (View B to A)</p>		(Blank)

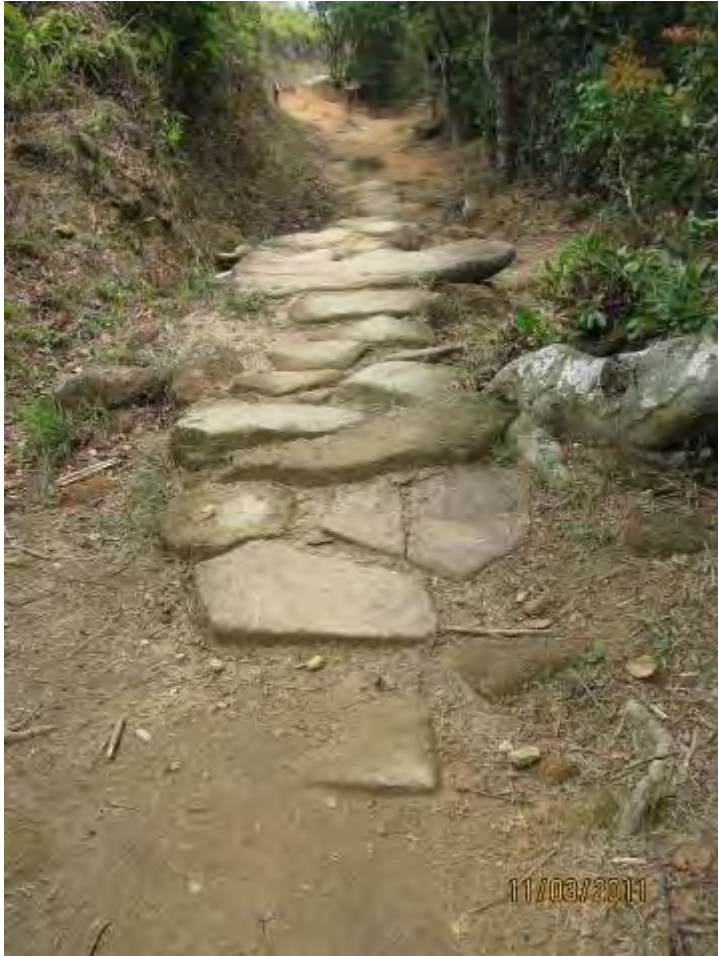
Photo Reference No.	Photographic Records	Photo Reference No.	Photographic Records
7

<p>Boulder section with missing boulders. (View B to A)</p>	8

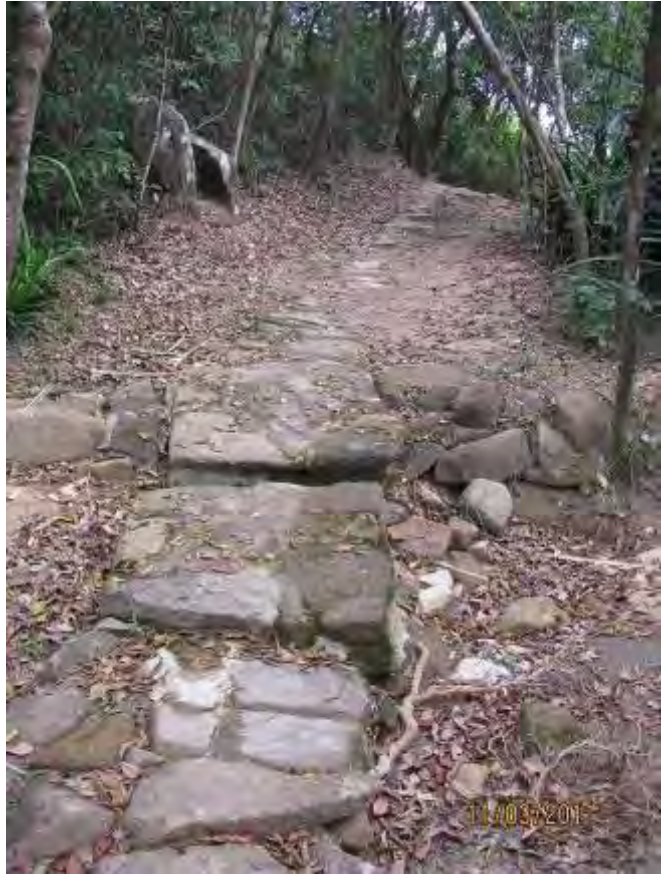
<p>Boulder section with boulders in-filled with concrete for stream crossing as strengthening work. (View A to B)</p>

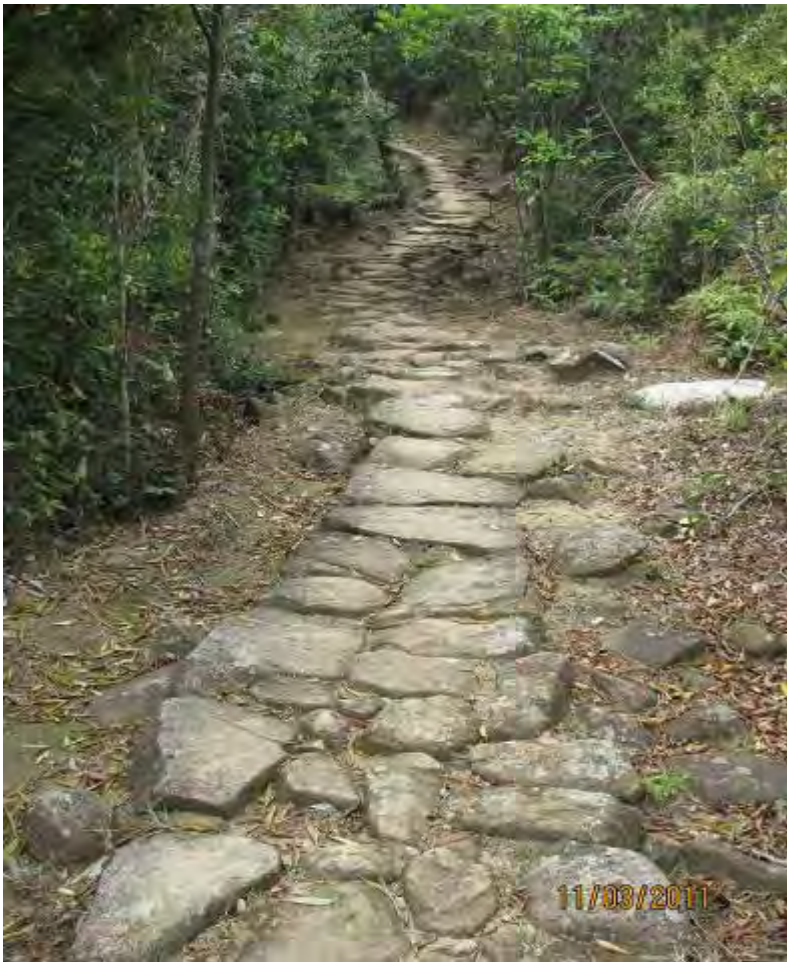
Photo Reference No.	Photographic Records	Photo Reference No.	Photographic Records
9

<p>Typical view of the boulder section. (View B to A)</p>		(Blank)

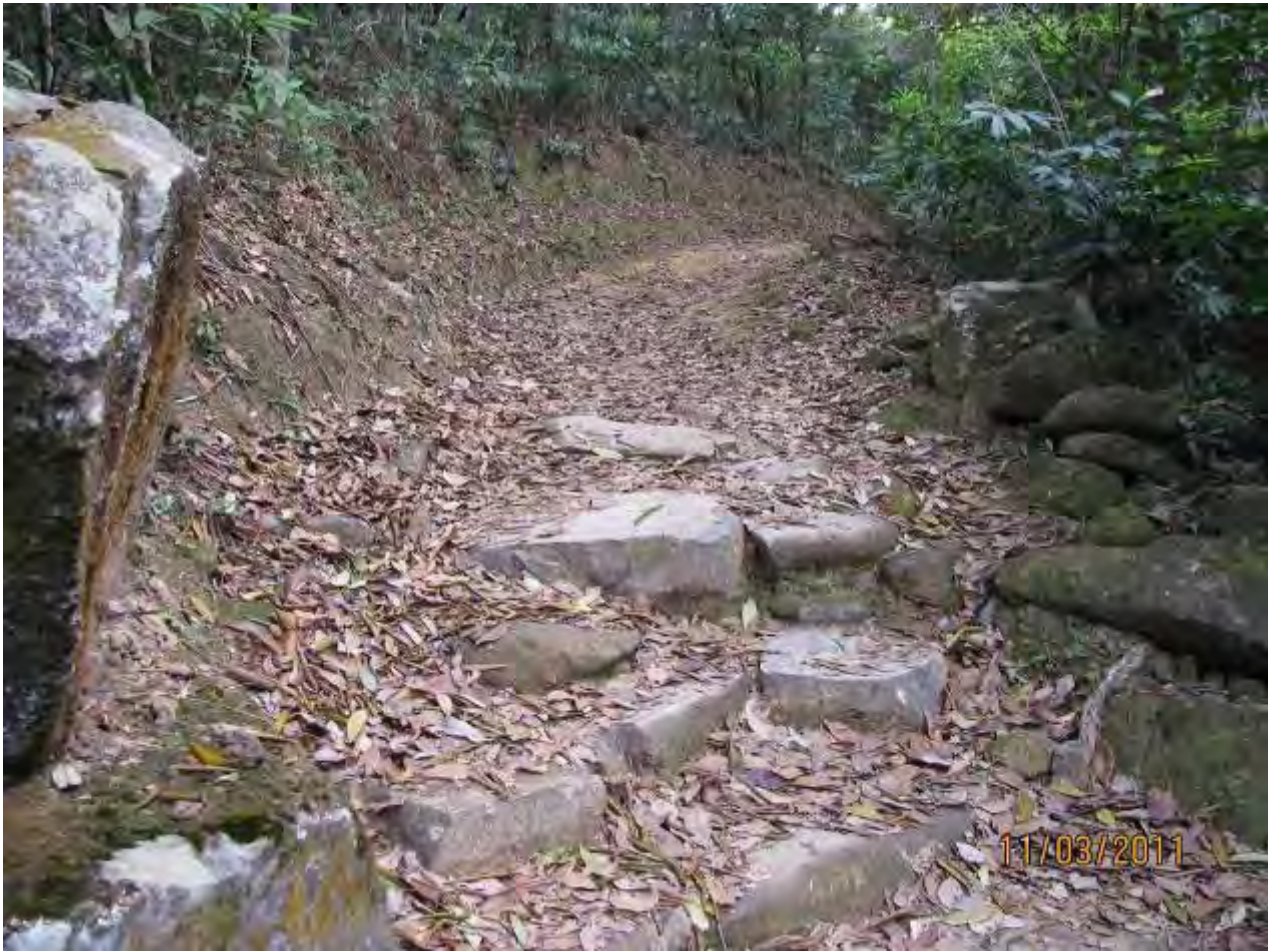
Photo Reference No.	Photographic Records
10

<p data-bbox="725 1270 1653 1305">Sections break between mud section and boulder section. (View B to A)</p>

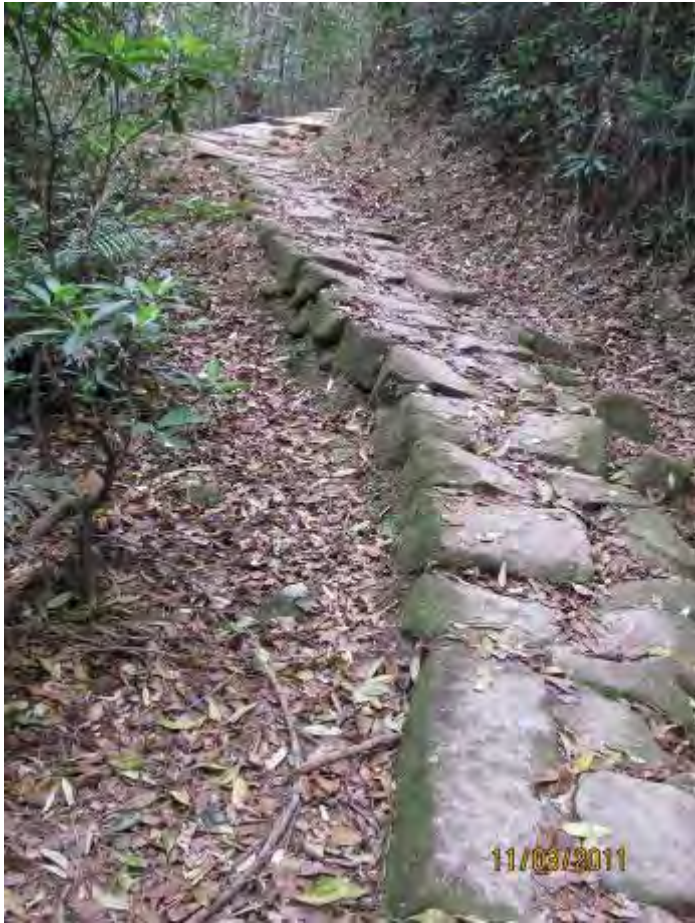
Photo Reference No.	Photographic Records	Photo Reference No.	Photographic Records
11

<p>Typical view of the boulder section showing part of the boulder footpath cross section view. (View B to A)</p>	12

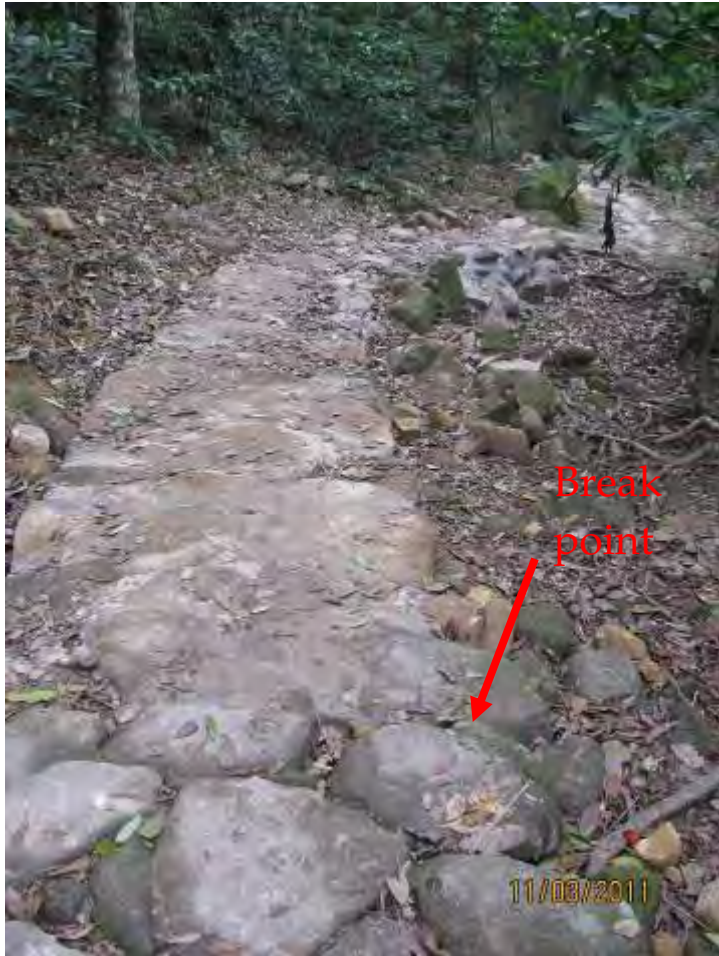
<p>Sections break point between boulder section and reworked section. (View A to B)</p>

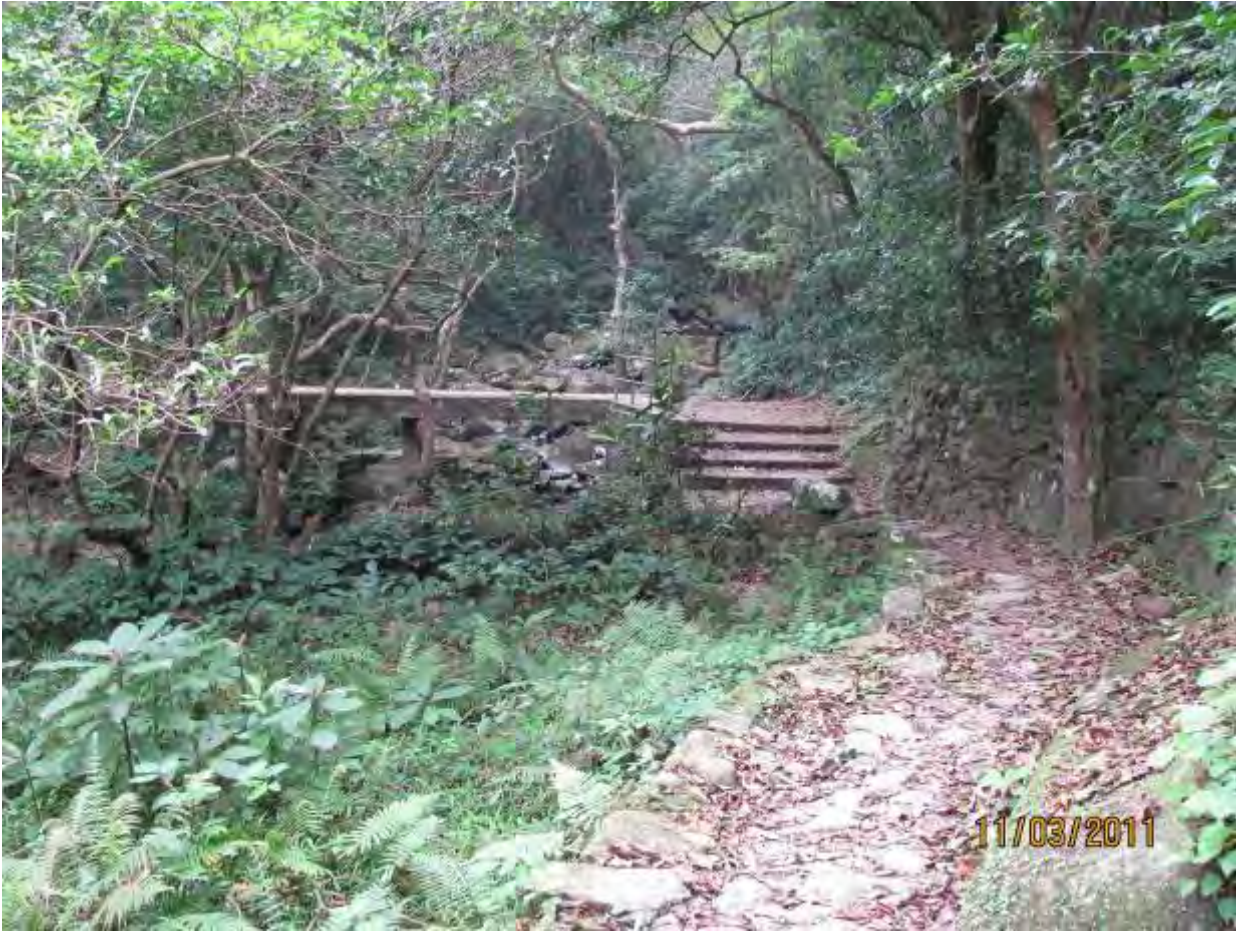
Photo Reference No.	Photographic Records
F1

<p data-bbox="772 1316 1603 1353">Concrete bridge for stream crossing. (View from north to south)</p>

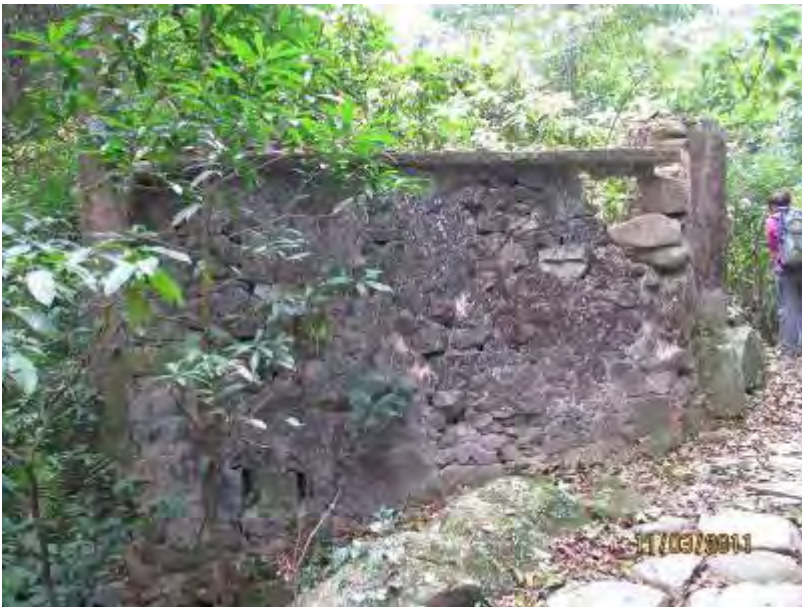
Photo Reference No.	Photographic Records	Photo Reference No.	Photographic Records
F2

<p>Ruined stone built structure. (View B to A)</p>	F2

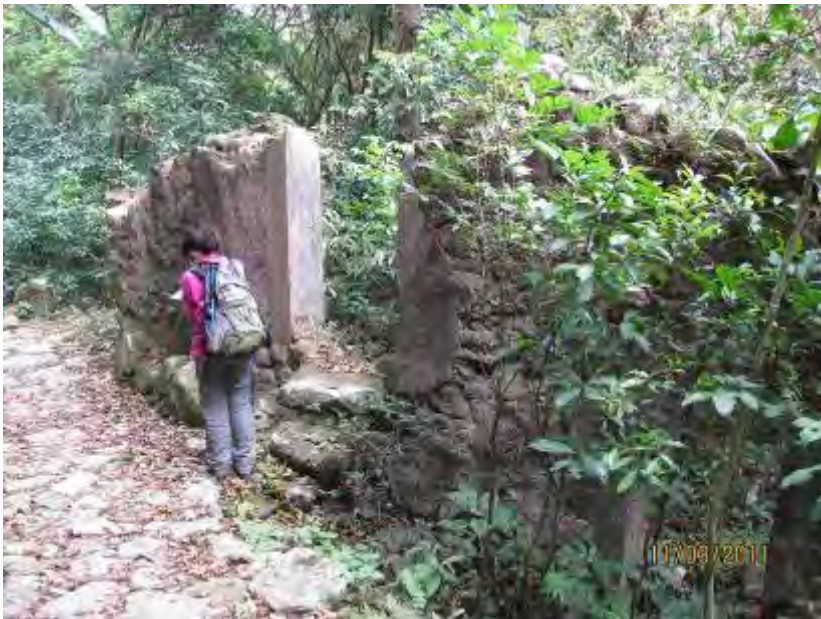
<p>View showing entrance to the ruin from the footpath. (View A to B)</p>

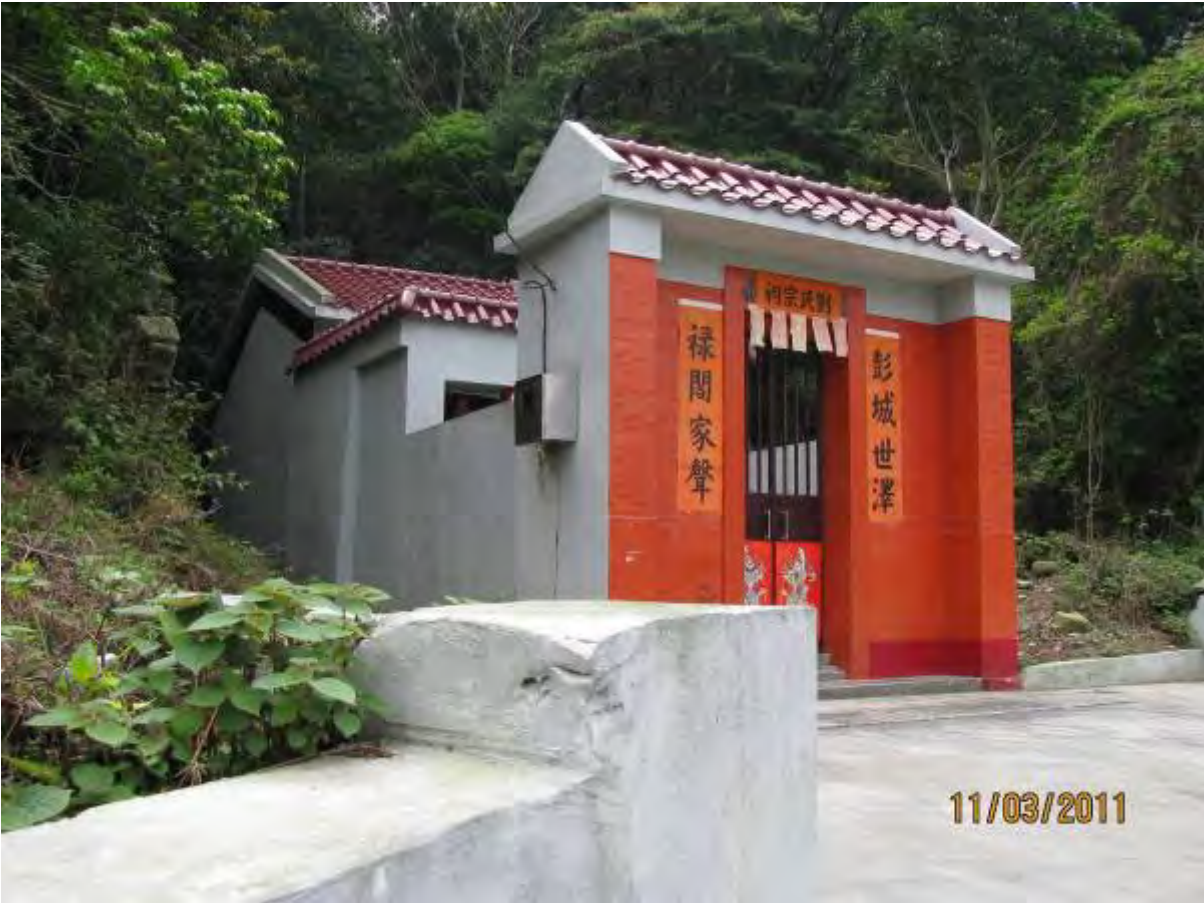
Photo Reference No.	Photographic Records
F3

<p data-bbox="869 1217 1509 1249">Lau Ancestral Hall. (Front of the Hall faces north)</p>

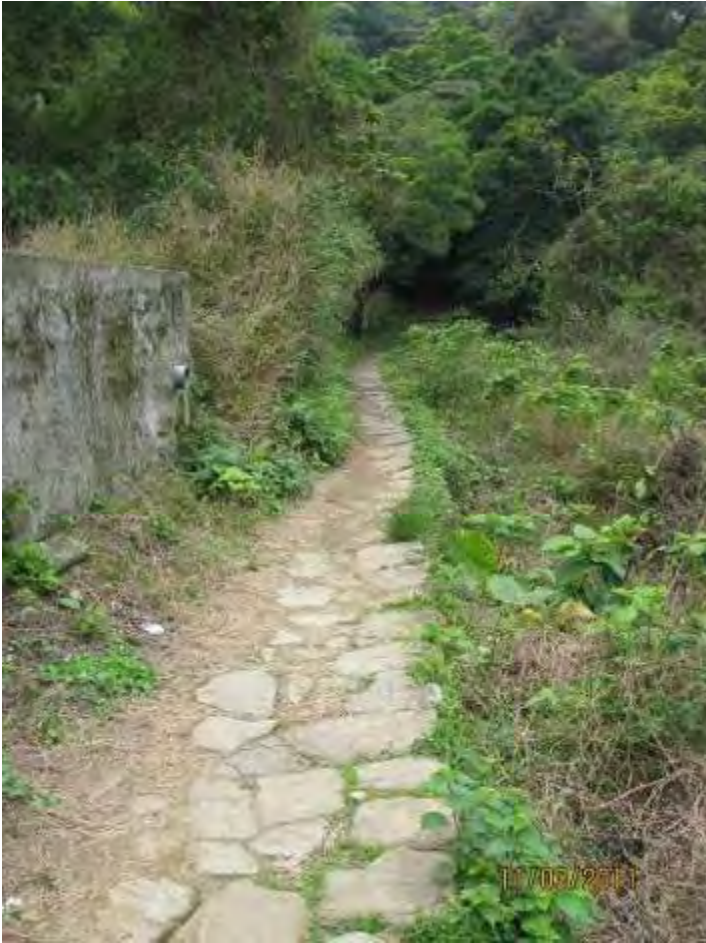
Photo Reference No.	Photographic Records	Photo Reference No.	Photographic Records
15

<p>Boulder section. (View A to B)</p>		(Blank)

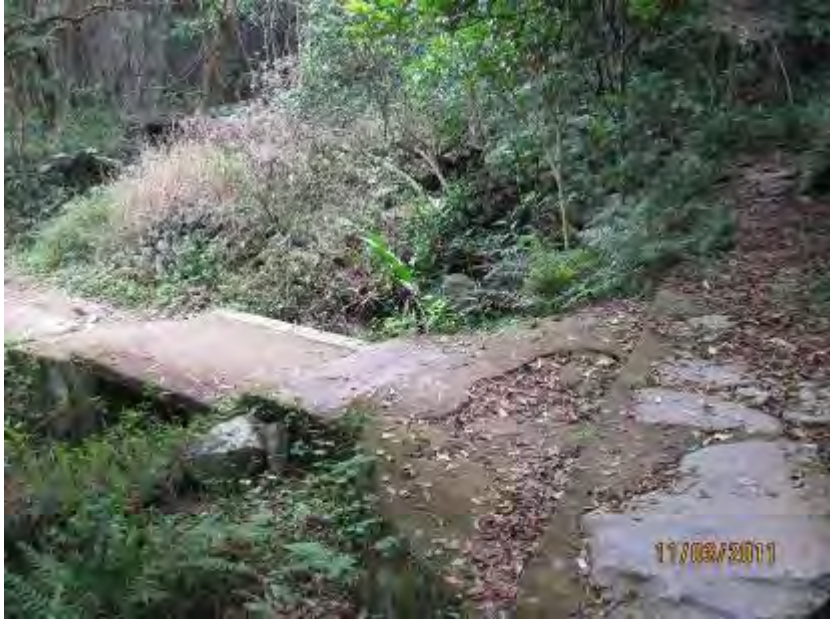
Photo Reference No.	Photographic Records	Photo Reference No.	Photographic Records
F4

<p>Concrete bridge</p>	F4

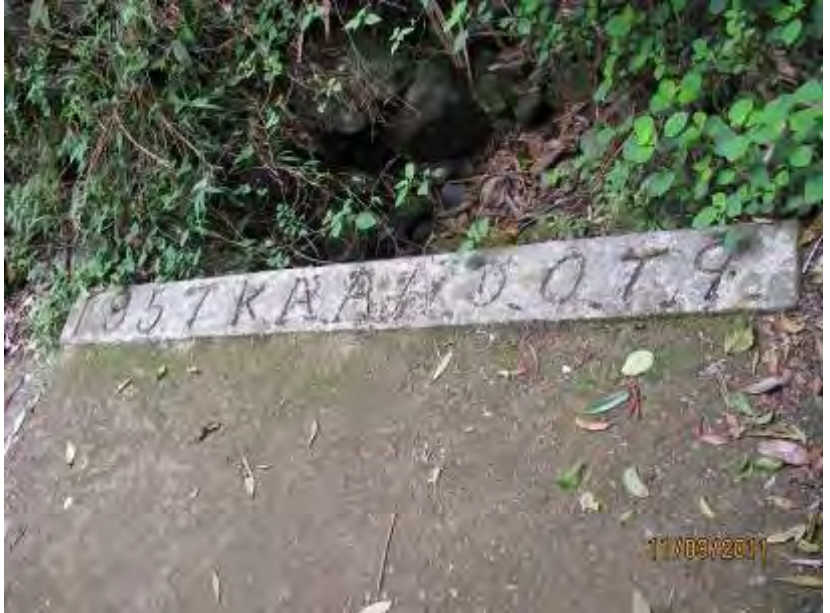
<p>Text on the bridge reads "1957 KAAA D.O.T.9."</p>

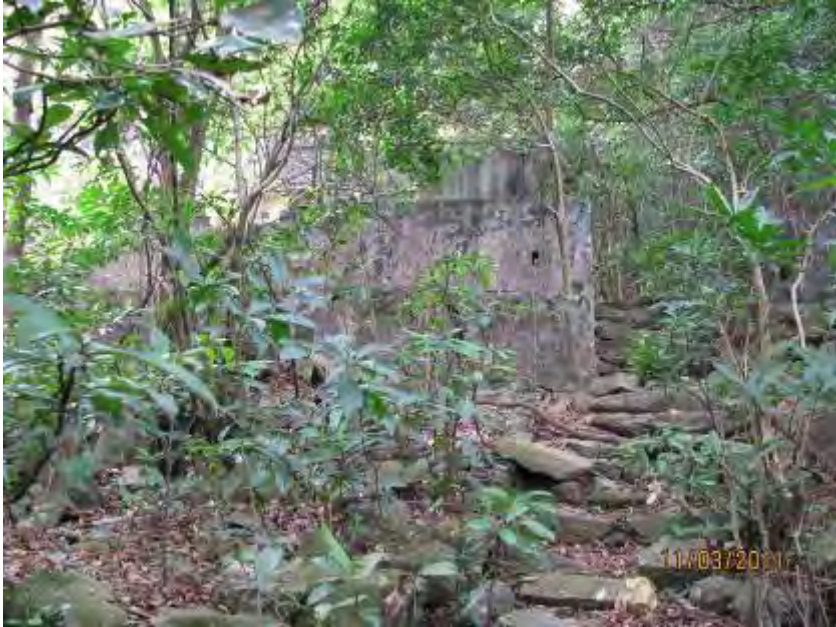
Photo Reference No.	Photographic Records	Photo Reference No.	Photographic Records
F5

<p>Abandoned building strctures.</p>	F5
