Antiquities and Monuments Office

Study on Old Trails in Hong Kong - Final Study Report

February 2014

Study on Old Trails in Hong Kong: *Final Study Report*

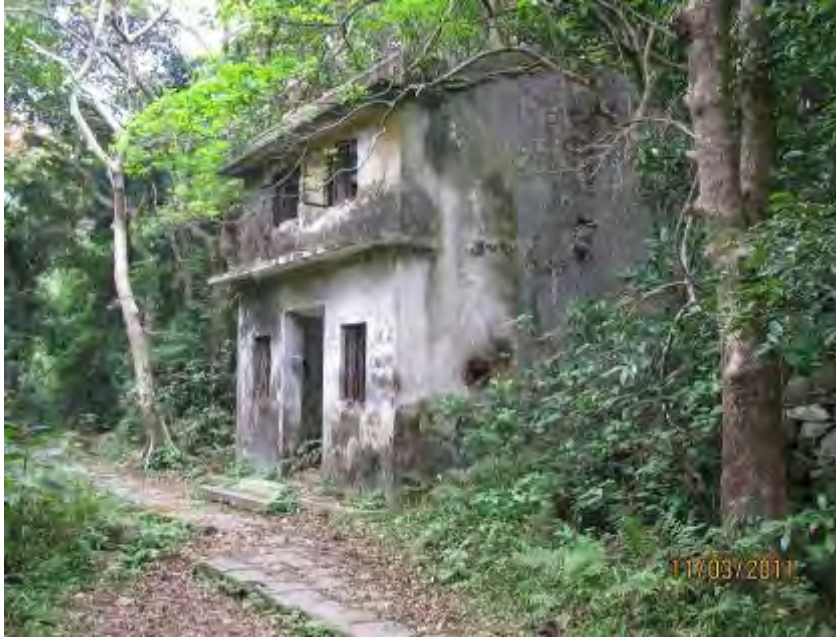
<p>Abandoned building strctures probably constructed in middle 20th century.</p>

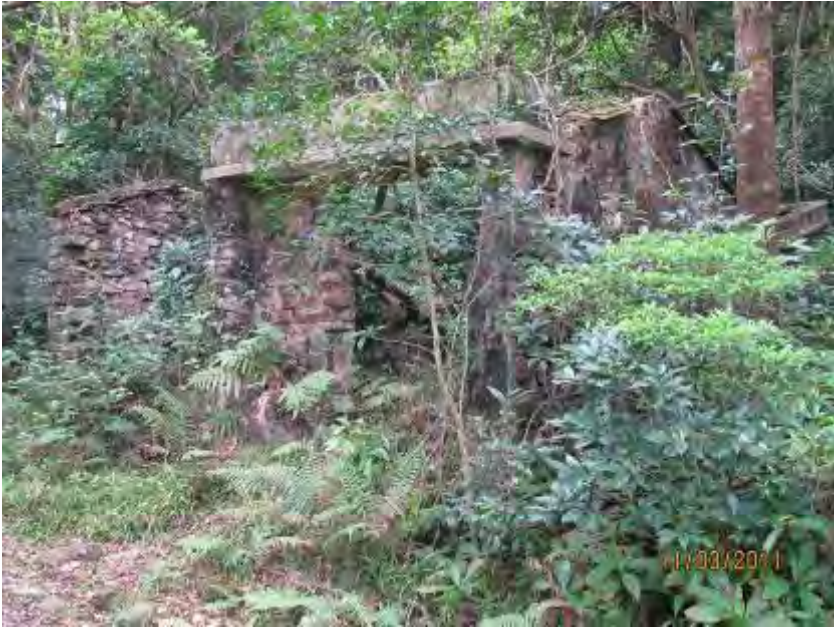
Photo Reference No.	Photographic Records	Photo Reference No.	Photographic Records
F5

<p>Abandoned building structures probably constructed in late 19th century to early 20th century.</p>	F5

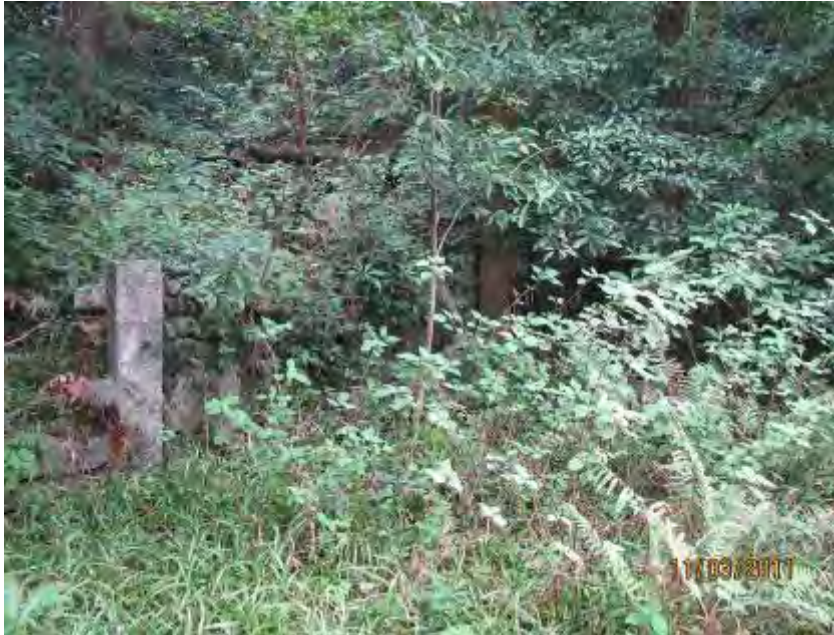
<p>Abandoned building structures probably constructed in late 19th century to early 20th century overgrown with abundant vegetation.</p>

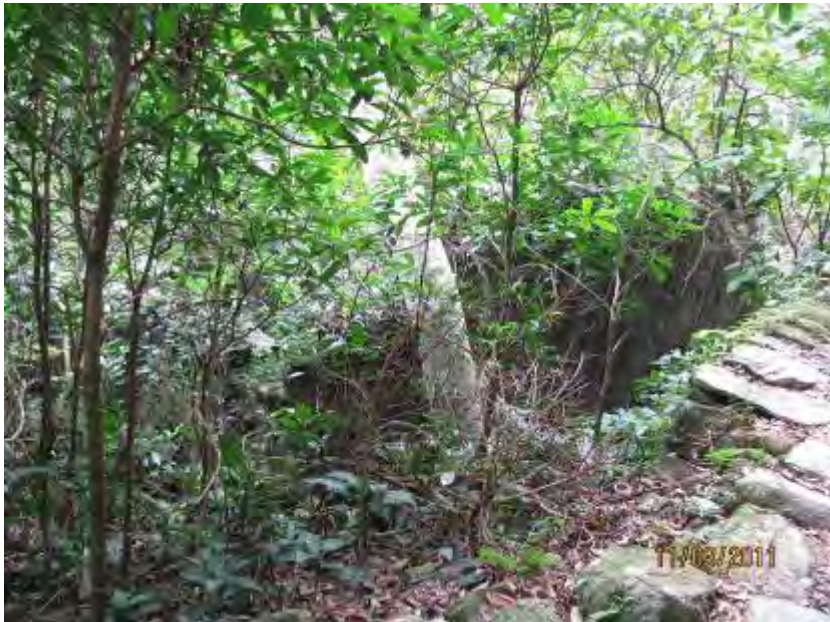
Photo Reference No.	Photographic Records	Photo Reference No.	Photographic Records
F6

<p>General view of the abandoned building structure mostly covered with vegetation.</p>	F6

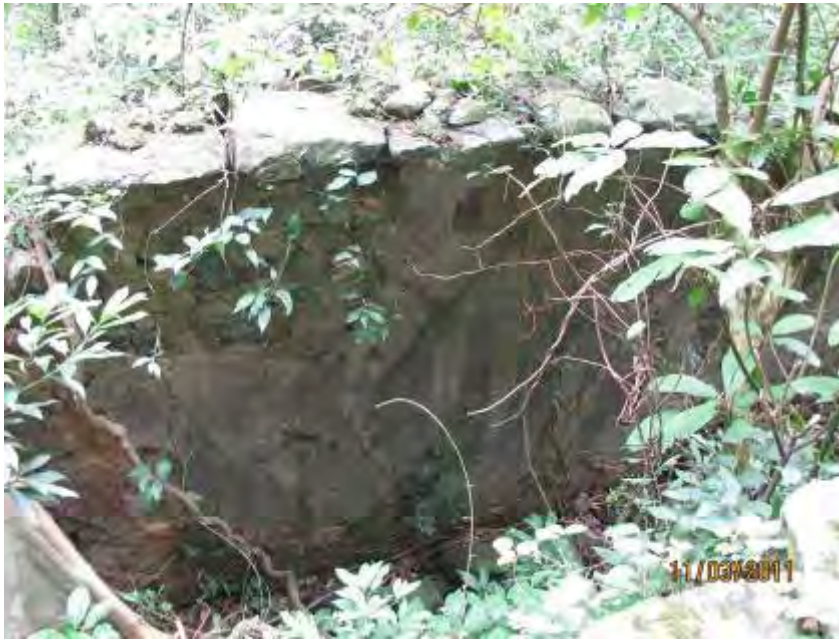
<p>View of a wall of the structure.</p>

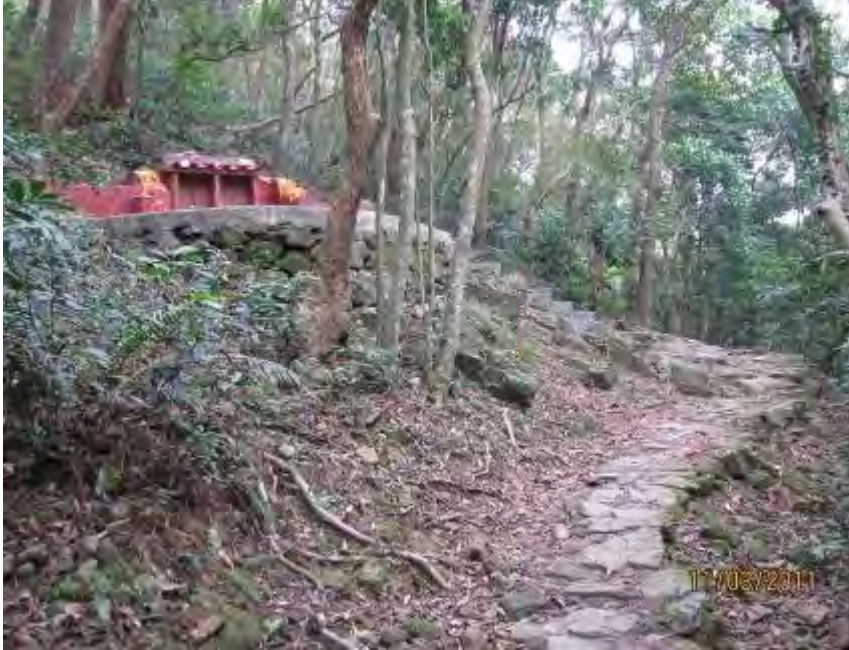
Photo Reference No.	Photographic Records	Photo Reference No.	Photographic Records
16

<p>An earth shrine by the boulder section. (View A to B)</p>	F7

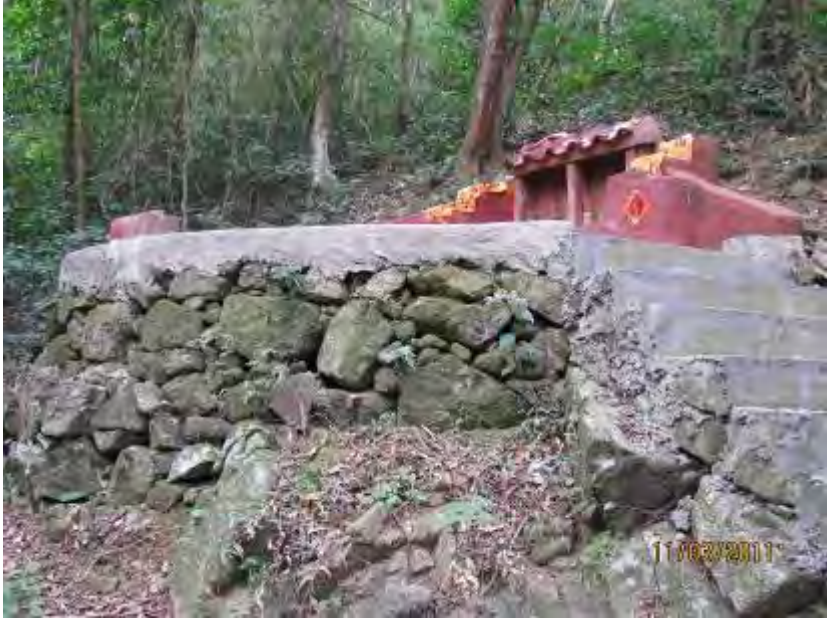
<p>General view of the shrine set on a slightly raised area within a raised platform that has stepped arms on either side. (Facing east)</p>

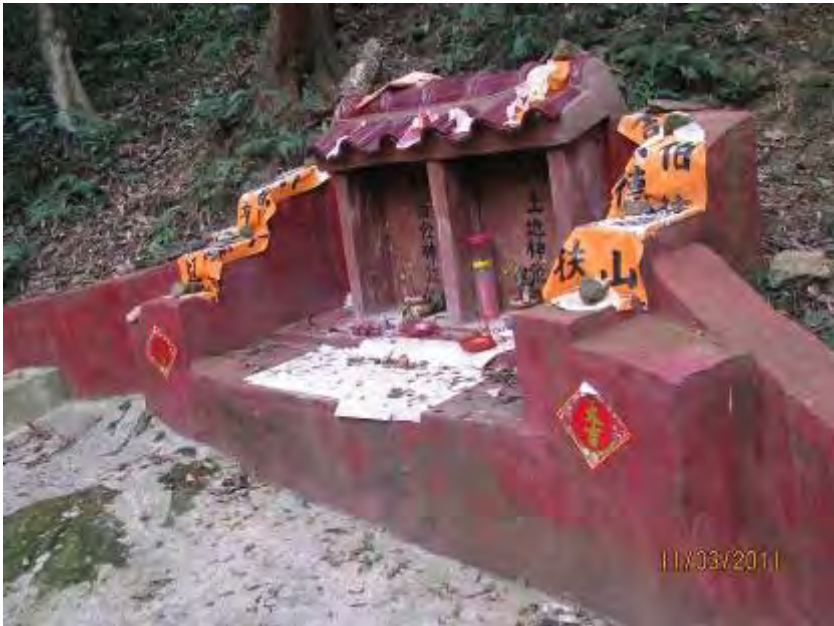
Photo Reference No.	Photographic Records	Photo Reference No.	Photographic Records
F7

<p>Armchair or throne shape shrine with two alcoves, a tiled roof of inter-locking glazed pan tiles and a roll-tile roof ridge.</p>	17

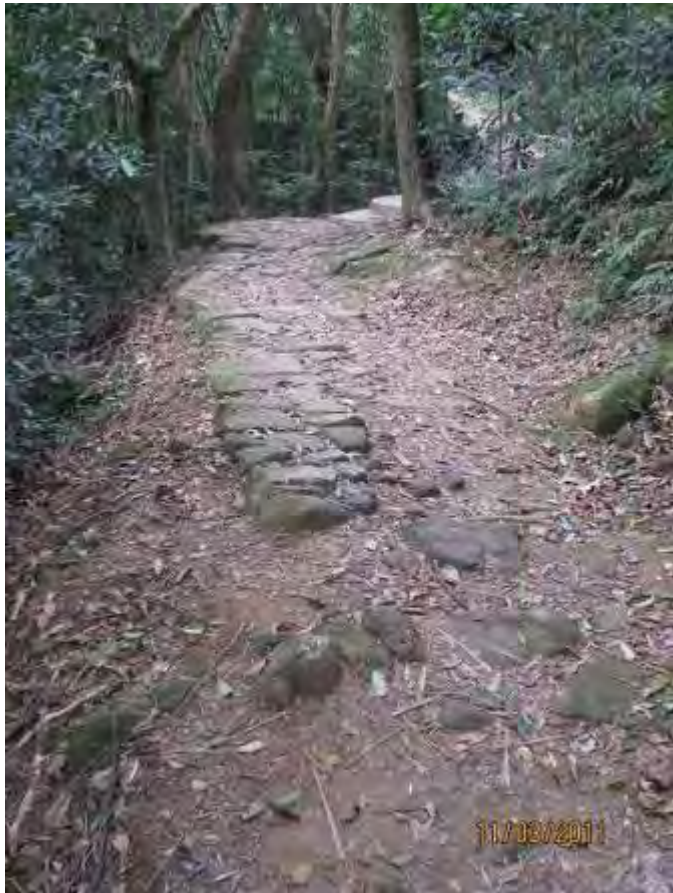
<p>Boulder section with missing boulders. (View B to A)</p>

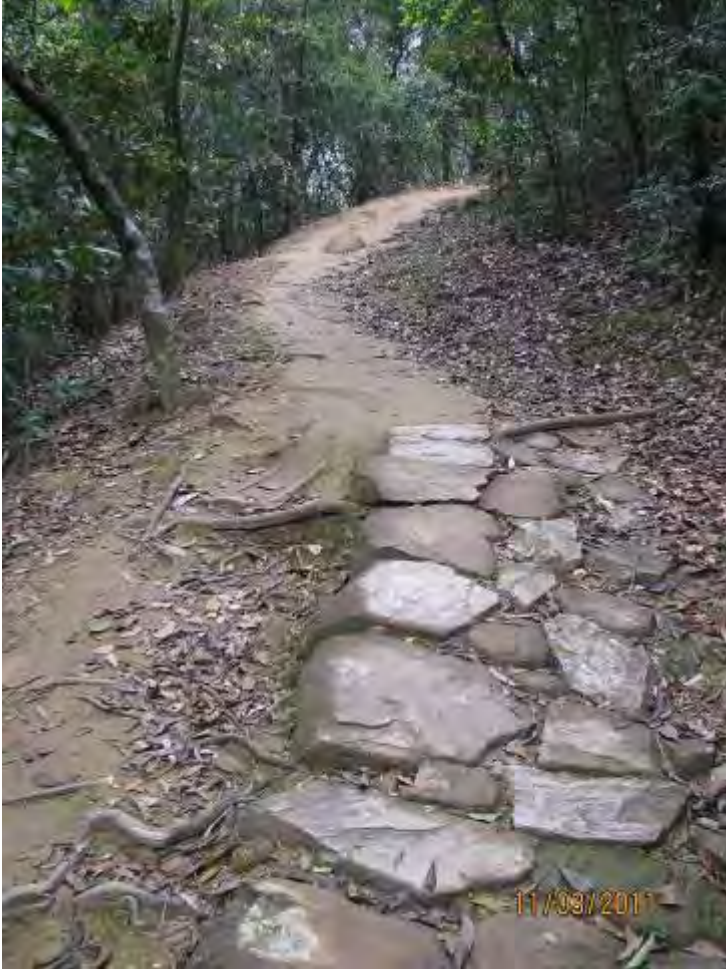
Photo Reference No.	Photographic Records	Photo Reference No.	Photographic Records
20

<p>Boulder section with occasional sections missed. (View B to A)</p>	21

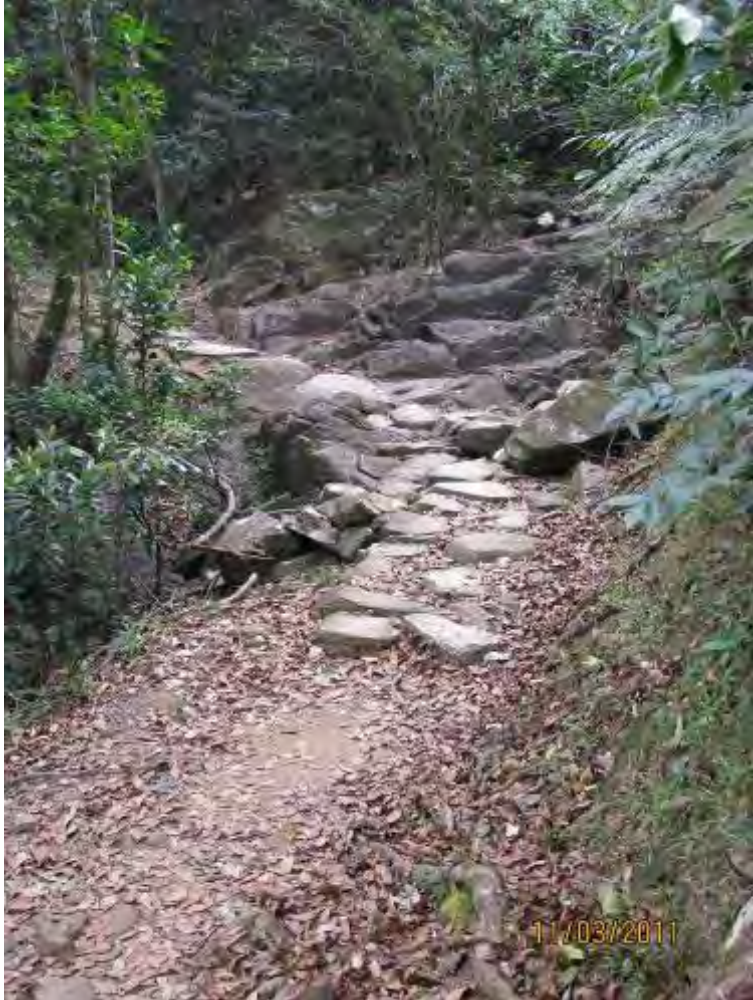
<p>End of boulder section and start of mud section. (View B to A)</p>

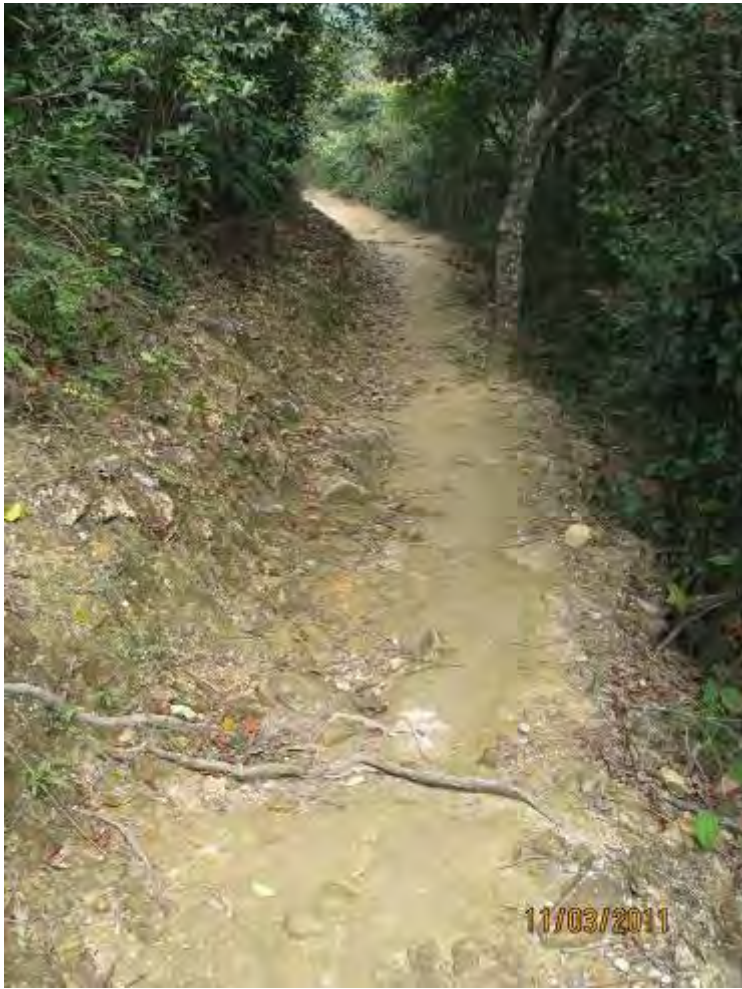
Photo Reference No.	Photographic Records	Photo Reference No.	Photographic Records
22

<p>View of typical mud section in this section. (View B to A)</p>	23

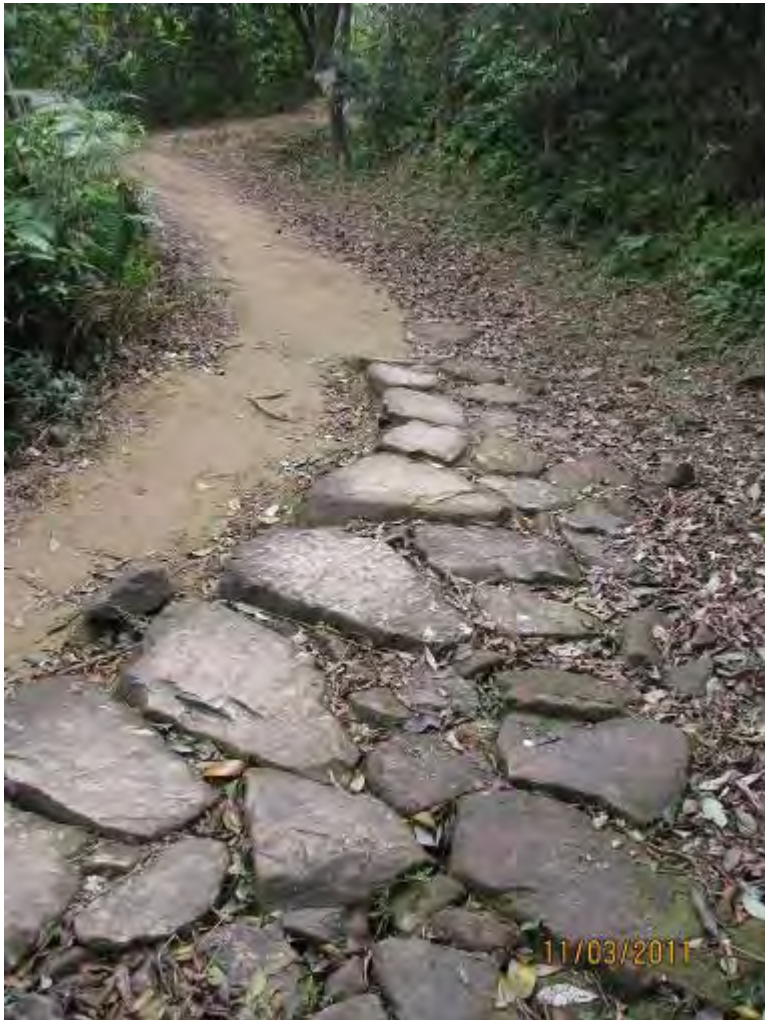
<p>Mud section end and boulder section starts. (View B to A)</p>

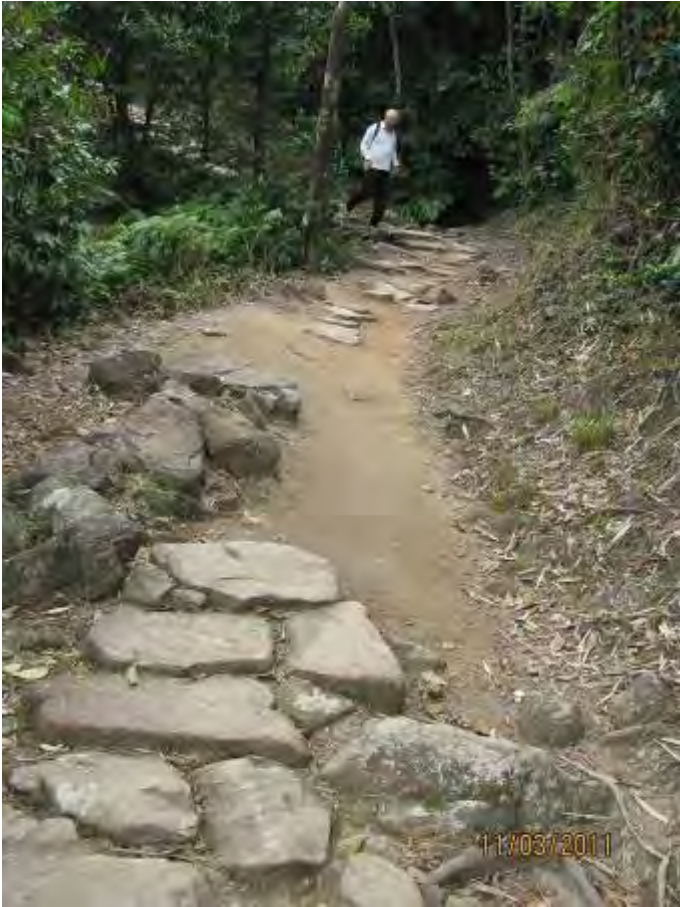
Photo Reference No.	Photographic Records	Photo Reference No.	Photographic Records
24

<p>Boulder section with occasional section with missing boulders. (View B to A)</p>	25

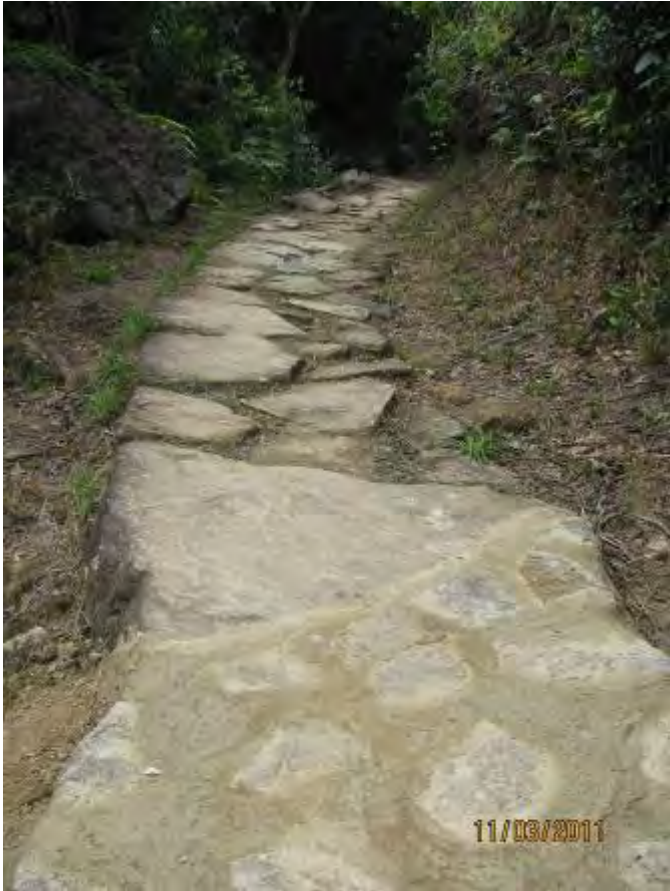
<p>Boulder section with occasional reworked parts. (View B to A)</p>

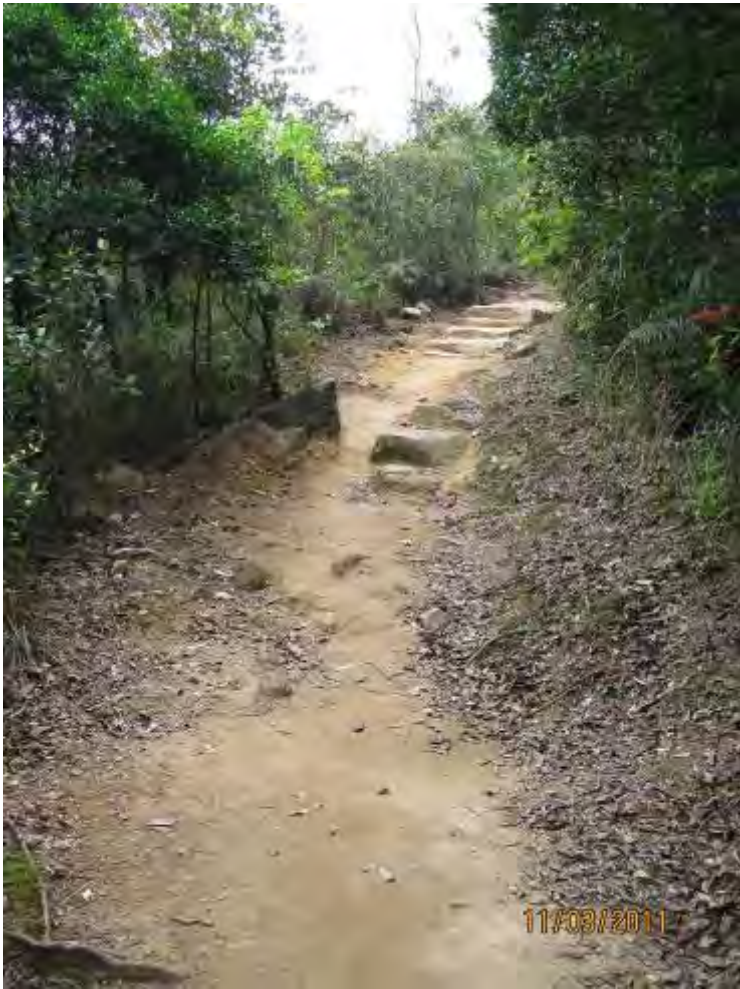
Photo Reference No.	Photographic Records	Photo Reference No.	Photographic Records
26

<p>Boulder section with occasional eroded parts showing mud surface. Top of photo shows reworked steps. (View B to A)</p>	27	  <p>End of mud section and boulder section appears again towards Point B. (View B to A)</p>

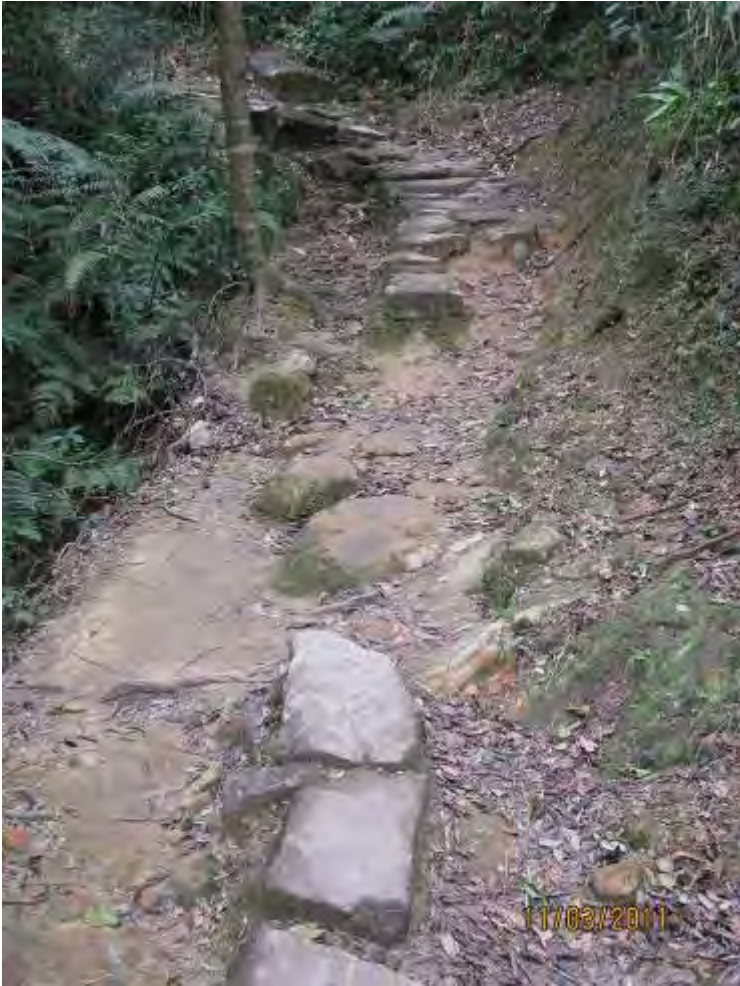
Photo Reference No.	Photographic Records	Photo Reference No.	Photographic Records
28

<p>Boulder section with occasional sections with missing boulders. (View B to A)</p>	29

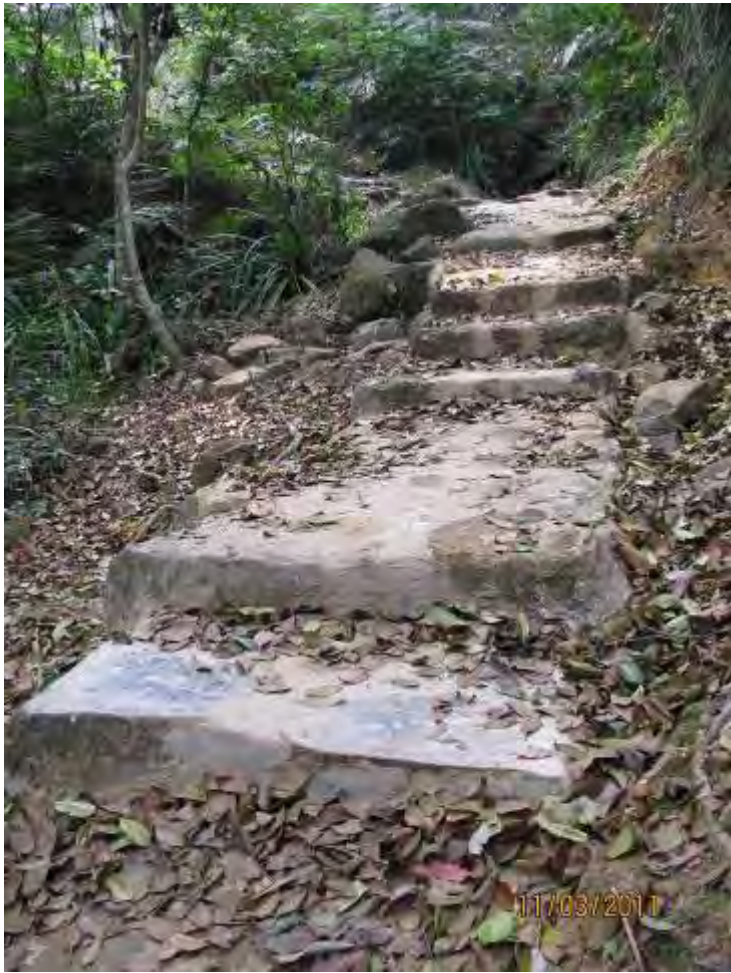
Photo Reference No.	Photographic Records	Photo Reference No.	Photographic Records
30

<p>Boulder section with reworked steps. (View B to A)</p>	31

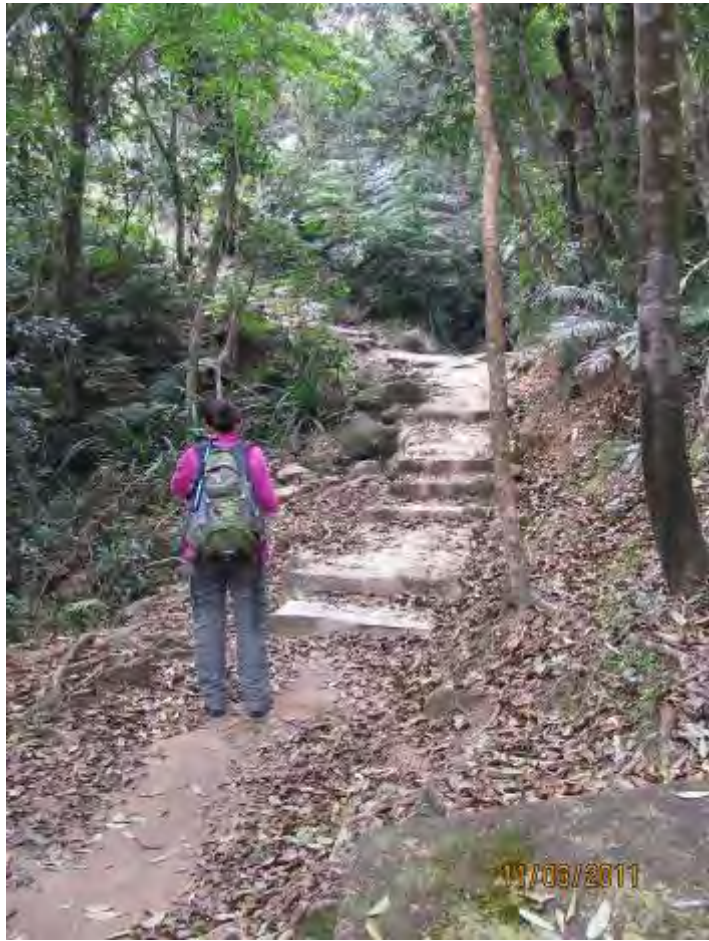
<p>Boulder section ends with reworked steps and mud surface starts. (View B to A)</p>

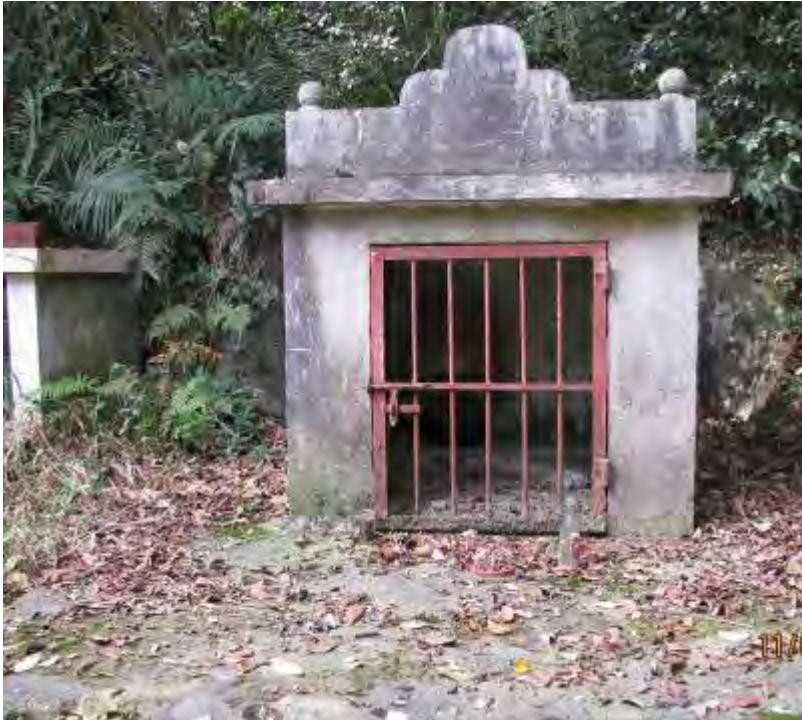
Photo Reference No.	Photographic Records	Photo Reference No.	Photographic Records
F8

<p>Funerary urn with concrete shelter and metal by the footpath.</p>	F8

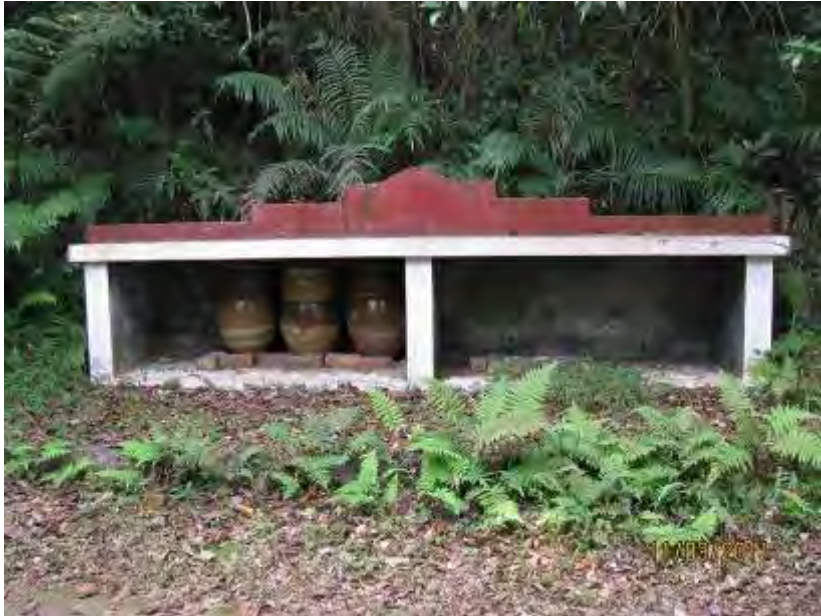
<p>Funerary urns with concrete shelter by the old footpath.</p>

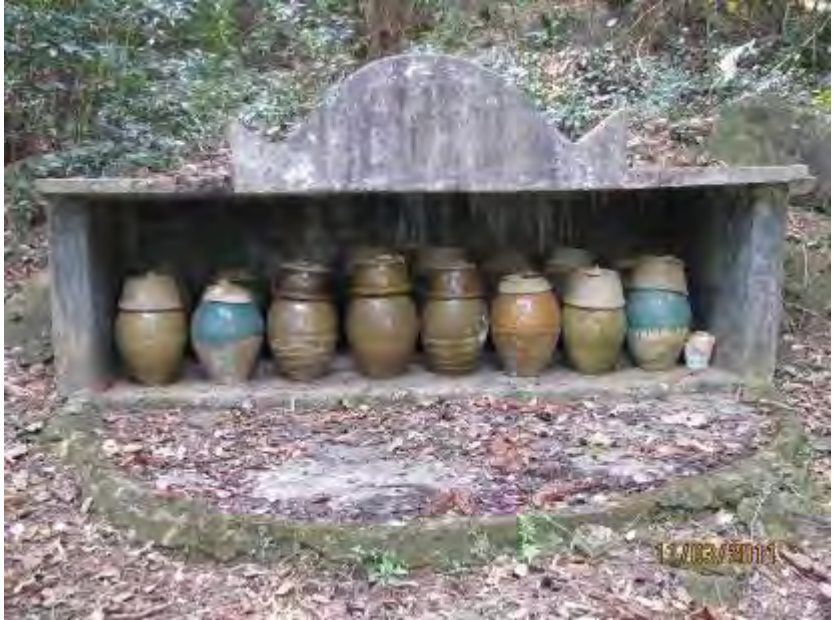
<p>Funerary urns with concrete shelter by the footpath.</p>

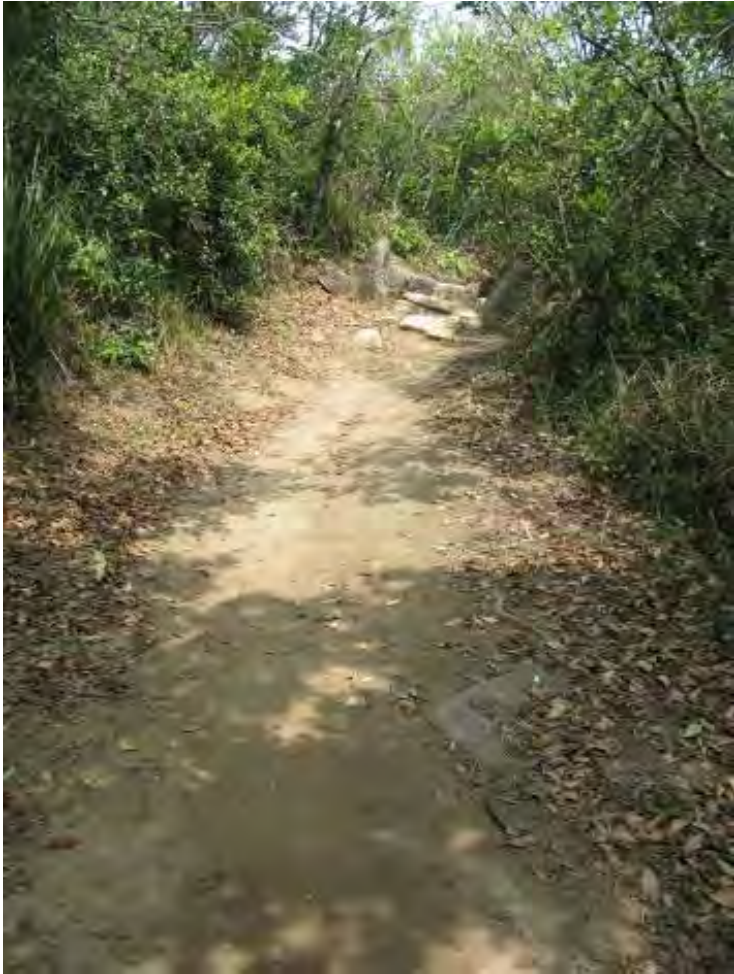
Photo Reference No.	Photographic Records	Photo Reference No.	Photographic Records
6

<p>Boulder section with occasional missing boulders. (View A to B)</p>	7

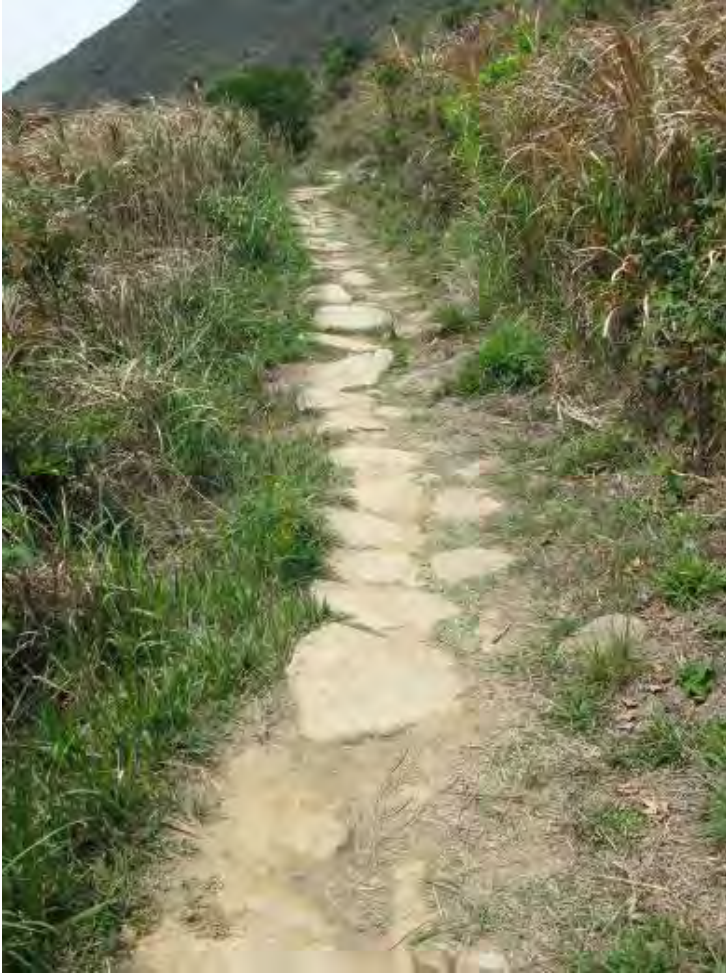
Photo Reference No.	Photographic Records	Photo Reference No.	Photographic Records
10

<p>Boulder section. (View B to E)</p>	11

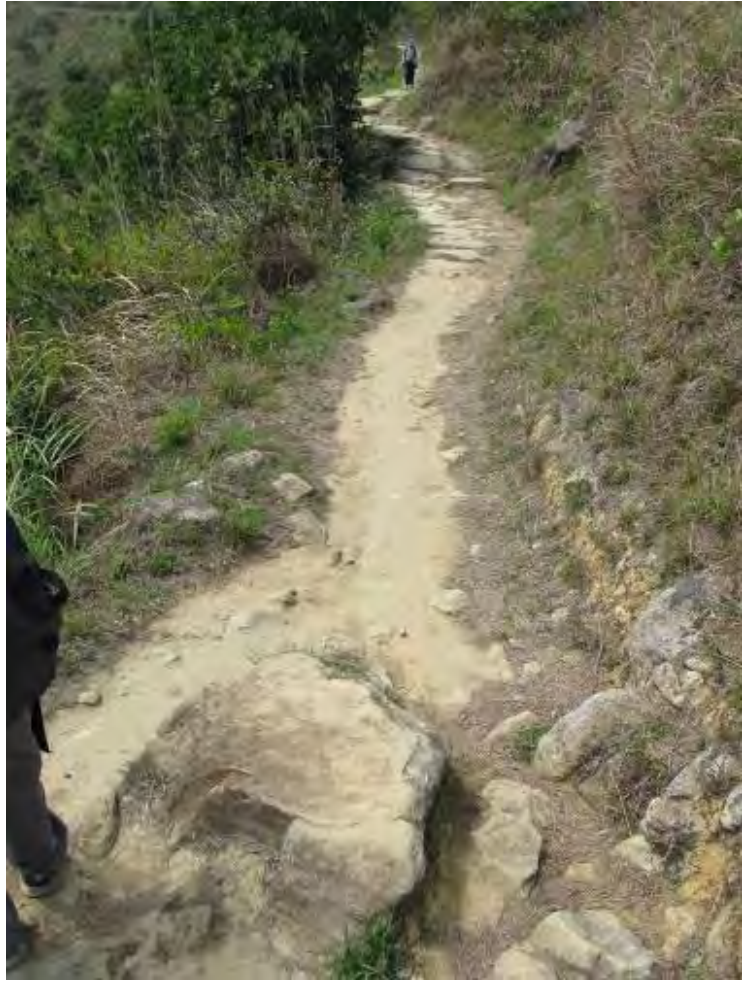
<p>A section of the boulder section with missing boulders. (View B to E)</p>

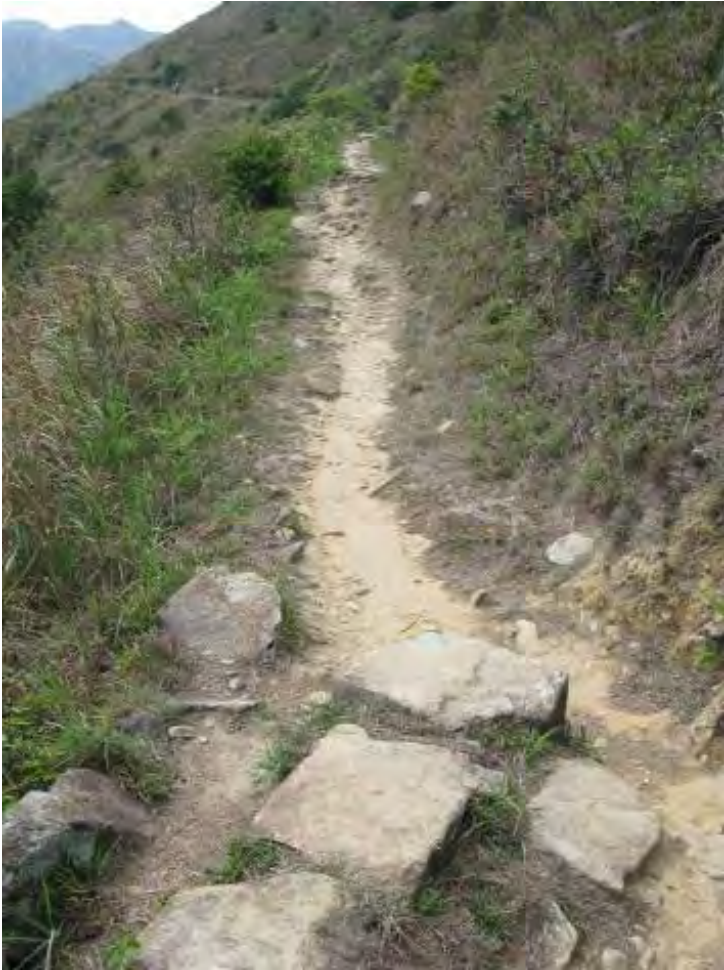
Photo Reference No.	Photographic Records	Photo Reference No.	Photographic Records
12

<p>A section of the boulder section with missing boulders. (View B to E)</p>	13

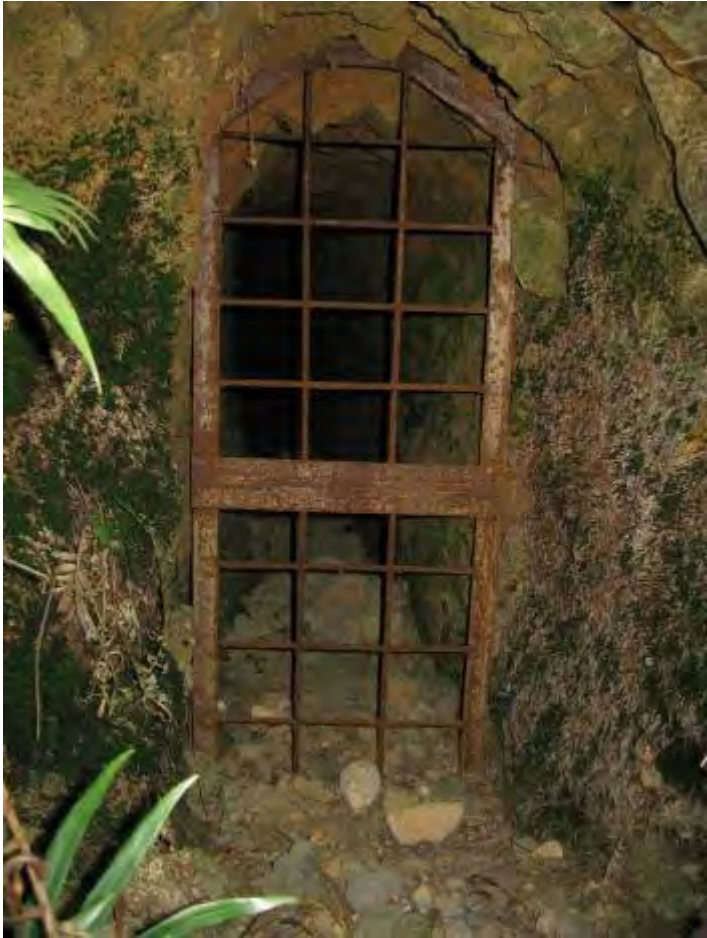
<p>Entrance with a metal fence. Depth of the cave/tunnel cannot be determined.</p>

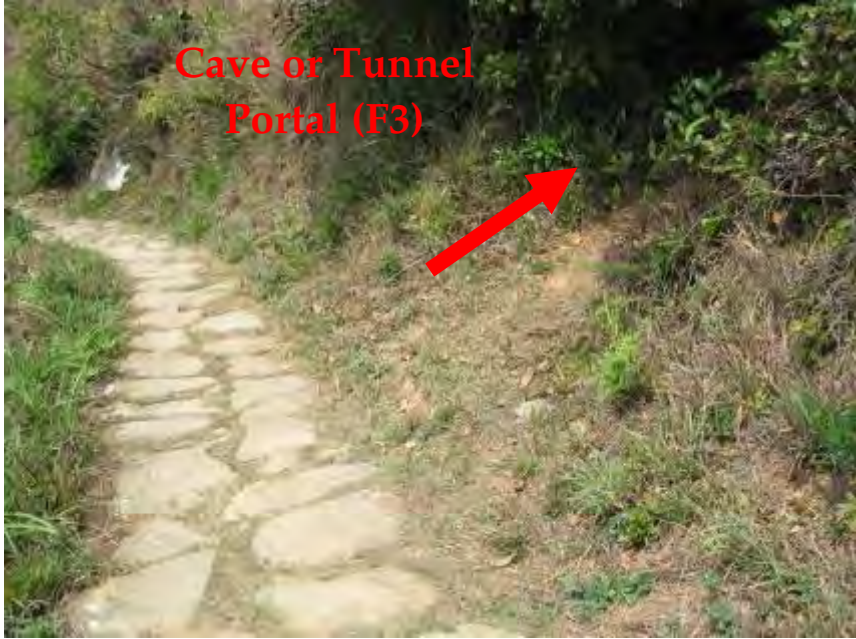
Photo Reference No.	Photographic Records	Photo Reference No.	Photographic Records
14

<p>Typical view of the boulder section along this section generally in good condition. (View B to E). Entrance to the cave/tunnel portal</p>	F3

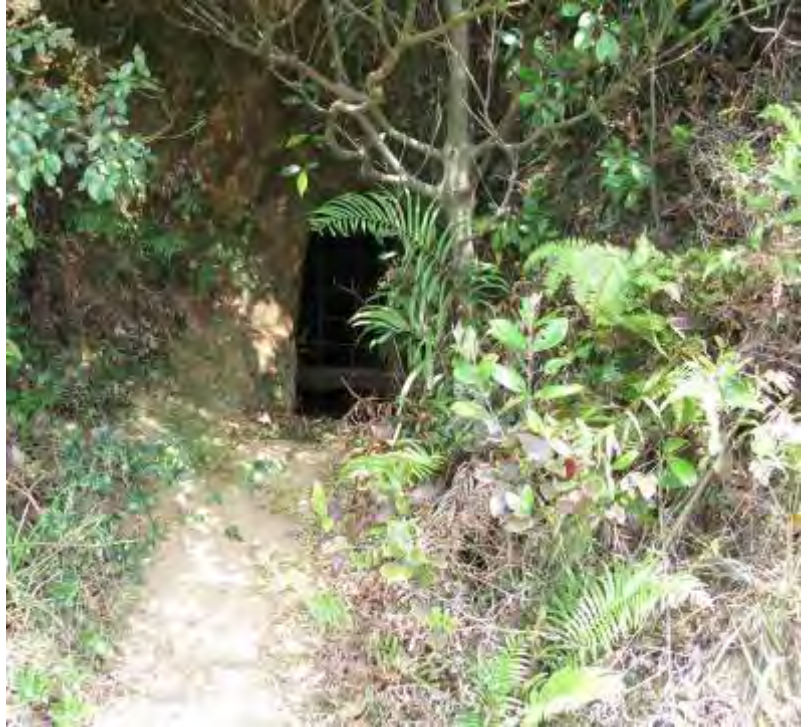
<p>Entrance with a metal fence. The entrance is about 1m high, a human body width.</p>

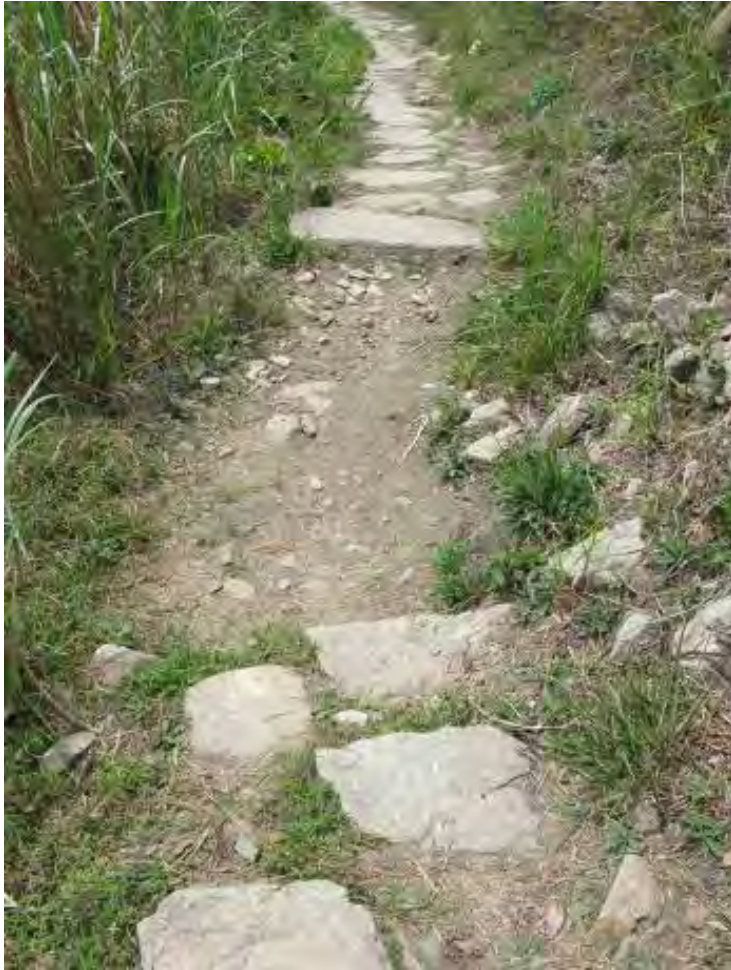
<p>A section of the boulder section with missing boulders. (View B to E)</p>		(Blank)

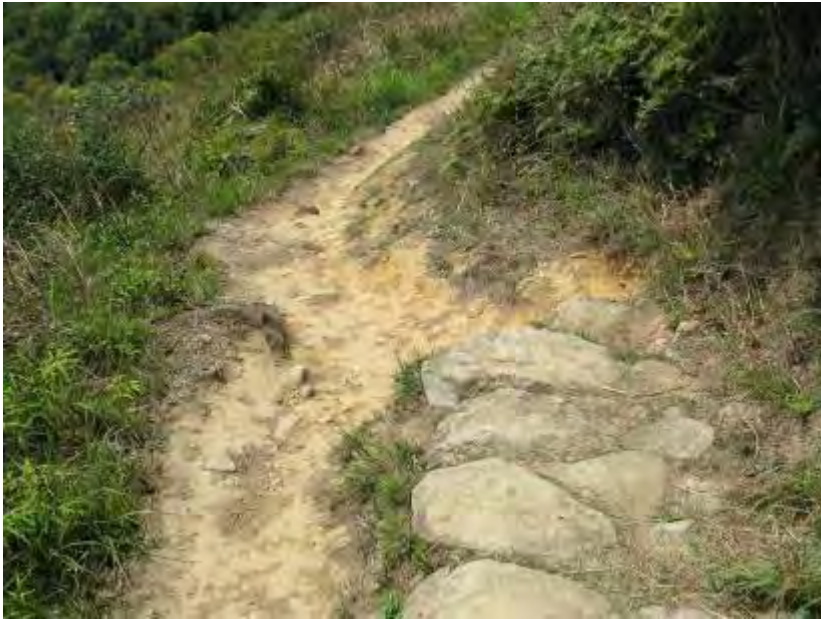
<p>Break point between boulder section and mud section. (View B to E)</p>

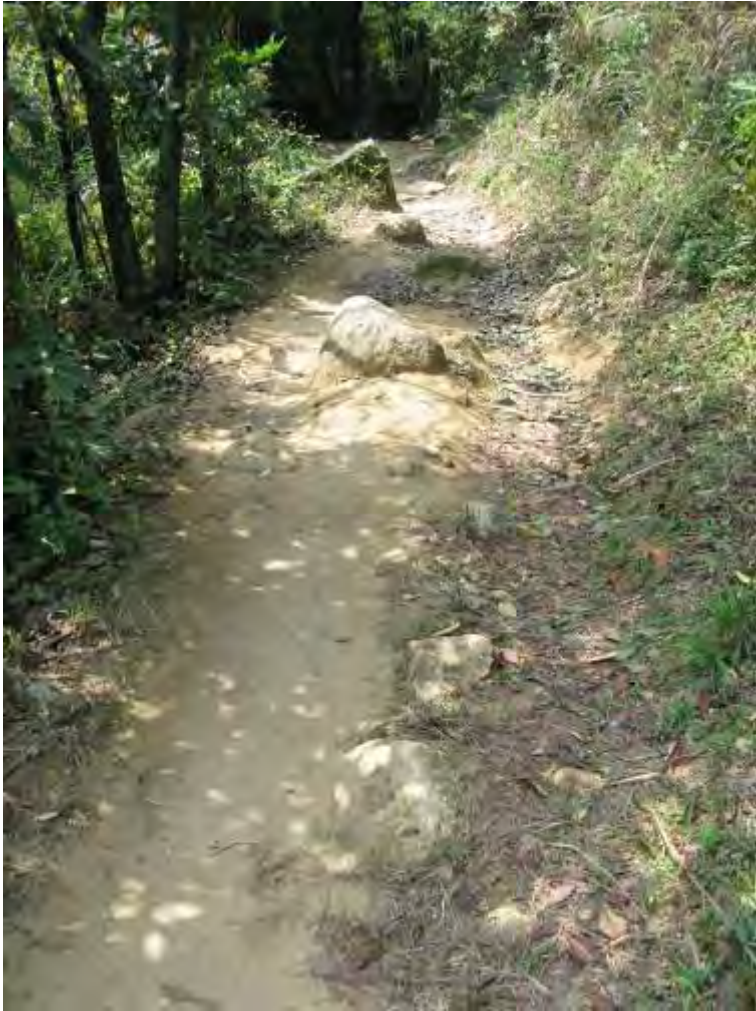
<p>Mud section with scattered boulders.</p>	21

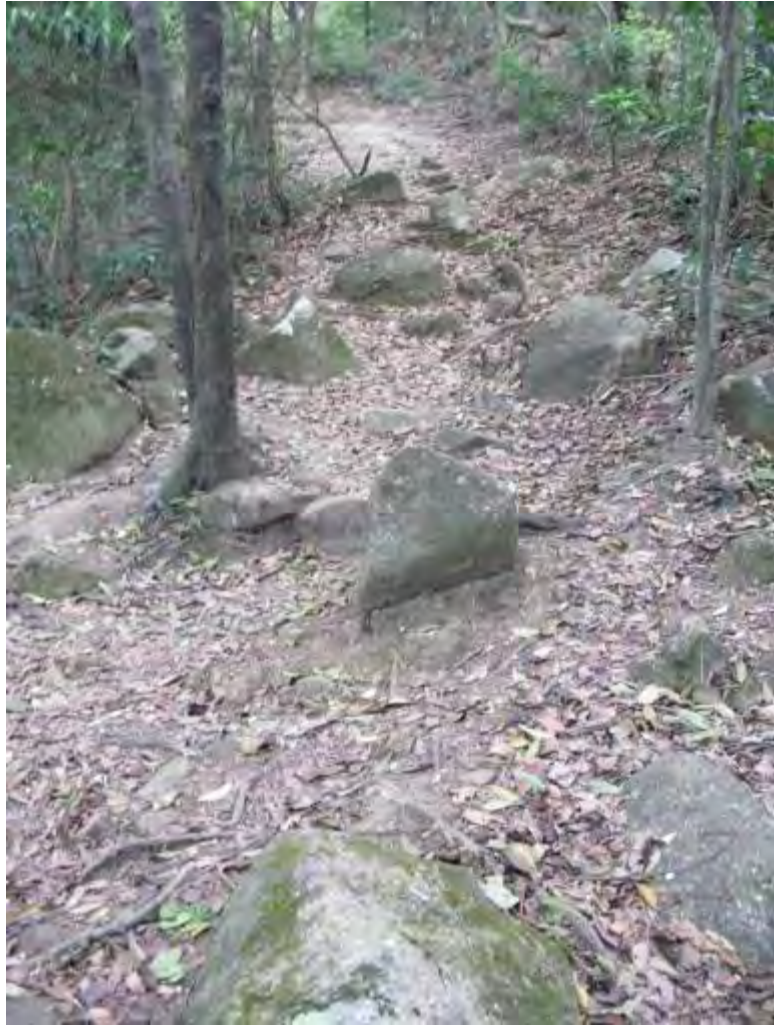
<p>Mud section with scattered boulders. (View E to D)</p>

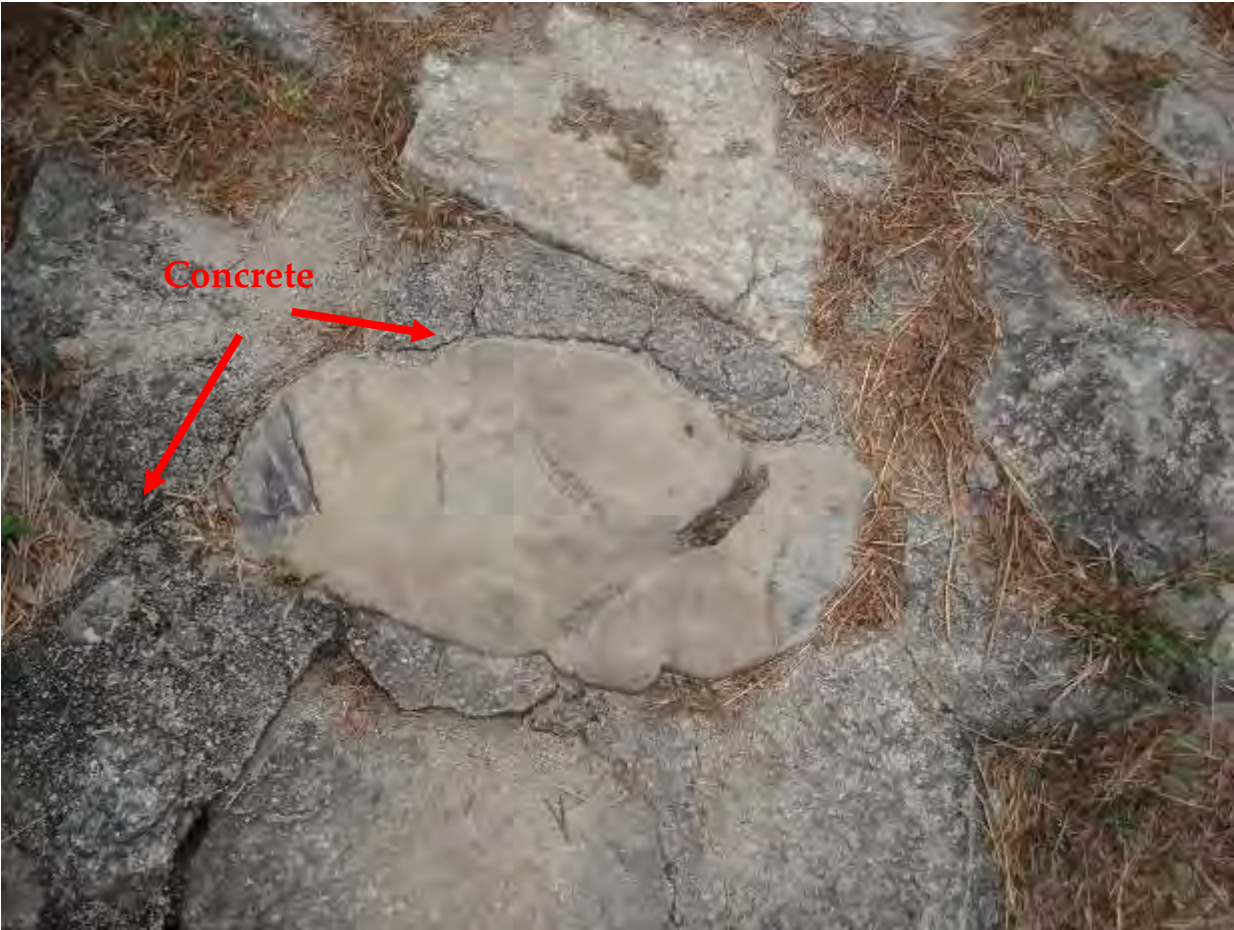
<p data-bbox="853 1249 1520 1284">A close-up view of boulders with in-filled concrete.</p>
