Antiquities and Monuments Office

Study on Old Trails in Hong Kong - Final Study Report

February 2014

Study on Old Trails in Hong Kong: *Final Study Report*

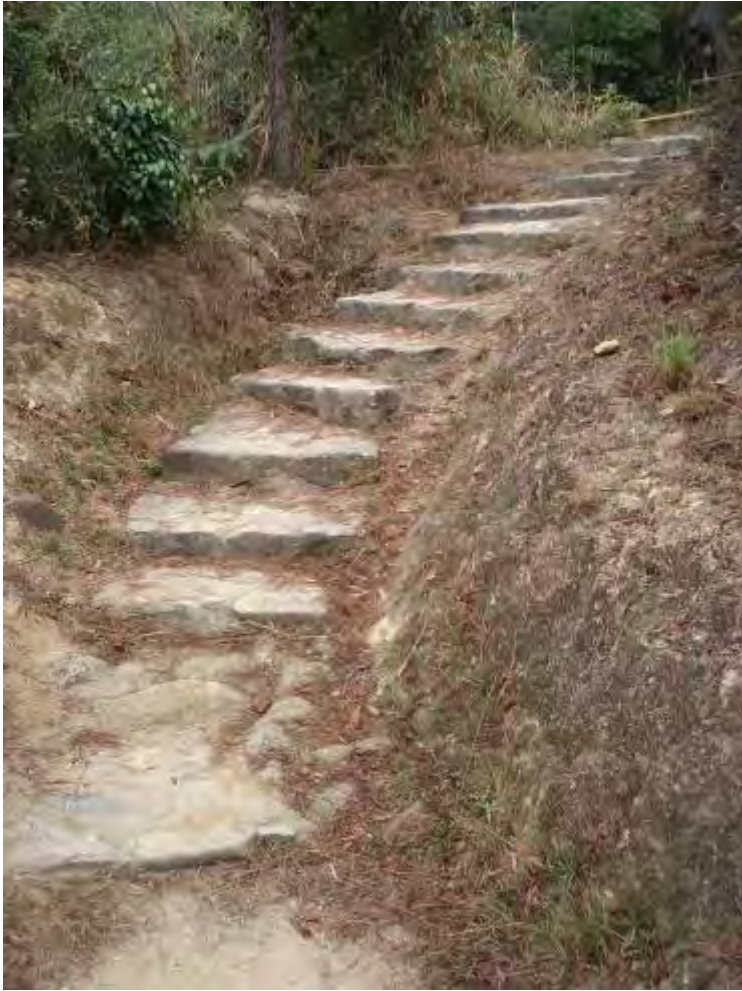
<p>Modern boulder steps constructed by AFCD (view A to B)</p>

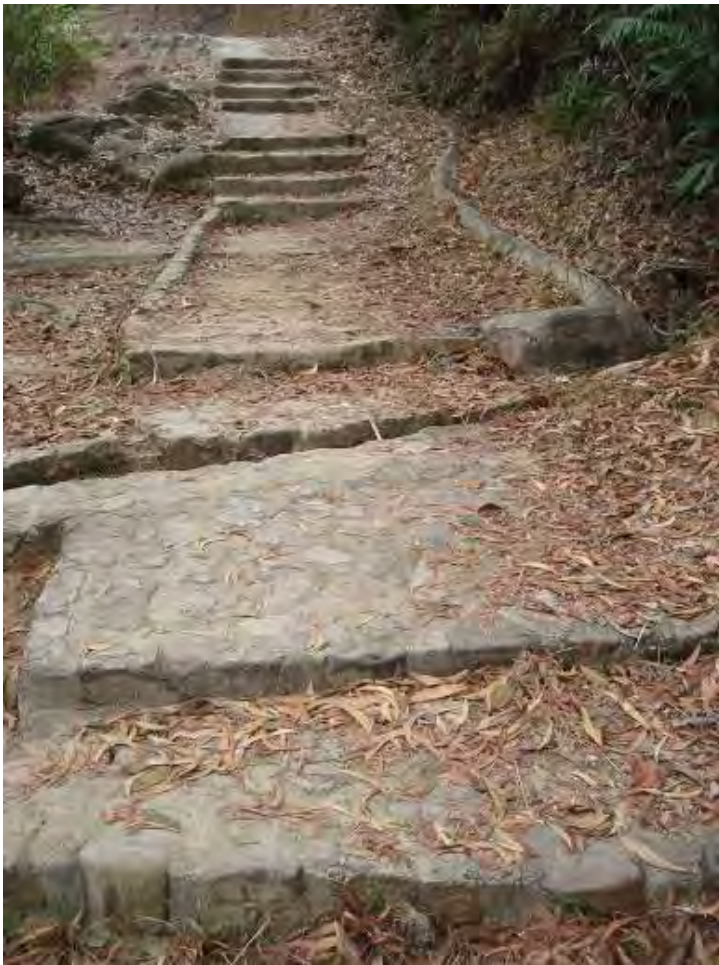
<p>A wide reworked section maintained by AFCD (view A to B)</p>

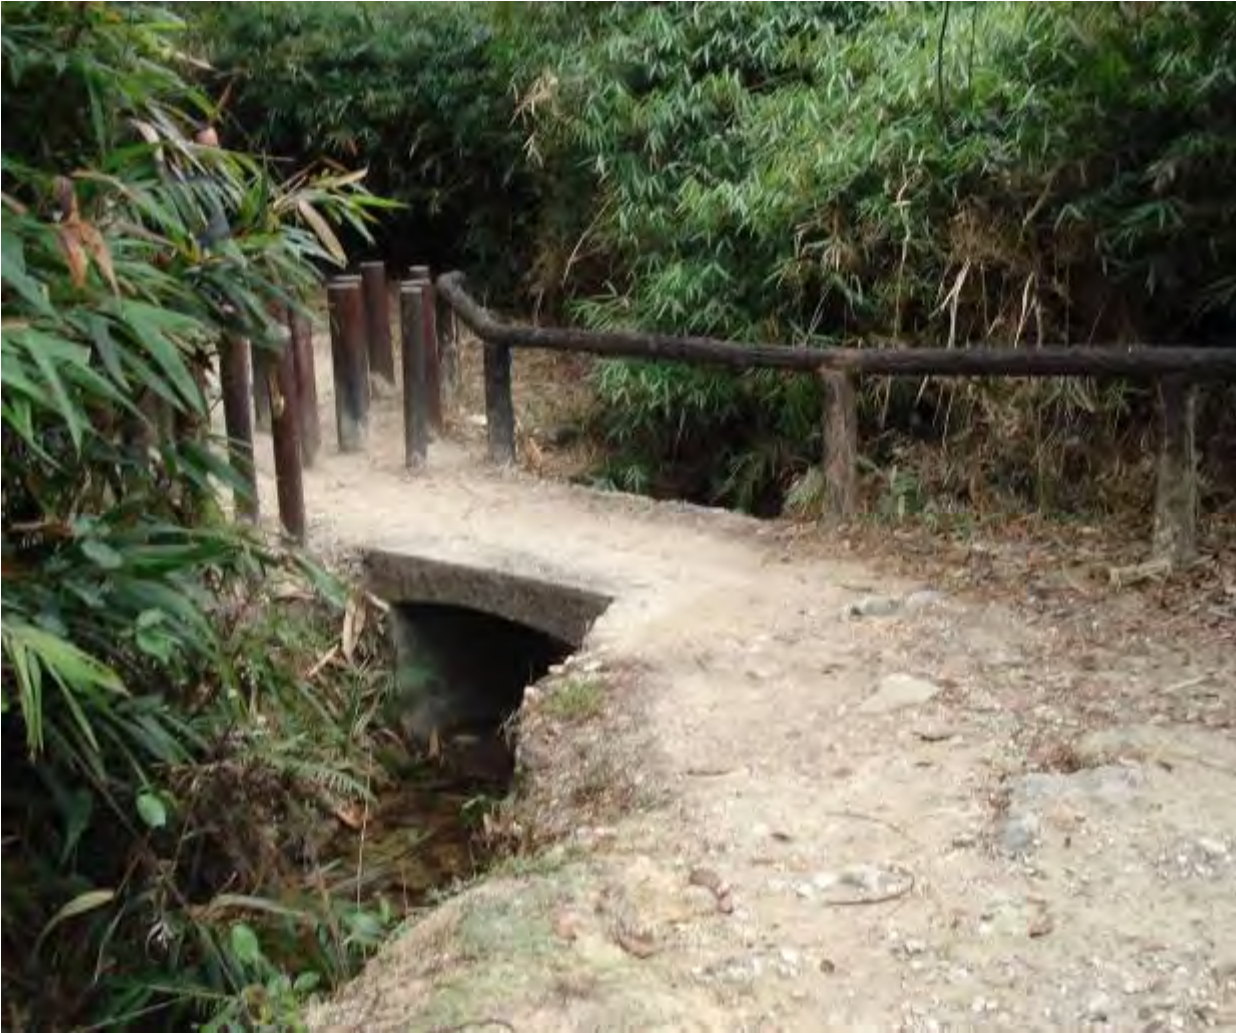
<p data-bbox="432 1305 1944 1345">Another bridge found along the Trackway; the railings and wood posts are made of modern materials. (View A to B)</p>

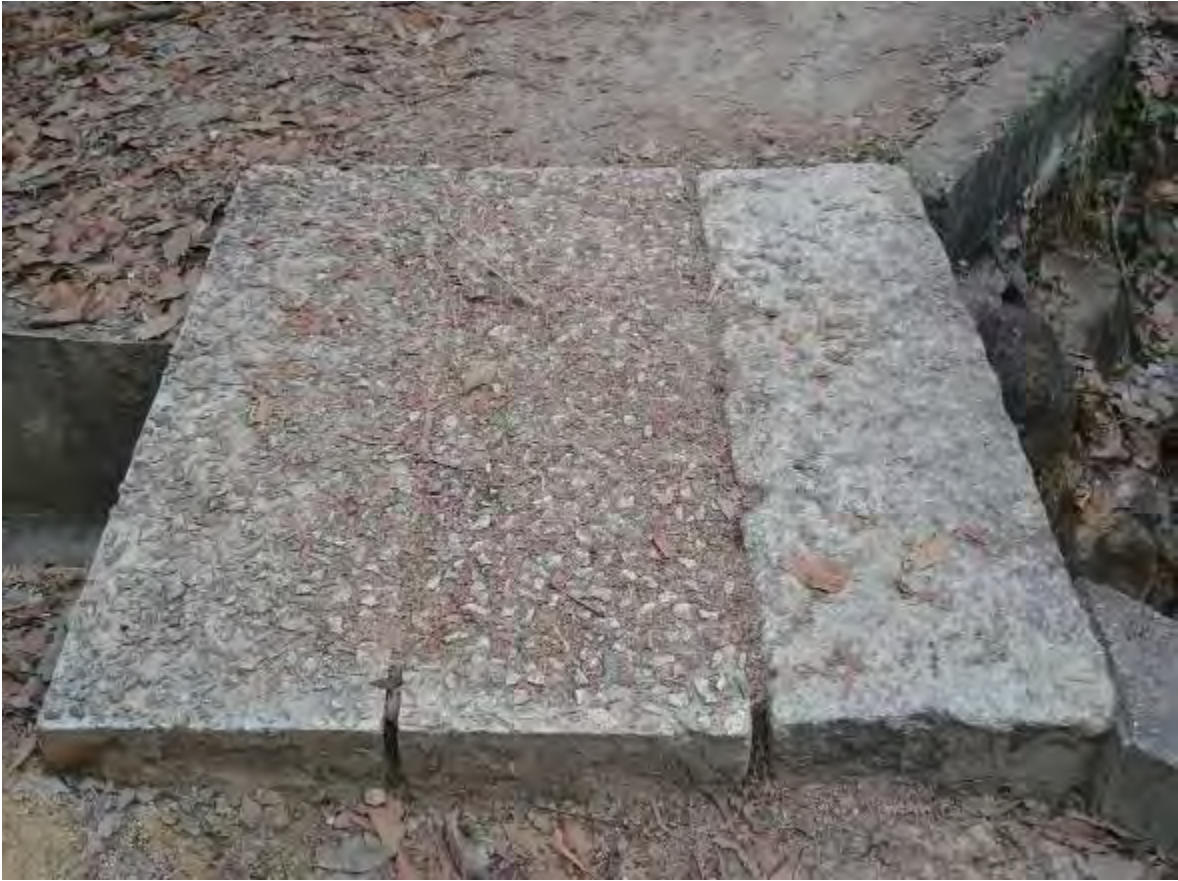
<p data-bbox="264 1157 2107 1310">Simple crossing are formed by concrete of three slabs each approximately 20 cm. wide, allowing a walkway of about 60 cm width across the water course in line with the old footpath. Two of them are probably pre-made slab with gravel-concrete mix. One of them (the right one) is granite with feathering marks. The granite slab is believed to be original. It is likely that they have been carried some distance by hand, a difficult and laborious task. (View A to B)</p>

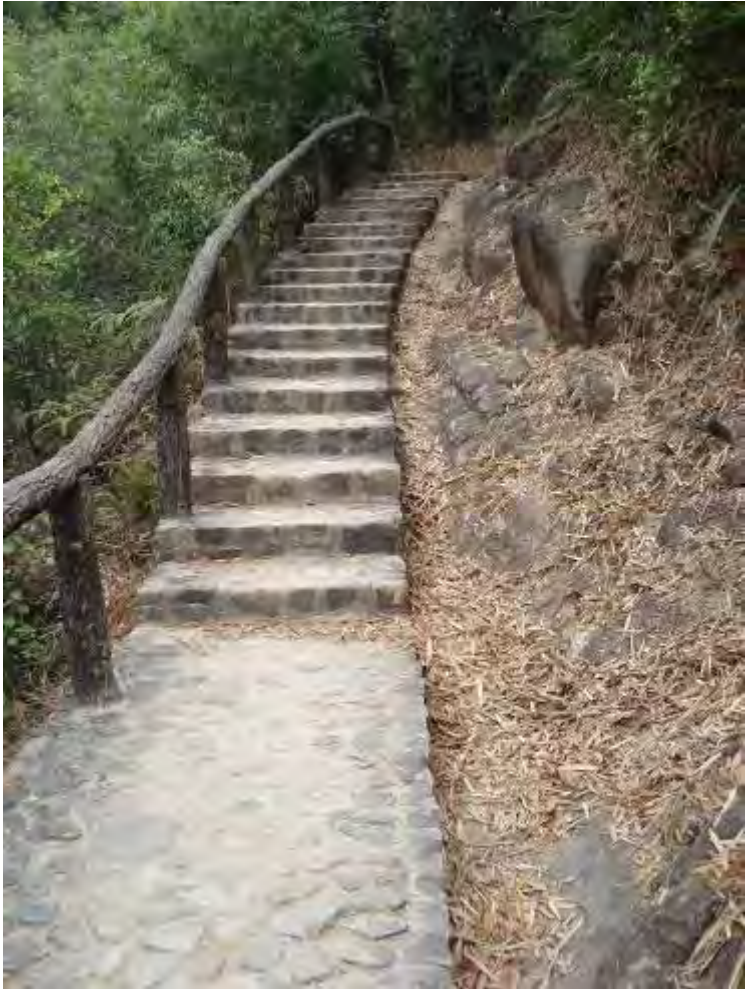
<p>A reworked section of steps with modern railings (view B to A)</p>

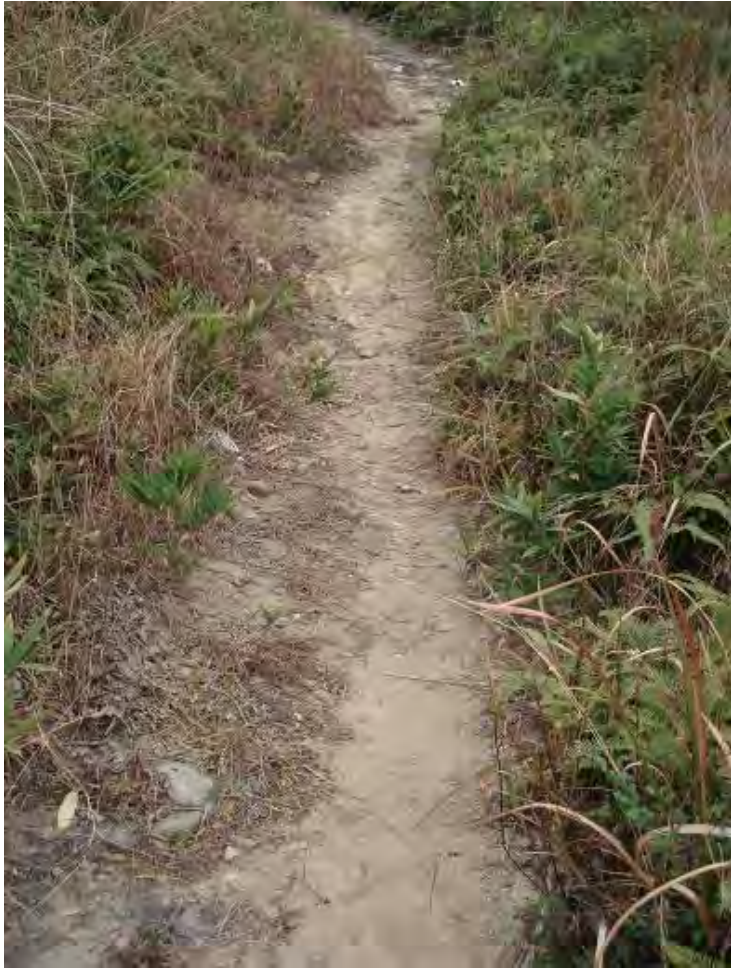
Photo Reference No.	Photographic Records	Photo Reference No.	Photographic Records
1

<p>Mud section along the footpath. (View B to A)</p>	2

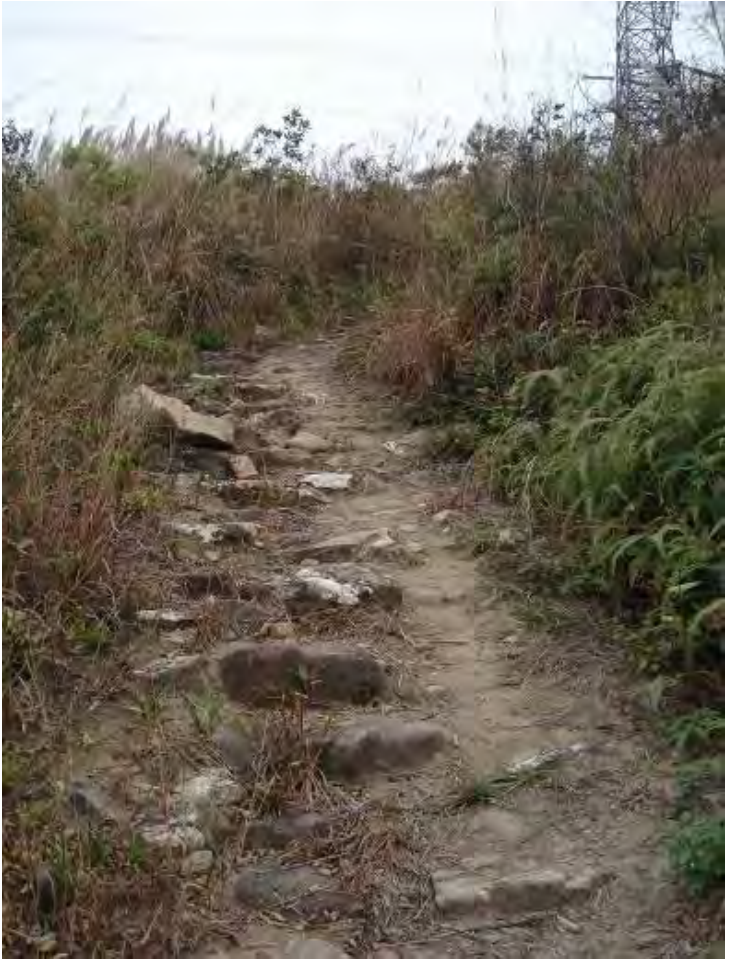
<p>Boulder steps. (View B to A)</p>

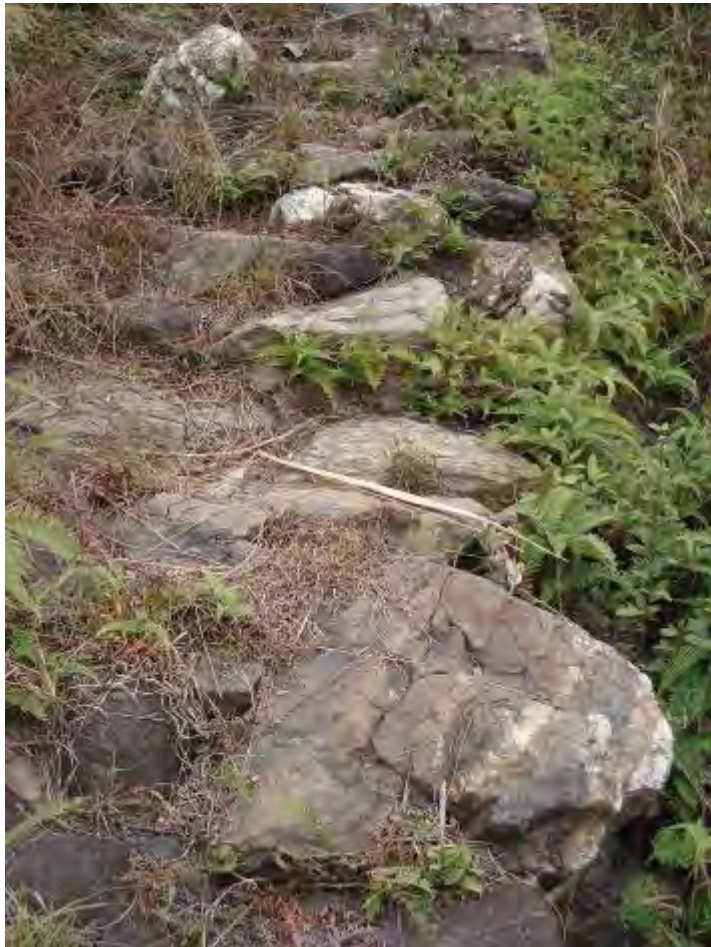
Photo Reference No.	Photographic Records	Photo Reference No.	Photographic Records
5

<p>Boulder steps. (View B to A)</p>	6

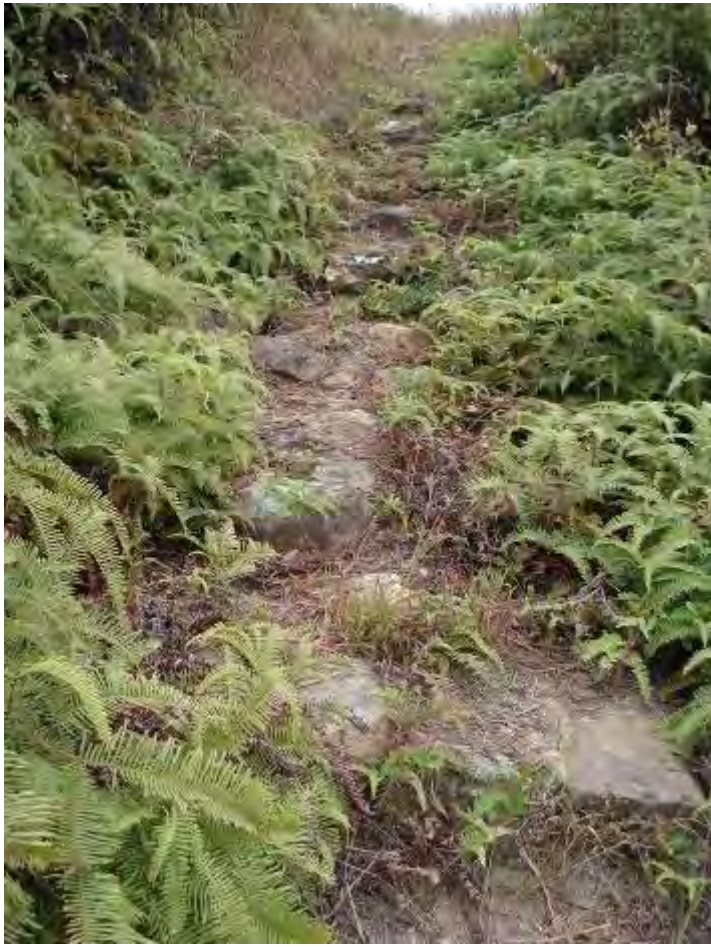
<p>Severely overgrown vegetation almost covered the boulder section. (View B to A)</p>

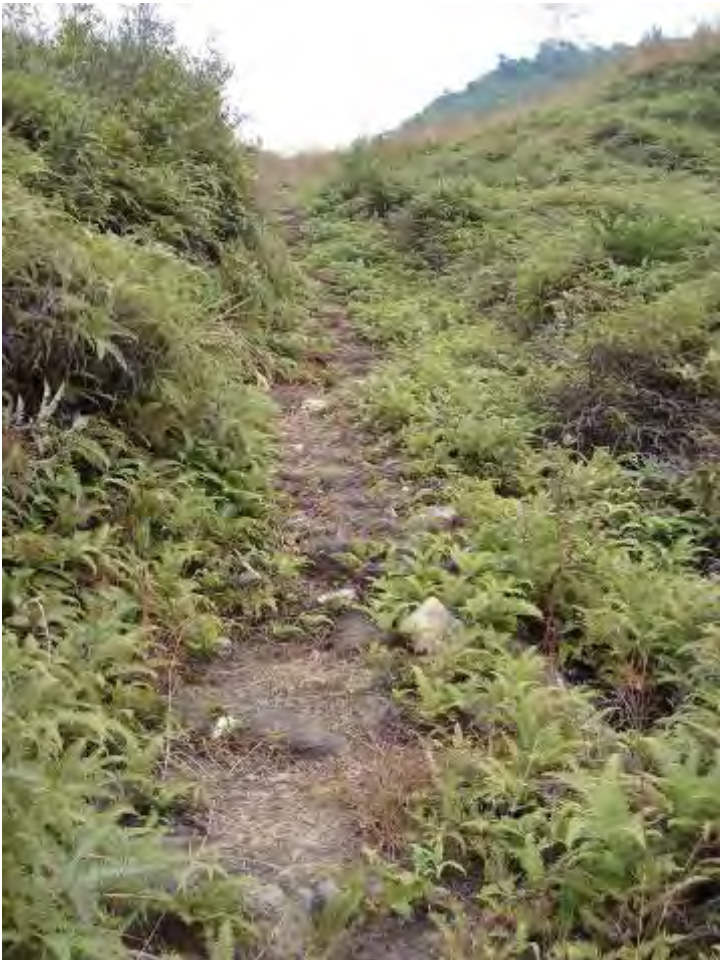
Photo Reference No.	Photographic Records	Photo Reference No.	Photographic Records
7

<p>The rather steep gradient of the boulder steps. (View B to A)</p>	8

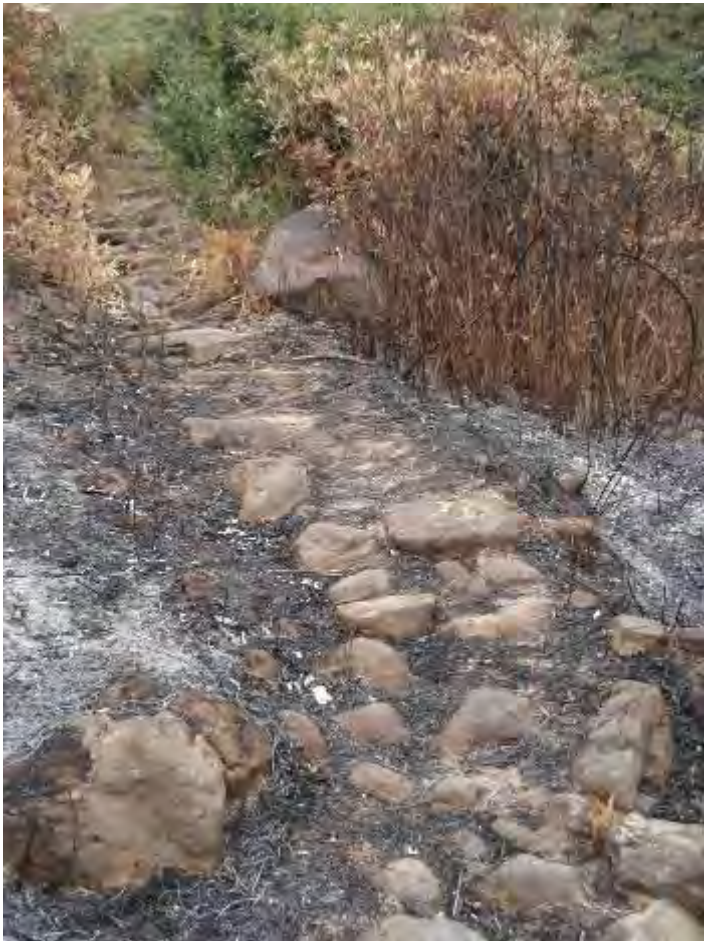
<p>Boulder steps and the burnt vegetation adjacent to the steps. (View A to B)</p>

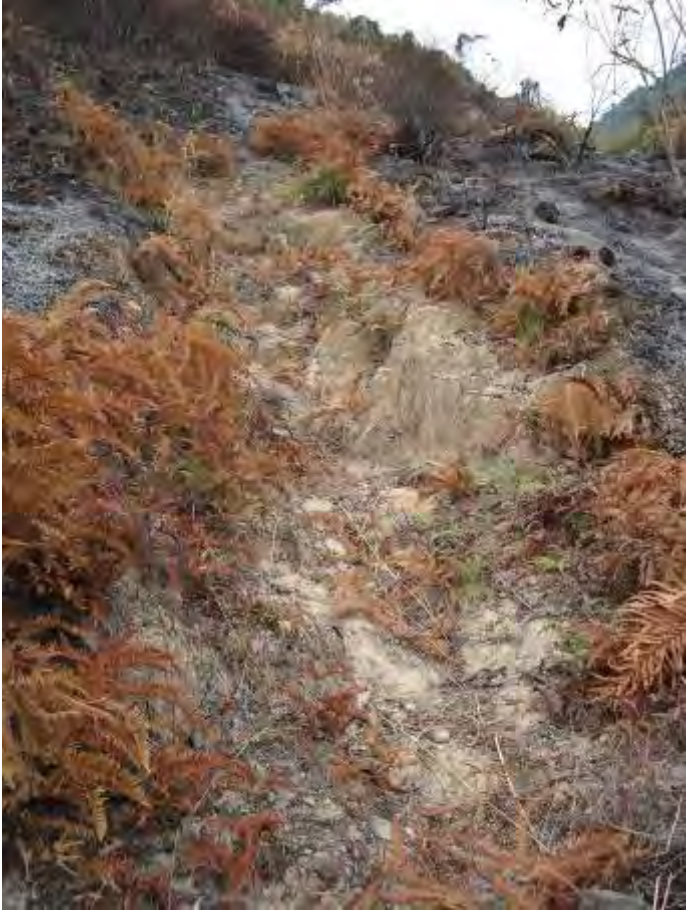
Photo Reference No.	Photographic Records	Photo Reference No.	Photographic Records
9

<p>The poor condition of the footpath is shown by severely burnt vegetation at both sides of the footpath; boulders can hardly be identified. (View B to A)</p>	10

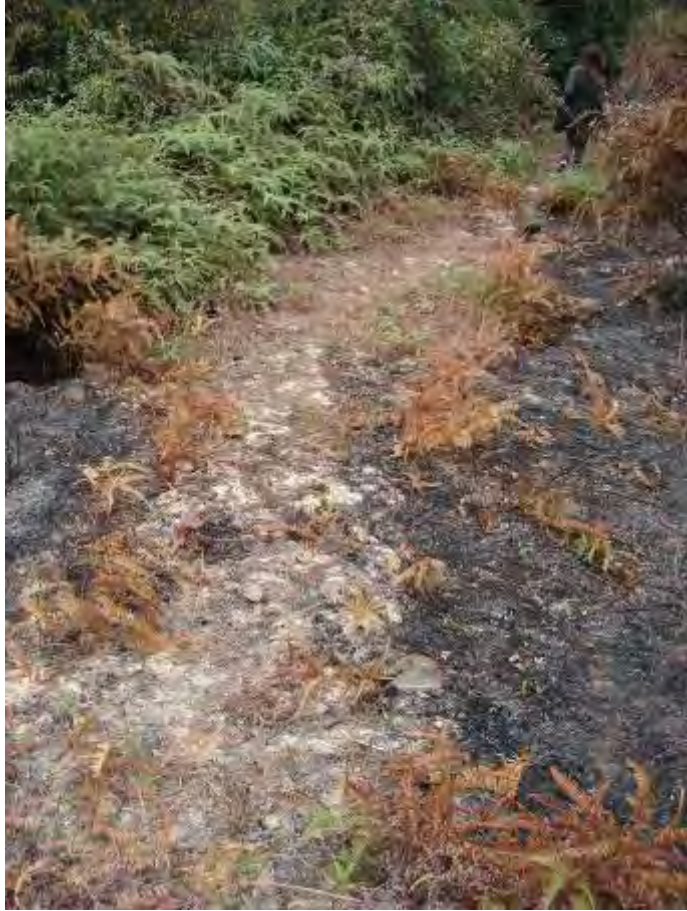
<p>Vegetation at both sides of the path was burnt to ash; the boulder/mud section can vaguely be seen in between the burnt vegetation. (View A to B)</p>

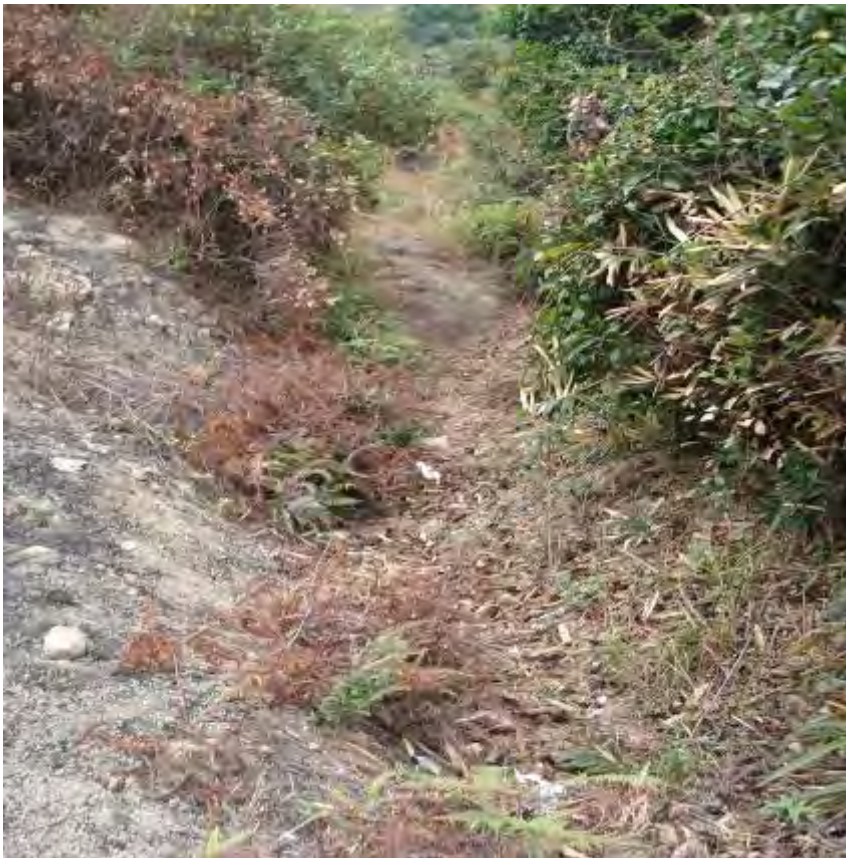
Photo Reference No.	Photographic Records	Photo Reference No.	Photographic Records
B

<p>This photo marks the ending point of the Trackway (i.e. B) as no more boulder/mud sections can be found beyond this point. (View A to B)</p>	Gr 1 and Gr 2

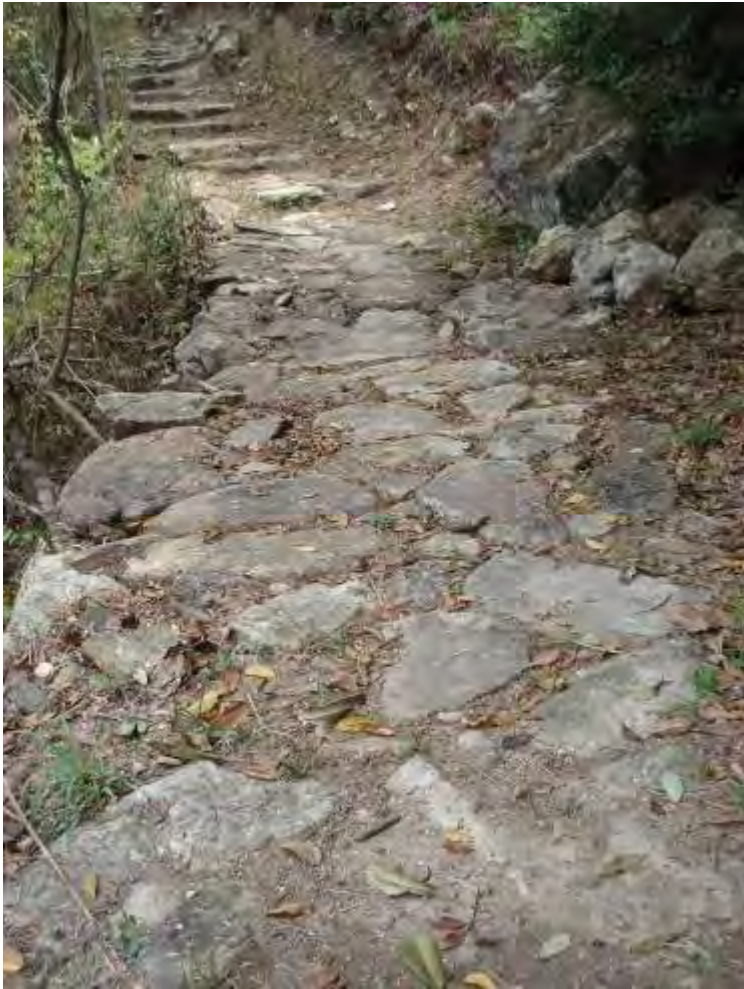
Photo Reference No.	Photographic Records	Photo Reference No.	Photographic Records
9

<p>A probable intermittent stream location along the footpath (view B to A)</p>		(Blank)

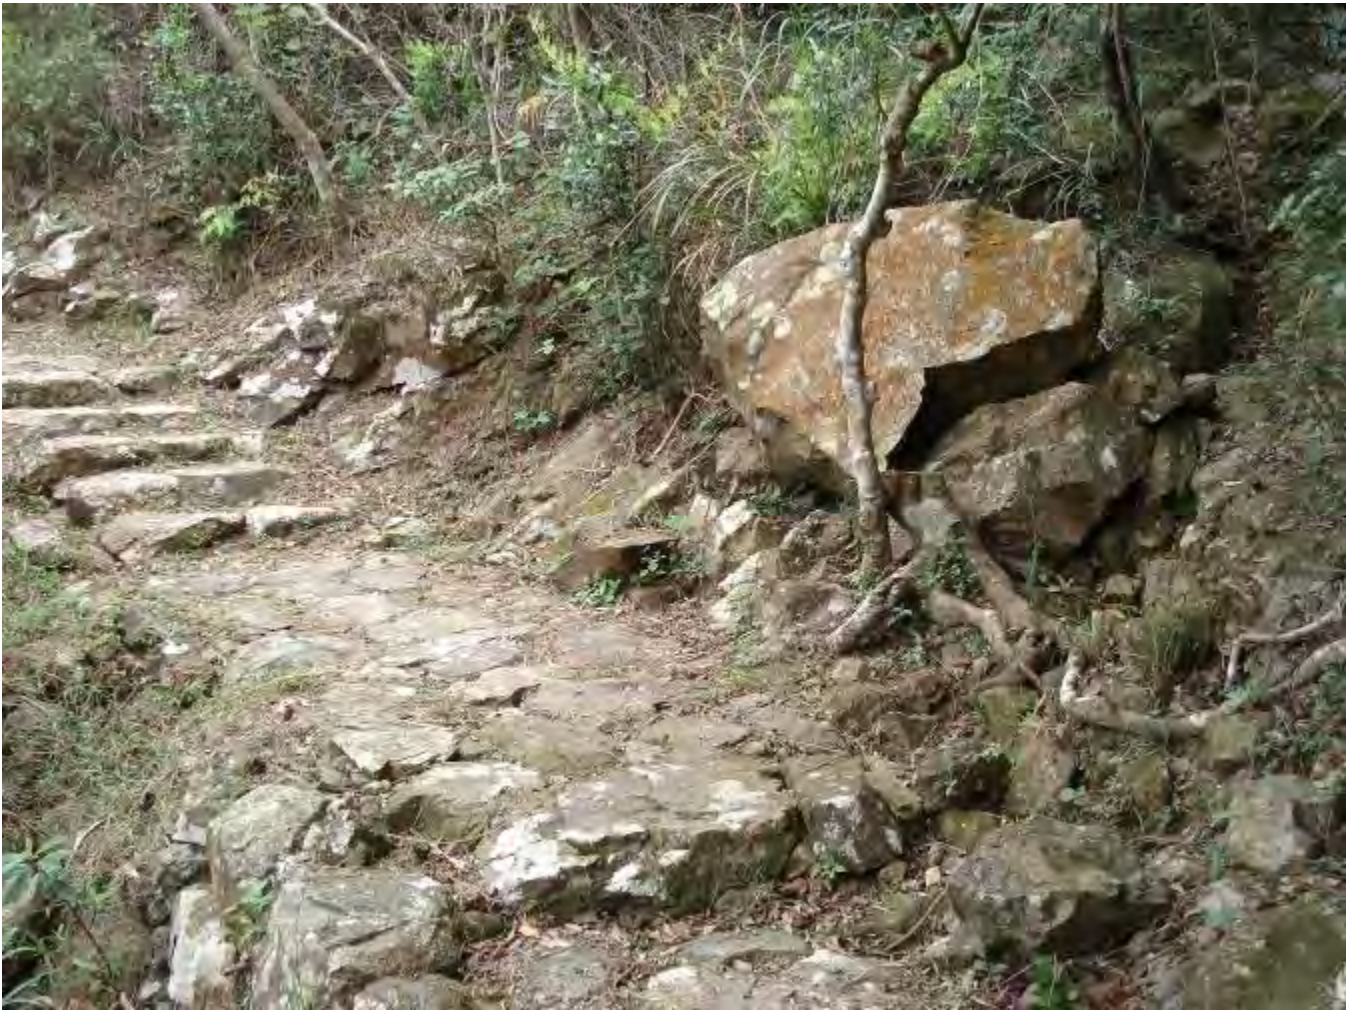
Photo Reference No.	Photographic Records
10

<p data-bbox="801 1281 1619 1315">Another probable location of intermittent stream (view B to A)</p>

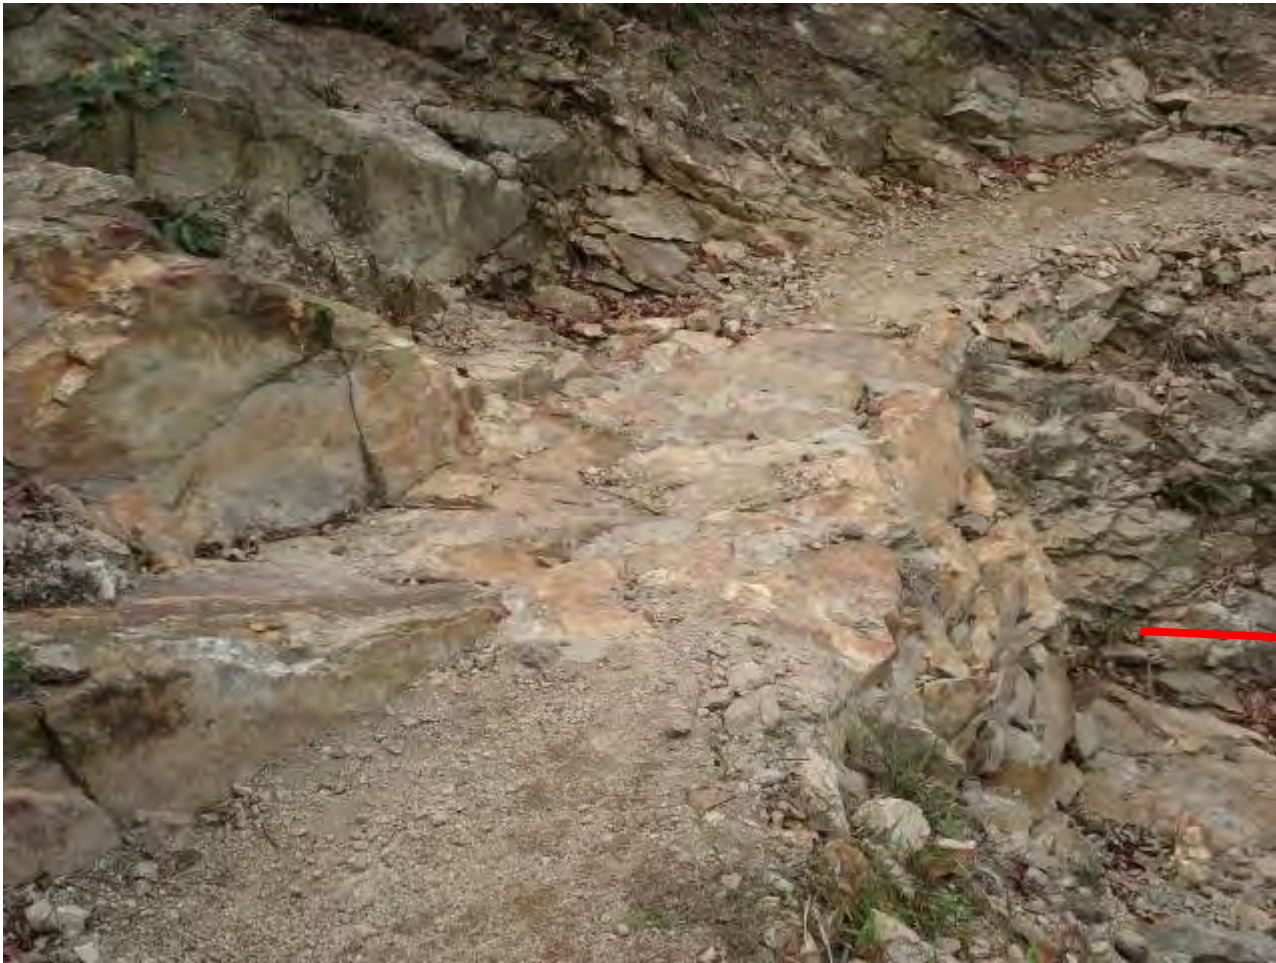
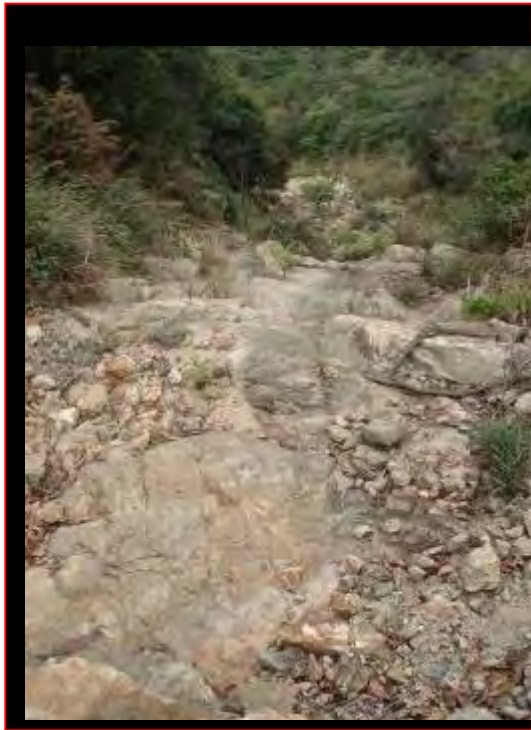
Photo Reference No.	Photographic Records
12	<div data-bbox="262 236 1534 1203">

</div> <p data-bbox="1697 1034 2107 1066">View from Trackway outwards</p> <p data-bbox="262 1235 2107 1305">Location of previous landslide. It was observed that there were boulders that had been reinforced with concrete after landslide incident which indicated that the section was likely boulder paved. The section between Point 11 and Point 12 is regarded as reworked section (view A to B).</p>

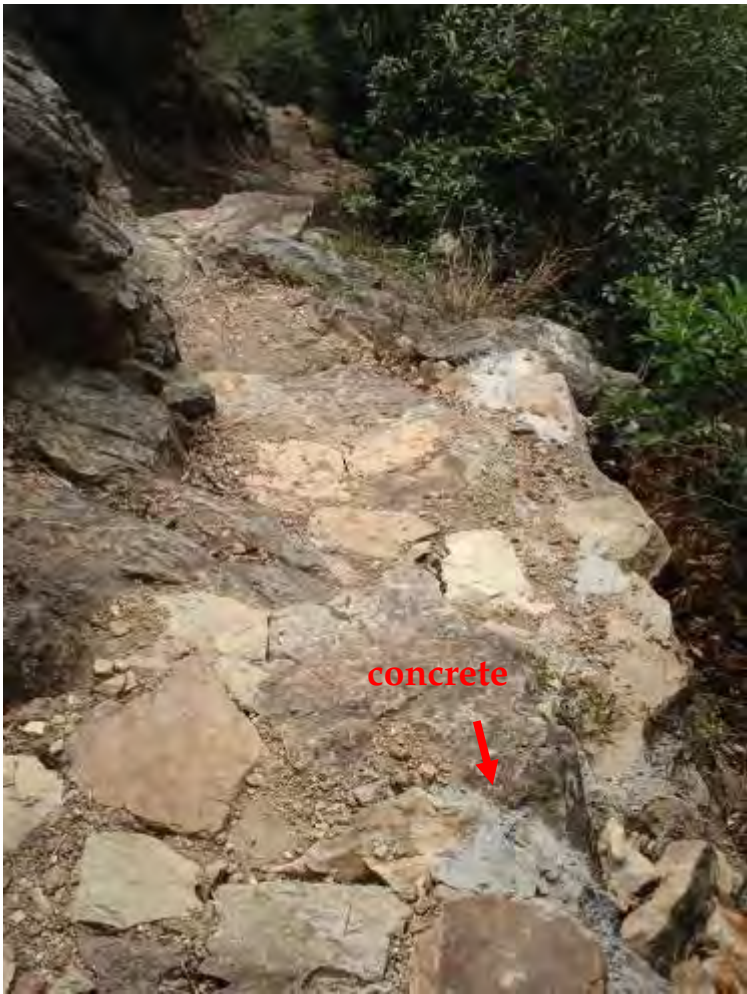
Photo Reference No.	Photographic Records	Photo Reference No.	Photographic Records
20

<p>Irregularly-shaped reworked boulders with apparent in-filled concrete. (View A to B)</p>	21

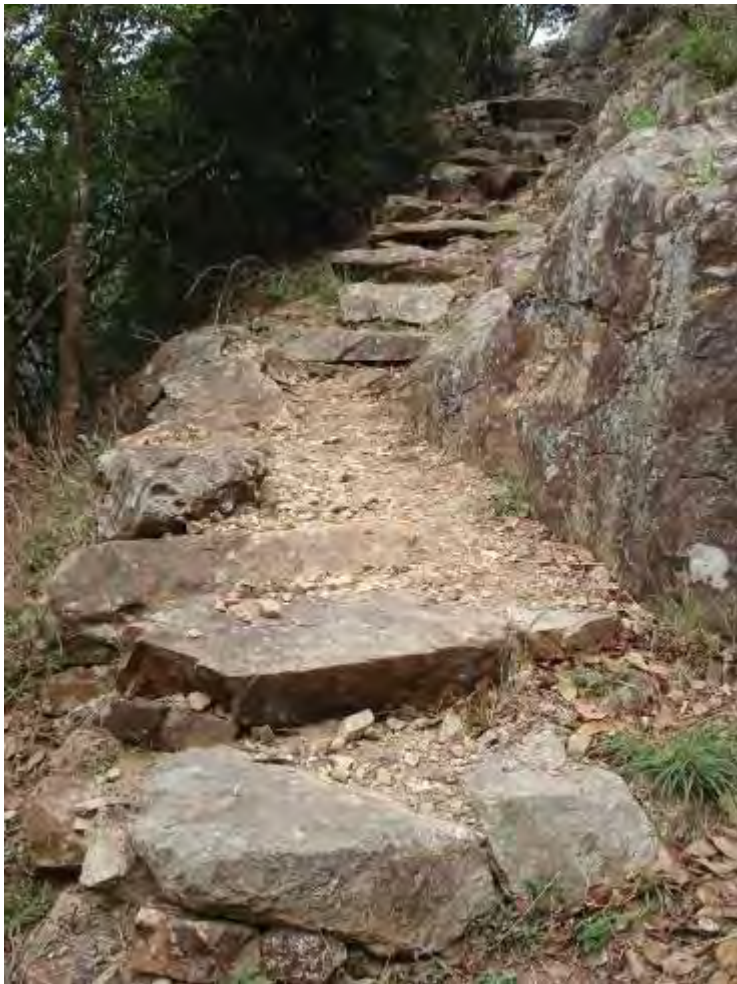
<p>Boulder steps. (View B to A)</p>

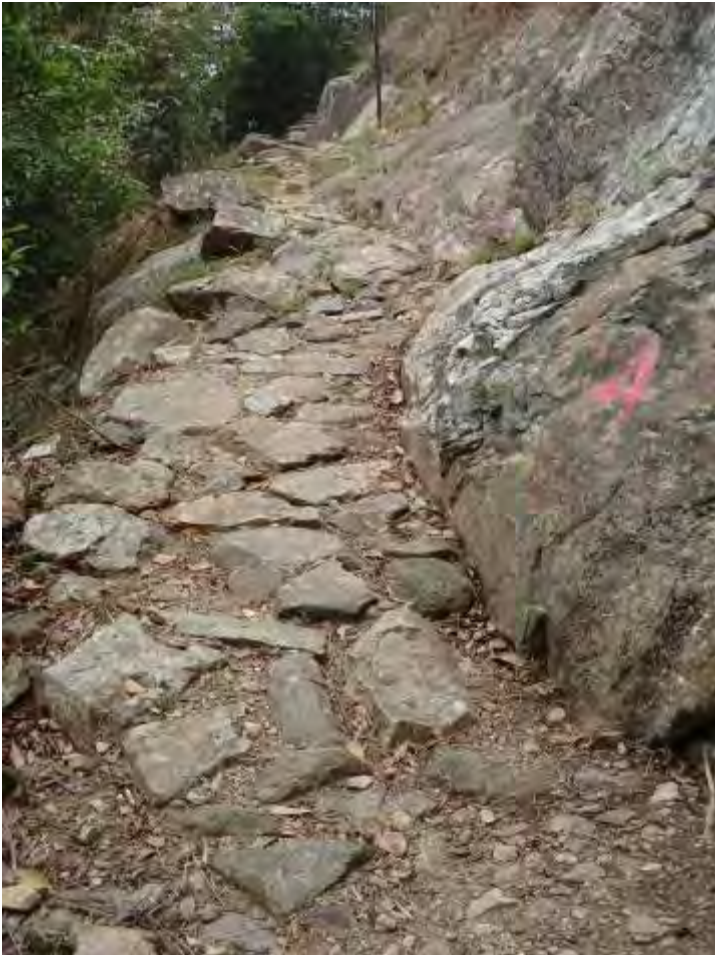
<p>Boulder section (view B to A)</p>	23

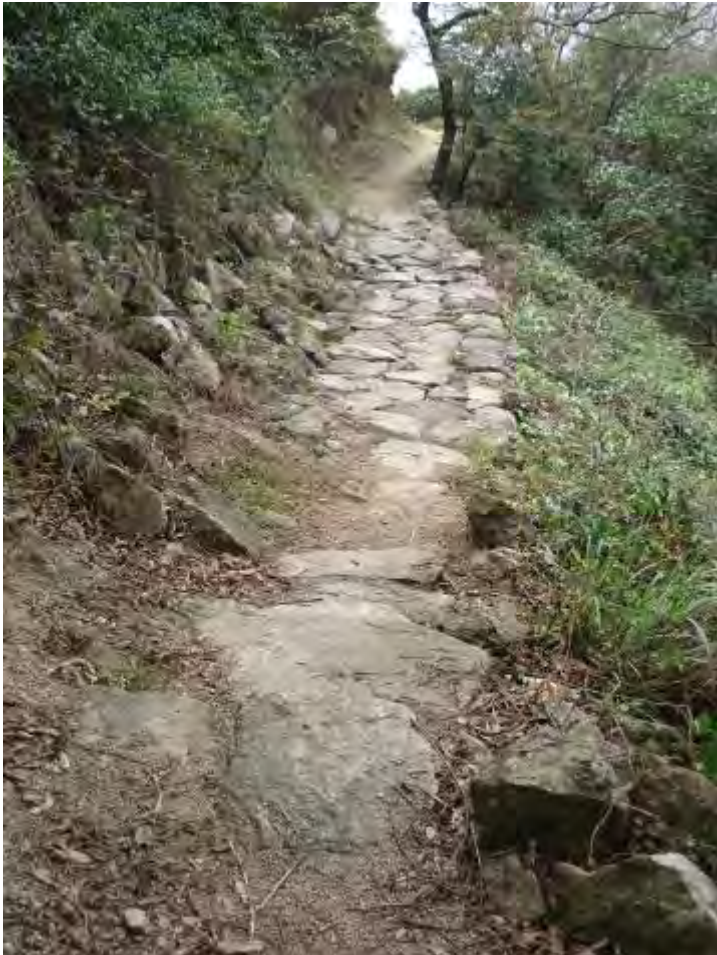
<p>Boulder section (view A to B)</p>

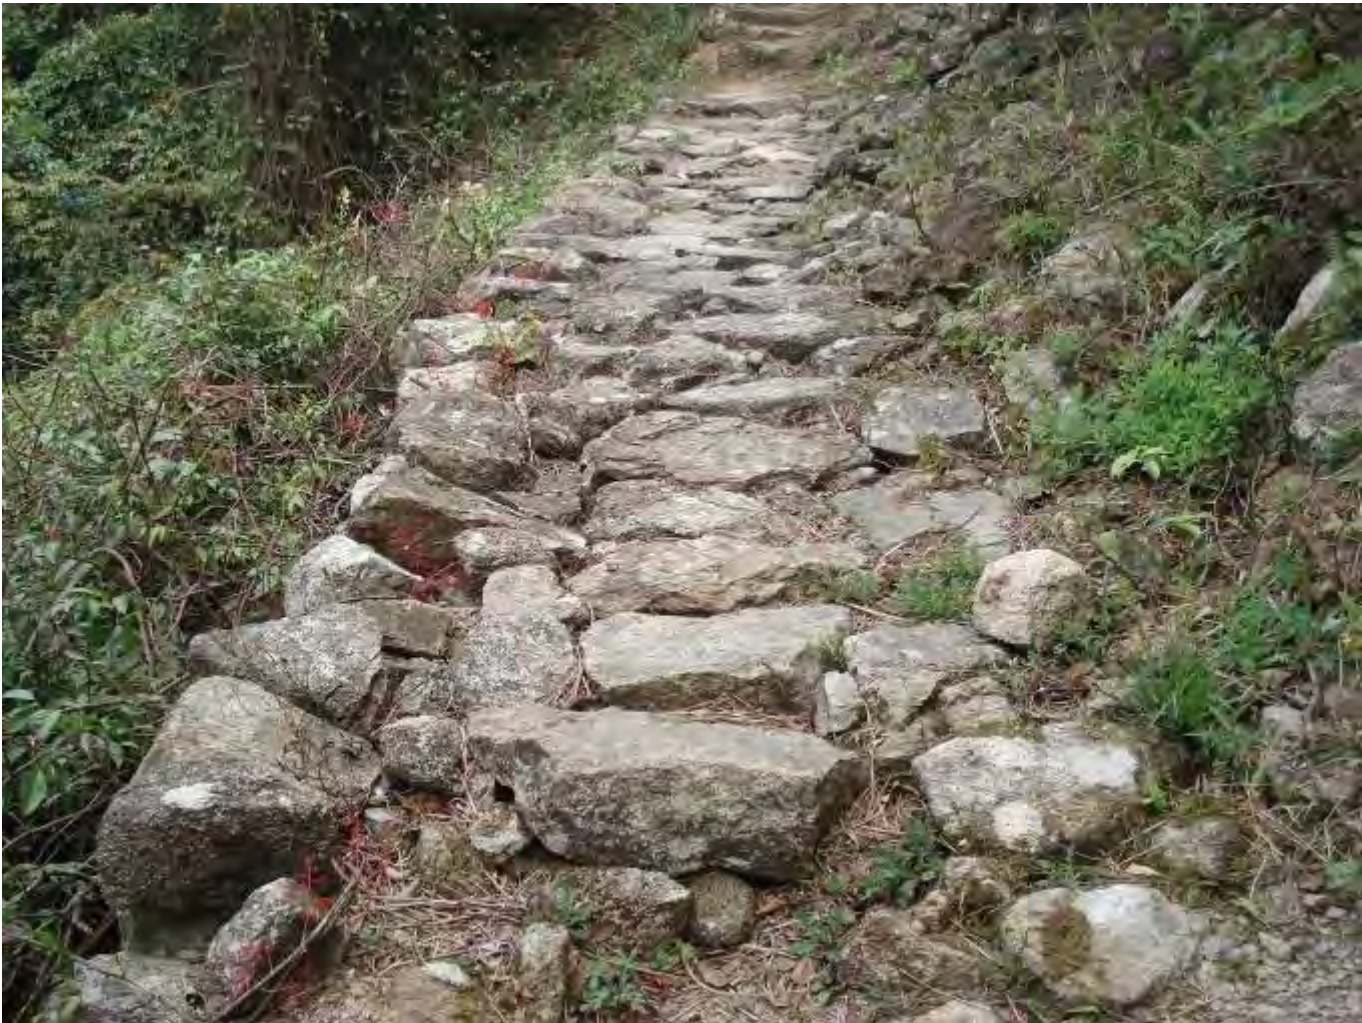
Photo Reference No.	Photographic Records
23

<p data-bbox="801 1294 1576 1329">View of the boulder section from the opposite (view B to A)</p>

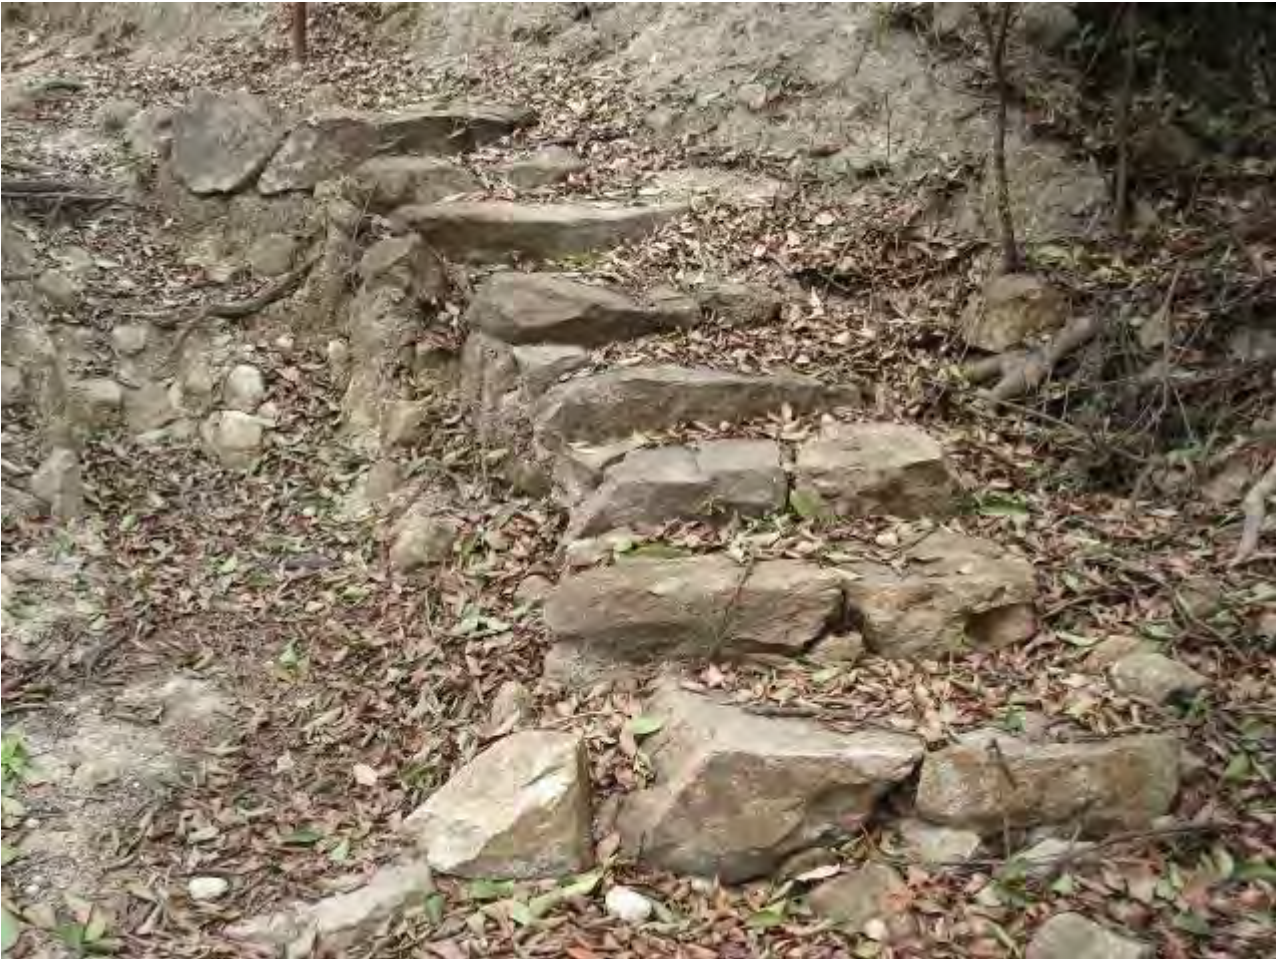
Photo Reference No.	Photographic Records
25

<p data-bbox="770 1262 1608 1297">Boulder steps covered with plenty of fallen leaves. (View B to A)</p>

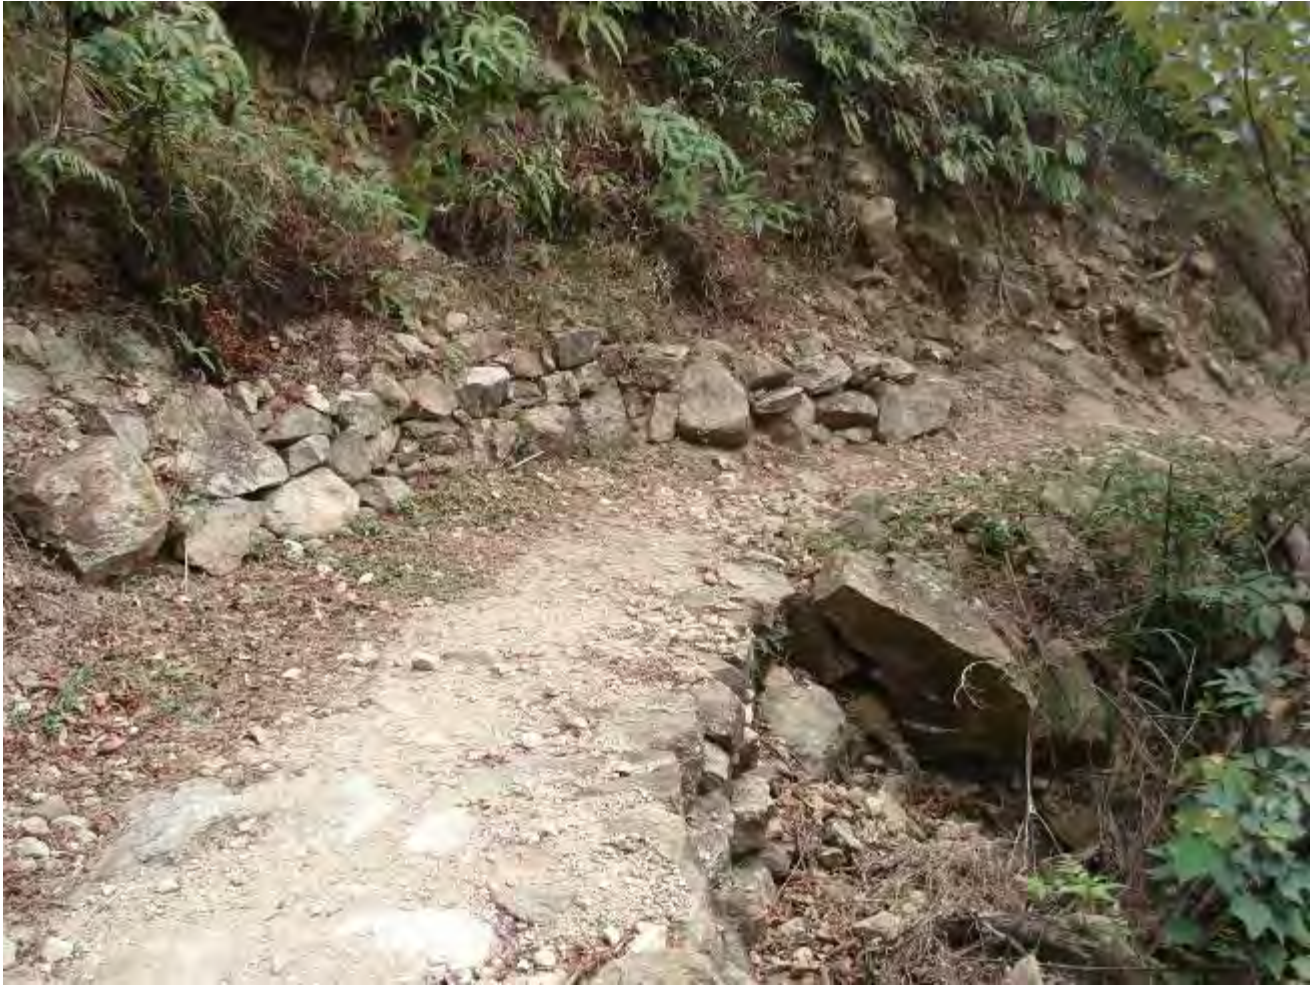
Photo Reference No.	Photographic Records
26

<p data-bbox="719 1257 1657 1295">A section of footpath with a boulder wall structure beside. (View A to B)</p>

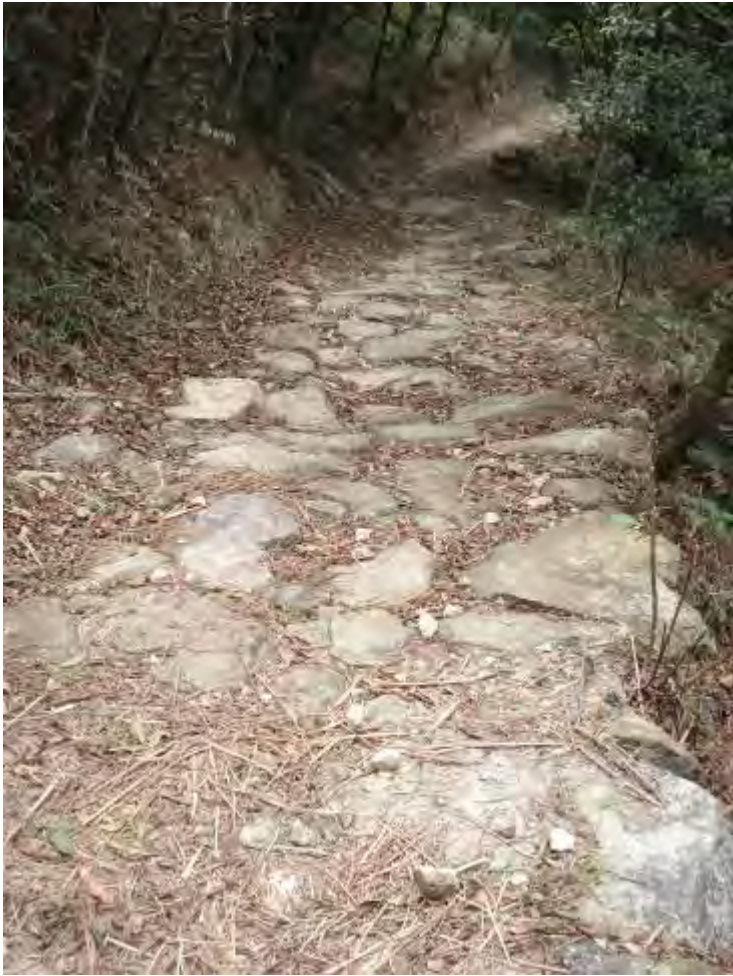
<p>Flat boulder surface with many tree branches (view A to B)</p>	28
