Antiquities and Monuments Office

Study on Old Trails in Hong Kong - Final Study Report

February 2014

Study on Old Trails in Hong Kong: *Final Study Report*

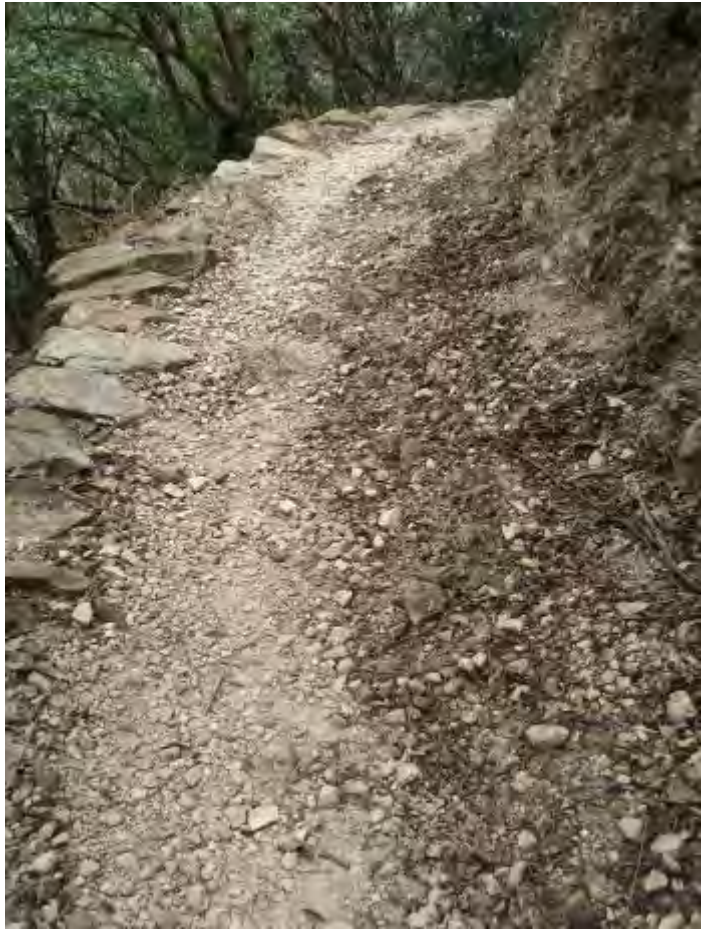
<p>Neatly arranged large boulders were found at the edge of the footpath by the cliff; many small stones scattered upon the footpath probably because of the heavy weathering and frequent landslides (view B to A)</p>

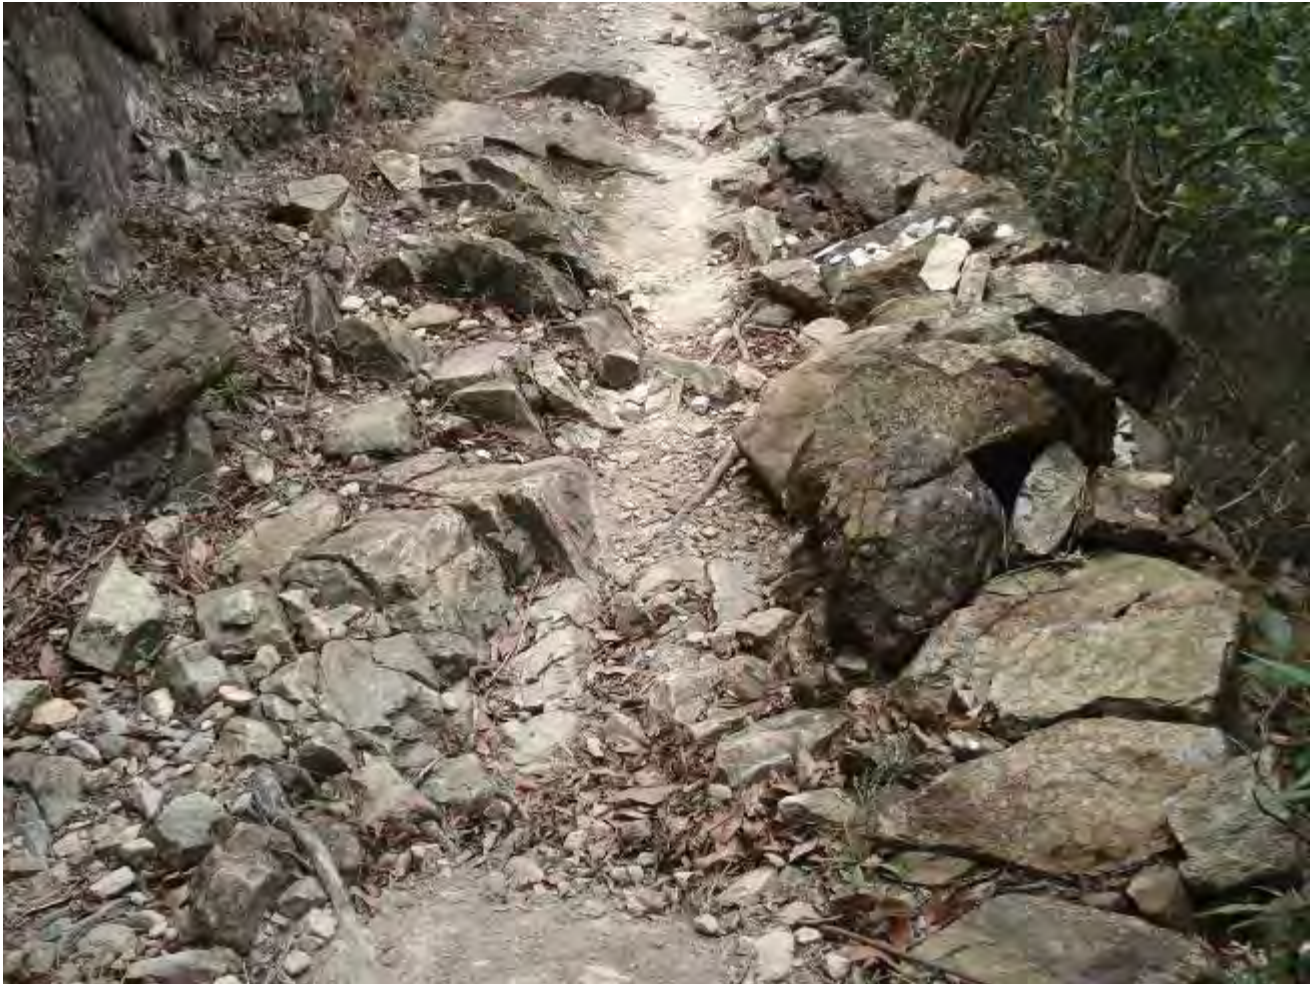
Photo Reference No.	Photographic Records
29

<p data-bbox="667 1273 1709 1308">Rugged surface of footpath with boulders and stones at both sides (view A to B)</p>

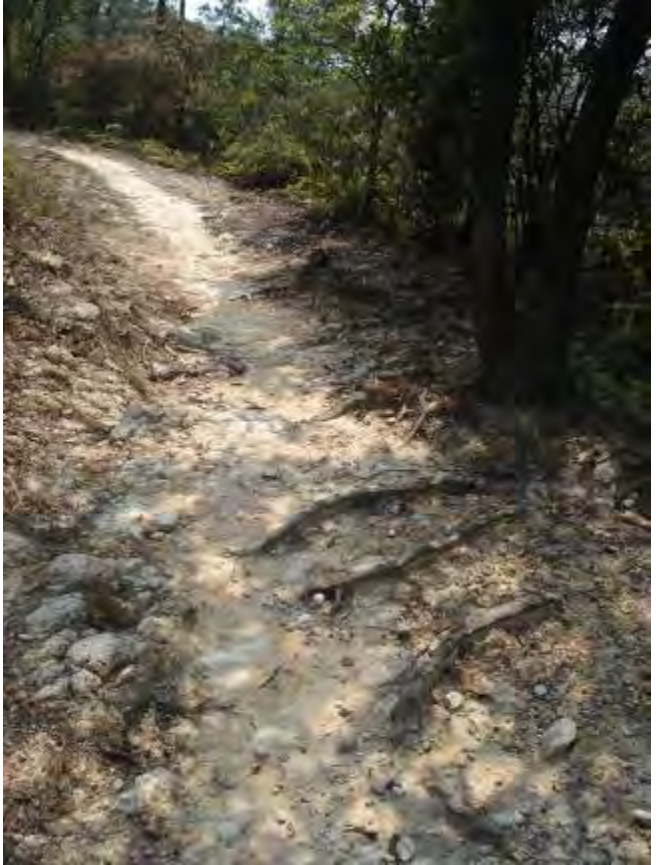
<p>A few tree roots encroaching the mud section of the footpath (view A to B)</p>

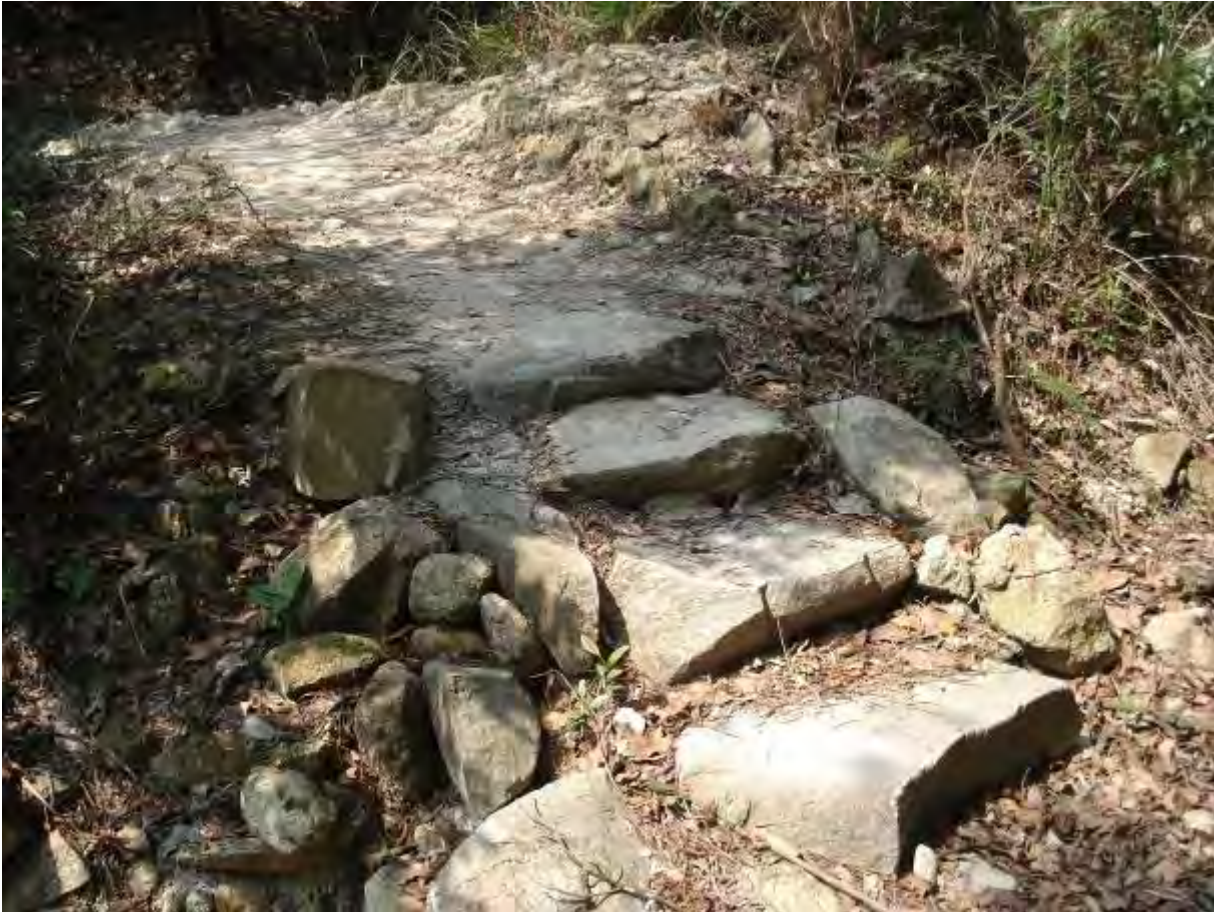
Photo Reference No.	Photographic Records
35

<p data-bbox="792 1214 1585 1251">A section of reworked steps along the footpath (view B to A)</p>

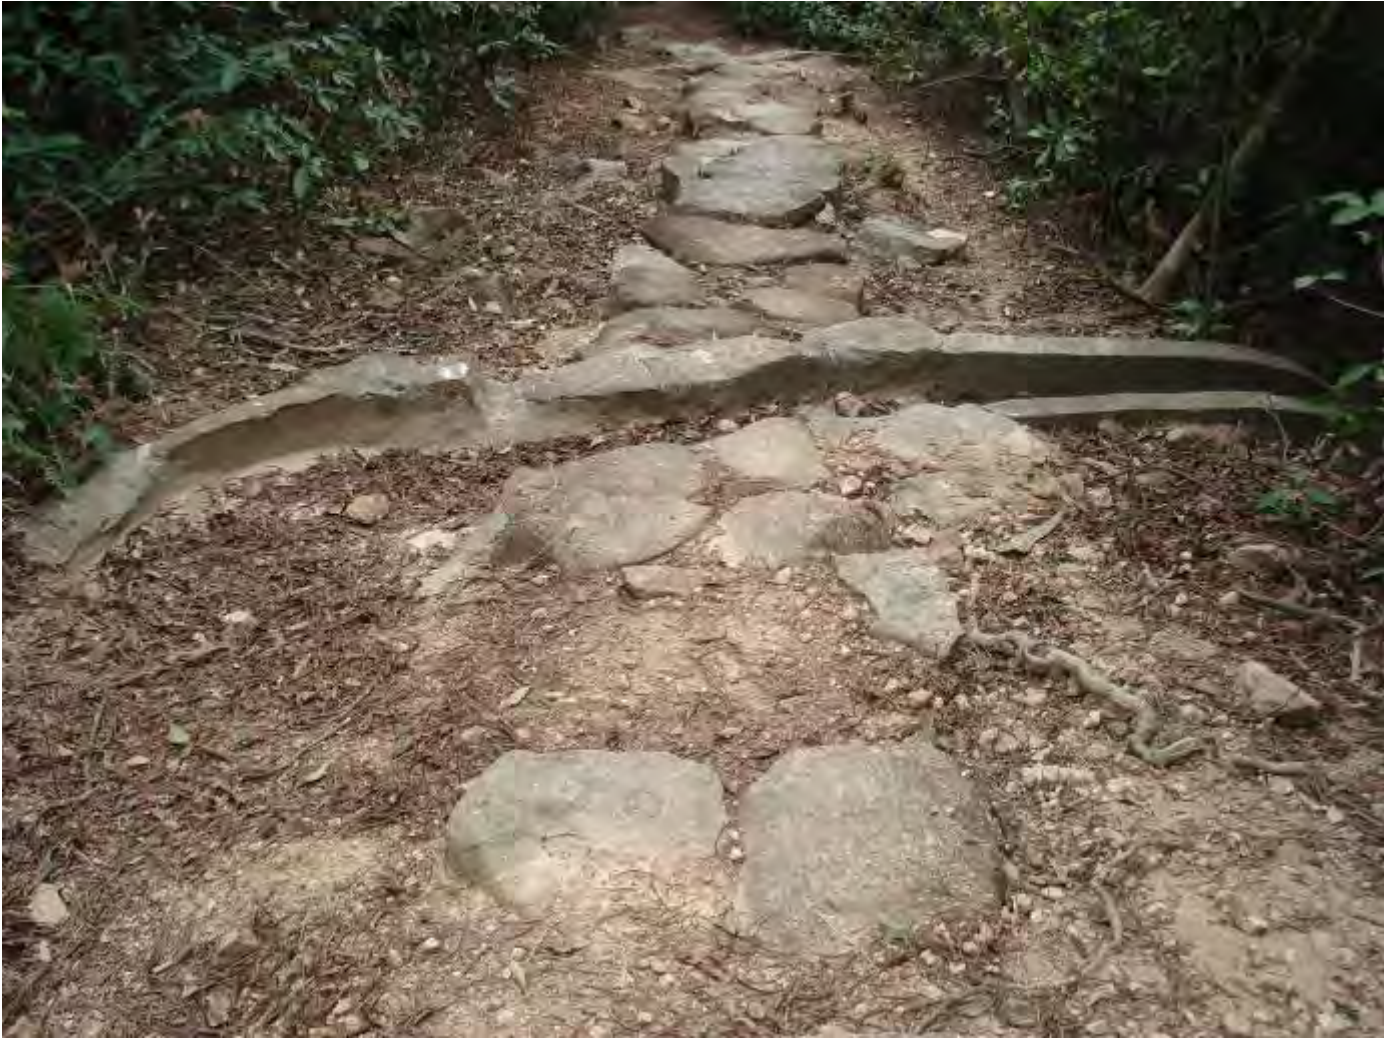
Photo Reference No.	Photographic Records
43

<p data-bbox="786 1315 1592 1347">A modern drain cutting across the boudler steps (view A to B)</p>

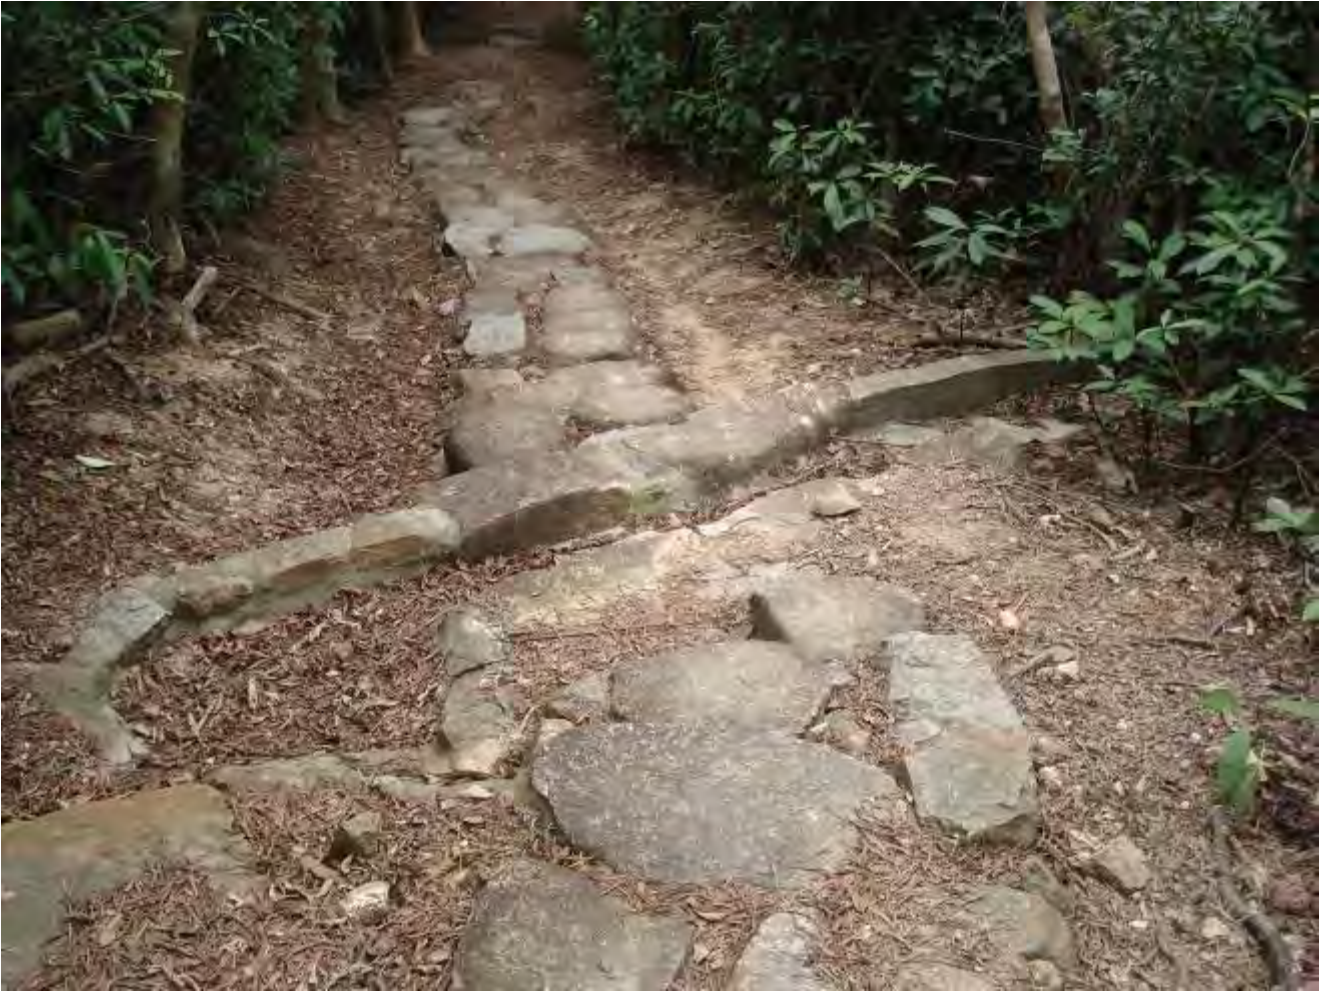
Photo Reference No.	Photographic Records
44

<p data-bbox="741 1265 1637 1302">Another modern drain cutting across the boulder steps (view A to B)</p>

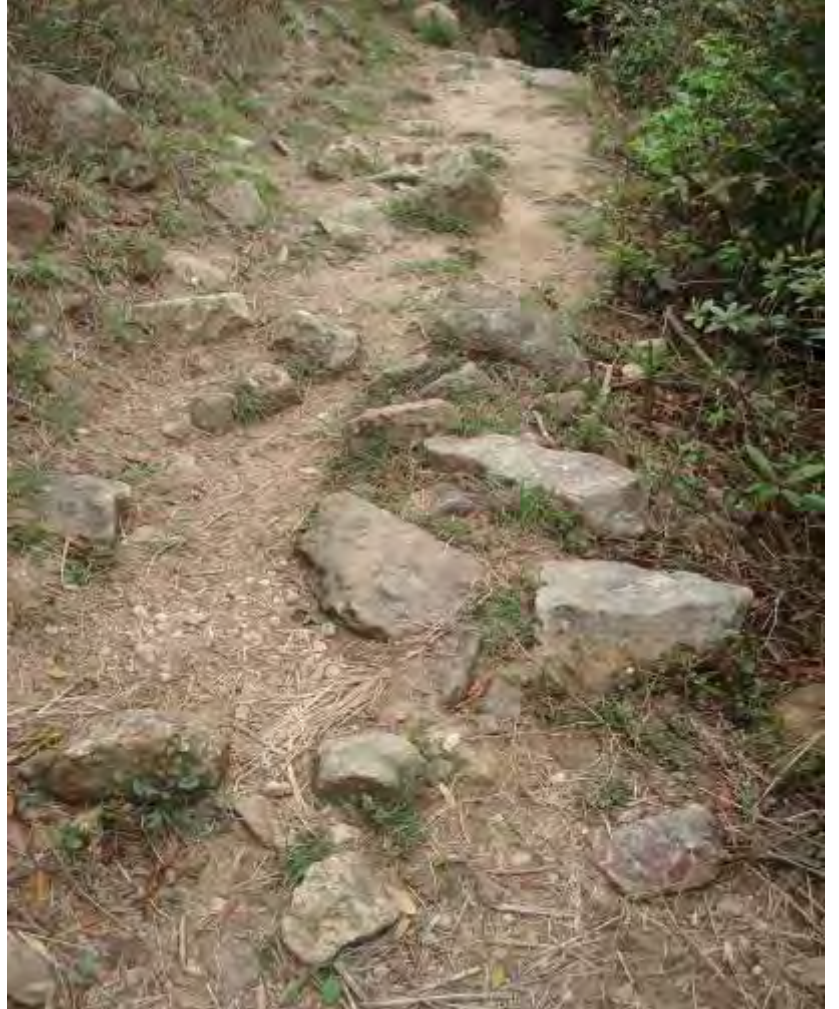
<p>Occasional boulders in irregular shapes on the mud section (view B to A)</p>

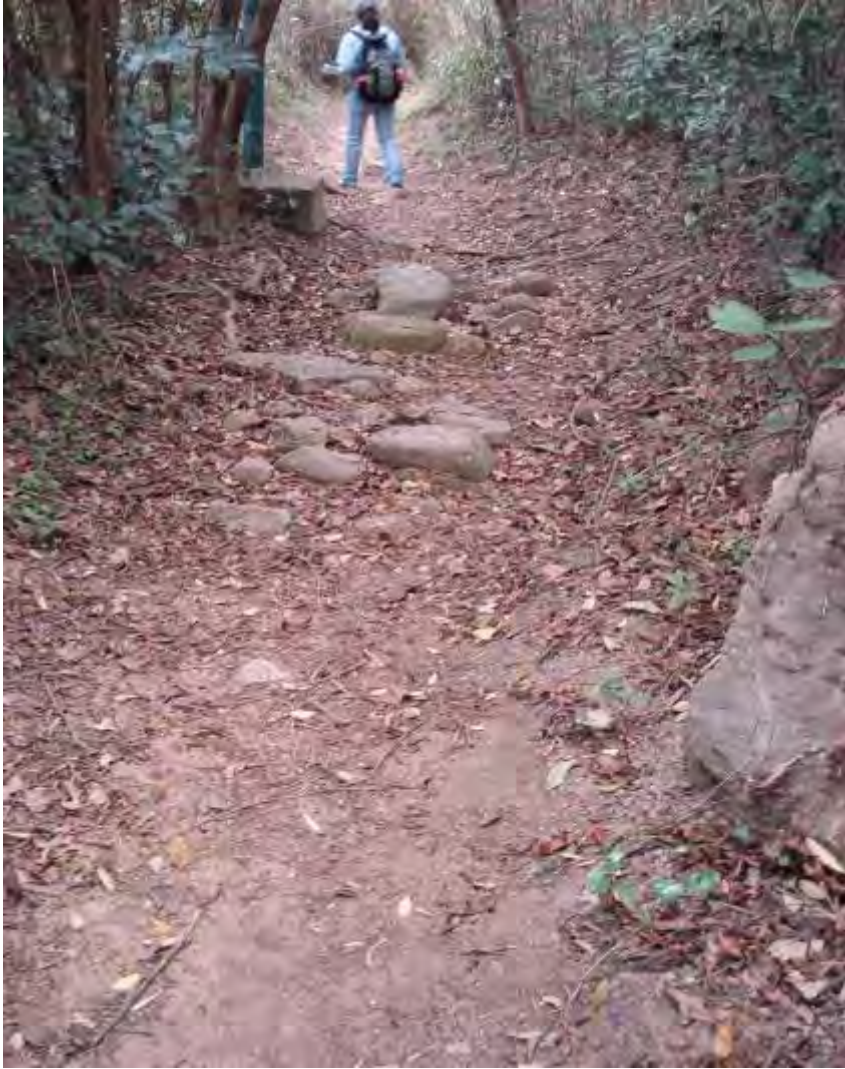
<p>Occasional boulders in irregular shapes on the mud section (view A to B)</p>		(Blank)

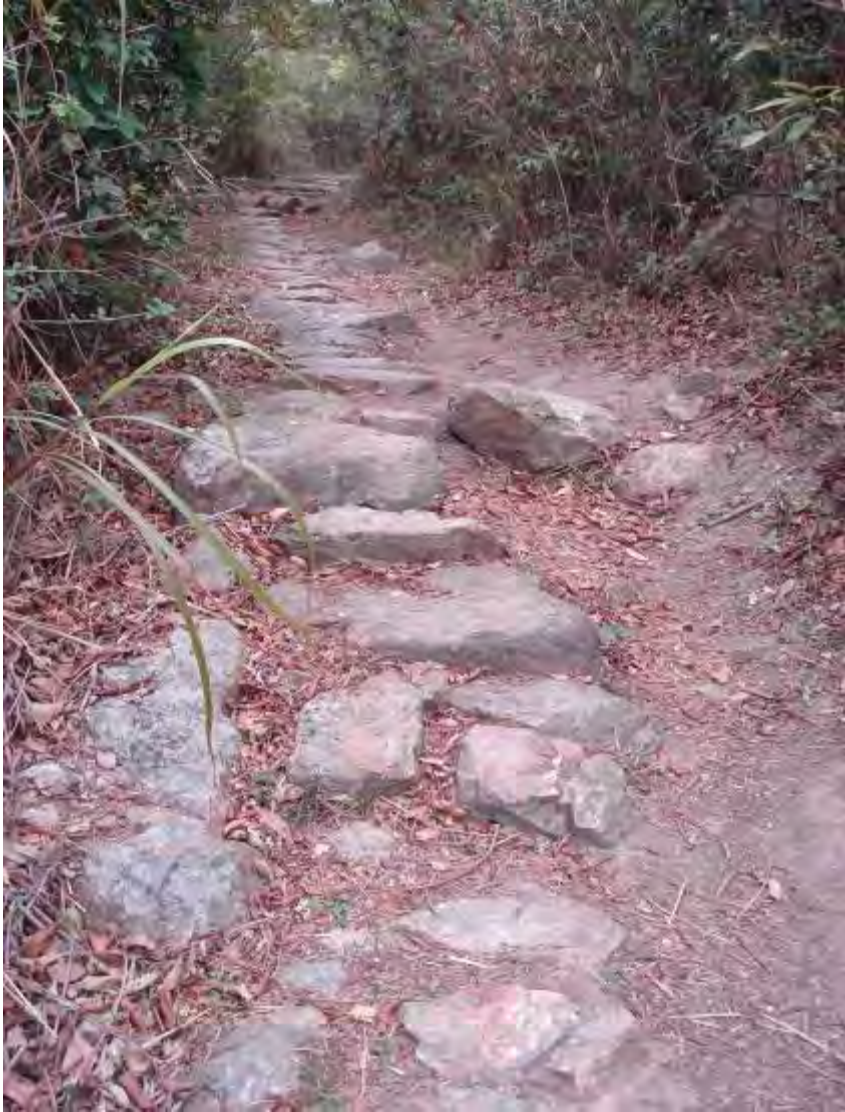
Photo Reference No.	Photographic Records	Photo Reference No.	Photographic Records
12

<p>Uphill boulder path. (View A to B)</p>		(Blank)

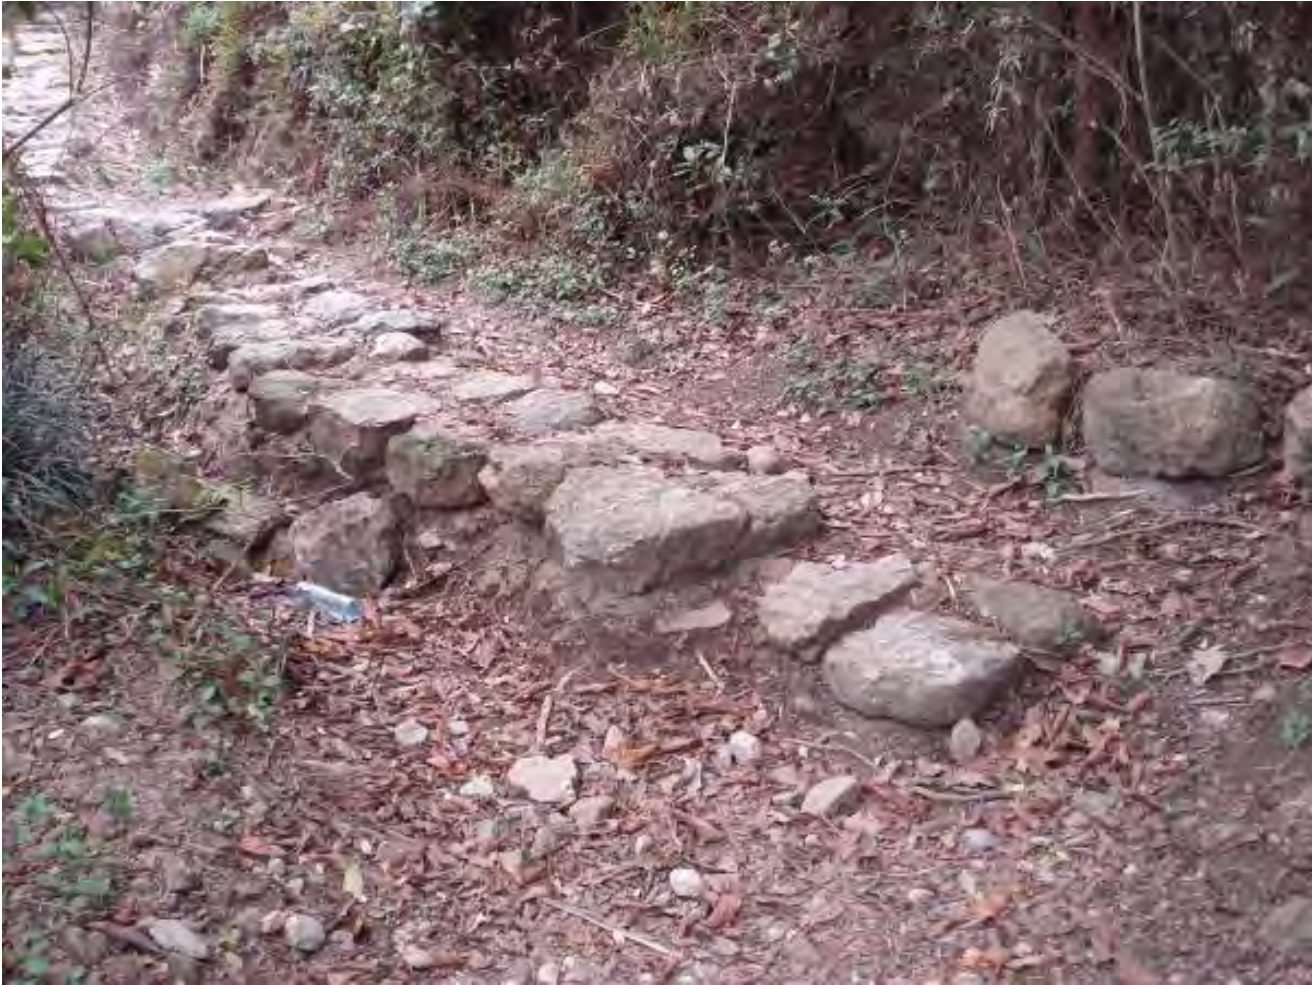
Photo Reference No.	Photographic Records
13

<p data-bbox="792 1257 1585 1294">Side view of one of the intact boulder sections. (View A to B)</p>

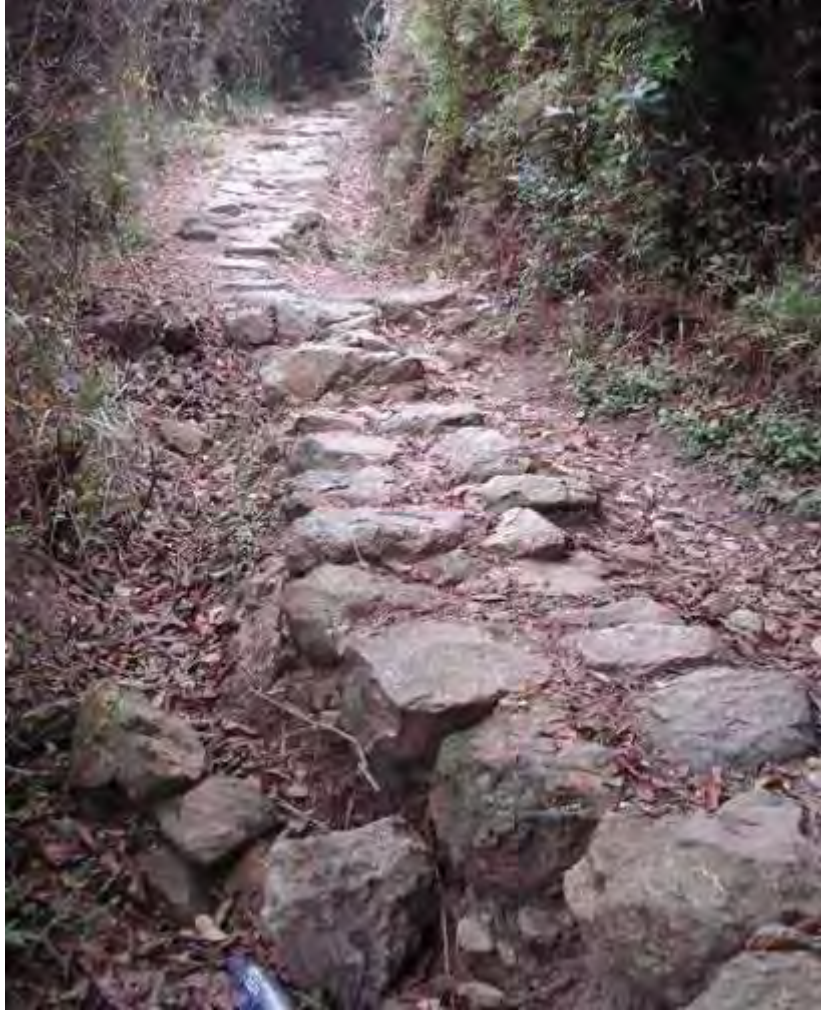
Photo Reference No.	Photographic Records	Photo Reference No.	Photographic Records
13

<p>Intact boulder section with boulders aligned in a more regular pattern. (View A to B)</p>	14

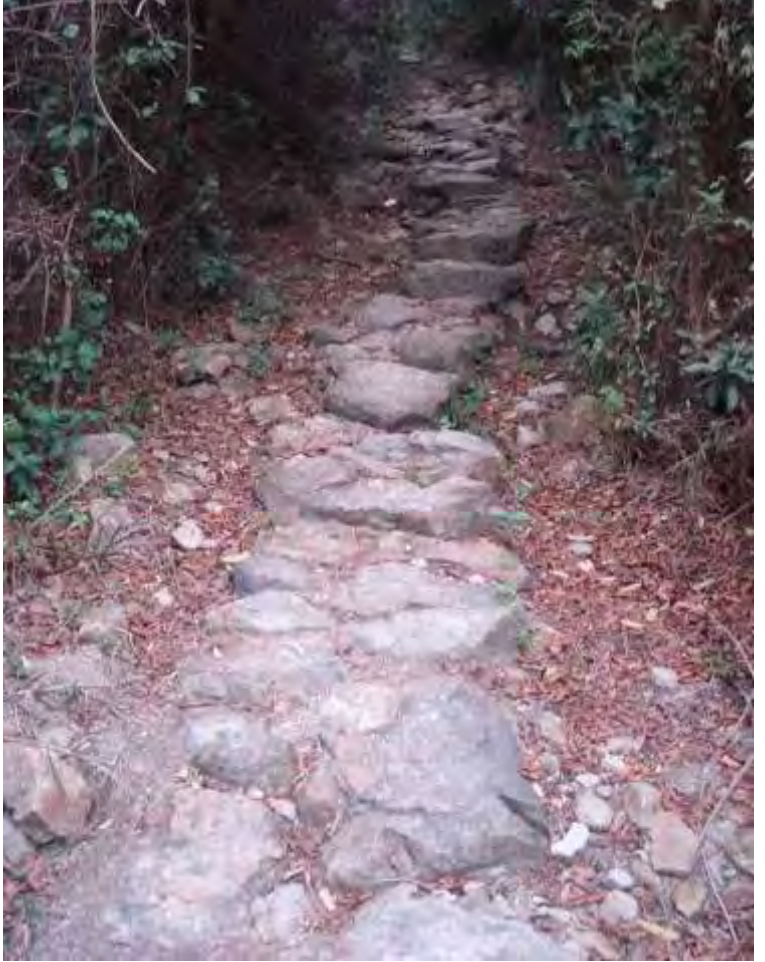
<p>Uphill path placed with boulders in a regular manner; heavily overgrown vegetation at both sides of the footpath. (View A to B)</p>

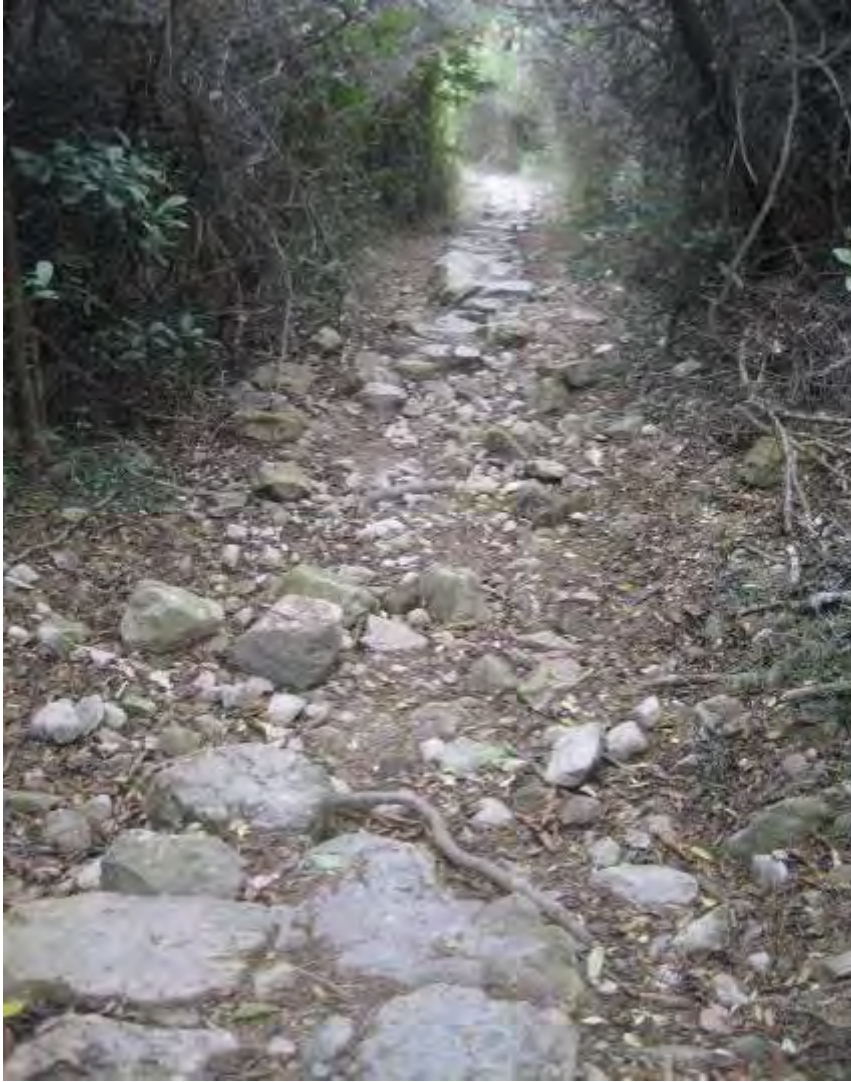
Photo Reference No.	Photographic Records	Photo Reference No.	Photographic Records
15

<p>Uphill footpath made of less regular boulders and cobbles. (View A to B)</p>		(Blank)

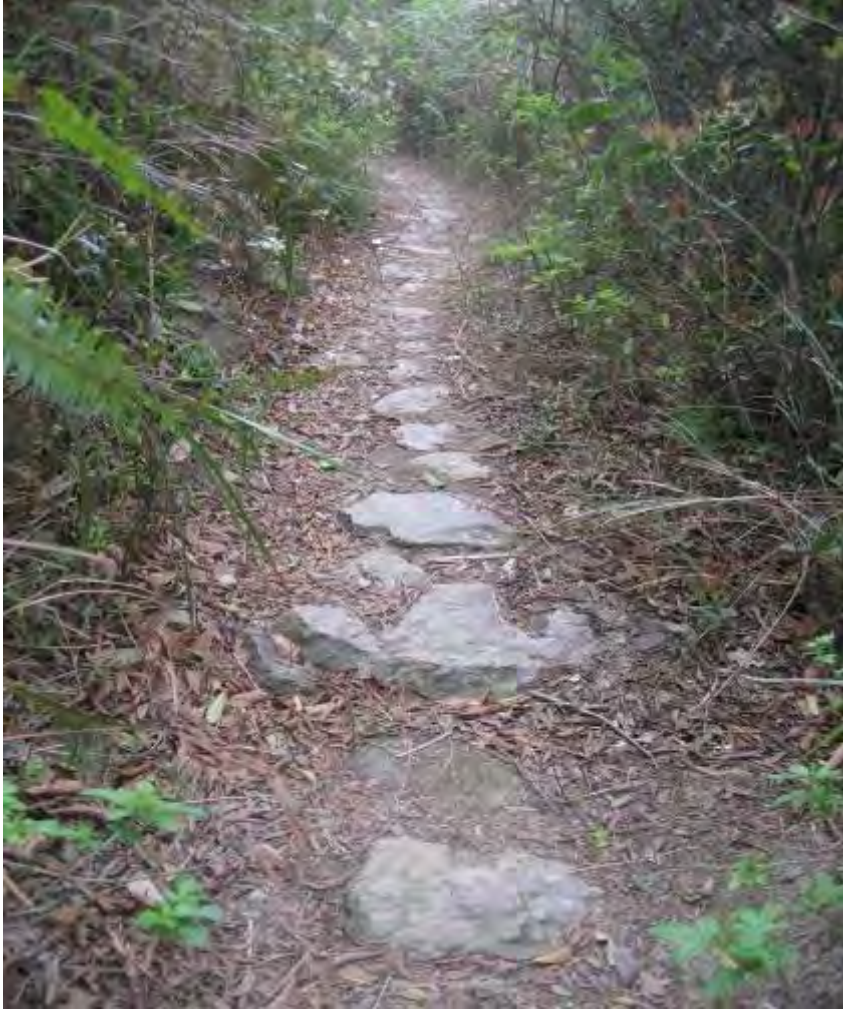
Photo Reference No.	Photographic Records	Photo Reference No.	Photographic Records
17

<p>Flat boulders aligned at the narrow footpath; overgrown vegetation at both sides of the footpath. (View A to B)</p>		(Blank)

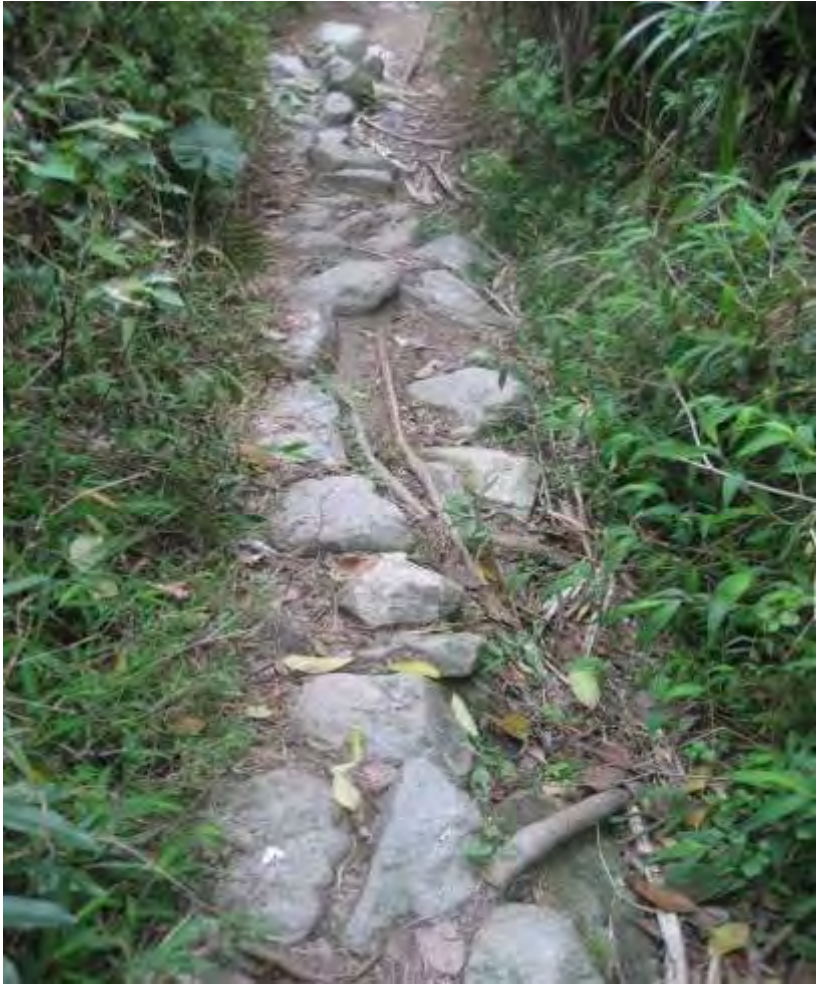
<p>Irregular boulders with occasional tree roots and fallen leaves. (View A to B)</p>

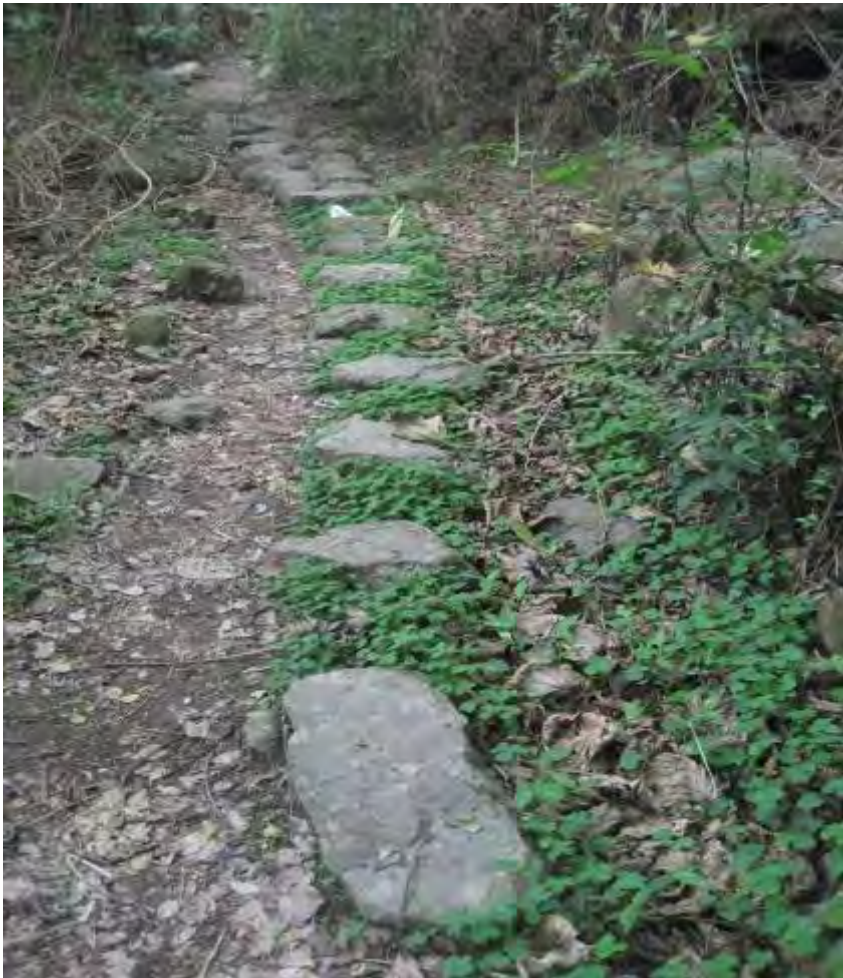
Photo Reference No.	Photographic Records	Photo Reference No.	Photographic Records
27

<p>Boulder slabs arranged in a line with vegetation overgrown in between the boulders. (View A to B)</p>	F2	  <p>A ruined village house hidden behind the overgrown vegetation in Yi O Kau Tsuen.</p>

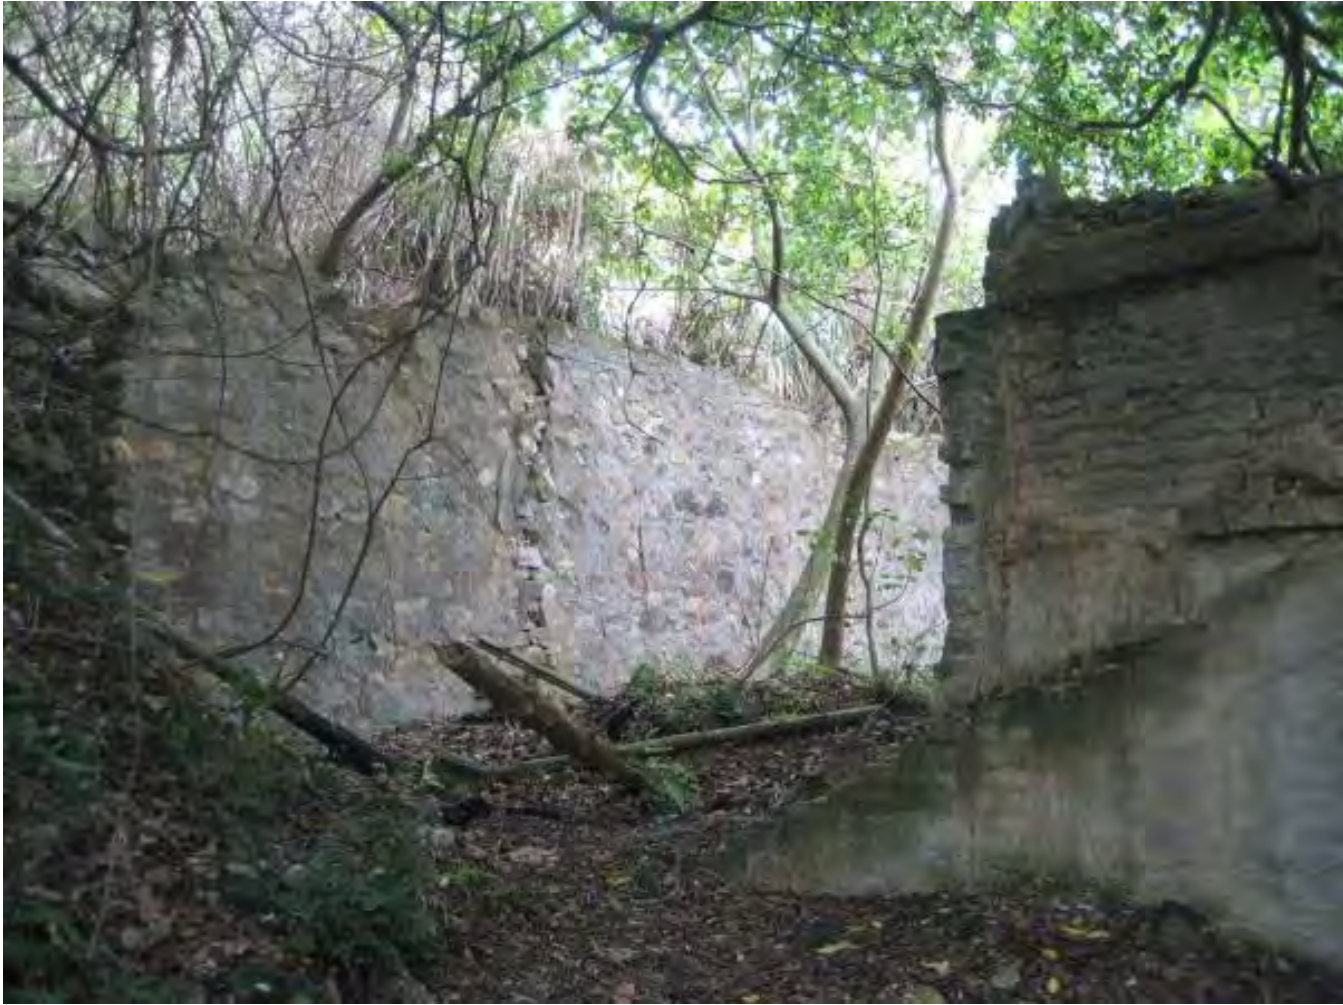
Photo Reference No.	Photographic Records
F2

<p data-bbox="555 1289 1850 1329">This ruined village house has its roof collapsed and been invaded by heavily overgrown vegetation.</p>

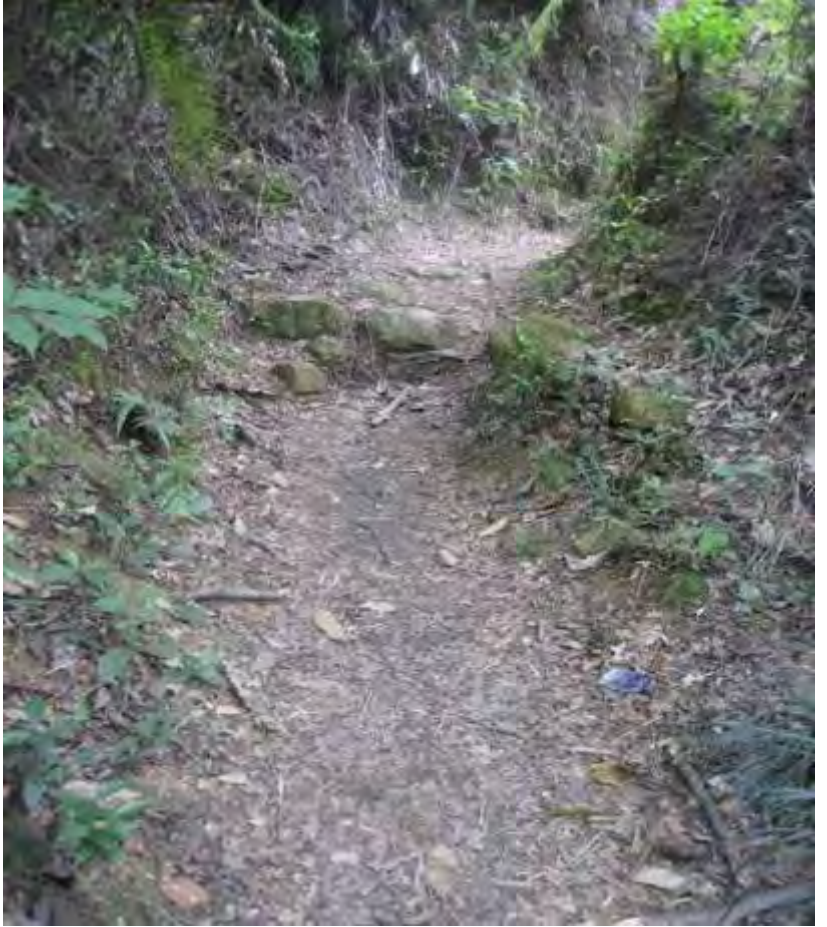
<p>Mud section with a few steps made of boulders. (View A to B)</p>

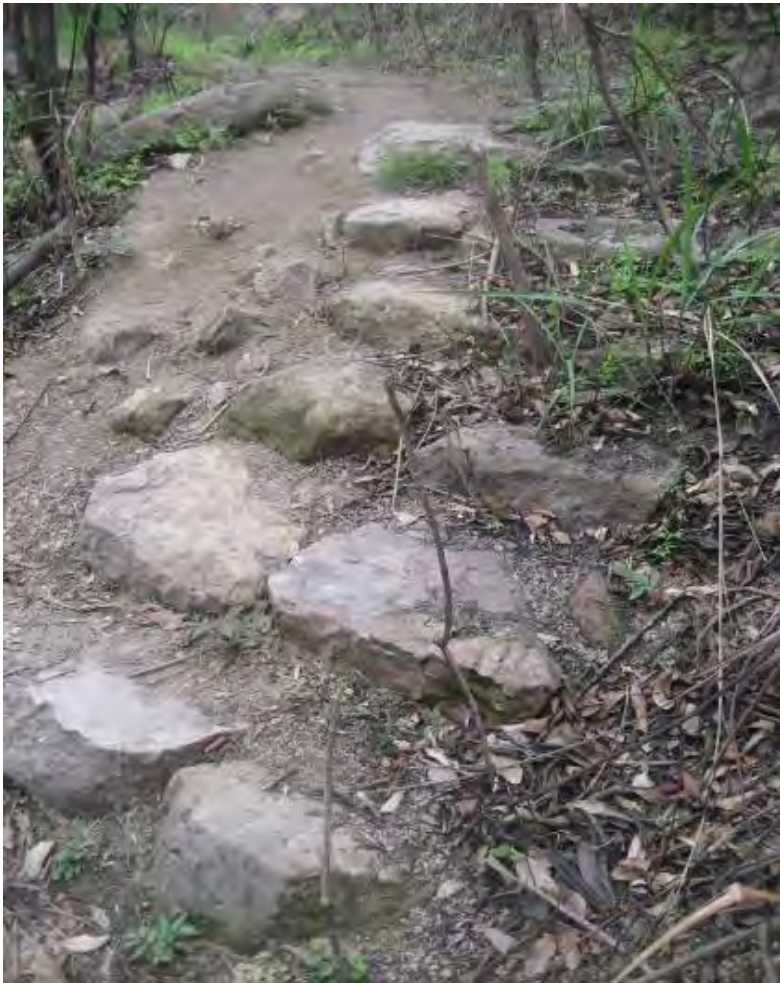
Photo Reference No.	Photographic Records	Photo Reference No.	Photographic Records
33

<p>Mud section with occasional boulder steps. (View A to B)</p>	B

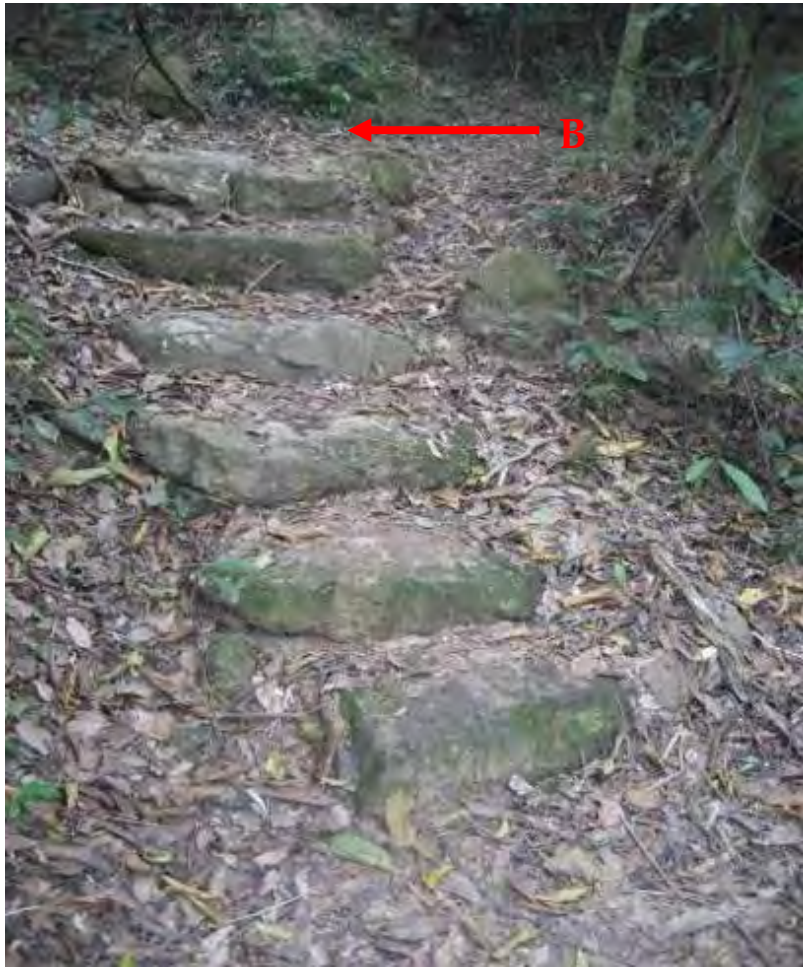
<p>Mud section with occasional boulder steps. End of which indicating the ending point of the footpath.</p>

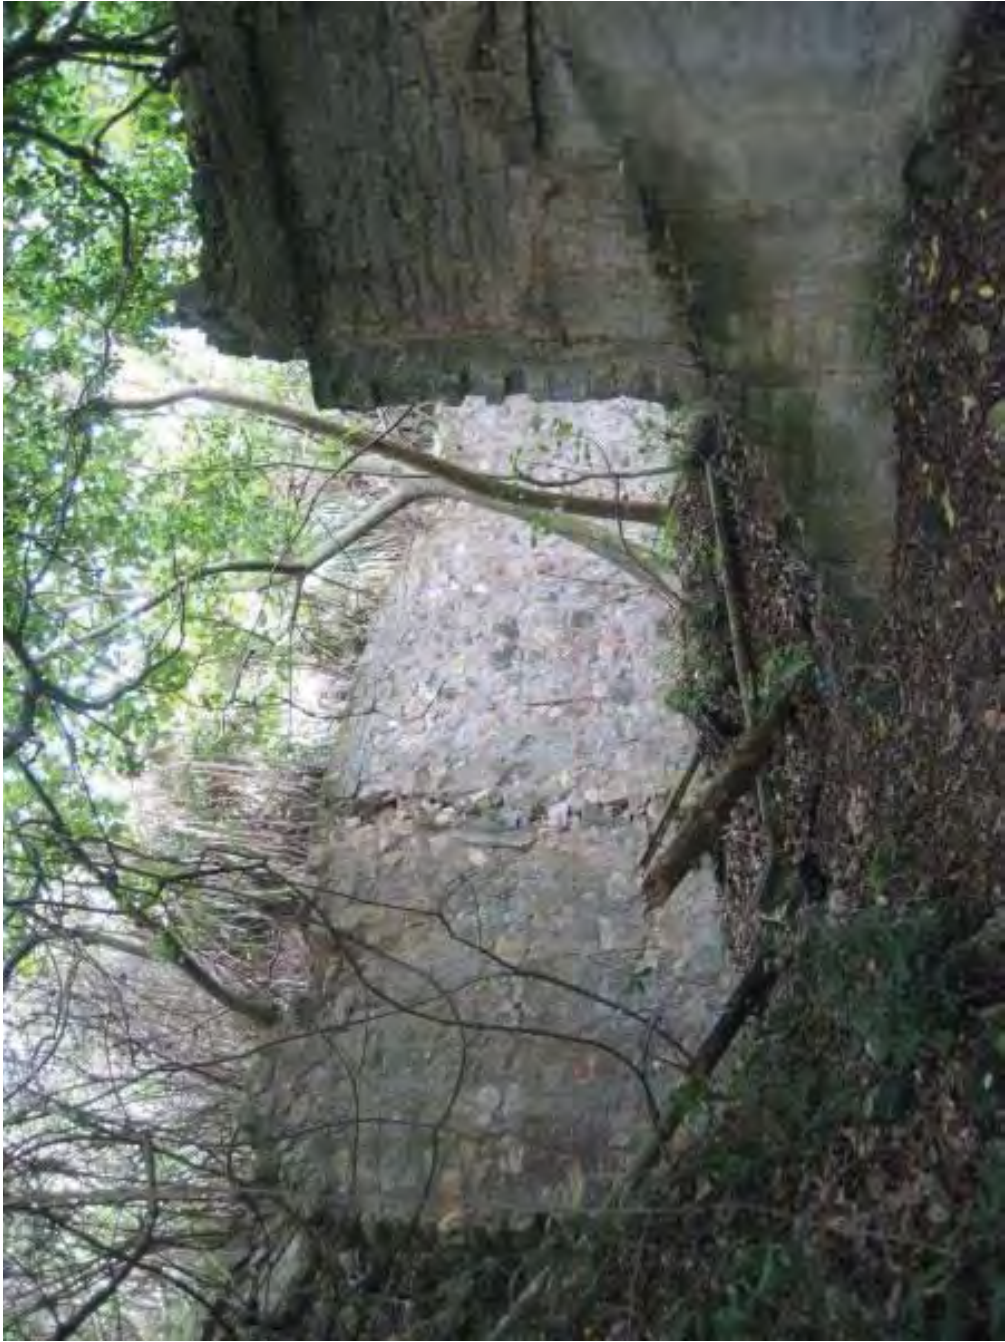
Photo Reference No.	Photographic Records
F2

<p data-bbox="1291 389 1326 1682">This ruined village house has its roof collapsed and been invaded by heavily overgrown vegetation.</p>

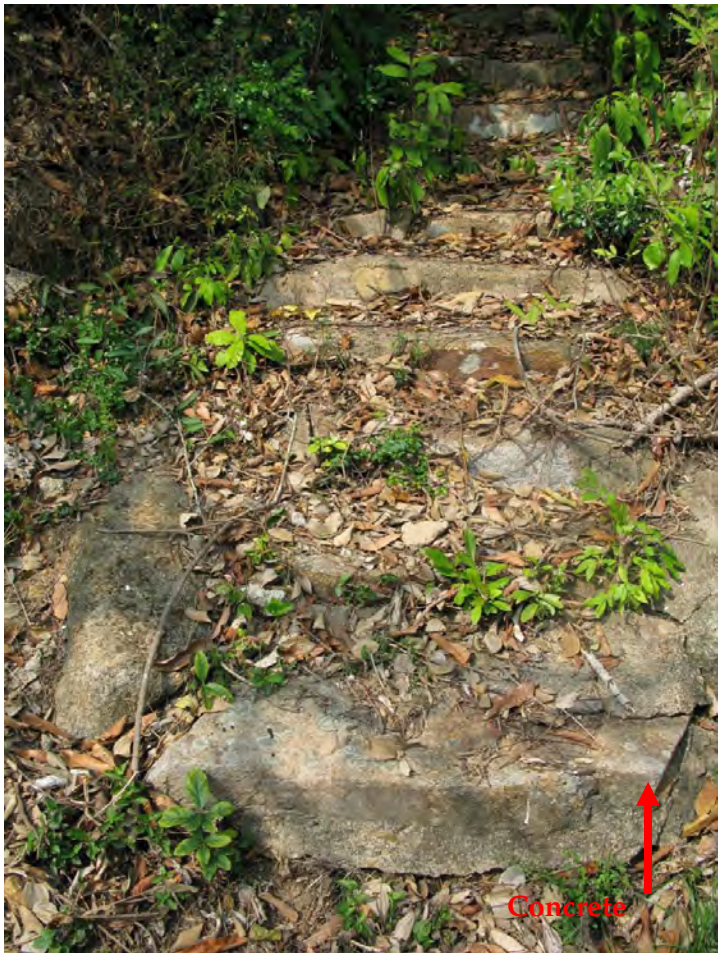
Photo Reference No.	Photographic Records	Photo Reference No.	Photographic Records
1

<p>Boulder steps with signs of concrete repairs. (View A to B)</p>	2

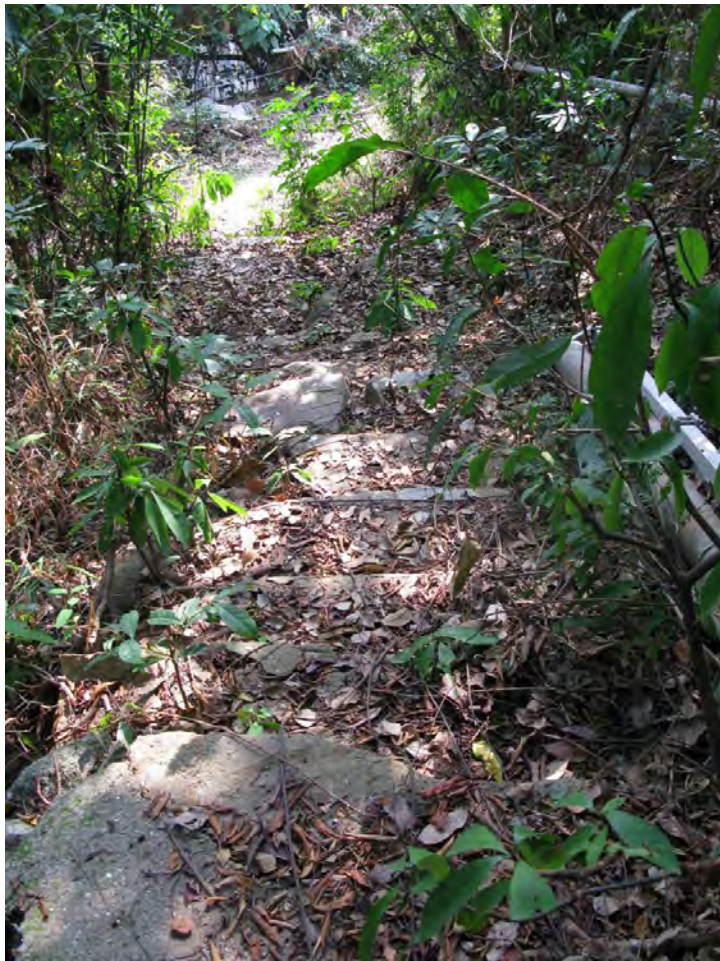
<p>Boulder steps with signs of concrete repairs. (View B to A)</p>

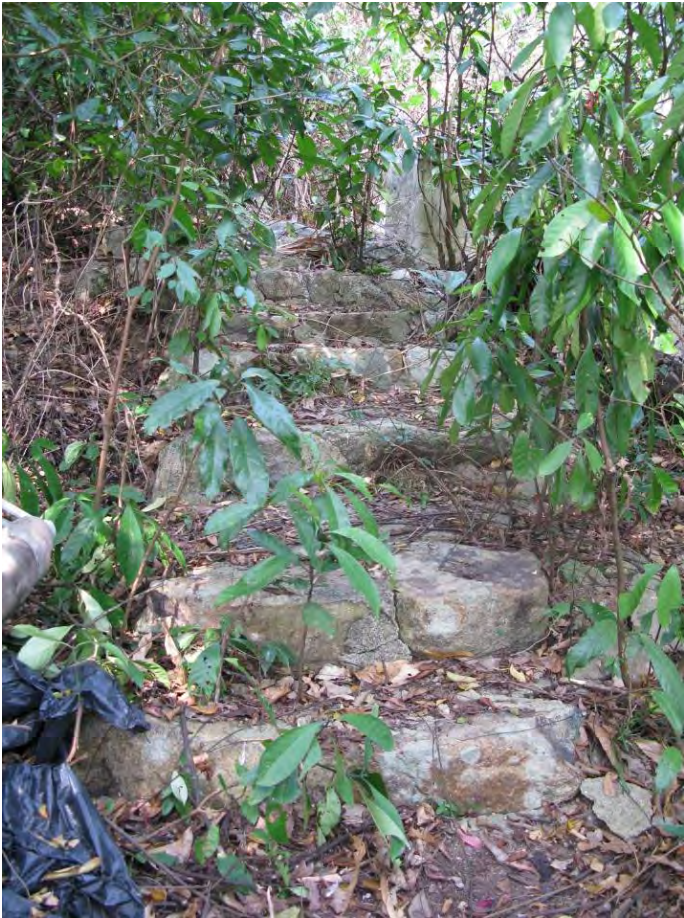
<p>Boulder steps with signs of concrete repairs. (View B to A)</p>	4
