Antiquities and Monuments Office

Study on Old Trails in Hong Kong - Final Study Report

February 2014

Study on Old Trails in Hong Kong: *Final Study Report*

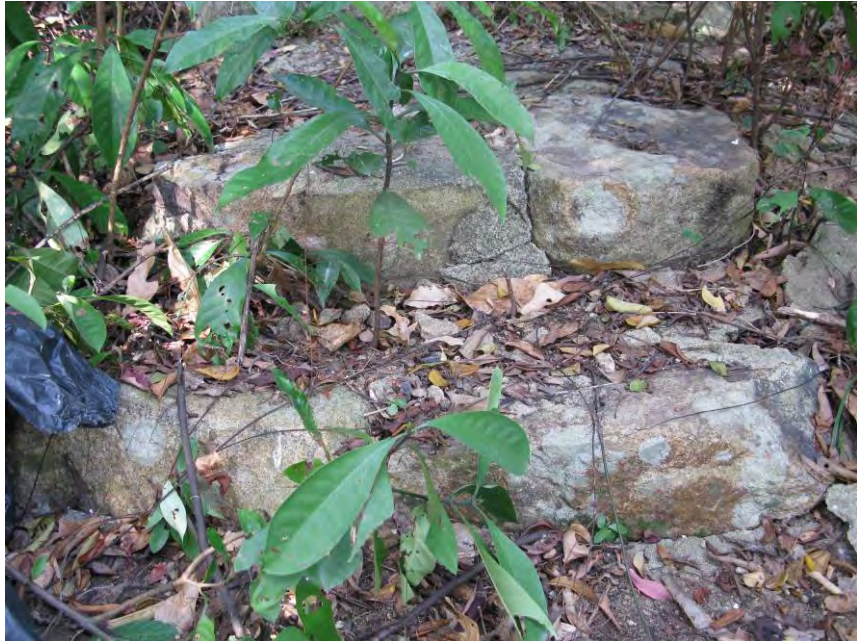
<p>Close up view of Boulder steps. (View B to A)</p>

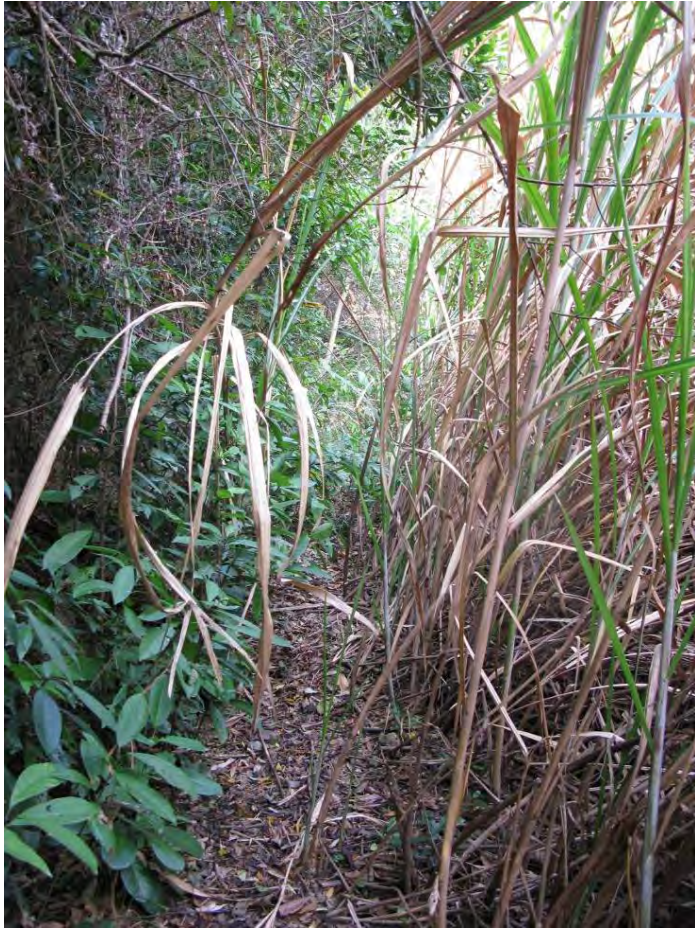
<p>Mud section covered with dry leaves. (View A to B)</p>	6

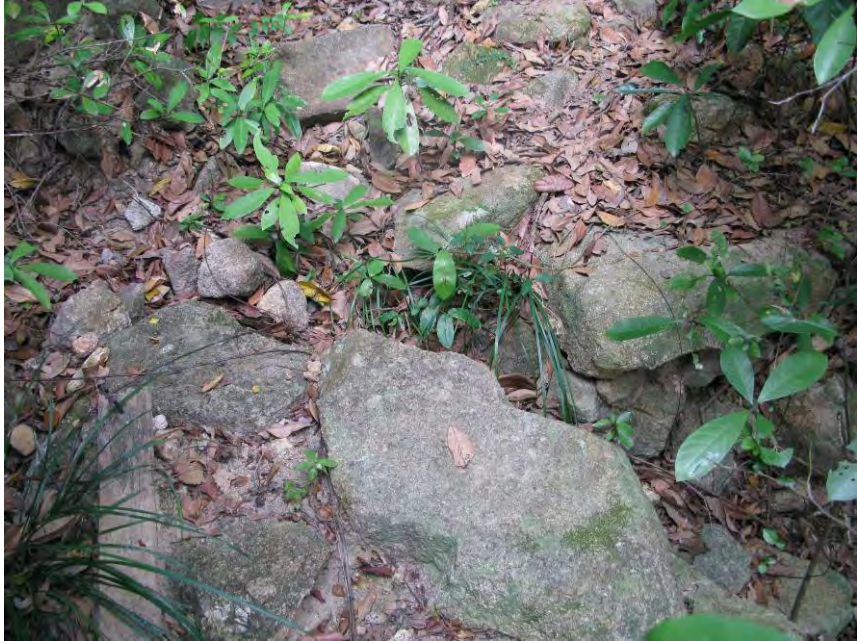
<p>Boulder drains across the footpath. (View A to B)</p>

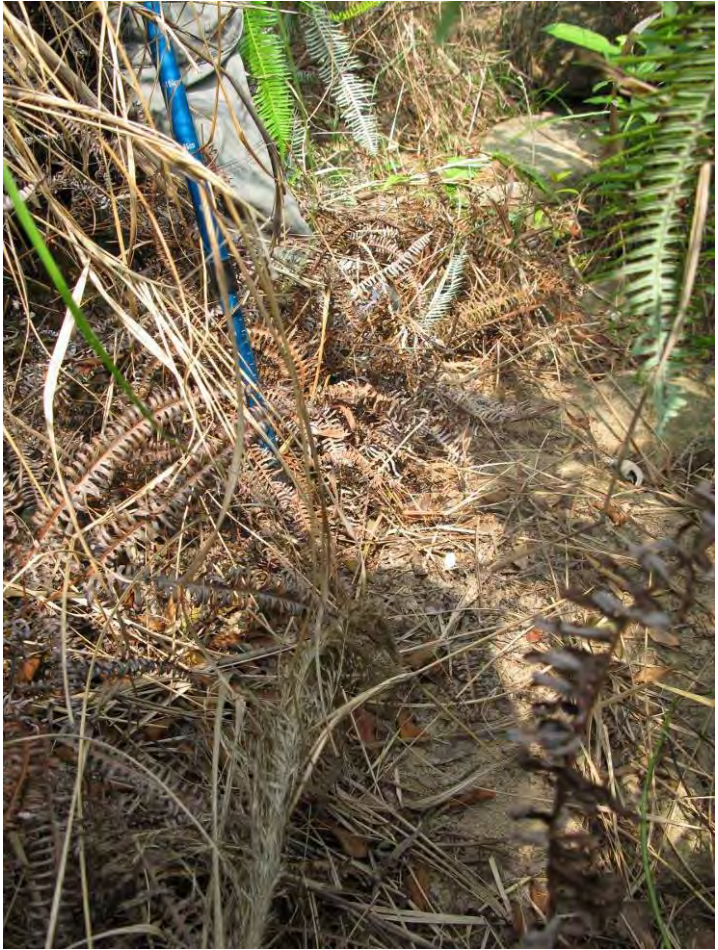
<p>Boulder section mostly covered by dry grass/leaves. (View A to B)</p>

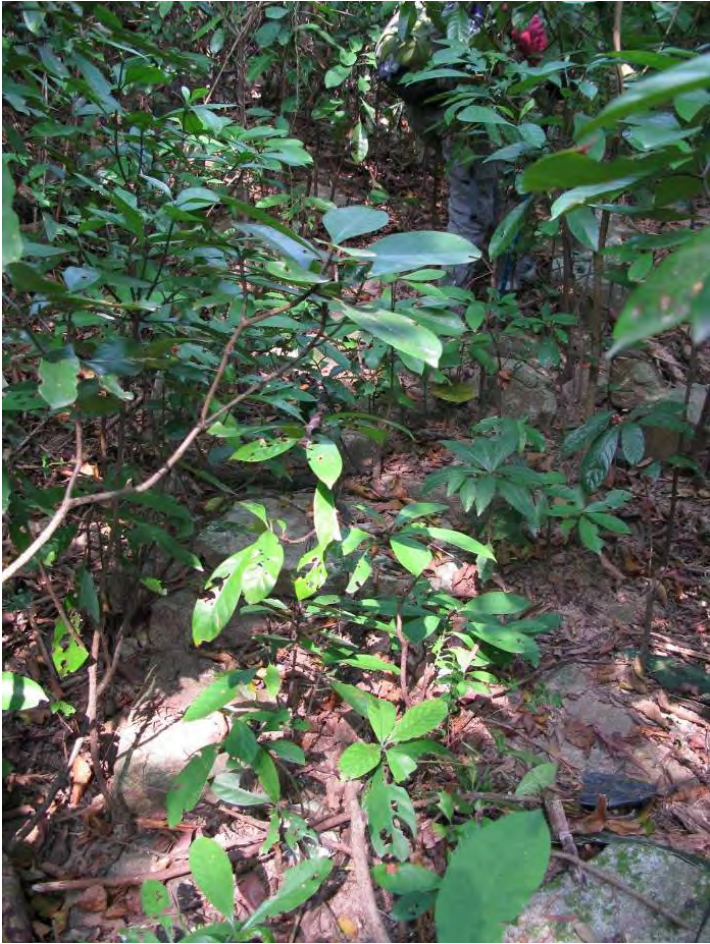
<p>Boulder section with vegetation growing around the boulders. (View A to B)</p>		(Blank)

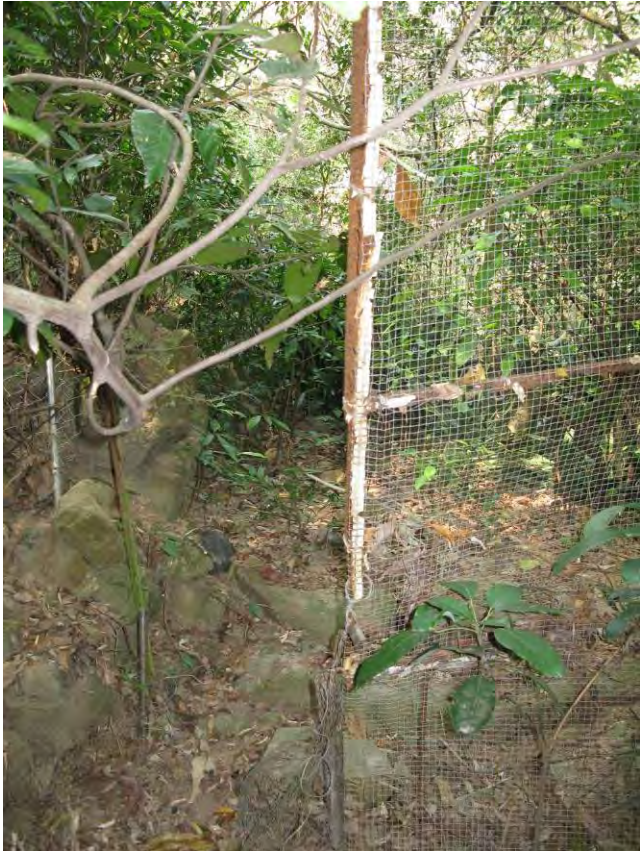
<p>Boulder section end at a broken gate. (View A to B)</p>		(Blank)

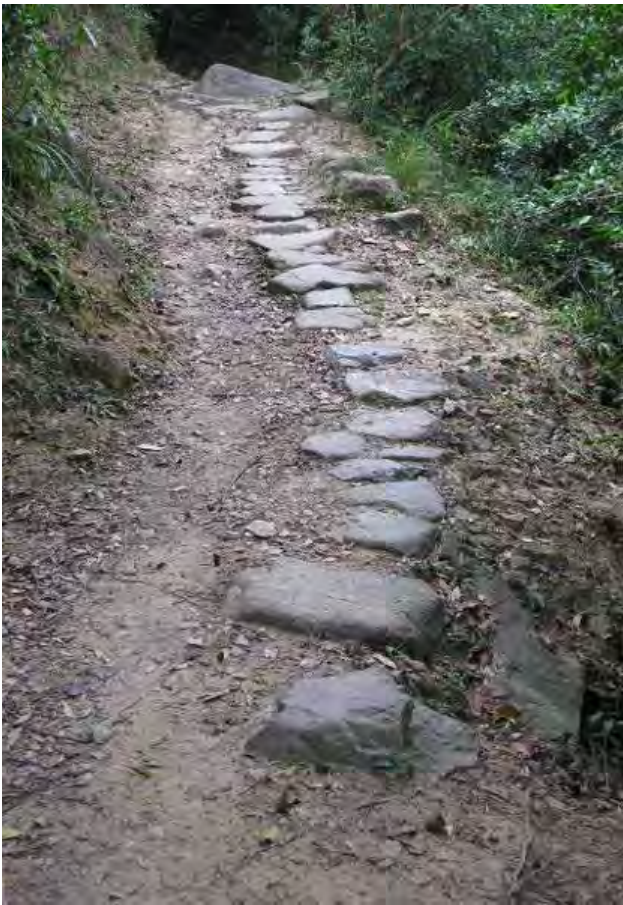
<p data-bbox="579 1955 1393 2033">Occasionally identified short boulder path along mud section. (View B to A)</p>

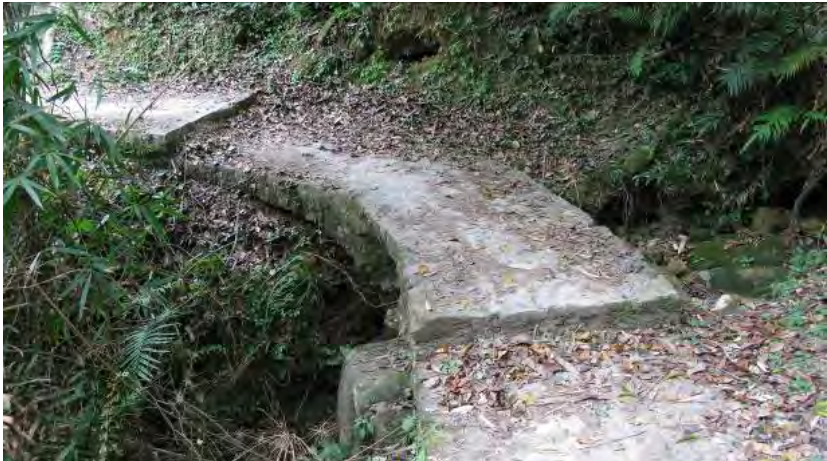
<p data-bbox="560 763 1414 837">Granite slabs built stream crossing surfaced with concrete. (View A to B)</p>
3

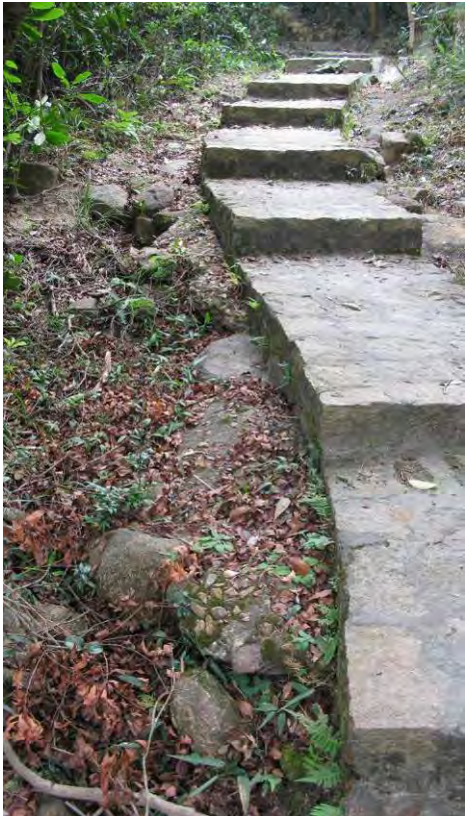
<p data-bbox="571 1120 1401 1193">Possible alignment of the boulder path beneath reworked path. (View from A to B).</p>
5

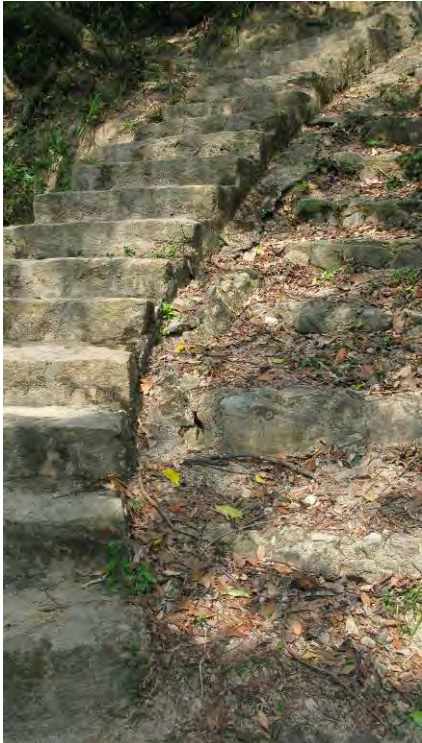
<p data-bbox="579 1995 1393 2069">Possible alignment of the boulder path next to reworked path. (View from B to A).</p>

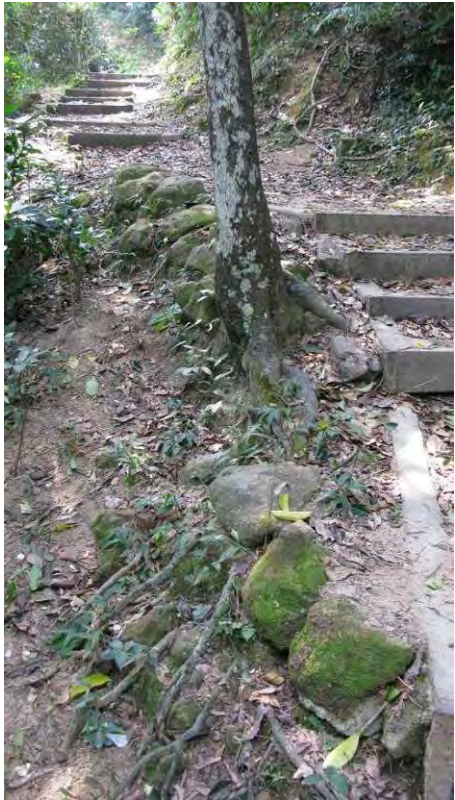
<p data-bbox="571 2000 1401 2076">Possible alignment of the boulder path beneath reworked steps along the mud surfaced section. (View from A to B).</p>

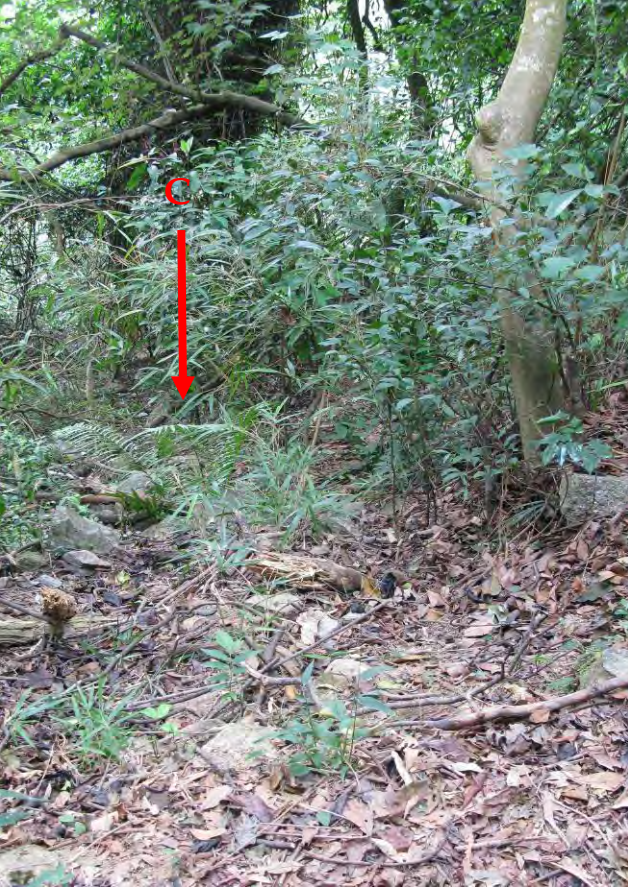
<p data-bbox="676 1727 1297 1760">Location C (blocked by overgrown vegetation).</p>

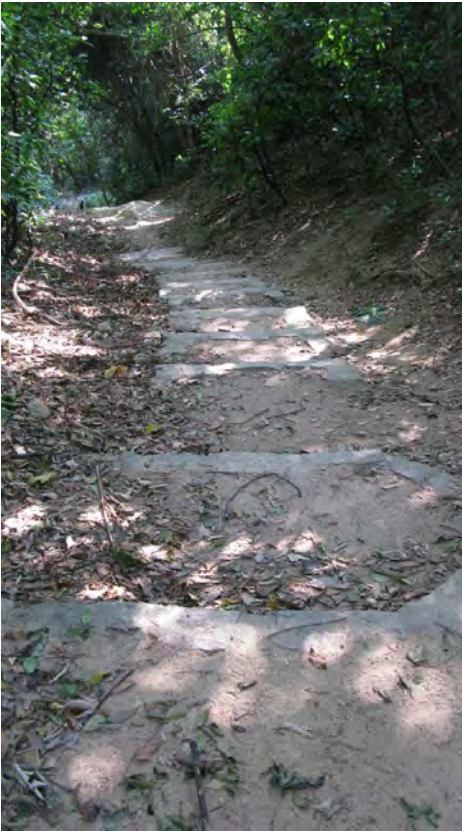
<p data-bbox="686 2036 1284 2069">Typical view of reworked path. (View C to D)</p>

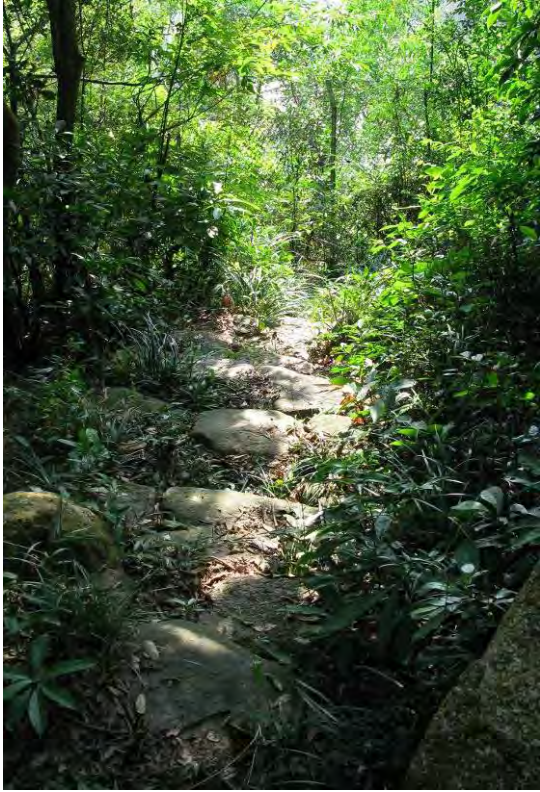
<p data-bbox="592 1093 1380 1128">Boulder path and a dead end with fence. (View from A to B)</p>
D

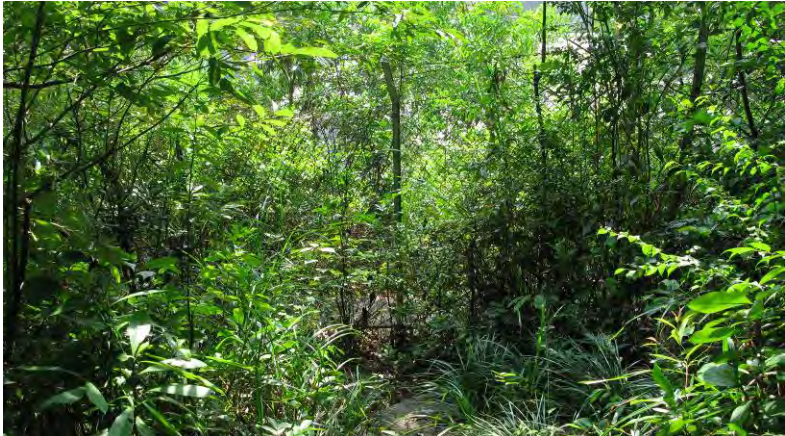
<p data-bbox="584 1621 1388 1697">Location D showing a dead end blocked by a fence at top of a modified slope.</p>

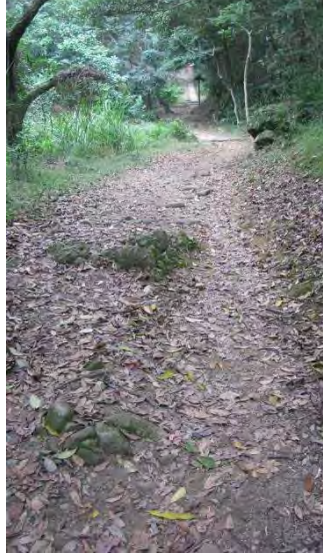
<p data-bbox="560 2011 1453 2045">Typical mud section and reworked section at top end. (View A to B)</p>

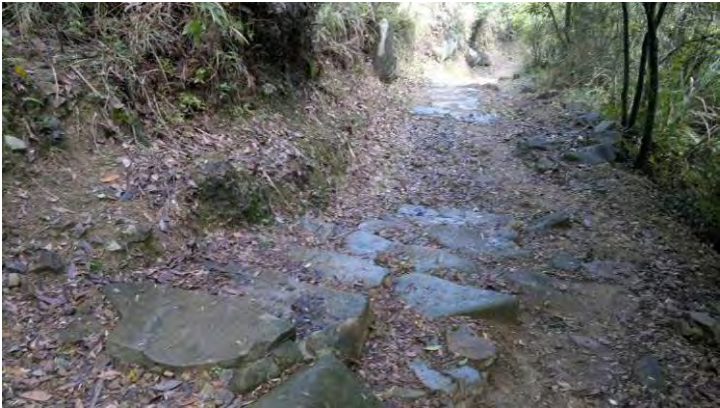
<p data-bbox="568 779 1445 853">Boulder path with occasional mud surface section. (View from B to A)</p>
3

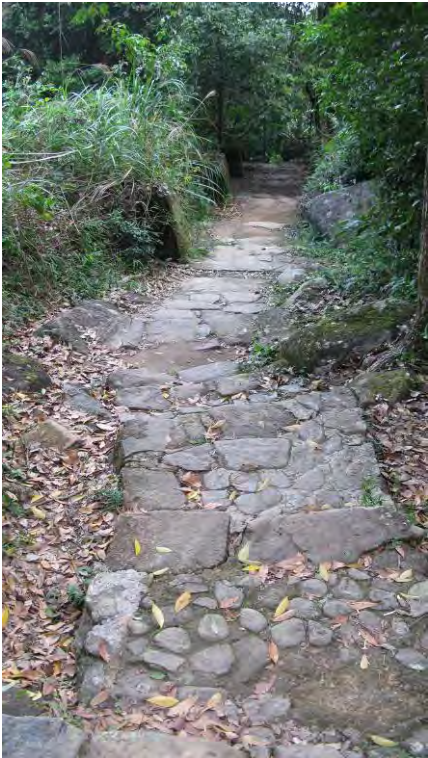
<p data-bbox="612 1128 1398 1162">Boulder path with modern modification. (View from A to B)</p>
5

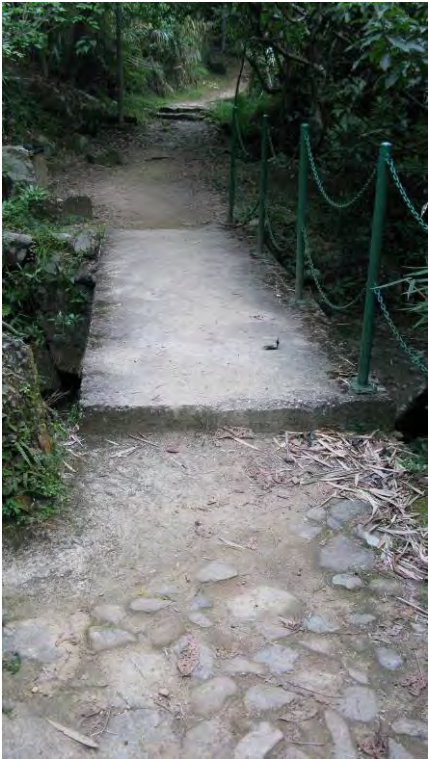
Photo Reference No.	Photographic Records
6

<p data-bbox="616 1128 1394 1164">Concrete bridge along the boulder path. (View from B to A)</p>
7

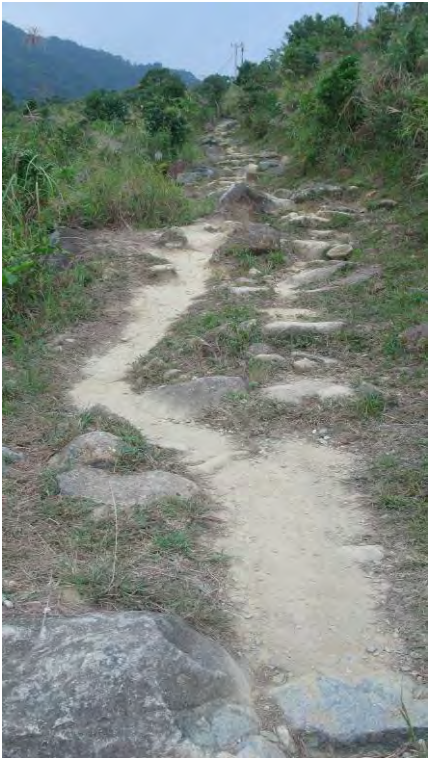
Photo Reference No.	Photographic Records
8

<p data-bbox="587 1128 1422 1205">Deteriorated boulder path with occasional mud surface section. (View from B to A)</p>
9

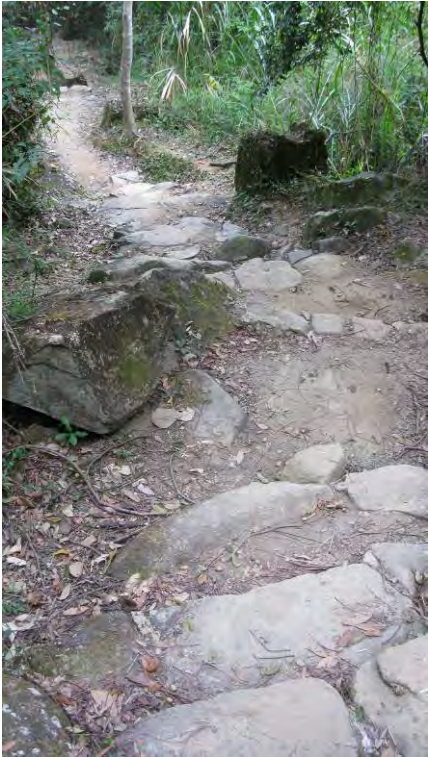
<p data-bbox="676 2018 1335 2094">Boulder path with occasional mud surface section. (View from A to B)</p>

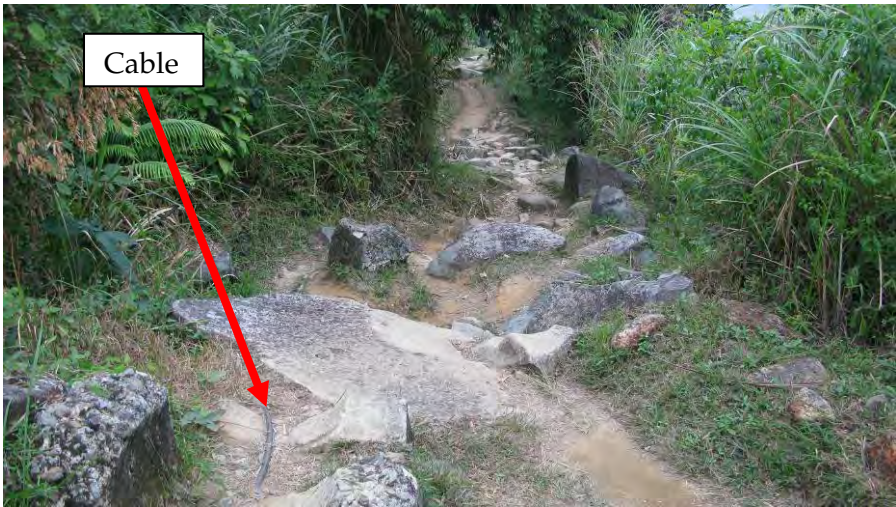
Photo Reference No.	Photographic Records
10

<p data-bbox="564 875 1445 909">Deteriorated boulder path with cable intrusion. (View from B to A)</p>
11

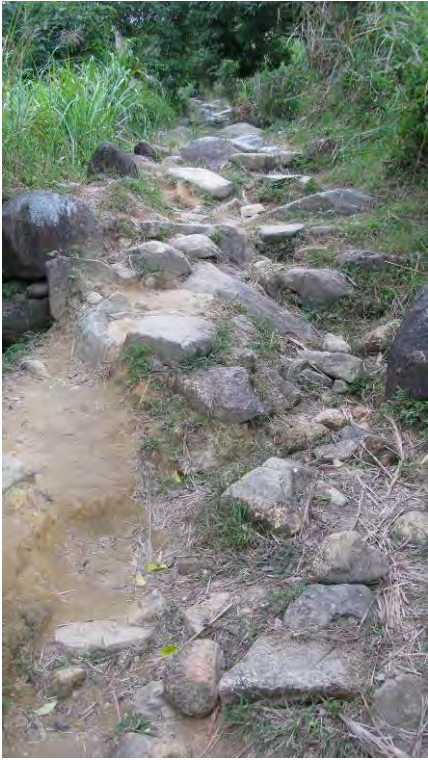
<p data-bbox="703 1727 1308 1760">Deteriorated boulder path. (View from B to A)</p>

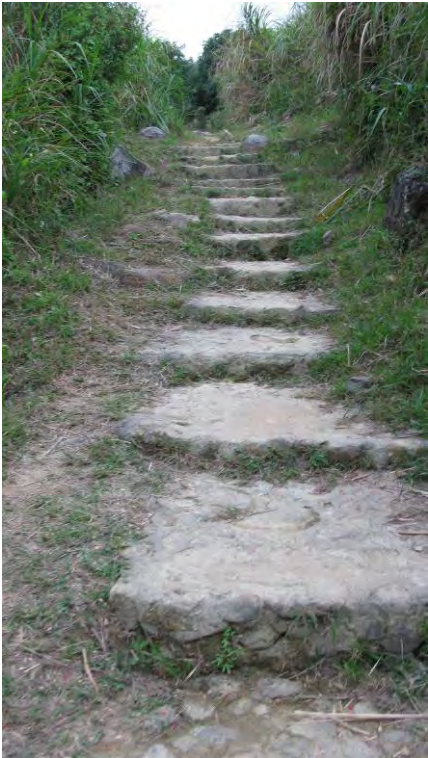
Photo Reference No.	Photographic Records
12

<p data-bbox="563 1128 1449 1164">Boulder section with occasional reworked path. (View from B to A)</p>
13

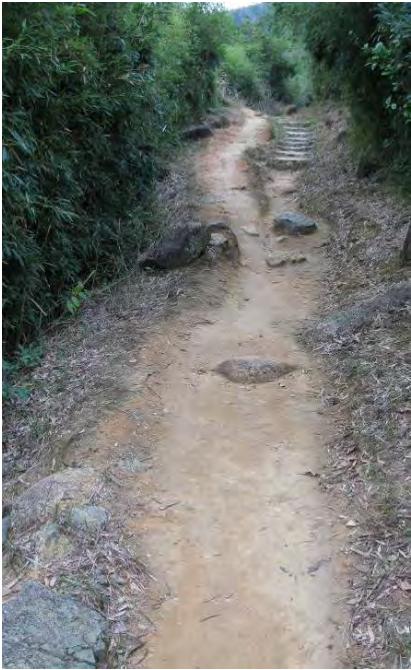
<p data-bbox="596 1532 1414 1565">Mud section with occasional boulder path. (View from B to A)</p>
16

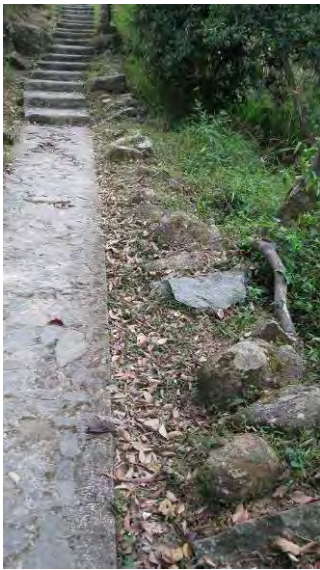
Photo Reference No.	Photographic Records
17

<p data-bbox="555 936 1455 1010">Signs of boulder path next to modern concrete path. (View from B to A)</p>
18

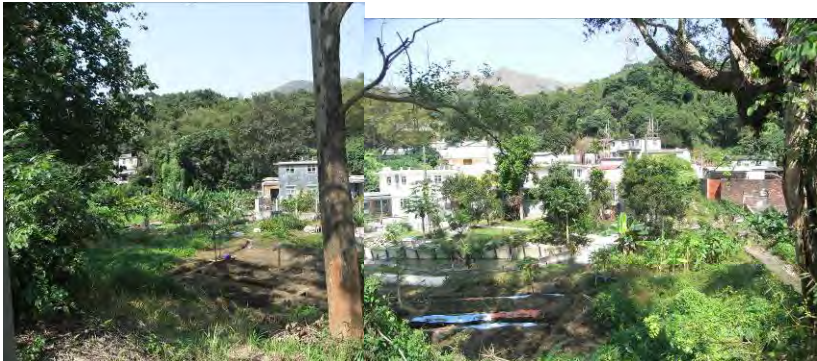
Photo Reference No.	Photographic Records
4

<p data-bbox="566 734 1386 801">General view of village houses blocking the original path (view south to north)</p>
5

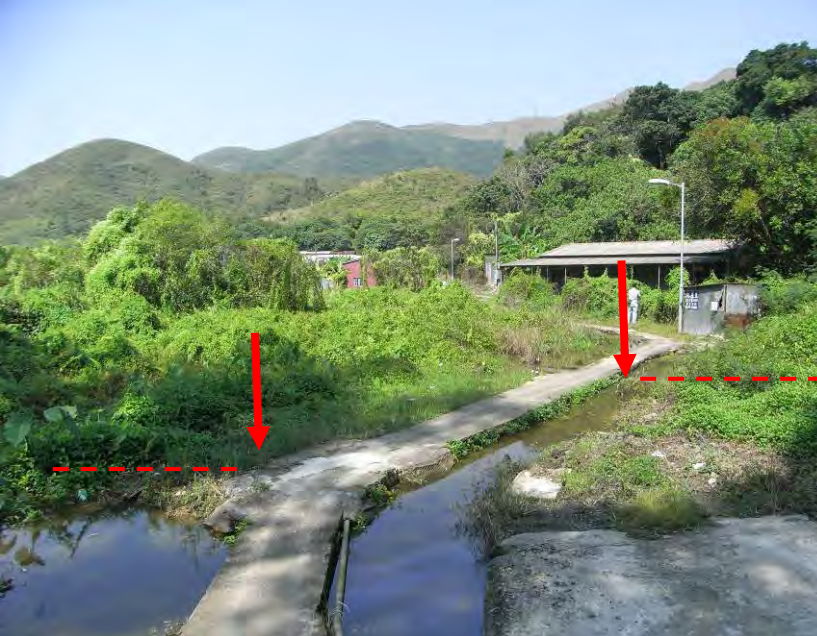
<p data-bbox="566 1507 1386 1619">Typical concreted village path, east-west paths blocked by thick vegetation (see junction to the east-west paths in red arrow) (view A to B)</p>

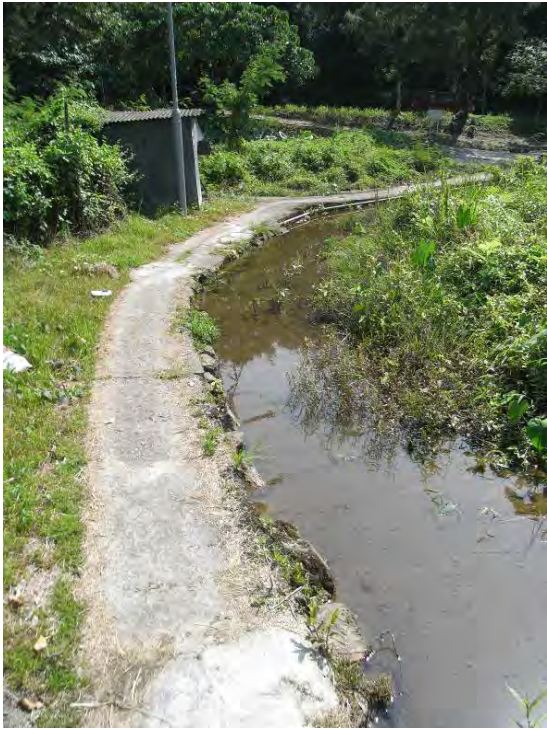
Photo Reference No.	Photographic Records
6

<p data-bbox="571 1099 1385 1173">Reworked concrete path with original boulder paving beneath it. (View A to B)</p>
7

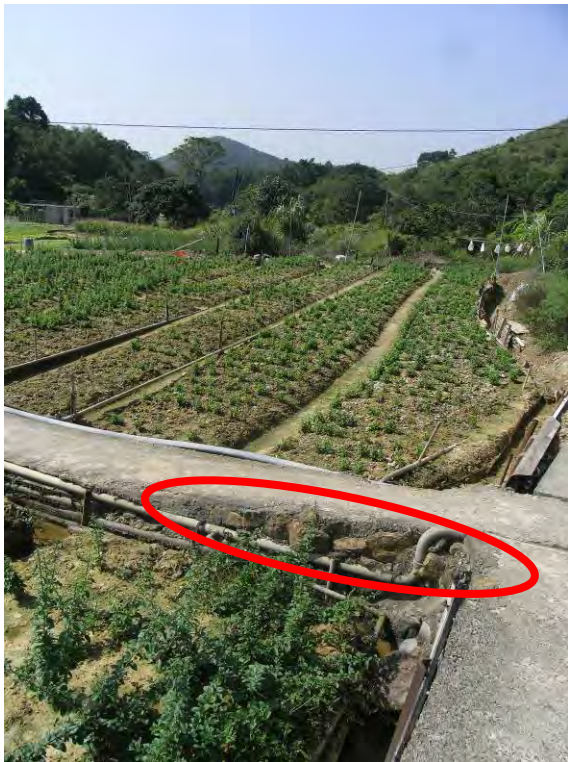
<p data-bbox="592 1865 1362 1944">Reworked concrete path showing signs of boulders paving underneath (view A to B).</p>

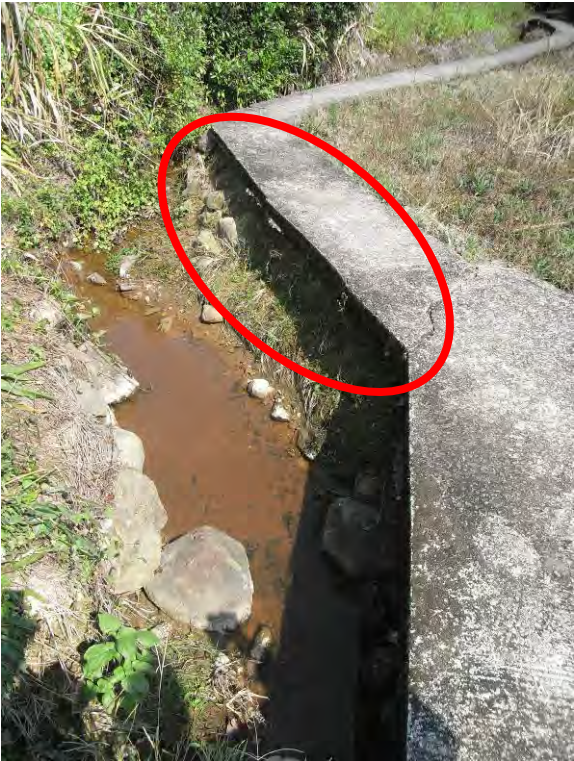
Photo Reference No.	Photographic Records
14

<p data-bbox="619 1128 1337 1205">Concreted path leading to Wo Hang showing boulders underneath (view B to A).</p>
15

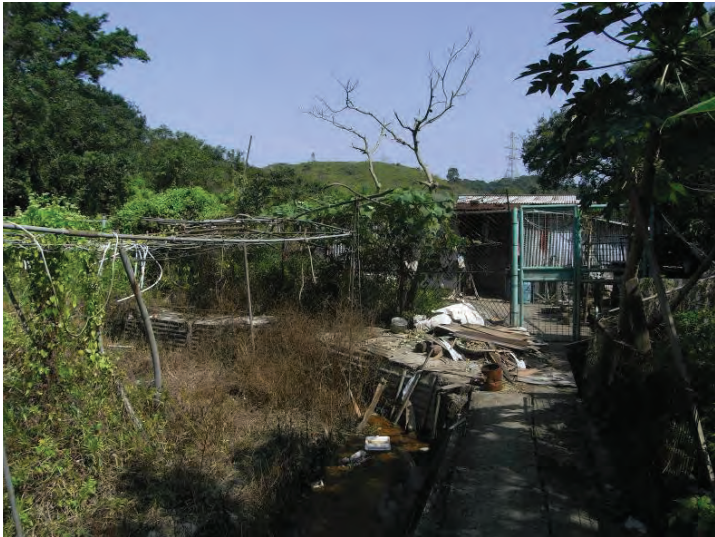
Photo Reference No.	Photographic Records
16

<p data-bbox="597 884 1360 953">Blocking of village path leading to Wo Hang village (view B to A).</p>
B

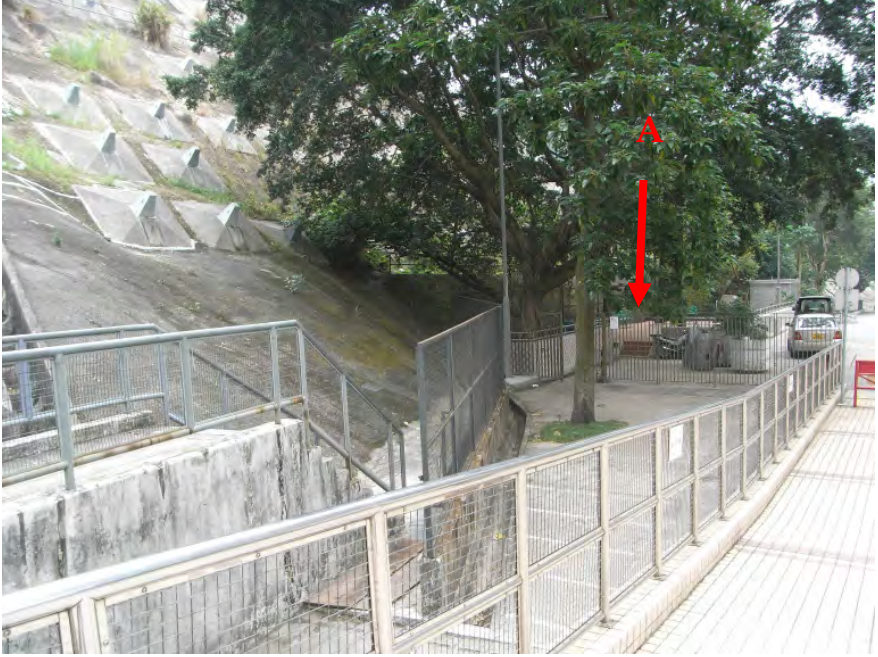
Photo Reference No.	Photographic Records
A

<p data-bbox="756 1133 1241 1167">Point A, entrance to the old footpath.</p>
1

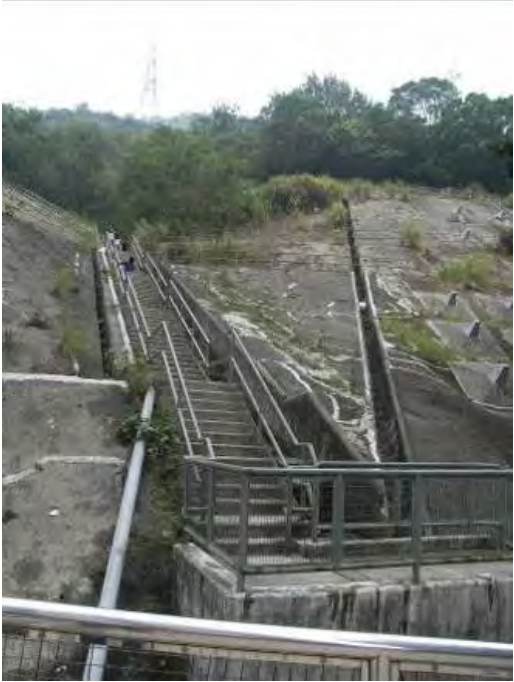
<p data-bbox="560 1906 1441 1973">Starting Point A and steps along modern retaining wall. (View A to B)</p>

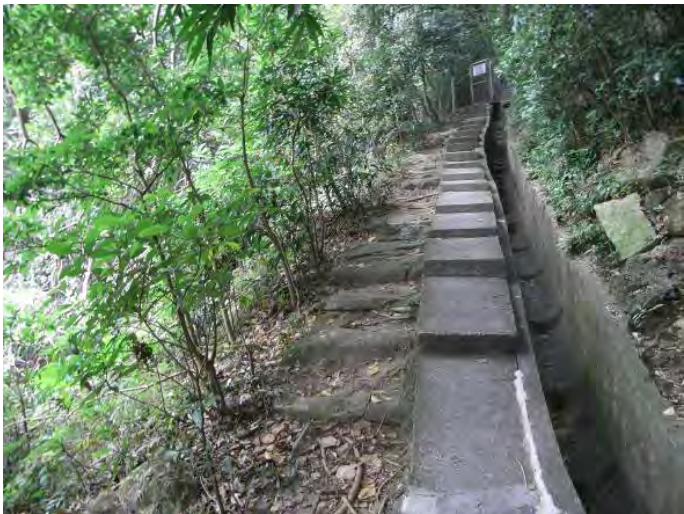
<p data-bbox="560 887 1437 958">Boulder path that partly covered with thin cement next to concrete steps. (View A to B)</p>
3

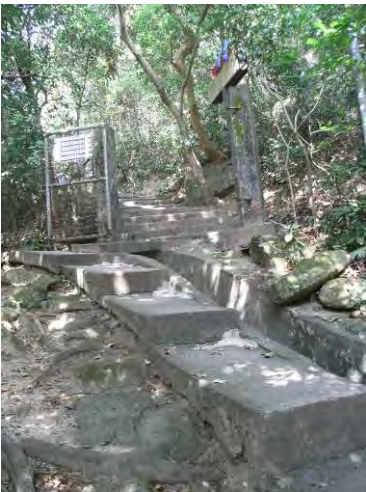
<p data-bbox="576 1509 1422 1581">Alignment of the boulder path linking to Kwan Yam temple was cut by concrete path and a surface drain.</p>

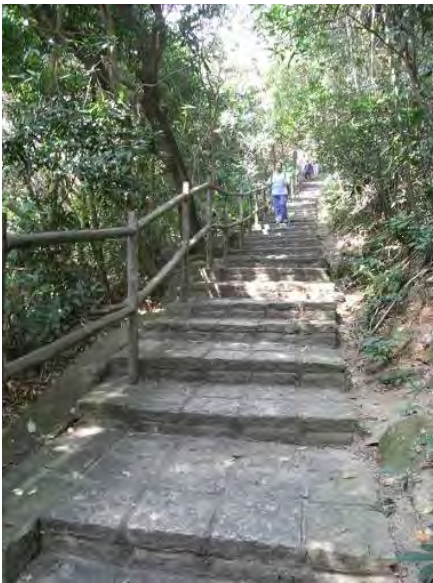
<p data-bbox="718 952 1276 985">Typical reworked path. (View from A to B)</p>
5

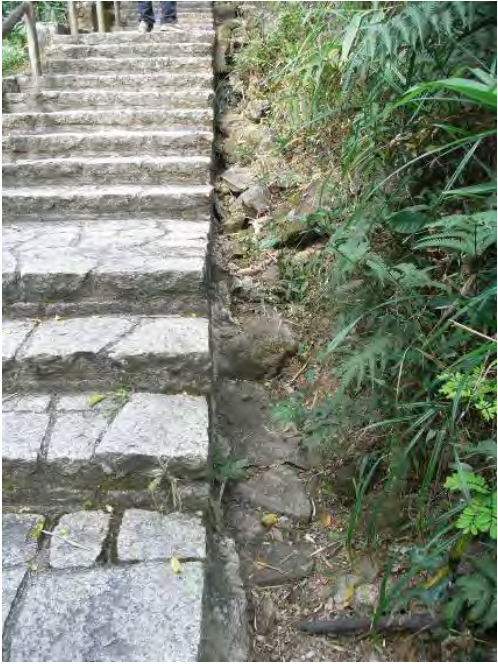
<p data-bbox="576 1630 1422 1668">Boulder path by/beneath the reworked path. (View from A to B)</p>

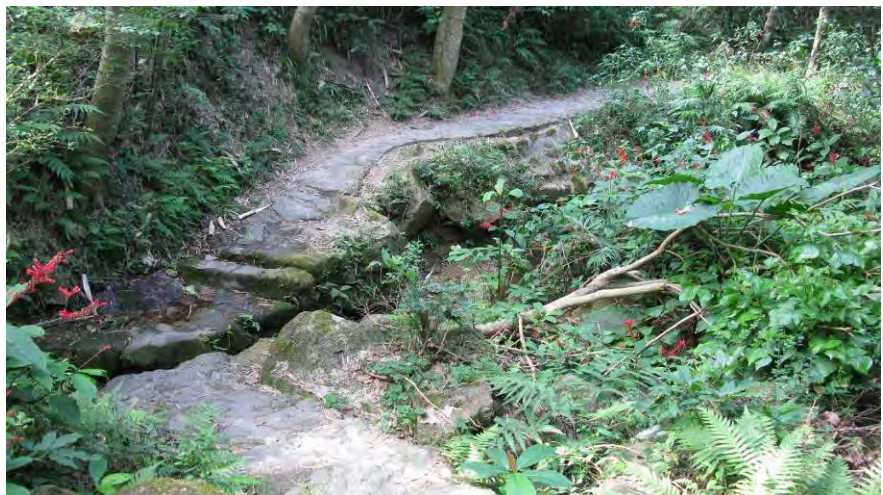
<p data-bbox="563 1494 1436 1568">Profile of the boulder path with reworked surface. (View from B to A).</p>

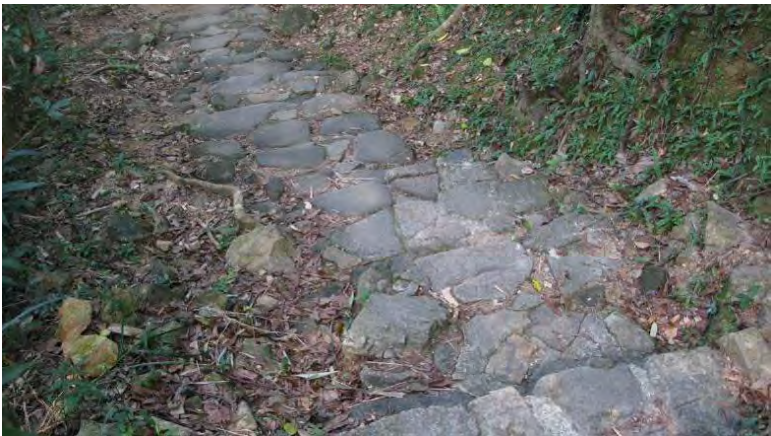
<p data-bbox="580 804 1418 880">Typical reworked path still showing the original boulders (view from A to B)</p>
14

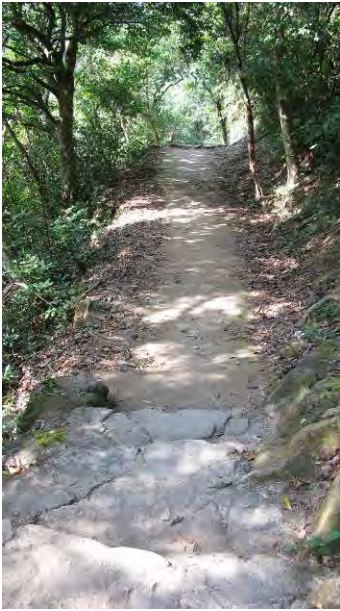
<p data-bbox="592 981 1406 1055">Reworked boulder path with occasional mud surfaced section (view from A to B).</p>
19

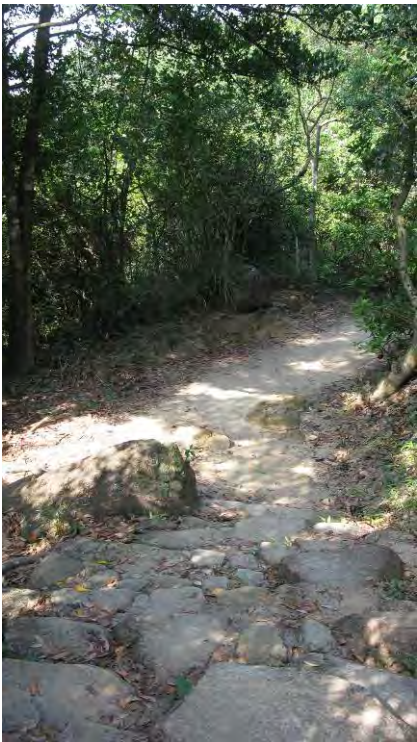
<p data-bbox="563 1115 1434 1189">Occasional mud surfaced section along boulder path (view from A to B).</p>
21

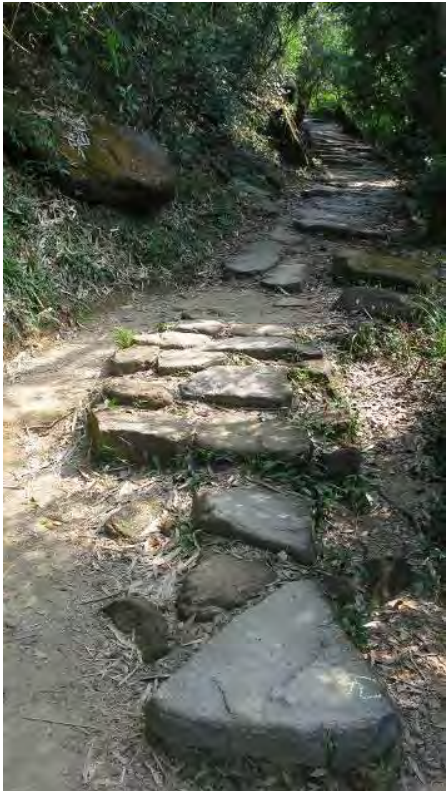
<p data-bbox="632 2036 1366 2069">Deteriorated section of boulder path (view from B to A).</p>

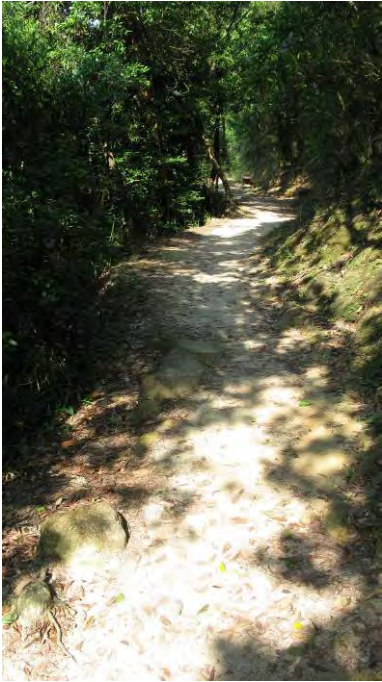
<p data-bbox="788 1977 1209 2011">Mud section (view from B to A).</p>

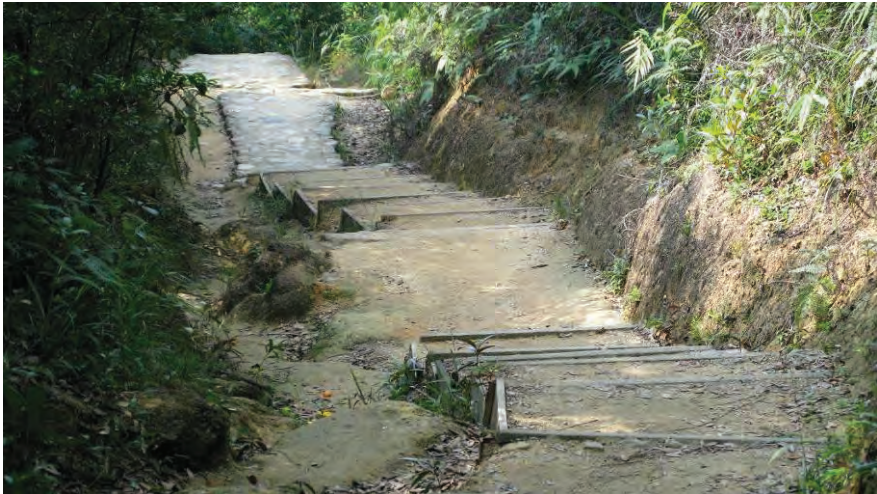
<p data-bbox="576 869 1422 943">Showing two types of reworked method along reworked section (view from A to B).</p>
25

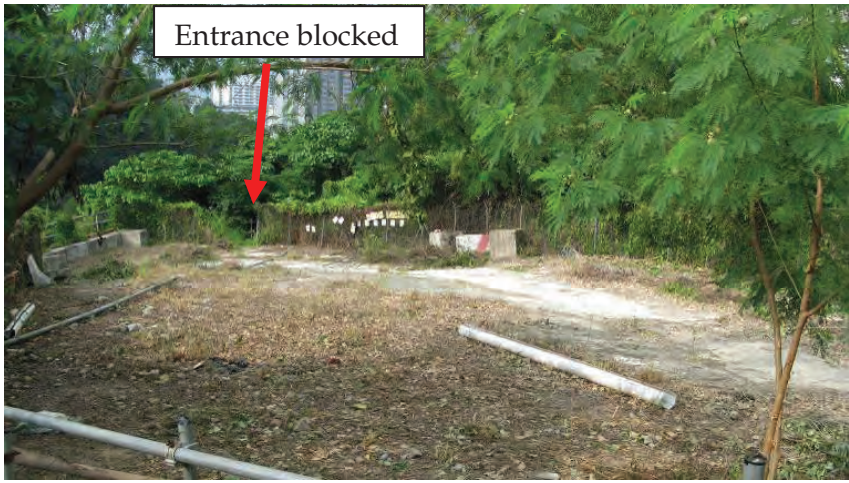
<p data-bbox="555 1462 1437 1574">Entrance to survey of a section of the path blocked as it is fenced as construction work site due to adjacent construction work (view from A to B).</p>

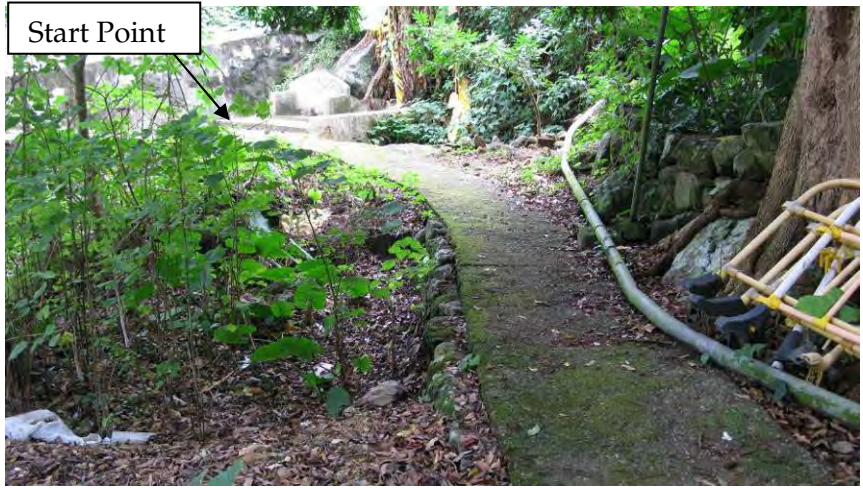
Photo Reference No.	Photographic Records
A	<div data-bbox="587 443 1453 929">

</div> <p data-bbox="571 958 1469 1032">Start Point A starts from the earth shrine. Boulder path can be seen under thin concrete. (View B to A)</p>
1	<div data-bbox="614 1061 1425 1514">

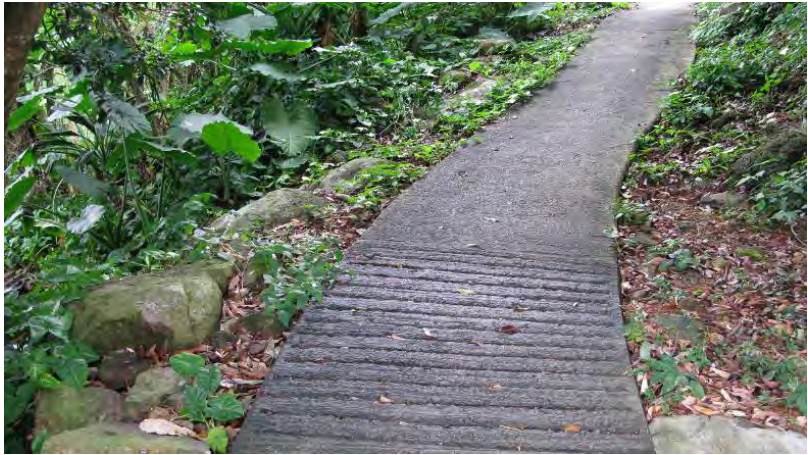
</div> <p data-bbox="579 1543 1460 1581">Concrete paved path with boulders seen by the path. (View A to B)</p>
2	<div data-bbox="579 1608 1460 1845">

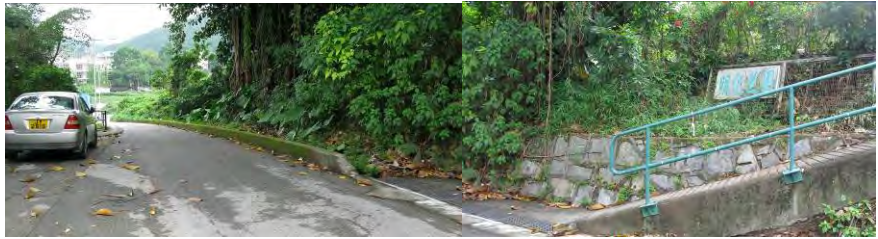
</div> <p data-bbox="667 1874 1372 1912">Original paths cut by modern road. (View from west)</p>

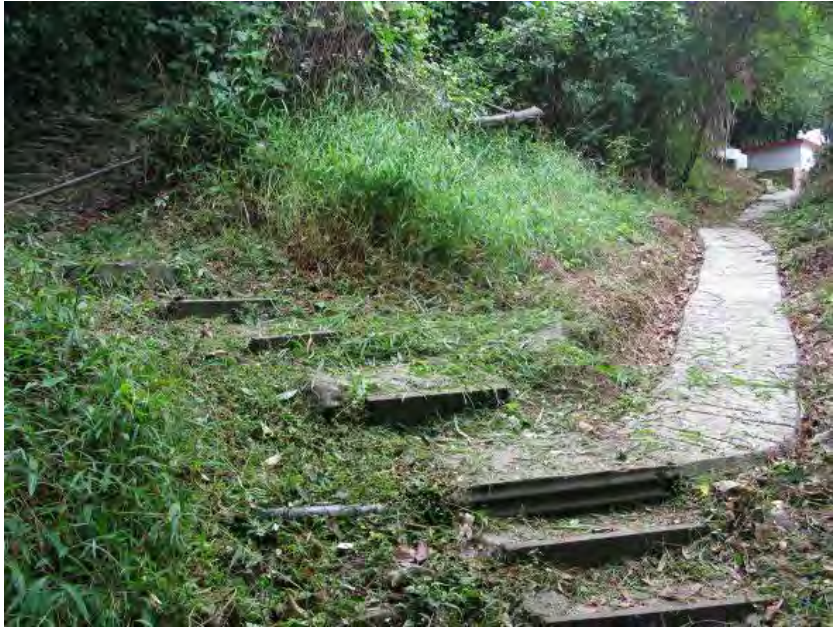
<p data-bbox="560 1588 1479 1664">Repaired boulder path with concrete to stabilise them (left path) and a branched concrete footpath to graveyard. (view A to B)</p>

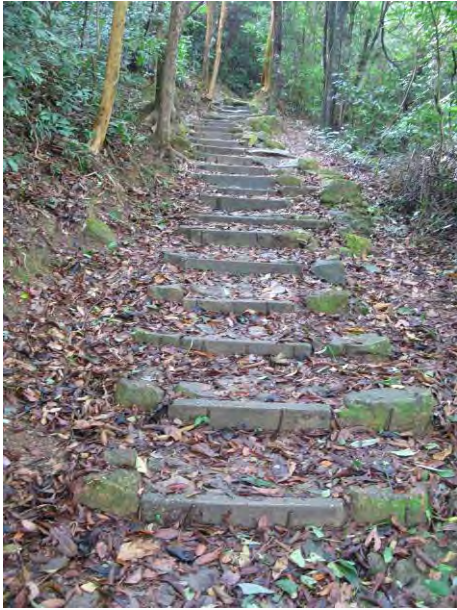
<p data-bbox="638 1682 1399 1715">Typical repair method of boulder path (view from A to B).</p>

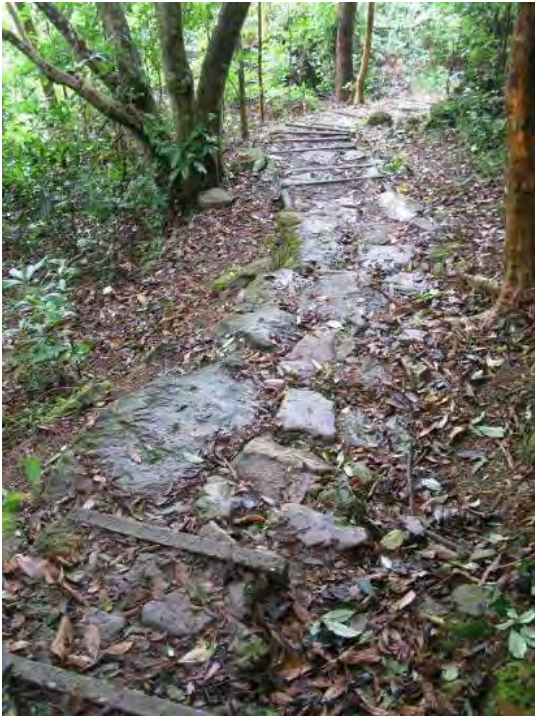
<p data-bbox="563 1086 1476 1122">Boulder path occasionally repaired with concrete slabs. (View B to A).</p>
8

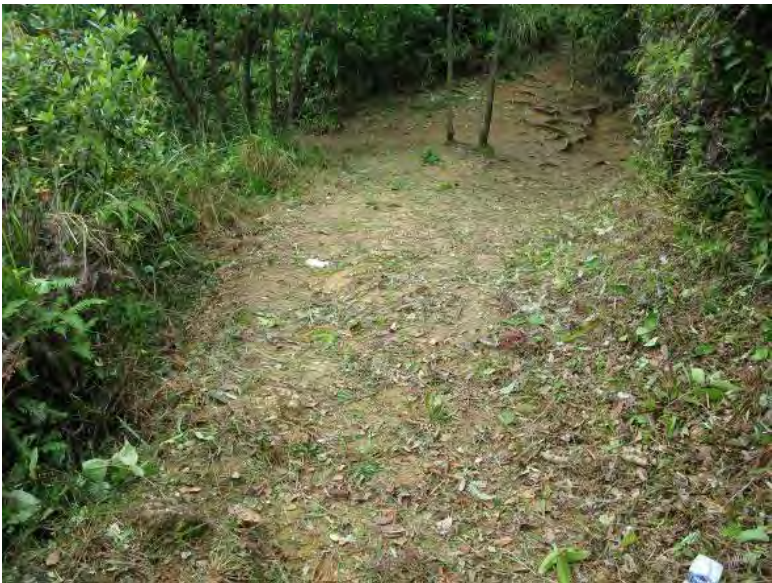
<p data-bbox="791 1760 1248 1796">Typical mud section (view B to A).</p>

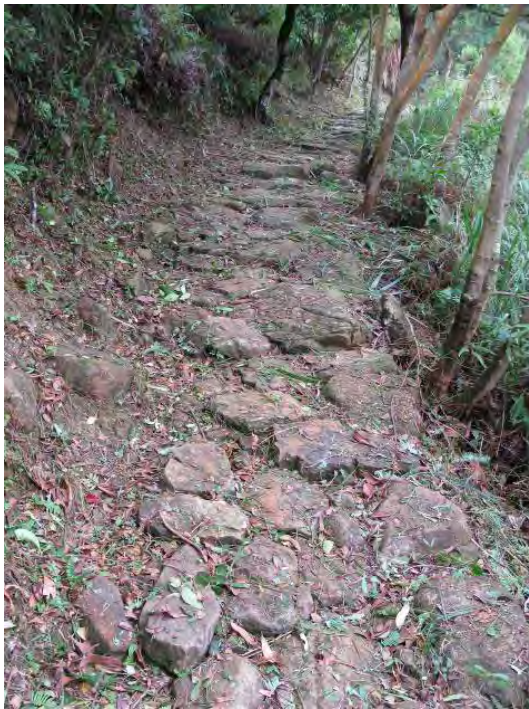
<p data-bbox="703 1077 1337 1115">Boulder section on flat slope. (View from A to B)</p>
10

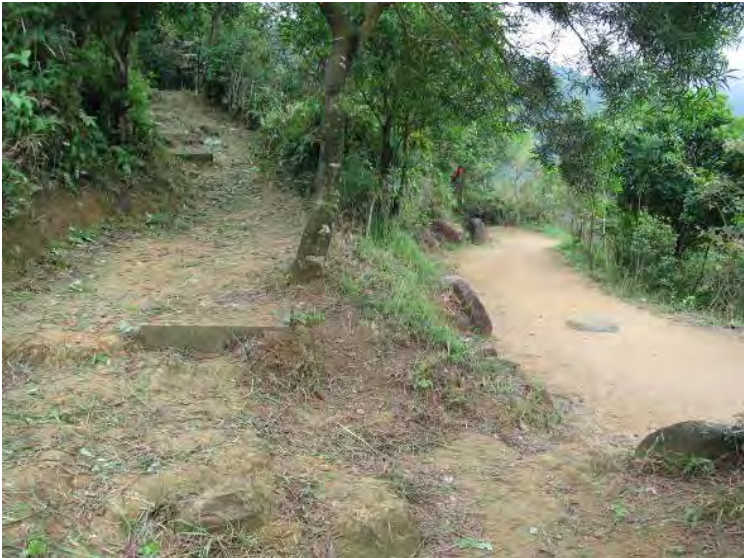
<p data-bbox="603 1727 1436 1805">Damaged boulder section on the left and exit to a mud surfaced platform on the right. (View from A to B)</p>
