Antiquities and Monuments Office

Study on Old Trails in Hong Kong - Final Study Report

February 2014

Study on Old Trails in Hong Kong: *Final Study Report*

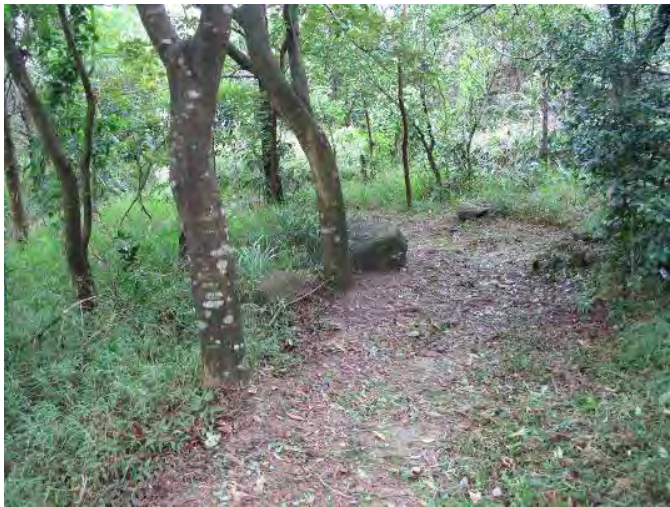
<p data-bbox="842 875 1198 913">Mud Section (view B to A).</p>
12

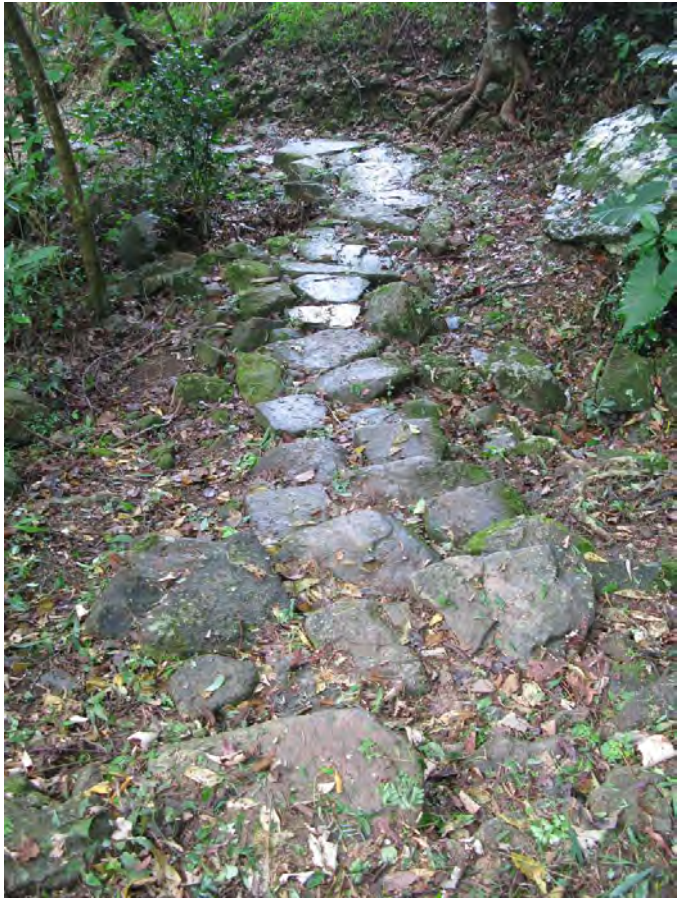
<p data-bbox="826 1865 1214 1904">Boulder section (view B to A)</p>

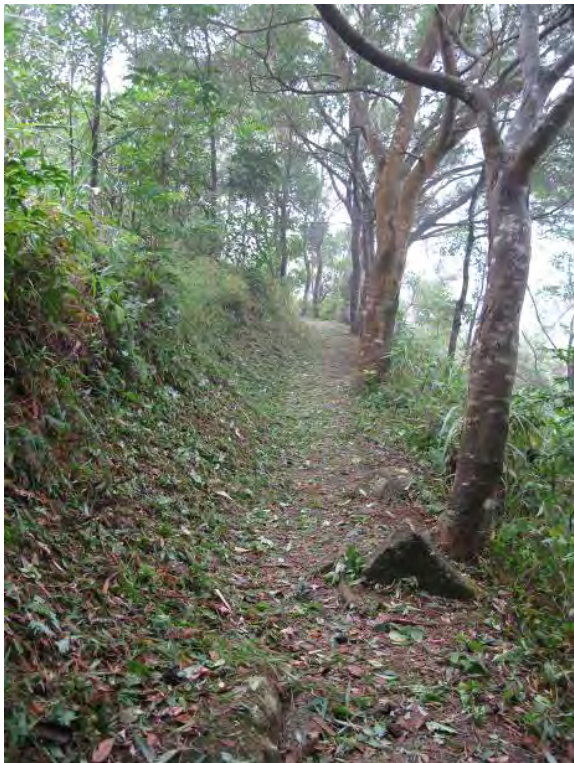
<p data-bbox="842 1131 1193 1167">Mud Section (view A to B)</p>
14

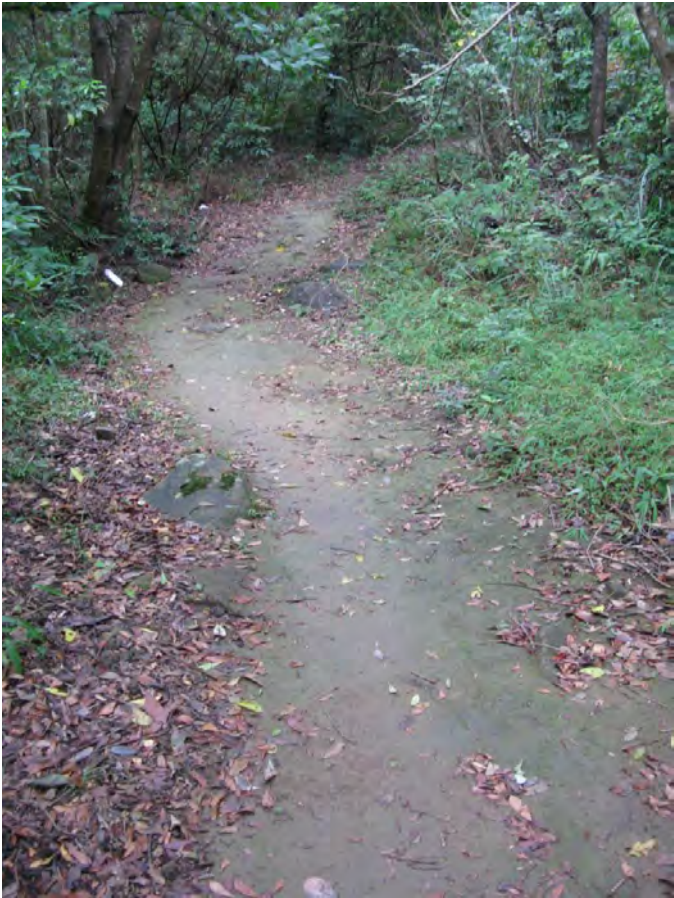
<p data-bbox="938 1668 1102 1702">Mud section</p>

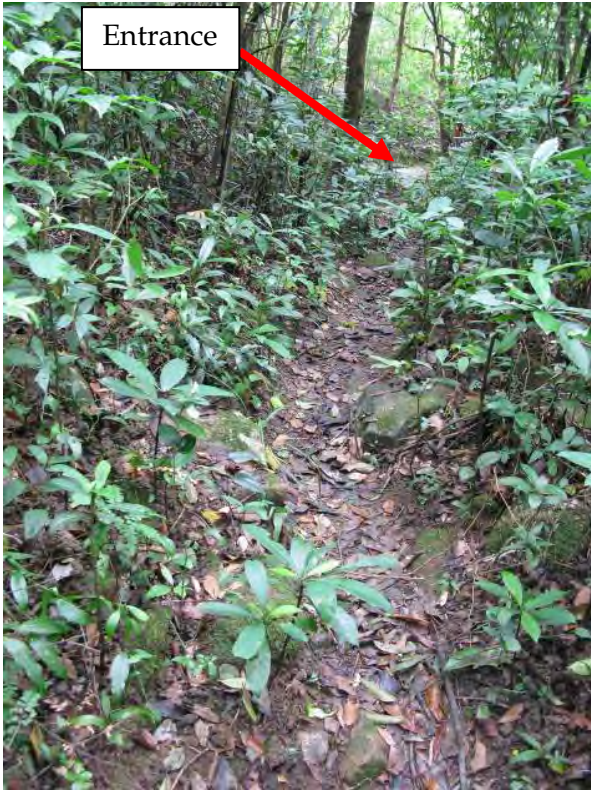
<p data-bbox="603 1856 1433 1935">Entrance of trail to Tai No Sheung Yeung from Maclehorse Trail Section 4 showing mud surface (view B to A).</p>

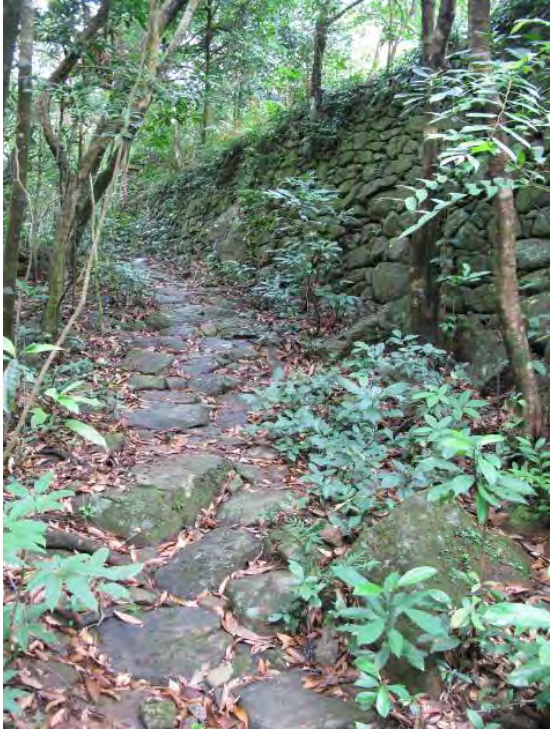
<p data-bbox="574 1888 1465 1964">Intact boulder section by boulder built retaining wall of farmland at Tai No Sheung Yeung (view B to A)</p>

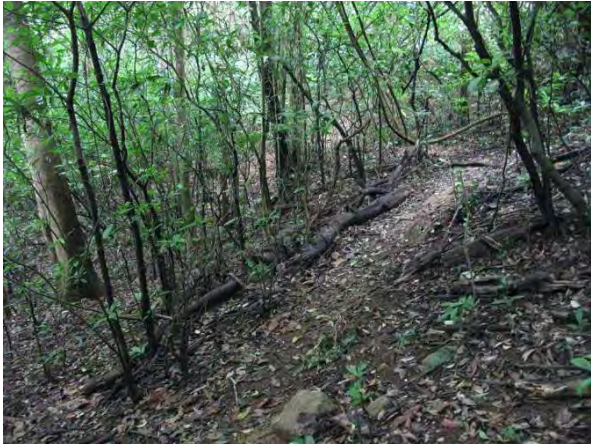
<p data-bbox="842 815 1197 851">Mud Section (view B to A)</p>
22

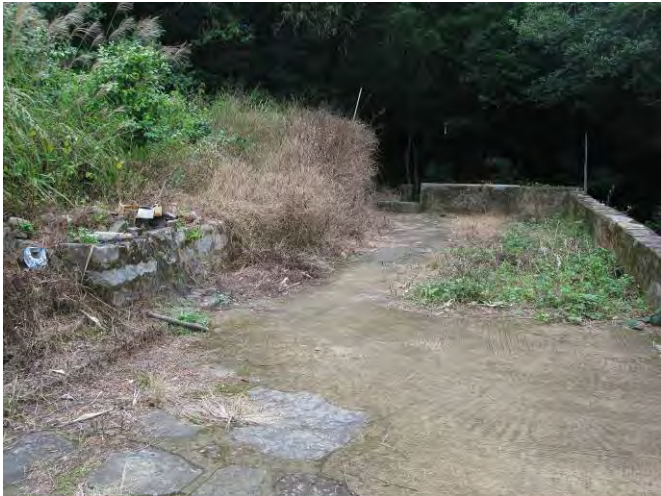
<p data-bbox="580 869 1458 904">Platform in front of the Tsang's ancestral hall with concrete surface</p>
25

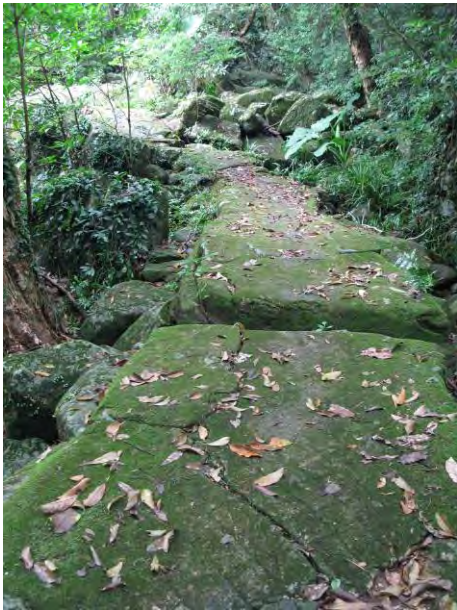
<p data-bbox="564 1570 1474 1641">Occasionally seen Boulder section with concrete surface near the ruin of Tai No village (view B to A)</p>

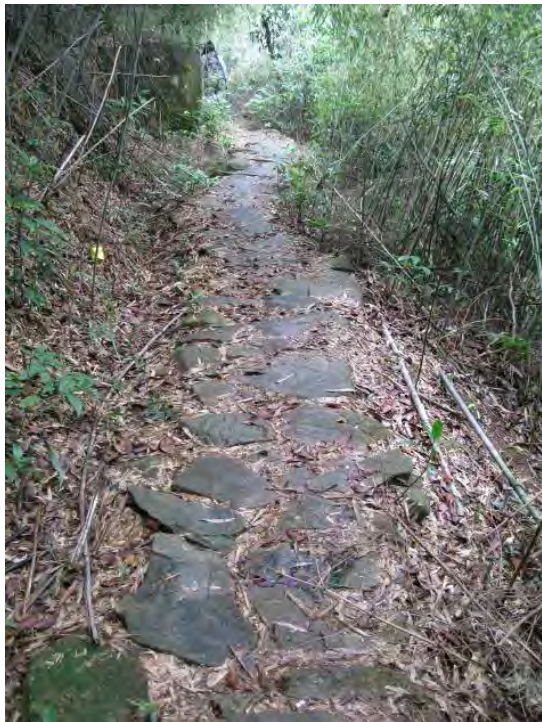
<p data-bbox="786 1093 1249 1126">Intact boulder section (view A to B)</p>
27

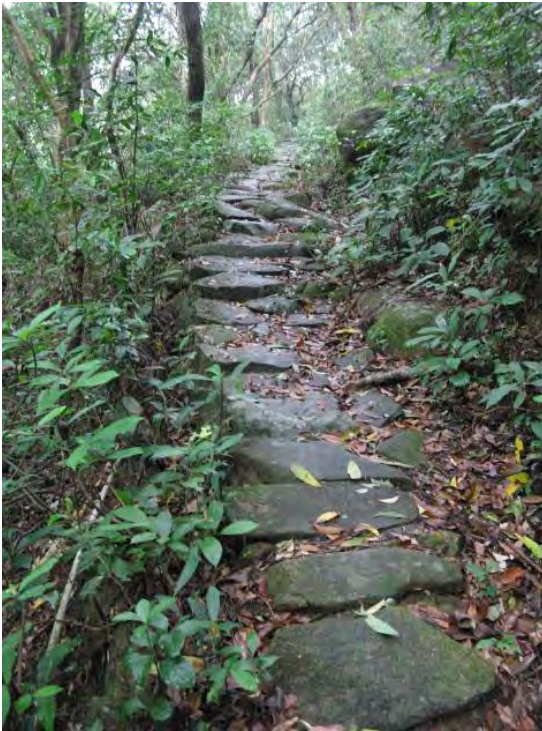
<p data-bbox="786 1915 1249 1948">Intact boulder section (view B to A)</p>

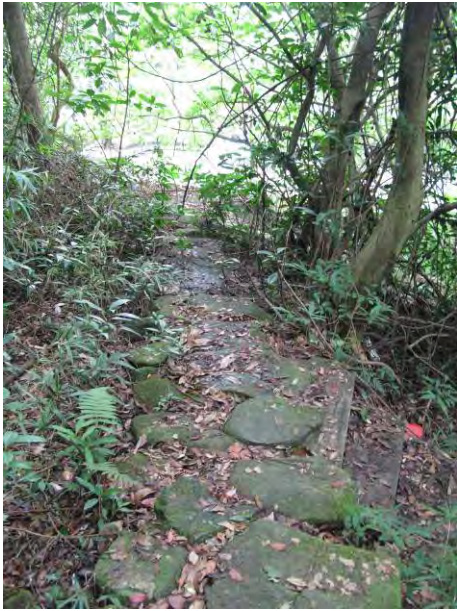
<p data-bbox="582 981 1455 1014">End of Boulder path which is destroyed by cut slope. (view A to B)</p>
29

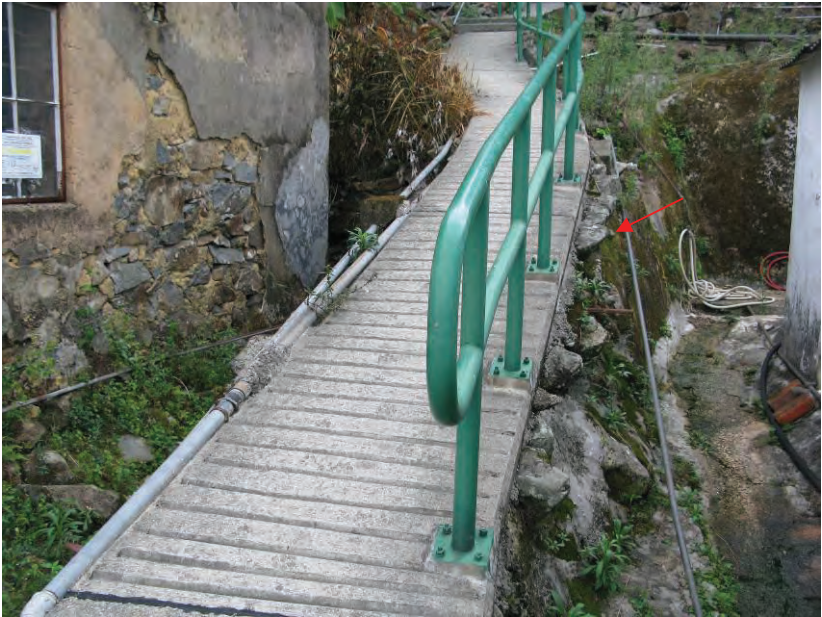
<p data-bbox="563 987 1476 1059">Boulders can be seen beneath the concrete path at section view. (View B to A)</p>
B

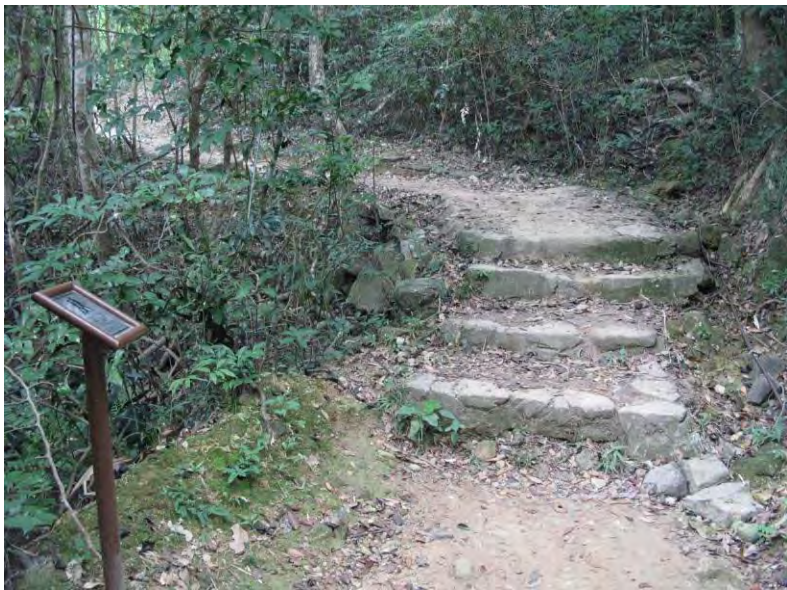
<p data-bbox="579 1713 1382 1749">Typical mud surface path with reworked steps (view B to A).</p>

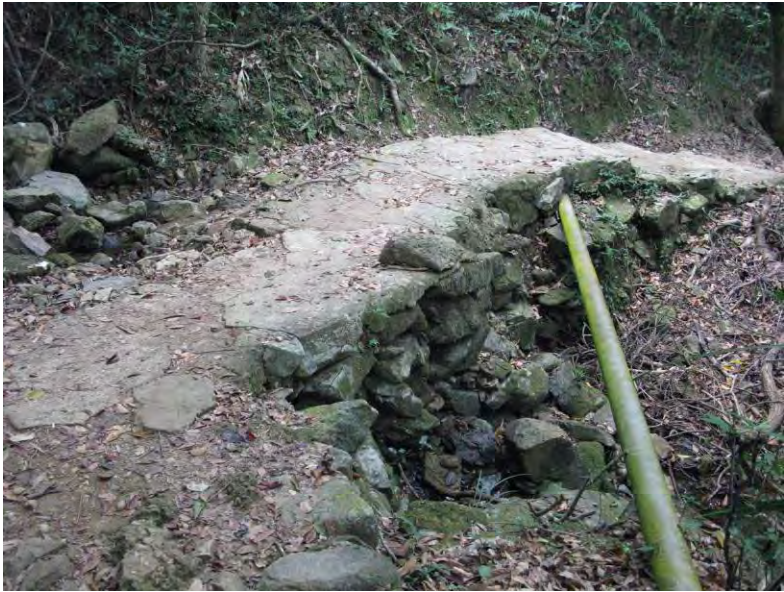
<p data-bbox="587 891 1374 969">Typical stream crossing with modern intrusion and concrete surface (view A to B).</p>
3

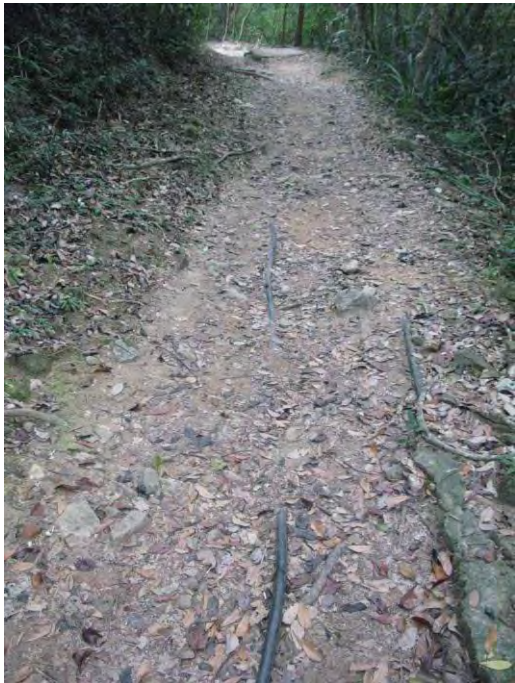
<p data-bbox="563 1704 1398 1783">Typical mud section with underground utilities exposed. (View A to B)</p>

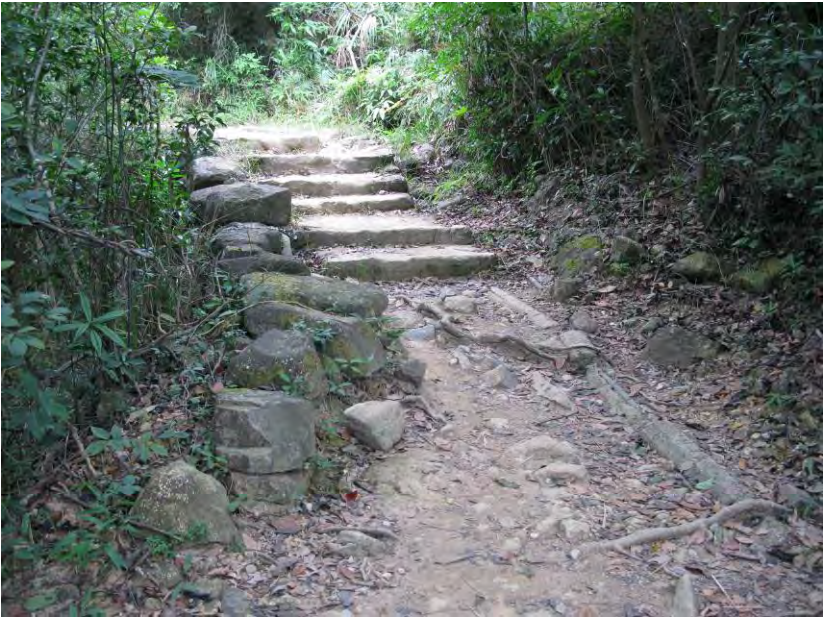
<p data-bbox="555 913 1401 992">Rarely found boulder section replacing by modernised steps and mud surface. (View from B to A)</p>
7

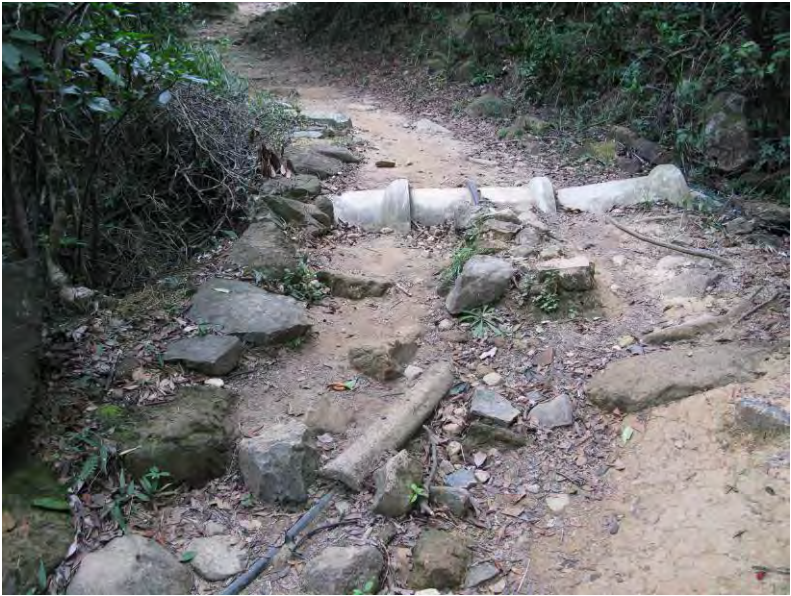
<p data-bbox="584 1639 1378 1718">Evidence of path damaged by modern underground utilities commonly seen along the path. (View from B to A)</p>

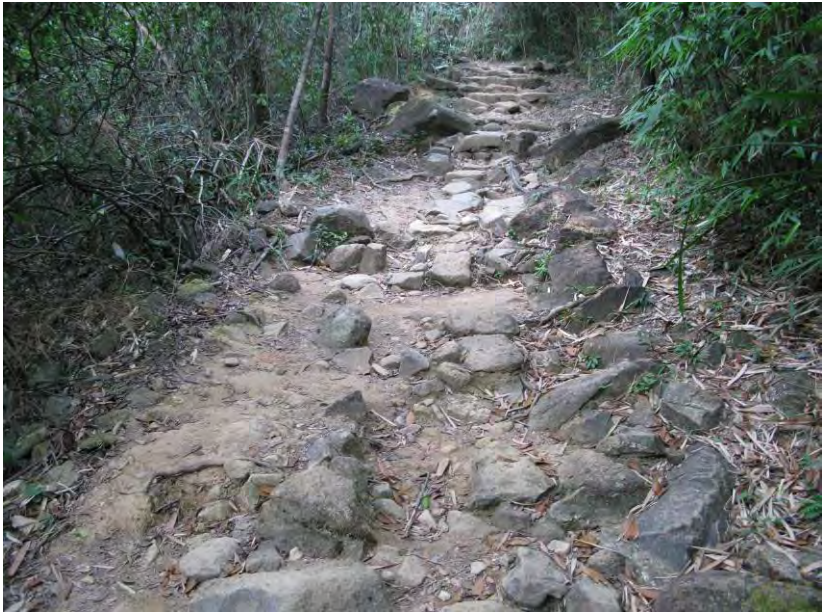
<p data-bbox="644 913 1316 947">Boulder path heavily disturbed. (View from B to A)</p>
9

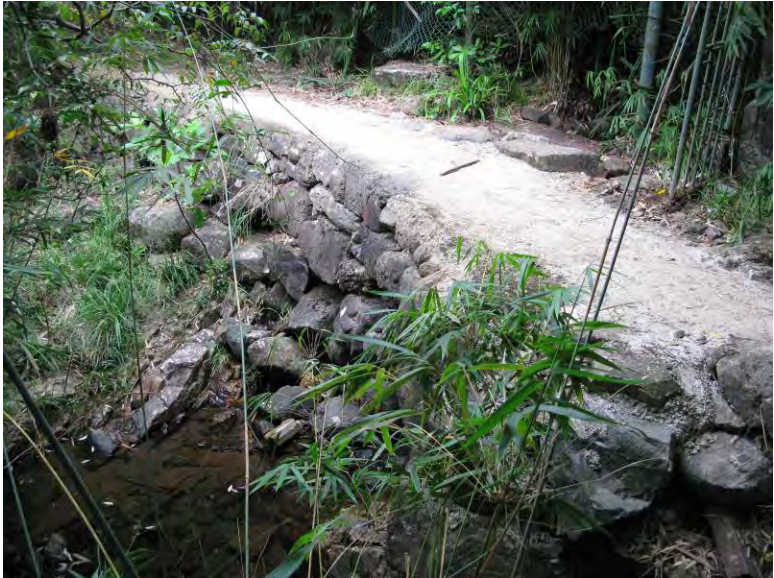
<p data-bbox="568 1583 1393 1657">Bounders paved stream crossing surfaced with concrete. (View from B to A)</p>
